# STRUCTURAL REHABILITATION PROJECT FOR CULVERT STRUCTURES

TERRA NOVA NATIONAL PARK,  
NEWFOUNDLAND AND LABRADOR

PROJECT NO. 1099

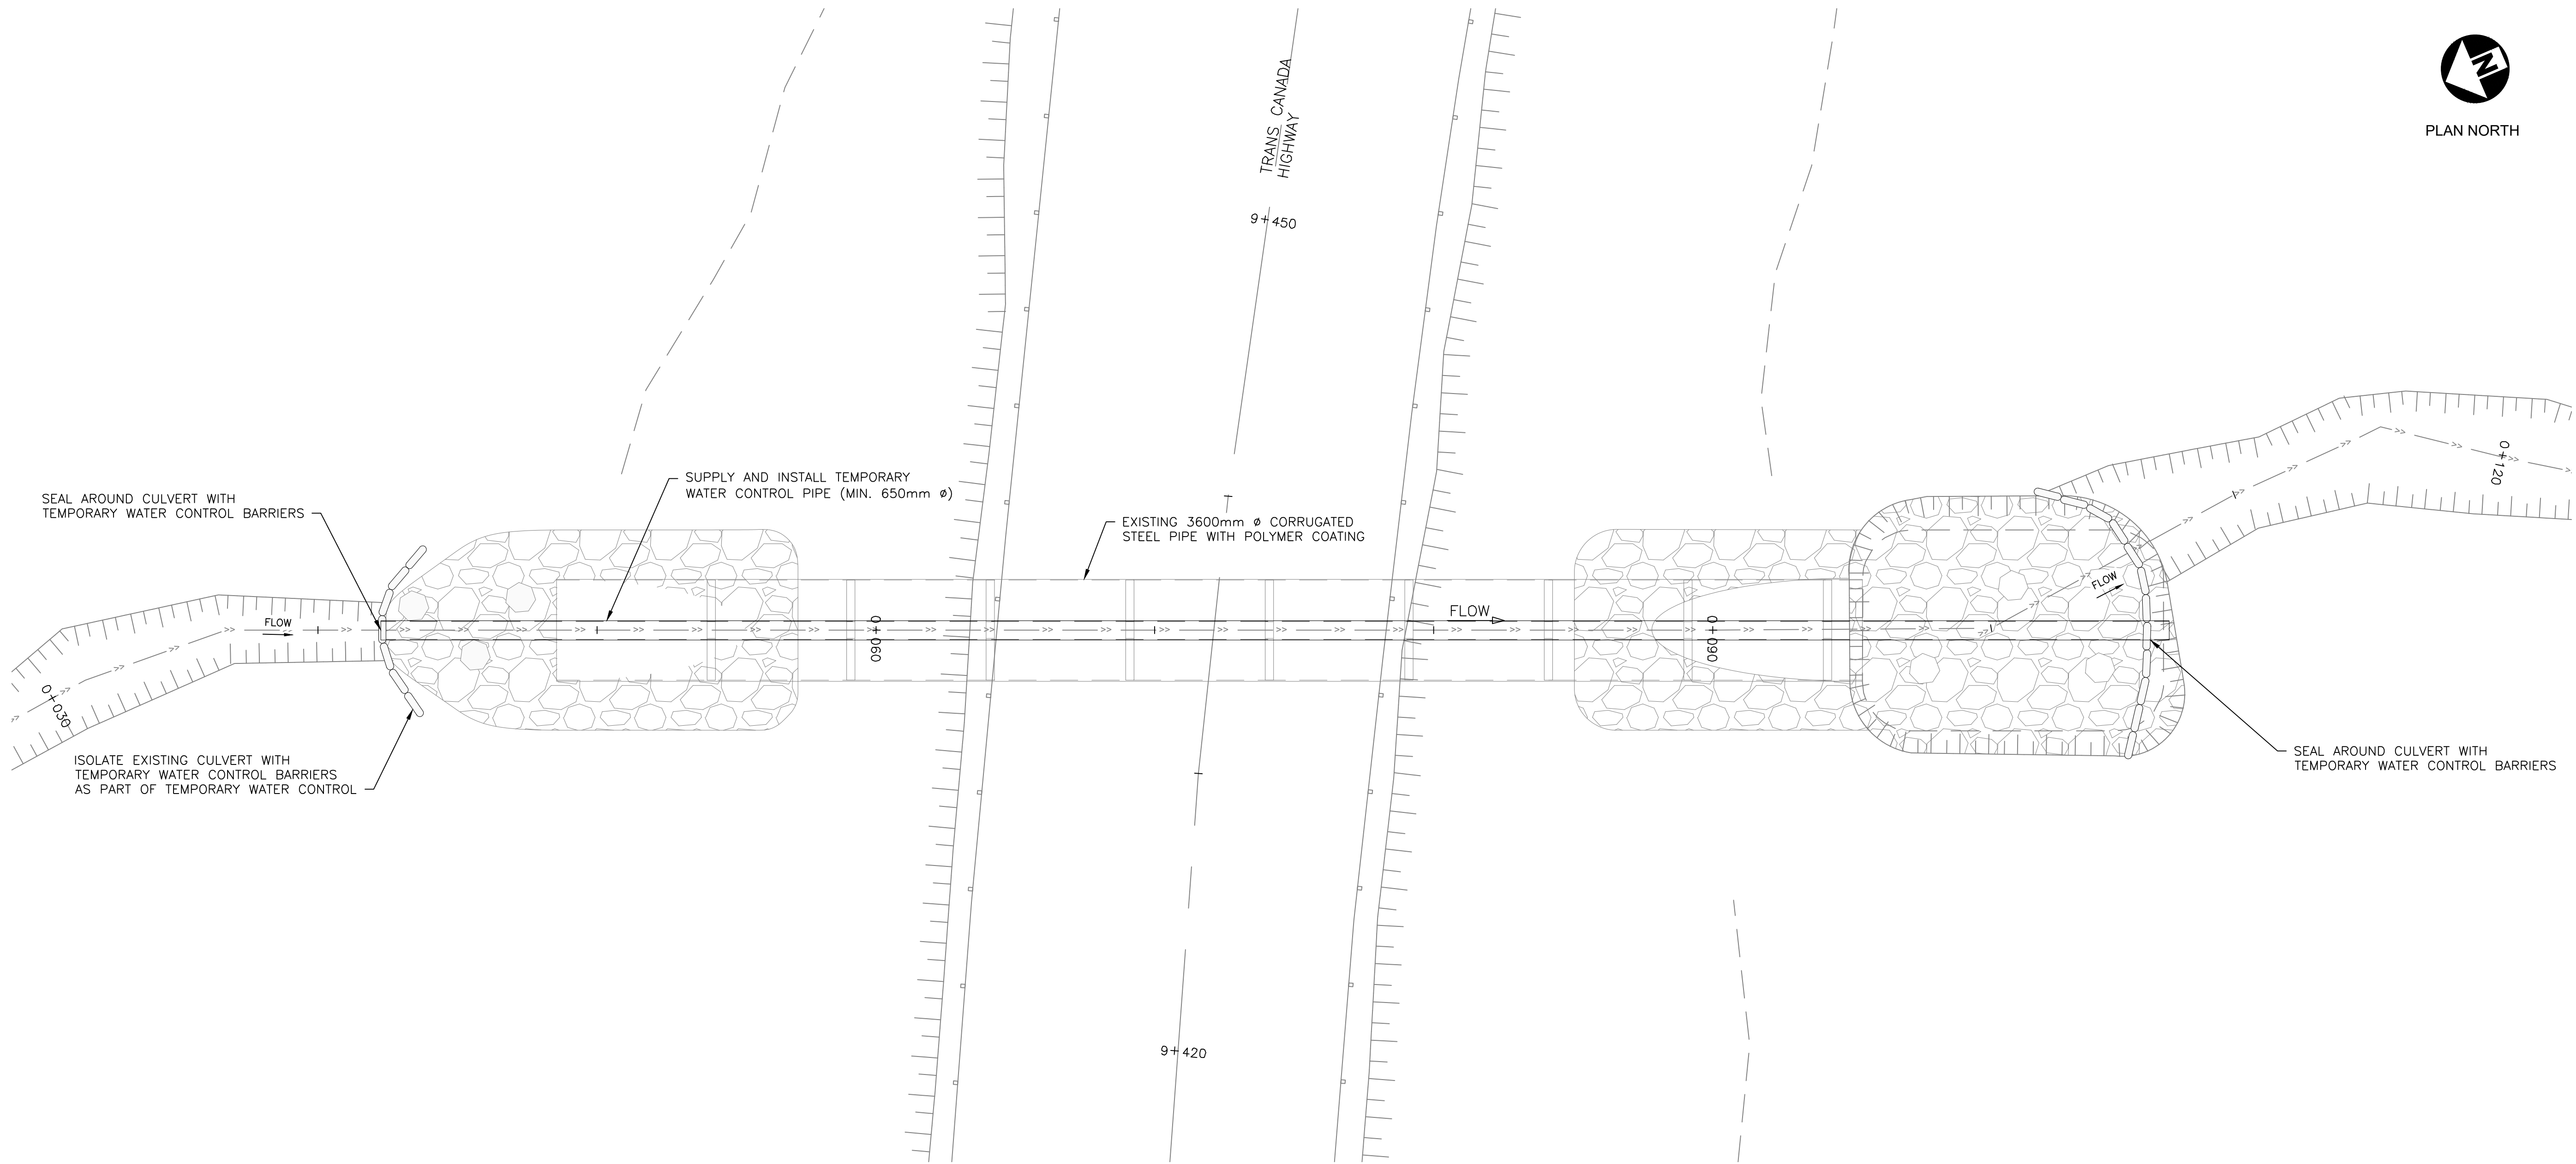
PLAN VIEW  
SCALE: 1:125

PLATTERS COVE PIPE CONDITION - VISUAL VOIDS				
VOID	X (RELATIVE TO INLET)	Y (RELATIVE TO PIPE BOTTOM)	PIPE WALL	TYPE OF ANOMALY AND DESCRIPTION
V-1	6.90m	-	-	OFFSET JOINT BY APPROX. 40mm WITH VISIBLE COUPLER
V-2	14.10m	275mm	WEST EAST	OFFSET JOINT BY APPROX. 50mm
V-3	20.10m	-	-	OFFSET JOINT BY APPROX. 30mm WITH VISIBLE COUPLER AND LVL 3 WATER INFILTRATION EVIDENT
V-4	34.20m	-	-	OFFSET JOINT BY APPROX. 60mm WITH VISIBLE COUPLER
V-5	40.20m	-	-	OFFSET JOINT BY APPROX. 50mm WITH VISIBLE COUPLER
V-6	46.80m	275mm	WEST	LVL 3 WATER INFILTRATION AT BOLT
V-7	46.80m	550mm	EAST	LVL 3 WATER INFILTRATION AT BOLT
PLATTERS COVE PIPE CONDITION - BCT VOIDS				
BCT-1	20.60m	825mm	WEST	LVL 3 WATER INFILTRATION AT SEAM
BCT-2	25.80m	825mm	EAST	LVL 3 WATER INFILTRATION AT BOLT
BCT-3	28.20m	825mm	WEST	LVL 3 WATER INFILTRATION AT BOLT
BCT-4	37.80m	825mm	WEST	LVL 2 WATER INFILTRATION AT SEAM

- VOIDS TO BE FILLED WITH CLSM. INJECTION PLAN SHALL BE APPROVED BY THE ENGINEER. BOTH VISUAL AND BCT VOIDS TO BE INJECTED.
- INJECTION LOCATION TO BE CONFIRMED BY CONTRACTOR ON SITE.
- MINIMUM TEMPORARY WATER CONTROL FLOW = 0.43m<sup>3</sup>/s.
- SUPPLY AND INSTALL TEMPORARY WATER CONTROL PIPE (MINIMUM  $\phi$  = 650mm)

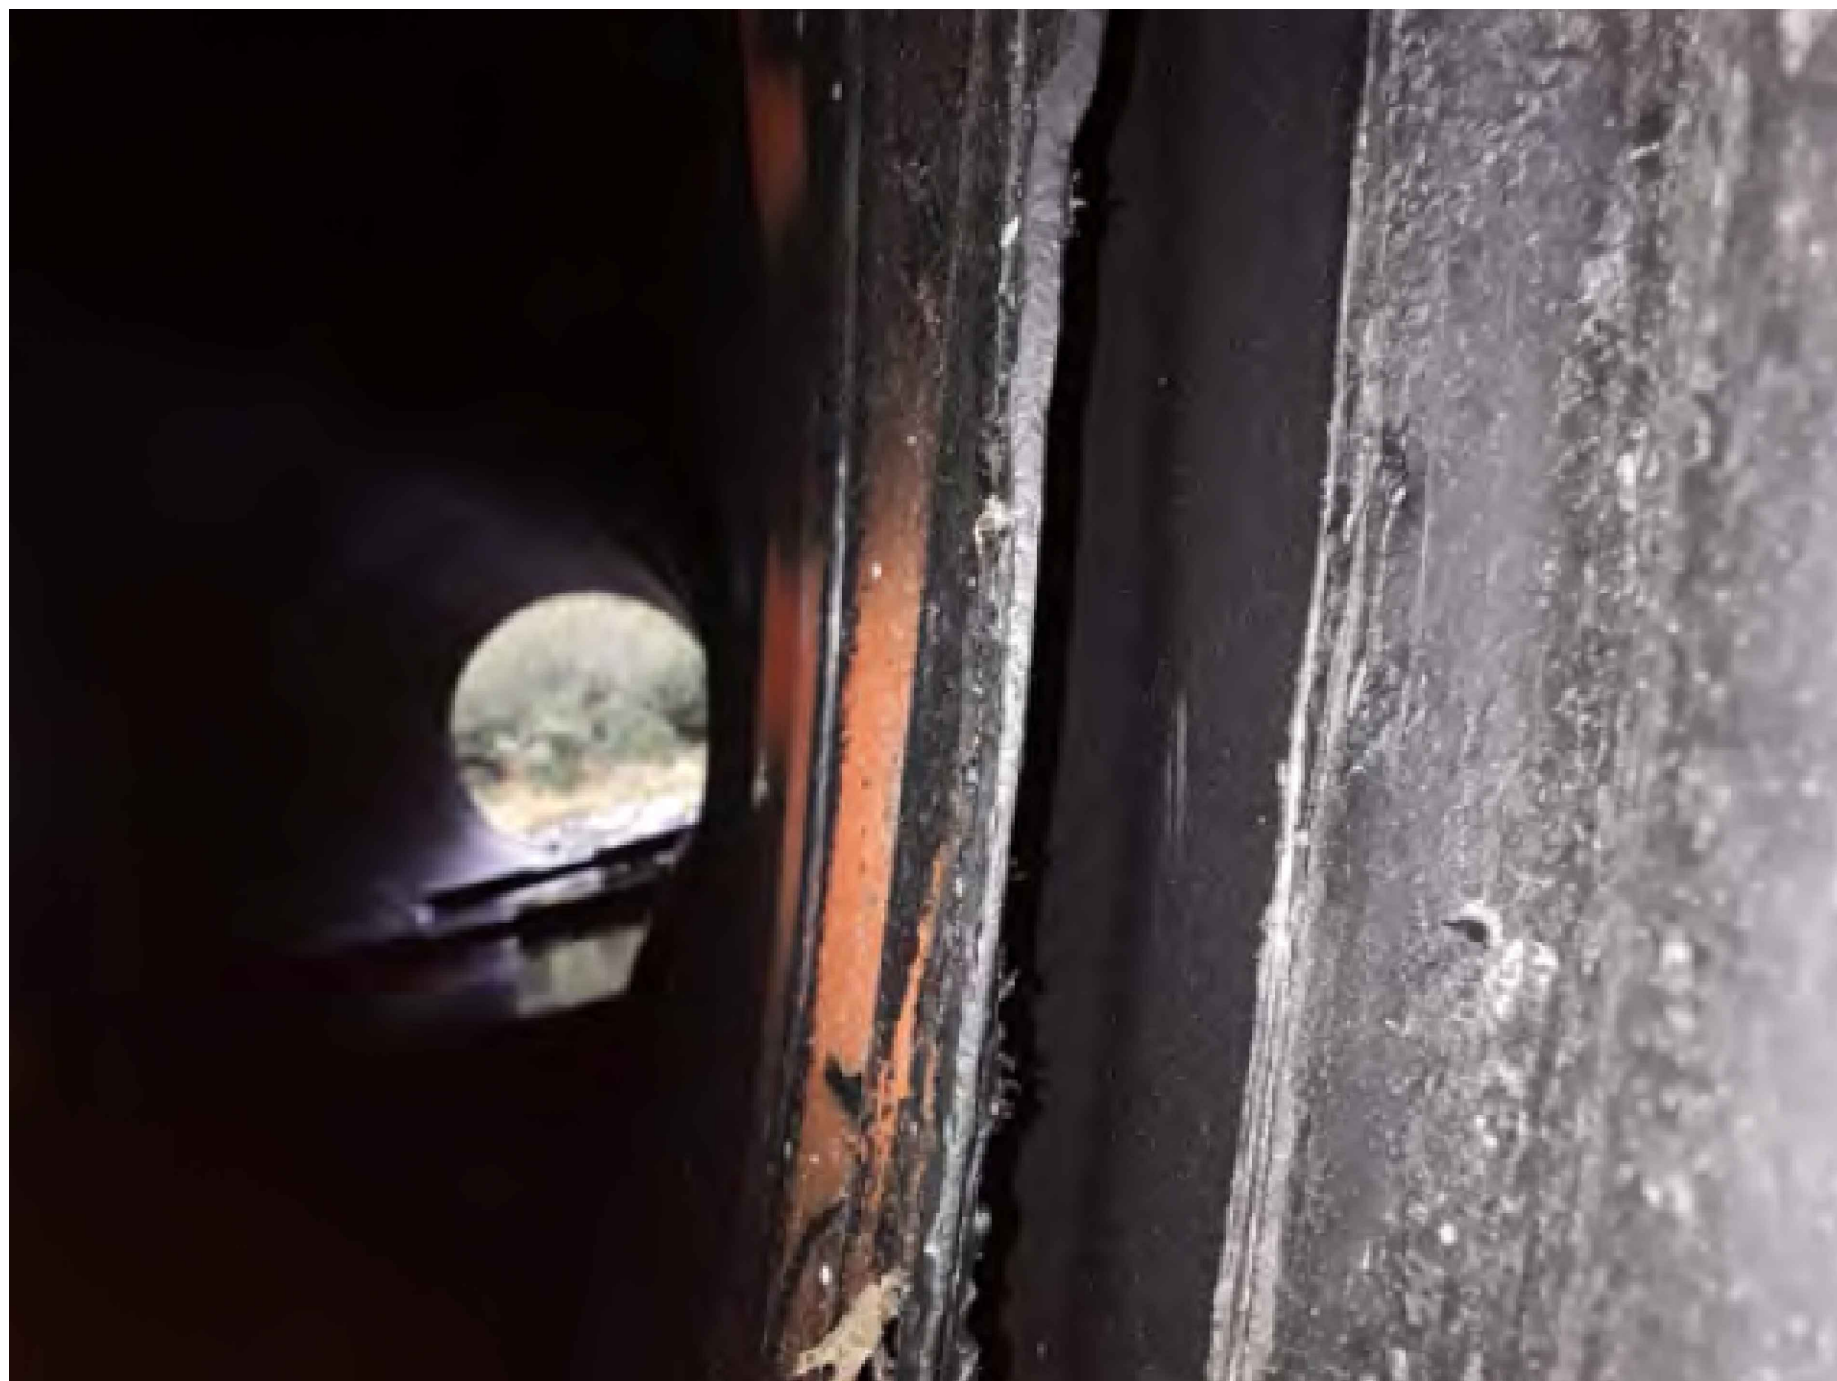
EXAMPLE PHOTO:  
V-3 OFFSET JOINT BY APPROXIMATELY 30mm WITH A VISIBLE COUPLER AND LEVEL 3 WATER INFILTRATION EVIDENT.

TYPICAL CULVERT OFFSET JOINT REPAIR  
SCALE: 1:5

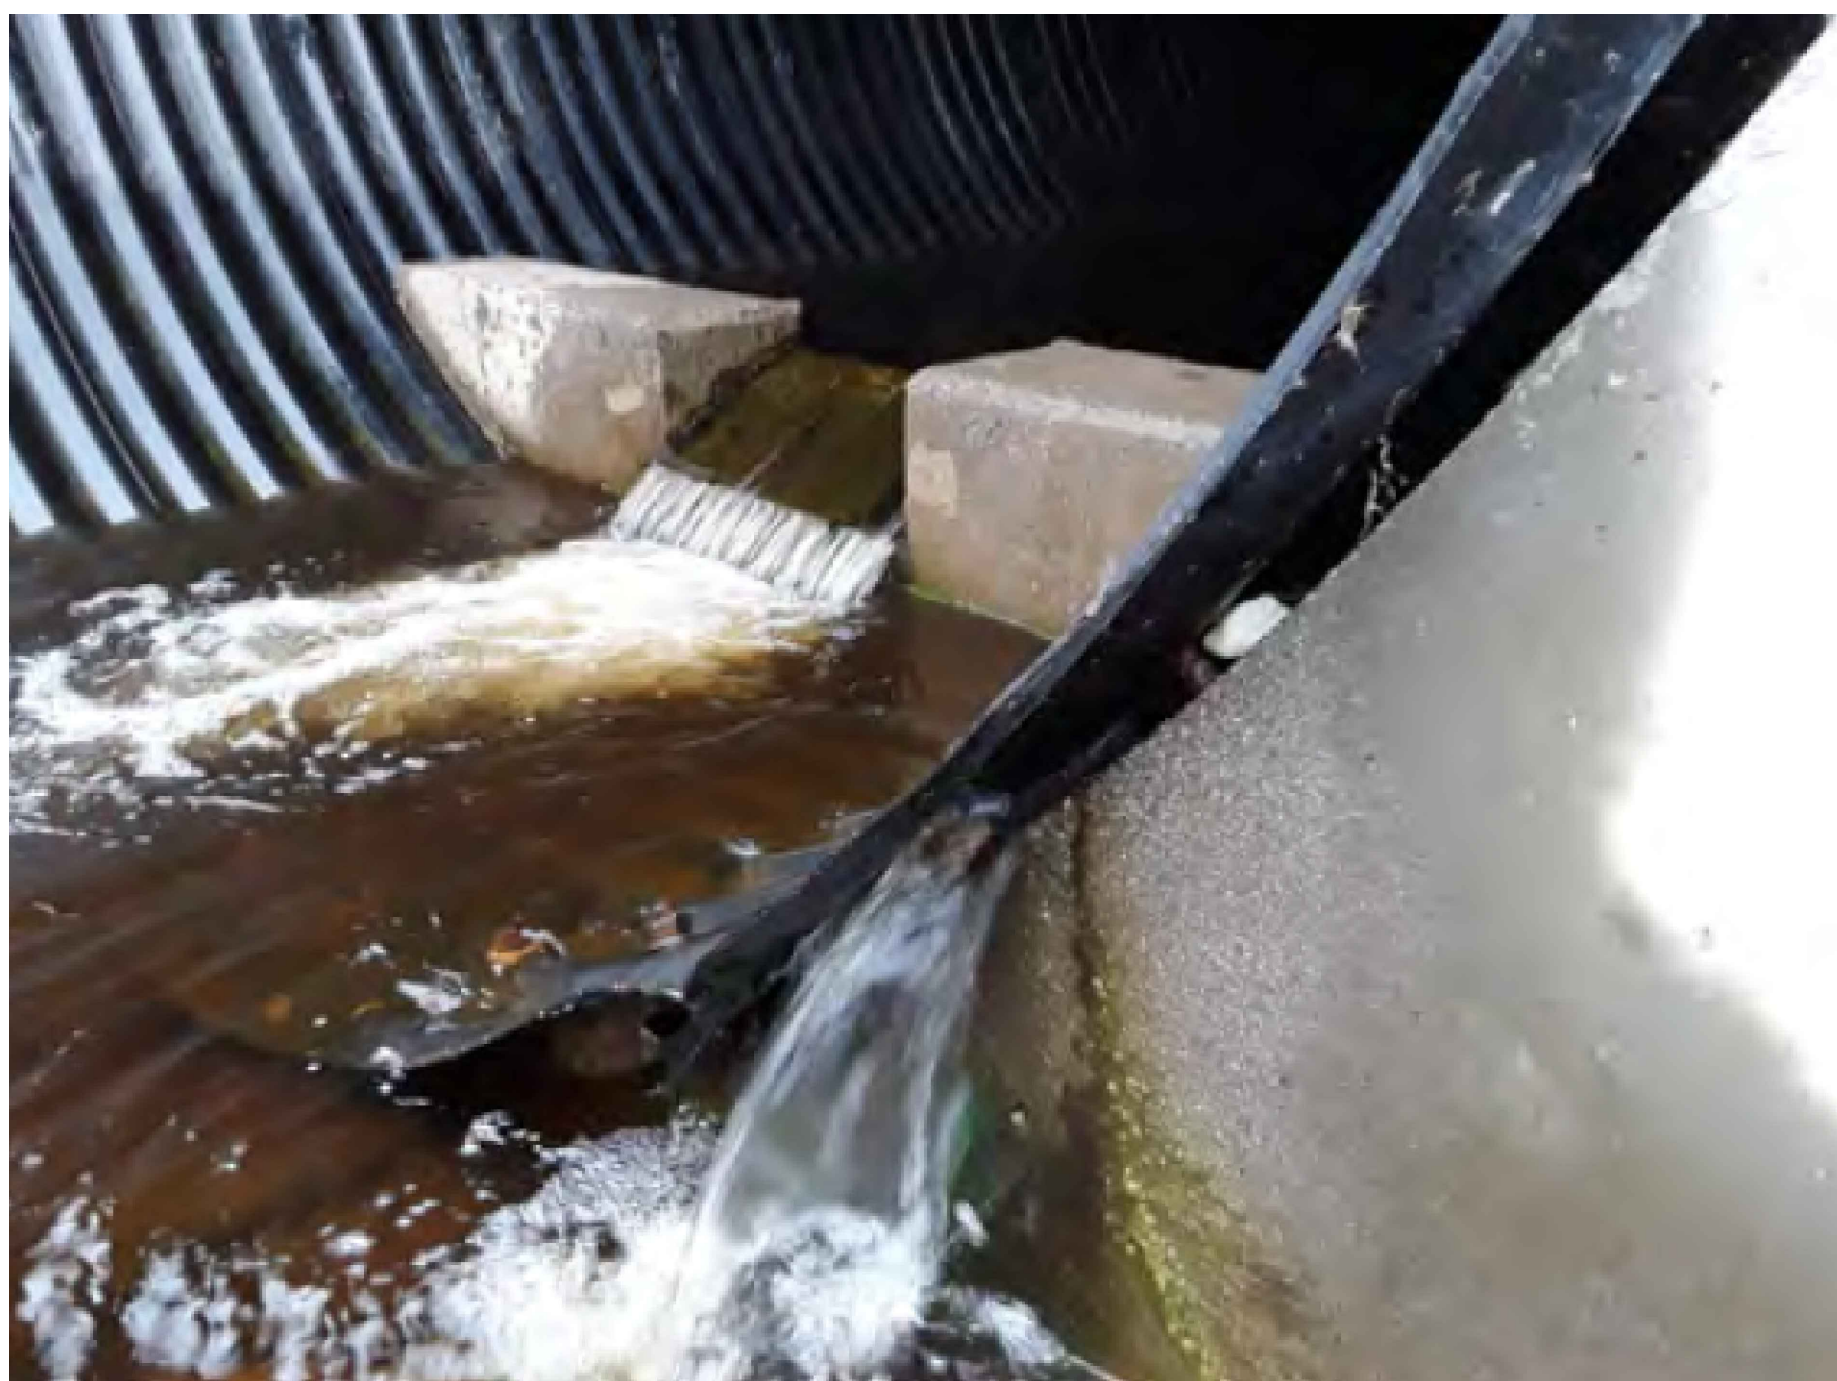
EXAMPLE PHOTO:  
ACTIVE WATER FLOWING BETWEEN PIPE WALL AND OUTLET CUTOFF WALL, WITH SEPARATION OF APPROXIMATELY 40mm.

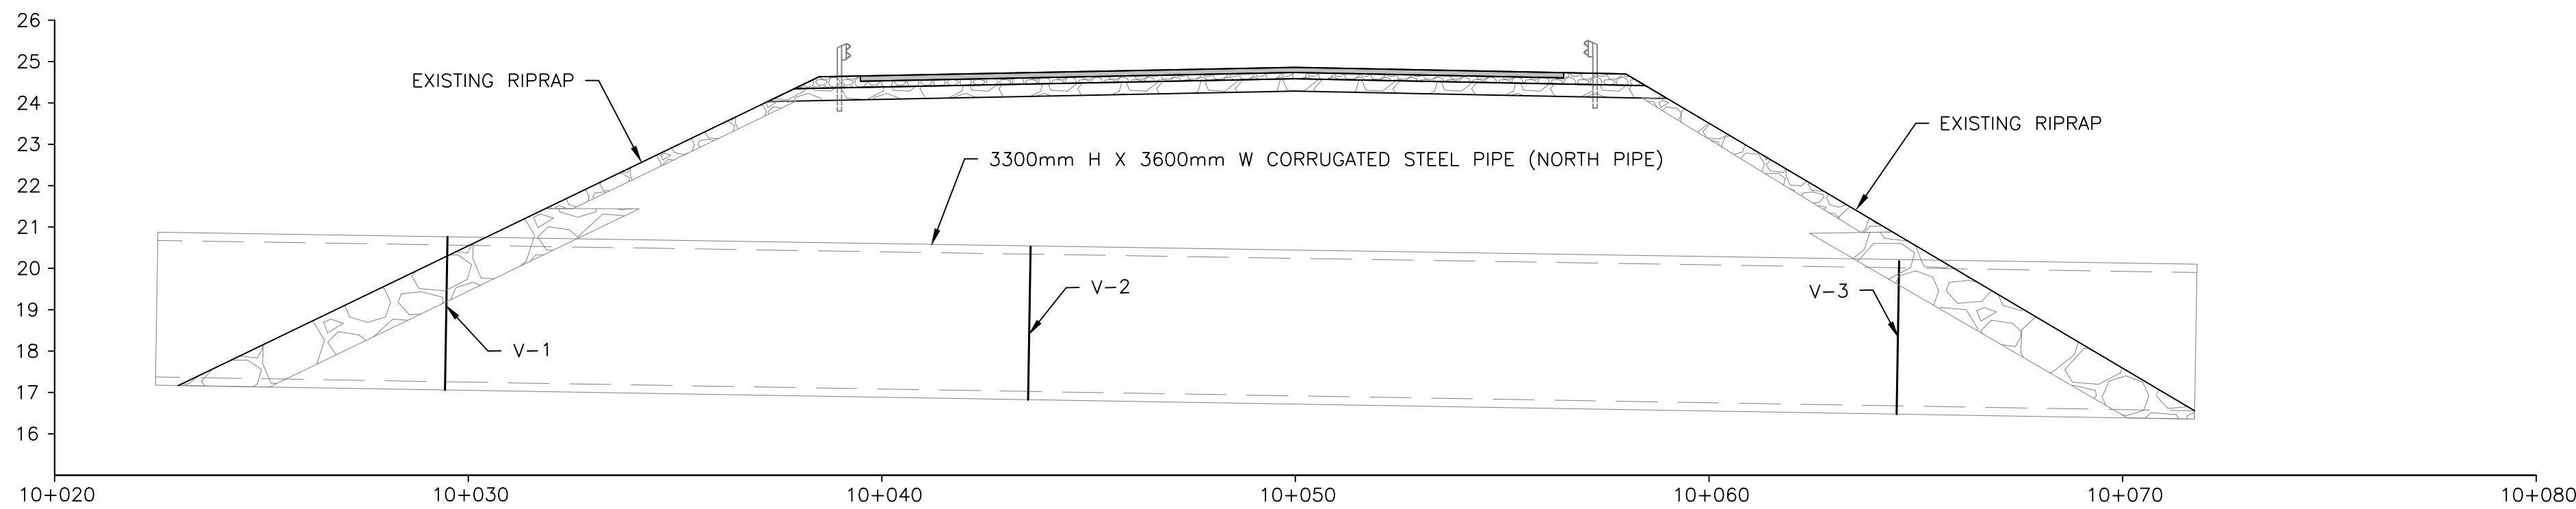
NORTH PIPE PROFILE VIEW

COBBLER'S BROOK NORTH PIPE CONDITION		
VISUAL ANOMOLIES		
ANOMALY	X (RELATIVE TO INLET)	TYPE OF ANOMALY AND DESCRIPTION
V-1	7.00m	SEPARATED AND OFFSET JOINT BY APPROX. 120mm WITH VISIBLE BACKFILL MATERIAL PRESENT AND SURFACE CORROSION AT JOINT CONNECTION
V-2	21.10m	SEPARATED AND OFFSET JOINT BY APPROX. 110mm WITH VISIBLE FILTER FABRIC AND BACKFILL MATERIAL PRESENT
V-3	42.10m	SEPARATED JOINT BY APPROX. 120mm WITH VISIBLE COUPLER

- VOIDS TO BE FILLED WITH CLSM. INJECTION PLAN SHALL BE APPROVED BY THE ENGINEER. BOTH VISUAL AND BCT VOIDS TO BE INJECTED.
- INJECTION LOCATION TO BE CONFIRMED BY CONTRACTOR ON SITE.
- MINIMUM TEMPORARY WATER CONTROL FLOW = 1.09m<sup>3</sup>/s
- REPAIR OFFSET JOINTS IN NORTH PIPE BEFORE IMPLEMENTING TEMPORARY WATER CONTROL WORKS.
- TEMPORARY WATER CONTROL LOCATION TO BE CONFIRMED BY CONTRACTOR ON SITE.

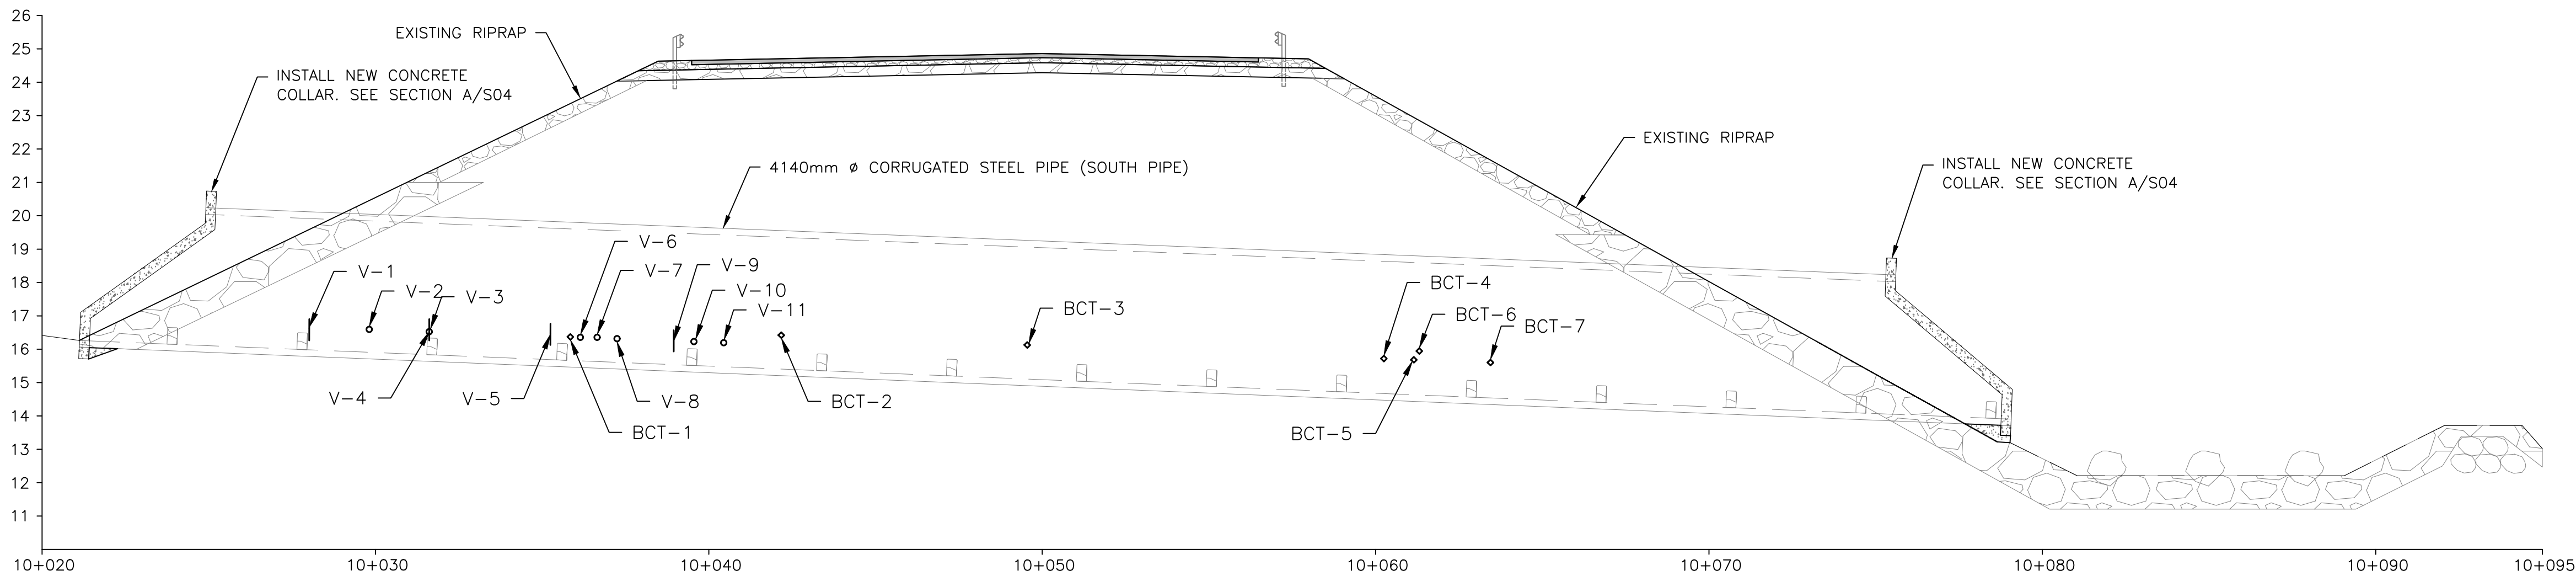
SOUTH PIPE PROFILE VIEW

COBBLER'S BROOK SOUTH PIPE CONDITION - VISUAL VOIDS				
VOID	X (RELATIVE TO INLET)	Y (RELATIVE TO PIPE BOTTOM)	PIPE WALL	TYPE OF ANOMALY AND DESCRIPTION
V-1	6.90m	690mm	SOUTH	LVL 3 WATER INFILTRATION AT SEAM
V-2	8.70m	690mm	SOUTH	LVL 3 WATER INFILTRATION AT BOLT
V-3	10.50m	690mm	NORTH	LVL 3 WATER INFILTRATION AT BOLT
V-4	10.50m	690mm	SOUTH	LVL 2 WATER INFILTRATION AT SEAM
V-5	14.10m	690mm	SOUTH	LVL 3 WATER INFILTRATION AT SEAM
V-6	15.00m	690mm	SOUTH	LVL 3 WATER INFILTRATION AT BOLT
V-7	15.50m	690mm	SOUTH	LVL 3 WATER INFILTRATION AT BOLT
V-8	16.10m	690mm	SOUTH	LVL 2 WATER INFILTRATION AT BOLT
V-9	17.80m	690mm	SOUTH	LVL 3 WATER INFILTRATION AT BOLT & SEAM
V-10	18.40m	690mm	SOUTH	LVL 3 WATER INFILTRATION AT BOLT
V-11	19.30m	690mm	SOUTH	LVL 3 WATER INFILTRATION AT BOLT
COBBLER'S BROOK SOUTH PIPE CONDITION - BCT VOIDS				
BCT-1	14.70m	690mm	SOUTH	LVL 3 WATER INFILTRATION AT SEAM
BCT-2	21.00m	1035mm	SOUTH	LVL 3 WATER INFILTRATION AT BOLT

BCT-3	28.40m	1035mm	NORTH	LVL 3 WATER INFILTRATION AT BOLT
BCT-4	39.10m	1035mm	SOUTH	LVL 2 WATER INFILTRATION AT SEAM
BCT-5	40.00m	1035mm	SOUTH	LVL 3 WATER INFILTRATION AT SEAM
BCT-6	40.15m	1380mm	SOUTH	LVL 3 WATER INFILTRATION AT BOLT
BCT-7	42.30m	1035mm	SOUTH	LVL 3 WATER INFILTRATION AT BOLT

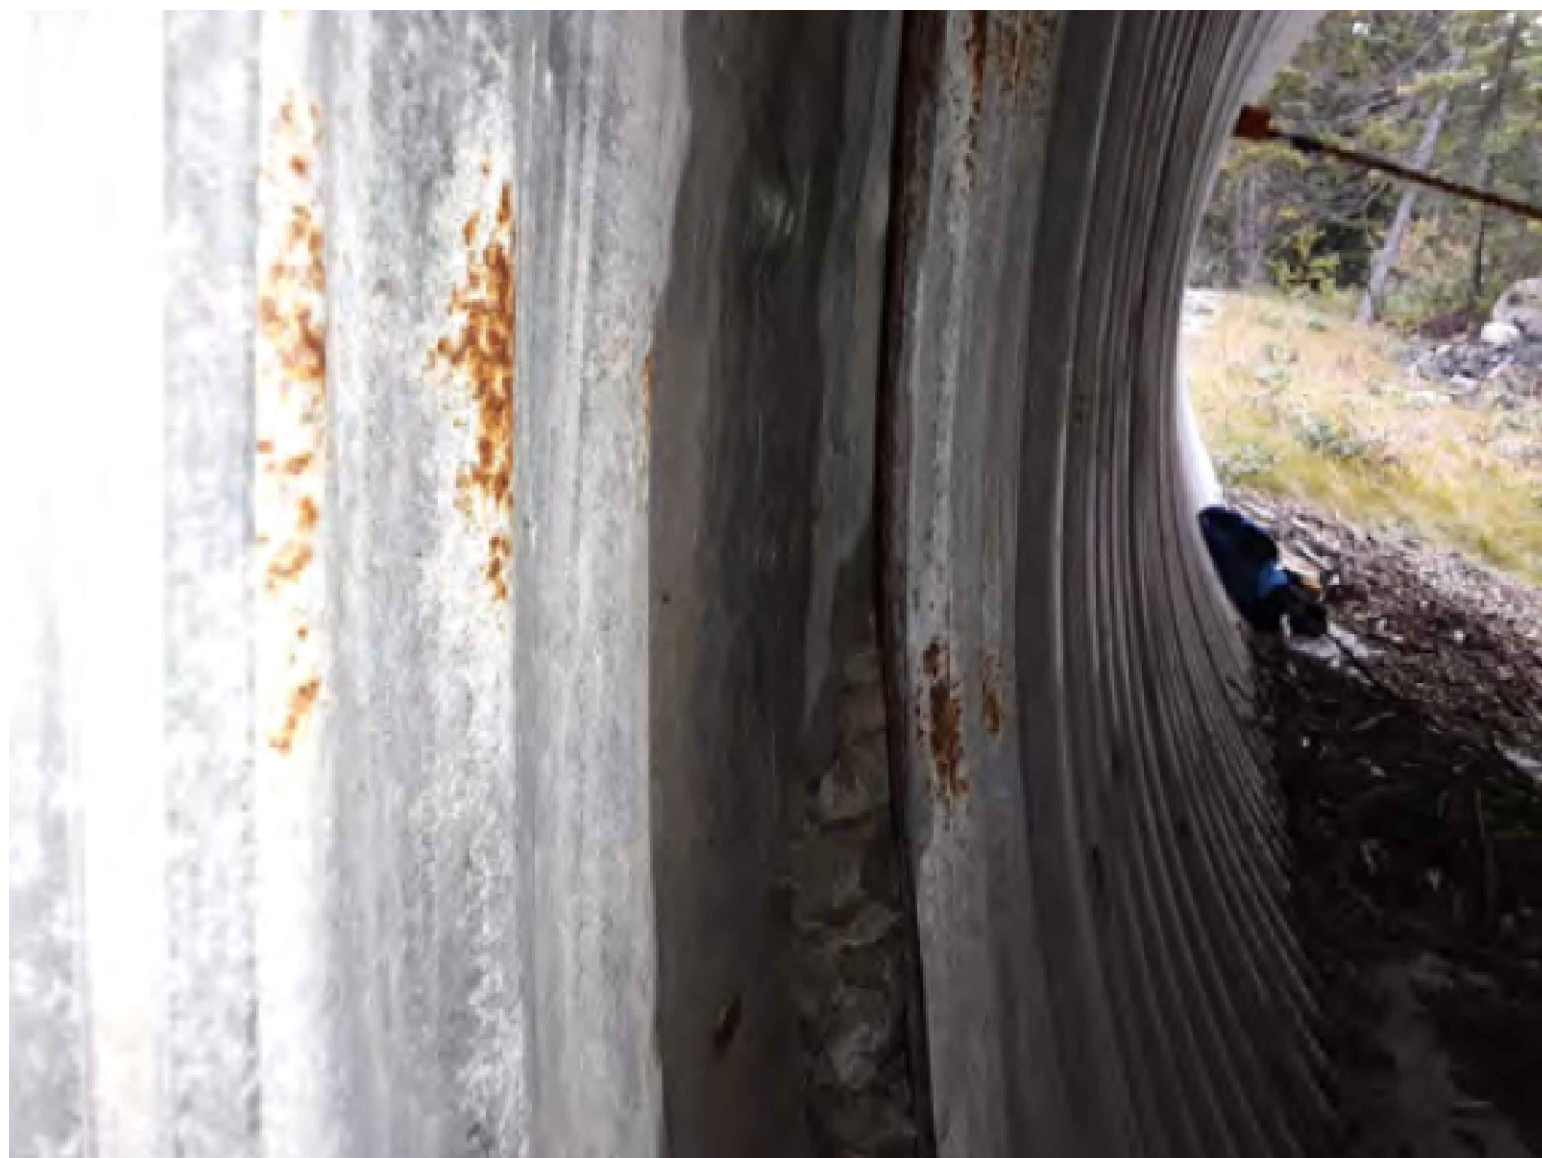
EXAMPLE PHOTO:  
V-J SEPARATED AND OFFSET JOINT BY APPROX. 120mm WITH VISIBLE  
BACKFILL MATERIAL AS WELL AS SURFACE CORROSION AT JOINT CONNECTION

CULVERT OFFSET JOINT REPAIR  
SCALE: 1:5
