Hazardous Building Materials Assessment

Boiler Room, Landline Room
and Electrical Room
Wabush Airport
2 Airport Road, Wabush, NL

December 17, 2020

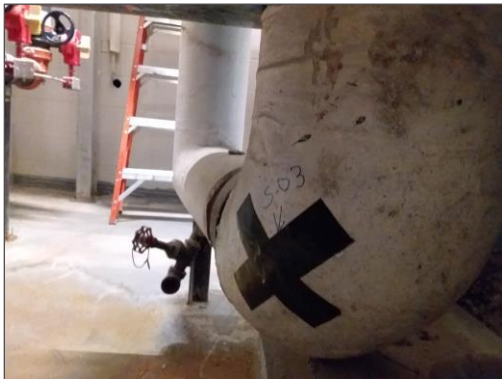
Parging cement, containing chrysotile asbestos, is present on a pipe elbow located on boiler # 2, an elbow on the domestic water supply pipe, and an elbow located on the cold-water domestic water supply piping in the boiler room (reference samples 285012-S003, 285012-S008 & 285012-S009 respectively). Parging cement containing chrysotile asbestos was also found on the heating return pipe (reference sample 285012-S006). The heating pipe return is 12" in diameter (10" pipe with 2" jacket) and is approximately 16 feet long. Parging cement is a friable insulation, jacketed with canvas and is in good condition.

View of Boiler #2 pipe elbow sample location (S003)

Remove asbestos-containing materials (ACM) prior to renovation, alteration, or maintenance if ACM may be disturbed by the work.

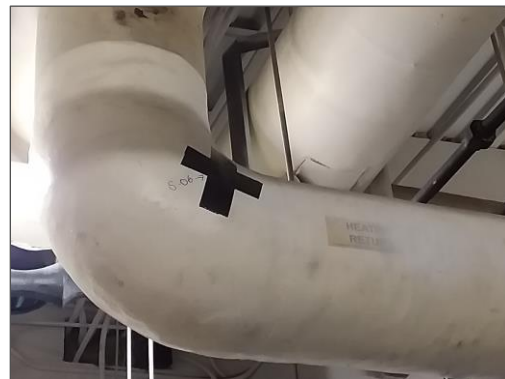
The remaining pipes and boilers are insulated with non-asbestos containing insulation. Insulation samples were collected from the boiler (reference sample 285012-S002), boiler exhaust piping (reference sample 285012-S004) and the domestic cold water straight run piping (reference sample 285012-S010). All samples collected did not detect the presence of asbestos.

View of Heating return pipe sample location (S006)

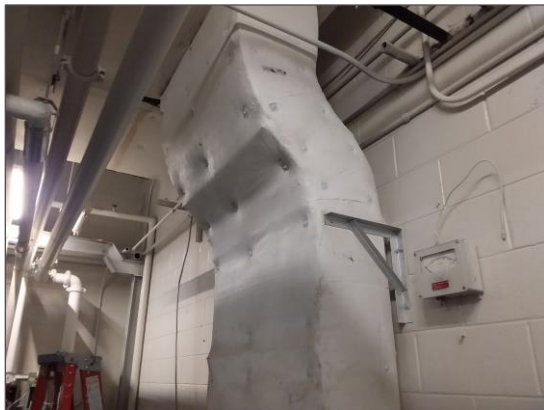
White duct insulation present on the main ductwork throughout the boiler room was collected for analysis and did not identify the presence of asbestos (reference sample 285012-S005).

View of main duct work inside boiler room

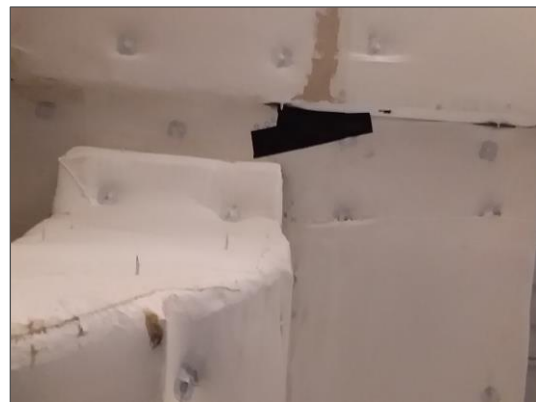
View of sample location (S005) of the main ductwork covering

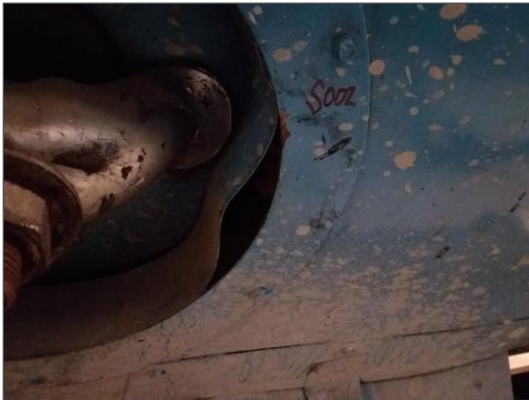
Boiler insulation was collected for analysis and did not identify the presence of asbestos (reference sample 285012-S002).

View of sample collection location (S002) for boiler insulation.

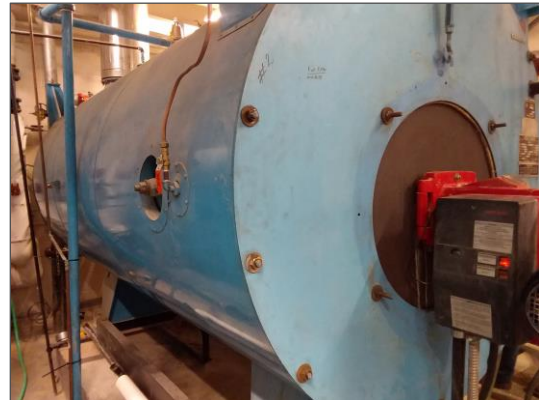
View of the access hatch where sample S002 was collected

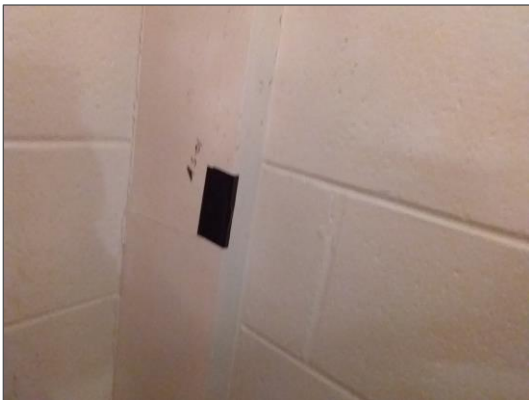
Drywall joint compound, containing chrysotile asbestos, is present on wall and ceiling finishes in the boiler room and landline room (reference samples 285012-S001 & 285012-S012). Assume all drywall joint compounds to be asbestos containing. Drywall joint compound is a non-friable material, painted and is in good condition in the boiler room. Approximately fifty-two square feet (52 ft²) of drywall joint compound was observed in poor condition in the landline room.

View of Boiler room drywall-joint compound sample location (S001)

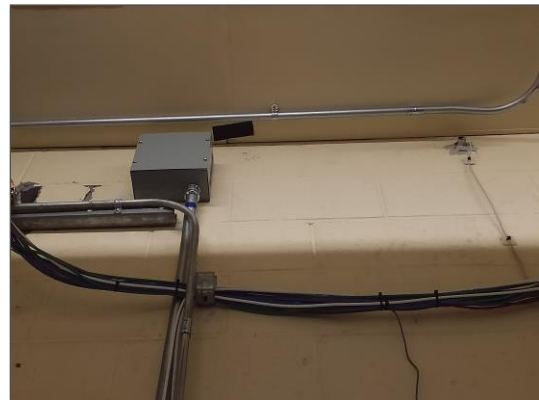
View of sample location S012. Landline room. Drywall -joint compound.

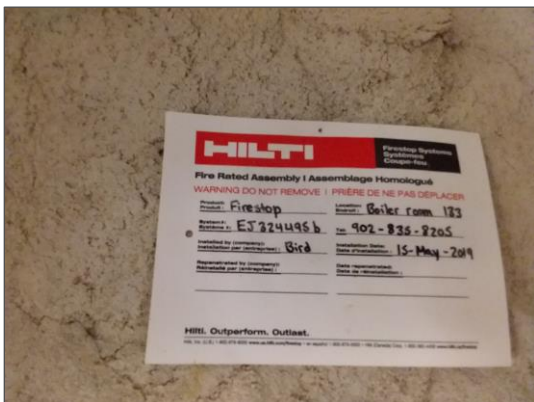
Spray fireproofing signage placed during firestop install

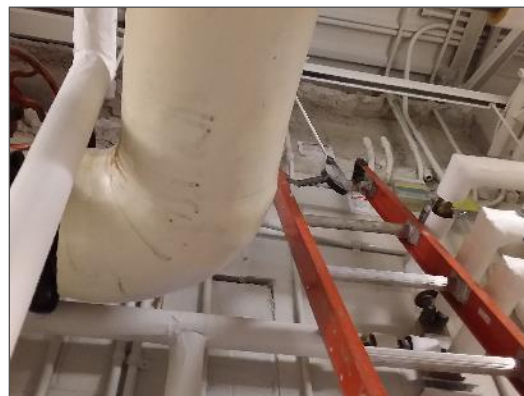
Spray fireproofing present on upper wall in the boiler room was collected for analysis and did not identify the presence of asbestos (reference sample 285012-S011).

View of fireproofing on upper wall of boiler room
