**FINAL REPORT  
INVESTIGATION AND DESIGN OF REMEDIATION MEASURES  
VENUS TAILINGS SITE**

**FINAL REPORT**  
**INVESTIGATION AND DESIGN OF REMEDIATION MEASURES**  
**VENUS TAILINGS SITE**

## Venus Mine Monitoring Program Review

**Venus Tailings and Former Mill Site**

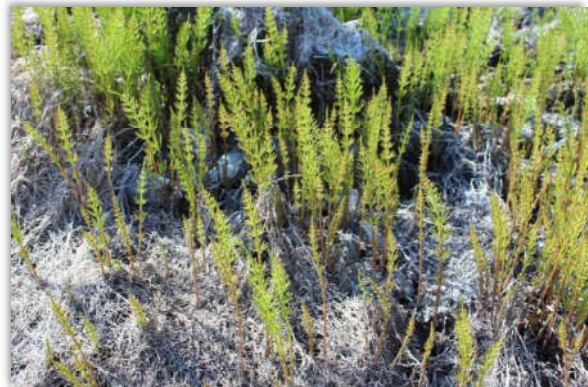
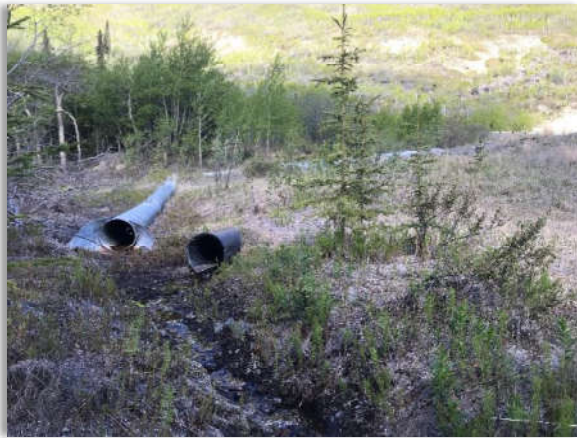
Arsenic concentrations measured in raspberry samples from the periphery of the tailings impoundment are high enough to pose acute health risks if adults consume more than 150 g of berries in one day. Children under the age of 5 may be at risk if they eat more than 35 g of berries in a single day. We advised against harvesting berries and other plants for consumption as country foods or traditional medicines from anywhere at Venus until the distribution and concentration of arsenic (and other metals) in vegetation consumed as country foods or used for traditional medicines is better understood.

Installing additional fencing to restrict public access to areas where soil arsenic is greater than 380 µg/g will also limit access to areas of the Site for collecting berries and other country foods/traditional medicines (e.g., *Equisetum*; see photo).
