Geotechnical Investigation

Boundary Road Swing Bridge

Simcoe County / City of Kawartha Lakes, Ontario

October 20, 2015

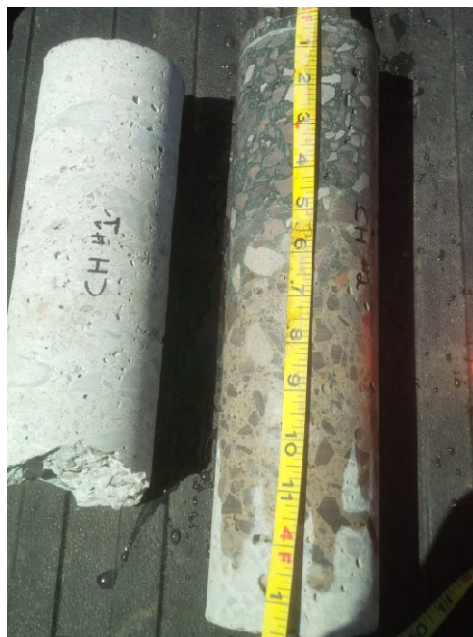
Figure 5.1 Concrete Cores

Two (2) concrete cores were obtained from the existing structure. The first core (CH-1) was obtained as a vertical core, from the swing bridge seat on the north abutment. This core was approximately 255 mm in depth and had an unconfined compressive strength of approximately 18.7 MPa. The second core (CH-2) was obtained as a horizontal core, from the west wall of the south abutment. This core was approximately 355 mm in depth and had an unconfined compressive strength of approximately 56.0 MPa. The concrete cores were generally light grey in colour, however the outer 100 to 150 mm of core CH-2 was a dark grey (greenish grey colour). The nominal aggregate size in core CH-1 was approximately 40 mm, while the nominal aggregate size in core CH-2 was approximately 19 mm. The aggregate in core CH-1 appears to sub-rounded to sub-angular, while the aggregate in core CH-2 appears to sub-angular to angular. An image of the concrete cores is provided as Figure 5.1.

The concrete core at the north abutment was retrieved as one piece, but had hairline fractures, which became evident after retrieval. The concrete seats of the abutments showed evidence of overall distress. These zones of weakened concrete in these surficial areas of the abutments should be removed and refaced appropriately with new concrete. The concrete core at the south abutment was obtained from the west abutment wall. The vertical faces of the abutments did not exhibit the same level of distress as the horizontal portions, minor repairs may be necessary on the vertical faces of the abutment walls to address any localized distresses. Significant concrete distresses were noted on the centre pier; the Client stated to GHD that a new concrete cap will be constructed while the swing span is removed.
