**REPORT ON  
PHASE I AND II SEISMIC EVALUATION  
CANADIAN HIGH COMMISSION  
BRIDGETOWN, BARBADOS**

November 2011

**J.L. RICHARDS & ASSOCIATES LIMITED**

**REPORT ON  
ASCE 31-03 TIER 1 AND TIER 2 SEISMIC EVALUATION  
CANADIAN HIGH COMMISSION  
BRIDGETOWN, BARBADOS**

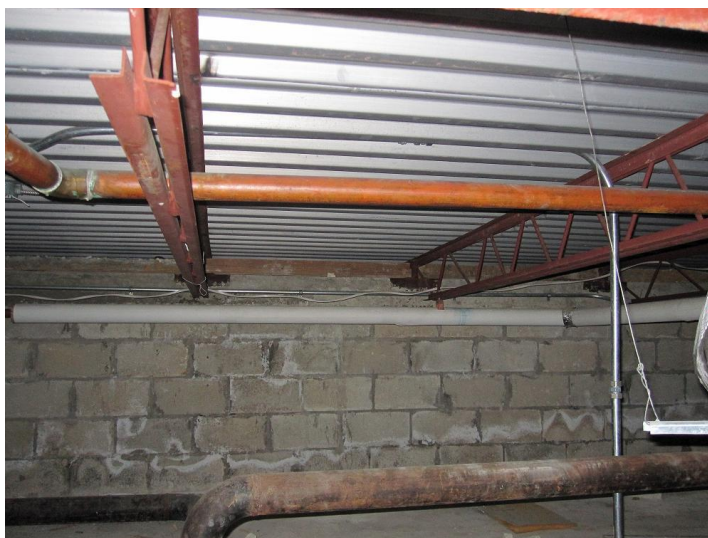
**Photograph No. 1 – Basement Foundation Wall Efflorescence**

The foundations were not visible. The basement slab and foundation walls were visible in a crawlspace accessed at the basement level. The basement walls consist of concrete masonry, as shown on the drawings. The HSS columns rest on base plates secured with two anchor bolts to the foundations. The concrete slab in the crawlspace appeared to be in good condition. The concrete masonry walls had areas of efflorescent staining, no other defects were noted. Photograph Nos. 1 and 2 show the basement foundation walls and efflorescence.

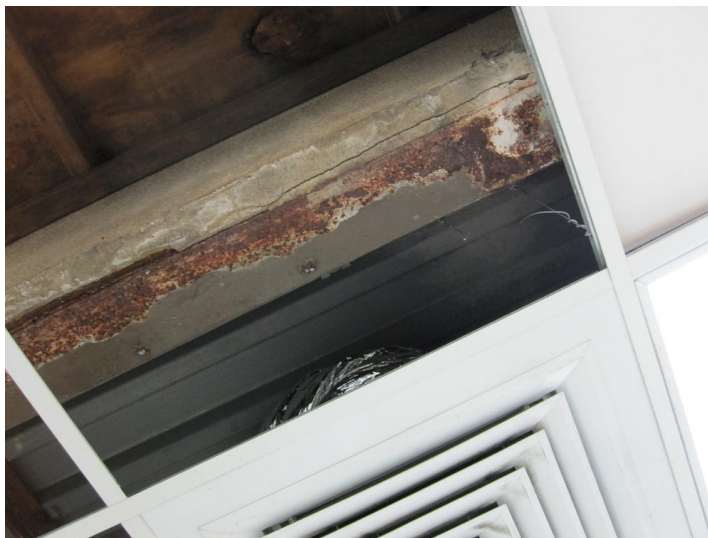
**Photograph No. 3 – Basement Level Member Corrosion**

At the basement level, corrosion of a steel beam and open web steel joist (OWSJ) were noted in the supply room. The corrosion is thought to be caused by moisture from an air conditioning unit. Maintenance staff is aware of the problem and have removed the ceiling panels in this area as shown in Photograph Nos. 3 and 4. No other damage or deterioration was noted at the basement level.

***Deterioration of Steel:*** There is visible rusting of a steel beam and joist in the maintenance supply room.

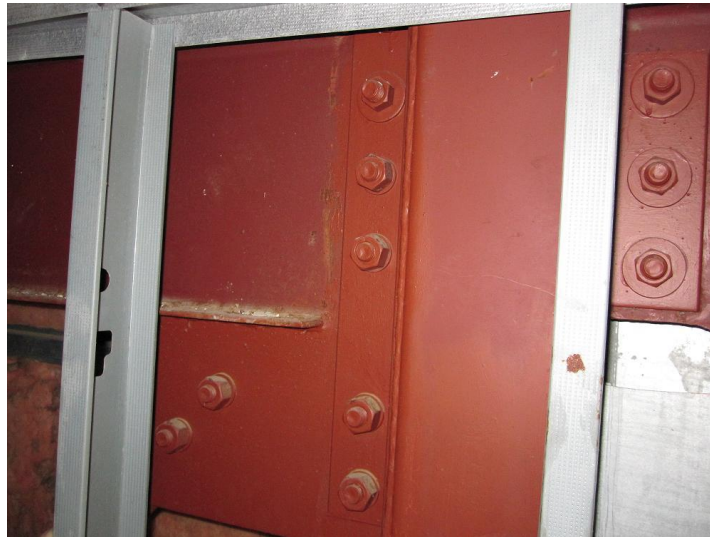
**Photograph 5 - : Structural Steel Column and Connection**

damage was noted in the steel structure with the exception of the corrosion in the maintenance supply room noted in the basement level. Examples of the structural steel columns and connections are presented in Photograph No. 5. Examples of the structural steel bracing and connections are presented in Photograph No. 6.

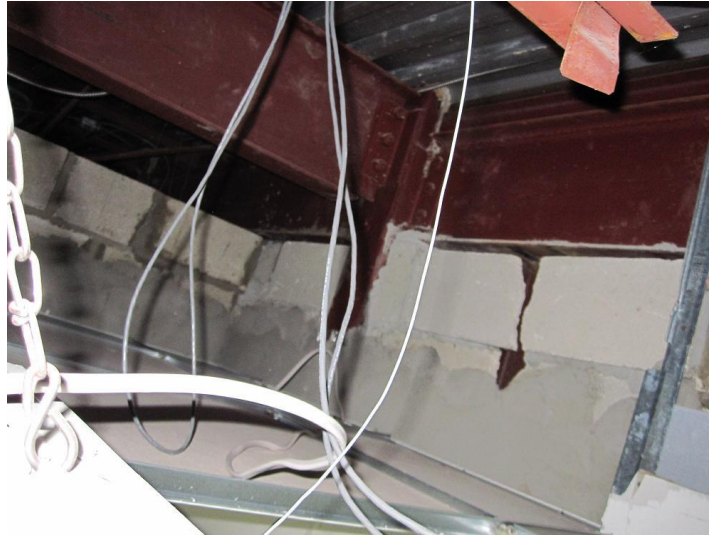
**Photograph 7: Unsupported Concrete Masonry Partition Wall**

Concrete masonry partition walls that are unsupported at the top of the wall were noted, as shown in Photograph No. 7.

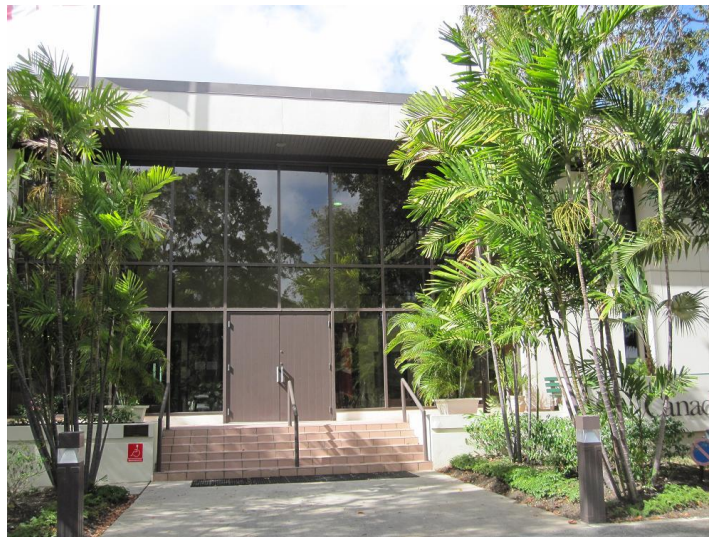
**Photograph No. 8 - Exterior Façade**

The exterior façade consists of glazing and concrete or masonry panels approximately 8 mm thick. No damage or deterioration was visible on the exterior façade. Photograph Nos. 8 and 9 present photographs of the exterior façade.

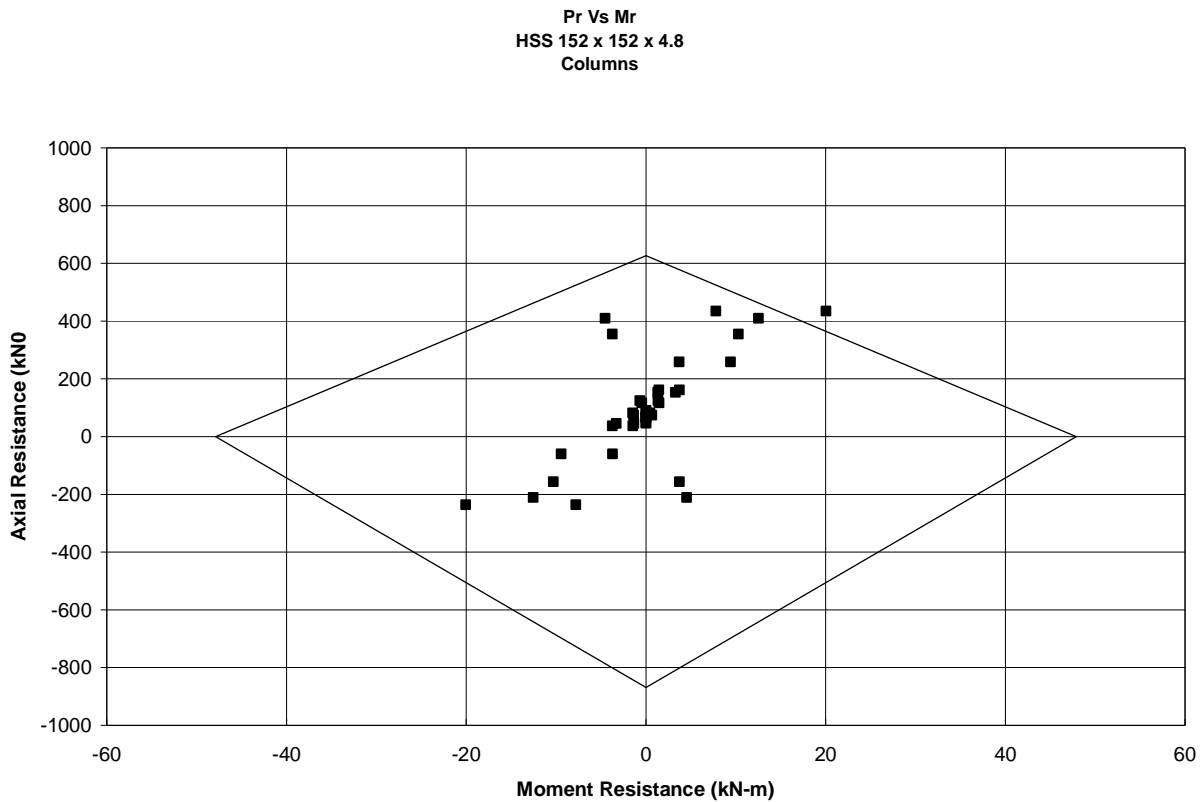
**Figure 3: Interaction Diagram for HSS Columns**

The interaction diagram in Figure 3 illustrates the allowable loading range for an HSS 152 x 152 x 4.8 section according to CAN/CSA S16-01. The lines represent the boundary of the allowable range of loading. Each point shown in the figure represents the loading of a column element under the governing load conditions. As can be seen, the column loading observed was generally within of the allowable limits, except for one load combination.

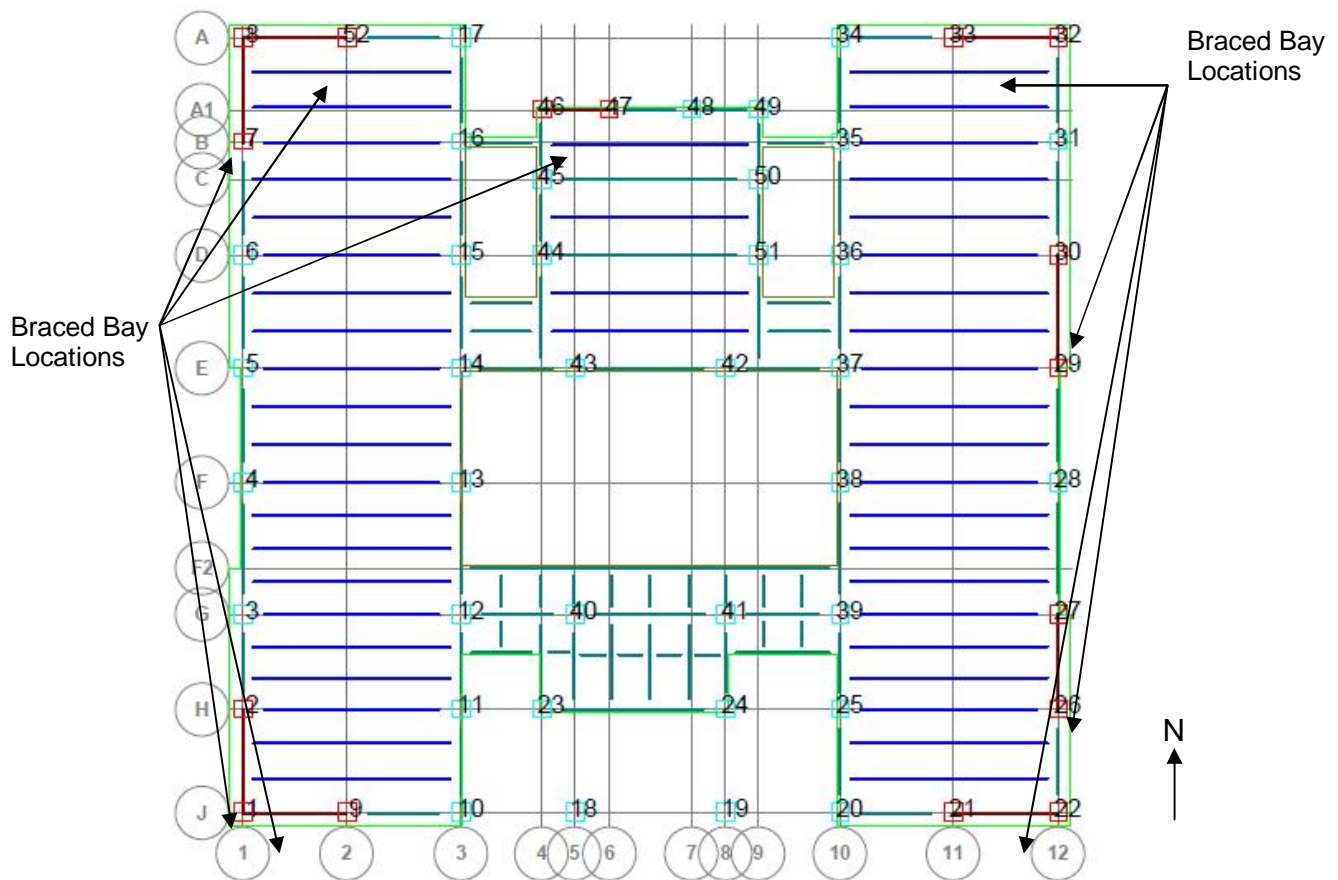
**Figure 4: Column Locations (Second Floor and Roof)**

Table 5 shows the demand/capacity ratios for the columns subjected to both axial and bending forces. Demand/Capacity ratios greater than 1 indicate columns with insufficient capacity for the design seismic loading.

As shown in Table 5 for the 100% Loading (Life Safety) Condition 5, the demand/capacity ratios for the columns range from 0.26 to 1.11 for the columns analyzed. The columns from the ground floor to the second floor have higher demand/capacity ratios than the columns from the second floor to the roof. The demand/capacity ratios for seven of the sixteen columns are over 1.0, the overstresses range from one percent to eleven percent. Considering the low overstress levels and the number of columns affected, these overstresses would probably not significantly affect the performance of the structure.

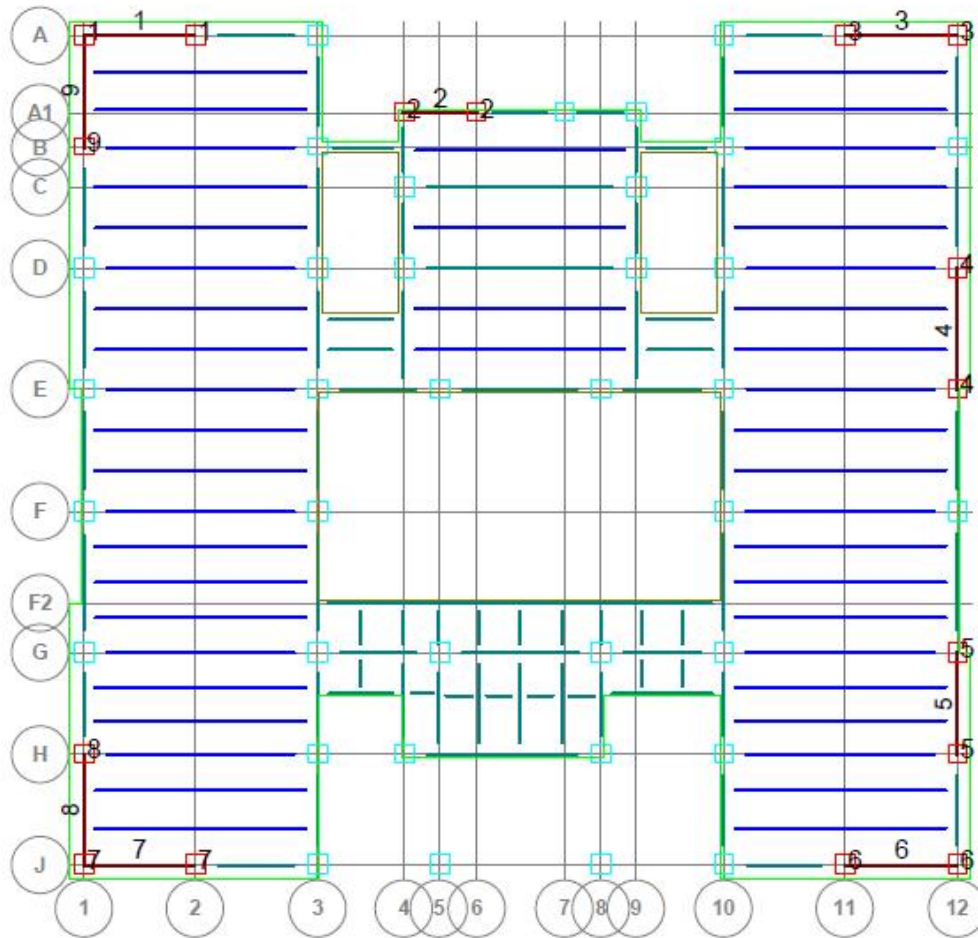
**Figure 5: Braced Frame and Beam Locations (Second Floor and Roof)**

Table 7 shows that the demand/capacity ratios for the braces in tension range from 0.30 to 2.09. Seventeen out of 36, or 47% of the braces have demand capacity ratios greater than 1.0 indicating an overstressed condition. Demand/capacity ratios for the 60% and 150% load conditions are shown for comparison. The demand/capacity ratios range from 0.19 to 1.25 for the 60% load condition and 0.46 to 3.13 for the 150% load condition.
