Mould Assessment and Remediation Plan

CFIA Sidney Building 12 – 8801 East
Saanich Road, North Saanich, BC

December 20, 2021

Project Number: 123222004

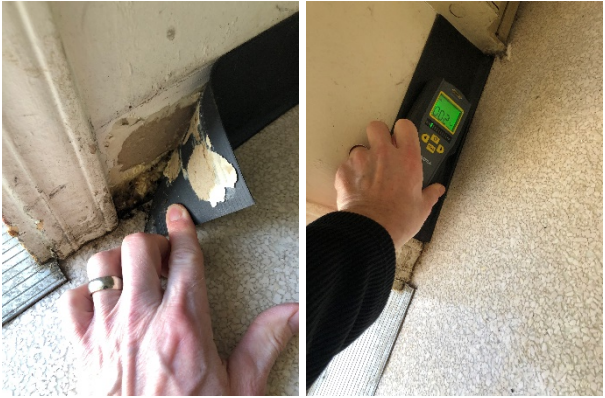
Building Area	Observation	Photo(s)
<p>Southwest entrance foyer</p>	<p>No visible suspect mould observed on exposed gypsum wall materials or gypsum materials concealed behind rubber cove base.</p> <p>No elevated moisture detected in gypsum wall materials tested.</p> <p>Wall configuration behind rubber cove base appears to include a gap, filled with expanding foam, between the bottom of the gypsum wall and the floor. This may have kept gypsum wall materials from becoming wet during the flooding event, in many instances/areas.</p>

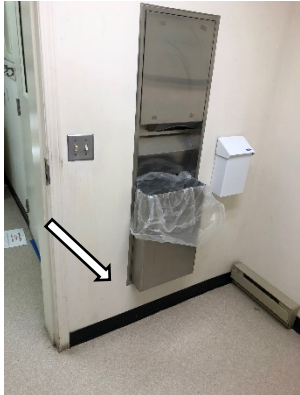
<p>Washroom</p>	<p>No visible suspect mould observed on exposed gypsum wall materials or gypsum materials concealed behind rubber cove base.</p> <p>Elevated moisture detected on lower portion of the north gypsum wall (east of the door, beneath the waste bin) – primarily behind the rubber cove base.</p> <p>No elevated moisture detected on other gypsum wall materials.</p>

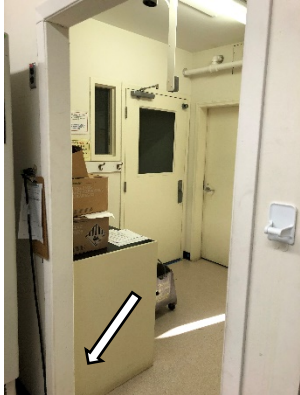
<p>Stairwell Entrance Foyer</p>	<p>No visible suspect mould observed on exposed gypsum wall materials or gypsum materials concealed behind rubber cove base.</p> <p>Elevated moisture detected on lower portion of the north gypsum wall.</p> <p>No elevated moisture detected on other gypsum wall materials.</p>

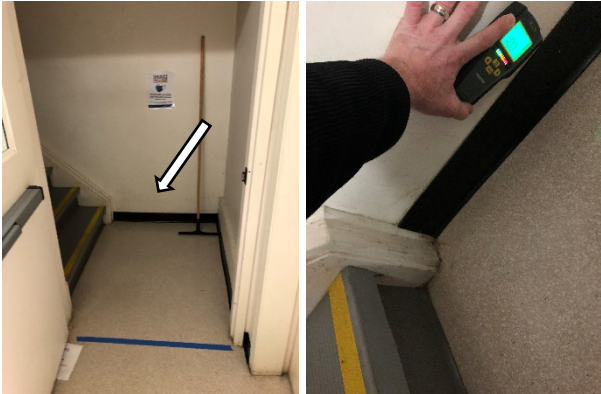
Building Area	Observation	Photo(s)
Stairwell	<p>No visible suspect mould observed on exposed gypsum wall materials or gypsum materials concealed behind rubber cove base.</p> <p>Elevated moisture detected on lower portion of the east gypsum wall.</p> <p>No elevated moisture detected on other gypsum wall materials or stair treads.</p>

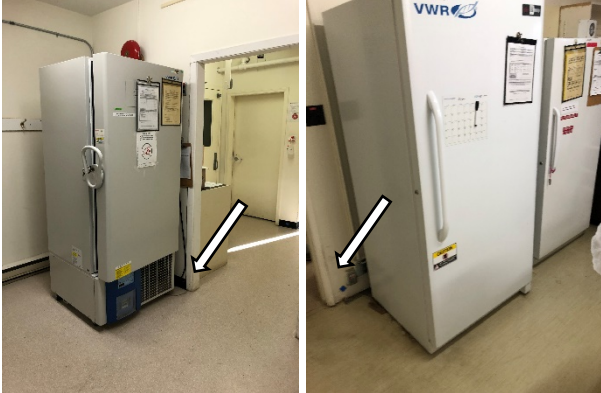
Central Foyer/Freezer Area	<p>No visible suspect mould observed on exposed gypsum wall materials or gypsum materials concealed behind rubber cove base.</p> <p>Elevated moisture detected on lower portion of the south gypsum wall (opposite the north wall of the stairwell foyer), on the lower portion of the west gypsum wall (north half) and on the lower portion of the wall leading to the electrical room.</p> <p>No elevated moisture detected on other gypsum wall materials.</p>

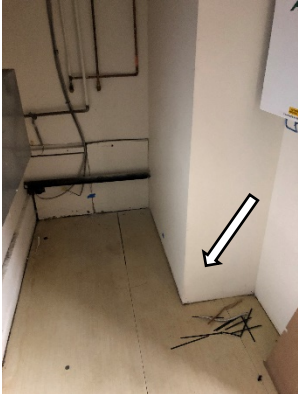
Electrical Room	<p>No visible suspect mould observed on exposed gypsum wall materials or gypsum materials concealed behind rubber cove base.</p> <p>Elevated moisture detected on lower portion of various gypsum wall sections.</p> <p>South wall includes a concrete curb (not conducive to supporting mould growth).</p>

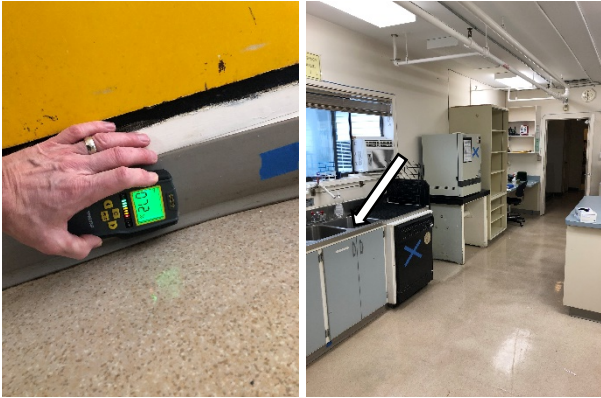
Building Area	Observation	Photo(s)
South Lab	<p>No visible suspect mould observed on exposed gypsum wall materials or gypsum materials concealed behind rubber cove base.</p> <p>Elevated moisture detected on lower portion of most exposed gypsum wall sections and on wooden toe kicks beneath cabinets/lab benches throughout.</p> <p>South wall includes a concrete curb (not conducive to supporting mould growth). Sink with ACM undercoating (shown at arrow) not anticipated to require action.</p>

- This will involve removal of toe kicks from such items throughout the South Lab and the Tissue Culture area
 - Assess areas beneath cabinets for remaining water and/or concealed wall materials that may be mould and/or moisture impacted.

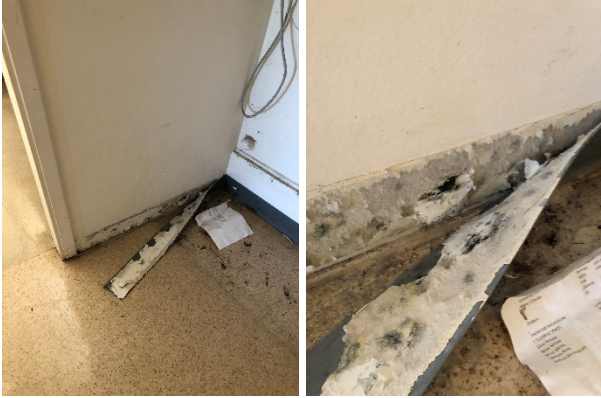
West Corridor and Sprinkler Room Foyer	<p>No visible suspect mould observed on exposed gypsum wall materials.</p> <p>Suspect visible mould on gypsum wall materials concealed behind rubber cove base along east wall (surface samples M-01 and M-02 collected).</p> <p>Elevated moisture detected on lower portion of exposed gypsum wall sections.</p> <p>South wall includes a concrete curb (not conducive to supporting mould growth).</p>

As indicated above, mould growth was confirmed on gypsum materials behind rubber cove base materials on the east wall of the west corridor. Although this was the only location that visible mould growth was observed during Stantec's assessment, conditions conducive to similar growth exist throughout the areas assessed (moist gypsum materials behind rubber cove base).

- Remove and dispose of the lower 60 cm (two feet) of wallboard materials (and underlying vapour barrier and insulation, if present) in areas where elevated moisture content was detected.

- Mould abatement protocols call for removal of visibly impacted materials plus 30 cm (1 foot) of clean materials in all directions. Depending on the conditions within wall cavities as materials are removed, it may be necessary to remove wall materials to heights greater than 60 cm, or small sections of adjacent walls, if they are not already planned for removal.

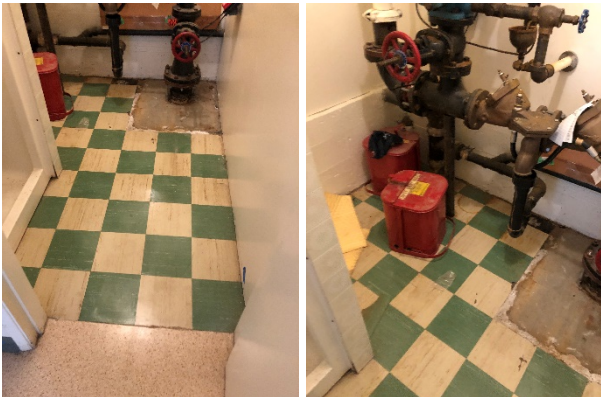
Sprinkler Room	<p>No visible suspect mould observed on exposed gypsum wall materials.</p> <p>Elevated moisture detected on lower portion of most exposed wall sections, including gypsum walls around shower.</p> <p>ACM floor tiles lifting in some instances.</p> <p>South and west walls include concrete curbs (not conducive to supporting mould growth).</p>

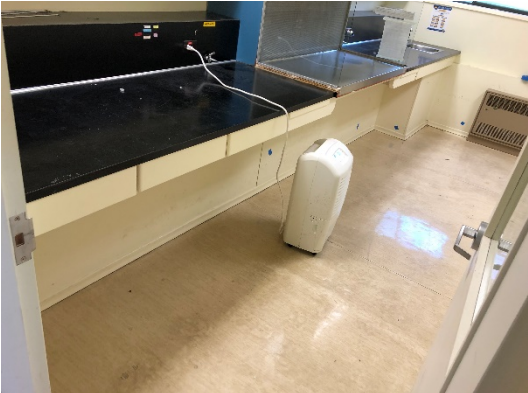
Building Area	Observation	Photo(s)
Tissue Culture Transfer Room	<p>No visible suspect mould observed on exposed gypsum wall materials or gypsum materials concealed behind rubber cove base.</p> <p>Elevated moisture detected sporadically on lower portion of various gypsum wall sections.</p>

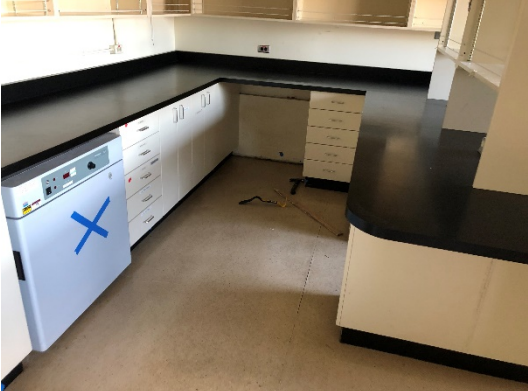
Tissue Culture Area	<p>No visible suspect mould observed on exposed gypsum wall materials or gypsum materials concealed behind rubber cove base.</p> <p>Elevated moisture detected on lower portion of most exposed gypsum wall sections and on wooden toe kicks beneath cabinets/lab benches throughout.</p>

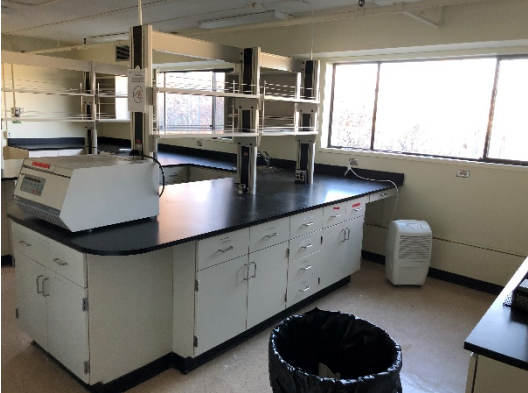
North Lab	<p>No visible suspect mould observed on exposed gypsum wall materials or gypsum materials concealed behind rubber cove base.</p> <p>Elevated moisture detected on lower portion of most exposed gypsum wall sections.</p> <p>Metal toe kicks on lab benches, and north wall appears to include a concrete curb (not conducive to supporting mould growth).</p>

- Remove metal toe kicks from cabinets associated with laboratory benches and counters throughout the North Lab.
 - Assess areas beneath cabinets for remaining water and/or concealed wall materials that may be mould and/or moisture impacted. Impacts are unlikely along the north wall, as it is presumed to have a concrete curb behind the cabinets.

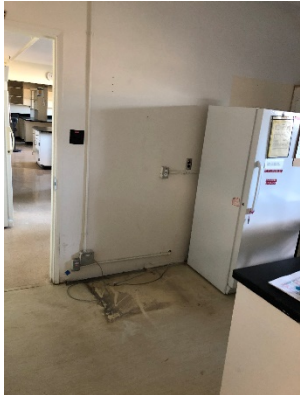
Building Area	Observation	Photo(s)
Centrifuge Room	<p>No visible suspect mould observed on exposed gypsum wall materials or gypsum materials concealed behind rubber cove base.</p> <p>No elevated moisture detected on exposed gypsum wall sections.</p> <p>North wall appears to include a concrete curb (not conducive to supporting mould growth).</p>

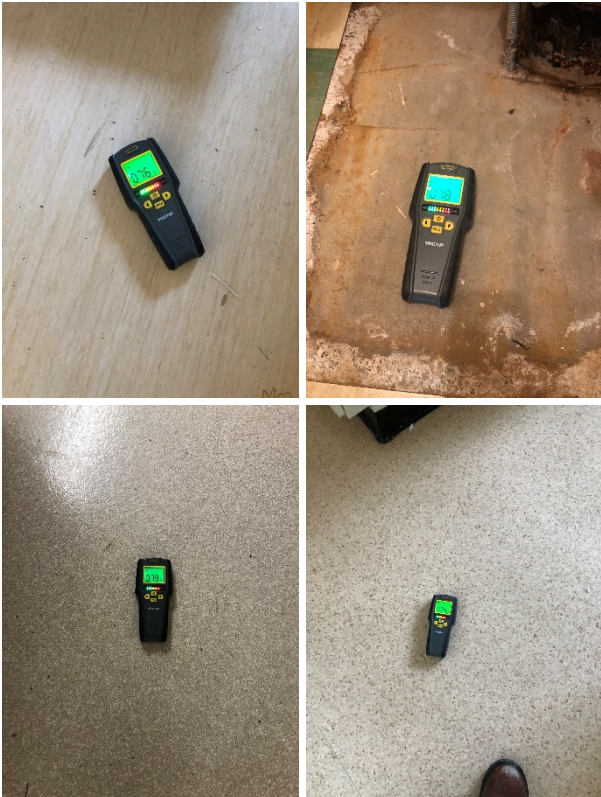
Floors (general, throughout)	<p>Elevated moisture detected in sheet flooring materials (sheet flooring) and exposed concrete throughout. Expected condition as sheet flooring is present on concrete, and the underlying concrete will have absorbed moisture during the flood event.</p> <p>Sheet flooring appears well adhered to concrete (no lifting, bubbling or excess moisture observed) and moisture conditions on the sheet flooring and underlying concrete materials are unlikely to lead to mould growth.</p>

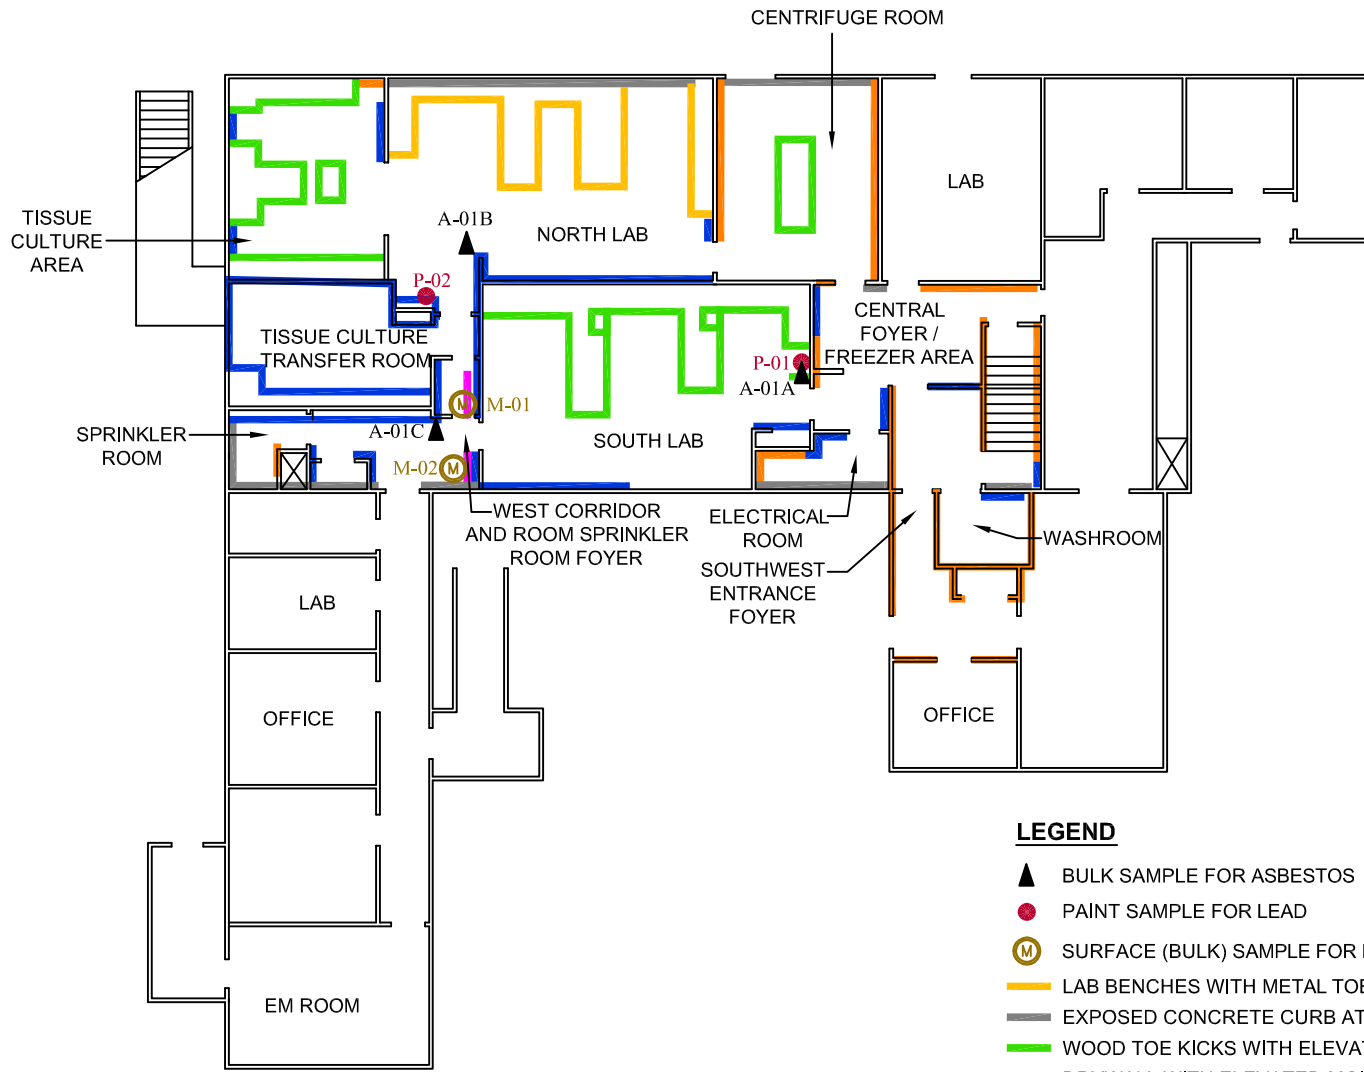
More detailed observations pertaining to mould and/or moisture that were made during this assessment are summarized in Table 1, below. Rooms referenced below are indicated on Drawing 2 in Appendix A, which also includes visual representations of observations (where possible) and locations of samples collected during this assessment.

MOULD/MOISTURE ASSESSMENT FINDINGS
