**Limited Hazardous Materials Investigation
8801 East Saanich Road, North Saanich, BC**

Canadian Food Inspection Agency
8801 East Saanich Road
North Saanich, BC V8L 1H3

Island EHS Project # 38686

February 2022 (Version 2)

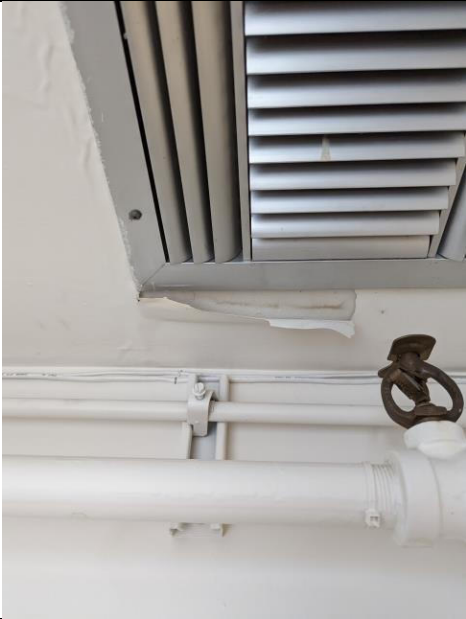
Sample: 38686 - 5
Location: Building 12 – Hallway, Ceiling
Description: Drywall Joint Compound
Asbestos: None Detected

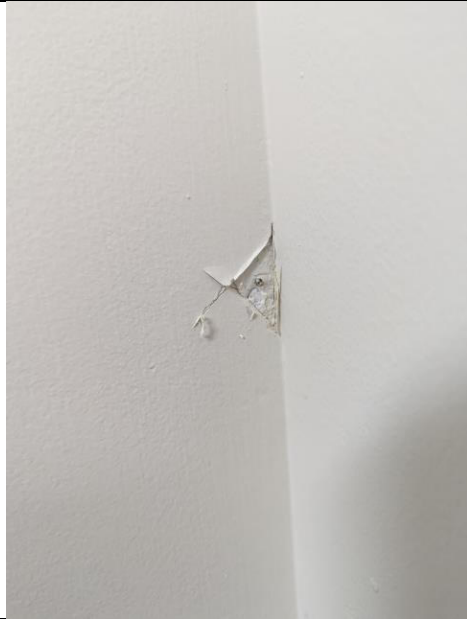
Sample: 38686 - 6
Location: Building 12 – Room 12, Wall
Description: Drywall Joint Compound
Asbestos: None Detected

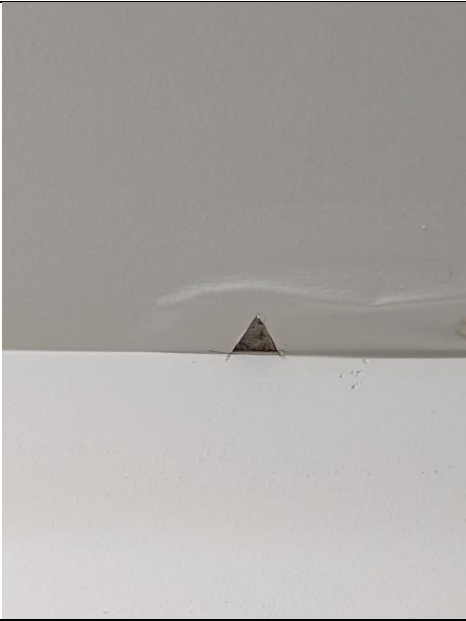
Sample: 38686 - 7
Location: Building 12 – Room 12, Ceiling
Description: Drywall Joint Compound
Asbestos: None Detected

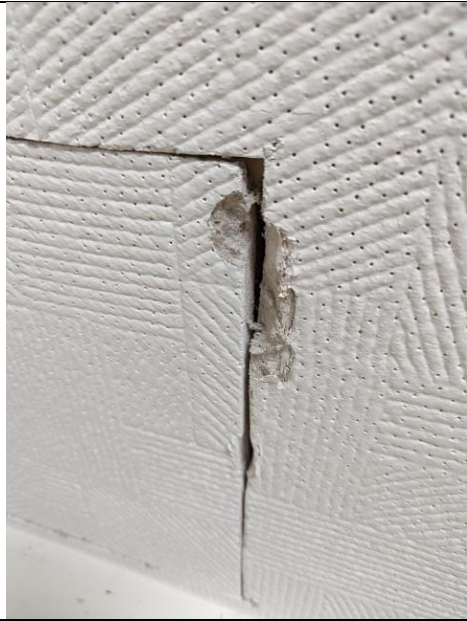
Sample: 38686 - 8
Location: Building 12, Room 12
Description: Acoustic Wall Board
Asbestos: None Detected

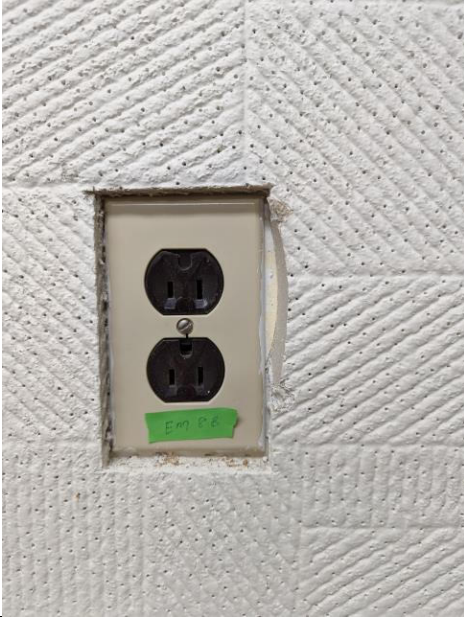
Sample: 38686 - 9
Location: Building 12, Room 12
Description: Acoustic Wall Board
Asbestos: None Detected

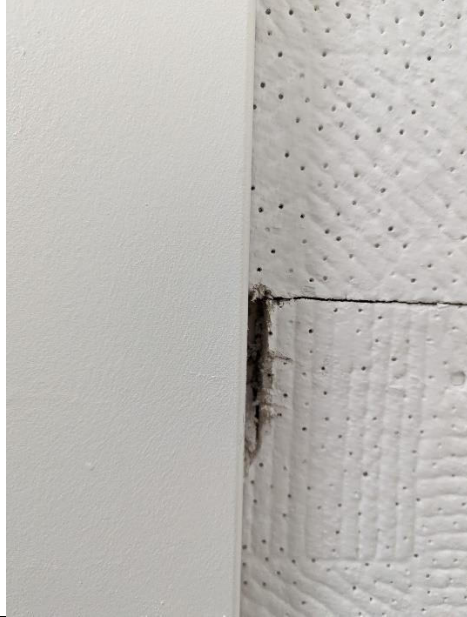
Sample: 38686 - 10
Location: Building 12, Room 12
Description: Acoustic Wall Board
Asbestos: None Detected

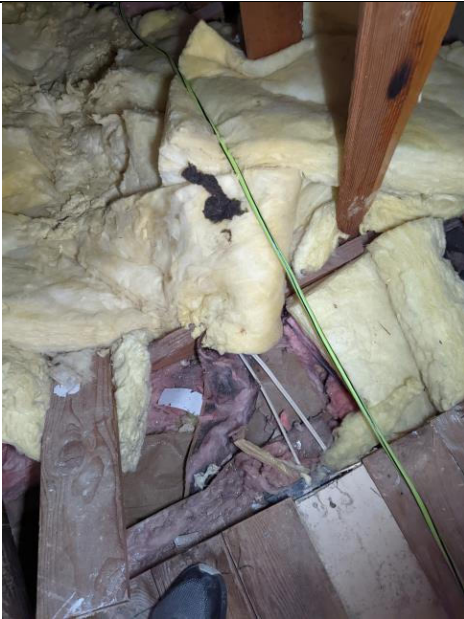
Sample: 38686 - 11
Location: Building 12 - Attic
Description: Insulation
Asbestos: None Detected

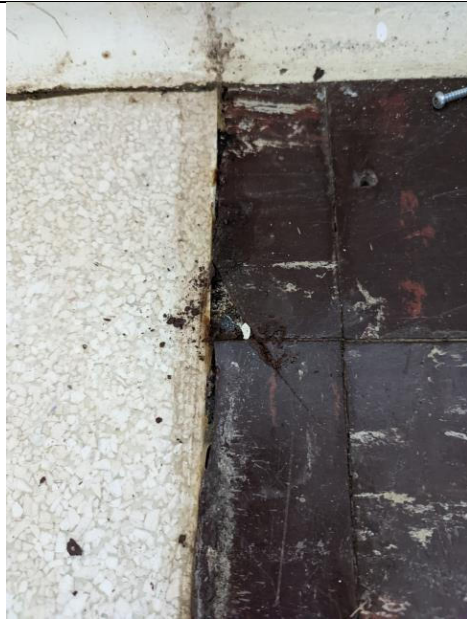
Stantec – Mould Assessment and Remediation Plan for CFIA Sidney Building 12 (Dec 20, 2021) found asbestos containing vinyl floor tile present in the Sprinkler room of building 12. Asbestos containing mastic was also noted on the underside of an unspecified sink in the flood affected area. Any sinks being removed by the flood remediation should be considered to have asbestos containing insulation on the underside and be removed for proper disposal using glove bag work procedures.

Sample: 38686 - 12
Location: Building 12, Room 13
Description: Vinyl Floor Tile
Asbestos: 3% Chrysotile

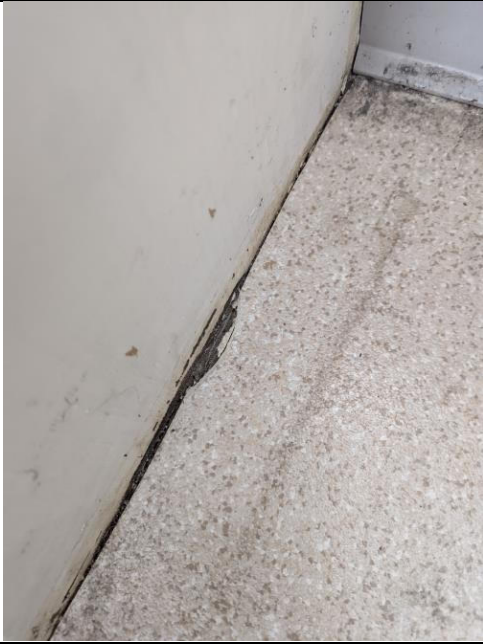
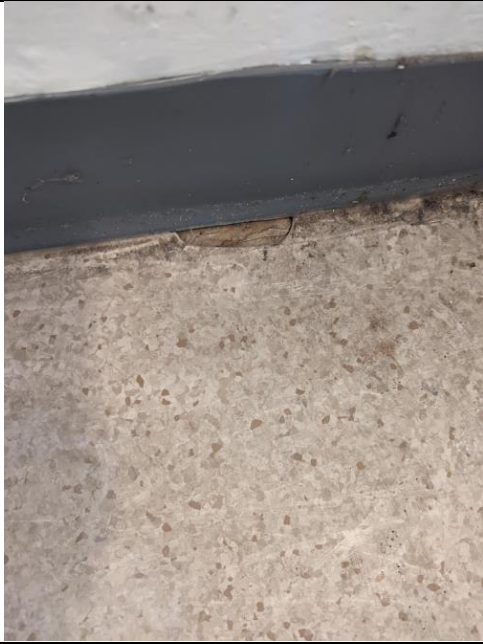
<p> Sample: 38686 - 13 Location: Building 12 – South Lab Description: Sheet Vinyl Flooring Asbestos: None Detected </p>	<p> Sample: 38686 - 14 Location: Building 12 – North Lab Description: Sheet Vinyl Flooring Asbestos: None Detected </p>

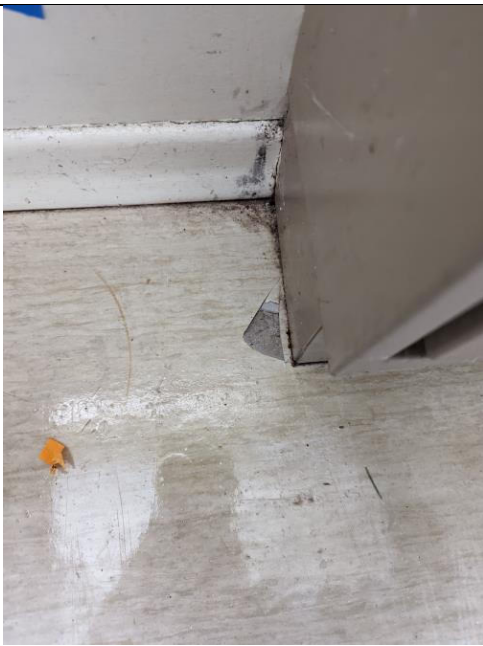
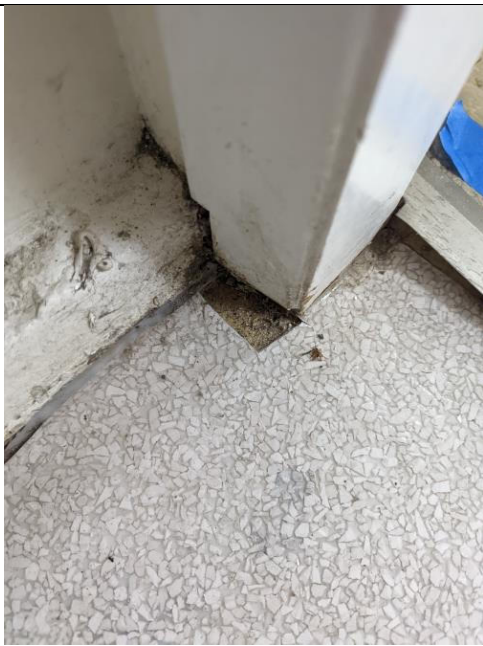
<p> Sample: 38686 - 15 Location: Building 12 – Tissue Culture Transfer Room Description: Sheet Vinyl Flooring Asbestos: None Detected </p>	<p> Sample: 38686 - 16 Location: Building 12 – Stairwell Entrance Foyer Description: Sheet Vinyl Flooring Asbestos: None Detected </p>

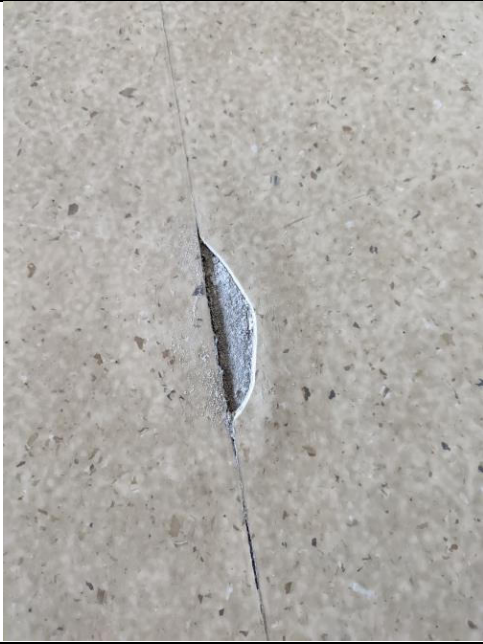
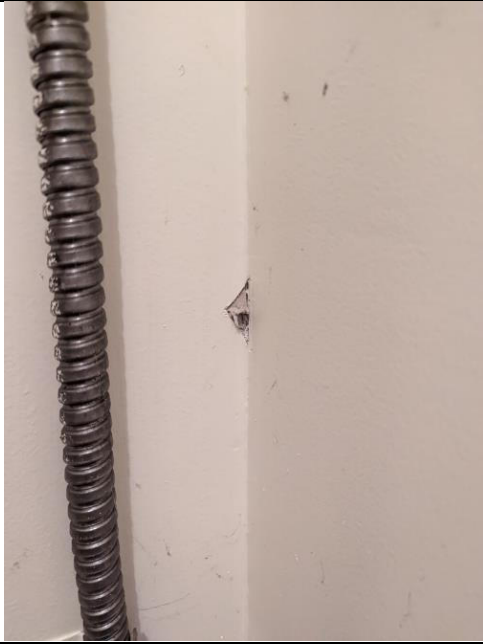
<p> Sample: 38686 - 17 Location: Building 12 – Tissue Culture Area Description: Sheet Vinyl Flooring Asbestos: None Detected </p>	<p> Sample: 38686 - 18 Location: Building 12 – Sprinkler Room Description: Drywall Joint Compound Asbestos: None Detected </p>

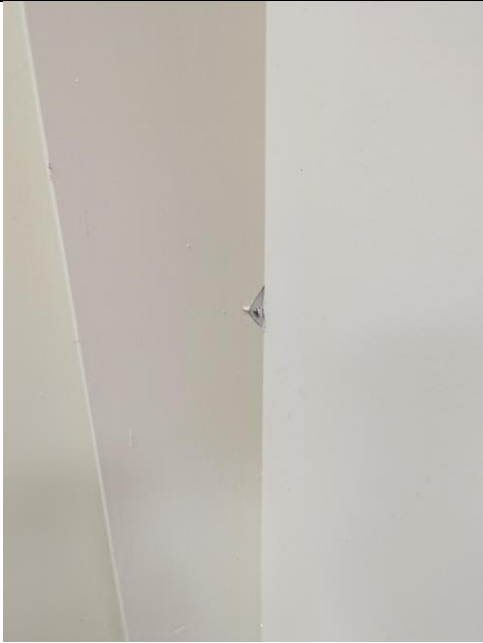
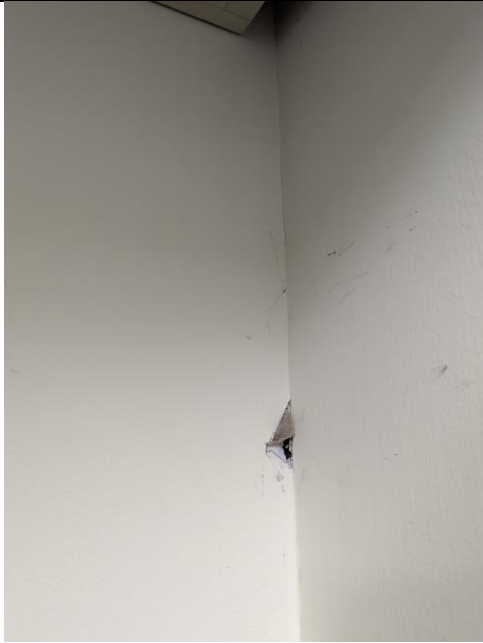
<p> Sample: 38686 - 19 Location: Building 12 – Tissue Culture Transfer Room Description: Drywall Joint Compound Asbestos: None Detected </p>	<p> Sample: 38686 - 20 Location: Building 12 – Tissue Culture Area Description: Drywall Joint Compound Asbestos: None Detected </p>

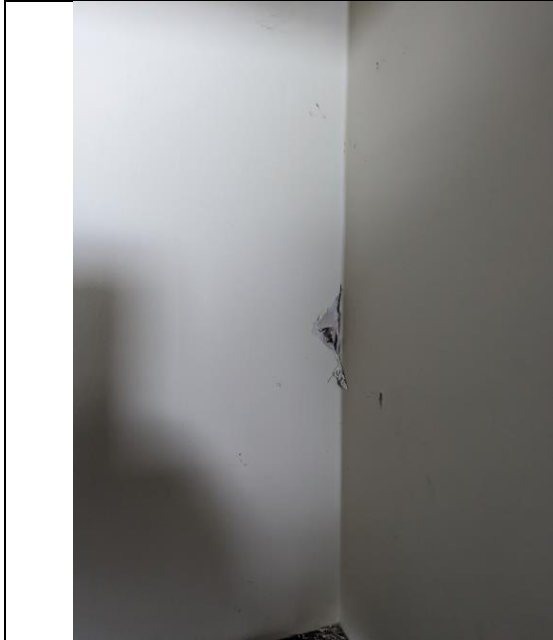
Sample: 38686 - 21
Location: Building 12 – North Lab
Description: Drywall Joint Compound
Asbestos: None Detected

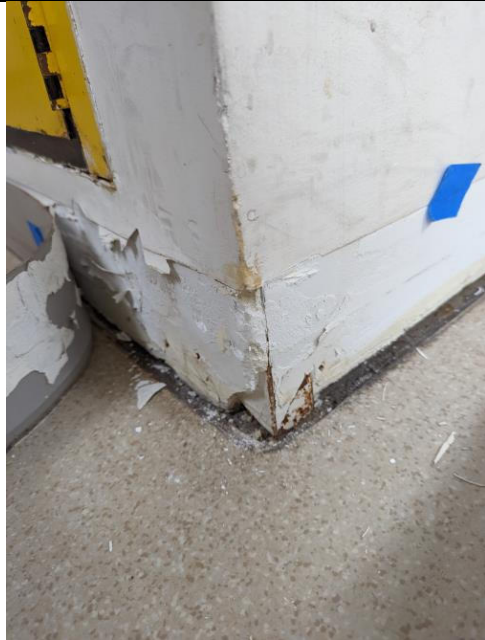
Sample: 38686 - 22
Location: Building 12 – South Lab
Description: Drywall Joint Compound
Asbestos: None Detected

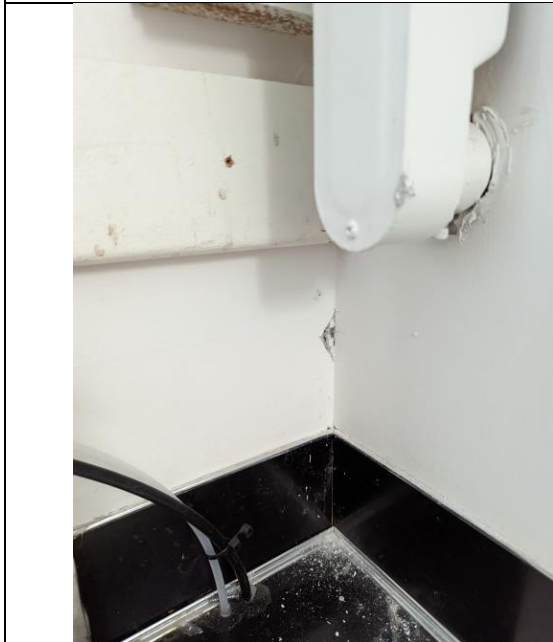
Sample: 38686 - 23
Location: Building 12 – Centrifuge Room
Description: Drywall Joint Compound
Asbestos: None Detected

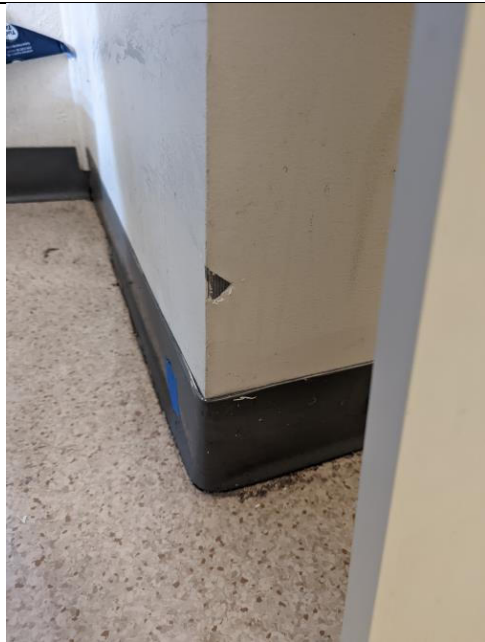
Sample: 38686 - 24
Location: Building 12 – West Hall
Description: Drywall Joint Compound
Asbestos: None Detected

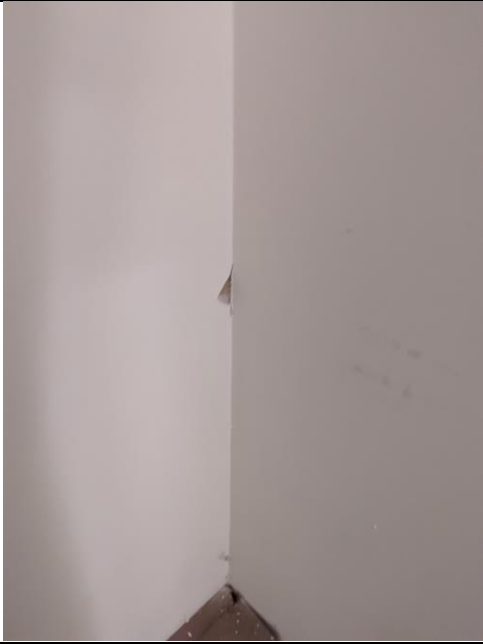
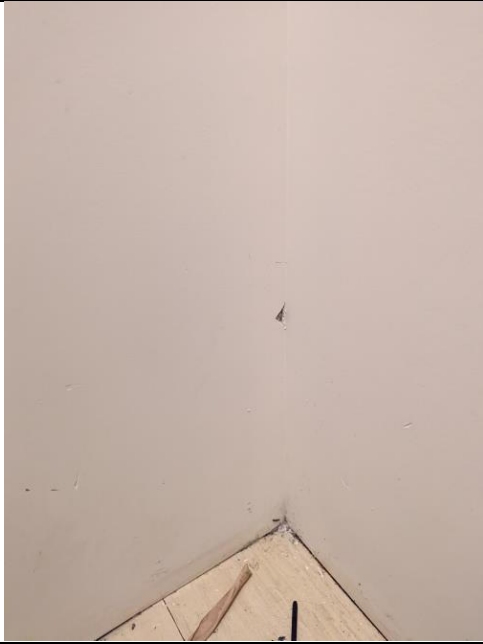
<p> Sample: 38686 - 25 Location: Building 12 – Stairwell Entrance Foyer Description: Drywall Joint Compound Asbestos: None Detected </p>	<p> Sample: 38686 - 26 Location: Building 12 – Electrical Room Description: Drywall Joint Compound Asbestos: None Detected </p>

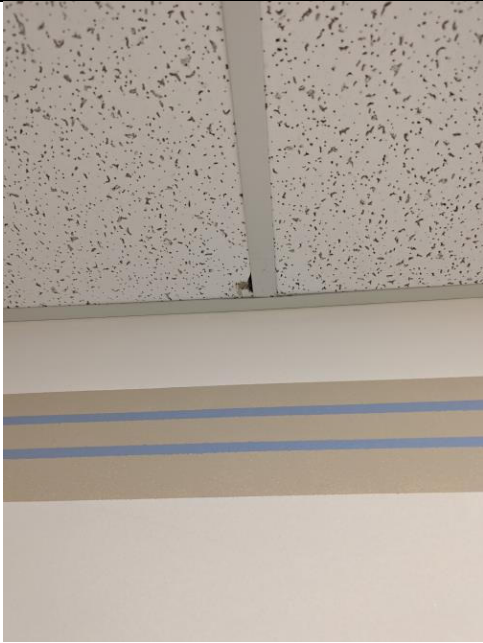
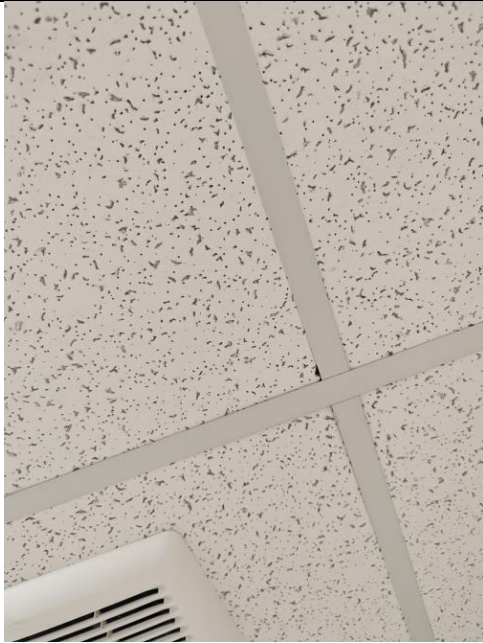
<p> Sample: 38686 - 27 Location: Building 12 – East Hall Description: Acoustic Ceiling Tile Asbestos: None Detected </p>	<p> Sample: 38686 - 28 Location: Building 12 – Washroom Description: Acoustic Ceiling Tile Asbestos: None Detected </p>

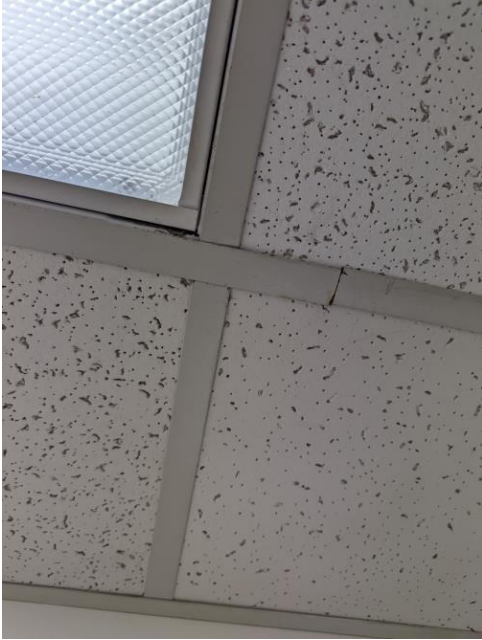
Sample: 38686 - 29
Location: Building 12 – Washroom
Description: Acoustic Ceiling Tile
Asbestos: None Detected

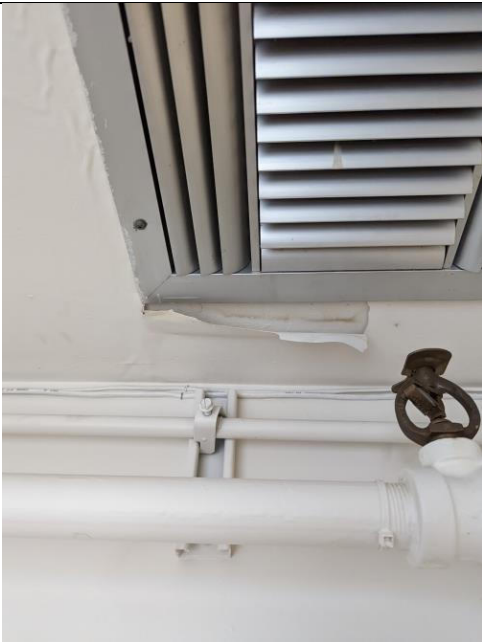
Sample: 38686 – Pb1
Location: Hall Outside Room 13
Description: White Paint
Lead Content: <60 ppm

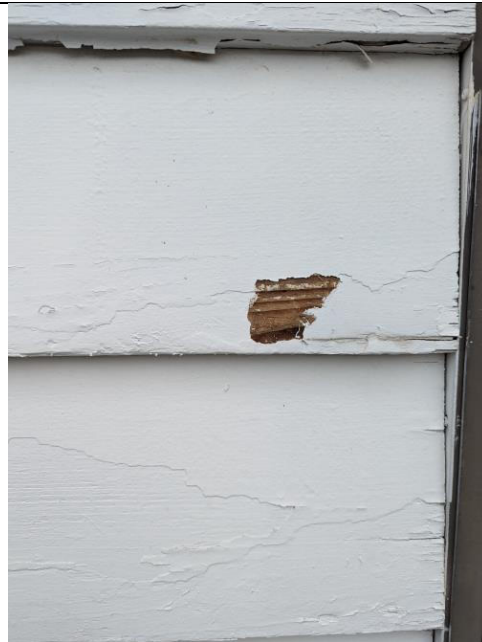
Sample: 38686 – Pb2
Location: Exterior of Building 12
Description: White Paint
Lead Content: 2210 ppm

Under the BC Hazardous Waste Regulation materials with identified lead-based paint destined for disposal at a licensed landfill facility must be tested for leachability to determine if they should be handled as a hazardous waste.
