August 18, 2020

RE: Pre-Demolition Designated Substances Report
Environmental Health Centre Building
50 Colombine Driveway, Tunney's Pasture, Ottawa, ON

Englobe File No.: GV-OT-041133

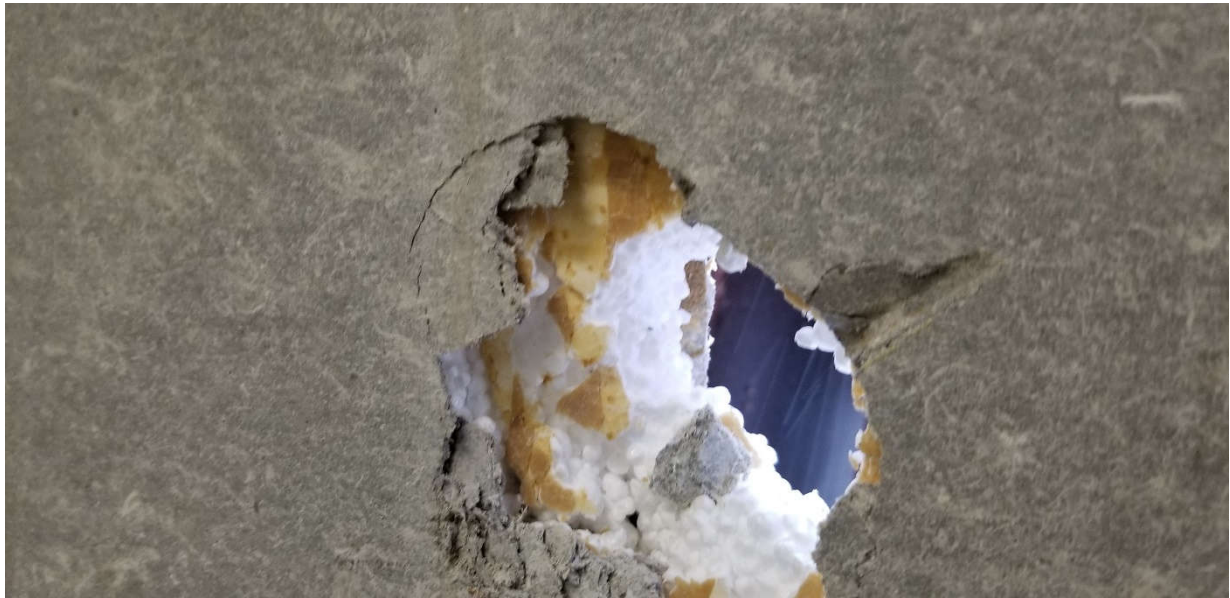
- Transite ceiling panels, observed in room B88, contains 15% Chrysotile asbestos (Sample 41133-05A).
- Double-layered Transite wall panels, observed in the penthouse, contains 15% Chrysotile asbestos (sample 41133-06A).

Photograph 1: Transite panels, observed in the penthouse, were confirmed to contain 15% Chrysotile asbestos (Sample ID 41133-06A)

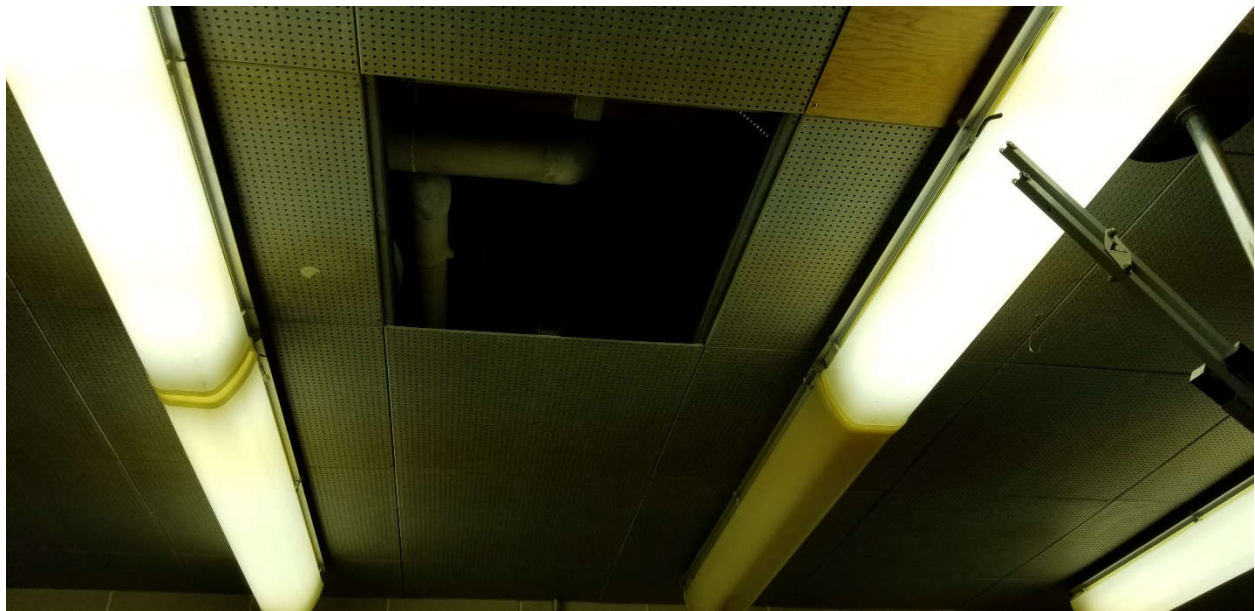
Photograph 2: Transite ceiling panels, observed in Room B88, were confirmed to contain 15% Chrysotile asbestos (Sample ID 41133-05A)

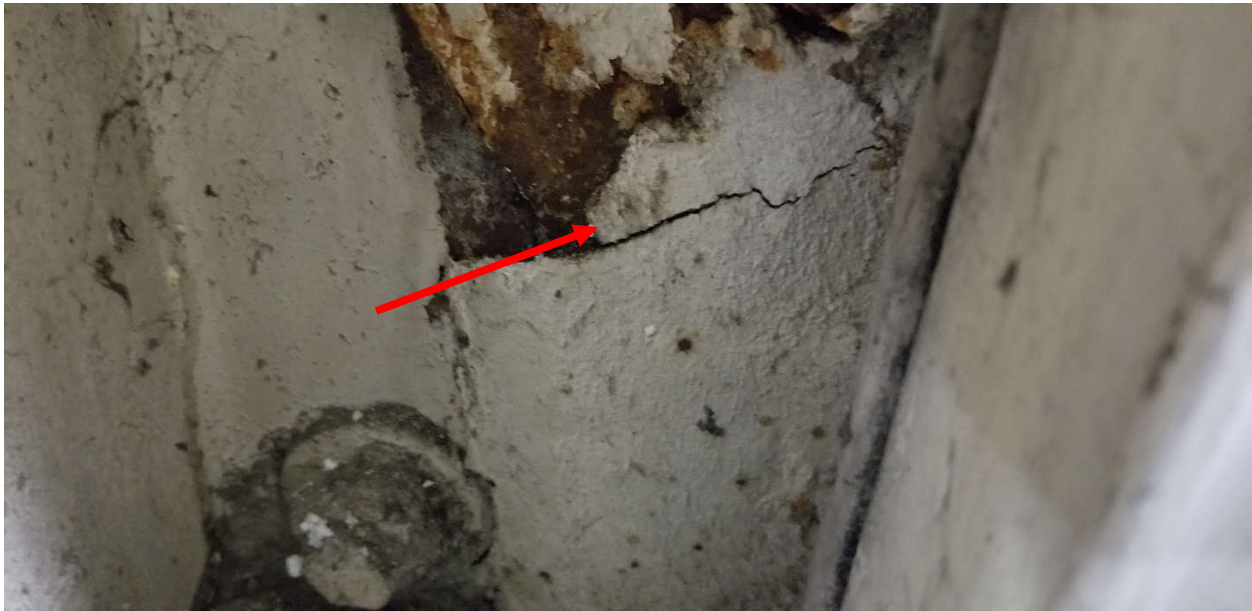
- Grey fibrous insulation, observed on the penthouse east, northern perimeter wall, contains 10% Chrysotile asbestos (sample 41133-13A).
- Parging cement, observed on the penthouse perimeter wall, contains 65% Chrysotile asbestos (Sample 41133-14A); and

Photograph 3: Parging cement on the Penthouse perimeter wall was confirmed to contain 65% Chrysotile asbestos (Sample ID 41133-14A).

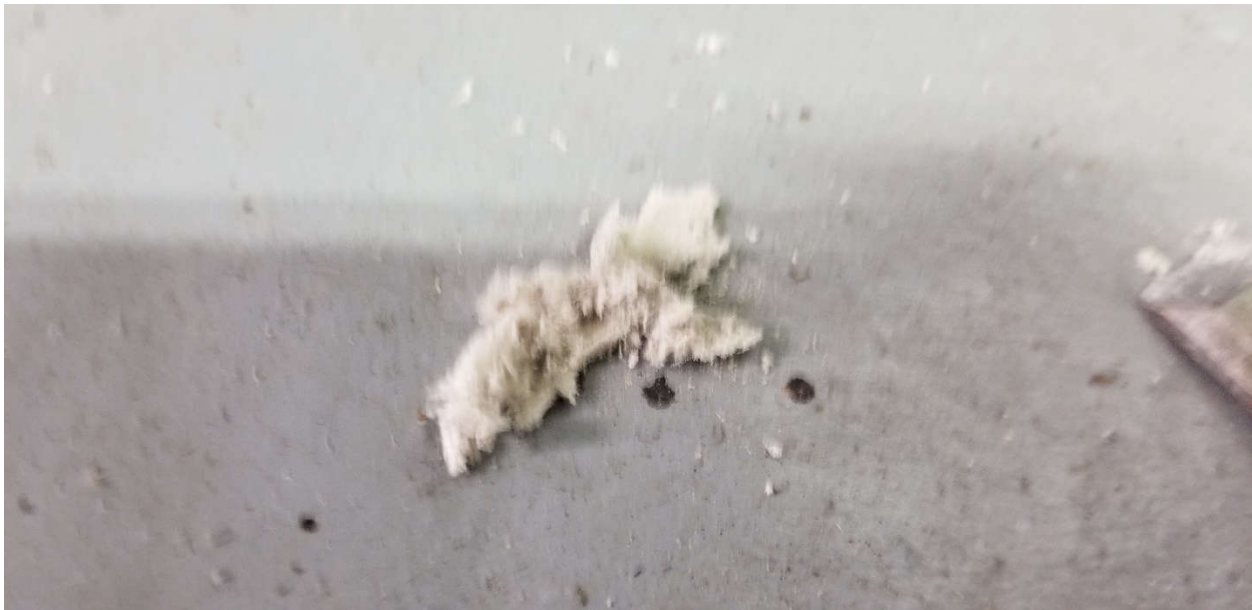
- Grey fibrous wall layer, observed on the penthouse north perimeter wall, contains 35% Chrysotile asbestos (sample 41133-16A).
- Black tar, observed on the exterior of Styrofoam (back-side), and present within the perimeter walls, contains 1% Chrysotile asbestos (Sample 41133-26A). This material is present behind multiple layers of wall finishing materials, whereby removal of the wall finishing materials is required to access (refer to ACM Database), and

Photograph 4: Grey fibrous wall coating, collected from the Penthouse perimeter wall, contains 35% Chrysotile asbestos (Sample ID 41133-16A).

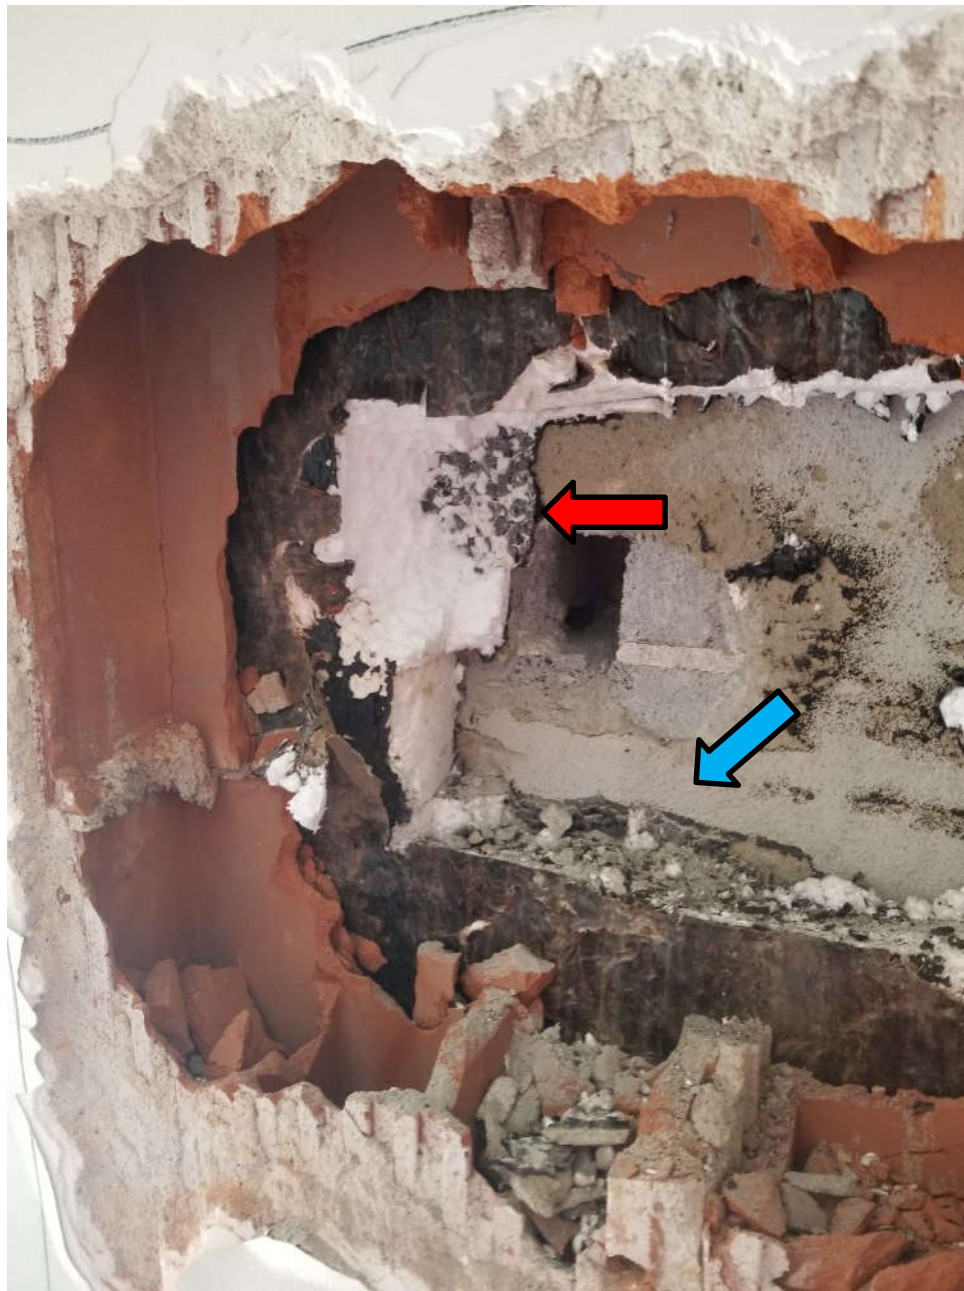
Photograph 5: Styrofoam, within the perimeter wall, contains tar layers on both sides. The tar on the exterior side (red arrow) contains 1% Chrysotile asbestos (Sample 41133-26A). Grey paring cement, within the perimeter wall (blue arrow), contains 1% Chrysotile asbestos (Sample 41133-21A[2]). To access the tar, demolition into the perimeter wall from the interior or exterior of the structure will be required. Materials are well adhered, whereby grinding, or mechanical means would be required for removal.

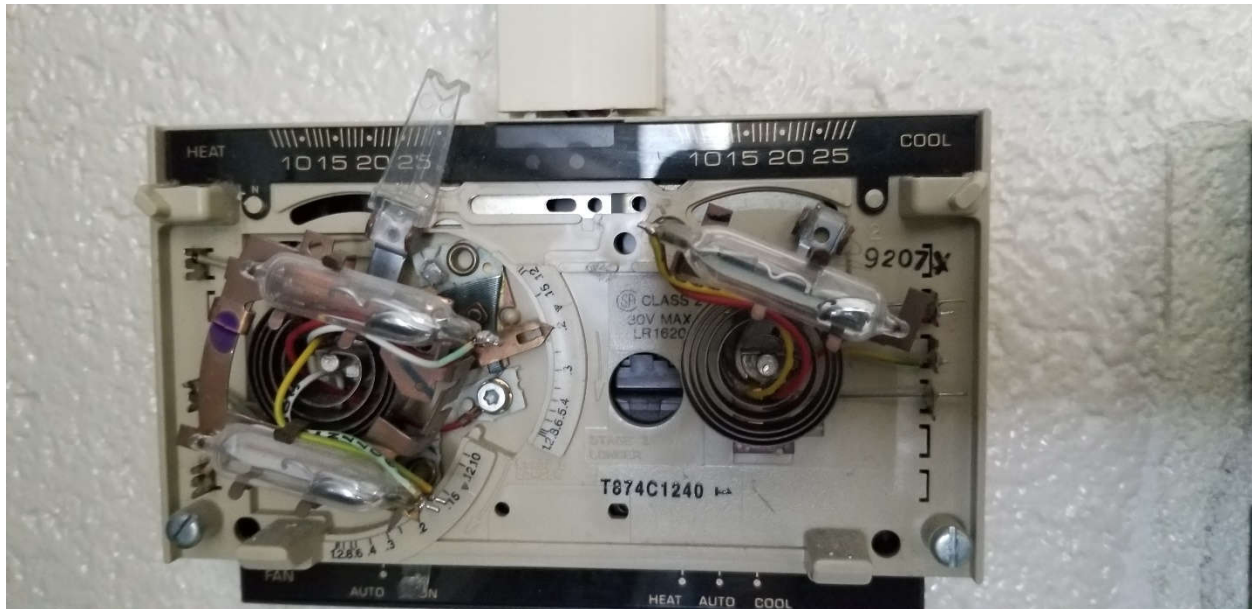
- Fluorescent light fixtures containing fluorescent light tubes, observed within the project areas. Fluorescent light tubes contain mercury in a vapour form and in the phosphor coating on the lamp tube.
 - Approximately 3,900 fluorescent light tubes were observed throughout the building, in fixtures and stored in boxes and closets.
- Thermostats, containing glass ampules of mercury, were observed throughout the building.
 - Approximately 10 mercury ampules were observed throughout the building.

Photograph 6: Thermostats, containing glass ampules of mercury, were observed throughout the building.

Liquid mercury is classified as a hazardous waste under O. Reg. 347/90, as amended. The transport of the waste to a disposal site is controlled by O. Reg. 347/90 and by the federal TDGA. It is now common practice to recycle fluorescent light tubes, and other items containing mercury, recovering the component materials, and avoiding the generation of hazardous waste.

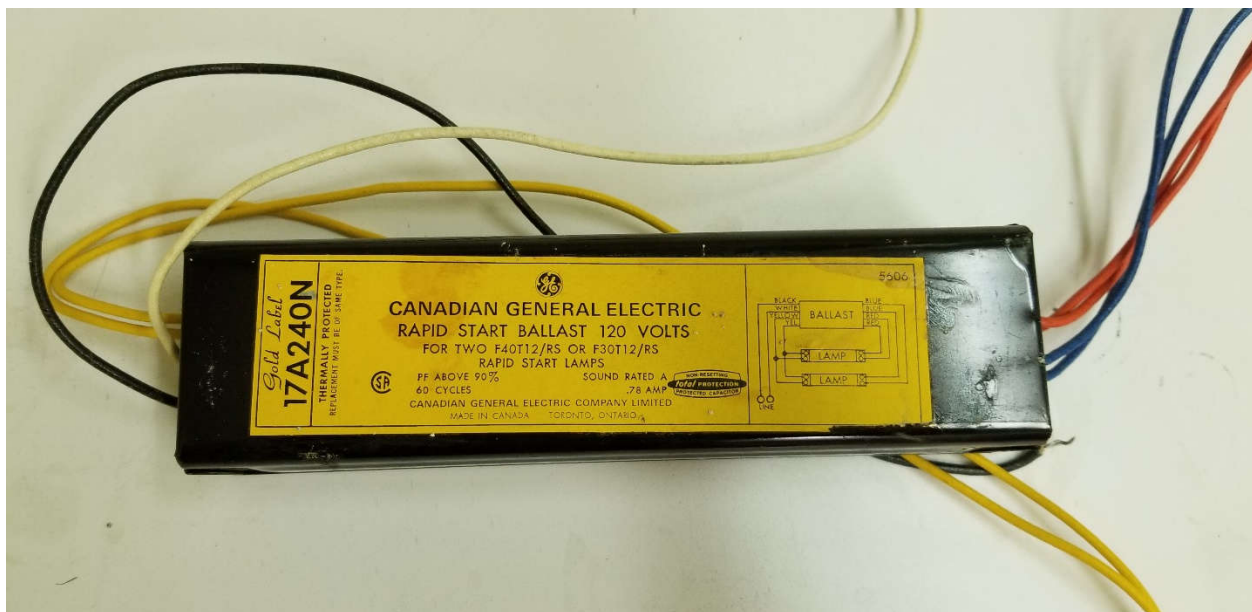
Light fixtures with T12 lamps are more likely to contain ballasts that were manufactured prior to 1981. T8 lamps are associated with light fixtures that were manufactured after the phase-out of PCB-containing ballasts. The letter "T" denotes the shape of the light fixture (e.g., tubular) and the number which follows indicates the diameter in eighths of an inch. Based on limited visual observations, Englobe observed suspected PCB ballasts within the building. As a due diligence measure, prior to removal, all ballasts should be inspected to confirmed PCB content. Approximately 2,000 ballasts are suspected throughout the building.

Photograph 7: PCB ballasts were observed within the building.

If PCB-containing equipment and/or materials are identified and must be removed, they should be disposed of in accordance with the Canadian Environment Protection Act's PCB Regulations, *O. Reg. 362/90 – Waste Management, PCBs*, and *O. Reg. 347, General – Waste Management*, as amended, are regulated under the Environmental Protection Act to regulate the handling, storage and transportation of hazardous substances and waste dangerous goods. The transport of PCB waste to the disposal site is controlled by the federal Transportation of Dangerous Goods Act.

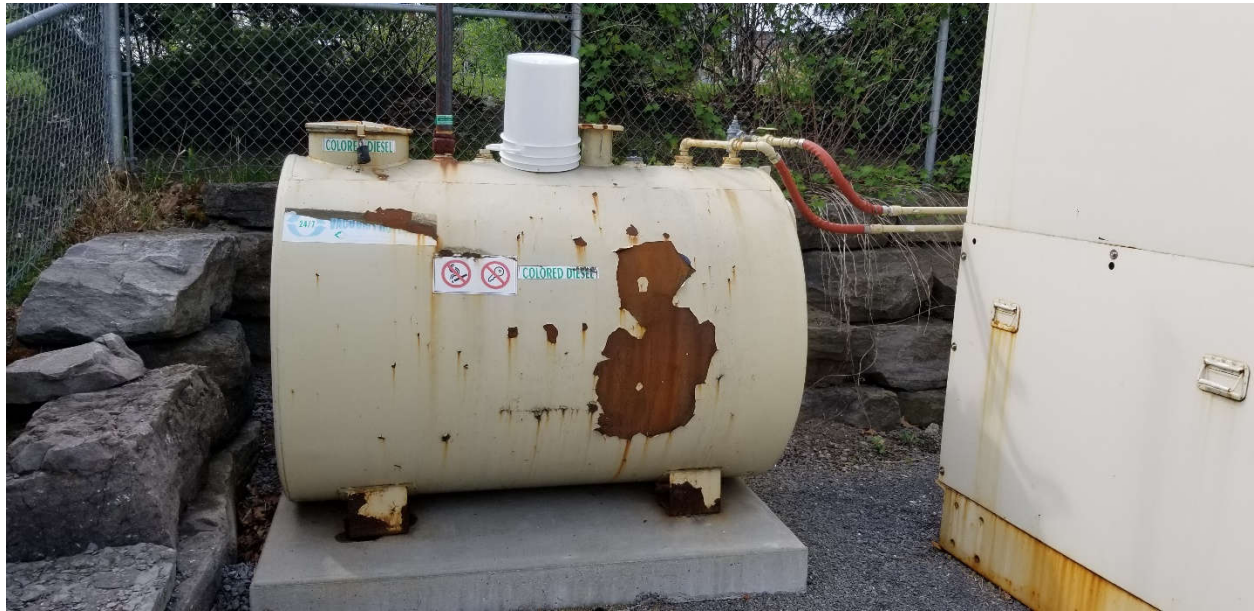
One (1) diesel storage tank with an estimated capacity of 7,500L was observed on the exterior east side of the site, in proximity to the loading dock.

Photograph 8: A diesel storage tank, with an estimated capacity of 7,500L, was observed on the exterior, eastern side of the building.

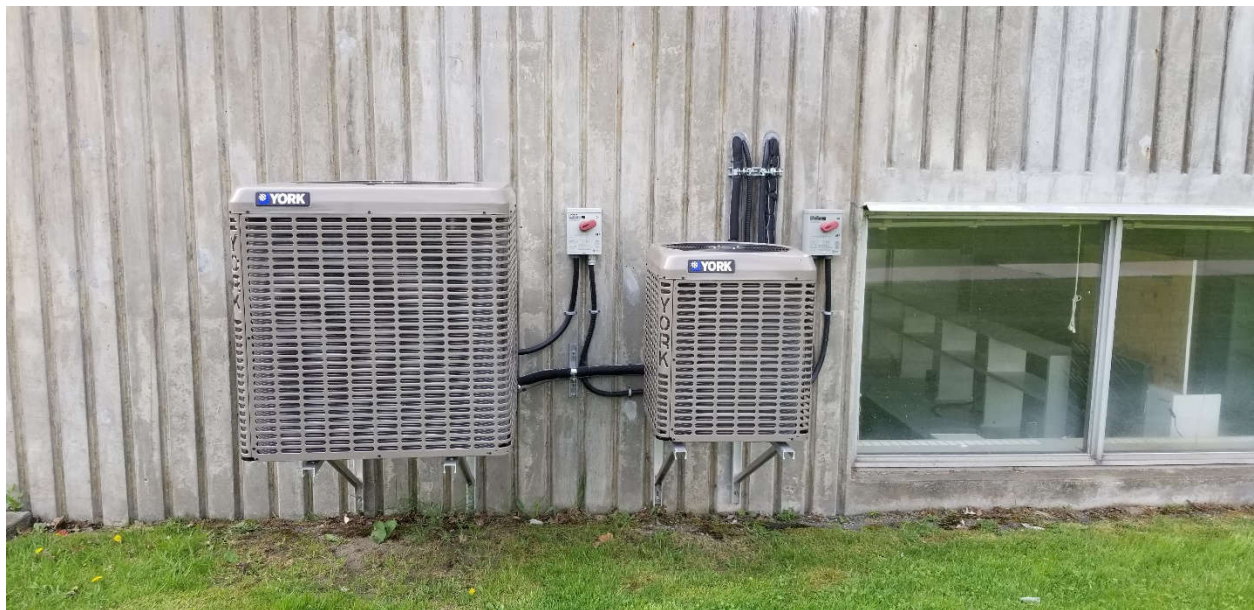
Photograph 9: External air handling units, confirmed to contain 10 lbs of R410A halocarbons.

- Federal Halocarbon Regulations (FHR), 2003,
- Ozone-depleting Substances and Halocarbon Alternatives Regulations, 2016,
- Environmental Code of Practice for Elimination of Fluorocarbon Emissions from Refrigeration and Air Conditioning Systems, 2015,
- O.Reg. 463/10, Ozone Depleting Substances and Other Halocarbons, and
- Federal Transport of Dangerous Goods Act and Ontario Dangerous Goods Transportation Act.
