**FINAL REPORT  
INVESTIGATION AND DESIGN OF REMEDIATION MEASURES  
VENUS TAILINGS SITE**

**PUBLIC WORKS AND GOVERNMENT SERVICES CANADA**  
1000 - 9700 Jasper Avenue  
Edmonton, Alberta  
T5J 4E2

**STEFFEN ROBERTSON AND KIRSTEN (CANADA) INC.**  
Suite 800, 580 Hornby Street  
Vancouver, B.C. V6C 3B6  
Tel: (604) 681-4196 • Fax: (604) 687-5532  
E-mail: [vancouver@srk.com](mailto:vancouver@srk.com) Web site: [www.srk.com](http://www.srk.com)

OCTOBER, 1998

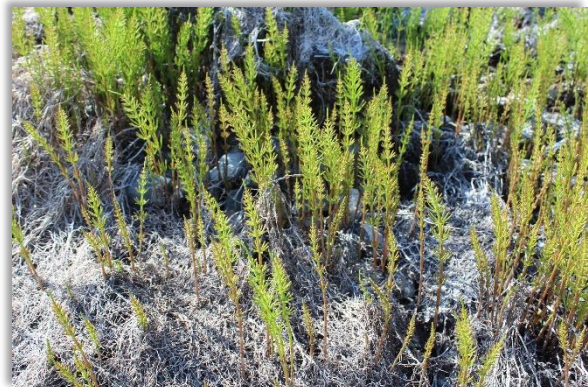
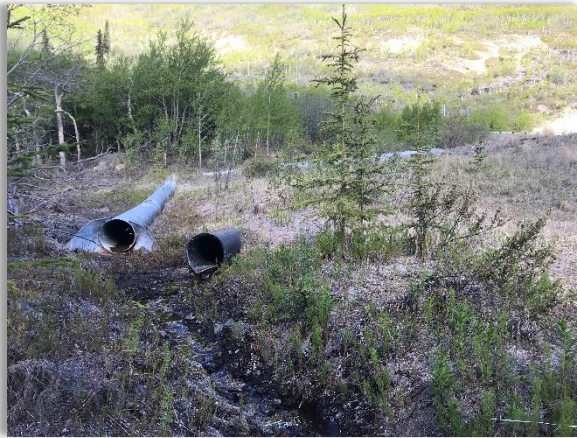
Arsenic concentrations measured in raspberry samples from the periphery of the tailings impoundment are high enough to pose acute health risks if adults consume more than 150 g of berries in one day. Children under the age of 5 may be at risk if they eat more than 35 g of berries in a single day. We advised against harvesting berries and other plants for consumption as country foods or traditional medicines from anywhere at Venus until the distribution and concentration of arsenic (and other metals) in vegetation consumed as country foods or used for traditional medicines is better understood.

Installing additional fencing to restrict public access to areas where soil arsenic is greater than 380 µg/g will also limit access to areas of the Site for collecting berries and other country foods/traditional medicines (e.g., *Equisetum*; see photo).

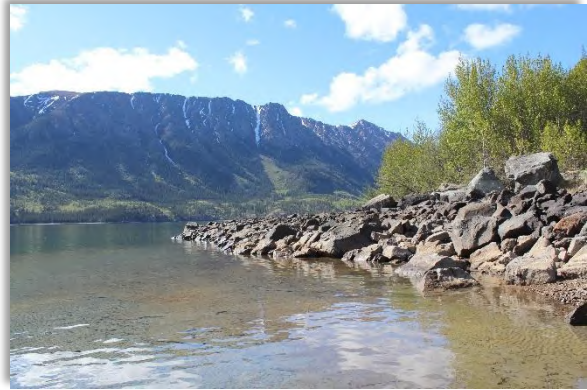
- Installing warning signs at areas where people are likely to access the Site by boat, in particular the mud bench area (see photo) near the outlet of Ditch Creek
- Installing pilings or other physical structures to prevent or dissuade people from landing a boat at the mud bench area near the outlet of Ditch Creek
