CCGS LIMNOS
STRUCTURAL MATERIAL LOSS SURVEY

XT6064-R

January 31, 2023

Canadian Coast Guard

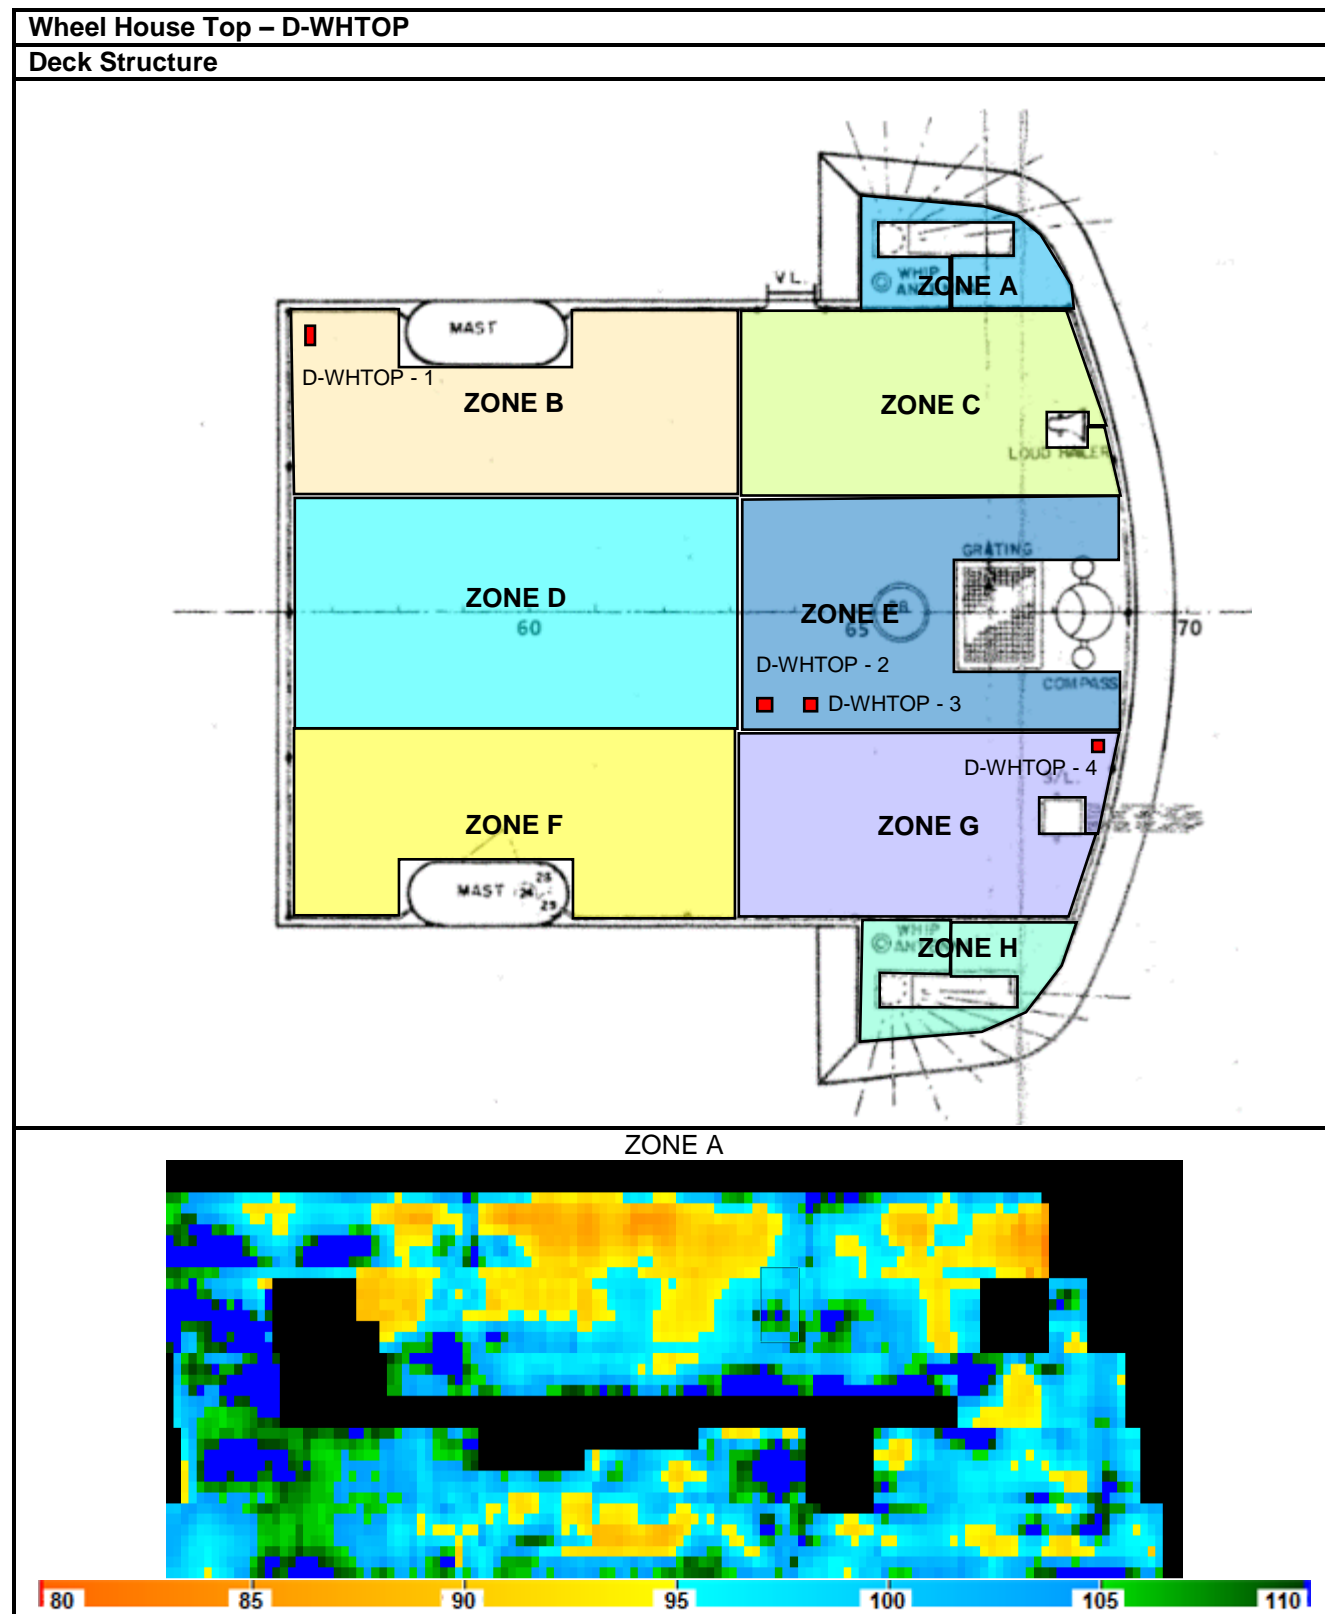
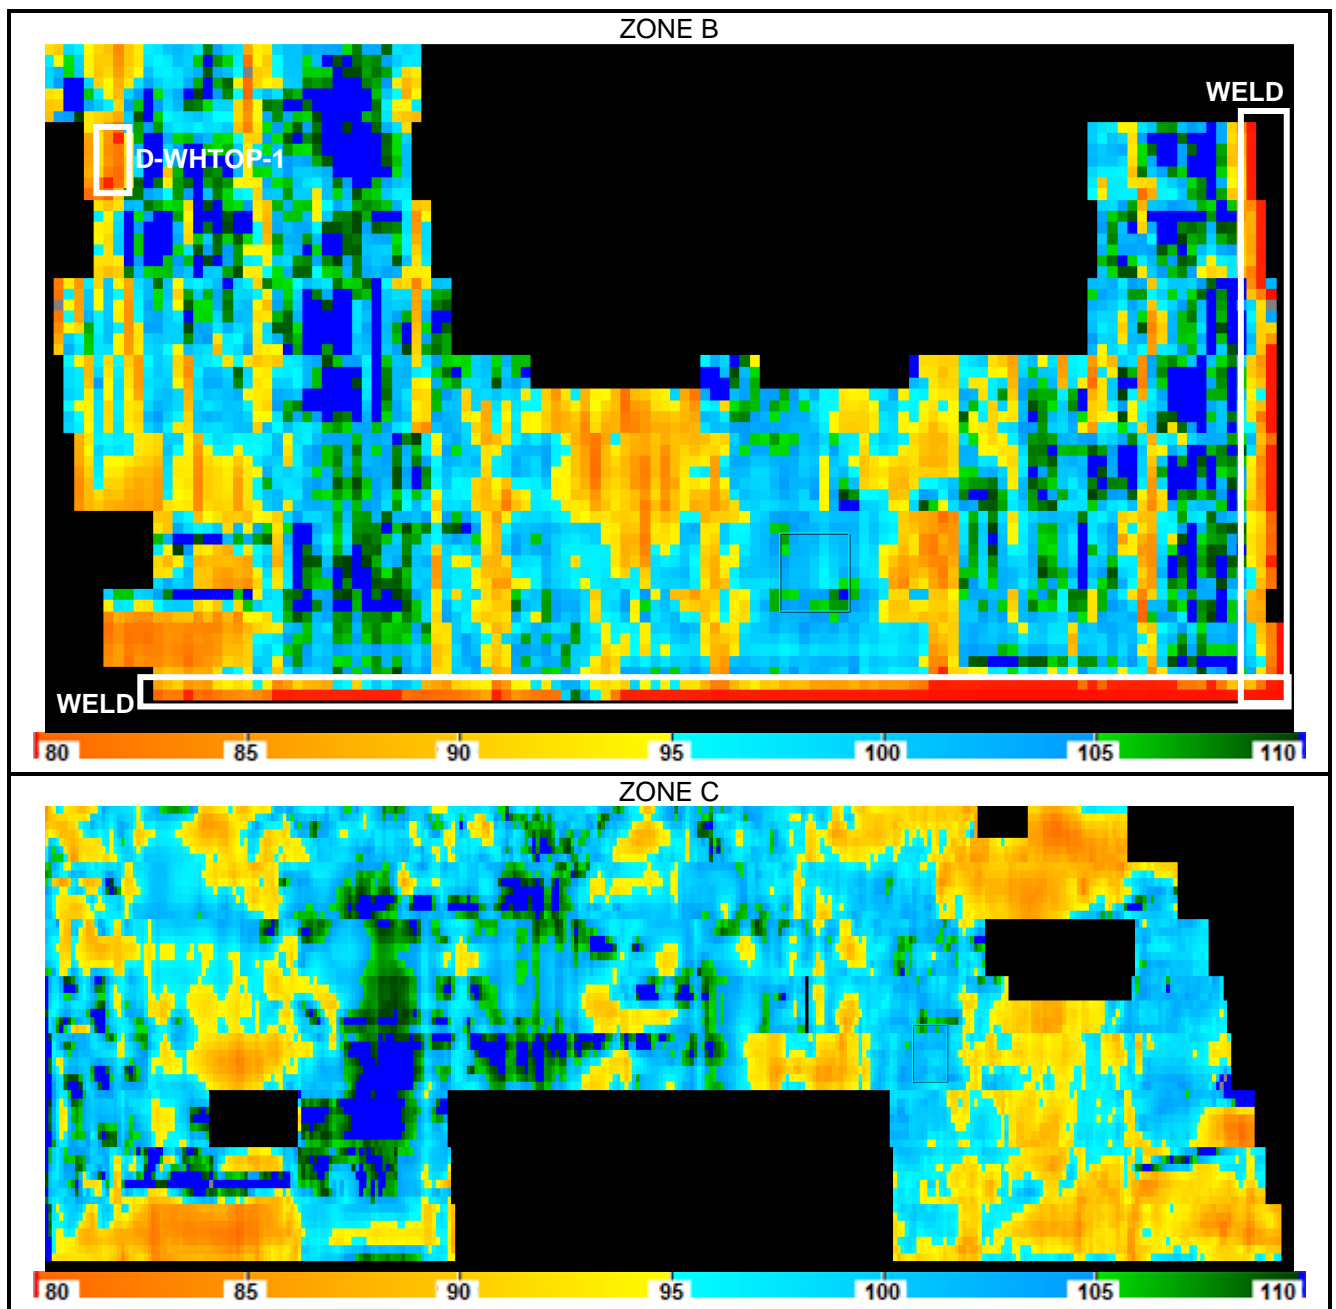
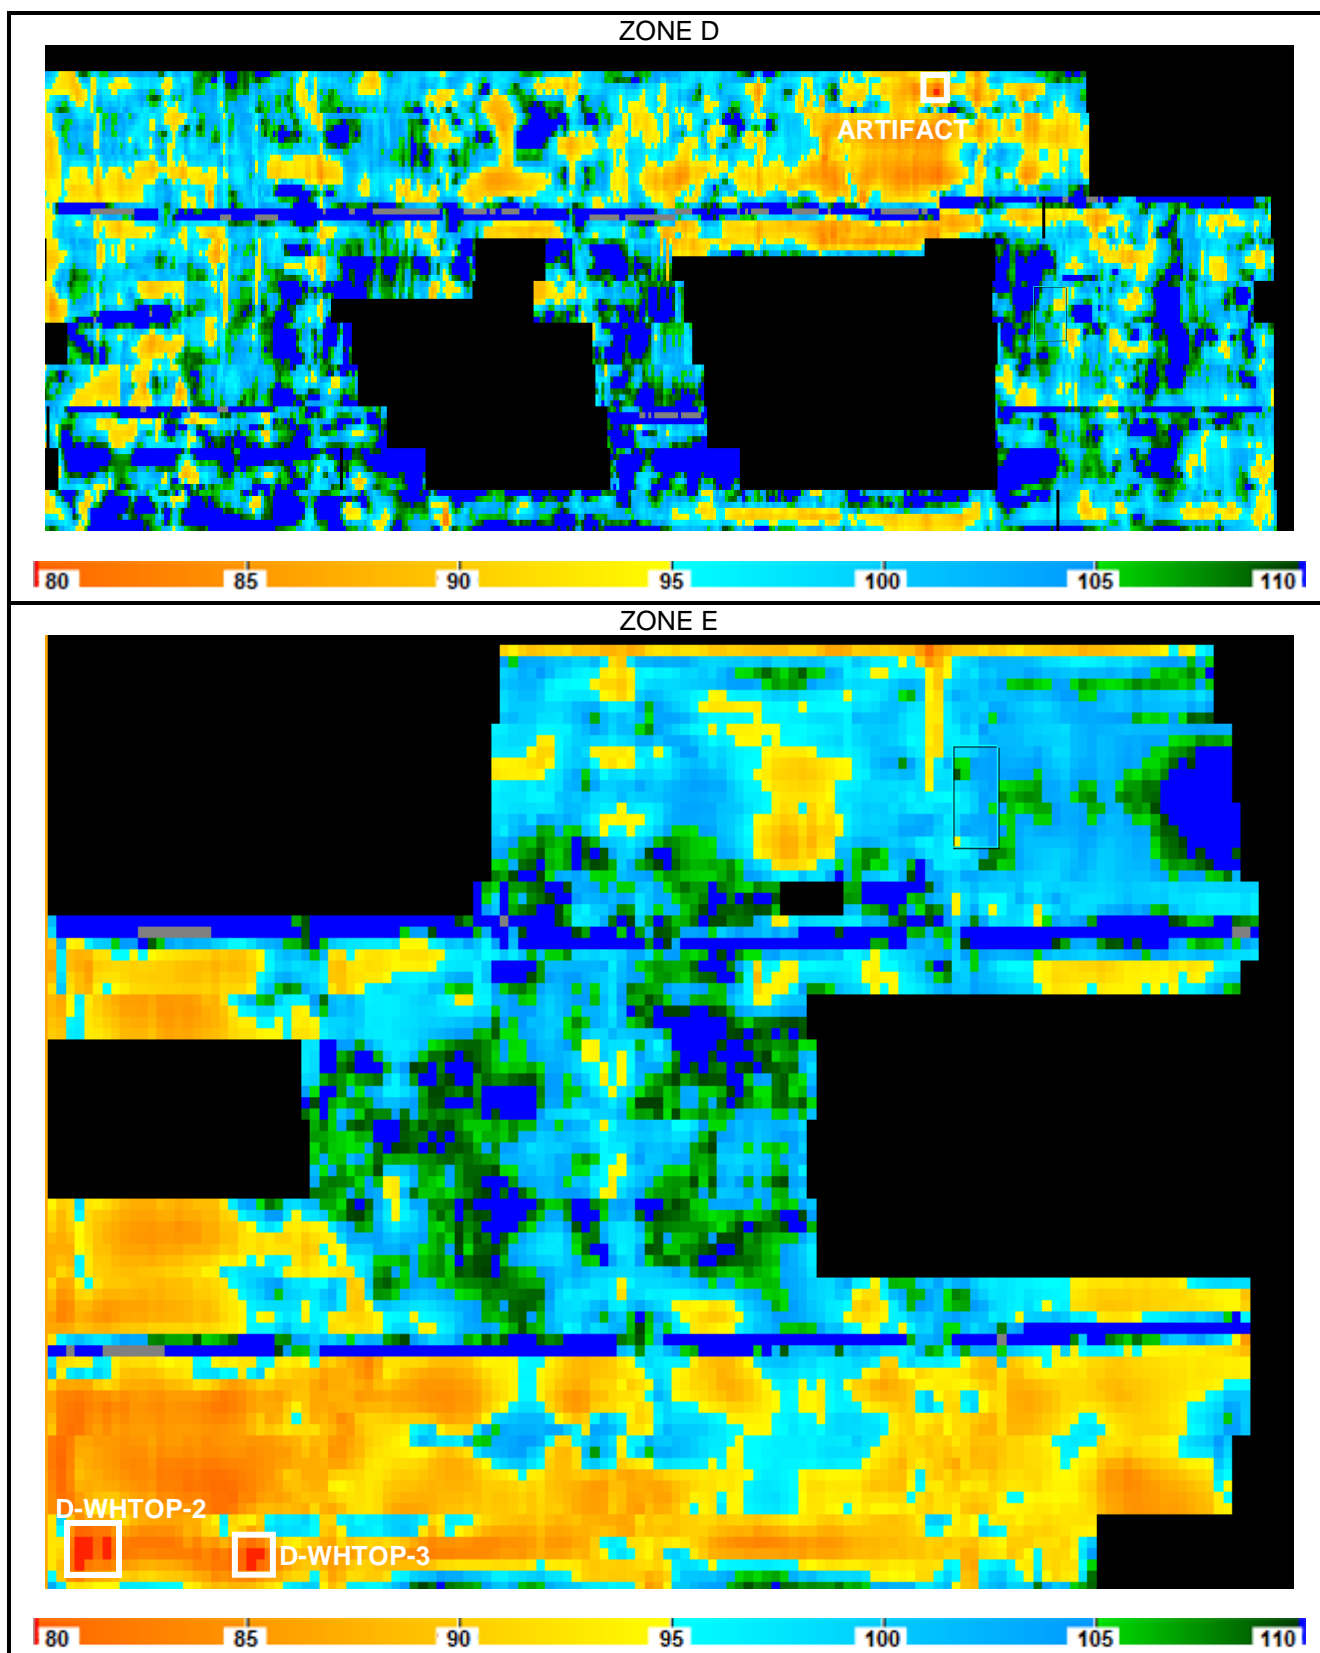
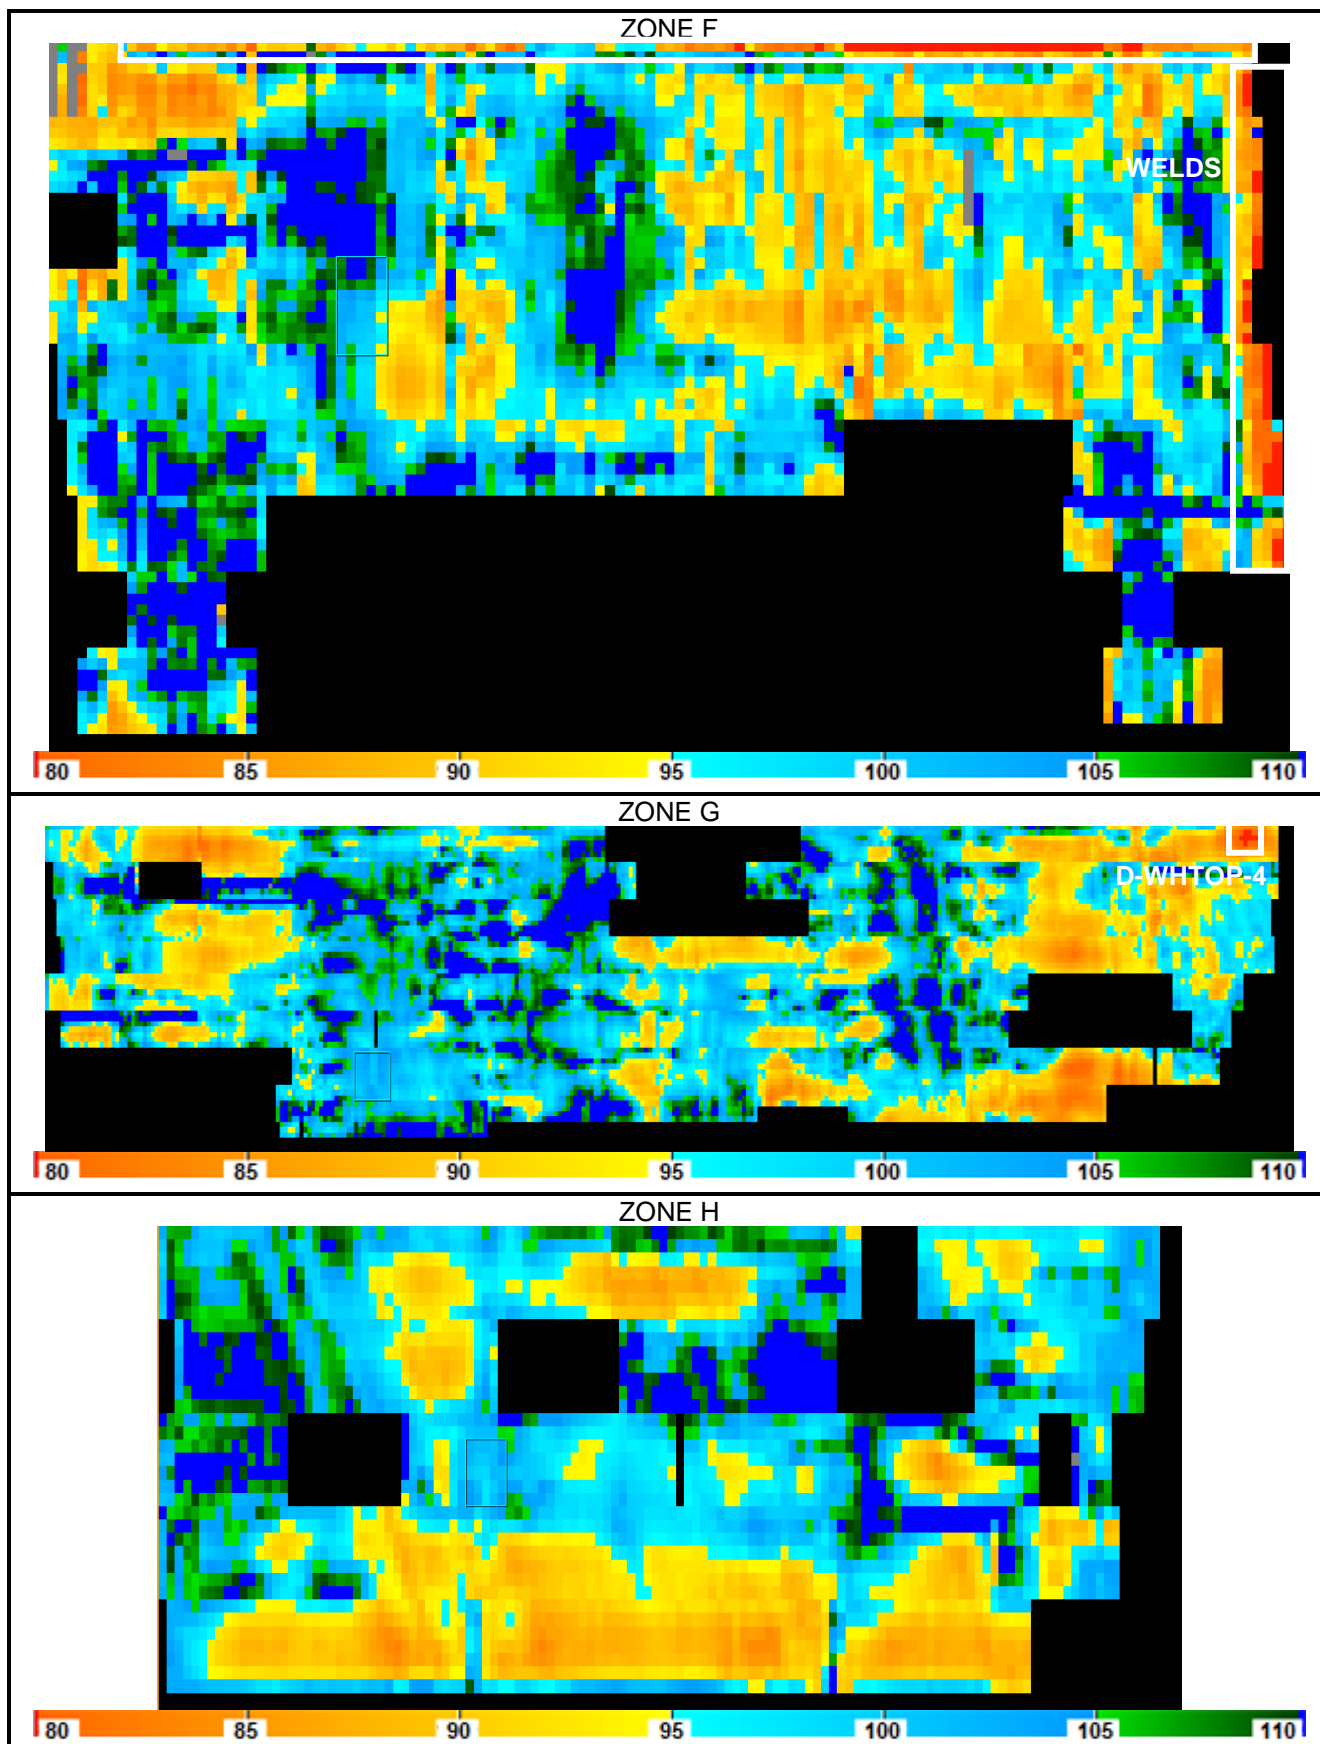
Areas Identified For Further Investigation		
D-WHTOP-1	Nominal Plate Thickness:	6.35mm
	Size:	75mm x 180mm
	Min Est WT%:	77.4% (~4.9mm)
	Avg Est WT%:	84.7% (~5.4mm)
D-WHTOP-2	Nominal Plate Thickness:	6.35mm
	Size:	80mm x 75mm
	Min Est WT%:	77.6% (~4.9mm)
	Avg Est WT%:	80.2% (~5.1mm)
D-WHTOP-3	Nominal Plate Thickness:	6.35mm
	Size:	50mm x 75mm
	Min Est WT%:	79.3% (~5.0mm)
	Avg Est WT%:	80.6% (~5.1mm)
D-WHTOP-4	Nominal Plate Thickness:	6.35mm
	Size:	65mm x 75mm
	Min Est WT%:	78.4% (~5.0mm)
	Avg Est WT%:	79.7% (~5.1mm)
NOTES: Zone D contains an artifact that is not corrosion, as the magnetic response curves of the PEC data in this area show that the low thickness signals are due to magnetic permeability differences.

D-WHTOP-1 is located near a stanchion mount, which can cause interference. Thus, it is recommended that UT measurements are conducted to verify the state of this area.

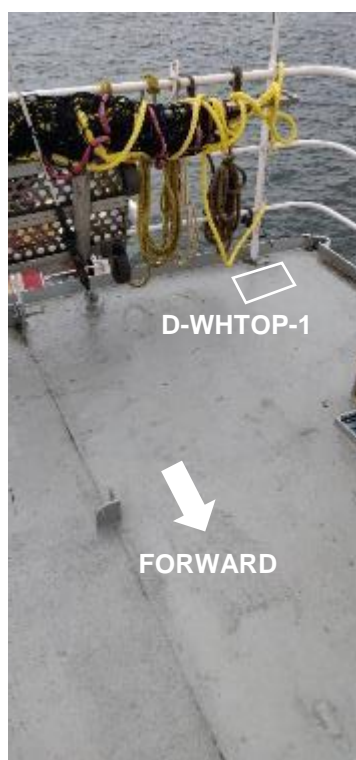
Figure 10 – Defect D-WHTOP-1 on the Aft Portside plate of the Wheel House Top

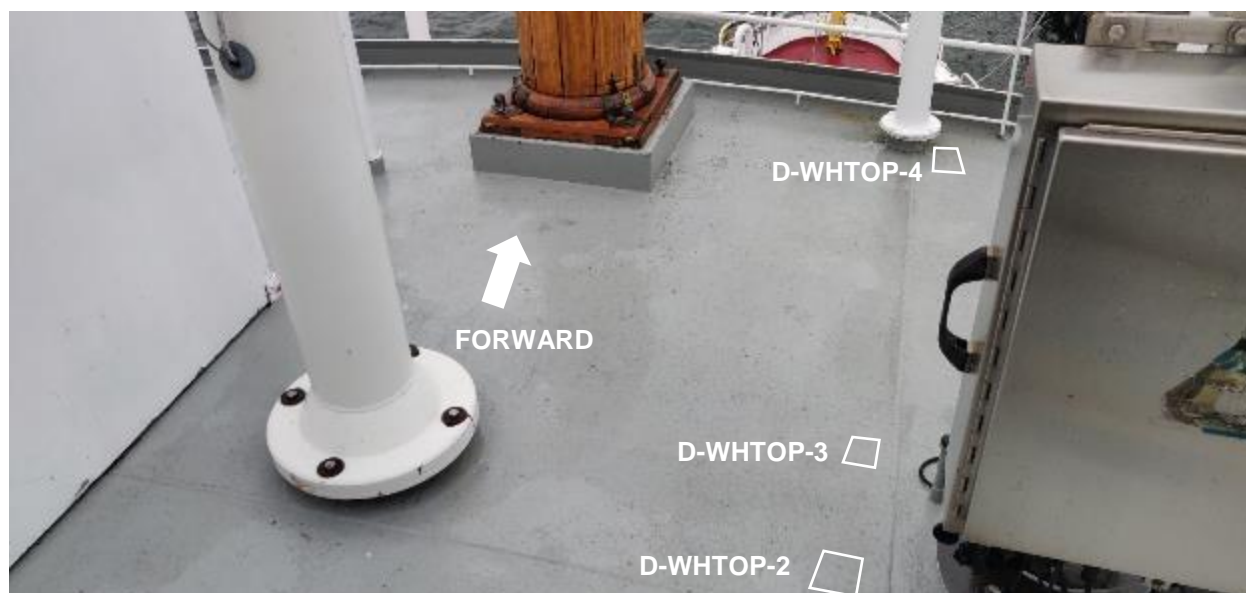
Four (4) defects below the 80% reporting threshold were located in this scan.

Figure 11 – Defects D-WHTOP-2 and D-WHTOP-3 on the Forward Middle Plate and D-WHTOP-4 on the Forward Starboard plate of the Wheel House Top

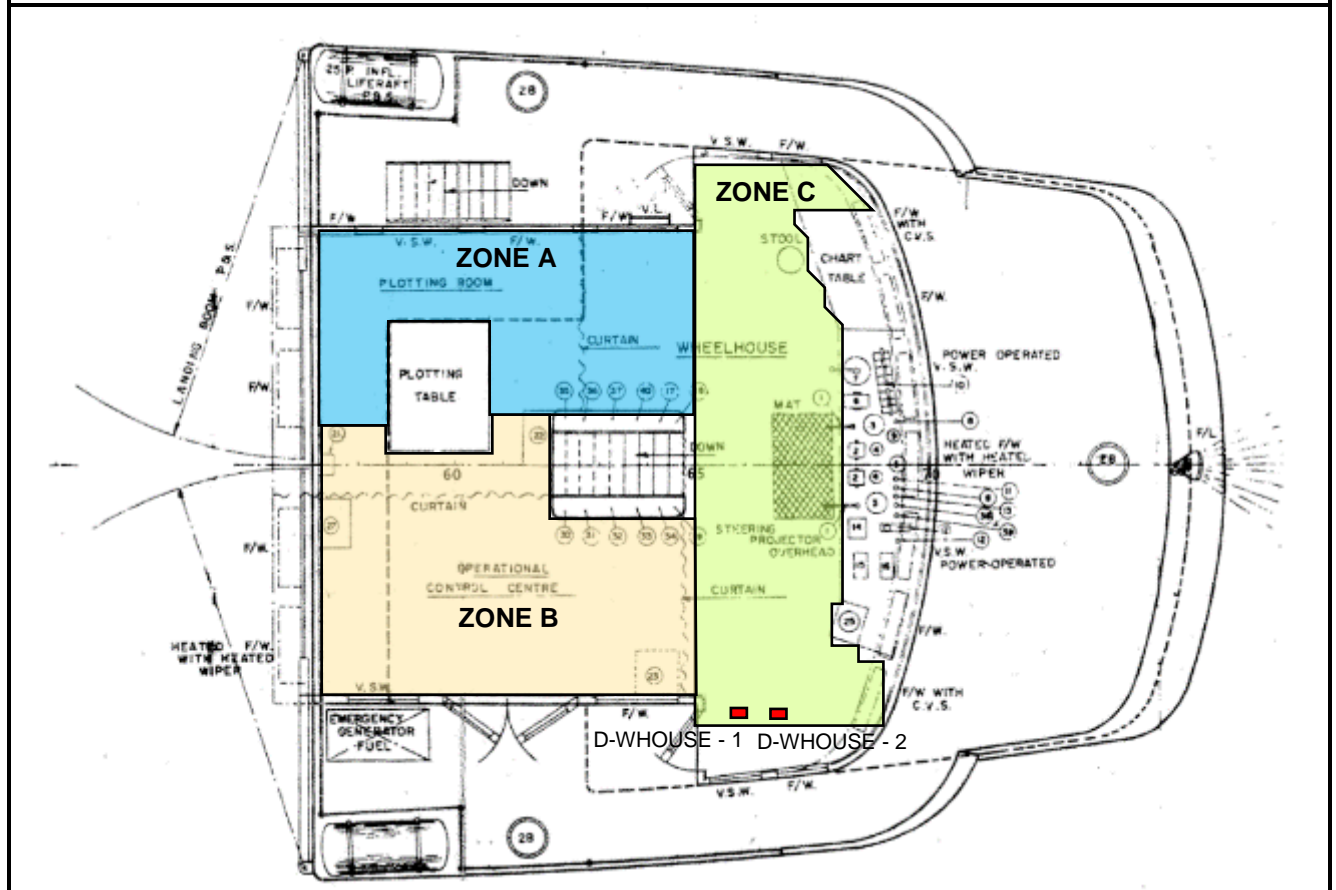
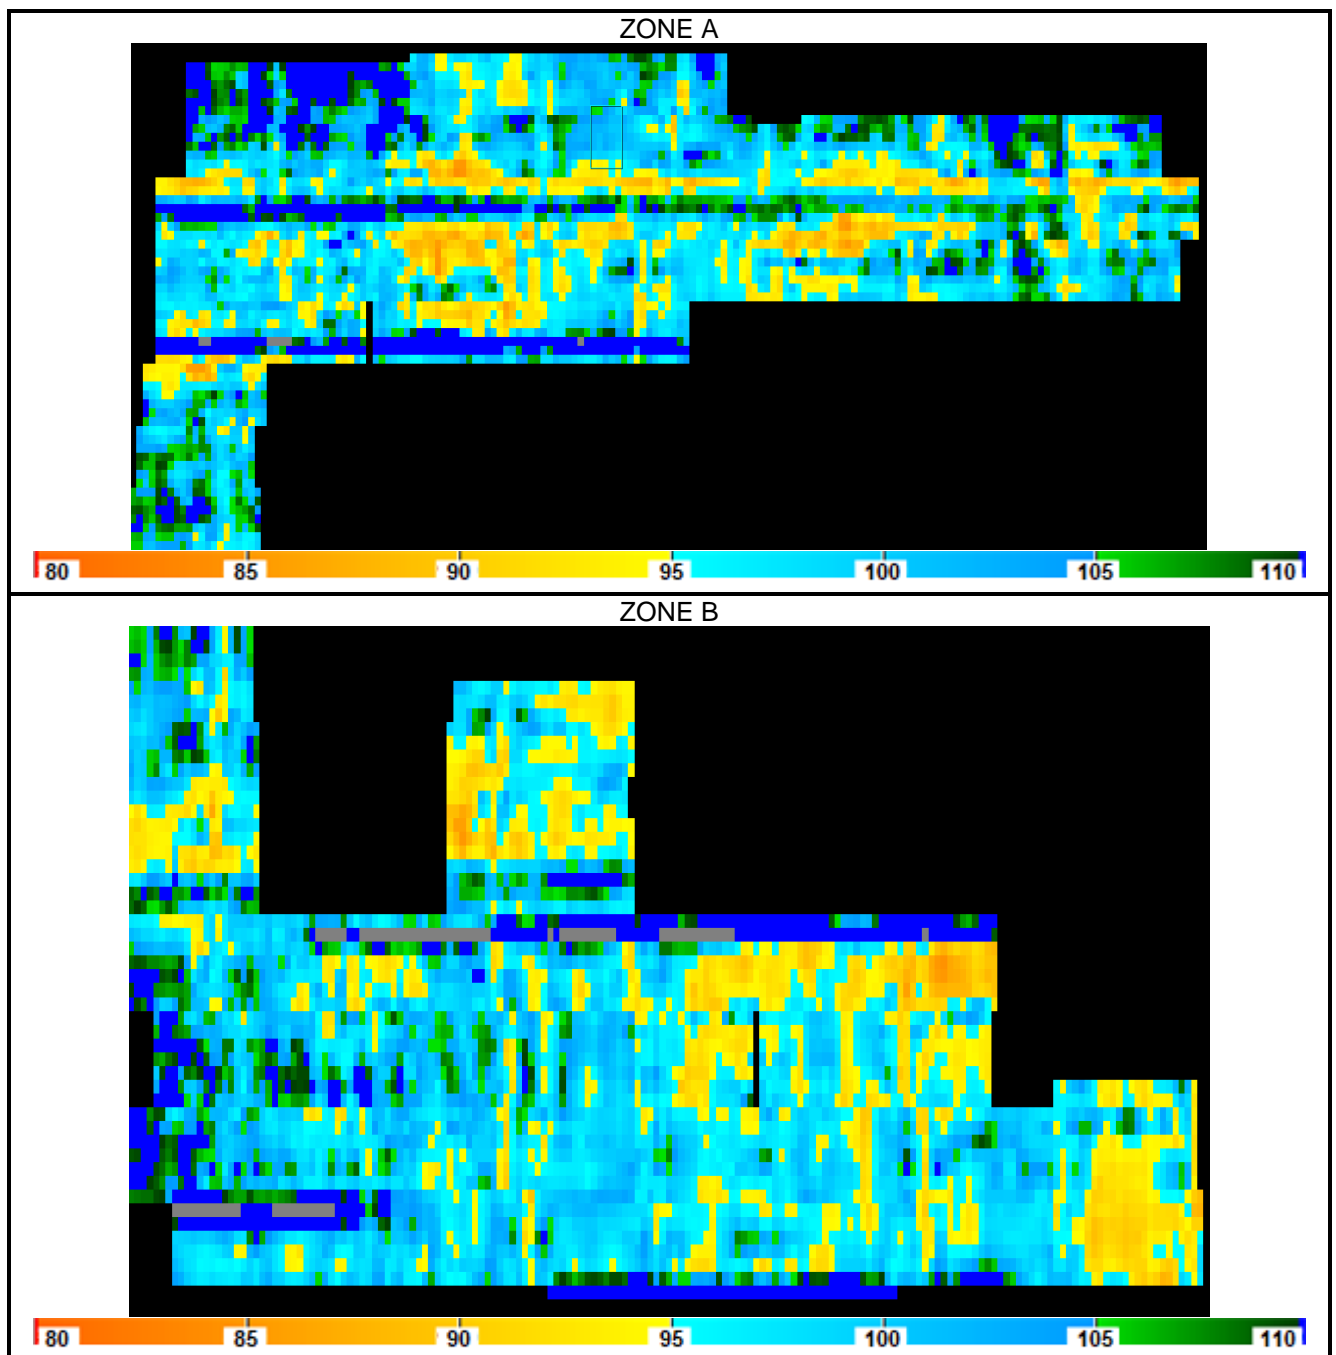
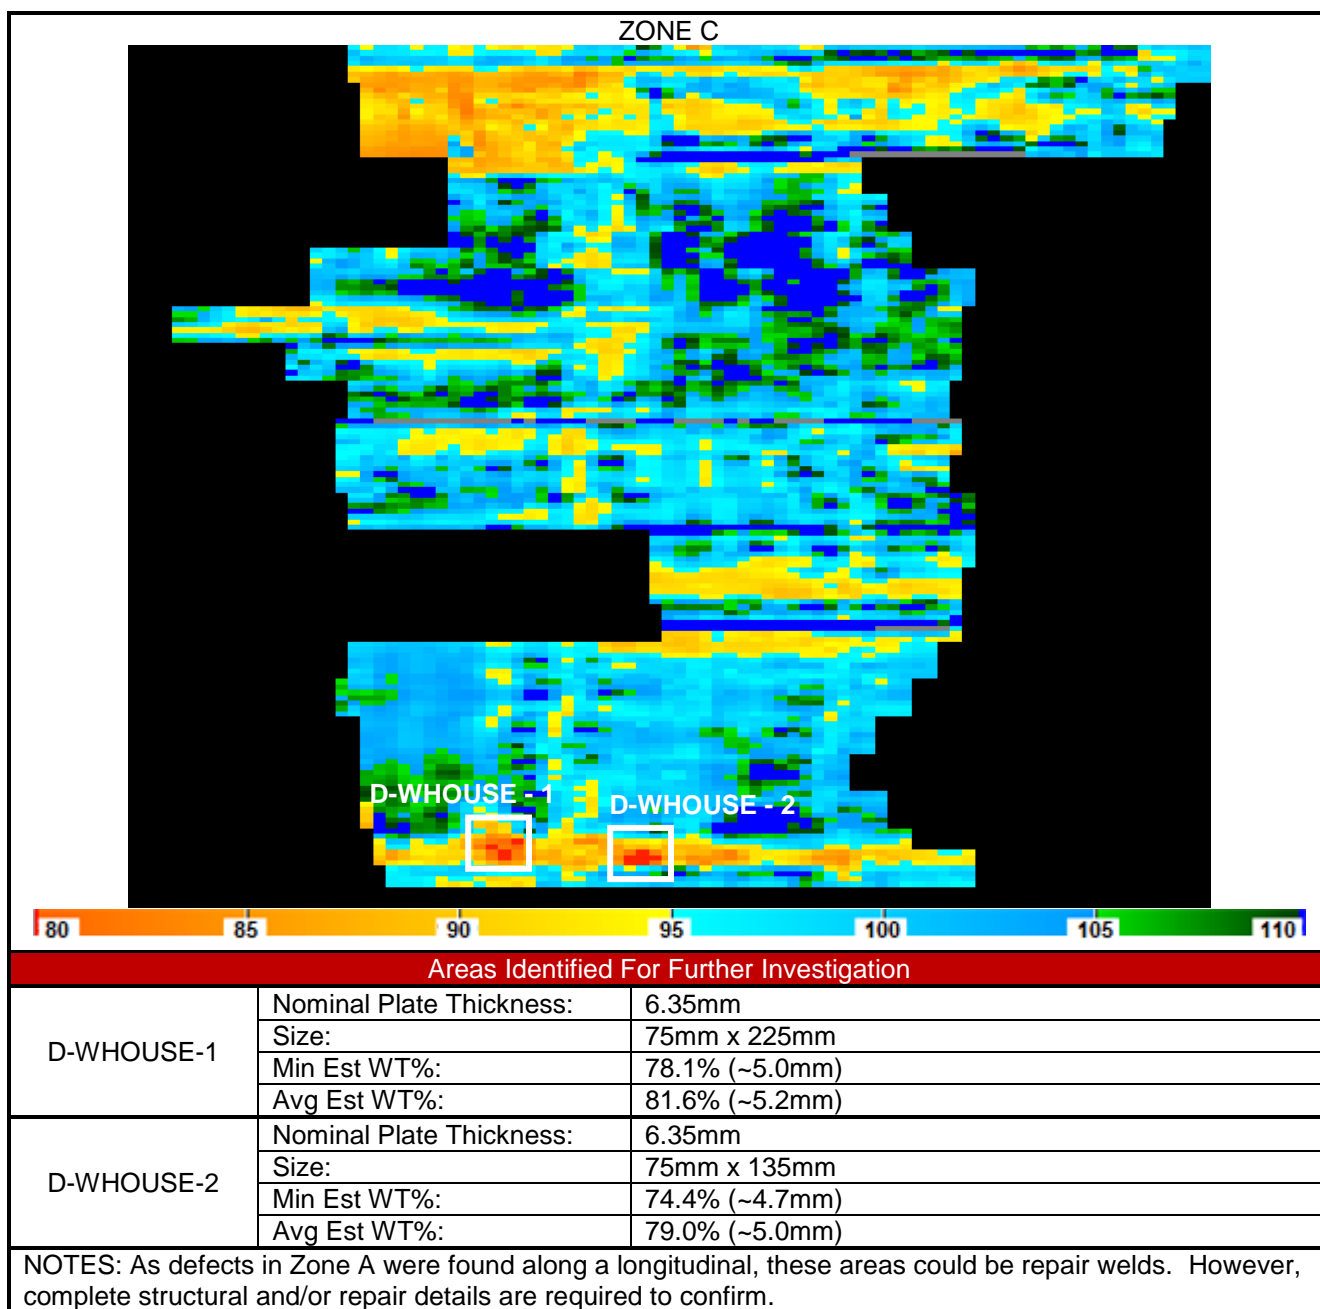
Wheel House – D-WHOUSE

Both D-WHOUSE-1 and D-WHOUSE-2 are located near the Wheel House entrance on a longitudinal structural member. This area is prone to corrosion as it is in proximity to a wet space (exterior deck) and is a high-traffic zone. However, it is possible this defect is in fact a weld repair or unknown structural feature and therefore it is recommended that the repair records in this area are reviewed and/or UT measurements are conducted to verify the state of this area.

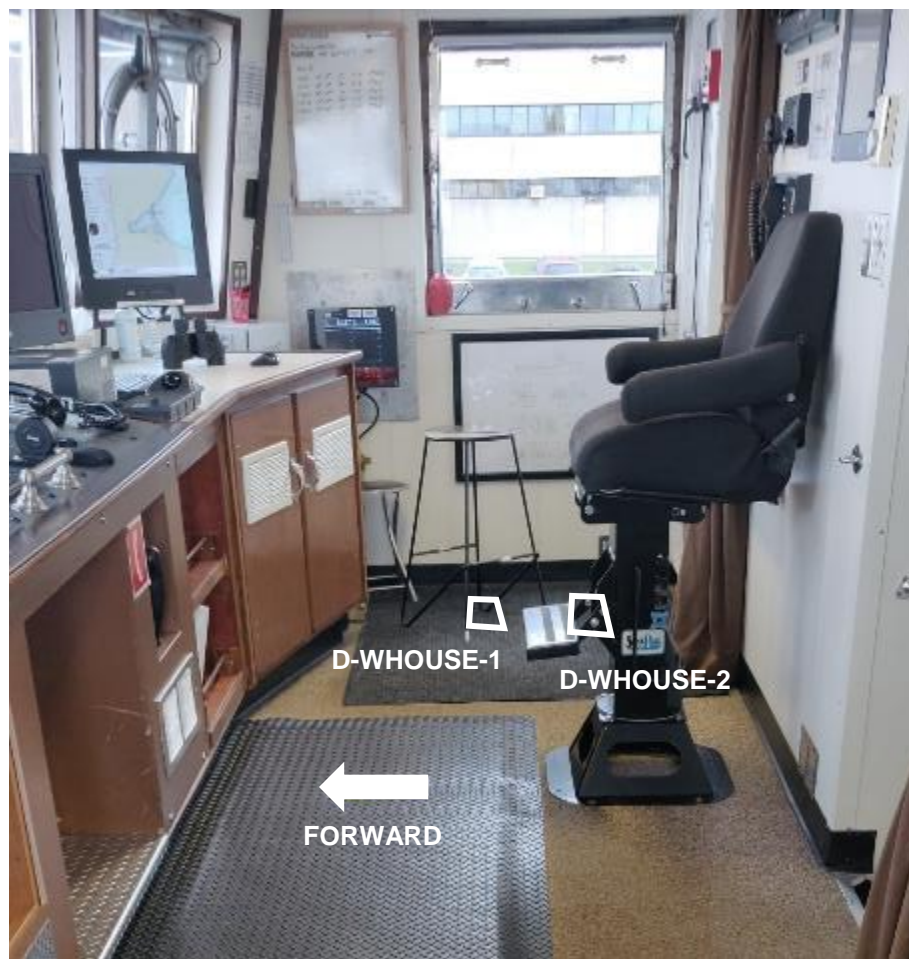
Figure 12 – Defects D-WHOUSE-1 and D-WHOUSE-2 at the Forward Starboard Side of the Wheelhouse

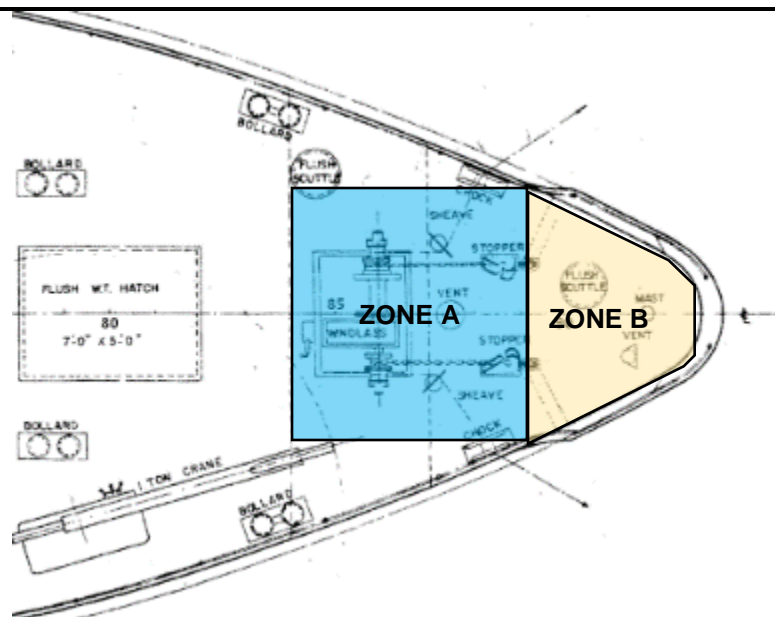
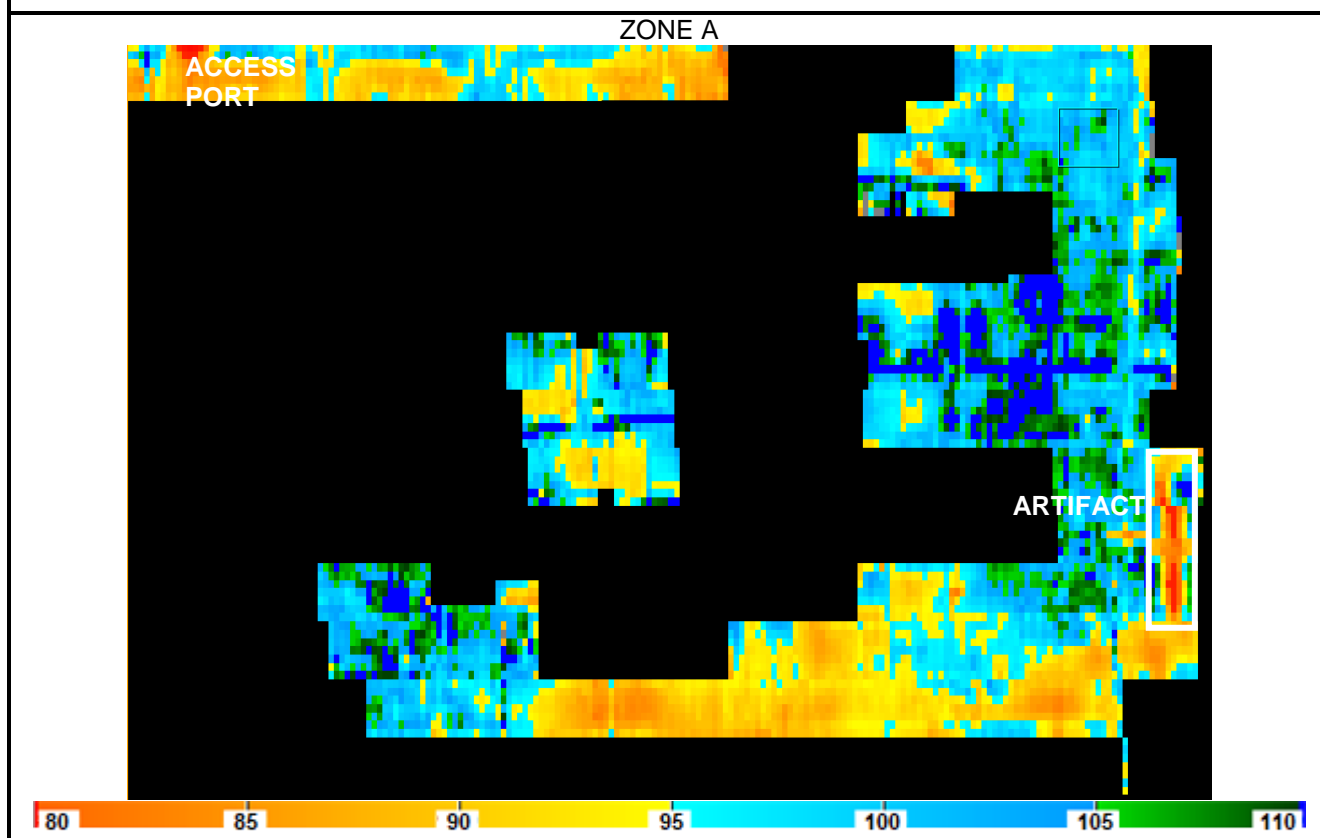
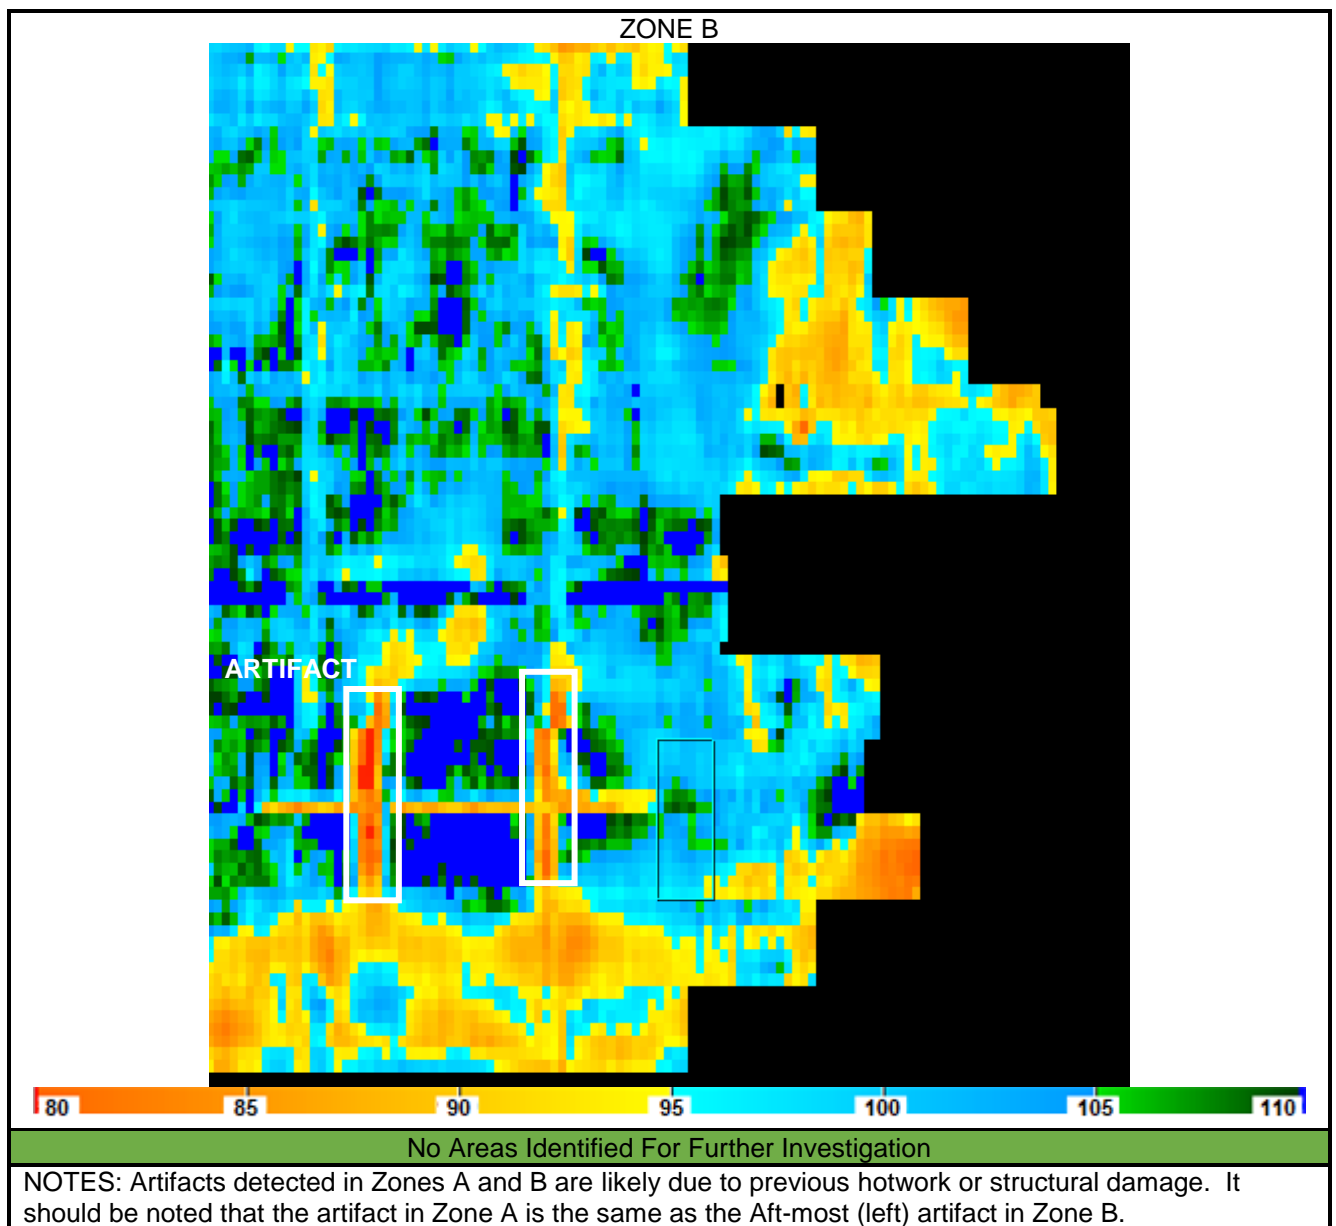
Anchor Windlass – D-AWIND

No defects below the 80% reporting threshold were located in this scan. The artifacts detected in the scan are likely due to previous hotwork or structural damage. During the survey, the CCGS LIMNOS crew indicated that the anchor windlass was previously actuated while the anchor was in the anchor pocket, causing strain to the structure in the area of the scan. Strain on the steel can cause local magnetic permeability variations, resulting in errant PEC measurements.

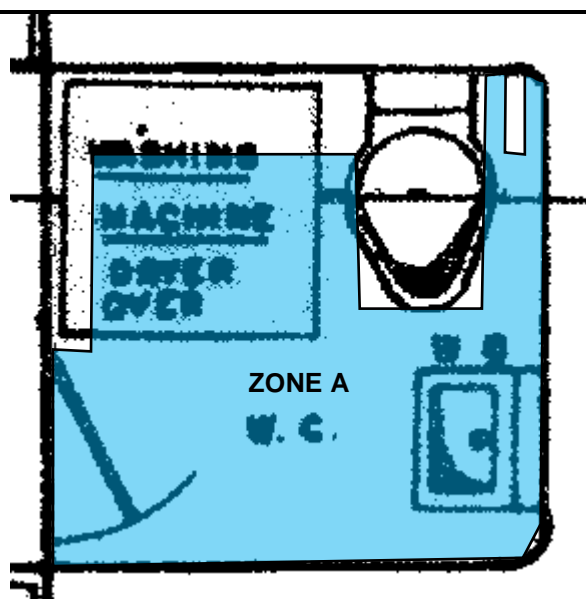
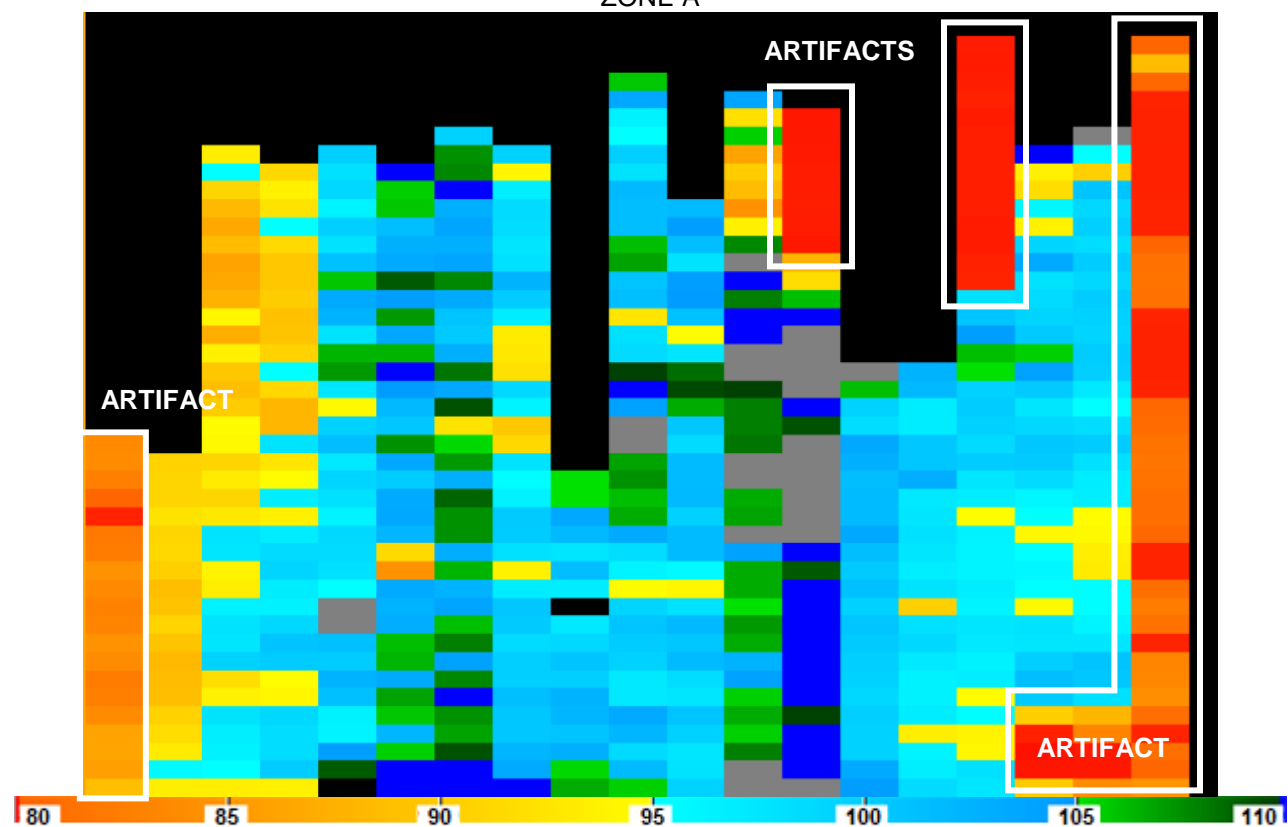
Main Deck Washplace – D-MDWP

NOTES: Multiple artifacts are found in this scan zone due to interference from the sandwich plate beneath the toilet and interference near the bulkheads.

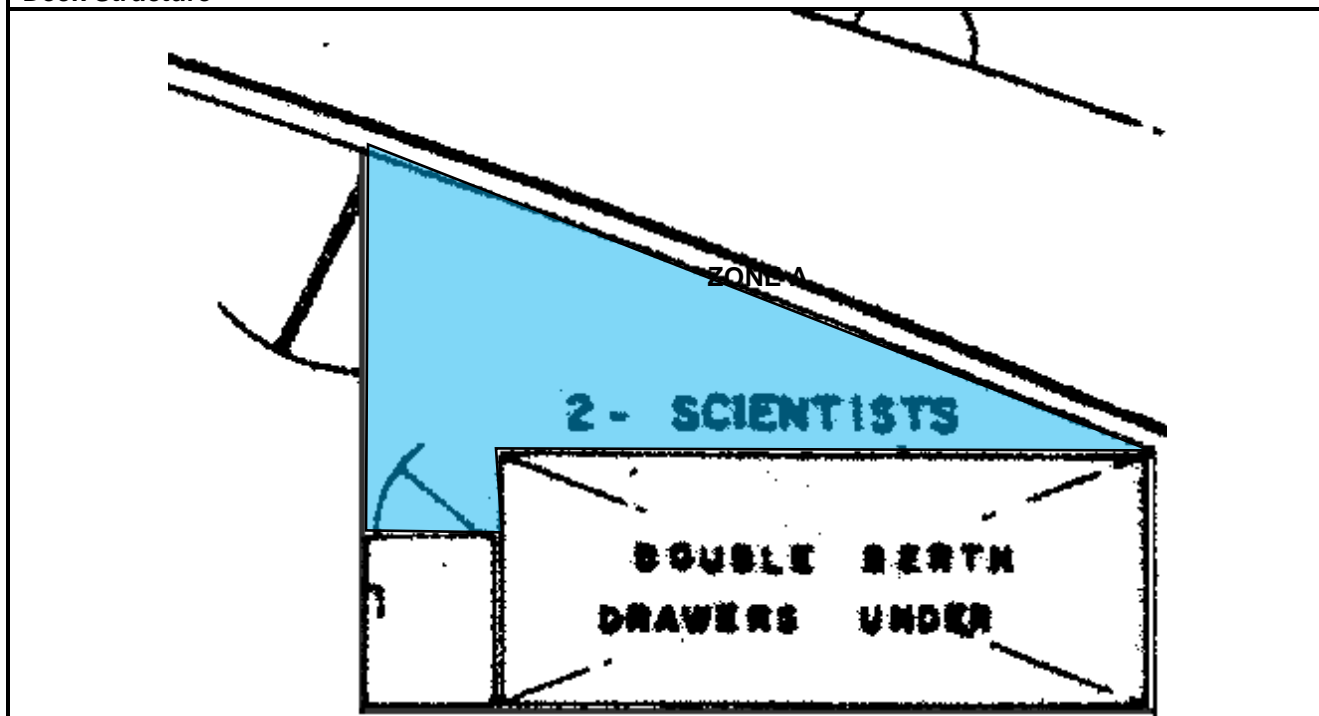
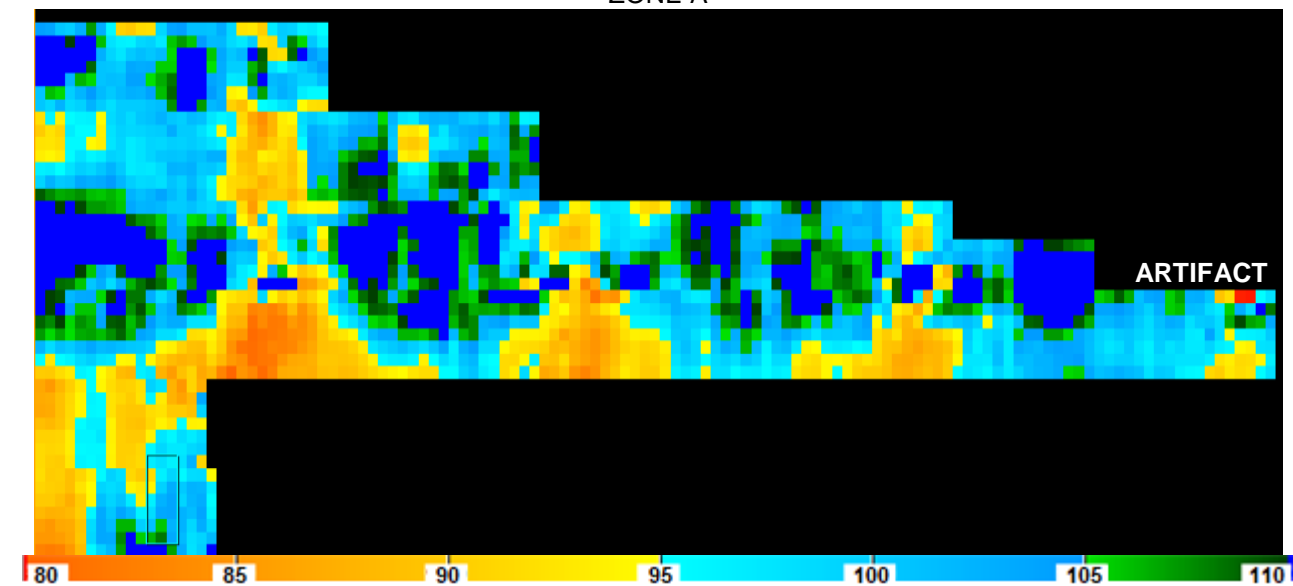
Main Deck Forward Port Cabin – D-FWPC

NOTES: The artifact in this zone is likely due to a weld or unknown structural feature, since magnetic response curves of the PEC data in the area of the artifact indicate that there is no corrosion present.
