CCGS LIMNOS
STRUCTURAL MATERIAL LOSS SURVEY

XT6064-R

January 31, 2023

Canadian Coast Guard

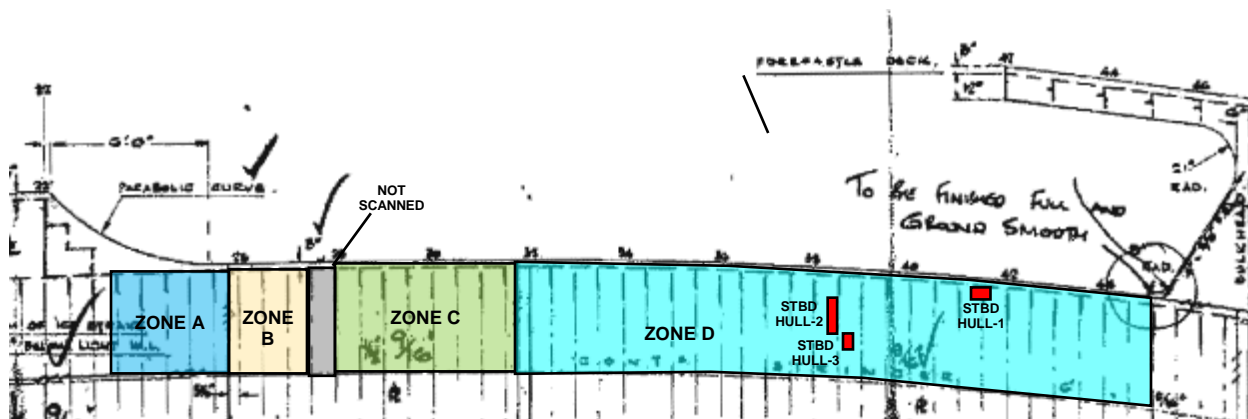
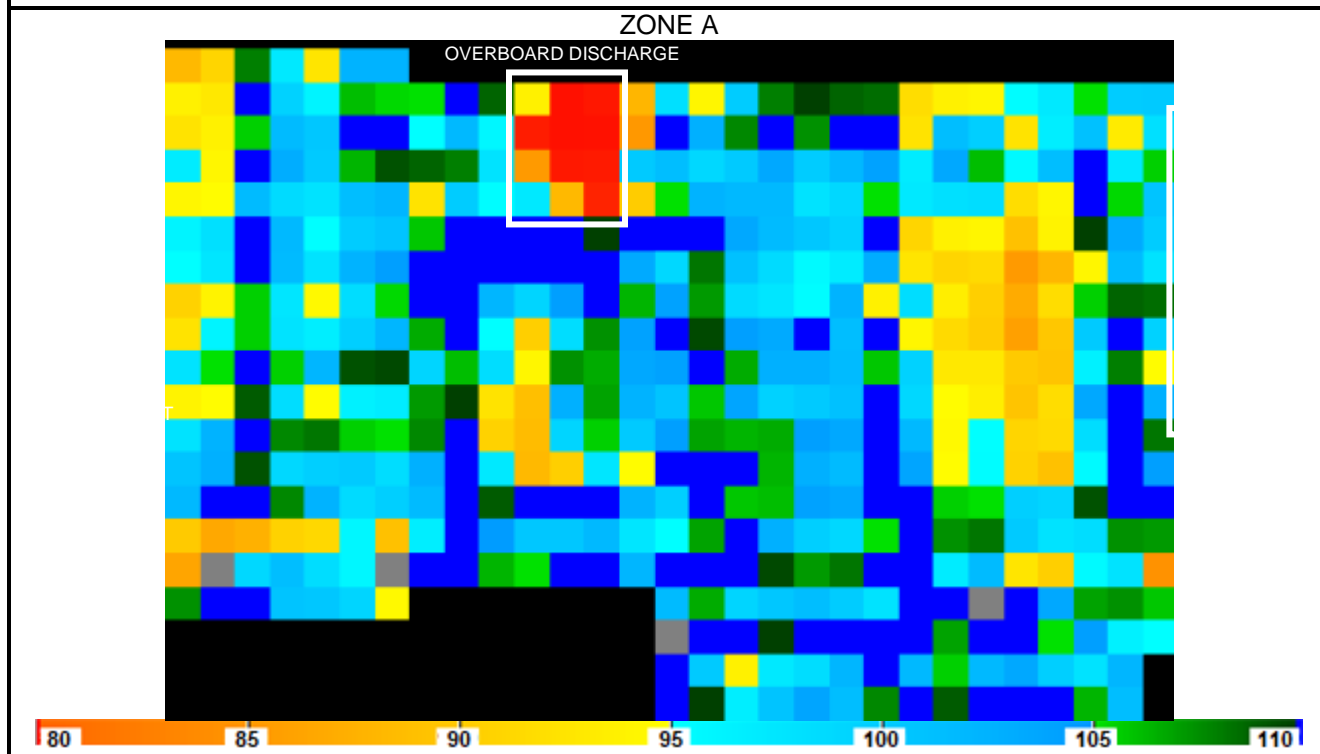
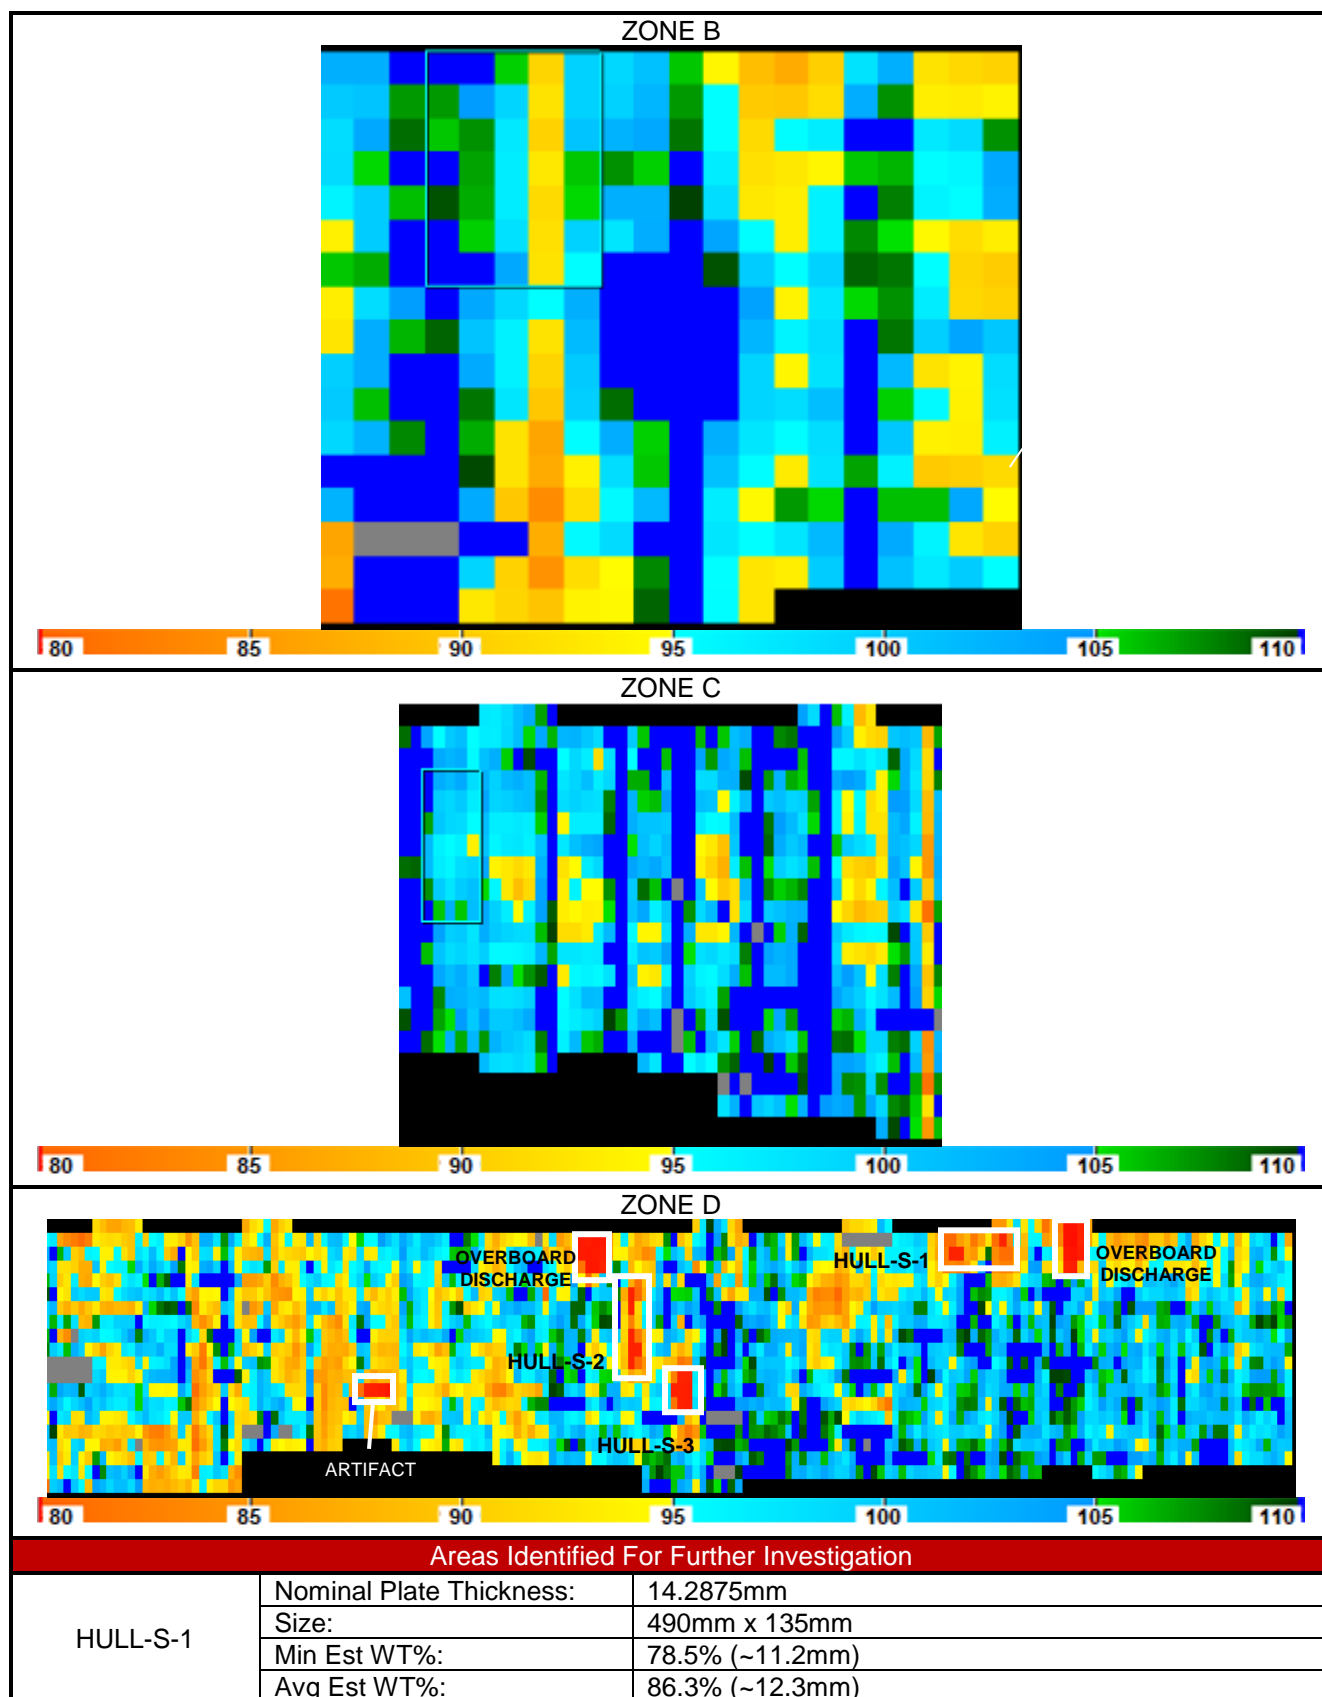
Starboard Side Hull – HULL-S

HULL-S-2	Nominal Plate Thickness:	14.2875mm
	Size:	225mm x 310mm
	Min Est WT%:	76.3% (~10.9mm)
	Avg Est WT%:	89.3% (~12.8mm)
HULL-S-3	Nominal Plate Thickness:	14.2875mm
	Size:	135mm x 135mm
	Min Est WT%:	72.7% (~10.4mm)
	Avg Est WT%:	77.6% (~11.1mm)
<p>NOTES: Given the tight frame spacing on the hull and the low resolution given by the probe, there is some uncertainty with the hull data. Therefore, a visual inspection and/or UT measurement of any low thickness measurements in the area is recommended to verify the steel conditions.</p> <p>HULL-S-1 is shown in Figure 13.</p>

Given the tight frame spacing on the hull and the low resolution given by the probe, there is some uncertainty with the hull data. Therefore, a visual inspection and/or UT measurement of any low thickness measurements in the area is recommended to verify the steel condition.

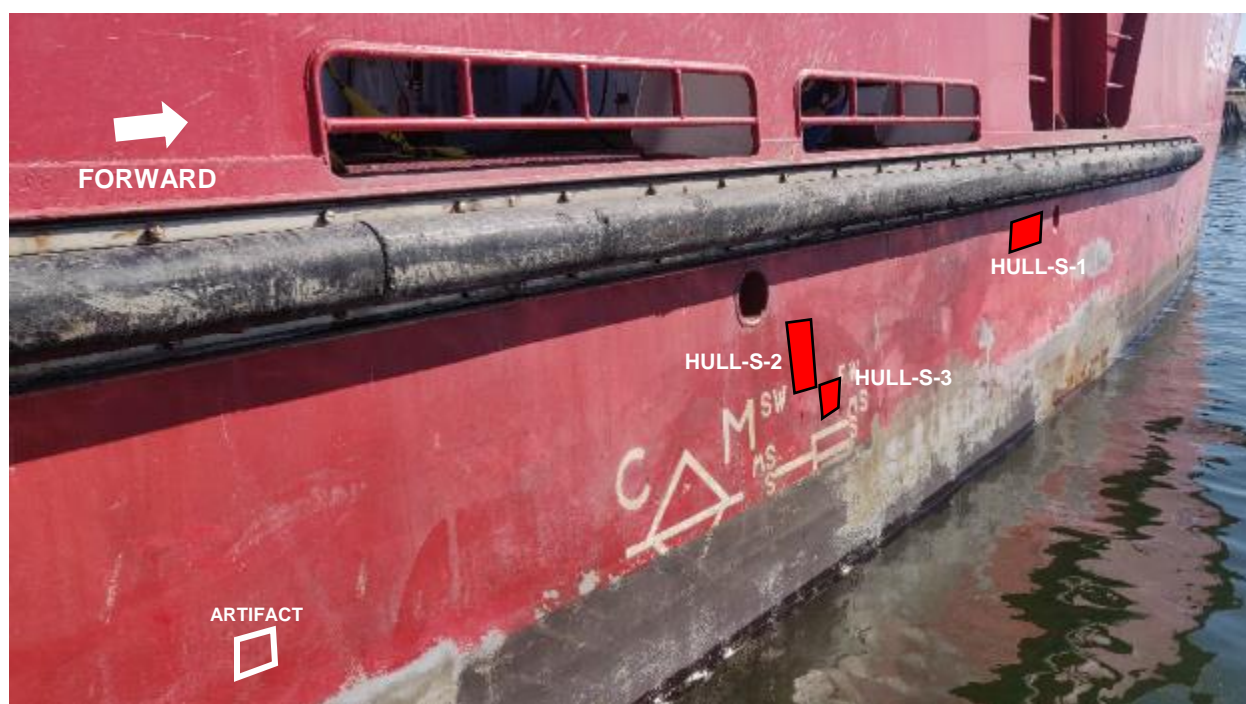
Location	Defect ID		
STBD Hull (FR 23.5-45)	HULL-S-1 (See 7.1)	Nominal Plate Thickness:	14.2875mm
		Size:	490mm x 135mm
		Min Est WT%:	78.5% (~11.2mm)
		Avg Est WT%:	86.3% (~12.3mm)
	HULL-S-2 (See 7.1)	Nominal Plate Thickness:	14.2875mm
		Size:	225mm x 310mm
		Min Est WT%:	76.3% (~10.9mm)
		Avg Est WT%:	89.3% (~12.8mm)
	HULL-S-3 (See 7.1)	Nominal Plate Thickness:	14.2875mm
		Size:	135mm x 135mm
		Min Est WT%:	72.7% (~10.4mm)
		Avg Est WT%:	77.6% (~11.1mm)

Figure 13 – HULL-S-1, HULL-S-2, HULL-S-3 and the HULL-S Artifact
