<b>Title - Sujet</b> Bridge Maintenance - Various Sites	
<b>Solicitation No. - N° de l'invitation</b> E0276-140605/A	<b>Amendment No. - N° modif.</b> 001
<b>Client Reference No. - N° de référence du client</b>	<b>Date</b> 2013-07-04
<b>GETS Reference No. - N° de référence de SEAG</b> PW-\$PWY-019-7042	
<b>File No. - N° de dossier</b> PWY-3-36070 (019)	<b>CCC No./N° CCC - FMS No./N° VME</b>
<b>Solicitation Closes - L'invitation prend fin at - à 02:00 PM on - le 2013-07-16</b>	<b>Time Zone</b> Fuseau horaire Pacific Daylight Saving Time PDT
<b>F.O.B. - F.A.B.</b> <b>Plant-Usine:</b> <input type="checkbox"/> <b>Destination:</b> <input checked="" type="checkbox"/> <b>Other-Autre:</b> <input type="checkbox"/>	
<b>Address Enquiries to: - Adresser toutes questions à:</b> Ngan, Ken (PWY)	<b>Buyer Id - Id de l'acheteur</b> pwy019
<b>Telephone No. - N° de téléphone</b> (604) 658-2755 ( )	<b>FAX No. - N° de FAX</b> (604) 775-6633

This Amendment 001 (Addendum No. 1) is raised to add an item to the work requirement, and to amend the unit price table accordingly.

## Sikanni Chief River Bridge

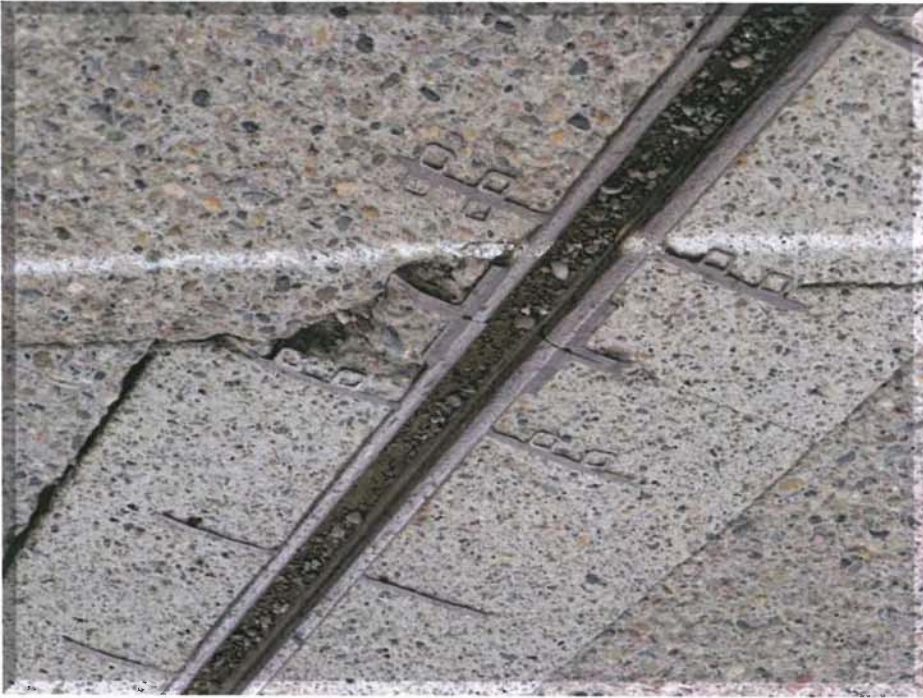
1. Deck Joint 1 at South Abutment

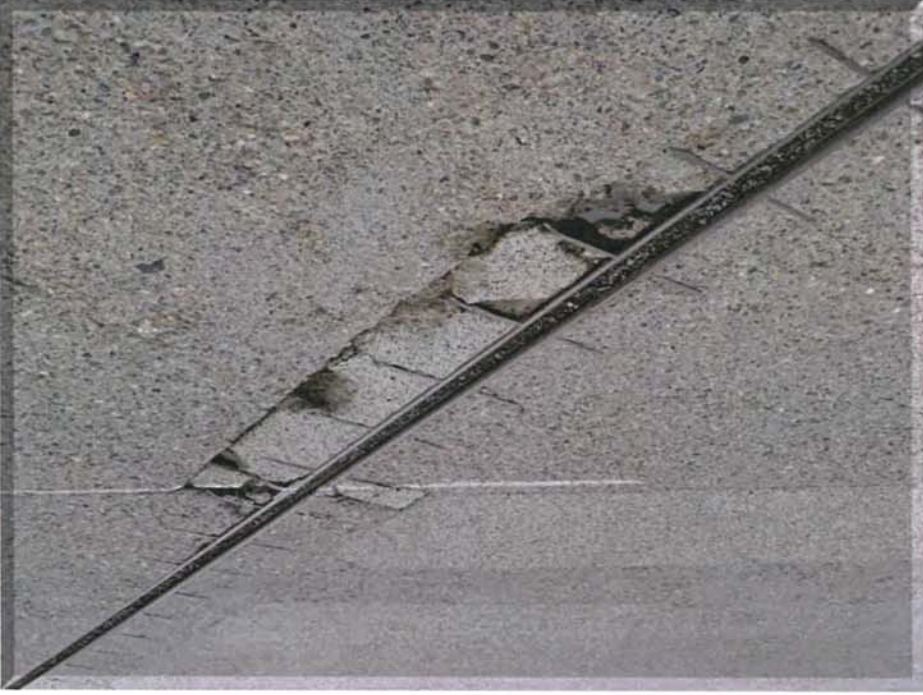
2. Cracked Deck Joint 2 at Pier 1

1. Add "Sikanni Chief River Bridge; km 256.1; Patching of Concrete Spall at pier 1/ pier2 Deck Joint" to the scope of work.
2. Unit price table modified to include (1). Delete the tender unit price table and replace with the attached.
3. Perform repair work as per drawing and instructions attached.
4. Perform Traffic Control as per specification section 01 35 31. The cost of Traffic Control shall be incidental to Patching of Concrete Spall at pier 1/ pier2 Deck Joint.
