APPENDIX A

PROJECT-SPECIFIC DESIGNATED SUBSTANCE AND HAZARDOUS

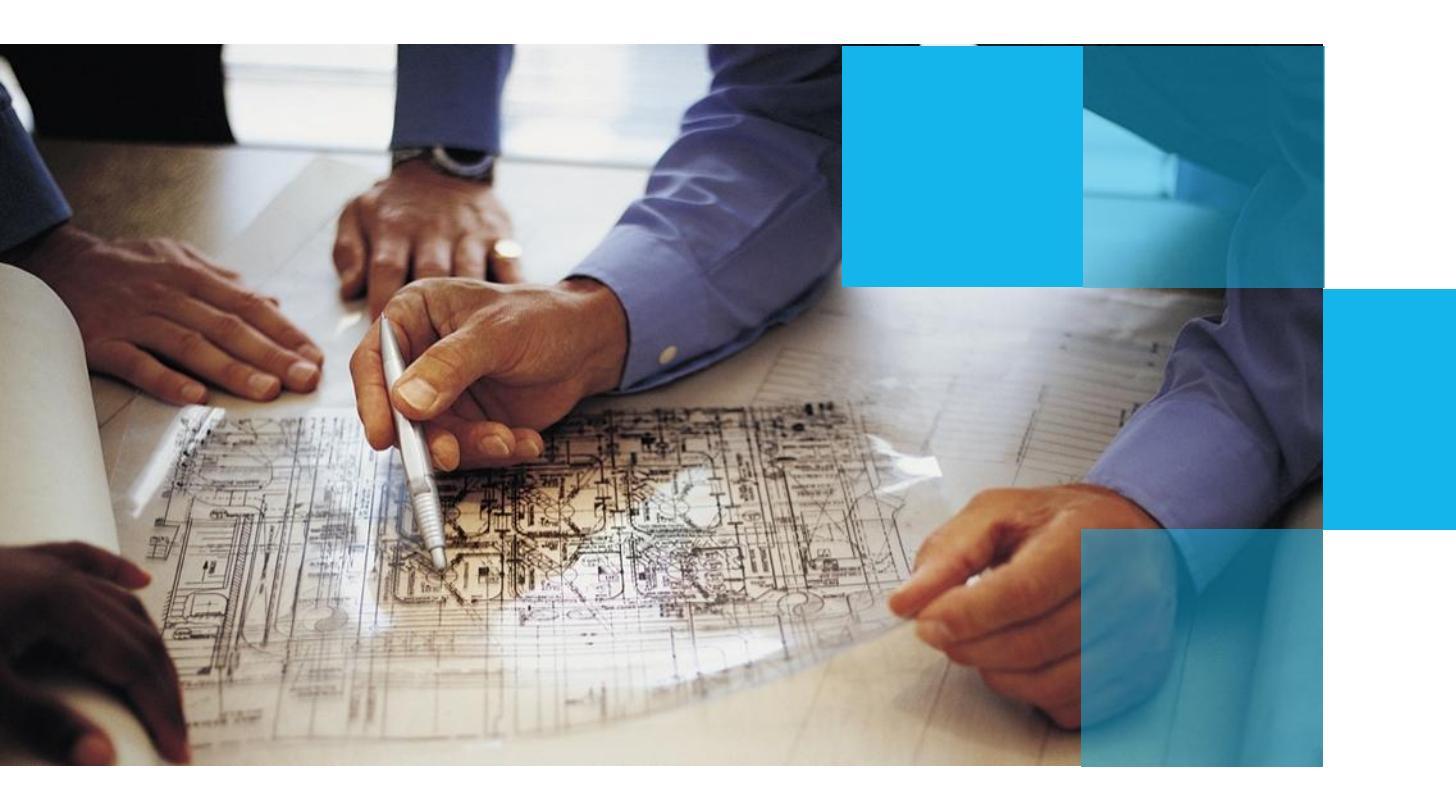
PROJECT-SPECIFIC DESIGNATED SUBSTANCE AND HAZARDOUS MATERIALS SURVEY REPORT

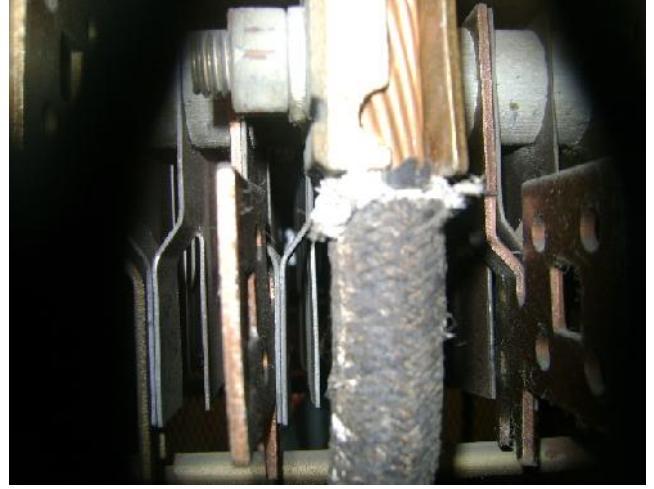
Photograph 1: [Control House Electrical Room - 2nd **Photograph 2:** [Control House Electrical Room (2nd Floor] Asbestos-containing grey 9"x9" vinyl floor tile Floor)] Presumed asbestos-containing electrical observed to be in fair condition around pipe conduit cable sheathing observed to be in fair condition. penetration.

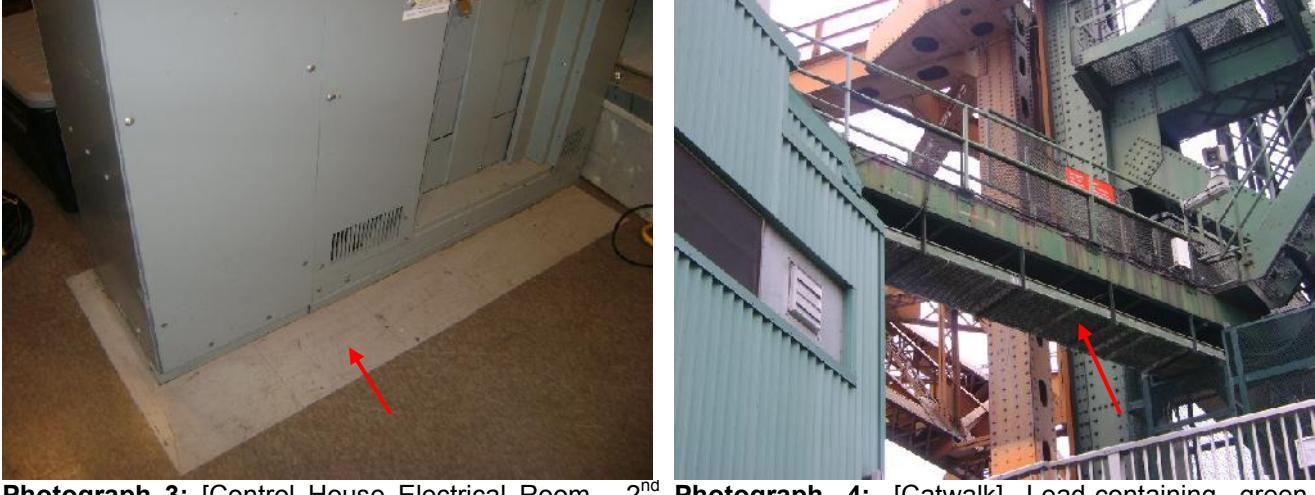
Photograph 3: [Control House Electrical Room - 2nd **Photograph 4:** [Catwalk] Lead-containing green Floor] Non-asbestos-containing 12"x12" off-white vinyl paint application observed to be in poor condition. floor tile with faint streaks (Sample Set BLB-1).

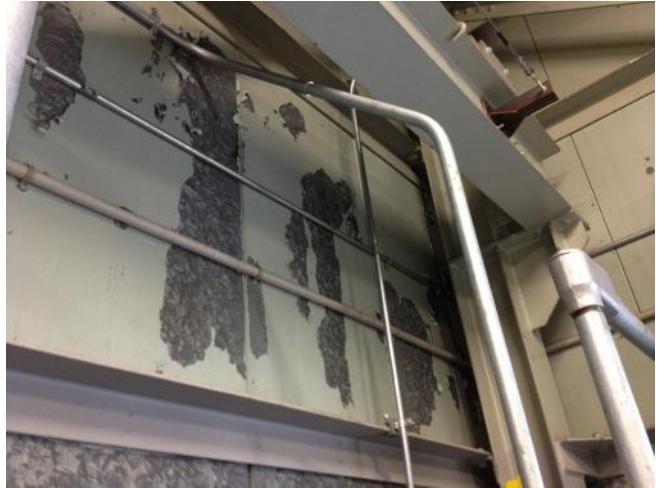
Photograph 5: [North / South Bridge Towers] Leadcontaining grey wall paint application in the mechanical room observed to be in poor condition.

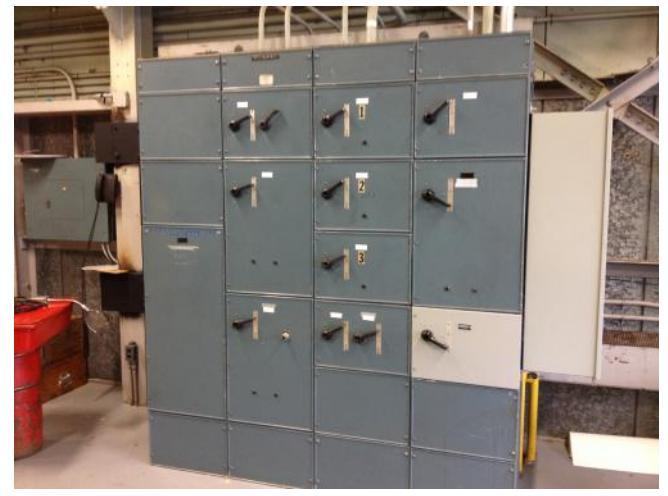
Photograph 6: [North / South Bridge Towers] "MCC" unit to me moved within the mechanical rooms.

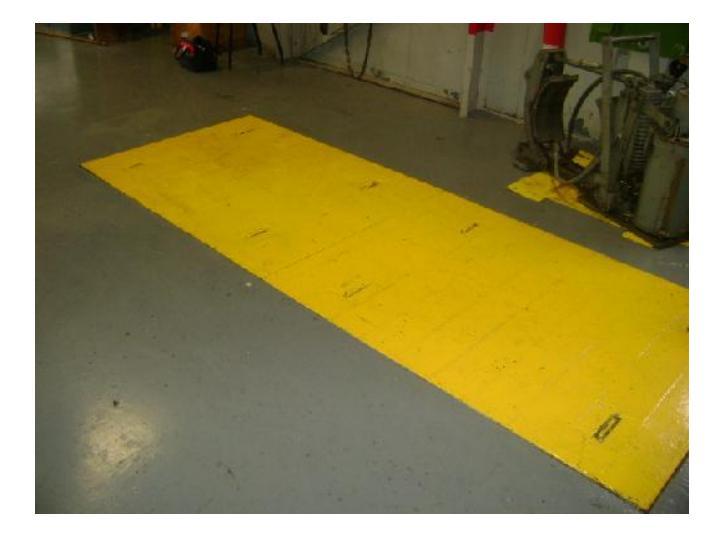
Photograph 7: [North/South Towers Mechanical Room] Lead-containing grey floor paint application observed to be in good condition.

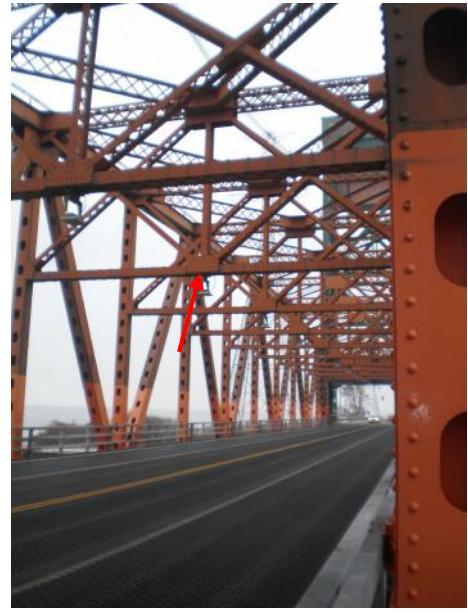
Photograph 8: [Lift Bridge Structure] Leadcontaining red primer paint application observed to be in fair condition.

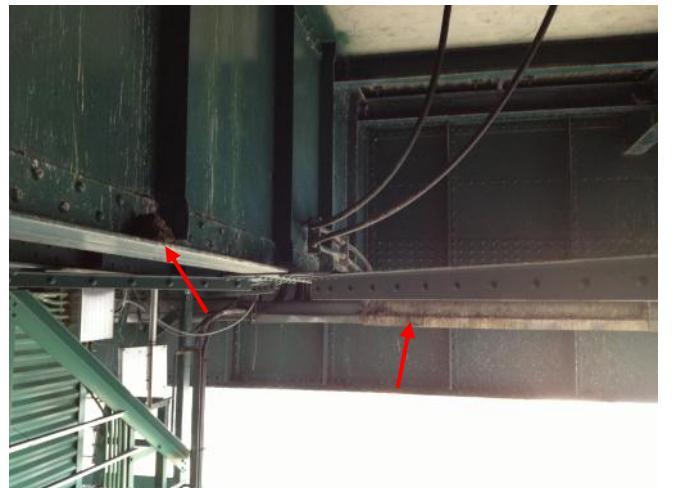
Photograph 9: [Bridge Tower, below Sheave Room] Guano observed on the bridge tower structure.

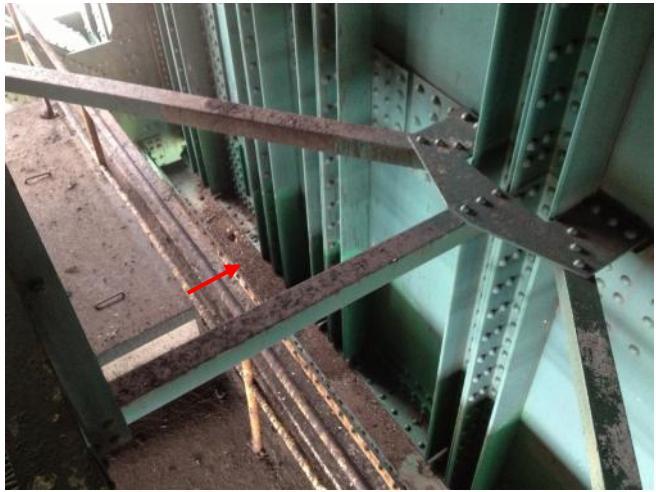
Photograph 10: [Bridge Tower, below Sheave Room] Guano observed on the bridge tower structure.

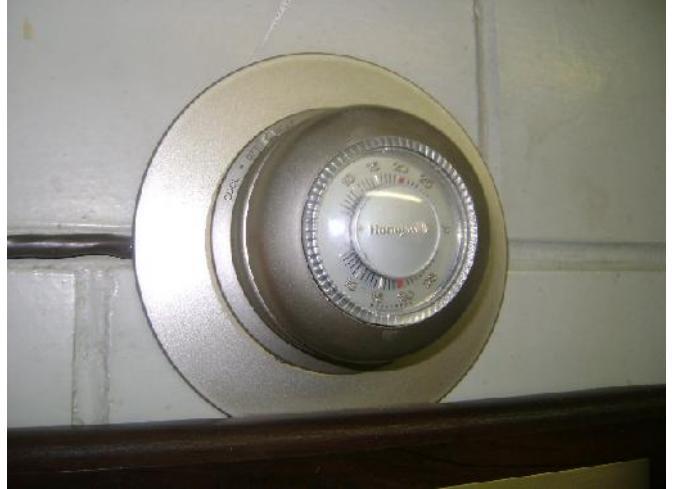
Photograph 11: [Control House – Electrical Room] Mercury-containing thermostat.

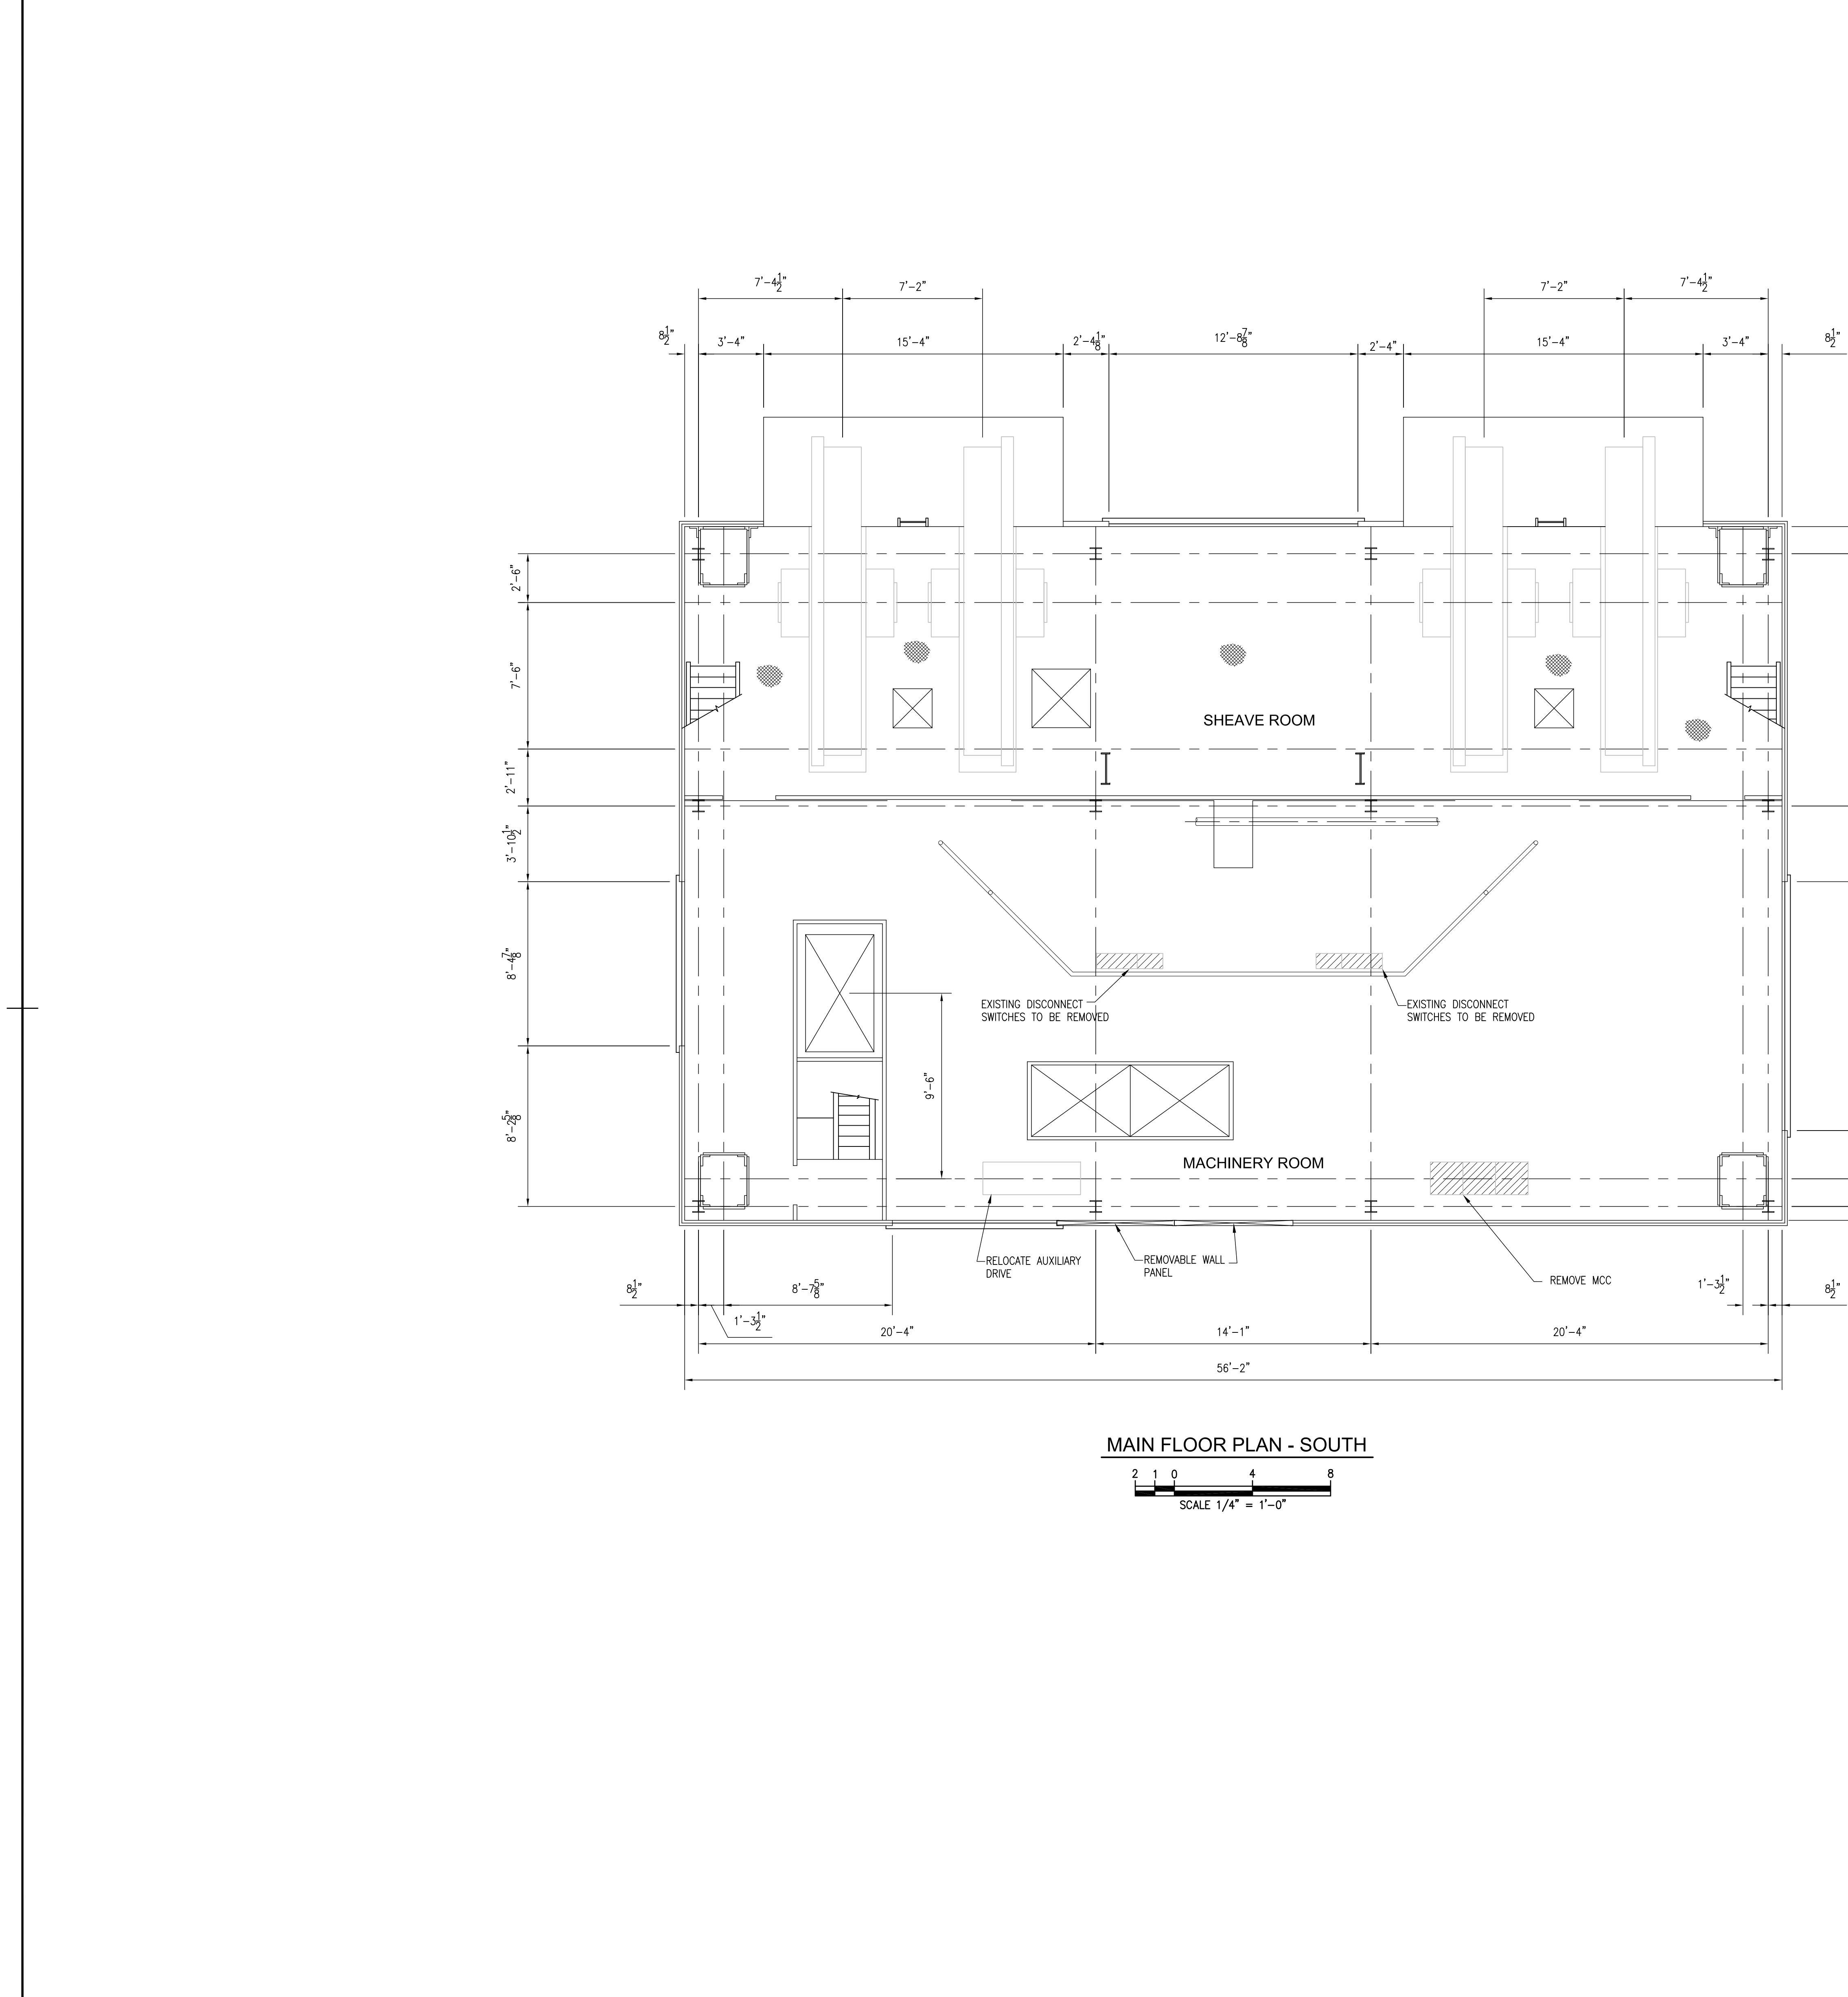
Burlington Lift Bridge – Controls, Drives and Overhead Cables Replacement PWGSC Project No. R.012641.002

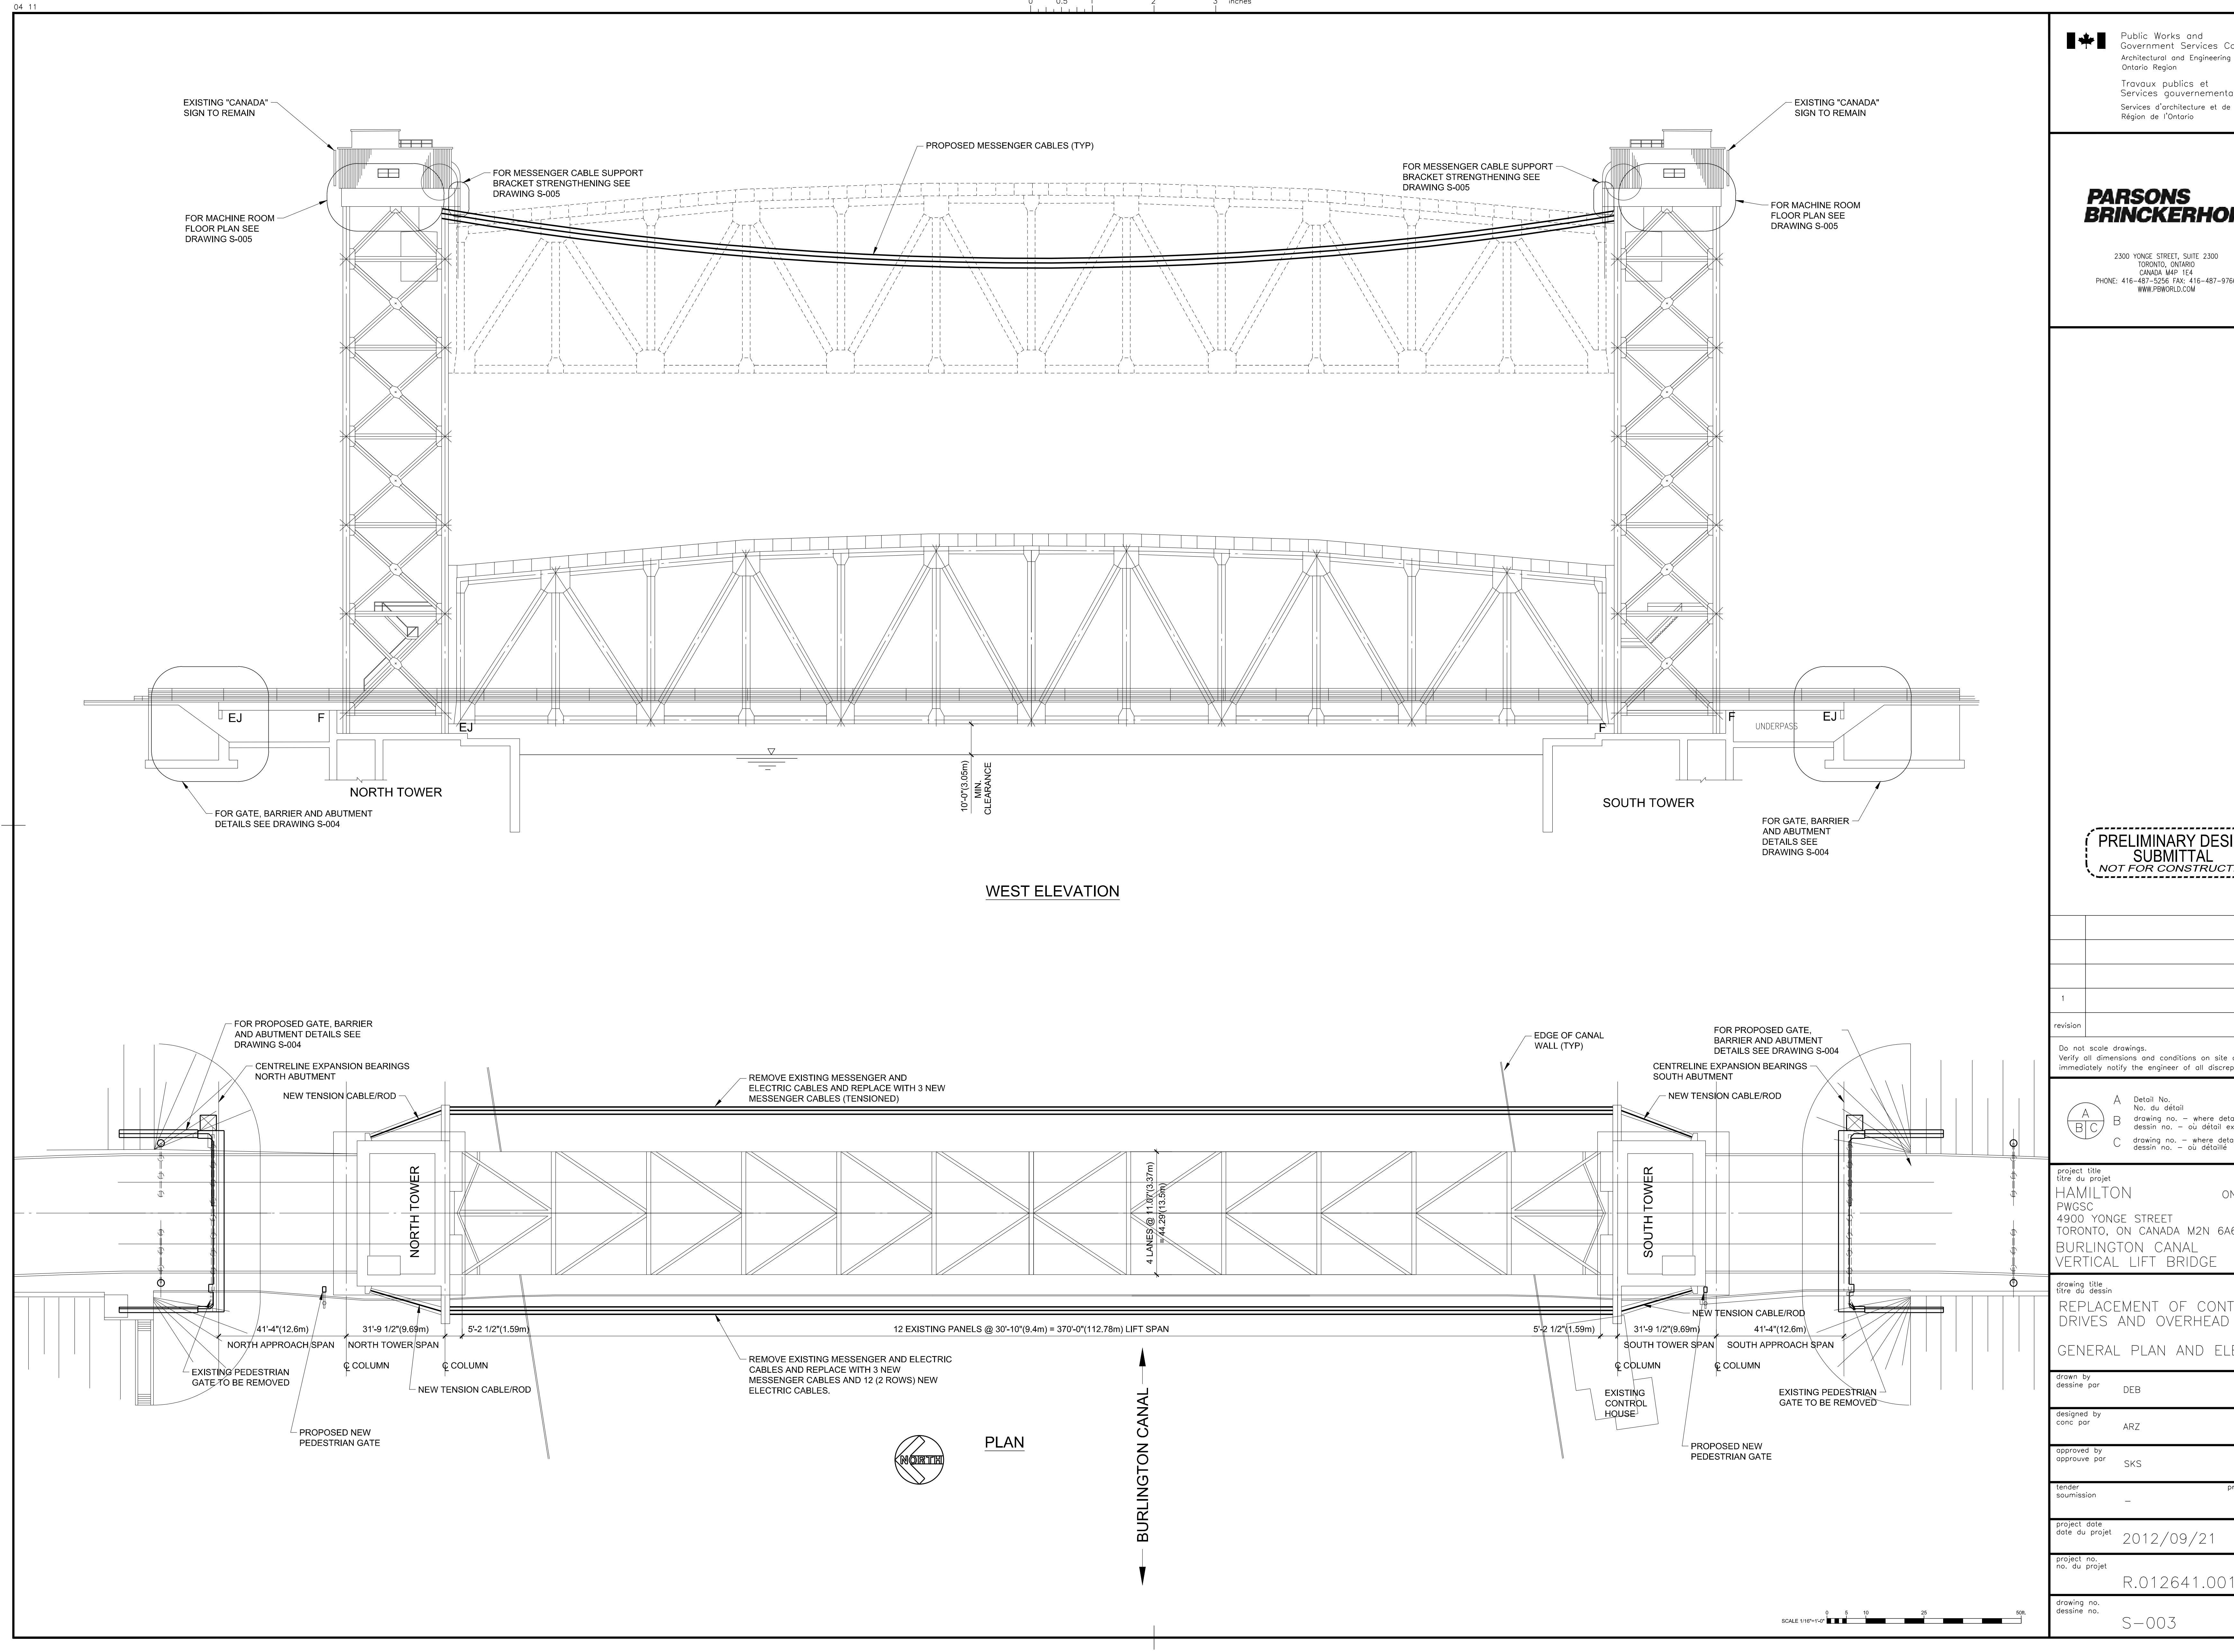
PLOTTED BY: DEB ● PLOTTED FOR: --- ● PLOT DATE & TIME: 2012-10-10 1:22:42 PM ● PLOT SCALE: 1:1 AT INPUT SHEET SIZE HERE SHEET SIZE. READ DRAWING ACCORDINGLY. FILE: R:\XS\DRAWINGS\2012\212XS149 - BURLINGTON CANAL VERTICAL LIFT BRIDGE\STRUCT\212XS149 S003.DWG

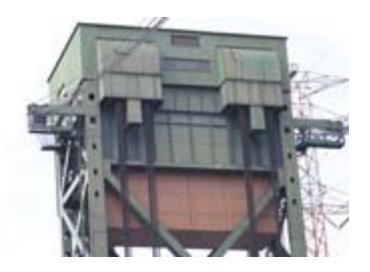
Figure 1: South side of north tower. Nest site is usually on ledge (just above brown counterweight).
