Q&A #1

Project: Tempered water and cross connection control

DESIGNATED SUBSTANCES AUDIT Agriculture and Agri-Food Canada Research Facility 93 Stone Rd. West, Guelph Ontario Guelph, Ontario

November 8, 2005

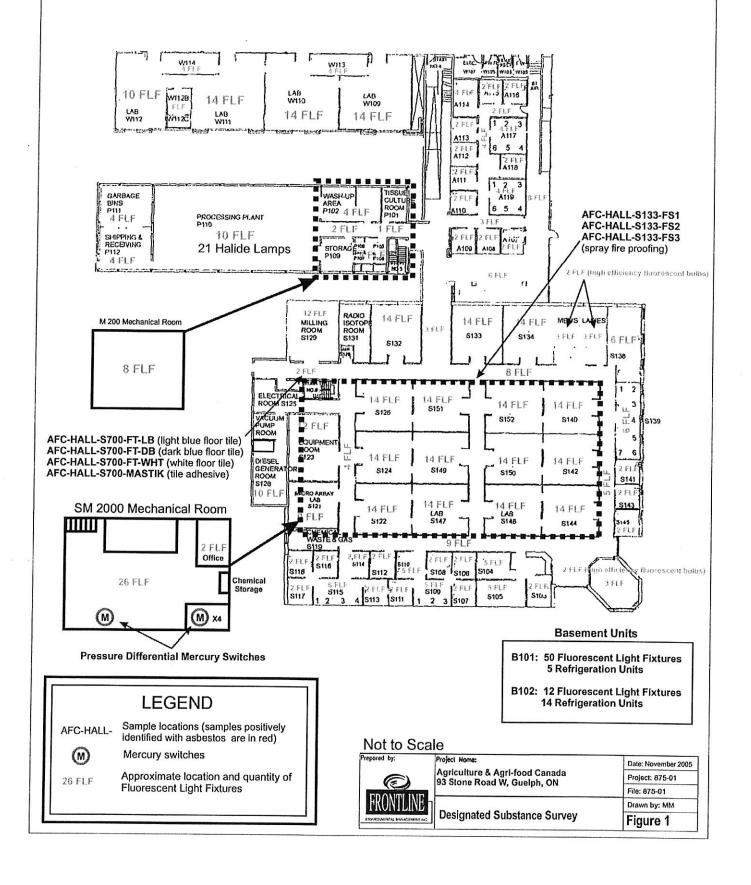
Mercury vapour has also been used in fluorescent light tubes. It is likely that the light tubes in the building contain mercury vapour. Approximately 550 fluorescent light tubes were identified during the inspection of the building. Locations of fluorescent light fixtures are detailed in Figure 1, included with this report.

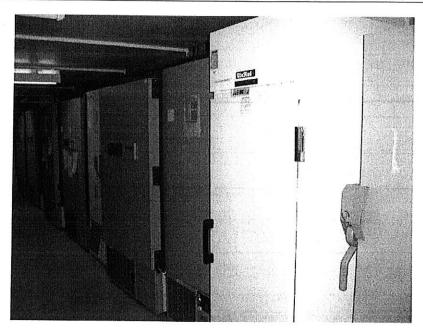
At the time of the inspection 19 refrigerator units were observed in the basement. These units may contain ODS's. Continued use and proper maintenance of these products is recommended.

Photo 1: Basement storage area. Refrigerator units may contain ozone-depleting substances.

In accordance with Ontario Regulation 189/94 the collection of refrigerant from air conditioning or refrigeration equipment prior to its removal or maintenance is required. The removal of such refrigerants should be conducted by a certified technician licensed to handle these compounds. Any site or facility used in the collection of refrigerant becomes part of a "refrigerant management system" that is subject to the requirements of Regulation 347 and the Environmental Protection Act.

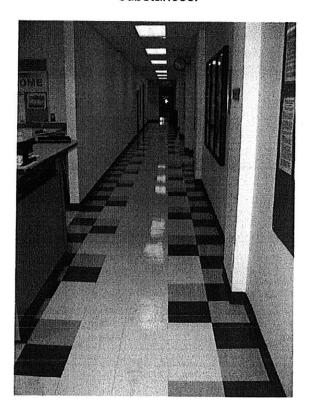
Photo 2: Reception Hallway.12" x 12" floor tiles, reported to be non- asbestos containing.
