**Project:** Eau tempérée et prévention des jonctions fautives

### **Designated Substances Audit**

**DESIGNATED SUBSTANCES AUDIT  
Agriculture and Agri-Food  
Canada Research Facility  
93 Stone Rd. West, Guelph Ontario  
Guelph, Ontario**

November 8, 2005

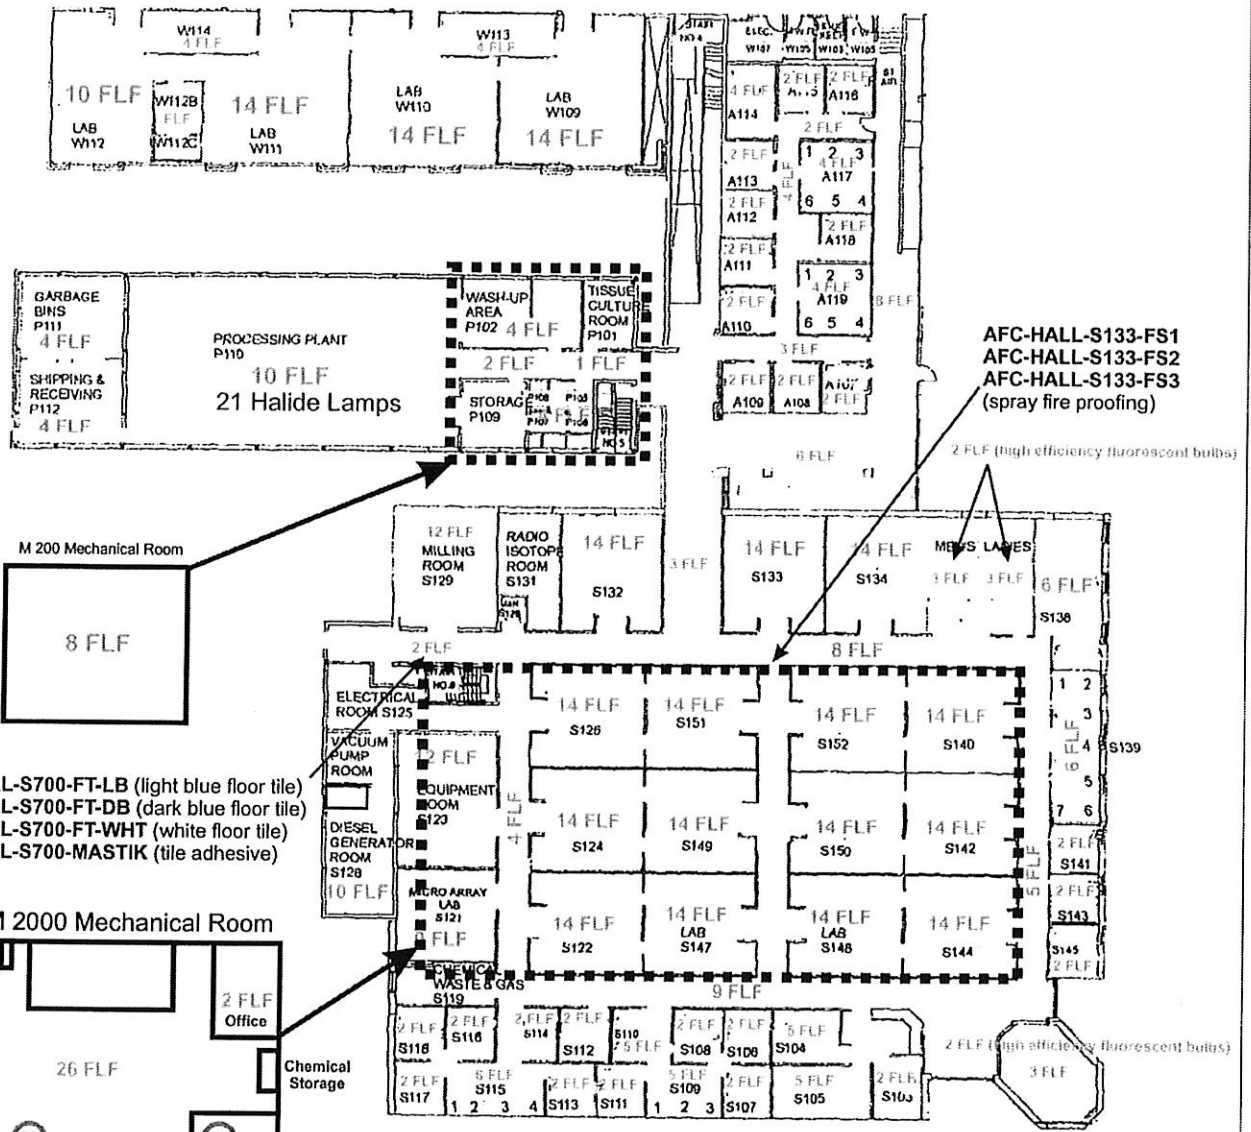
FRONTLINE ENVIRONMENTAL MANAGEMENT INC.	Prepared by:	Project Name:	Date: November 2005
		Agriculture & Agri-food Canada 93 Stone Road W, Guelph, ON	Project: 875-01
		File: 875-01	Drawn by: MM
	<b>Designated Substance Survey</b>		<b>Figure 1</b>

5 pressure differential switches within the mechanical room of the building were observed to contain mercury. It is possible that other switches within laboratory and mechanical equipment may contain mercury switches.

Mercury vapour has also been used in fluorescent light tubes. It is likely that the light tubes in the building contain mercury vapour. Approximately 550 fluorescent light tubes were identified during the inspection of the building. Locations of fluorescent light fixtures are detailed in Figure 1, included with this report.

AFC-HALL-S700-FT-LB (light blue floor tile)  
 AFC-HALL-S700-FT-DB (dark blue floor tile)  
 AFC-HALL-S700-FT-WHT (white floor tile)  
 AFC-HALL-S700-MASTIK (tile adhesive)

Pressure Differential Mercury Switches

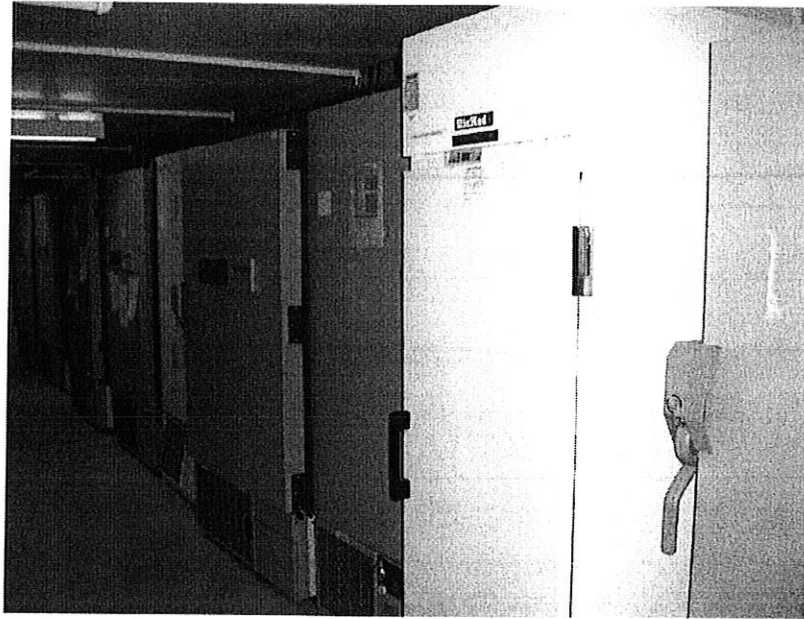
At the time of the inspection 19 refrigerator units were observed in the basement. These units may contain ODS's. Continued use and proper maintenance of these products is recommended.

**Photo 1:** Basement storage area. Refrigerator units may contain ozone-depleting substances.

In accordance with Ontario Regulation 189/94 the collection of refrigerant from air conditioning or refrigeration equipment prior to its removal or maintenance is required. The removal of such refrigerants should be conducted by a certified technician licensed to handle these compounds. Any site or facility used in the collection of refrigerant becomes part of a "refrigerant management system" that is subject to the requirements of Regulation 347 and the Environmental Protection Act.

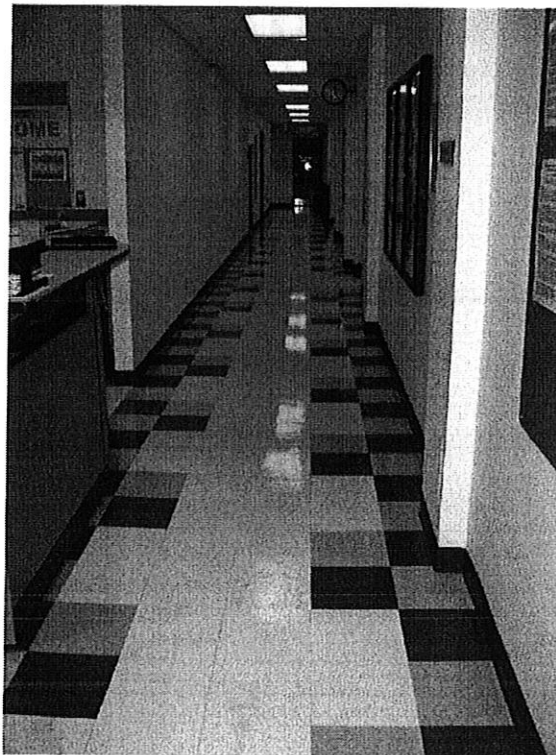
Based on laboratory analysis, all samples collected within the facility were reported as non-asbestos containing. It is possible that materials may be hidden in false ceilings and wall cavities/pipe chases and may not be visible until demolition has occurred. If suspected ACM's are discovered, all work should cease until the asbestos content of the suspect materials can

**Photo 2:** Reception Hallway. 12" x 12" floor tiles, reported to be non- asbestos containing.
