**Iqaluit, Nunavut  
DFO Bunkhouse Building 1074,  
Hazardous Material Abatement  
Solicitation # E0208-151273/A**

# HAZARDOUS MATERIALS ABATEMENT

**Final – Designated Substances Survey, Bunkhouse Building –  
Department of Fisheries and Ocean, Iqaluit, Nunavut**

June 26, 2012

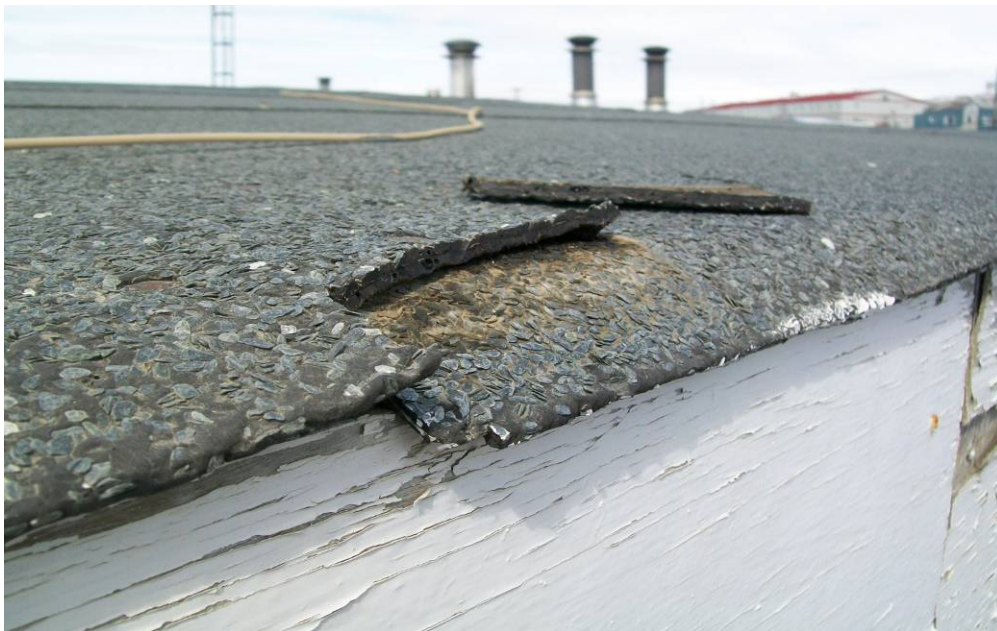
Friable asphalt roofing shingles are present across the entire roof of the building. Representative sample [RF-01C] collected from the roof of the building was found to contain 3% Chrysotile asbestos. FRANZ estimates that there is approximately 750 m<sup>2</sup> of friable asphalt roofing shingles across the roof areas of the building.

**Photograph 2:** View of asbestos-containing asphalt roof shingles on building. Sample (RF-01c) contained 3% Chrysotile asbestos.

Prior to the demolition of the building, all documented and assumed friable and non-friable ACMs should be removed from the building in accordance with both O.Reg. 278/05 and the Waste Asbestos document published by the Department of Environment, Government of Nunavut. Ontario Regulation 278/05 applies a strict assessment and abatement protocol whereas the Nunavut Waste Asbestos document focuses on handling and disposal of waste asbestos locally, where local landfills permit it. FRANZ recommends that asbestos abatement specifications, merging the above mentioned documents, be prepared for use by the abatement/demolition contractor during the demolition/abatement project scheduled for the site.

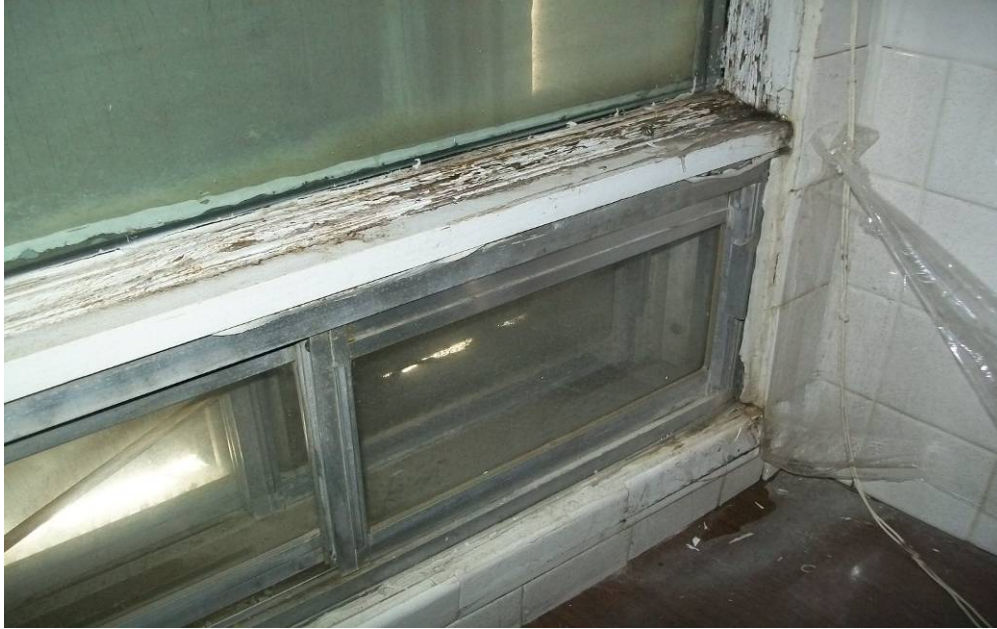
Friable window caulking was observed along the interior areas of windows along the west side of the building. Windows along the east wing of the building had been replaced with wooden framed units. There was no caulking observed along the interior side of these units. A representative bulk sample [CK(1)-01f] collected from the exterior area of the building was found to contain 4% Chrysotile asbestos. The caulking was observed to be in good condition. FRANZ estimates that there is approximately 1 m<sup>2</sup> of friable ACM caulking present on each window along the west wing as well as along the exterior side of most windows of the entire building.

**Photograph 3:** View of asbestos-containing caulking along window sill of older window in west wing of building. Sample of caulking contained 4% Chrysotile asbestos.

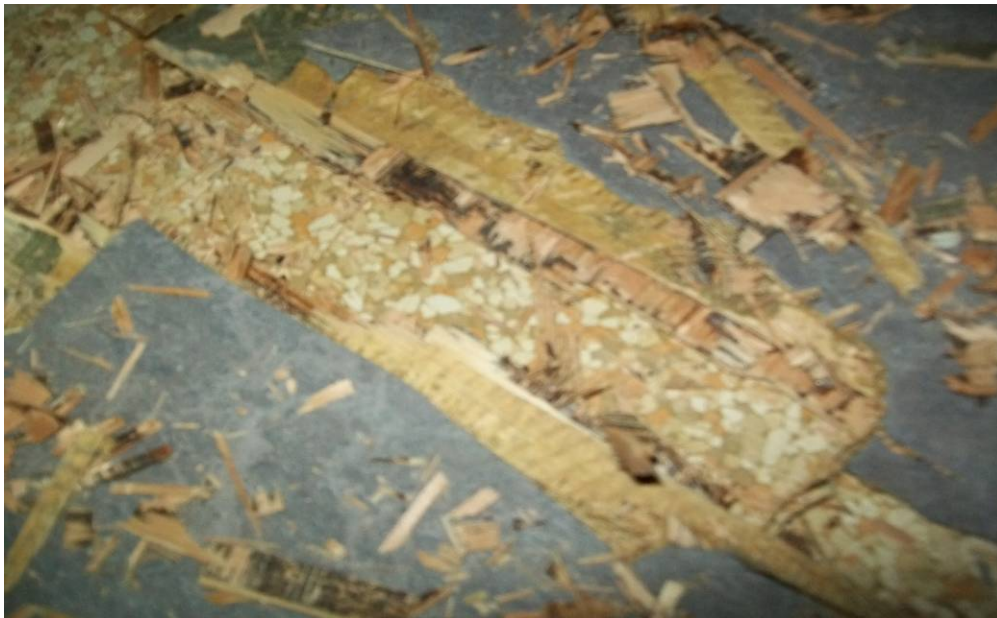
During the DSS, FRANZ observed nine (9) distinct types of friable VSF located throughout the east wing and connecting corridor of the building. Representative bulk sample [VSF(4)-01a] was found to contain 20% Chrysotile asbestos. In many areas, the flooring material was either completely exposed or covered with additional flooring material including carpeting and wood flooring. The VSF was observed to be in good condition. FRANZ estimates that there are approximately 200 m<sup>2</sup> of friable ACM VSF present throughout the building.

**Photograph 4:** View of asbestos-containing vinyl sheet flooring (VSF4) (white speckled) along floor of east wing of building. Sample (VSF4-01a) contained 20% Chrysotile asbestos.

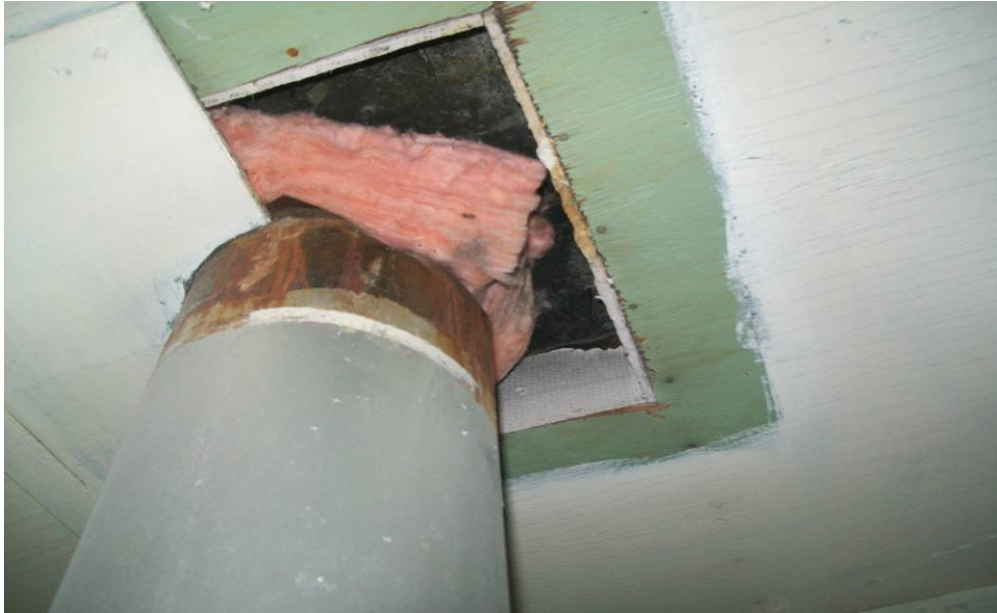
Non-friable ACM Transite sheeting was observed along the ceiling areas of two (2) rooms in the east wing of the building. The Transite was used to insulate older vent pipes that appeared to previously vent the rooms. The metal vents were cut off at the lower ceiling but remained in place. The flat Transite panels were located along the upper deck of the ceiling surrounding the

pipng. Representative sample [TR-01(a)] was found to contain 35% Chrysotile asbestos. The material was in good condition. FRANZ estimates that there is approximately 0.3 to 0.5 m<sup>2</sup> of Transite material in the ceiling area between 2-3 rooms of the east wing of the building.

**Photograph 5:** View of asbestos-containing cement Transite panel along upper ceiling of in east wing of building. Sample of Transite contained 35% Chrysotile asbestos.

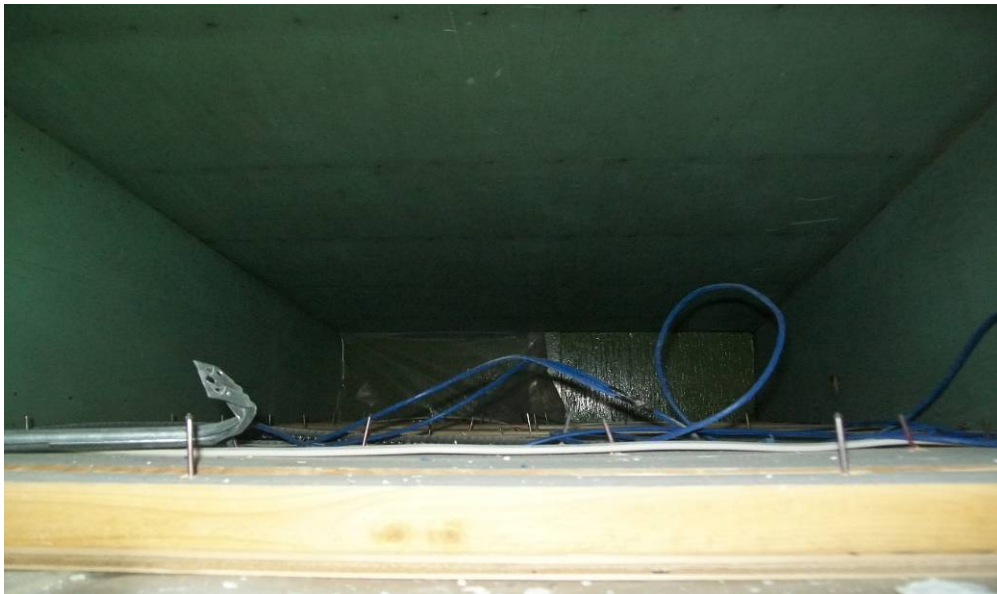
**Photograph 6:** View of older upper ceiling area of east wing of building. Paint samples collected from green paint of older ceiling contained 110,000 parts per million (ppm) of lead.

FRANZ recommends that a waste lead paint abatement document be prepared to guide the demolition/abatement contractor utilizing O. Reg. 490/09, Waste Lead and Lead Guideline documents for use during the demolition/abatement project scheduled for the site.

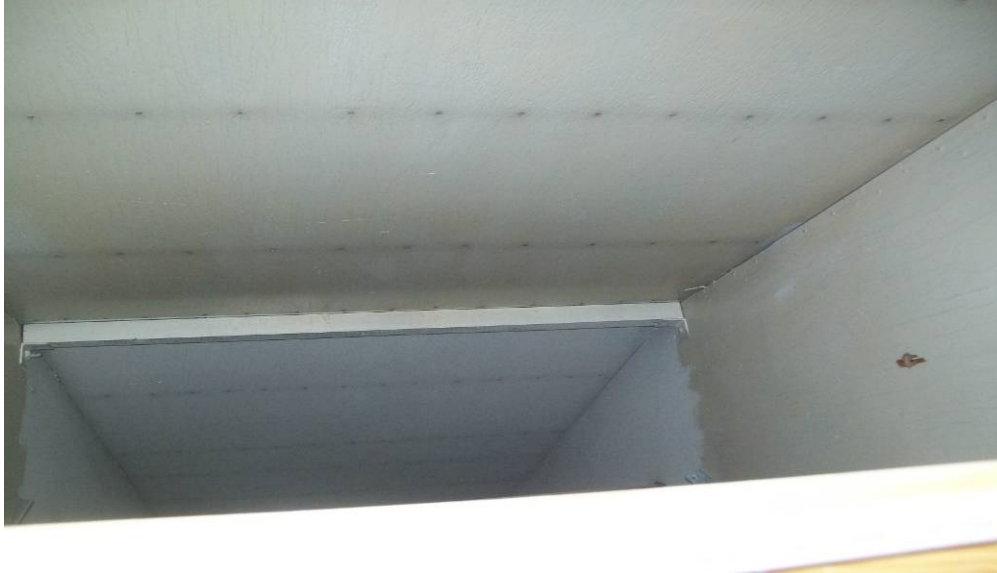
**Photograph 7:** View of older upper ceiling area of east wing of building. Paint samples collected from yellow paint of older ceiling contained between 7,800 – 64,000 ppm of lead.

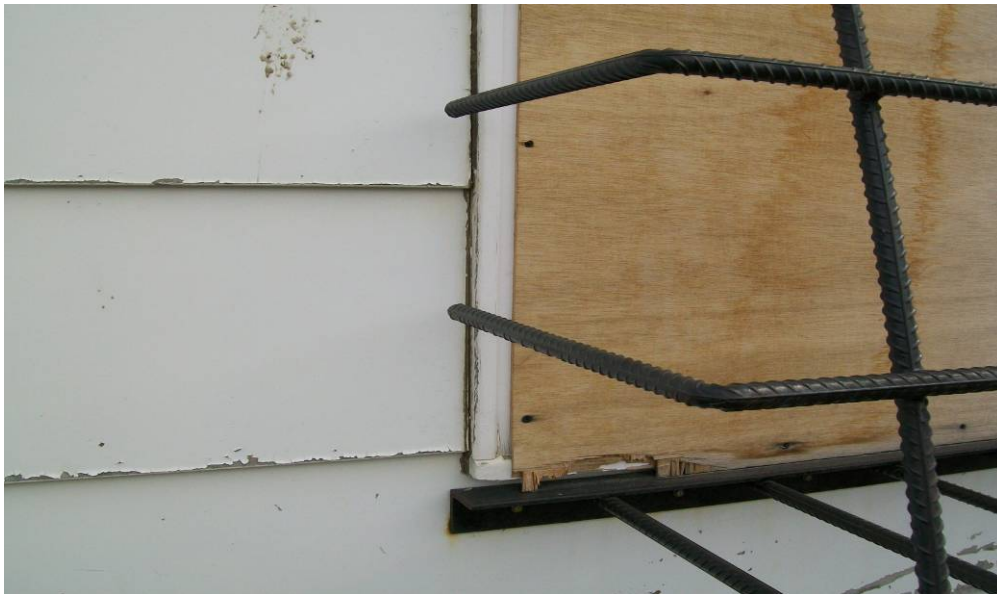
**Photograph 8:** View of white paint along the exterior window sill along the west side of the building. Paint sample collected contained 800 ppm of lead.

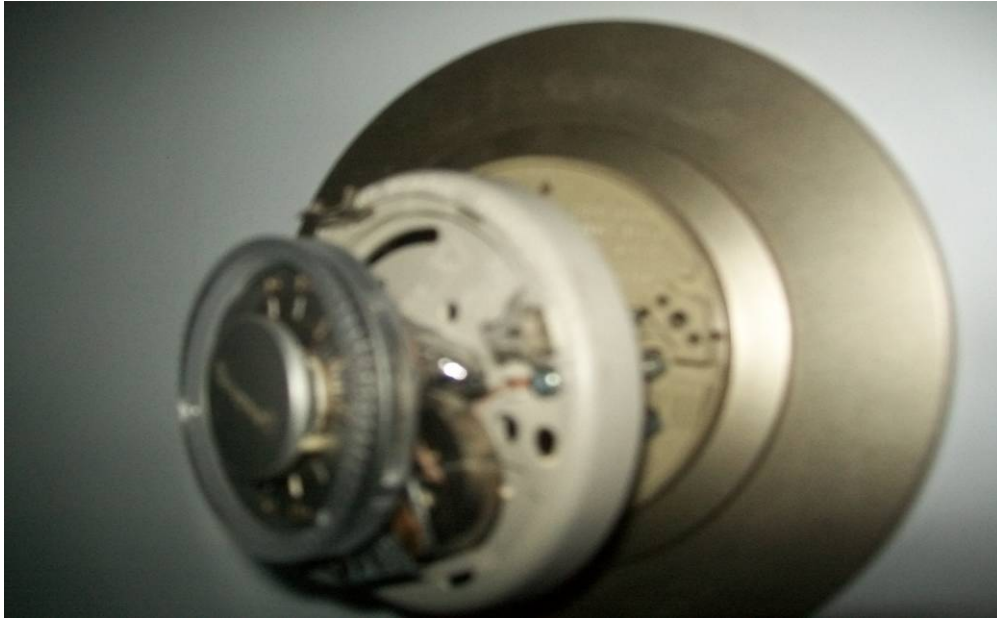
**Photograph 9:** View of wall mounted thermostat with mercury-containing ampoules along east wing.

FRANZ, therefore recommends that a waste mercury abatement document be prepared to guide the demolition/abatement contractor utilizing O. Reg. 490/09 and the Waste Mercury document for use during the demolition/abatement project scheduled for the site.

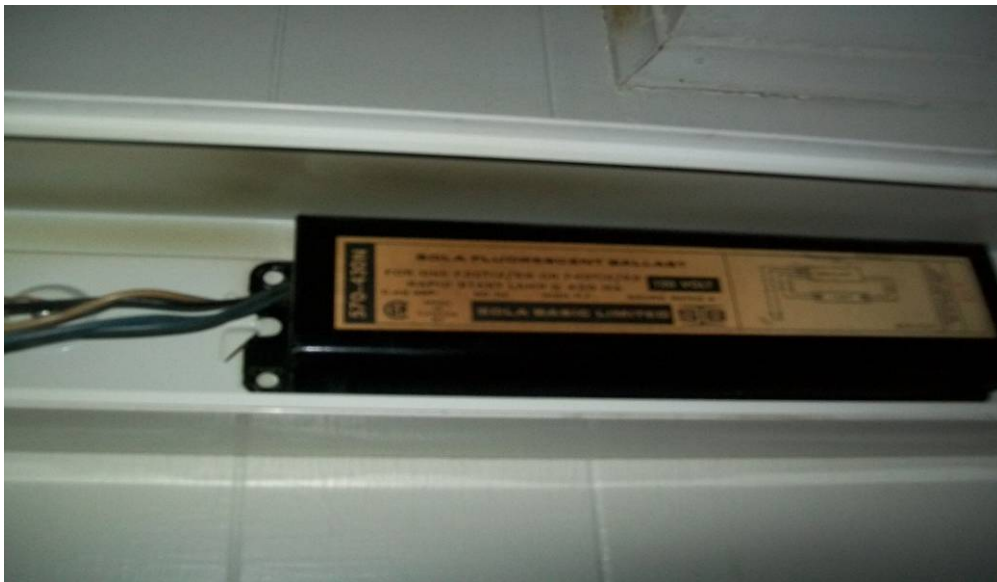
**Photograph 10:** View of assumed PCB-containing fluorescent lamp ballast along upper wall of washroom along west wing of building.

FRANZ recommends that a PCB abatement document be prepared to guide the abatement/demolition contractor utilizing NUEPA, Ontario Regulation 362, R.R.O. 1990 of the Ontario Environmental Protection Act (PCBs), and Ontario Regulation 347 of the Ontario Environmental Protection Act (Waste Management) for use during the demolition/abatement project scheduled for the site.

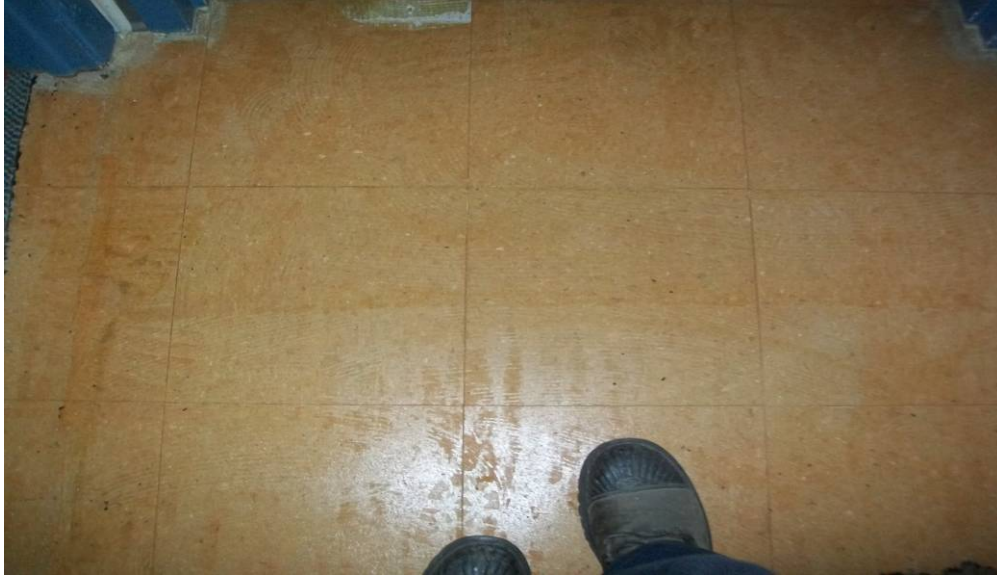
false positives for certain types of materials, including VFTs. PLM is limited by the visibility of the asbestos fibres. Many floor tiles contain fibres too small to be resolved by PLM. Should PWGSC remove any VFTs as part of the proposed demolition project, FRANZ can submit the tile samples for Transmission Electron Microscopy (TEM), which is a higher cost and more precise form of laboratory analysis. TEM analysis is not required under current legislation when dealing with bulk material issues. This level of analysis is recommended for sites where no other ACMs were documented and confirmation of non-ACM in VFTs would eliminate the requirement to prepare an Asbestos Management Plan (AMP) for a site. Otherwise, the regulation requires that these materials be assumed to contain asbestos; therefore, FRANZ is assuming the VFTs are asbestos.

**Photograph 11:** View of typical assumed asbestos-containing vinyl floor tiles (“VFTs”) under carpeting along floor of west wing of building.

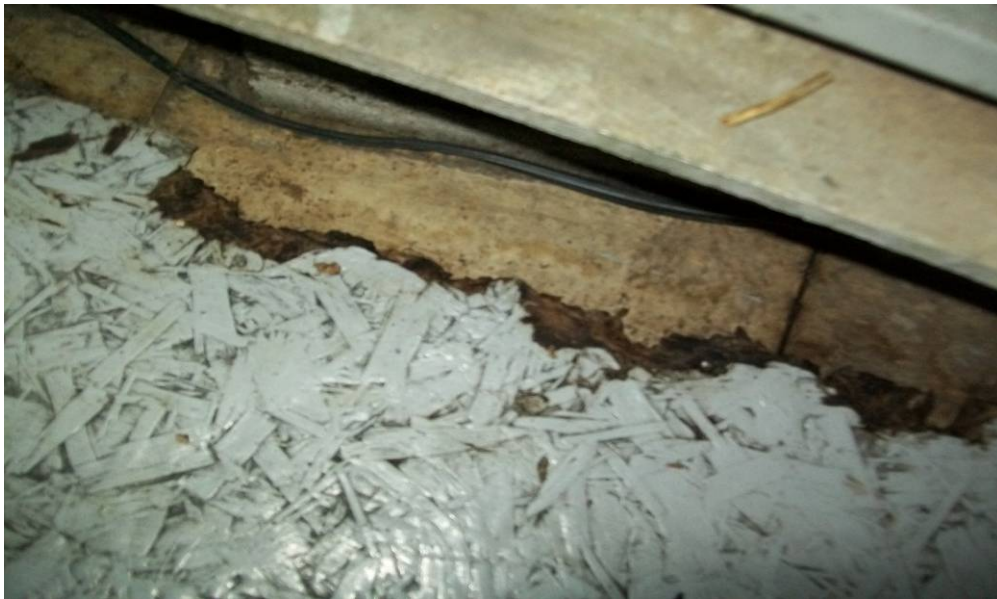
**Photograph 12:** View of additional typical assumed asbestos-containing VFTs under wood and other flooring material of building.
