Project No.: 219.05112.00010
Client Reference No.: DFRP # 16096, ARMS # 00394, FCSI # 16096079

**RE: REQUEST FOR PERMIT
PROPOSED REMEDIATION ACTIVITIES
WILMER MARSH UNIT, COLUMBIA NATIONAL WILDLIFE AREA
NEAR WILMER, BC**

Pre-Remediation Field Activities
Former Refuse Site – Wilmer Marsh Unit
Near Wilmer, British Columbia

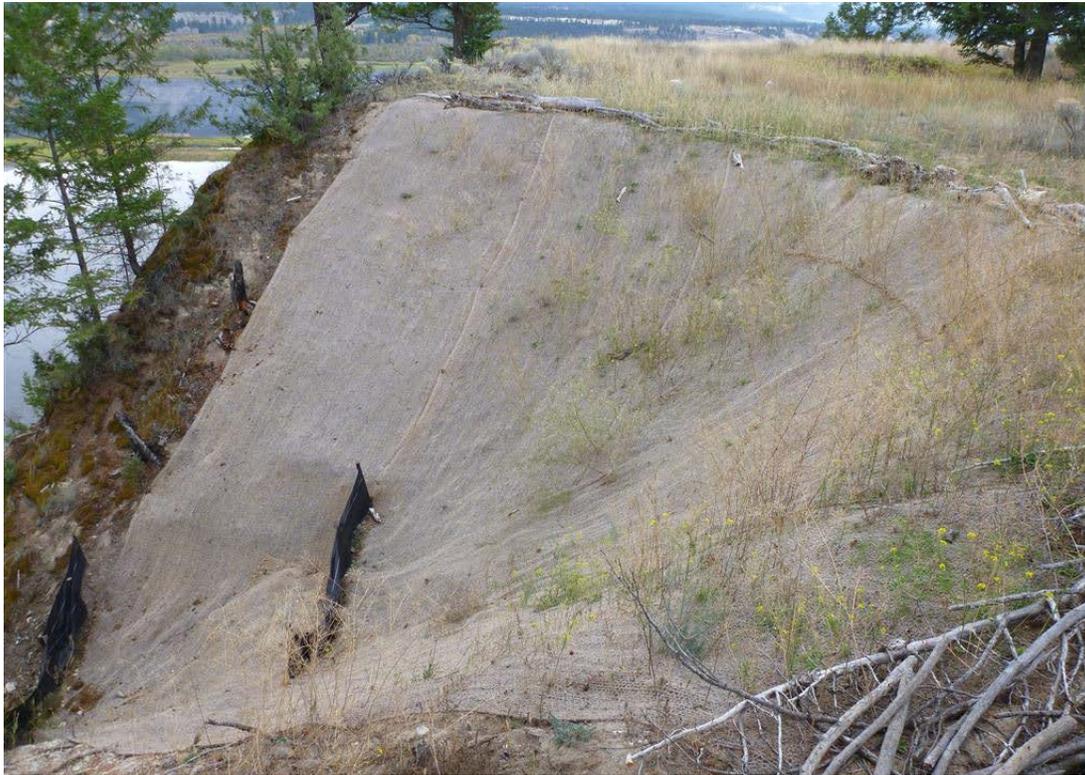
The sediment fencing and erosion control matting in the uplands gully area were observed to be undisturbed. No signs of erosion were observed and the sediment fencing and matting appeared to be functioning adequately. No seed growth was observed although weed species such as sweet clover and flixweed (Photo 1) were noted to be establishing in the gully.

Photo 1: View of uplands bench gully seeded in spring 2014.

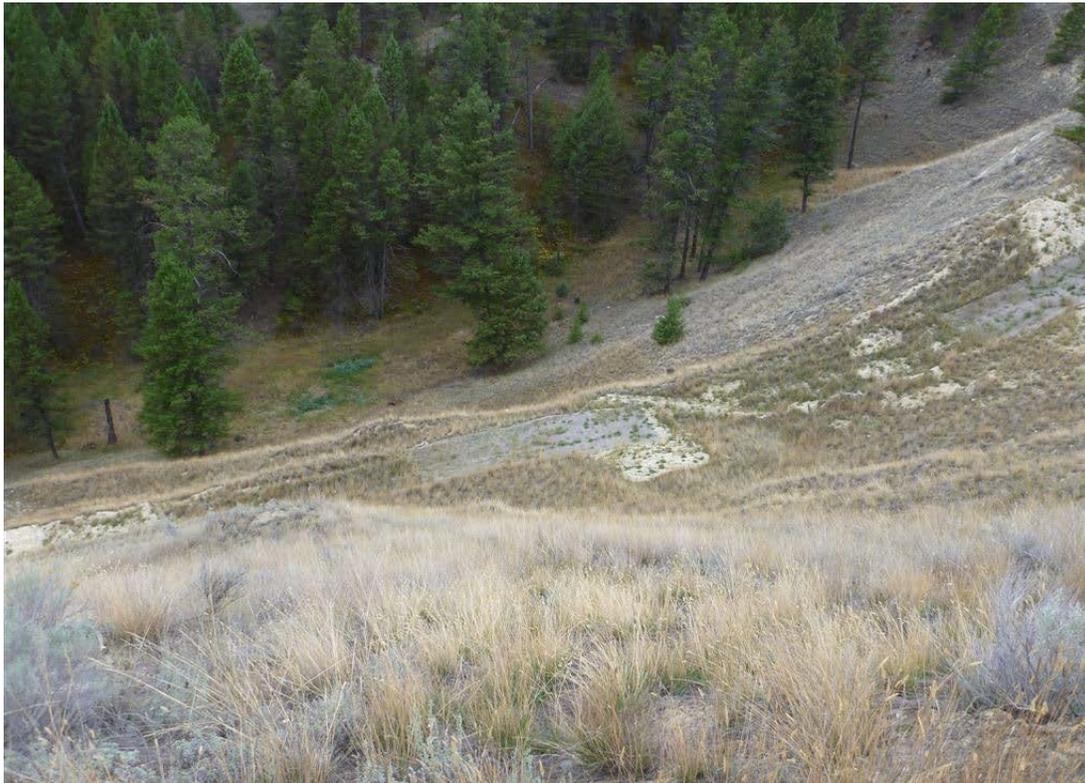
The area around the test pits advanced in the trail were also observed to be stable and the erosion control matting and coarse woody debris appeared to be functioning adequately. No signs of seed growth were present (Photo 2). However, incursion of crested wheatgrass and other weed species from the north slope into the disturbed areas was observed (Photo 3).

Photo 2: View of trail test pits seeded in spring 2014.

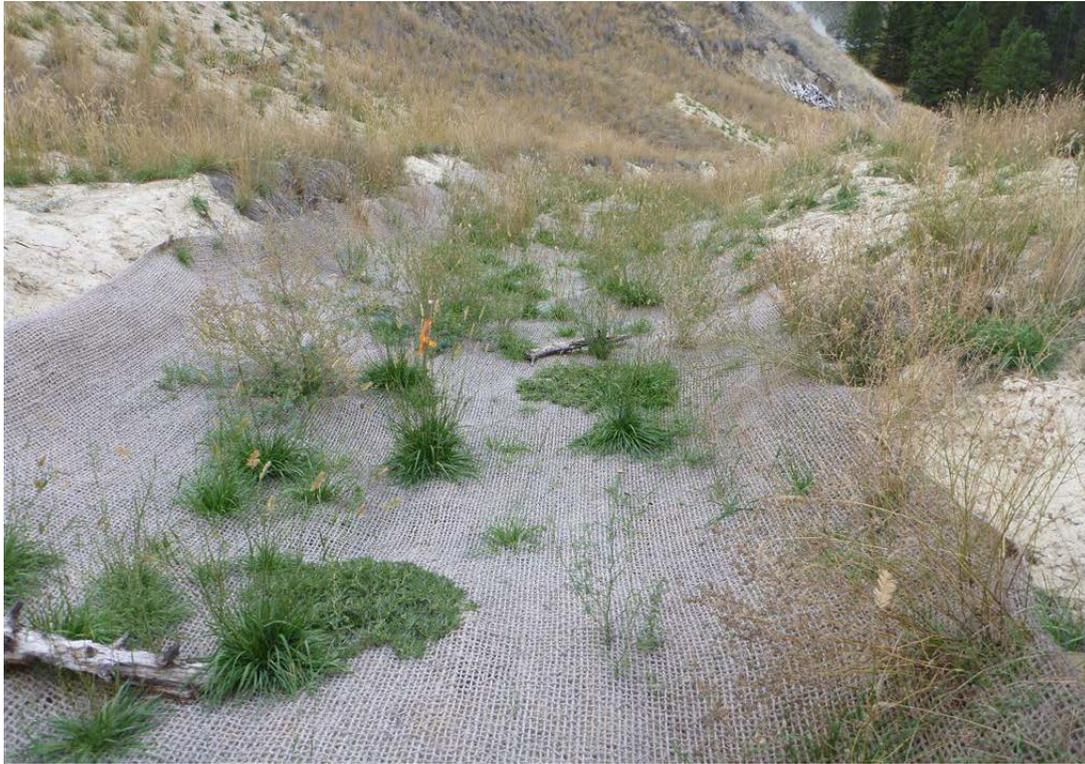
Photo 3: Incursion of crested wheatgrass and other weeds in areas disturbed by 2013 test pits.

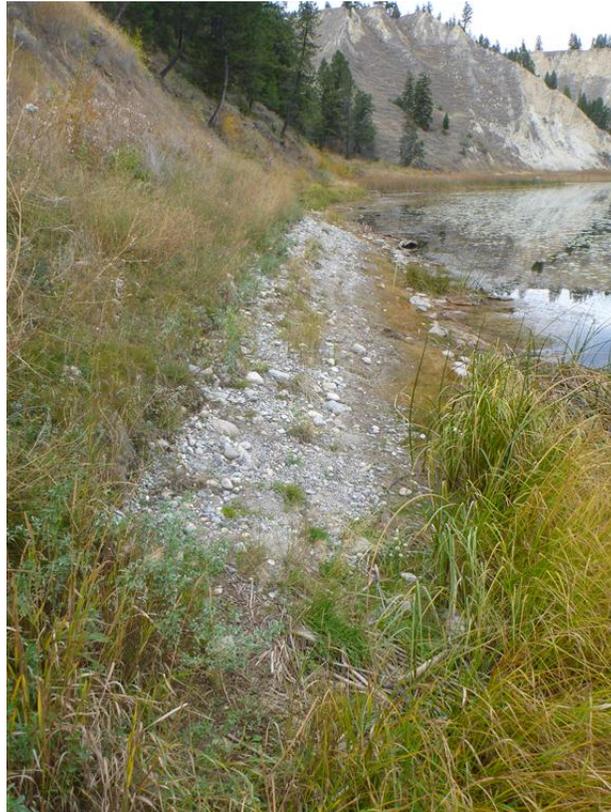
The marsh shoreline was noted to be stable and continuing to re-vegetate (Photo 4). Willow stakes appeared to be growing adequately (Photo 5).

Photo 4: Marsh shoreline is stable and continuing to re-vegetate.

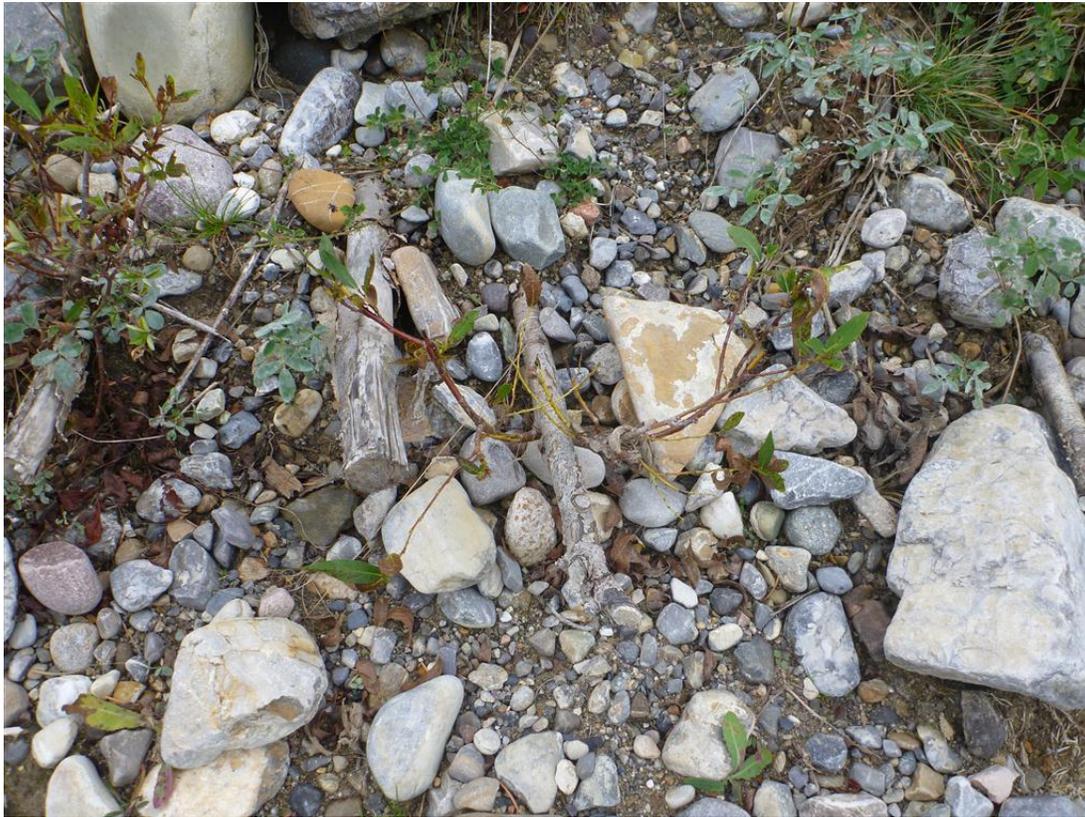
Photo 5: Willow stakes continuing to grow at marsh.

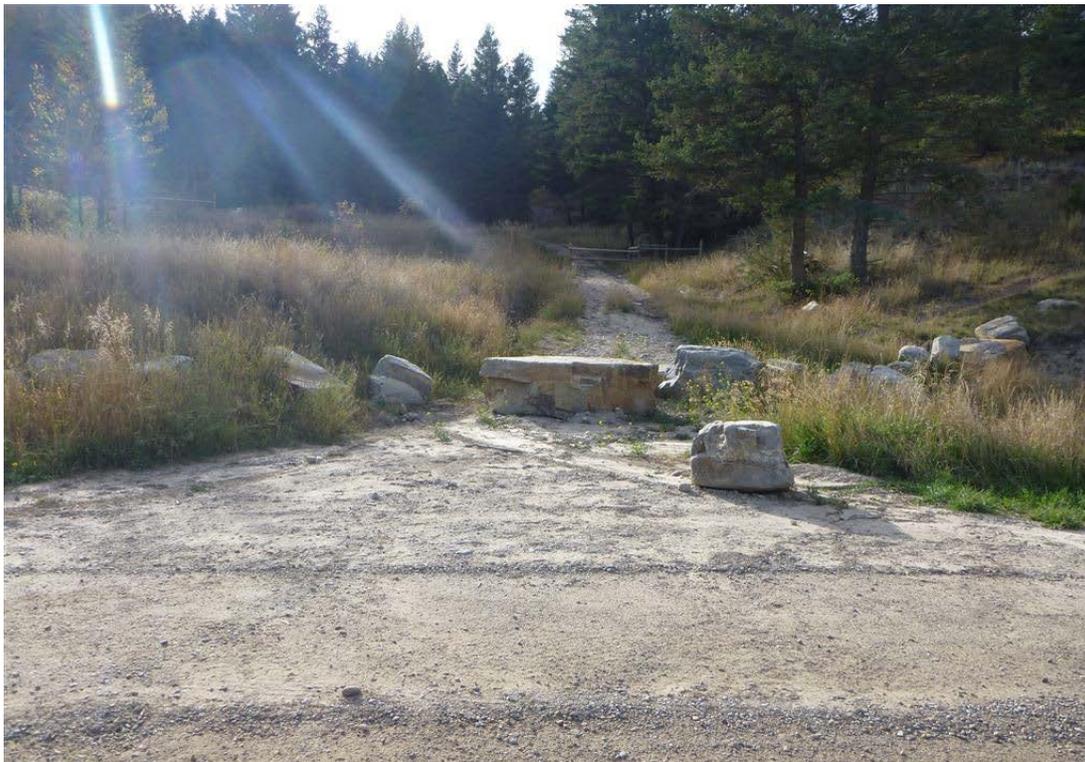
The fence line along the road southwest of the Site was found to have been cut and the rock barrier altered (Photos 6 and 7). Evidence of recent activity through the breach in the fence was noted (single track, likely a dirt bike).

Photo 6: Rock barrier altered presumably for dirt bike or ATV activity.

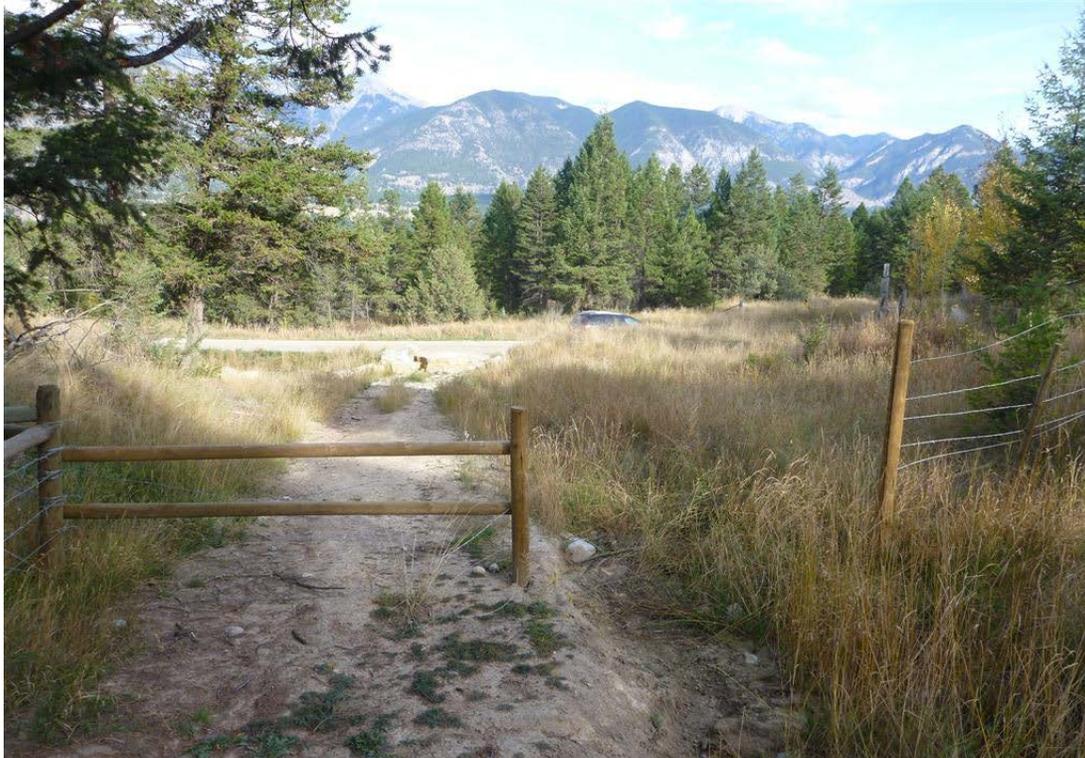
Photo 7: Fence cut at entrance to old ATV trail.

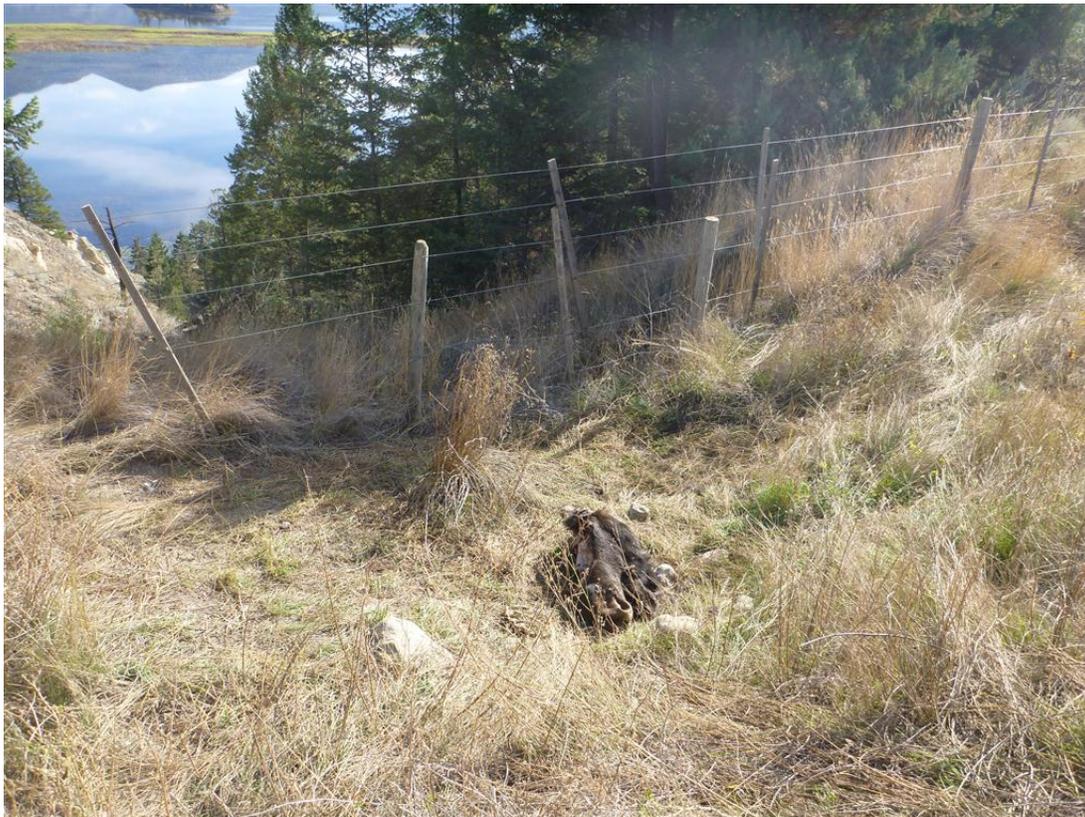
SLR walked along Westside Road to identify potential backfill sources within the Wilmer Marsh Unit for future remediation activities. During the walkover, a moose head was observed in the road ditch (Photo 8). As hunting is prohibited in this area, SLR notified the local Conservation Officer (Sgt. Lawrence Umsonst, Columbia – Kootenay Zone).

Photo 8: Moose head observed along Westside Road – north of site.

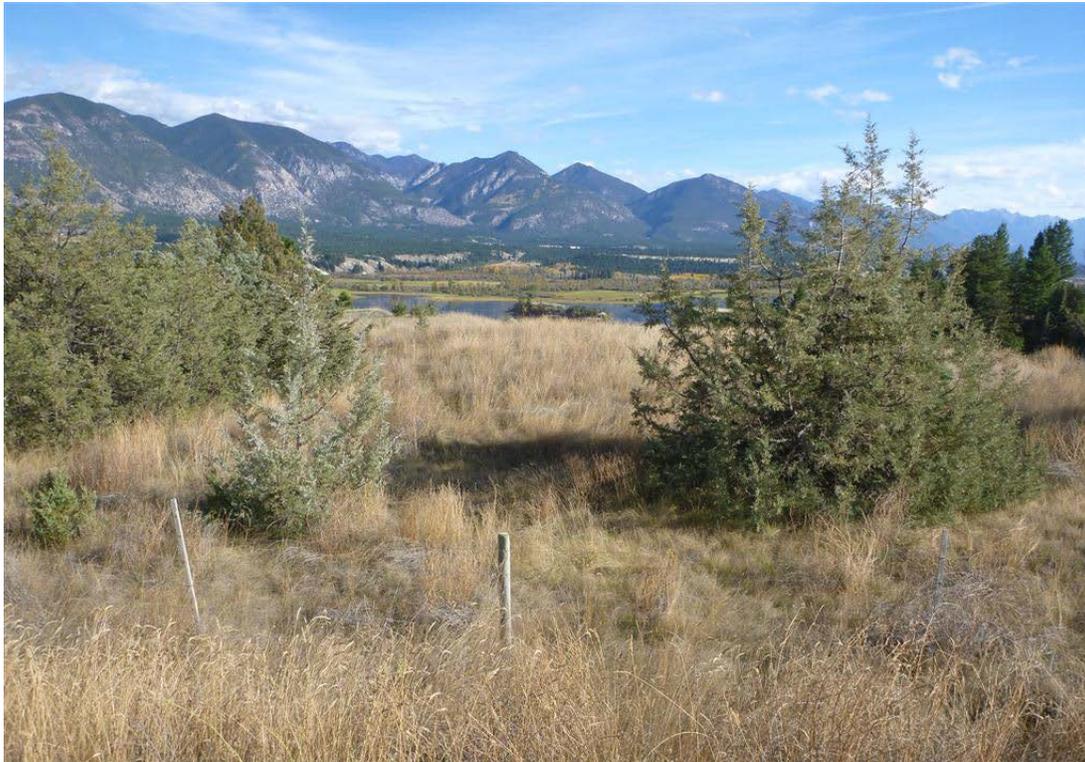
During the reconnaissance for potential backfill sources, SLR identified dumping on an uplands bench north of the Site (Photo 9). The majority of the dumping appeared to be historic (old vehicles located downslope in areas overgrown by trees, some small tin can dumps) although some more recent debris (broken sheet glass) was also observed on the bench. As well, in an area closer to the road, there appeared to be slightly mounded terrain which was vegetated by disturbance species such as crested wheatgrass (Photo 10). This was noticeable as the surrounding areas were observed to be comprised of native grasses and other vegetation. Coordinates of the debris and the mound were recorded.

Photo 9: Uplands bench north of site with observed historic dumping.

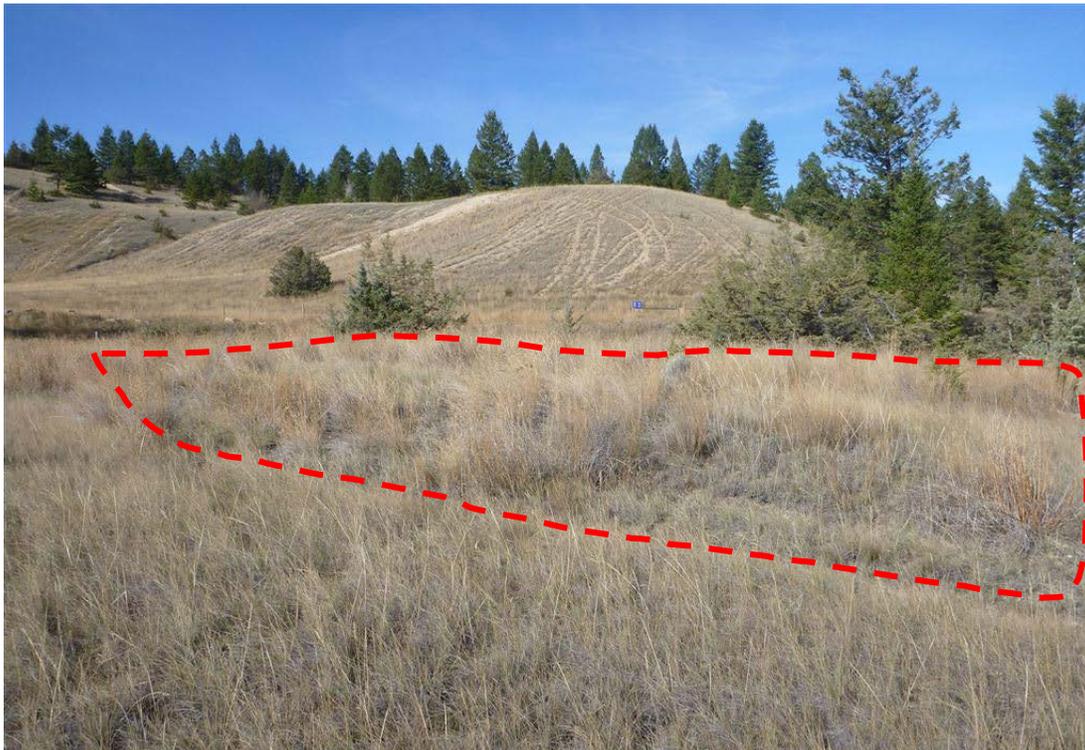
Photo 10: Mounded area on uplands bench north of site with disturbance vegetation (red dashed area).

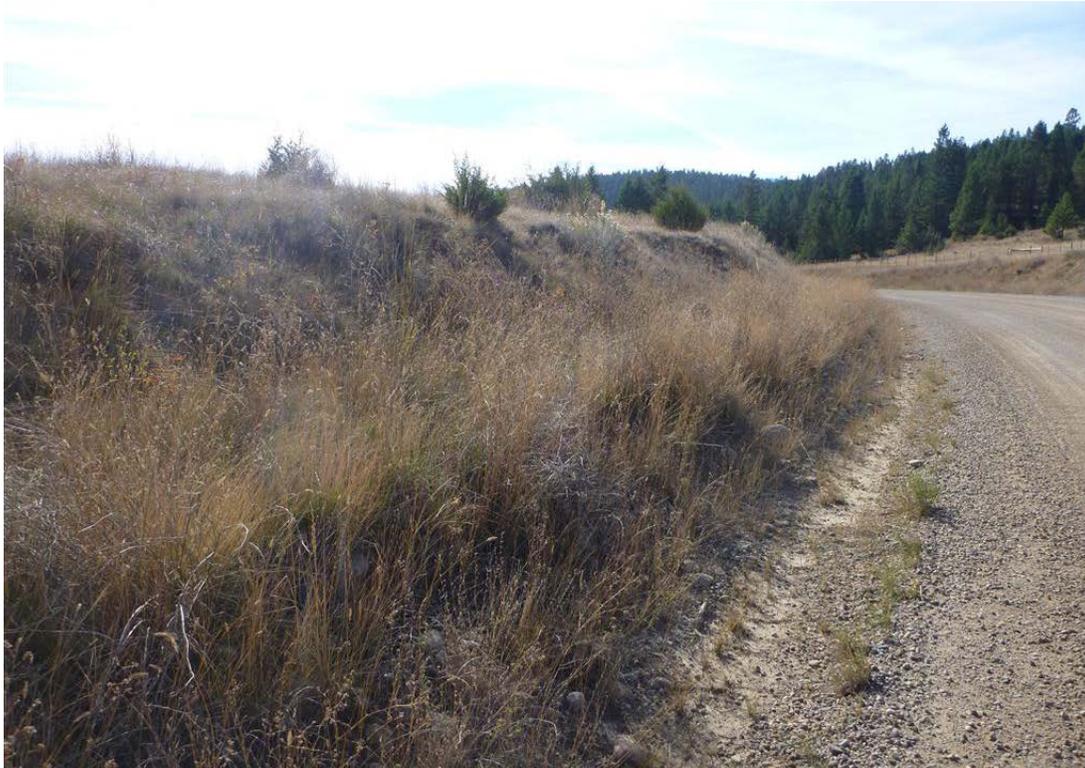
Photo 11: View of proposed backfill source along Westside Road.

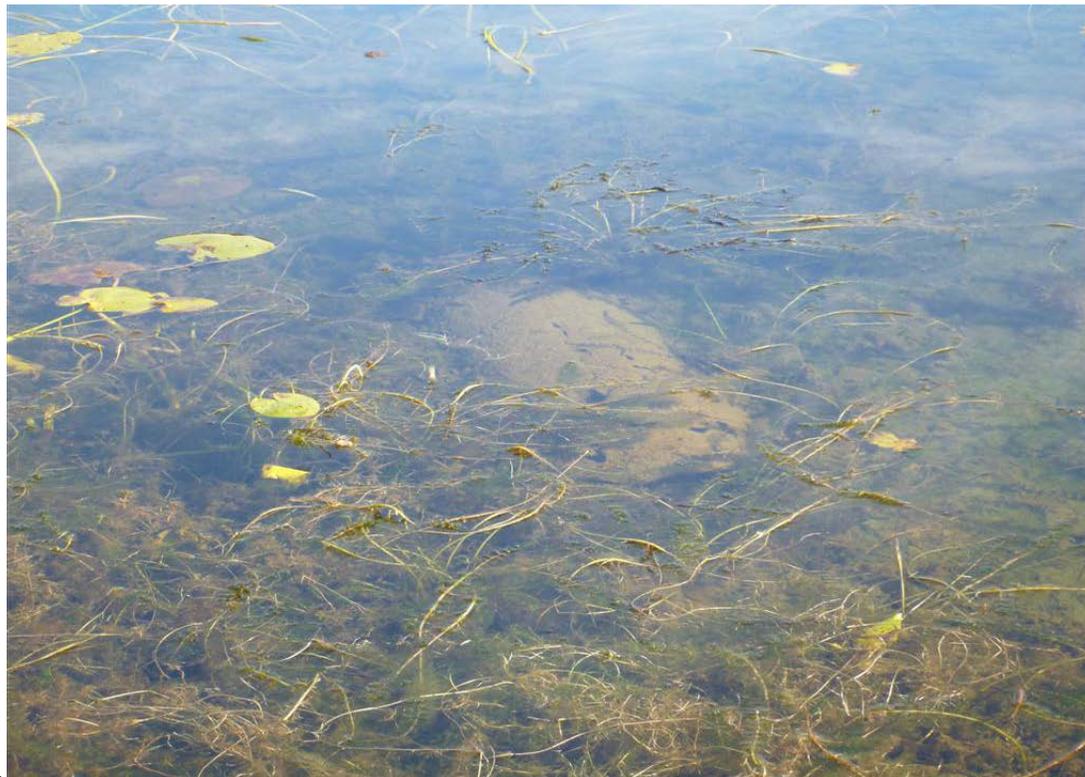
Photo 12: Metal tank observed within water in marsh area.

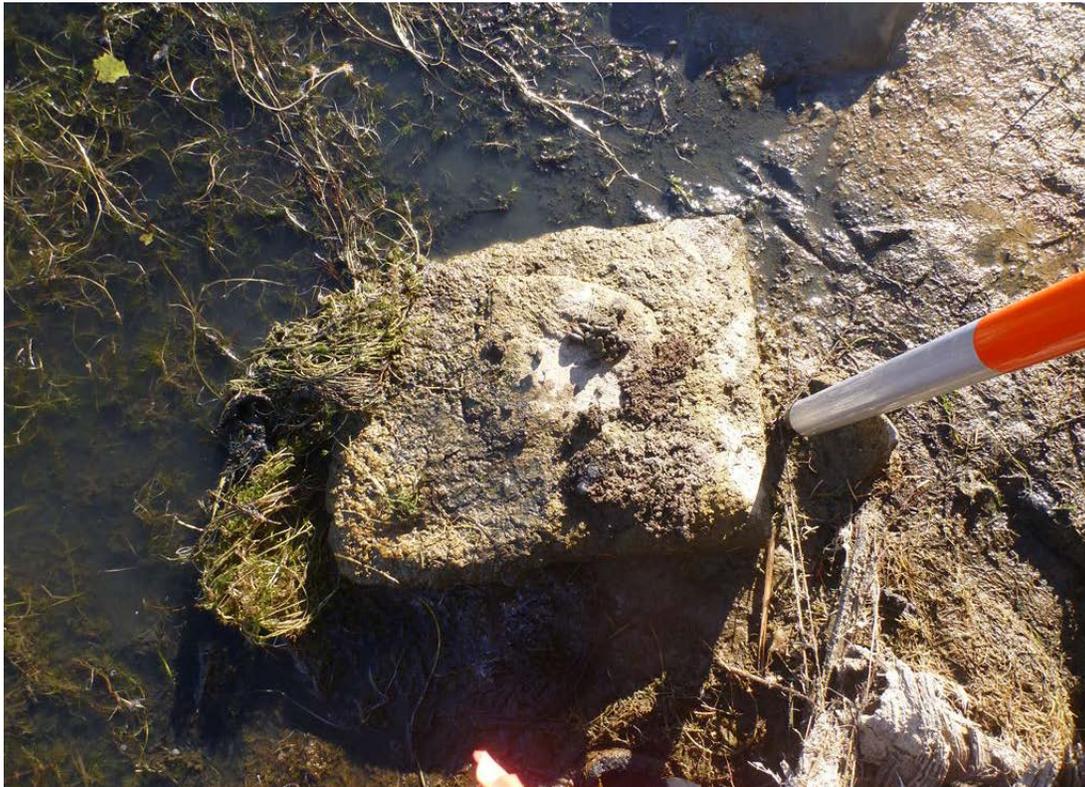
Photo 14: Concrete block observed along marsh.

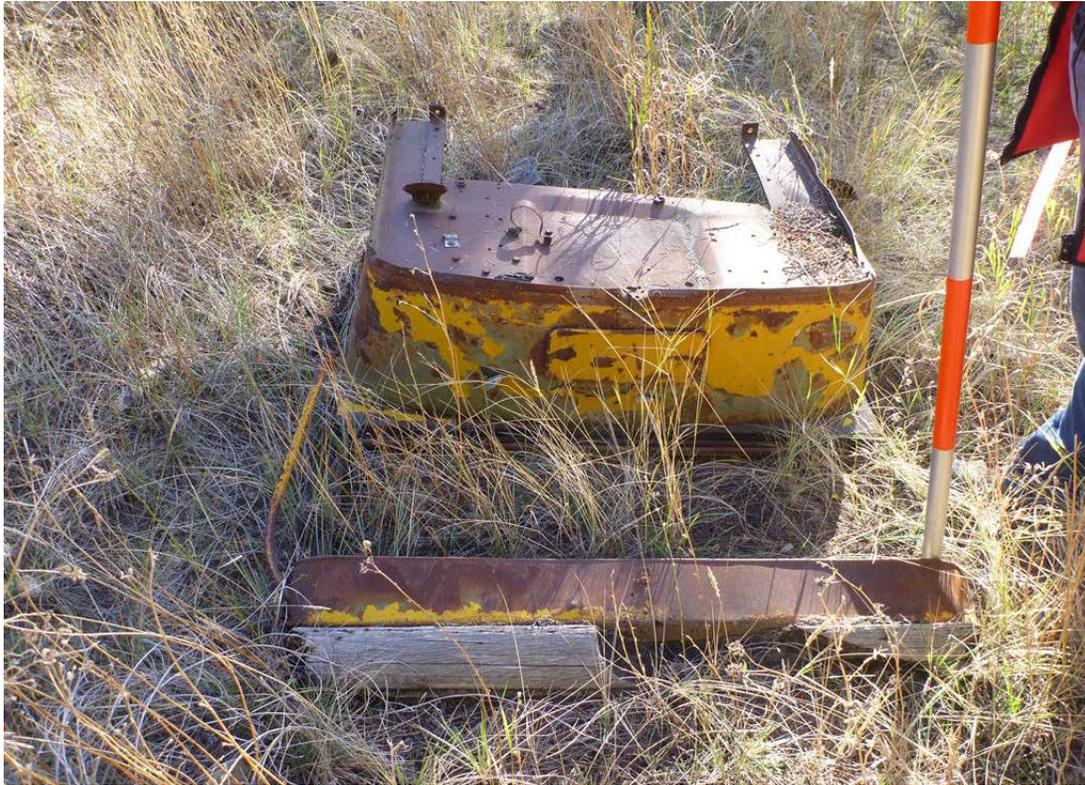
Photo 15: Example of metal debris observed in gully located south of trail.

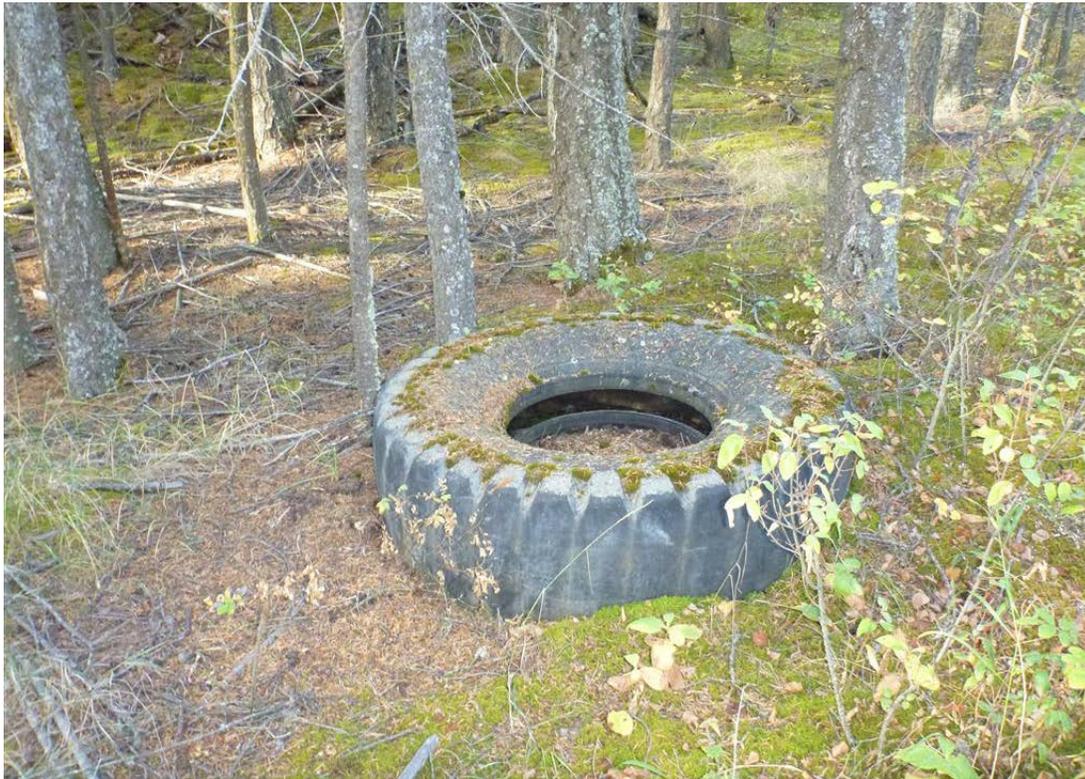
Photo 16: Example of tire observed in gully located south of trail.

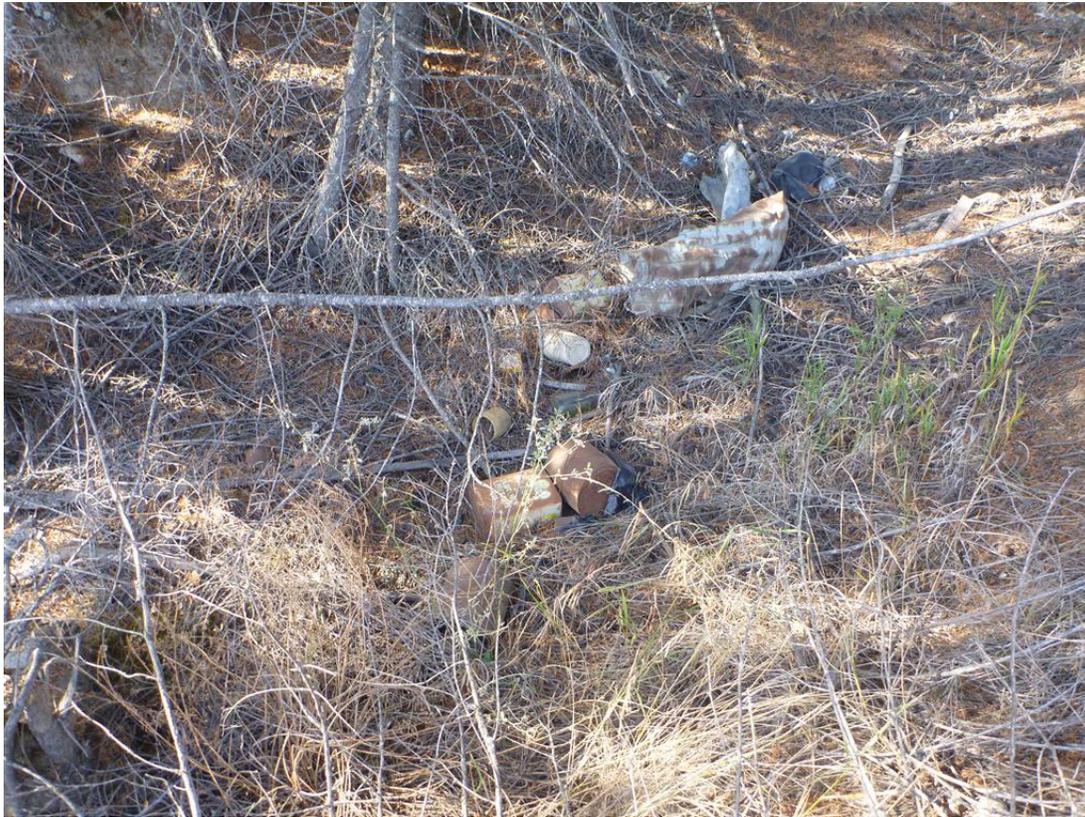
Photo 17: Example of surficial debris in trail area.

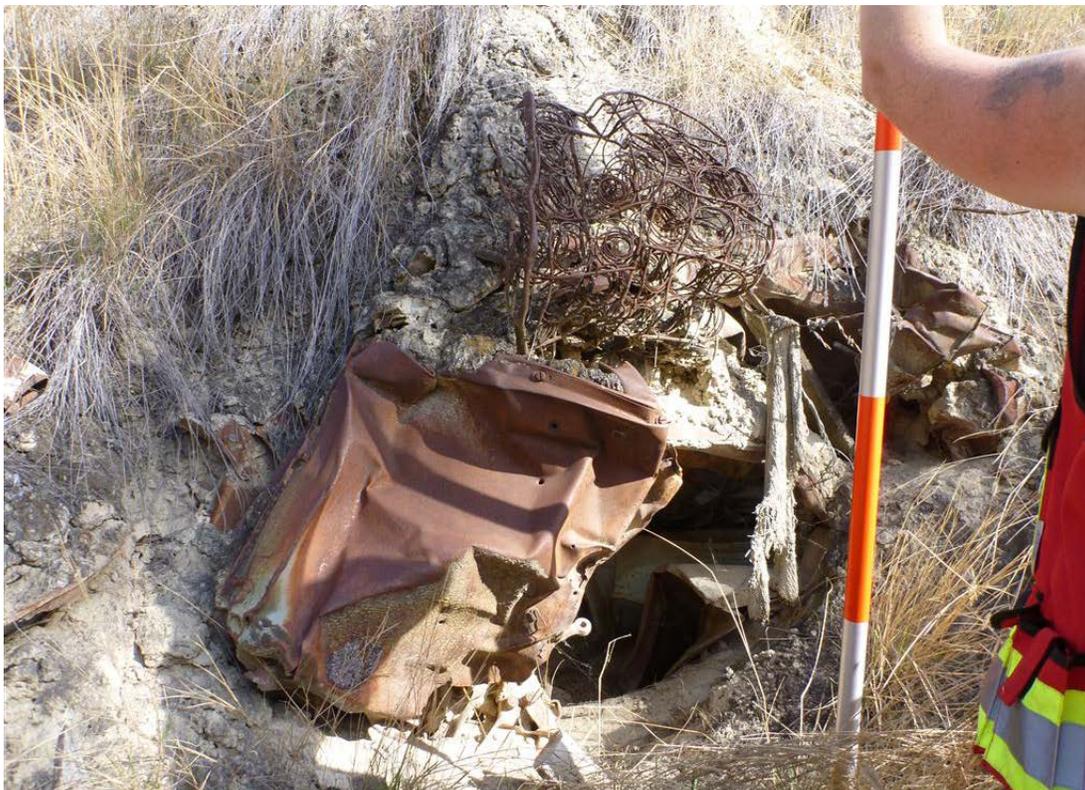
Photo 18: Example of partially buried debris in trail area.

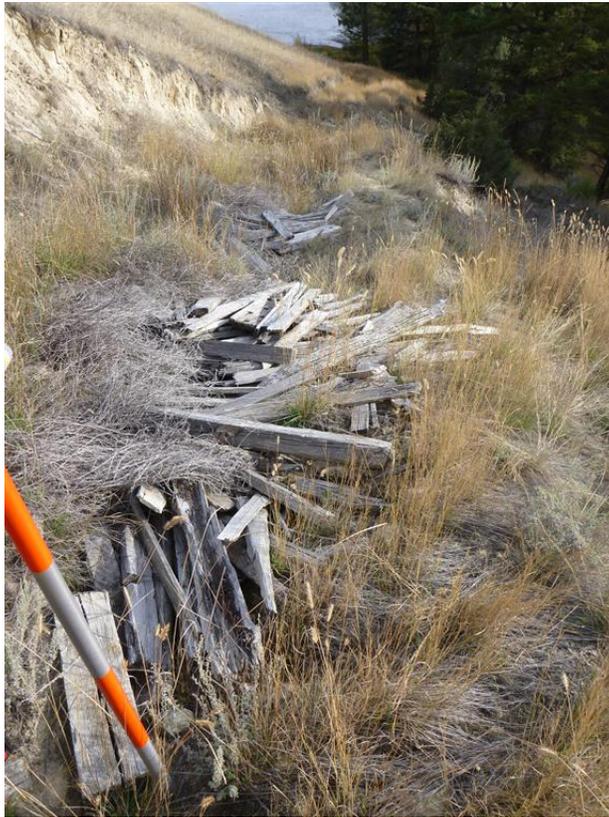
Photo 19: Area of wood debris observed along the trail.

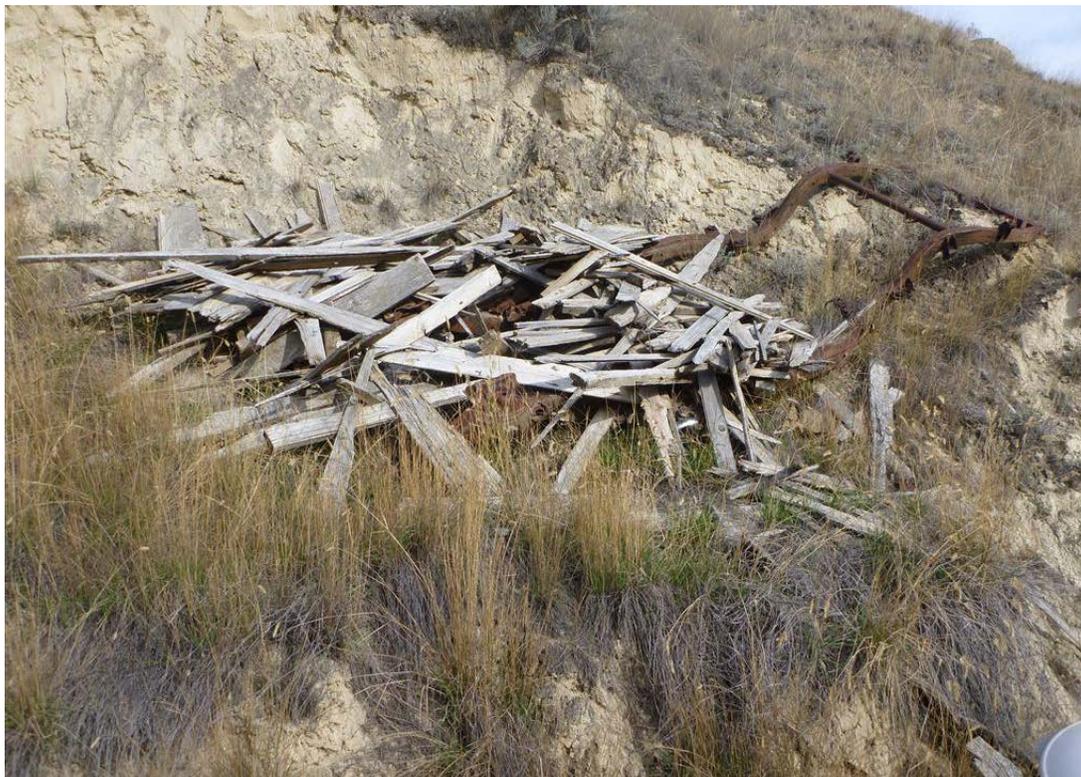
Photo 20: Mixed wood and metal debris observed on slope north of trail.

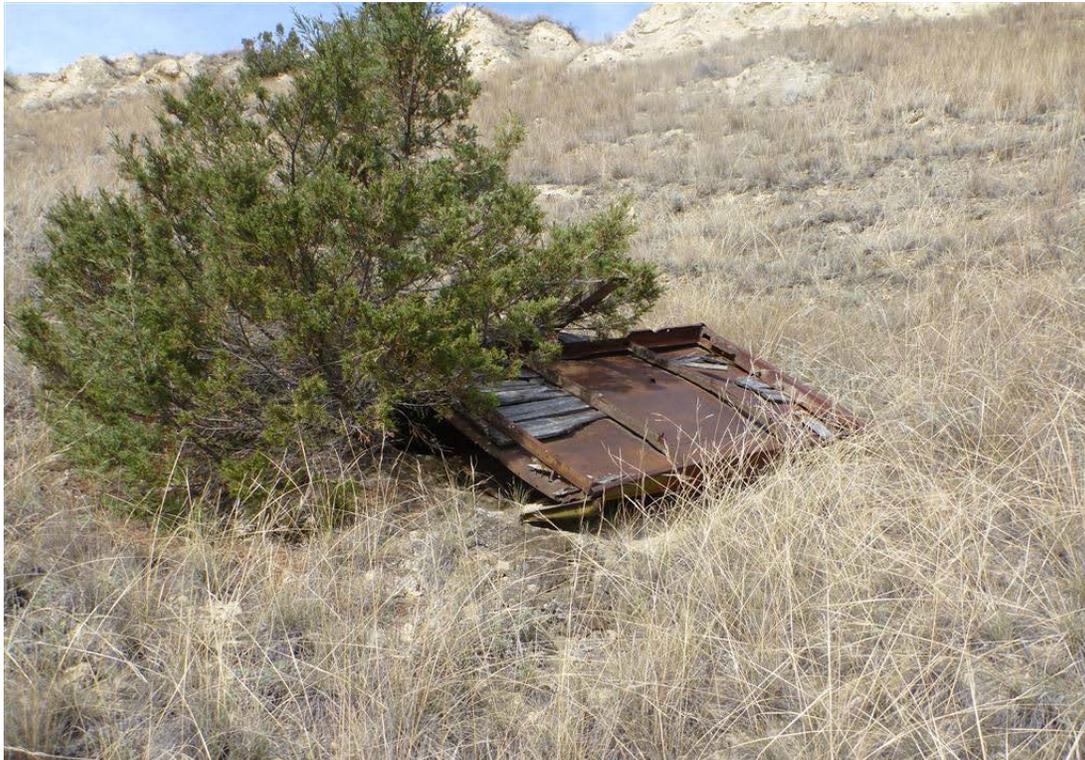
Along the trail and slope north of the trail, 13 pieces of surficial metal debris were identified. Wood debris piles and one piece of concrete were also noted. Larger areas of debris were mapped using a polygon which included a wood pile (Photo 19) and a pile of mixed wood and metal debris (Photo 20). The wood debris included lumbered wood with nails. One large piece of metal was observed north of the trail within an area of native vegetation (Photo 21).

Photo 21: One large piece of metal debris observed on the slope north of the trail.

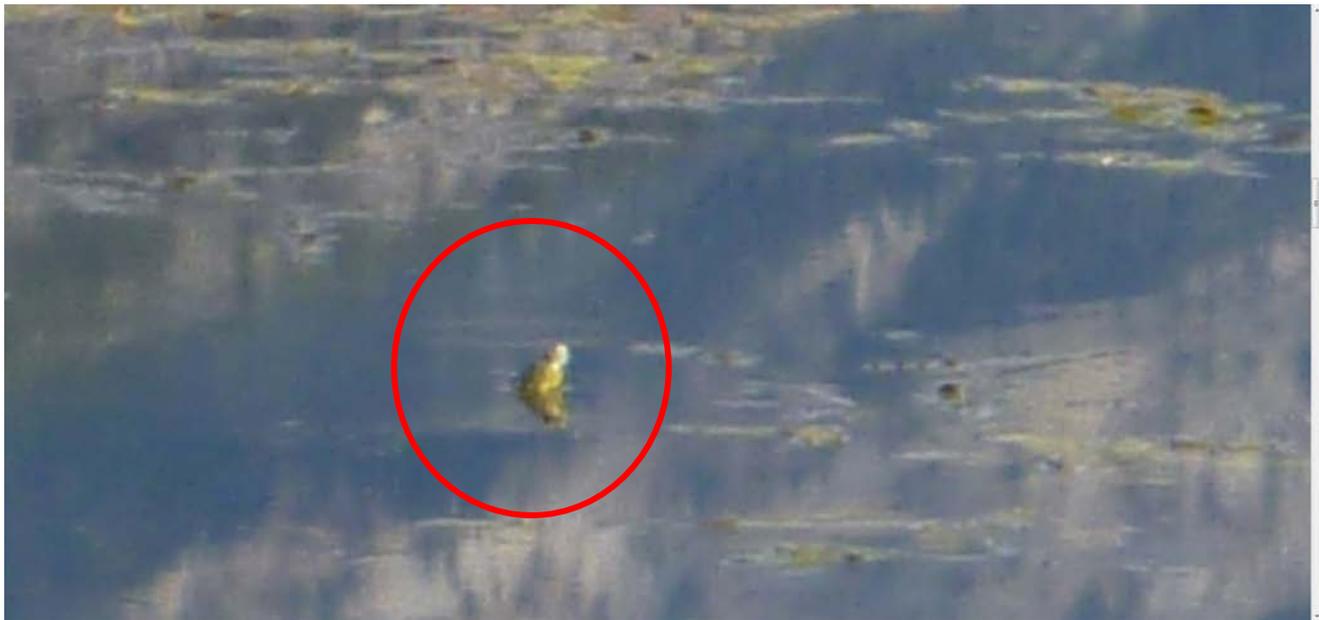
On another occasion, two turtles were observed. A photograph of one of the turtles was attempted (see Photo 22). However, due to the distance from the shore and the turtle's limited exposure above the water surface, the photograph is not definitive for identification purposes.

Photo 22: Turtle observed in water along marsh.

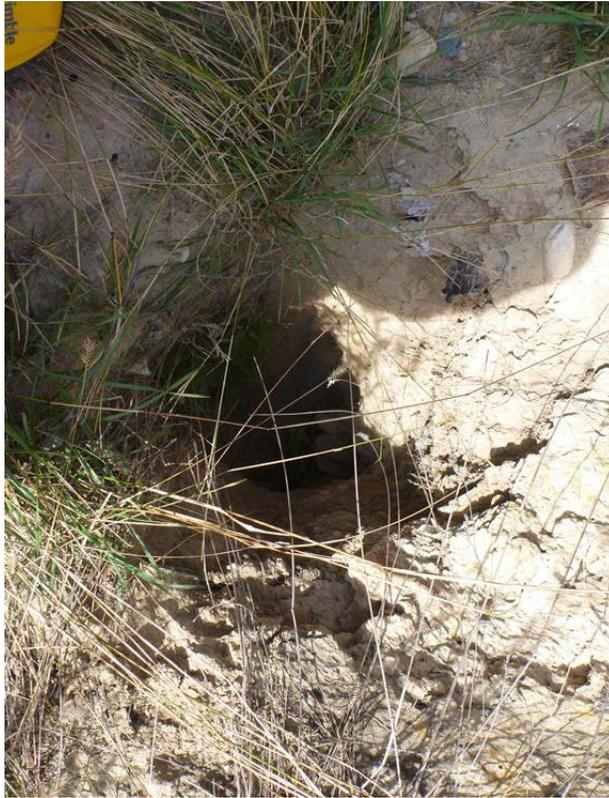
One abandoned badger burrow was observed at the north end of the gully downslope of the trail area (Photos 23 and 24). Three entrances to the burrow were observed. The entrances were heavily overgrown by vegetation and lichens were present on the soil, suggesting that this burrow was abandoned a number of years ago.

Photo 23: Abandoned badger burrow, view of entrance.

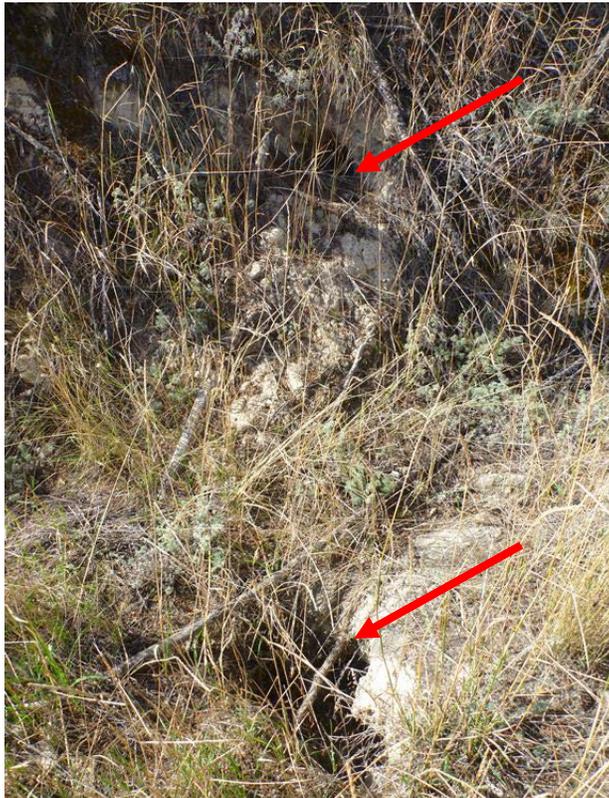
Photo 24: Abandoned badger burrow, view of entrances (denoted by red arrows).

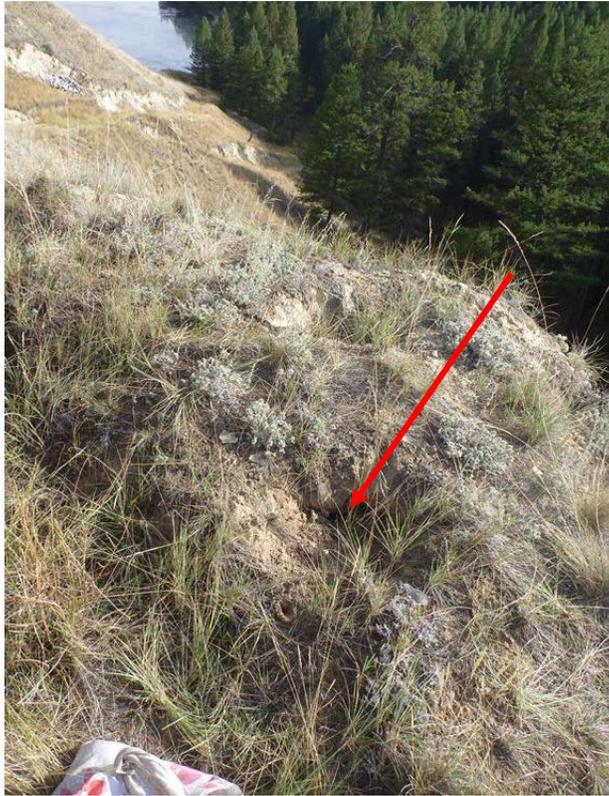
A second abandoned badger burrow was observed to the south of the upper part of the trail (Photo 25). Two entrances were found, both covered in vegetation and lichens, suggesting that this burrow was abandoned a number of years ago as well.

Photo 25: Abandoned badger burrow observed along upper part of trail (at red arrow).

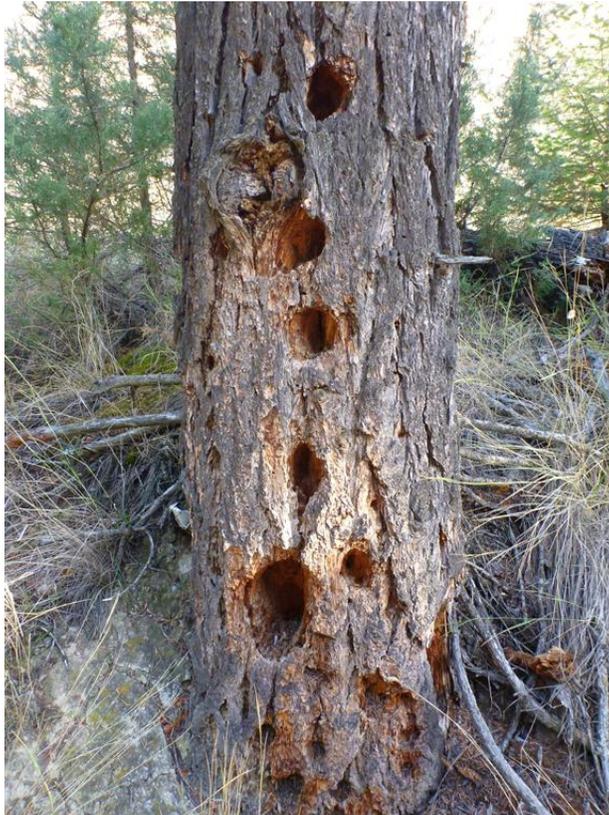
Photo 26: View of wildlife tree observed in gully south of the trail (cavities present).

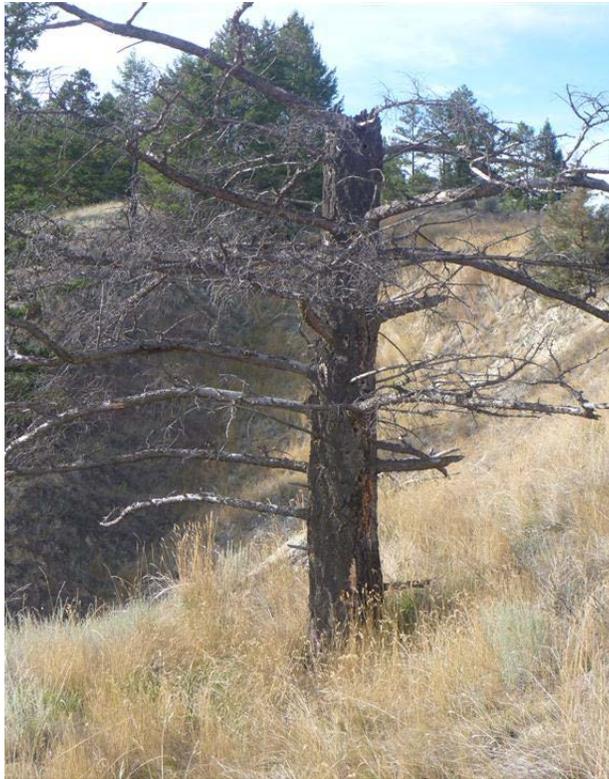
Photo 27: Wildlife tree observed south of the trail.

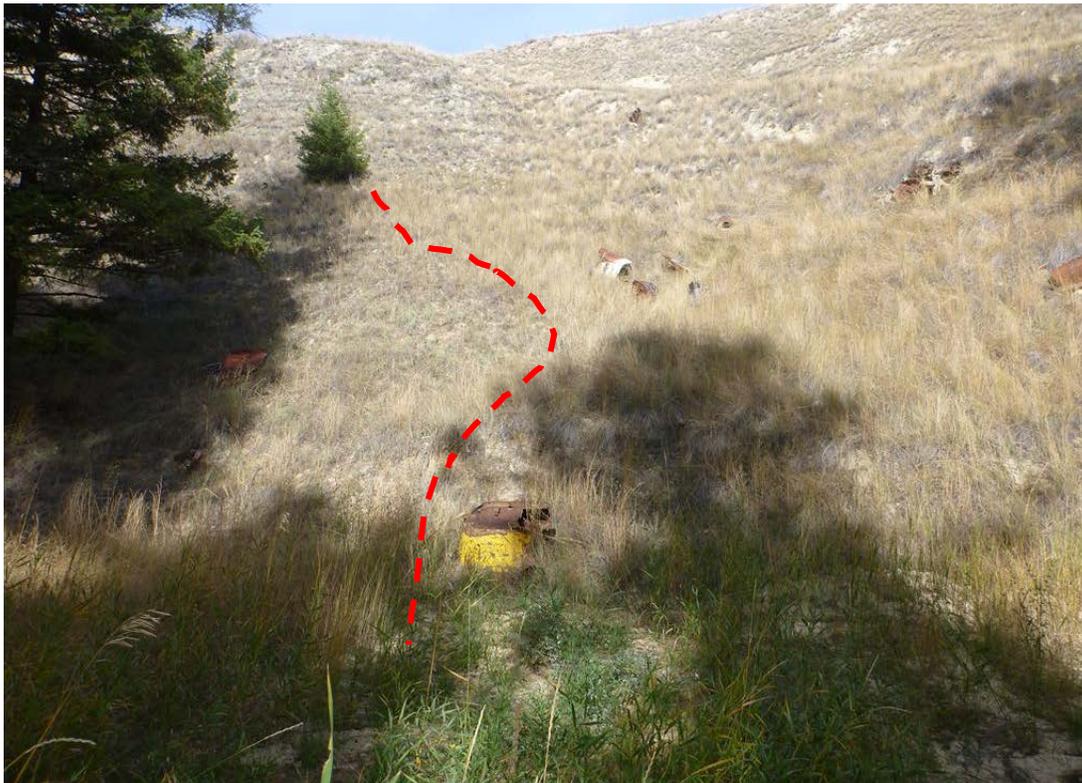
Photo 28: Area of native vegetation identified south of trail (to left of red dashed line).

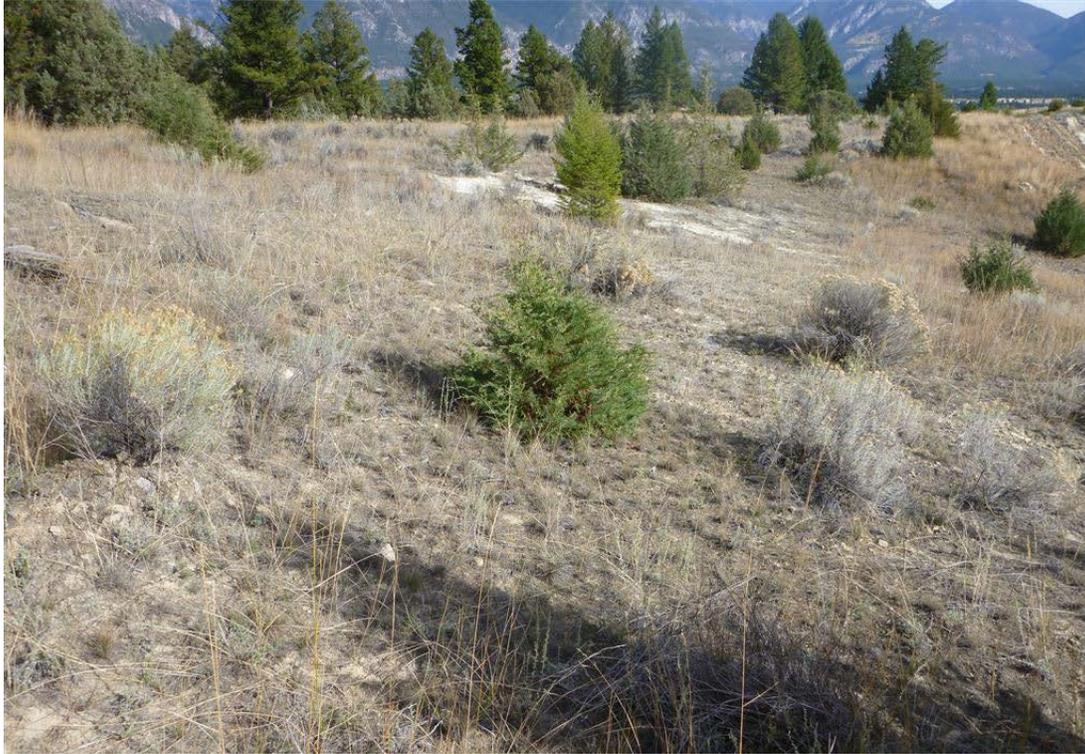
Photo 29: Native vegetation identified on the upland bench, north of the trail.
