**TENDER ADDENDUM****NCC - Summer 2015 Rehabilitation Project****NCC tender file # AL1558****January 29, 2015****ADDENDUM NO: 7****ADDENDA À LA SOUMISSION****CCN - Travaux de Rénovation Été 2015****Dossier de soumission de la CCN no. AL1558****Le 29 janvier 2015****ADDENDA NO: 7**

<b>DESCRIPTION OF WORK:</b> NCC - Summer 2015 Rehabilitation Project
--

**Attachment 1:  
Figures / Photos**

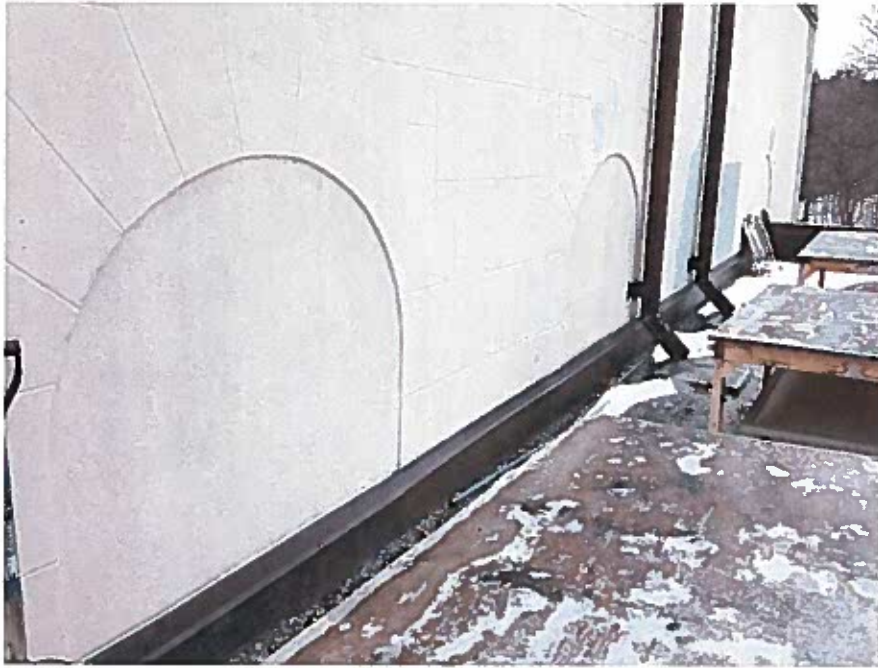
**Photograph No. 1**

- It is exp's understanding that the ballroom roof is to be replaced and will likely impact the flashing and the plaster walls that surround the roof. The following materials were observed within the roof space:

- Roof: A roof-cut was completed by George Cyr roofing. It was determined that the roof consisted of a black tar/bitumen material over blue foam insulation / foamboard. The roof was determined to be the same as that observed during roof cuts completed as part of the elevator DSS program completed by exp in April, 2014 (OTT-00218432-F0). As such, a single sample was submitted to confirm the absence of asbestos. Based on the laboratory results, the ballroom roof was determined not to contain asbestos.

Asbestos-containing wall plaster. Roof and caulking around flashing is non-asbestos.

*Recommendation: If more than 1m<sup>2</sup> of the plaster is to be disturbed as part of the roof renovation program, the disturbance of the plaster material would have to be completed in accordance with modified outdoor Type 3 operations as per Section 15 to 18 of O.Reg. 278/05. Alternatively, a Type 2 operation as per Section 15 and 16 can be used.*

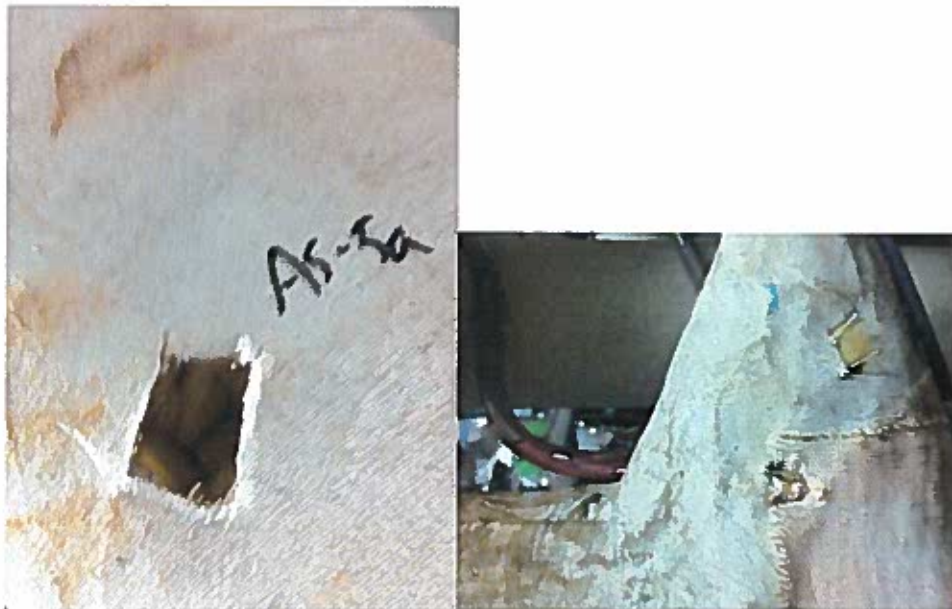
**Photograph No. 2**

- Pipe / Duct insulation: Canvas around fibreglass insulation was observed, collected and submitted for analysis from around pipe, ductwork and a valve (AS-5, 7, 9). The canvas material appeared to have a thin layer of paint and/or parging associated with it. Based on the laboratory results, the various canvas wraps were determined not to contain asbestos.

Non-asbestos canvas wrap (mechanical room).

There are no special asbestos recommendations regarding the handling of the aforementioned materials in the mechanical room.

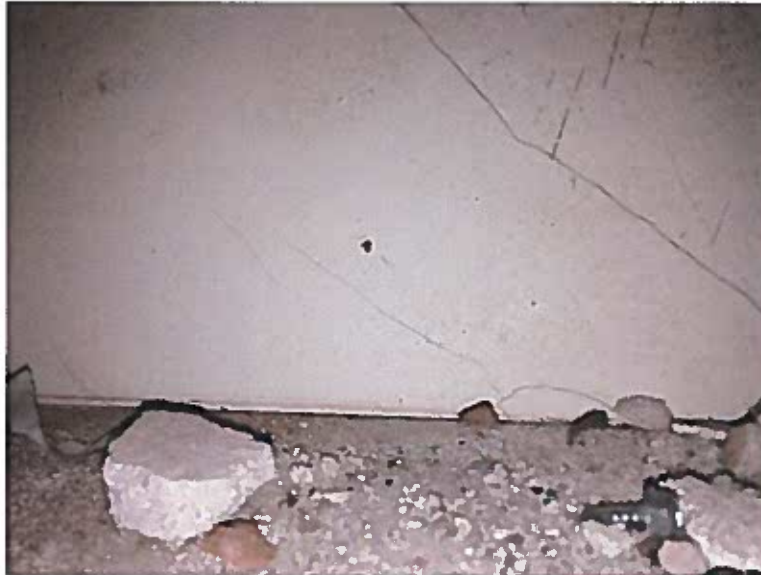
**Photograph No. 3**

- Wall / ceiling plaster: White on grey plaster was observed to form the walls and ceilings of the serveries room. In addition, this plaster also extended to the hallway. A total of five plaster samples (AS11-a,b,c,d,e) were collected from the serveries room and one plaster sample (AS-12) was collected from the hallway. The plaster was observed to consist of a white textured plaster over grey coarse plaster. Based on the laboratory results, the plaster within the serveries room and the adjacent hallway does not contain asbestos.

Non-asbestos ceiling/wall plaster debris on ceiling tile (serveries room).

There are no special asbestos recommendations regarding the handling of the aforementioned materials in the ballroom serveries room.

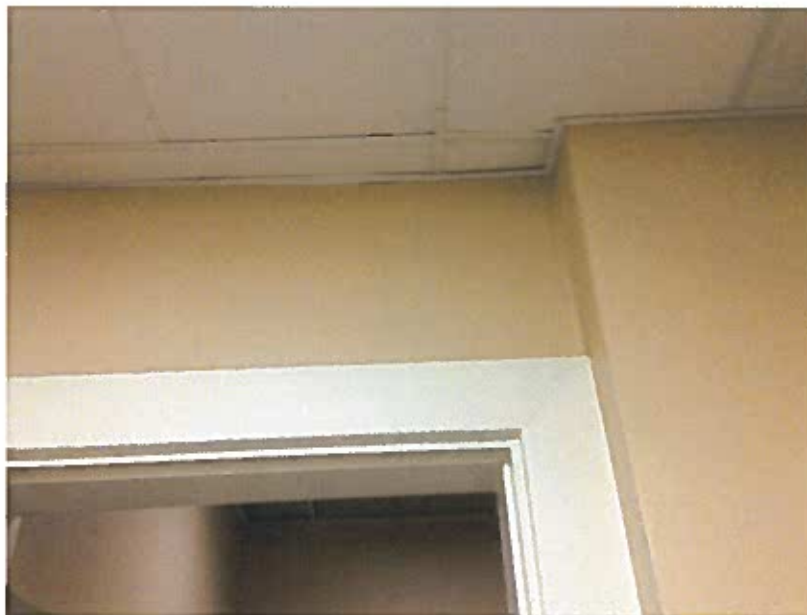
**Photograph No. 4**

- Ceiling tile: Drop ceiling tiles were observed within the serveries room. The tiles were 2'by4' solid ceiling tile with no visible pattern. Three samples were collected (AS-10a,b,c) and submitted for analysis. Based on the laboratory results, the ceiling tiles were determined not to contain asbestos.

Non-asbestos ceiling tile (serveries room).
