GRANVILLE ISLAND MARINE STRUCTURE REPAIRS OVERVIEW AQUATIC EFFECTS ASSESSMENT

File: 789-010.01 March 2015

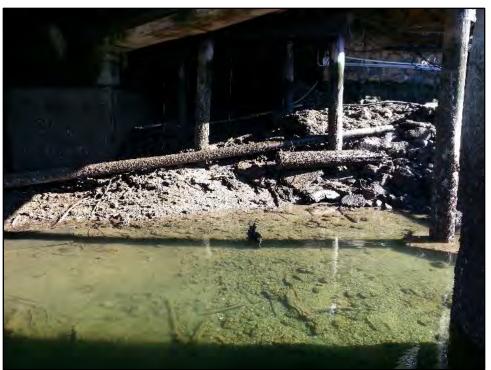
Photo 3 View of the Shoreline and Substrate underneath Lion's Gate Dock

Note: The area was littered with woody debris, wires and other urban waste.

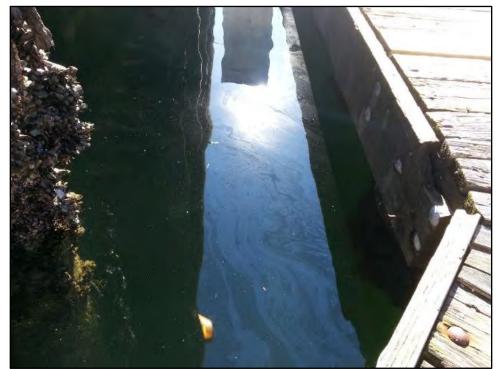
Photo 4 Hydrocarbon Sheen underneath Lion's Gate Dock

Note: The Project sites are adjacent to heavily used marinas and upland areas. Hydrocarbon sheens, such as this one underneath Lion's Gate Dock, were observed during the site visit.

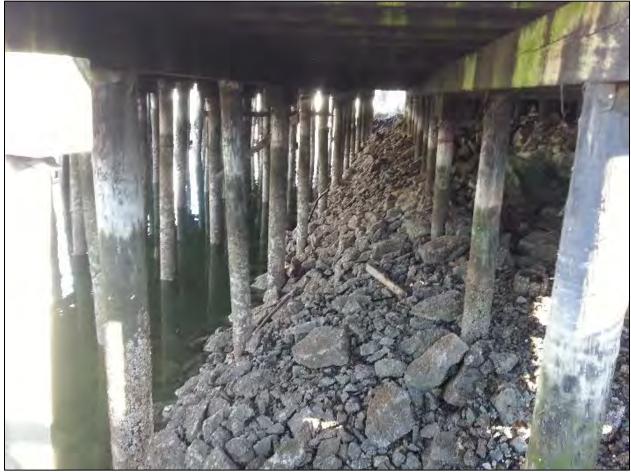
Photo 8 View of the Piles underneath West Dock

The Project will include the removal and replacement of five wooden piles supporting the West Dock (**Photo 8**). These piles are located in the high intertidal zones and replacement will occur within the footprint of the existing structures. The existing wooden piles will be extracted full length from the ground if possible; otherwise they will be cut off at the mud line. These piles are to be replaced with Coastal Douglas-fir timber piles of a minimum 36 cm (14") diameter to a minimum depth of penetration of 6.0 m below mud line or to refusal. The pile will be installed by pile-driving from a barge-mounted crane, except where it may be possible and advantageous to perform the work from the upland. Existing wharf structures may be removed to facilitate the works but will be replaced.

Oil-borne creosote is proposed as a preservative treatment for the piles to be applied in accordance with CSA 080 standards. Any bolts used in the timber piles and the bolt holes are also proposed for treatment with creosote. In addition, any cuts or breaks in the new timber would need to be treated with two coats of the specified treatment (assumed to be creosote).

Note: Five of the wooden piles are to be removed and replaced.

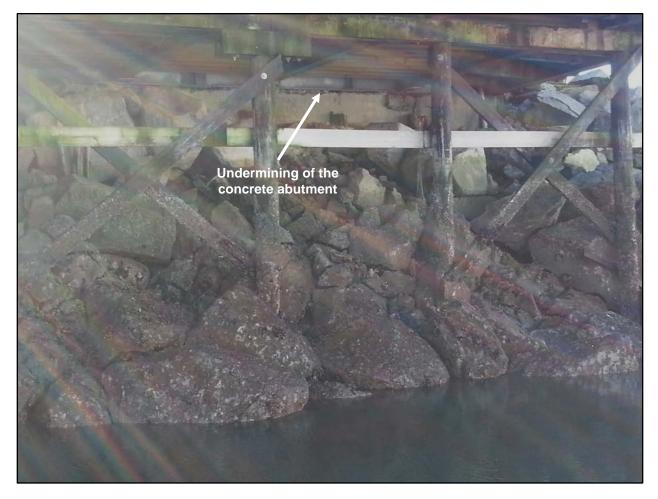
Some concrete works are proposed at Lion's Gate Dock, where the concrete and sub-beam will be retrofit and at Bridges Dock and the Public Market Wharf (**Photo 9**) to fill in areas where the upland concrete abutment has been undermined. Some minor excavation to ensure adequate filling of the voids will be required. All of these concrete structures appear to be located outside of the intertidal zone.

Photo 9 Concrete Undermining Observed by the Public Market Wharf

This Project involves filling voids within some of the concrete footings to prevent further undermining. All sites where concrete fill is proposed are located outside the intertidal zone and are not likely to be wetted by regular tides. The primary environmental concerns associated with the use of concrete near the marine environment is associated with concrete wastewater entering the marine environment. Provided that the mitigation measures and BMPs outlined in **Section 7.0** are followed, there is a low risk that concrete works will result in Serious Harm to fish.

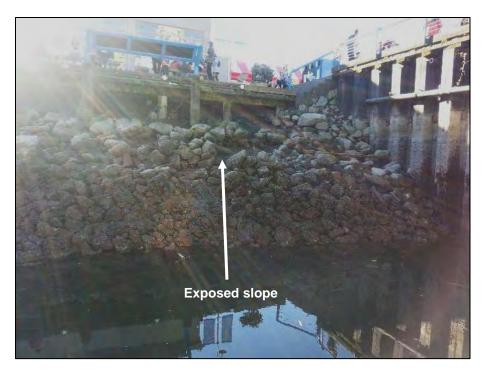
Downslope of the Public Market Boardwalk, some of the rip rap armouring on the steep intertidal zone has been failing (**Photo 10**). To reinforce the rock slope, additional placement of rip rap is proposed.

Photo 10 Rock Slope Protection to be Repaired along the Public Market Boardwalk

The additional rock slope protection proposed along the Public Market Boardwalk may result in a marginal increase in the footprint of the Project if rip rap is placed past the existing edge of the rock slope. However, the addition of rip rap to the existing shoreline may be beneficial by providing new attachment sites for algal species and marine invertebrates.

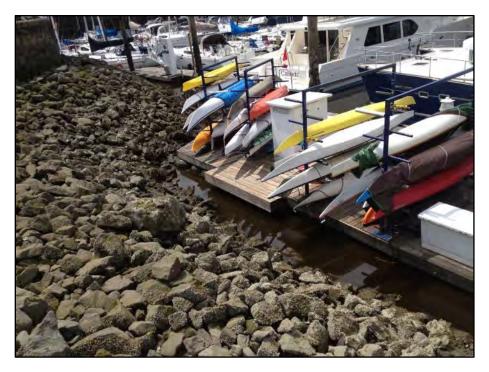
In addition, regrading of a 3 m long rock slope spanning 20 m adjacent to the Maritime Market Boardwalk is required to prevent the floating docks from stranding at low tide (**Photo 11** and **Photo 12**). The regarded bank will change from 3:1 to a 1.75:1 slope and will terminate at least 0.5 m before the edge of the floating dock at a depth of 1.5 m (relative to the lowest yearly tide elevation).

Photo 11 View of a Stranded Floating Dock at Low Tide Adjacent to the Maritime Market Boardwalk (Photo Courtesy of Parsons)

The regrading of the rock slope adjacent to the Maritime Market Boardwalk will result in the temporary disturbance to approximately 60 m^2 of rip rap and result in a steeper slope. As the target depth by the floating docks is -1.5 m (chart datum) some in-water works will be required that may result in the release of sediment-laden waters.

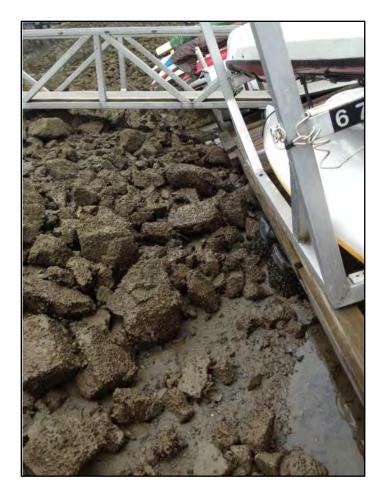
Photo 12 View of the Rock Slope and a Gangway Leading to a Stranded Floating Dock at Low Tide adjacent to the Maritime Market Boardwalk (Photo Courtesy of Parsons)

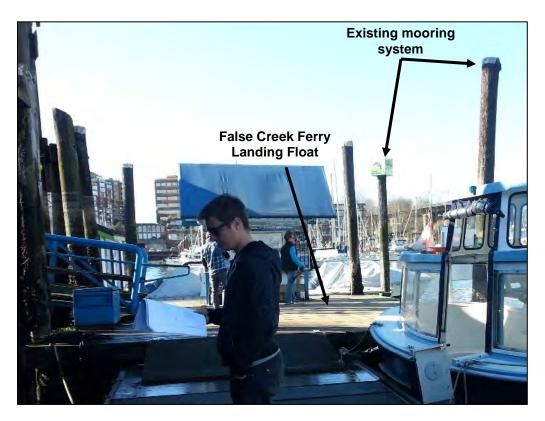
The existing timber False Creek Ferry Landing Float, adjacent to West Dock (**Photo 13**), is proposed for replacement with a new buoyancy foam filled concrete float. Although the design has not been finalized, the creosote-treated wooden mooring system is anticipated to be replaced with steel pipe piles (**Photo 14**).

Photo 14 False Creek Ferry Landing Float with Wooden Mooring Piles

The False Creek Ferry Landing Float proposed for replacement adjacent to the West Dock is anticipated to result in a net benefit due to the removal of a deteriorating timber landing float and treated creosote moorage infrastructure and replacement with steel and concrete infrastructure. The marginal increase in the footprint of the dock (approximately 2 m^2) is not anticipated to result in any significant effects to the marine environment. Provided that the mitigation measures and BMPs outlined in **Section 7.0** are followed, there is a low risk that rock slope protection works will result in Serious Harm to fish.

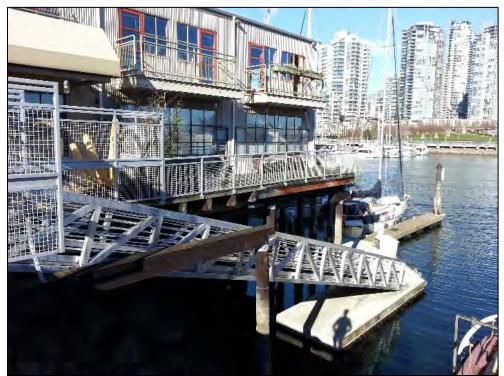
Cathodic protection (aluminum anodes) on outboard piles and installation of steel plate patches are proposed to prevent further corrosion and deterioration of piles (e.g., at the Northeast Seawall and Boardwalk (**Photo 15**) along the shoreline). Anodes will be installed on 161 piles along Granville Island at or below 0.0 m (chart datum) by a diver.

Note: Some minor works involving steel plate patching and cathodic protection on the steel piles is proposed.Photo 15 Wharf adjacent to Pier 32

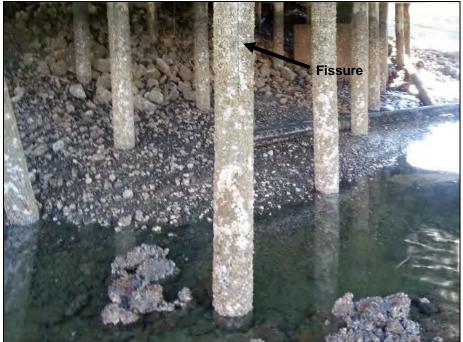
- **Note:** Steel bands are proposed to be installed in areas where the structural integrity of the wooden piles has been compromised, such as under the Lion's Gate Dock.
- Photo 16 Example of Wooden Piles with Compromised Structural Integrity, under the Lion's Gate Dock

At Lion's Gate Dock (**Photo 16**), Bridges Dock, West Dock and the Public Market Trestle, installation of steel bands is proposed around wooden piles that have been compromised (e.g., due to cracks and fissures in the wooden piles). No in-water works are anticipated.

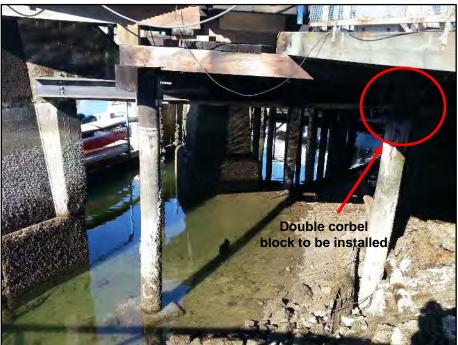
Note: Some minor works, involving fresh heading and installation of corbel blocks, are proposed such as under Lion's Gate Dock

Photo 17 Location of Proposed Installation of Corbel Blocks under Lion's Gate Dock

Fresh heading of piles and installation of corbel blocks and or sub-caps is proposed for a select number of piles at Lion's Gate Dock (**Photo 17**), West Dock, and the Public Market Wharf. These works will affect the top ends of the piles and no in-water works are anticipated.

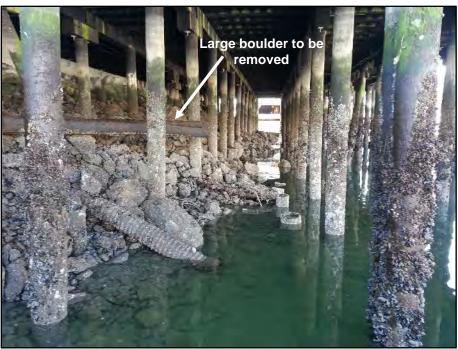
A large boulder (**Photo 18**), currently resting on a wooden pile under Bridges Dock, will be removed to prevent further shifting of the pile. The boulder is located in the intertidal zone but is exposed at low tide.

Photo 18 View underneath Bridges Dock Facing Southwest Showing the Concrete Abutment (left) and Piles where Steel Bands will be Installed

Note: A large boulder will also be removed.

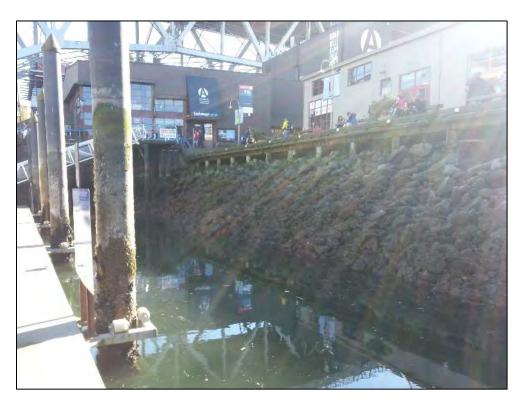
Photo 19 View of the Concrete Pedestals (right side of photo) to be Replaced adjacent to the Public Market Boardwalk

Replacement of concrete pedestals, forming the Public Market Boardwalk, and wooden posts along the upland of Lions Gate Dock is also proposed. These concrete pedestals (**Photo 19**) and wooden posts are located outside the intertidal zone. No in-water works are anticipated.
