PWGSC Ontario	SPECIFICATION	Section 00 00 00
Region Project	TITLE SHEET	Page 1
Number R.071694.050		2015-02-19

PROJECT TITLE STOKES BAY FRONT RANGE LIGHT STATION DFRP No. 10961  
KNIFE ISLAND, ONTARIO  
LEAD BASED PAINT ABATEMENT AND CONTAMINATED SOIL REMOVAL

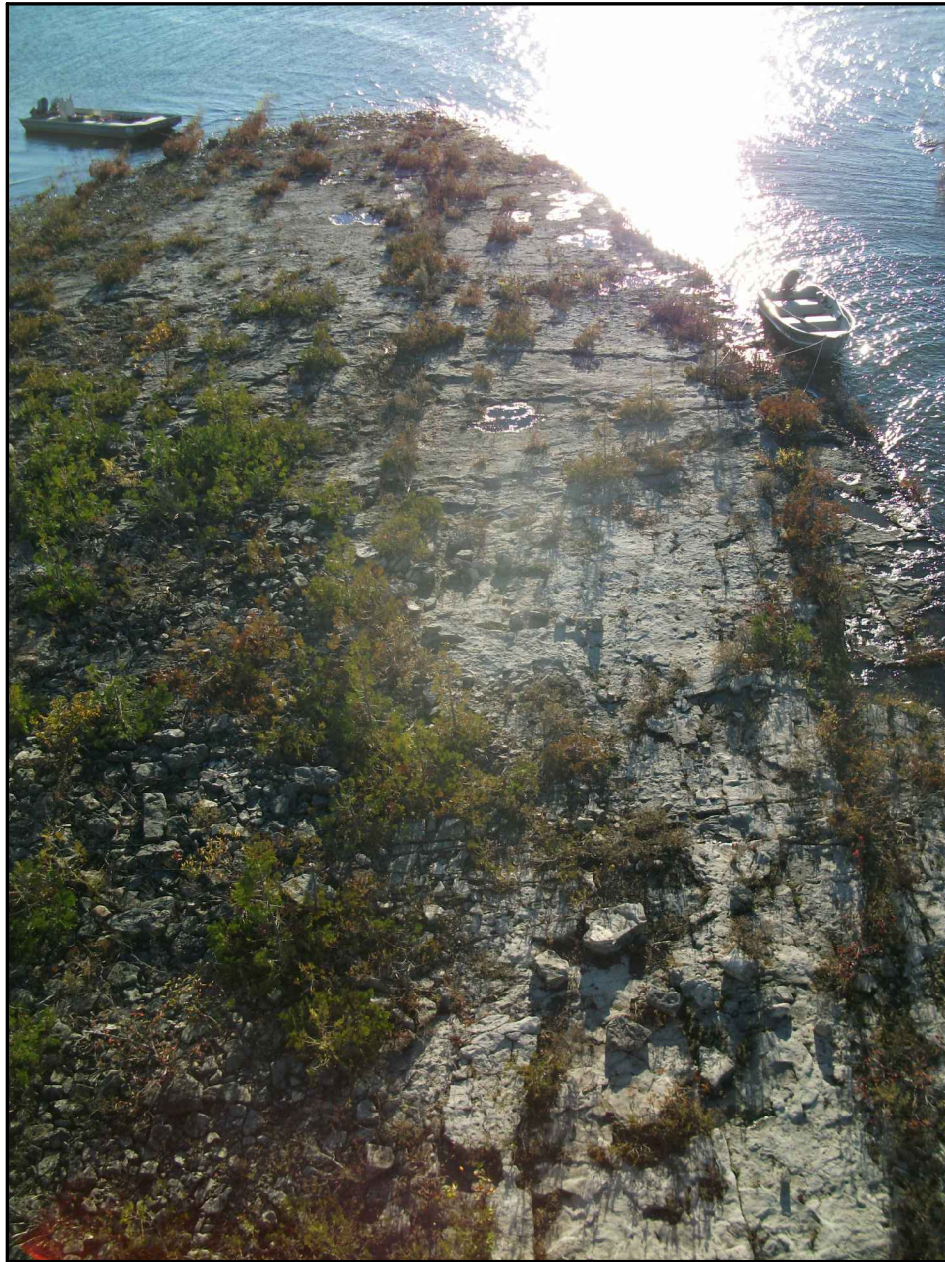
Photograph 3: Exposed bedrock with loose rocks and sparse vegetation (looking southwest from top of light towers).

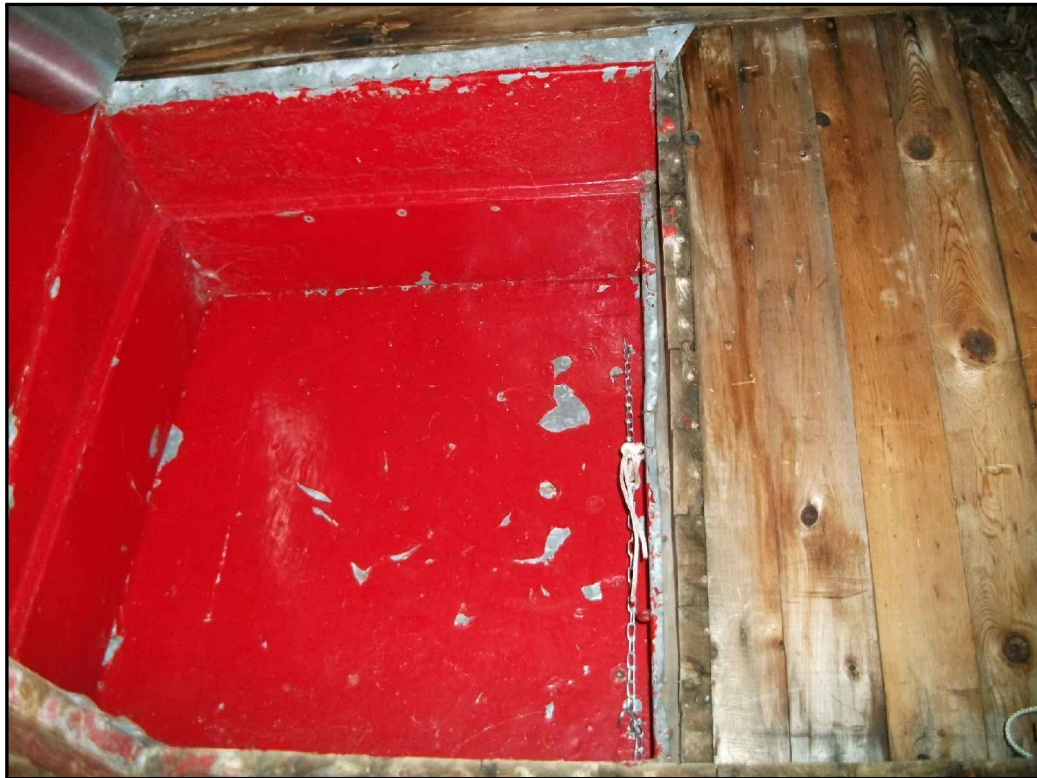
Photograph 8: Red lead-based paint (fair condition) on interior metal surface on 3rd floor of Old Light Tower.

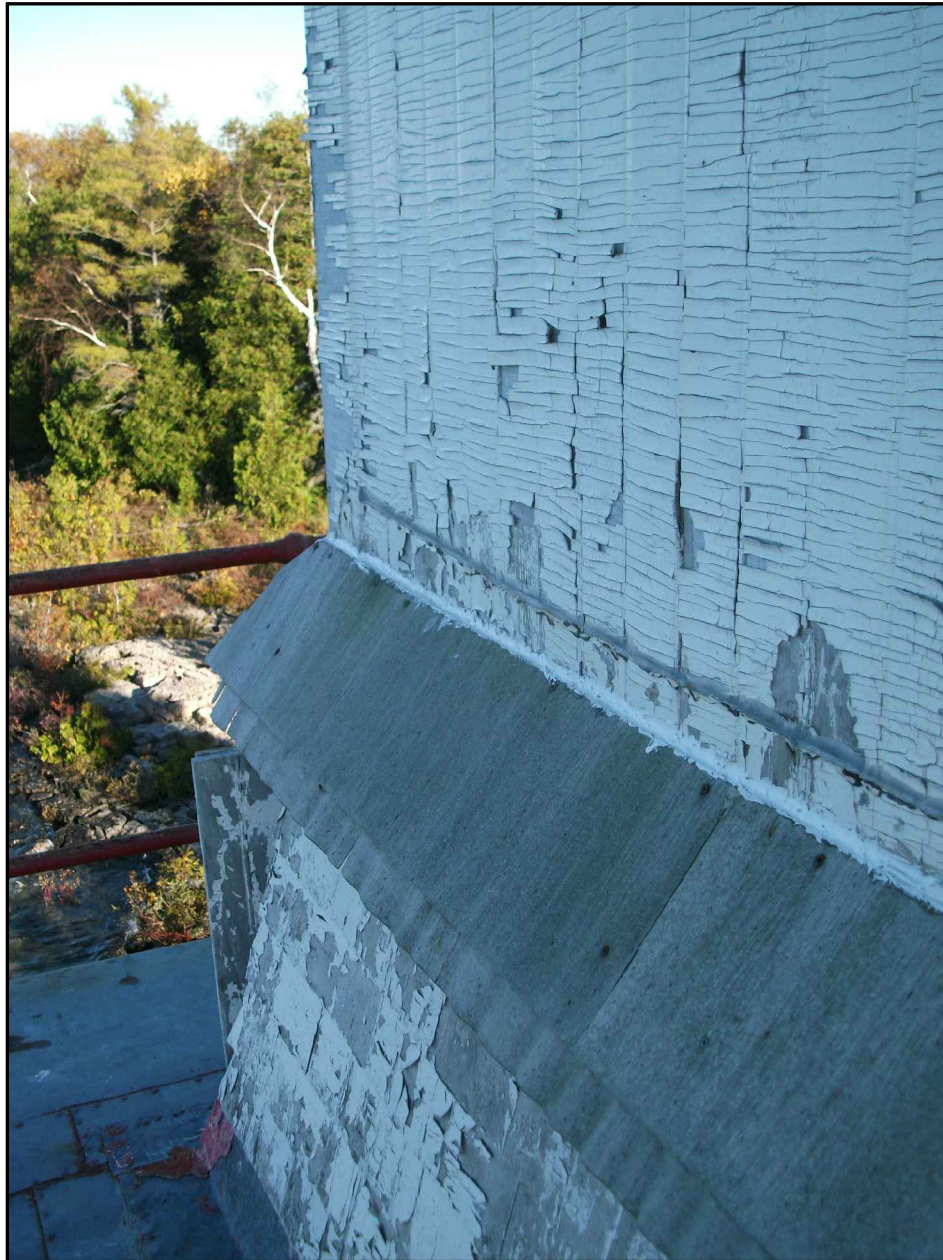
Photograph 9: White lead-based paint on exterior wood surface on 3rd floor of Old Light Tower.

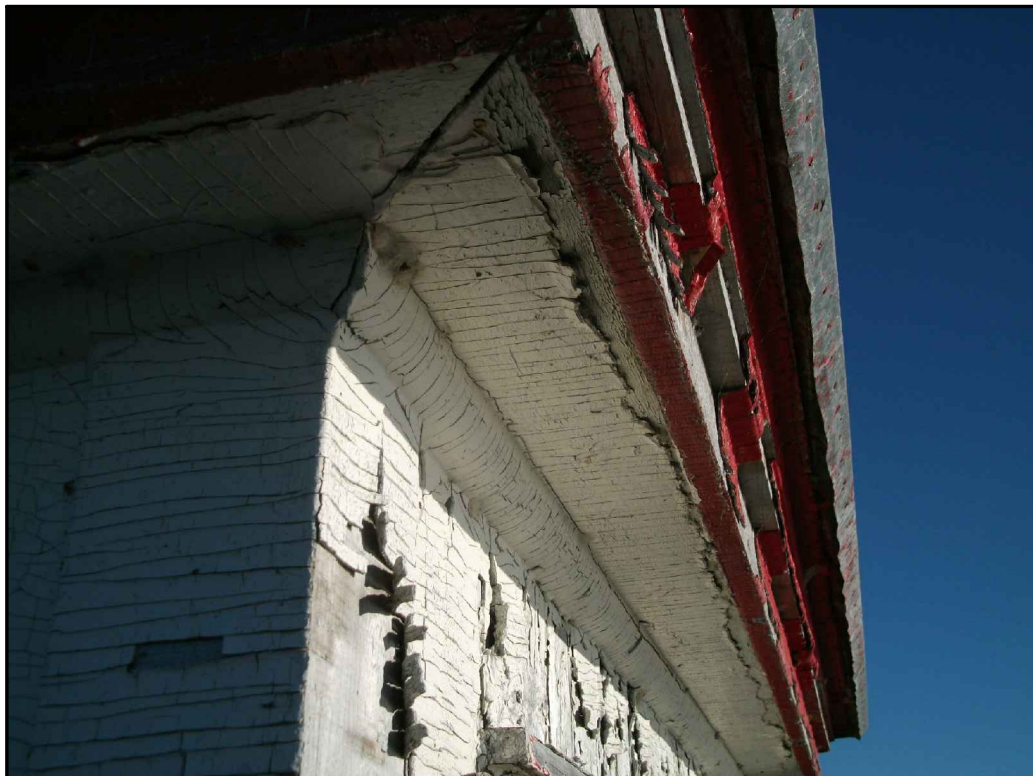
Photograph 10: Red lead-based paint (poor condition) on exterior wood trim on 3rd floor of Old Light Tower.

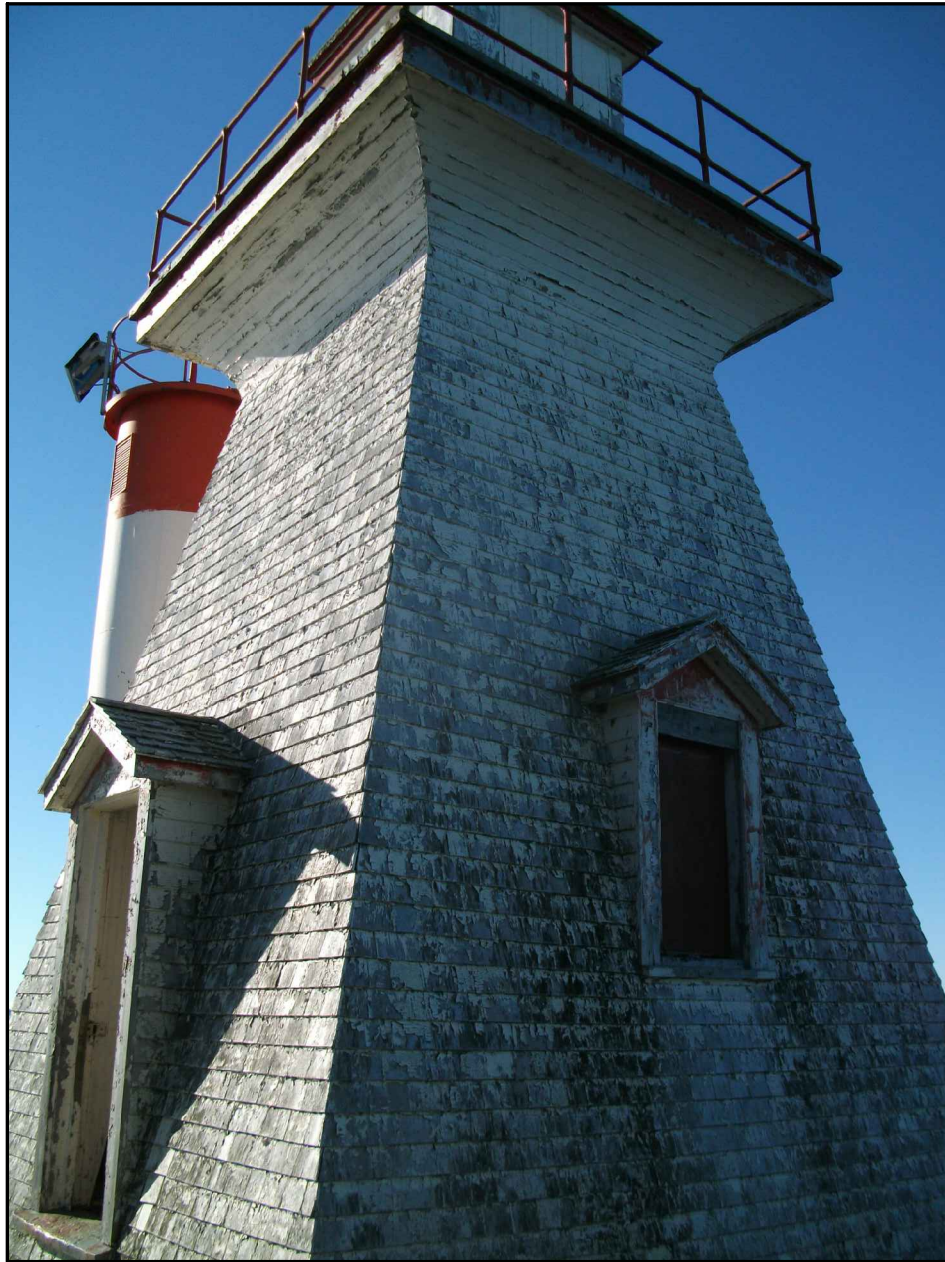
Photograph 11: White lead-based paint (poor condition) on exterior wood surface on 3rd floor of Old Light Tower.

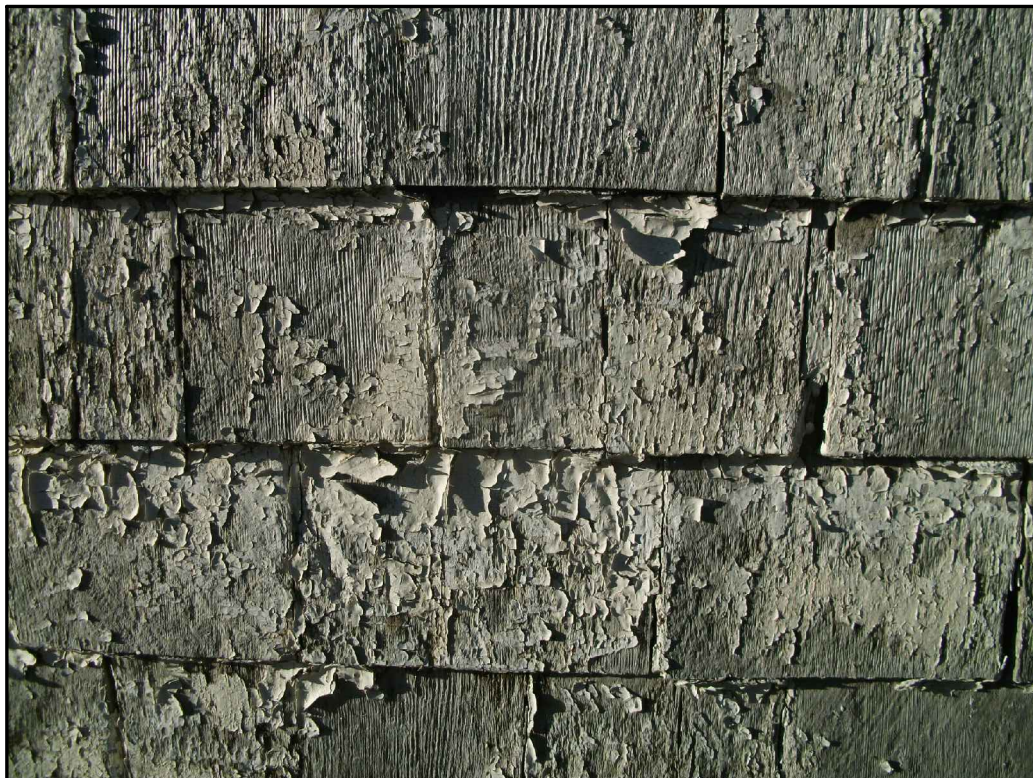
Photograph 12: White lead-based paint (poor condition) on exterior wood surface on west side of 1st floor of Old Light Tower.

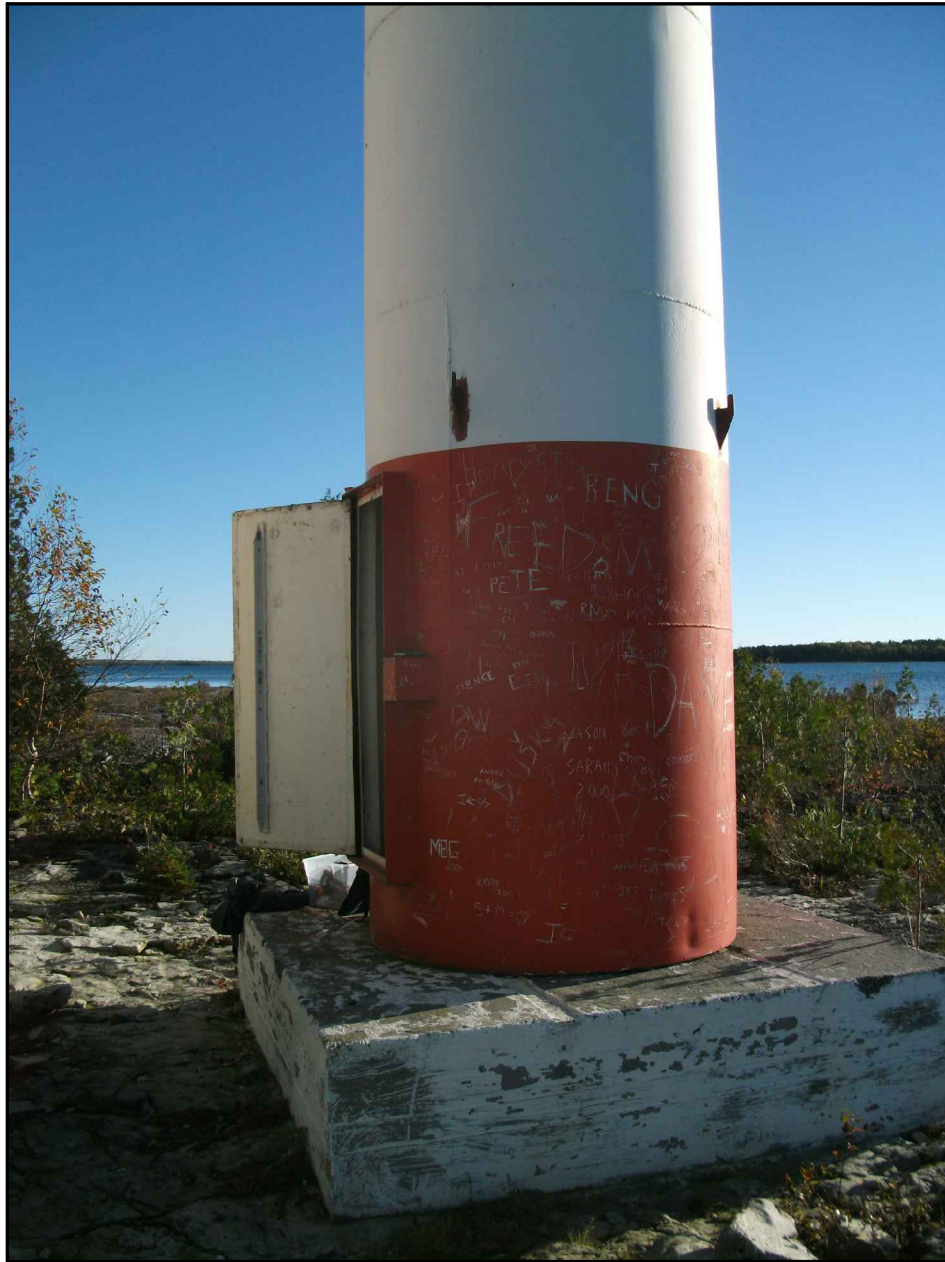
Photograph 13: Red lead-based paint (good condition) on exterior metal surface of New Light Tower (looking south).

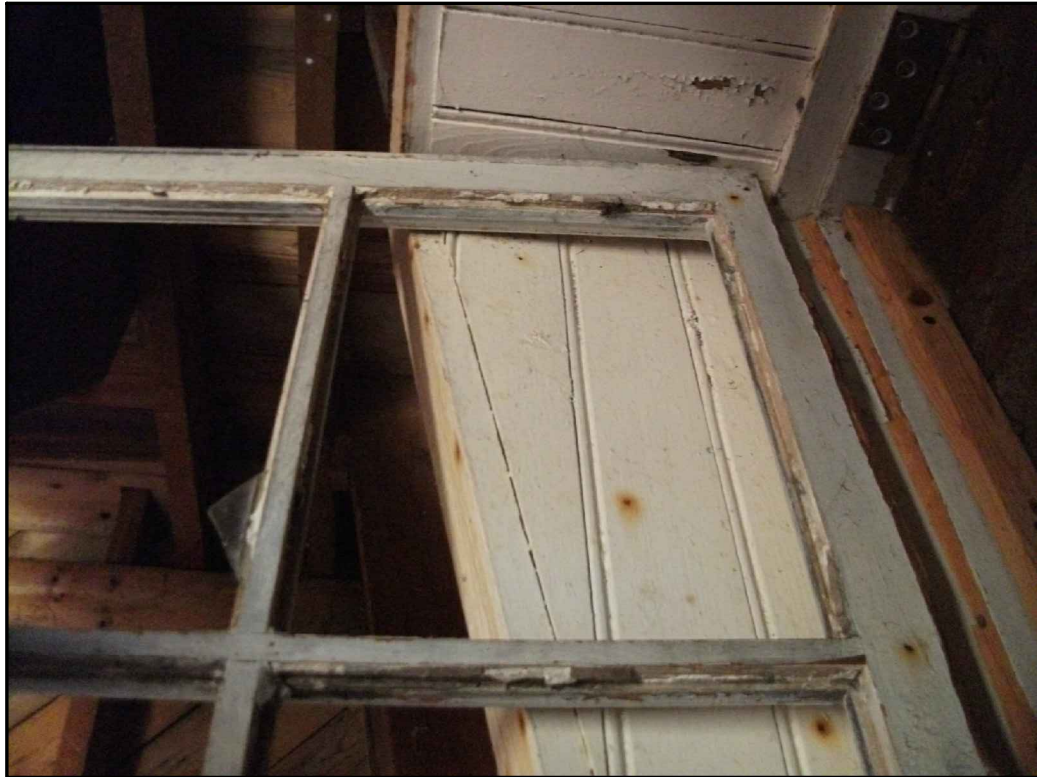
Photograph 14: White caulking (non-ACM) on 1st and 2nd floor windows of Old Light Tower.

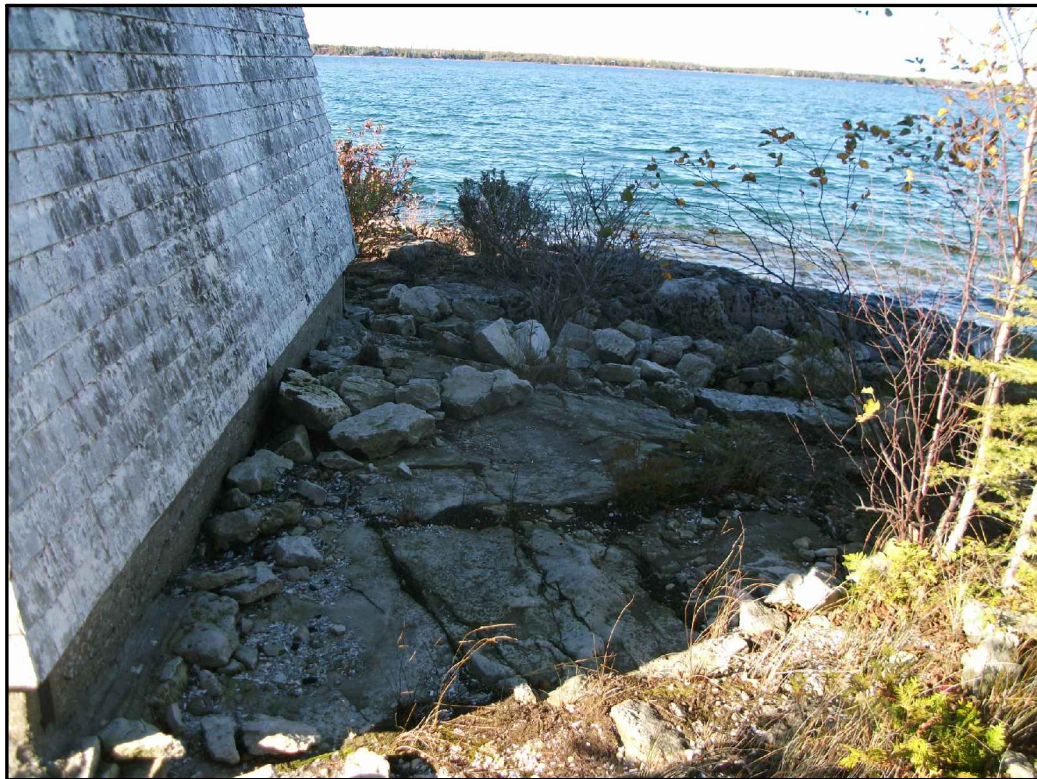
Photograph 17: Limited soil accumulation and vegetation in cracks between bedrock (looking northwest).

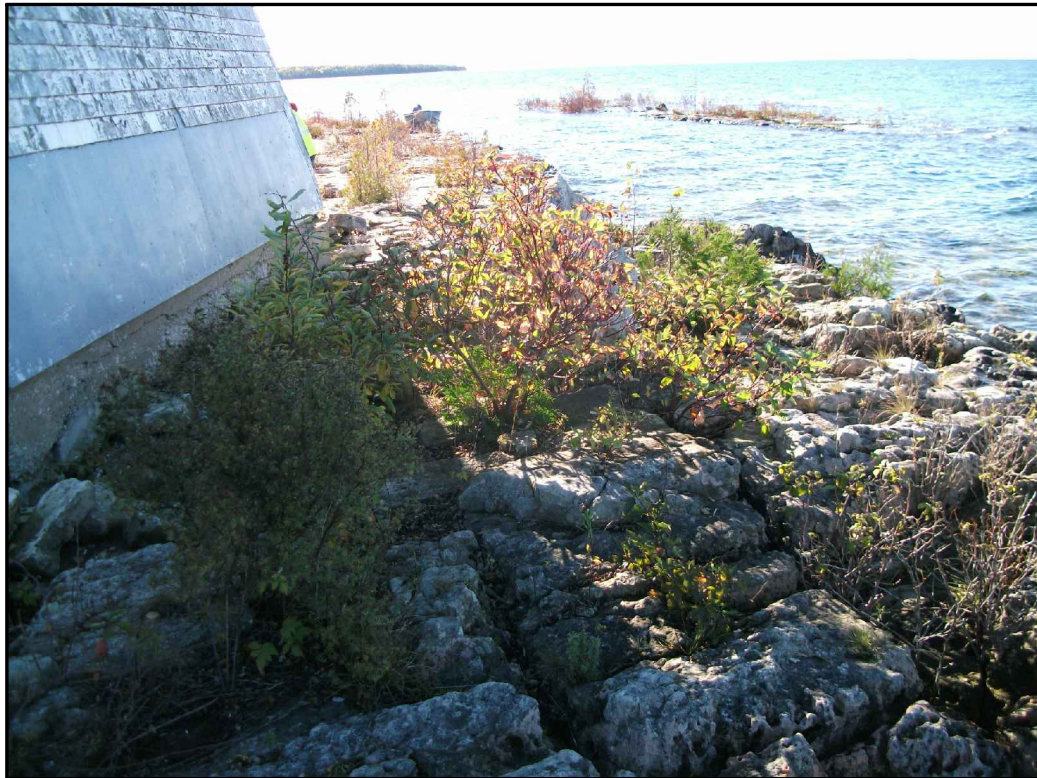
Photograph 18: Limited soil accumulation and vegetation in cracks between bedrock (looking southwest).

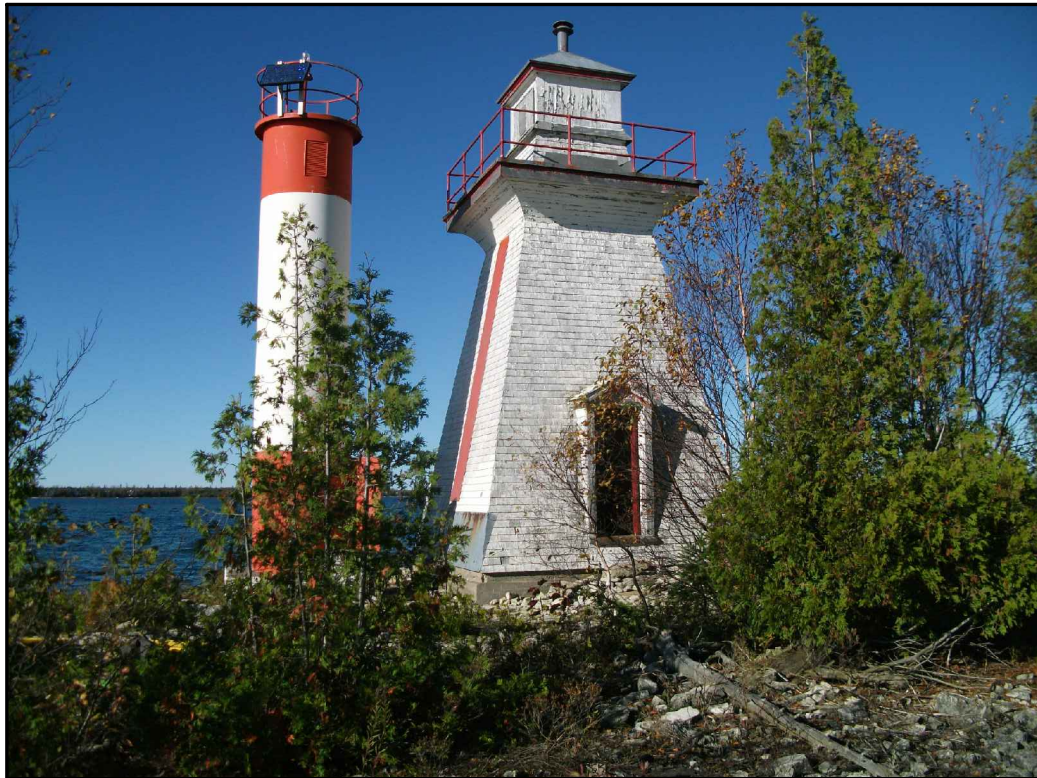
Photograph 19: Greater soil accumulation in vicinity of trees south and east of Old Light Tower (looking north).

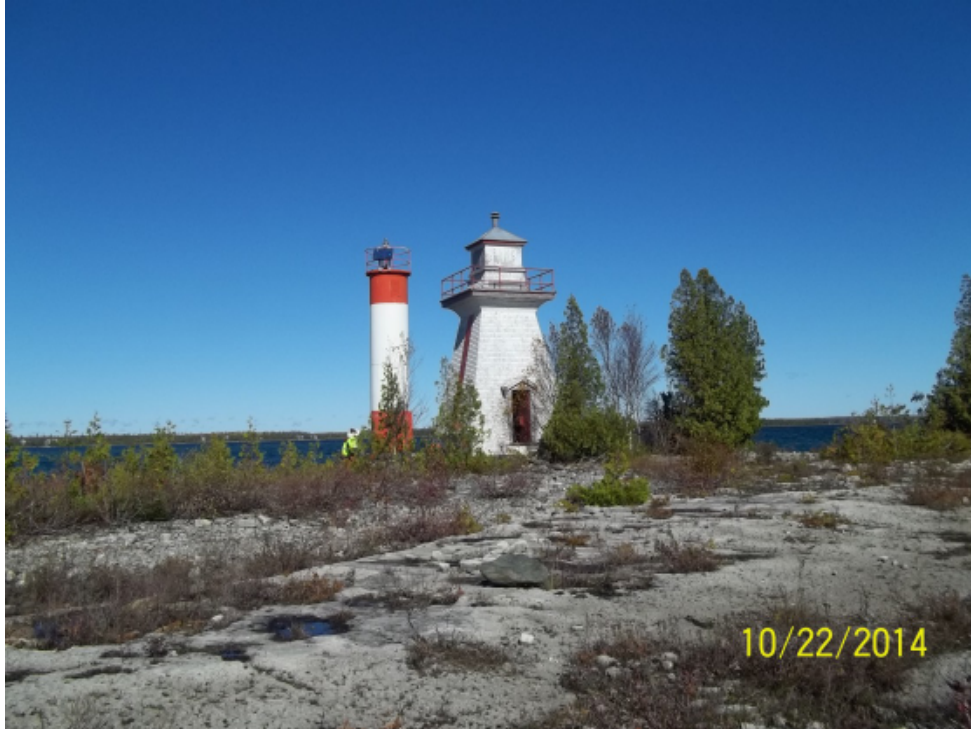
**Photo 1: View looking in a north direction.**

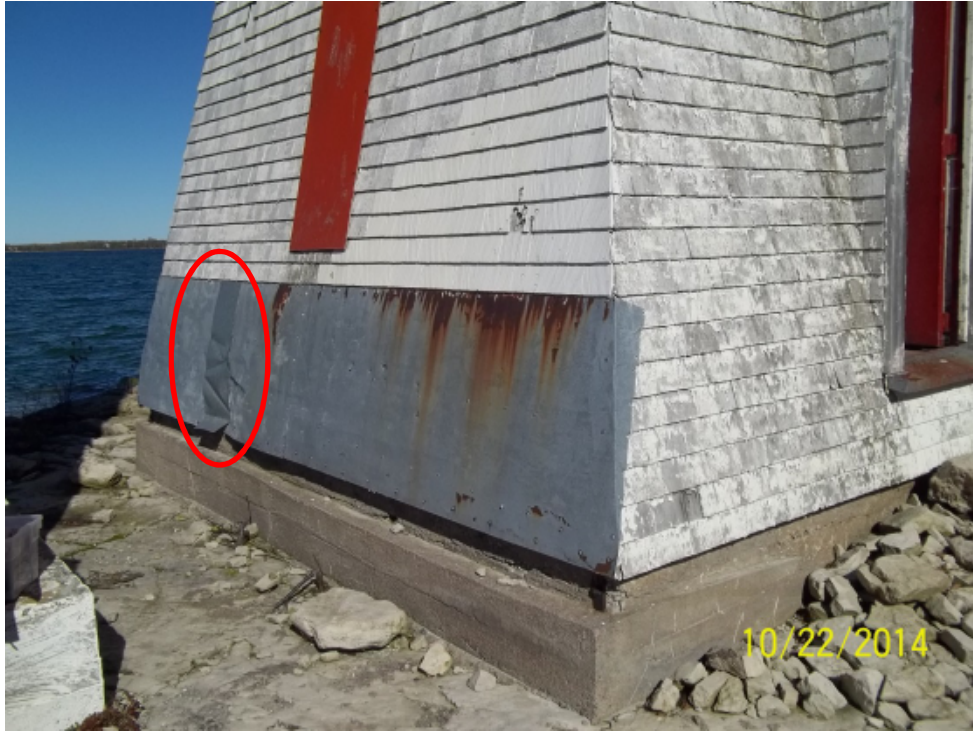
**Photo 7: West side of entrance with sheet steel siding, notice impacted area, and rusting along top edge. Repainted/replaced wood shingles.**

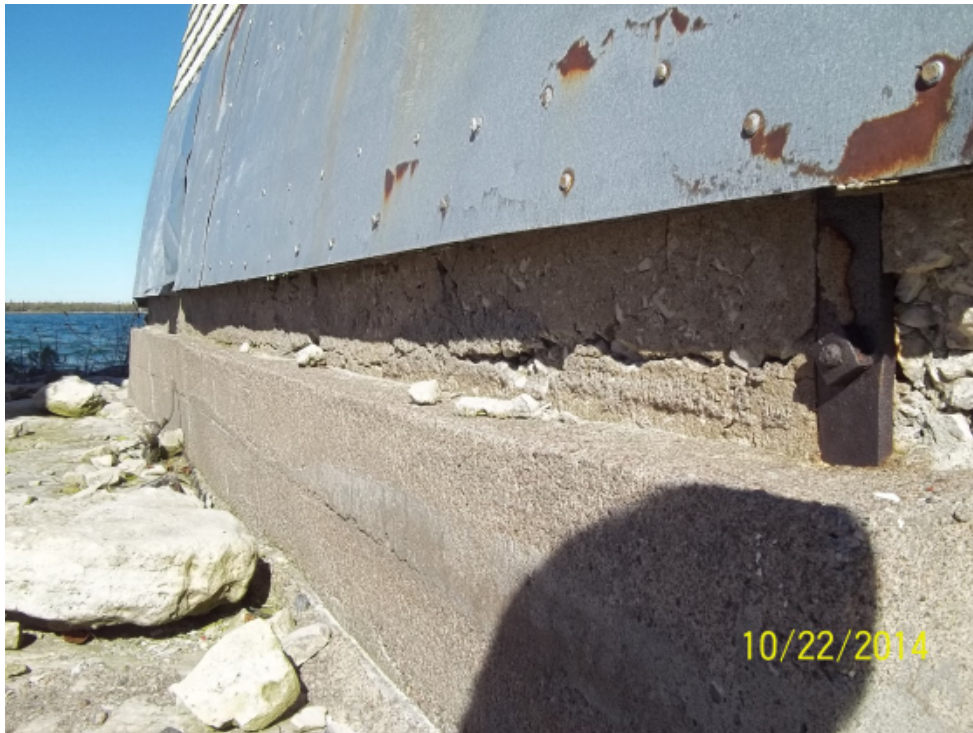
**Photo 8: Lighthouse southwest corner of foundation, with steel anchorage in foreground and deteriorated concrete foundation wall, with secondary pour on outside showing top ledge. Steel sheet covering wood shake cladding.**

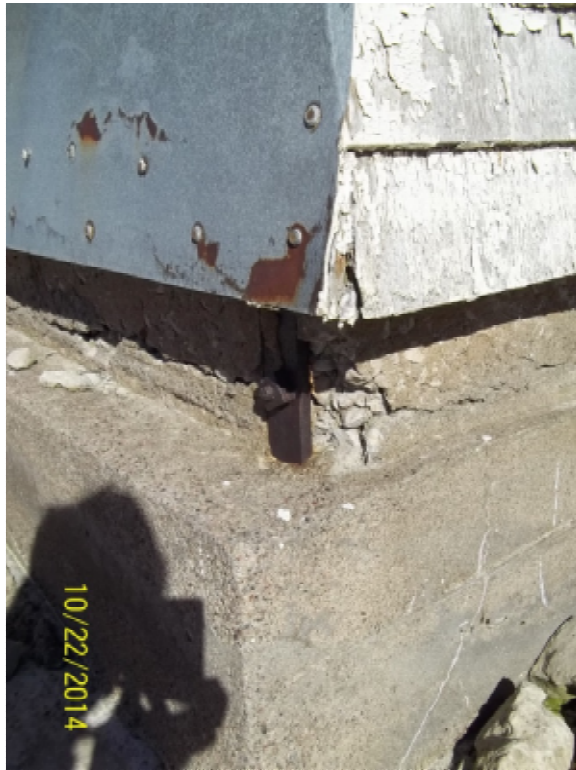
**Photo 9: Deteriorating foundation wall at southwest corner.**

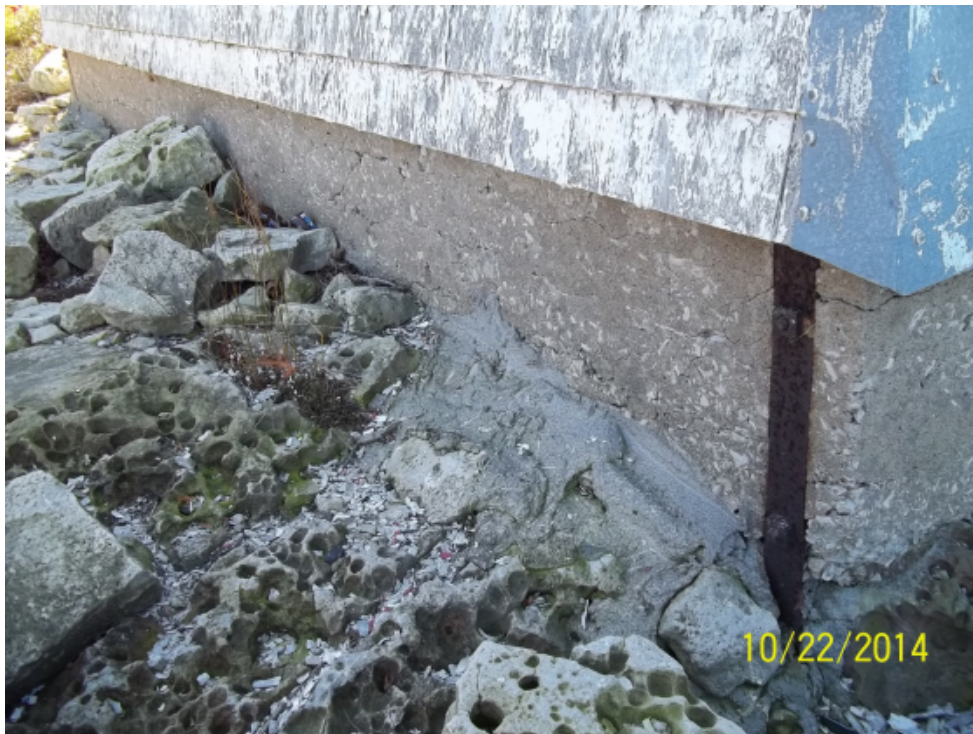
**Photo 10: Steel foundation strap at northeast corner.**

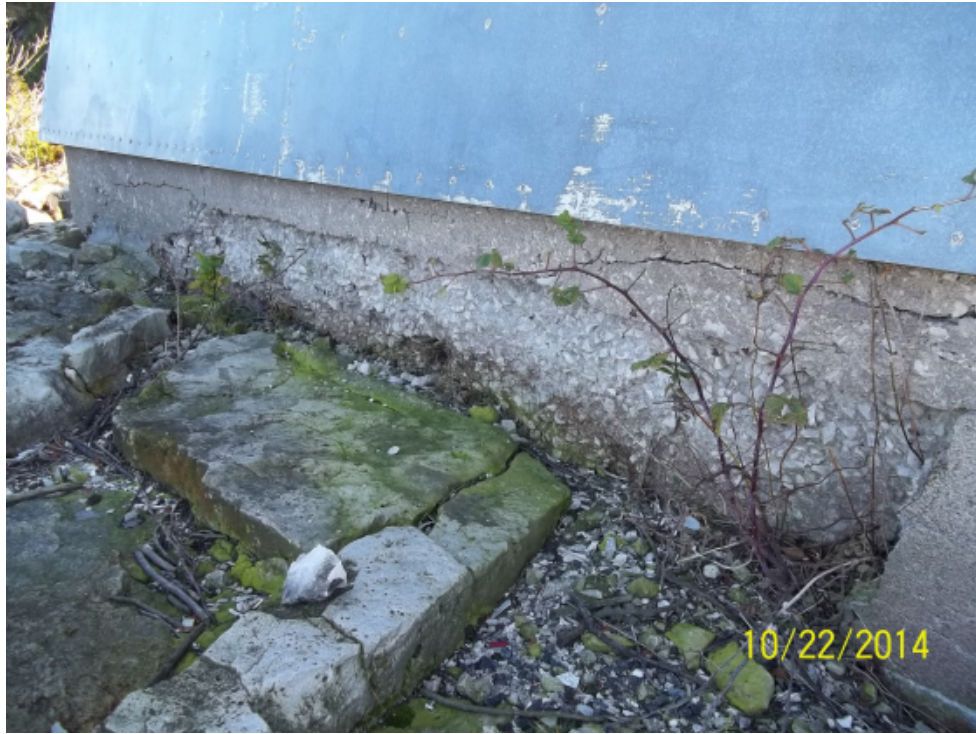
**Photo 11: View of north face of foundation wall.**

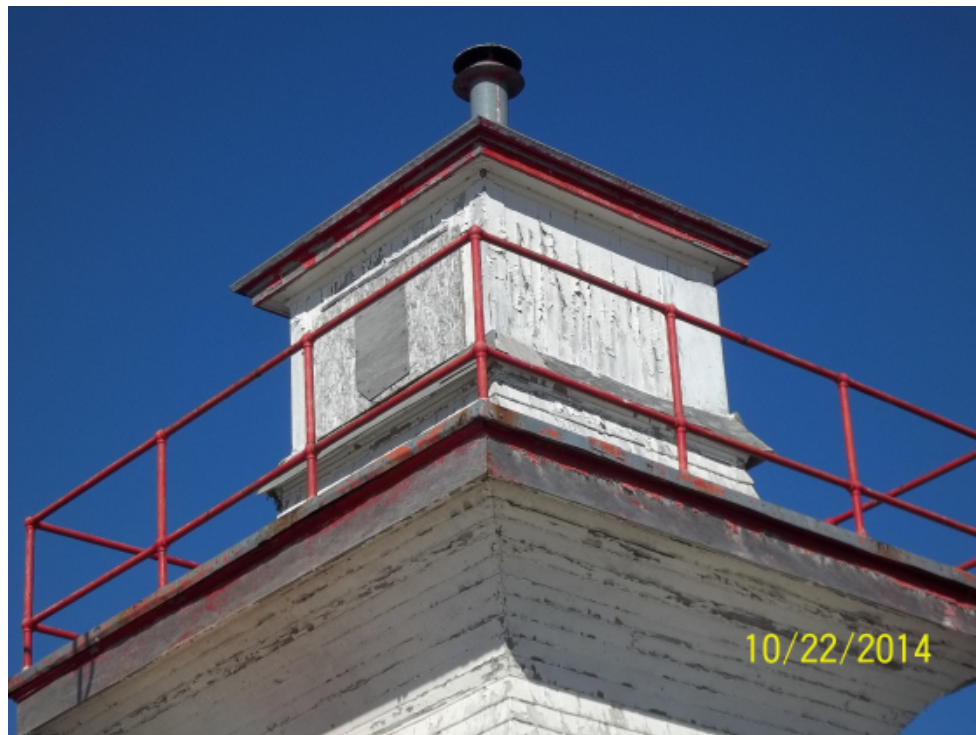
**Photo 12: View from the southwest looking at the top of the lighthouse.**

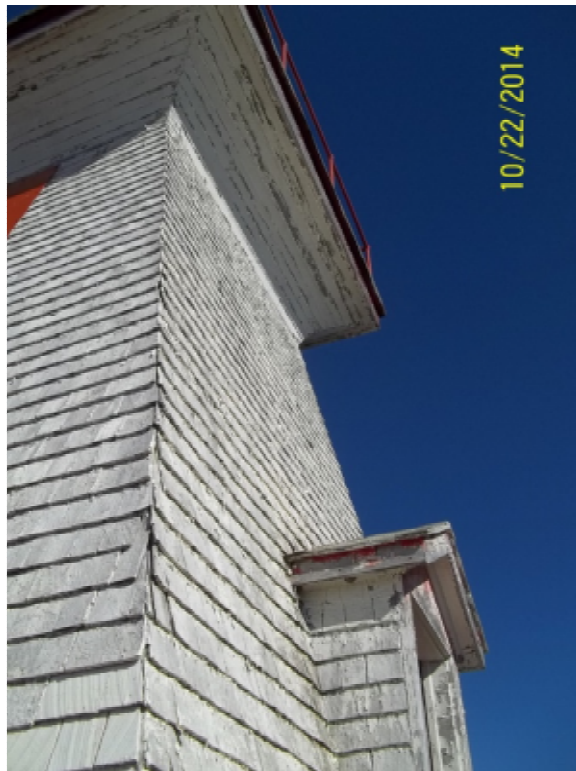
**Photo 13: East elevation of lighthouse exterior wall, generally poor paint condition.**

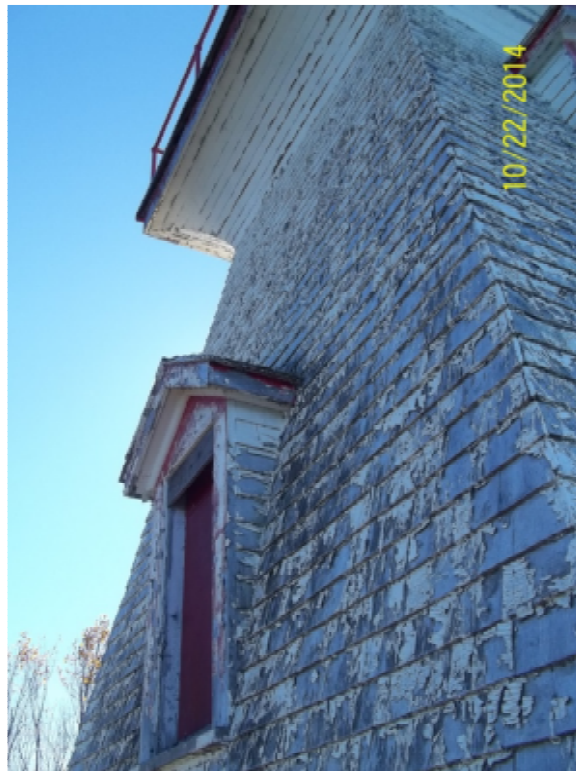
**Photo 14: Northeast elevation of lighthouse, poor paint condition.**

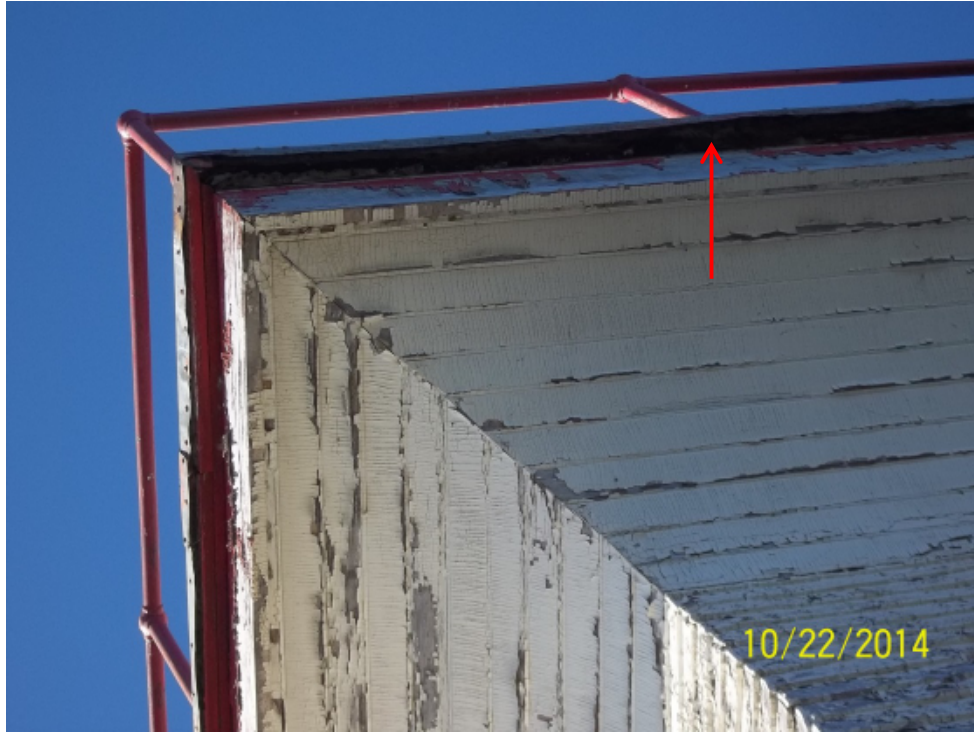
**Photo 15: Looking up at underside of lighthouse soffit, decayed wood along edge, under metal roofing.**

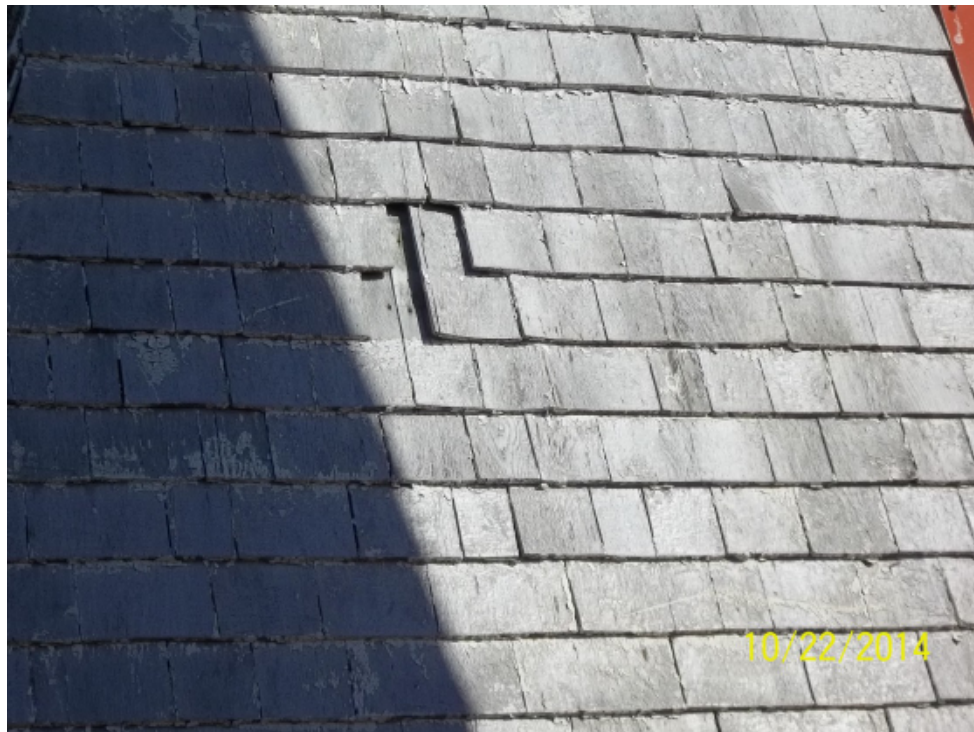
**Photo 16: Some missing wood shingles on sloping wall.**

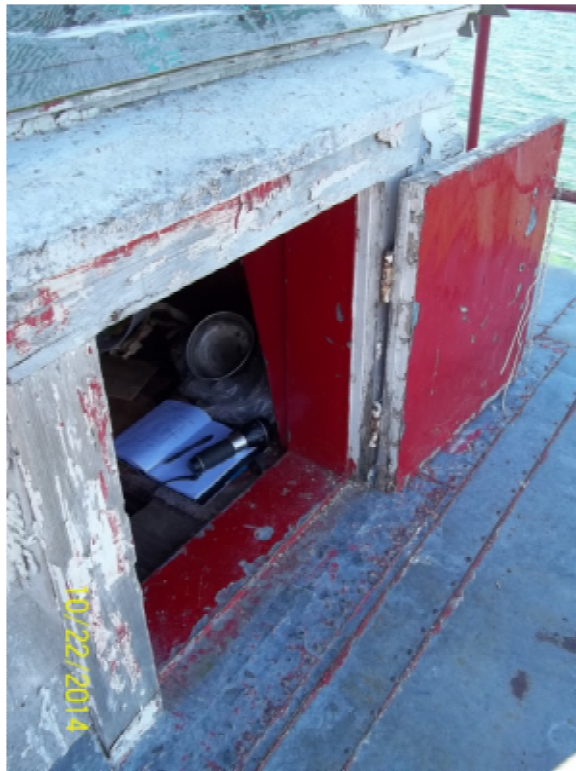
**Photo 17: View from upper exterior walkway looking back to hatch door on east side. Door closes but does not seal off opening fully.**

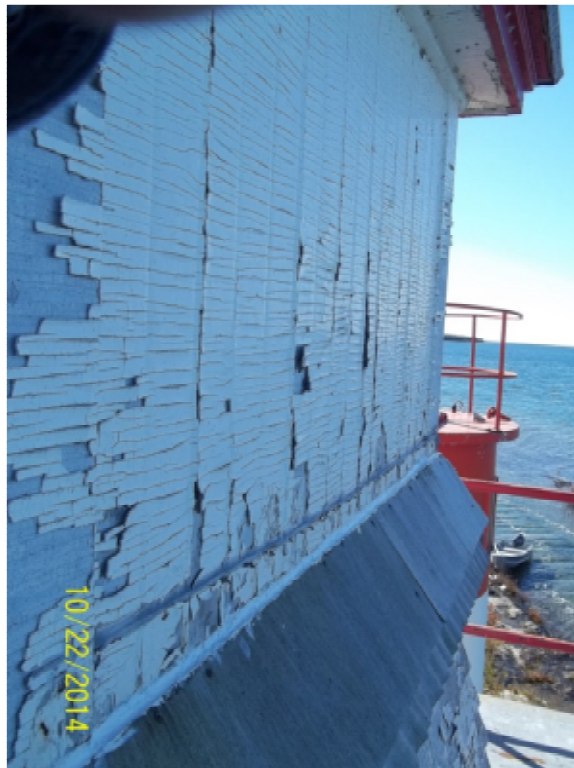
**Photo 22: North wall face at level above exterior walkway, paint in poor condition.**

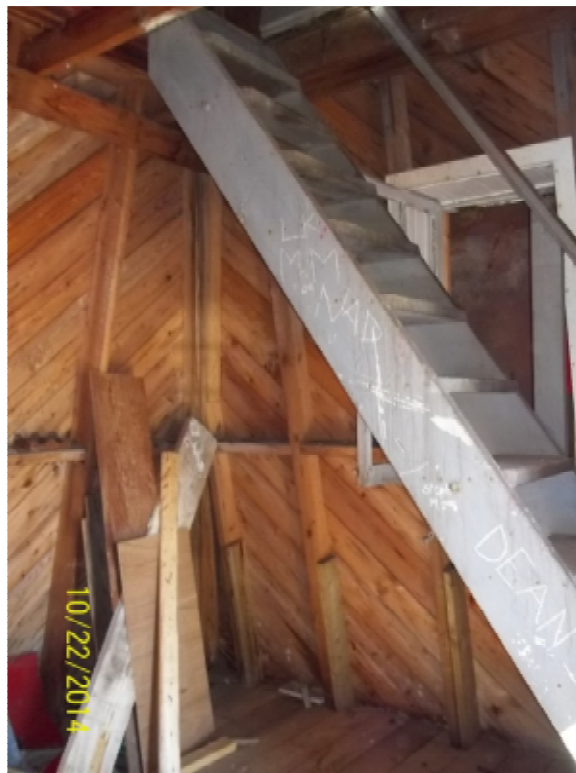
**Photo 23: Interior east side with stairs to second level. Note the pressure treated spliced studs with the original studs at the ground floor.**

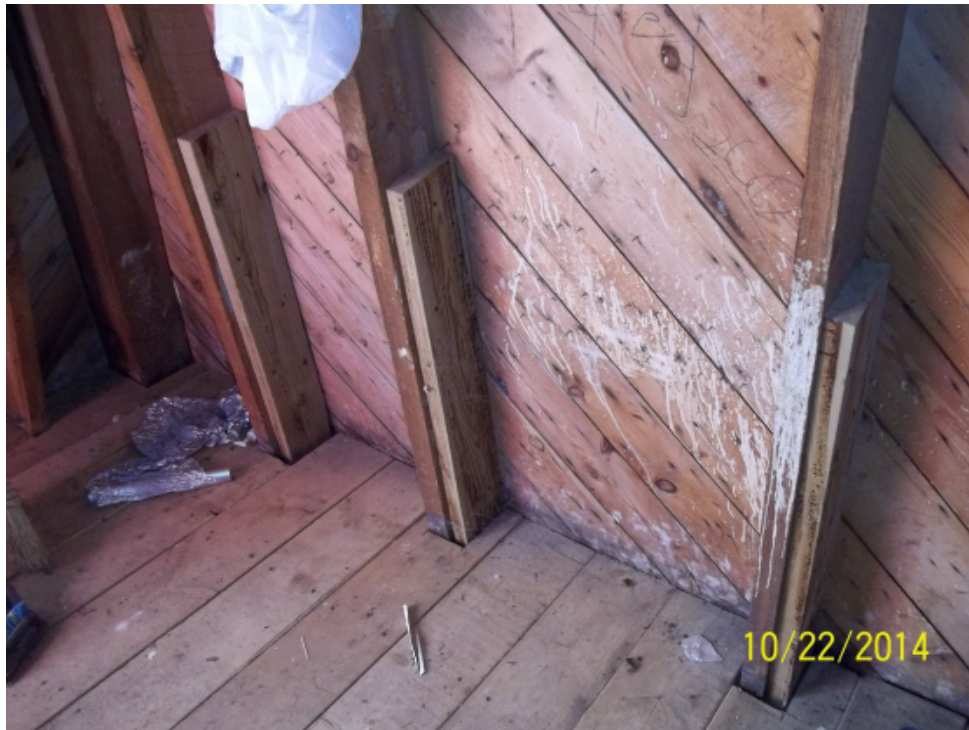
**Photo 24: View of interior wall framing at ground level, with base floor in very good condition and pressure treated spliced studs along wall.**

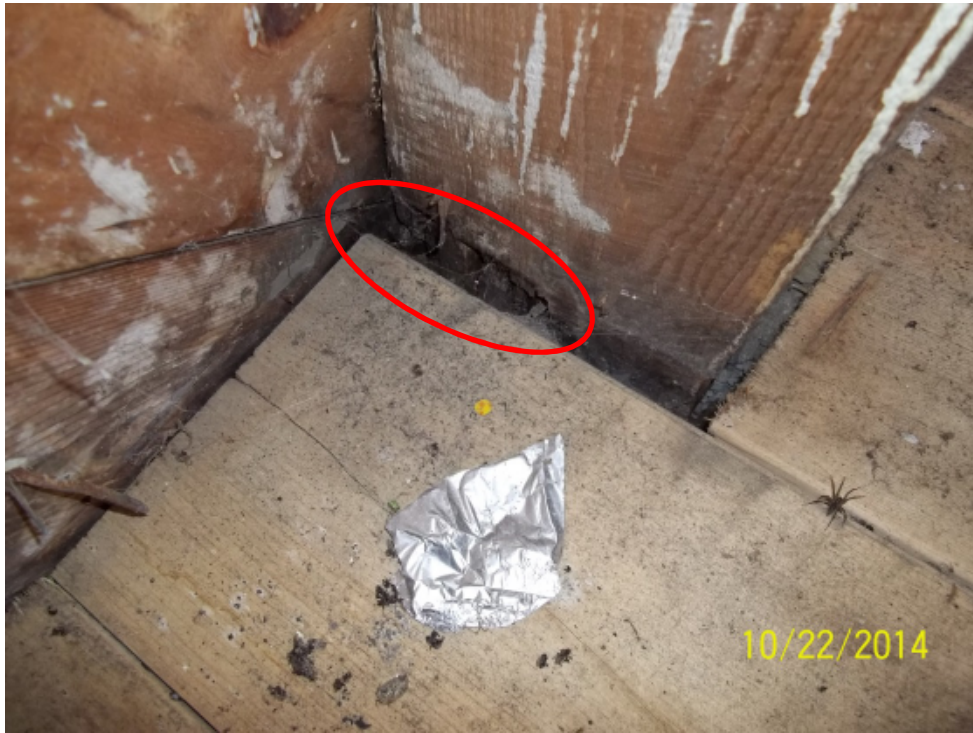
**Photo 25: Side wall wood stud framing where the studs meet the ground floor. Note the wood rot at and below the floor level.**

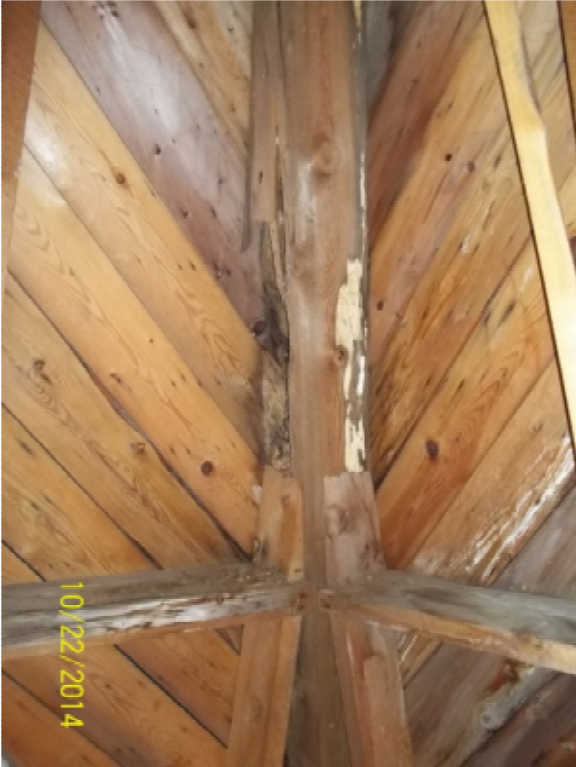
**Photo 26: Southeast corner post rotting at about mid-height.**

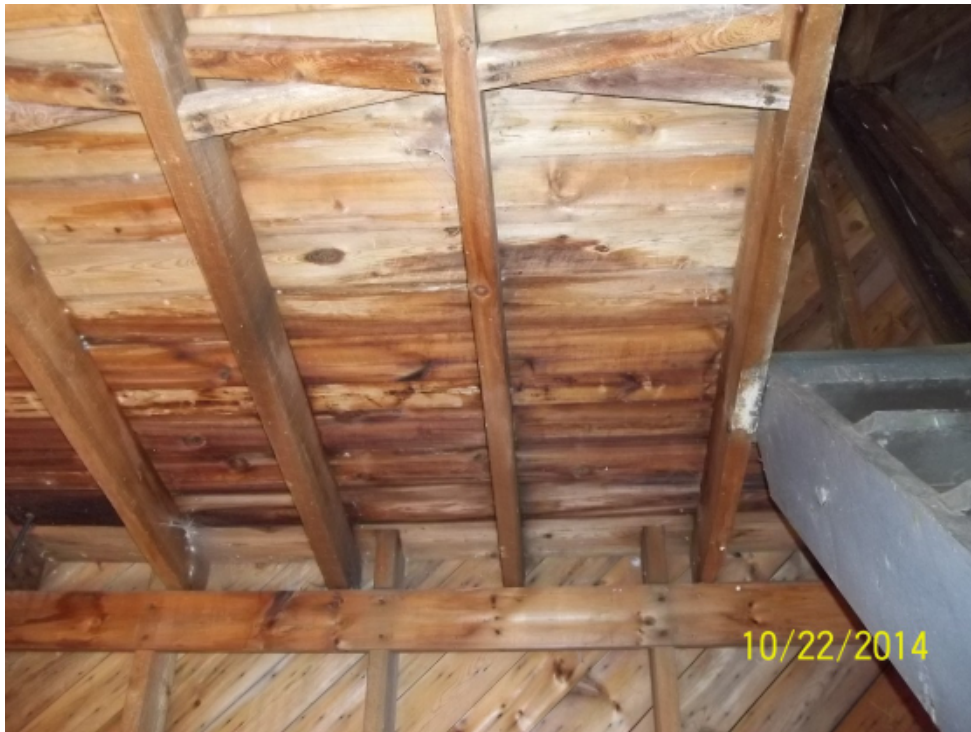
**Photo 27: View of underside of second floor framing, material in good condition but showing water stains.**

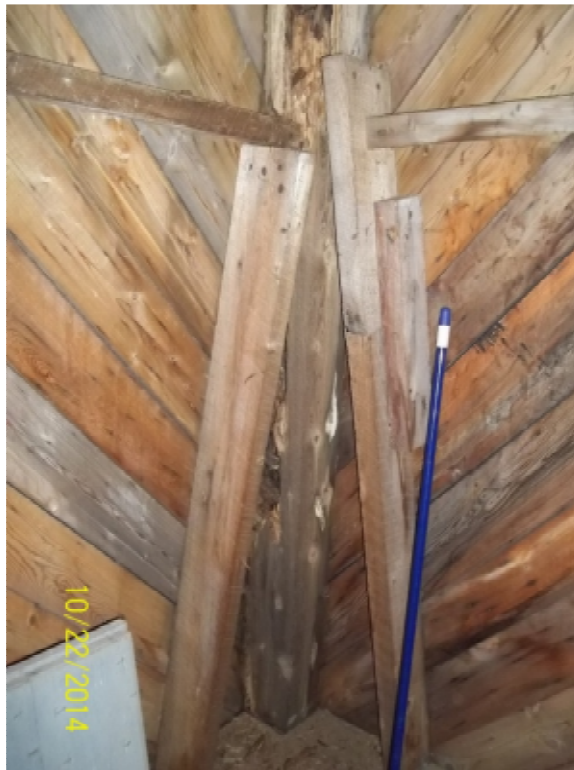
**Photo 28: View of southeast corner post which is rotting.**
