PWGSC Ontario	SPECIFICATION	Section 00 00 00
Region Project	TITLE SHEET	Page 1
Number R.071694.050		2015-02-19

PROJECT TITLE STOKES BAY FRONT RANGE LIGHT STATION DFRP No. 10961  
KNIFE ISLAND, ONTARIO  
LEAD BASED PAINT ABATEMENT AND CONTAMINATED SOIL REMOVAL

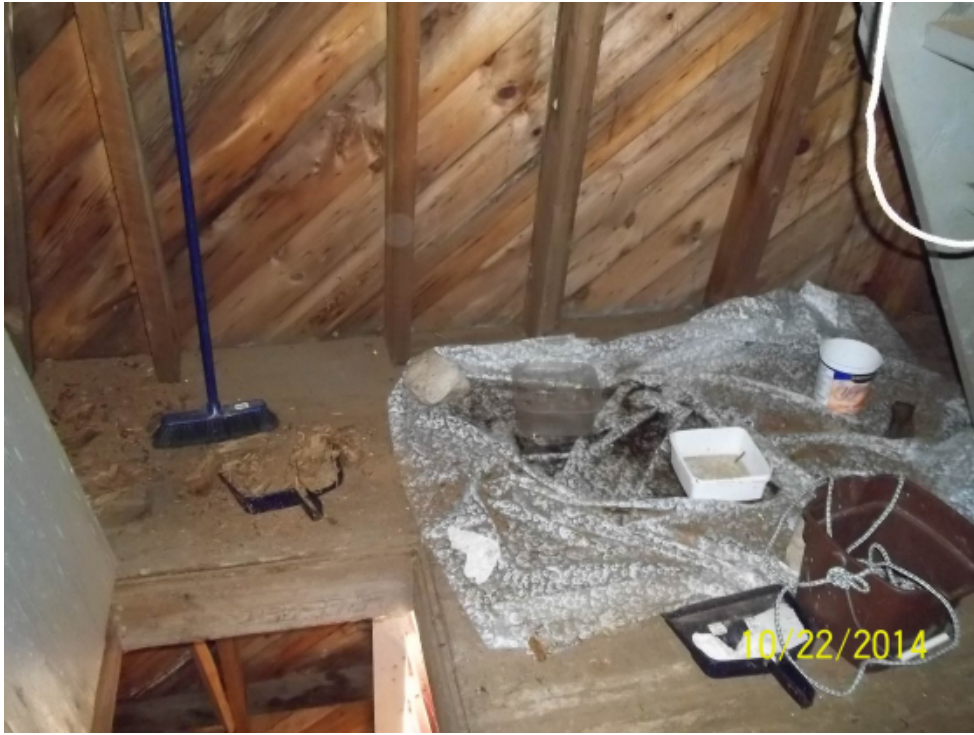
**Photo 29: Second floor with access opening. Note the buckets and plastic used to contain water leaks.**

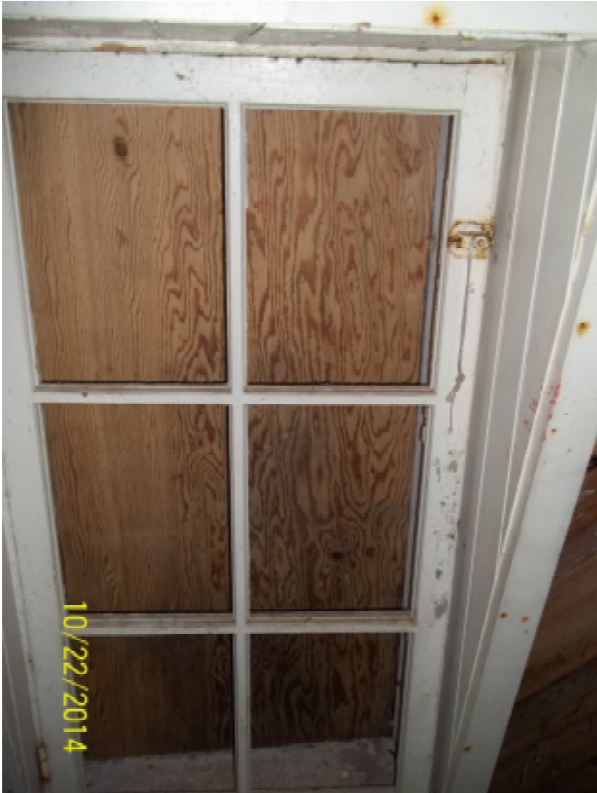
**Photo 30: Original window frame viewed from inside, clad over with plywood panel.**

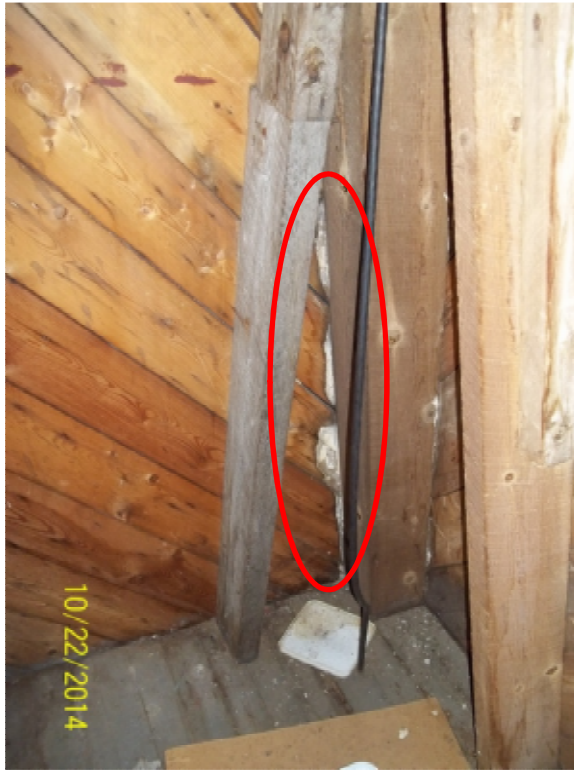
**Photo 31: Dry rot around the corner post spreading onto diagonal lumber sheathing.**

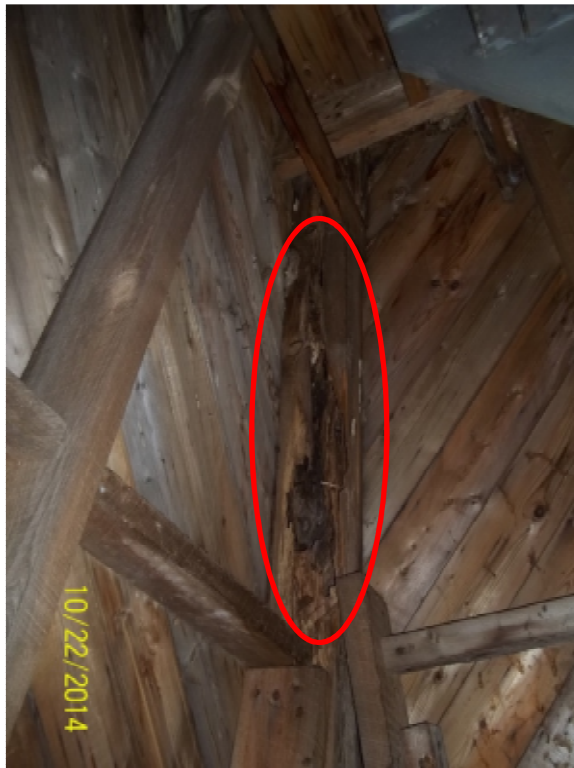
**Photo 32: Southeast corner post – disintegrating.**

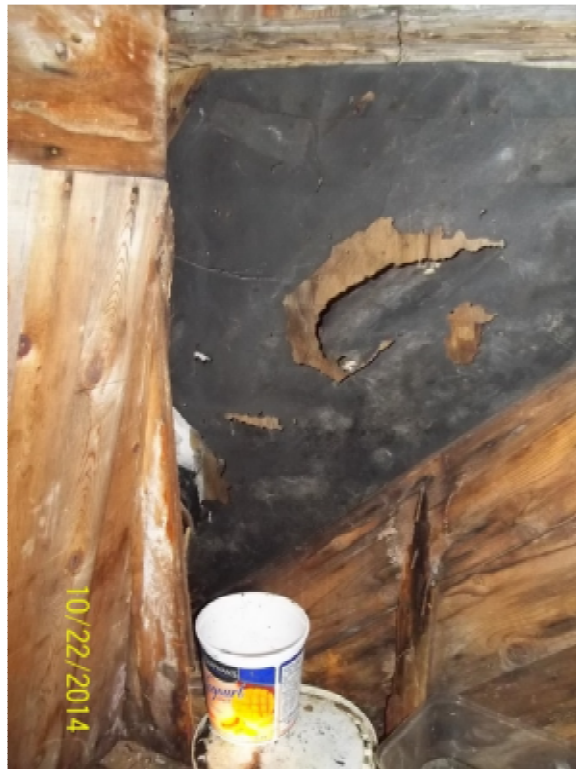
**Photo 34: High level southeast corner, some exterior sheathing missing or rotten.  
Back side of exterior black building paper evident.**

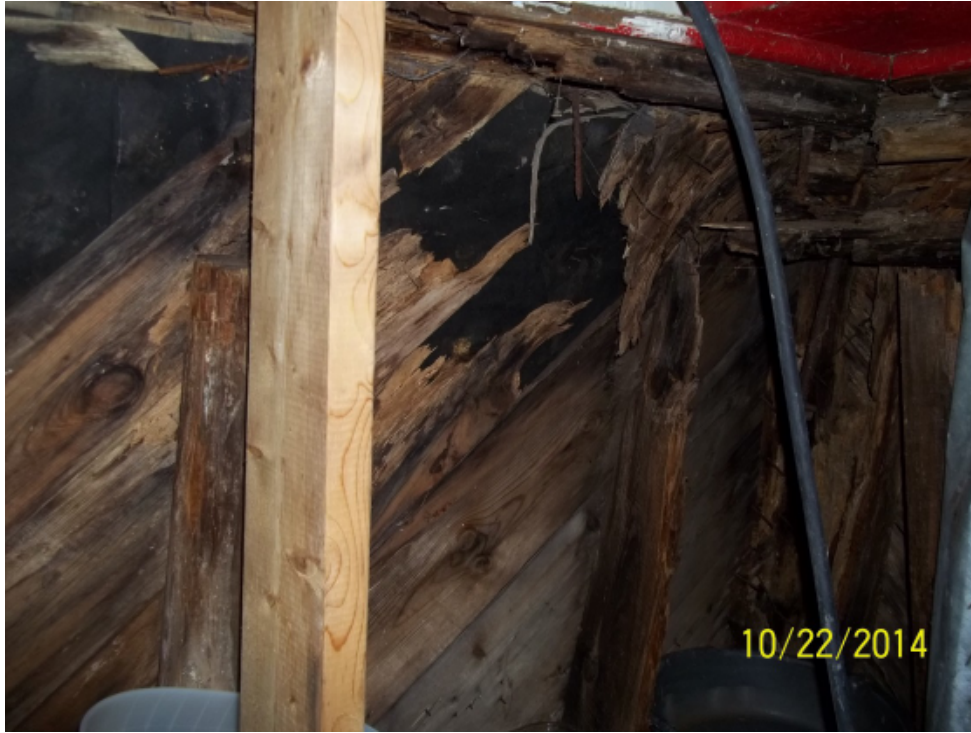
**Photo 35: Upper level, missing exterior sheathing due to wood rot.**

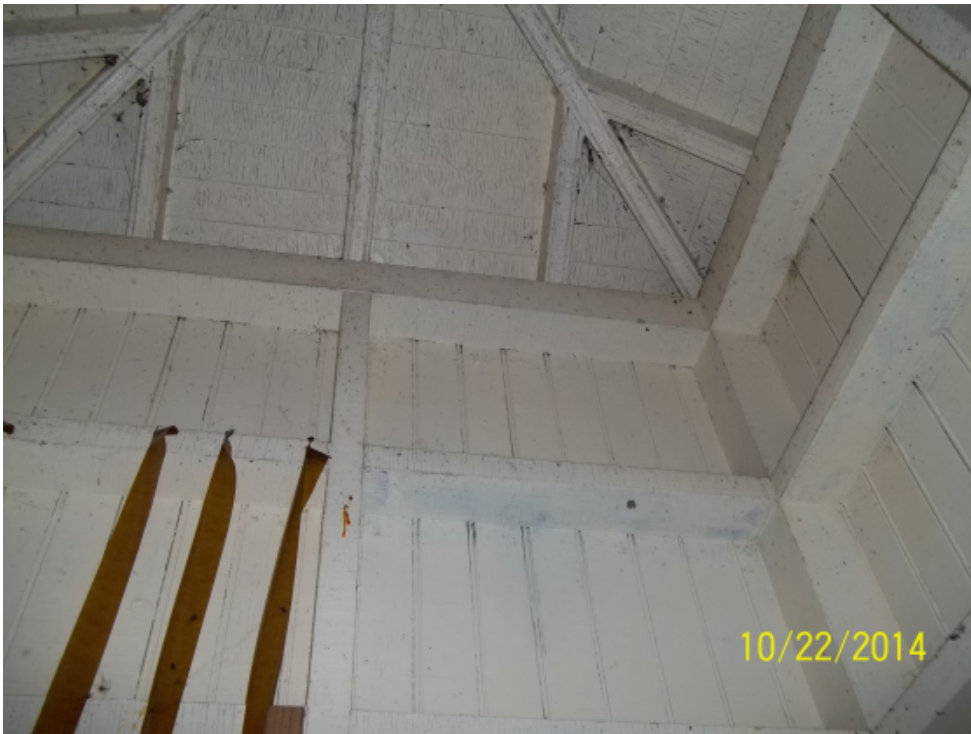
**Photo 36: View looking inside at upper level of lighthouse.**

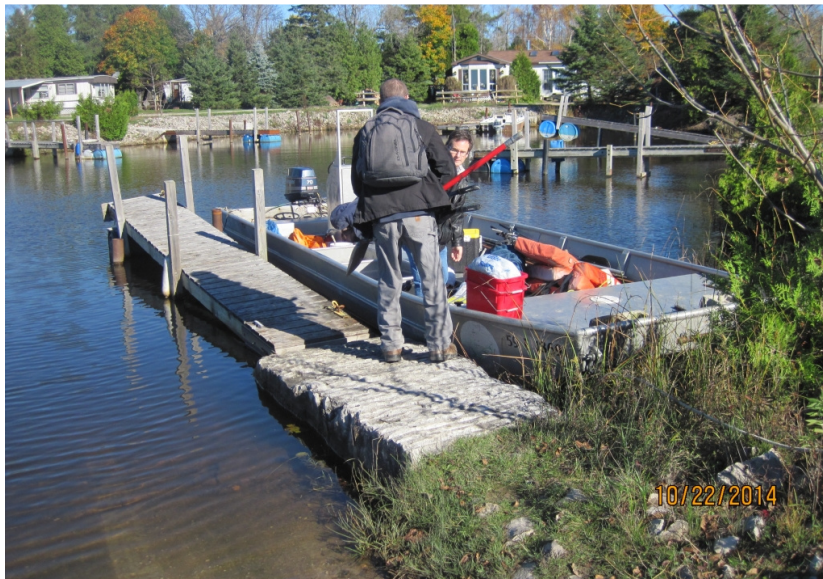
**Figure 2.1 Stokes Bay Camp & Marina Dock**

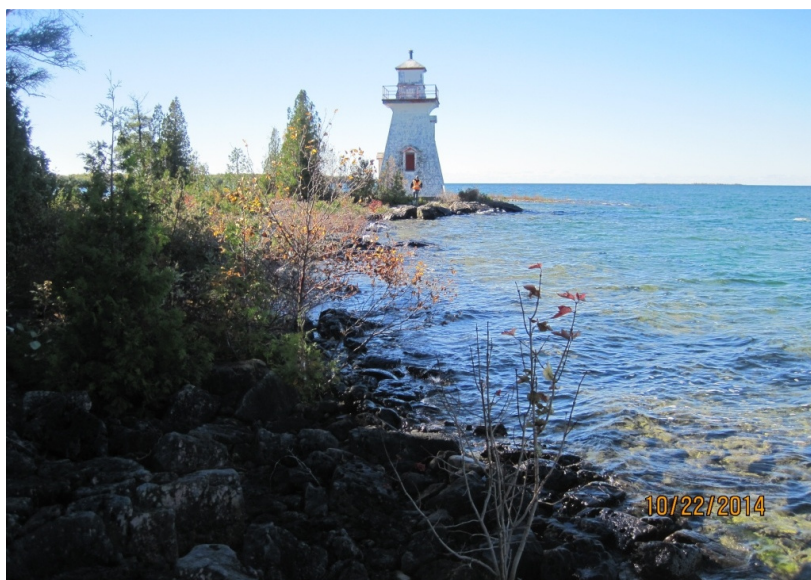
**Figure 2.4 Proposed Access Location (view looking west)**

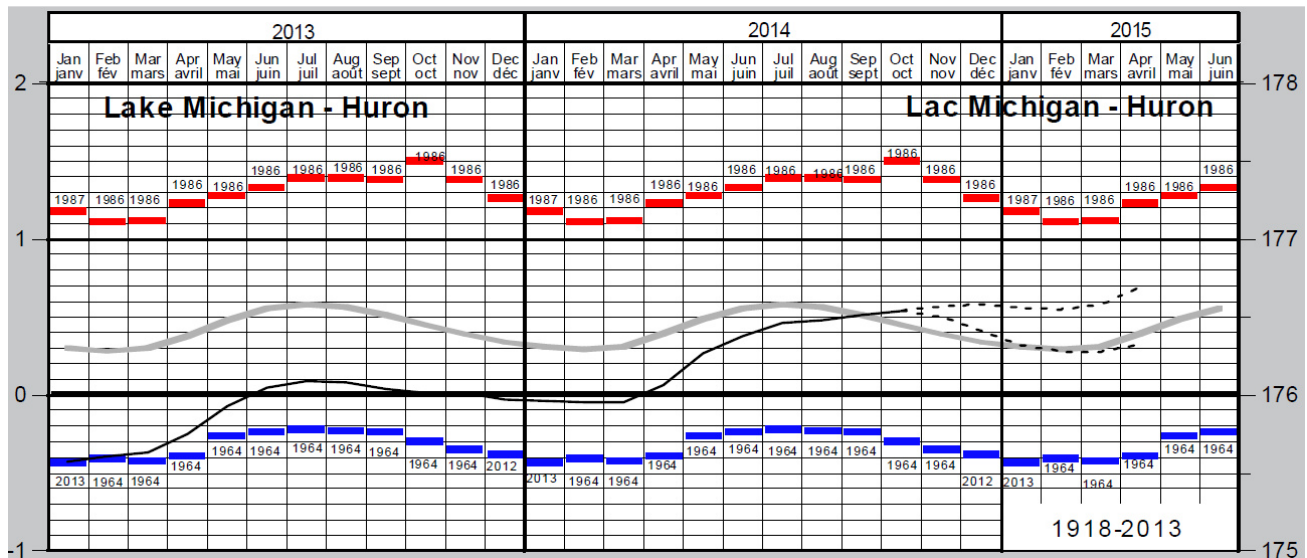
Figure 3.1 CHS Water Level Advisory for October 2014, Water Levels in Metres  
(Left axis relative to Chart Datum, right axis relative to IGLD85)

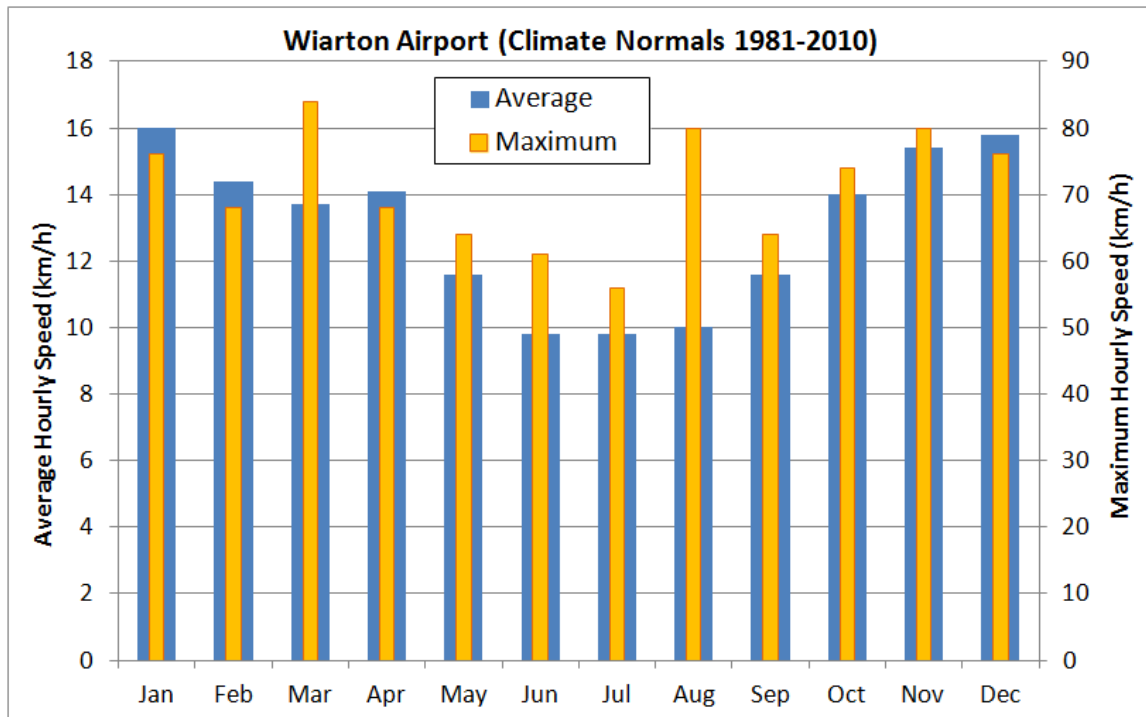
Figure 3.2 Monthly Variation in Wind Speed at Wiarion Airport

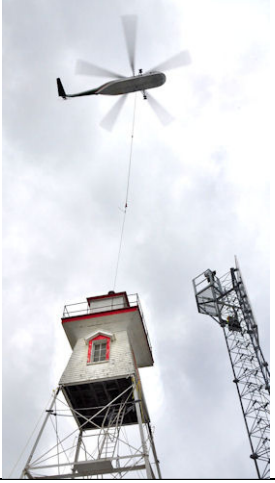
<b>Typical Particulars</b>	<p>20 m length                      8 m breadth                      2.4 m depth</p>	<p>11 m length                      3.7 m breadth                      1.8 m depth</p>	<p>Airbus Super Puma AS332 L1</p>
<b>Typical Capacity</b>	<p>285 t at 2.2 m full load draft                      230 t at 1.8 m part load draft</p>	<p>8.5 t including dump trailer (0.9 m full load draft)                      6.5 t material capacity</p>	<p>4 t including trailer and tether (full fuel)                      3 t material capacity</p>
<b>Round Trips (for 200 t)</b>	<p>1</p>	<p>31</p>	<p>67</p>
<b>Mob Demob</b>	<p>Float-in through Stokes Bay Entrance Channel</p>	<p>Truck to site and lift-in with crane (e.g. at DFO wharf) <sup>a</sup></p>	<p>Canadian operator (sourced from Ohio)                      Lifts delivered to nearby staging area</p>

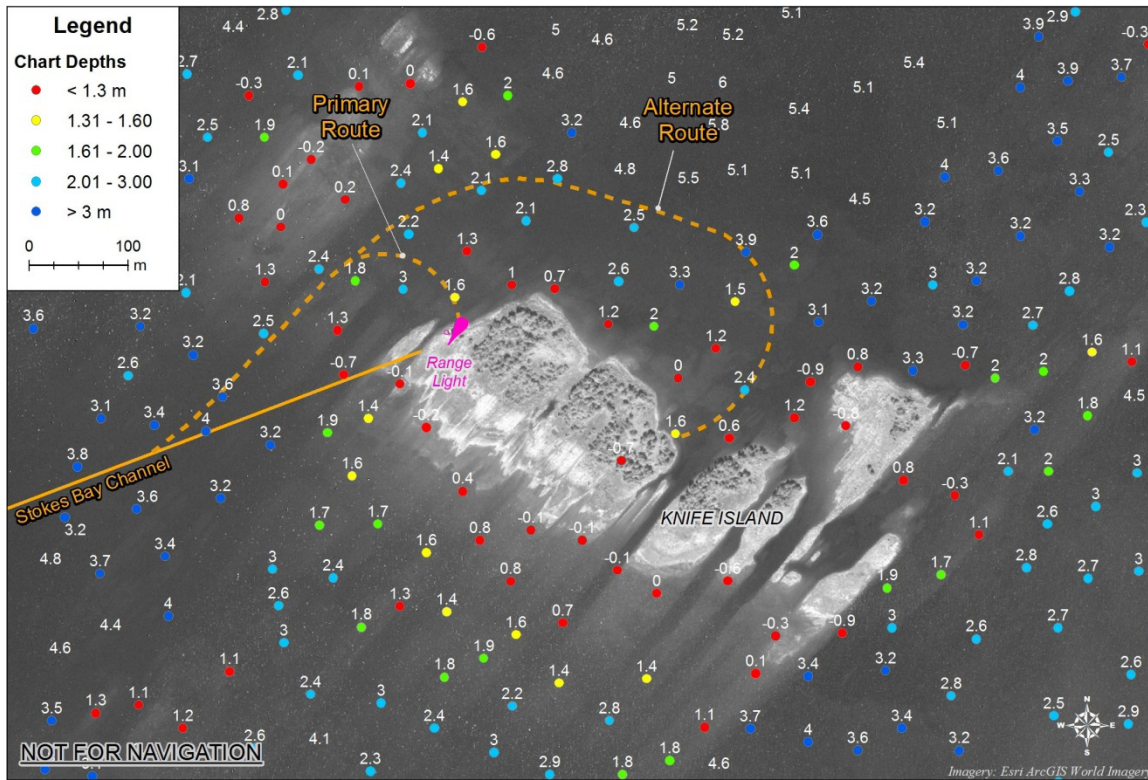
**Figure 4.4 CHS Sounding Data for Knife Island**

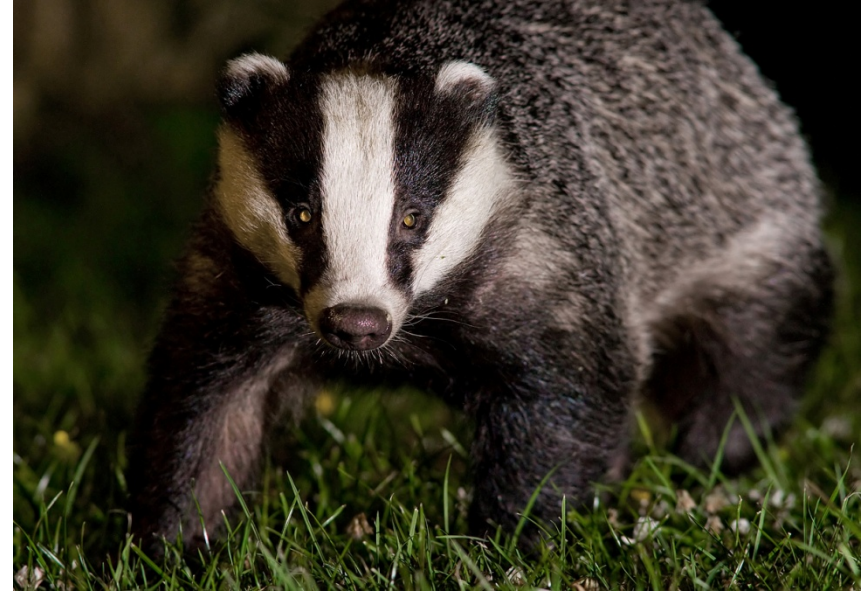
[Scott.Clemow@snclavalin.com](mailto:Scott.Clemow@snclavalin.com)

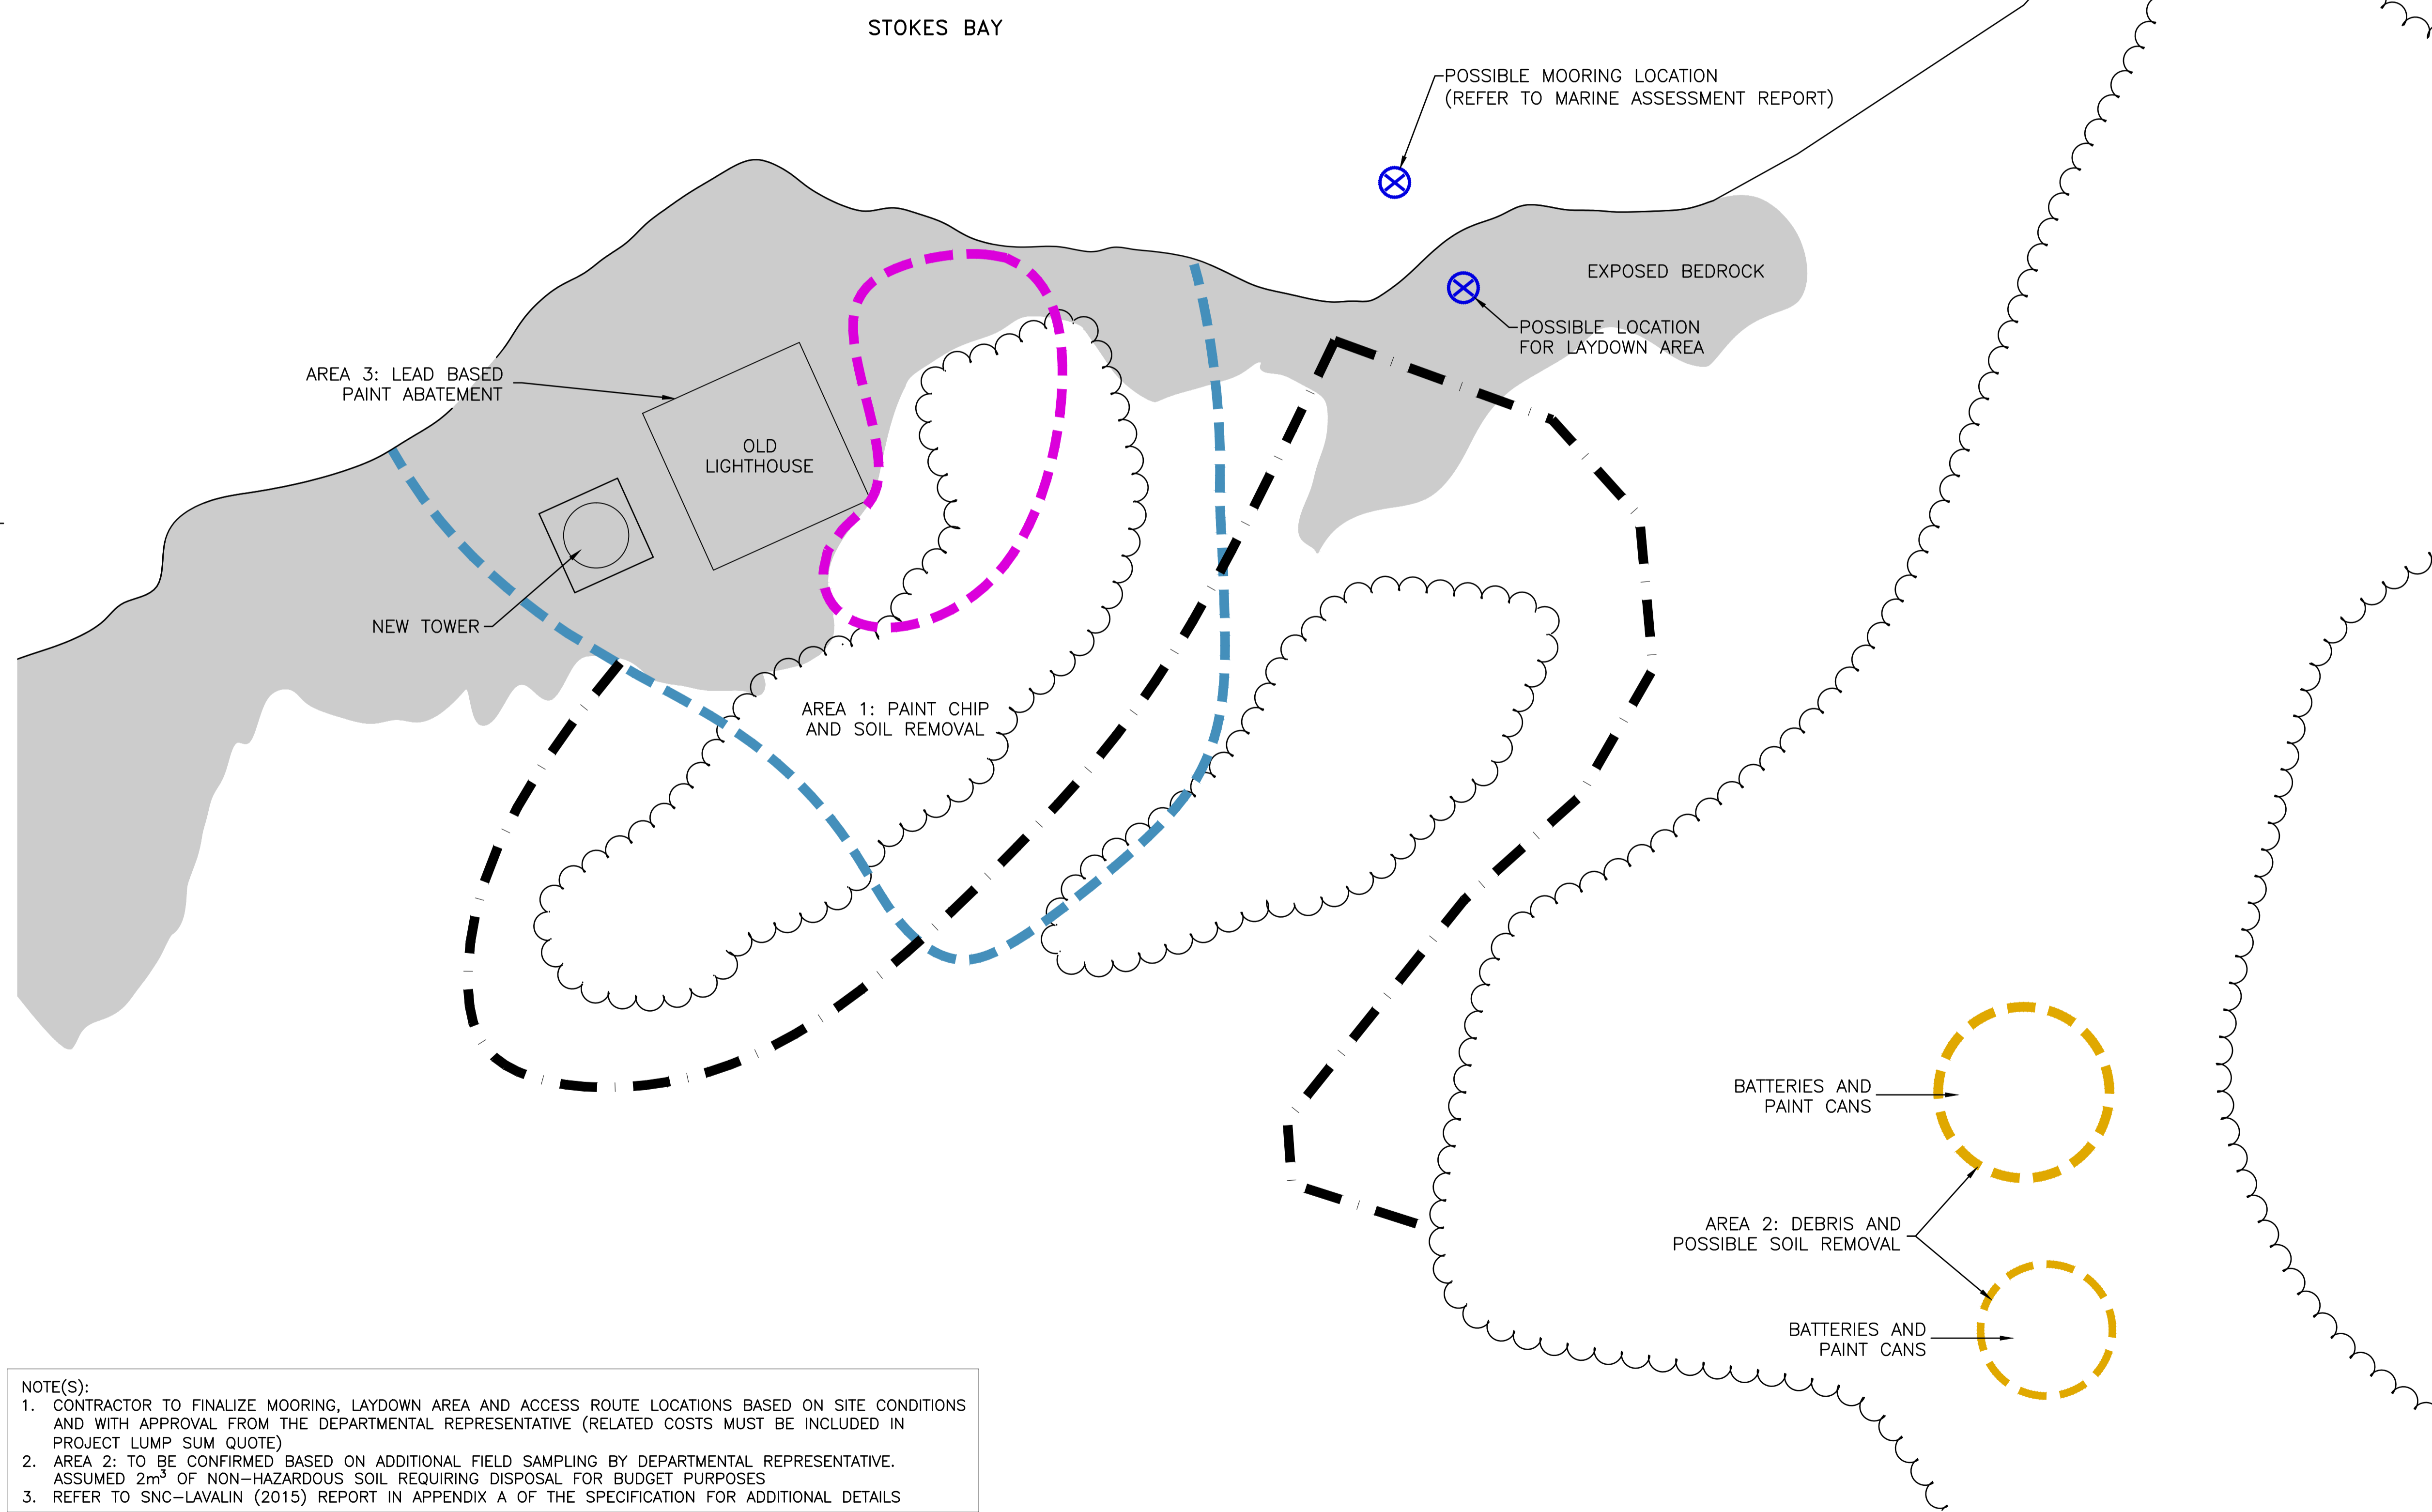
01	ISSUED FOR TENDER	2015-03-23
01	ISSUED FOR CLIENT REVIEW	2015-02-20
revision		date

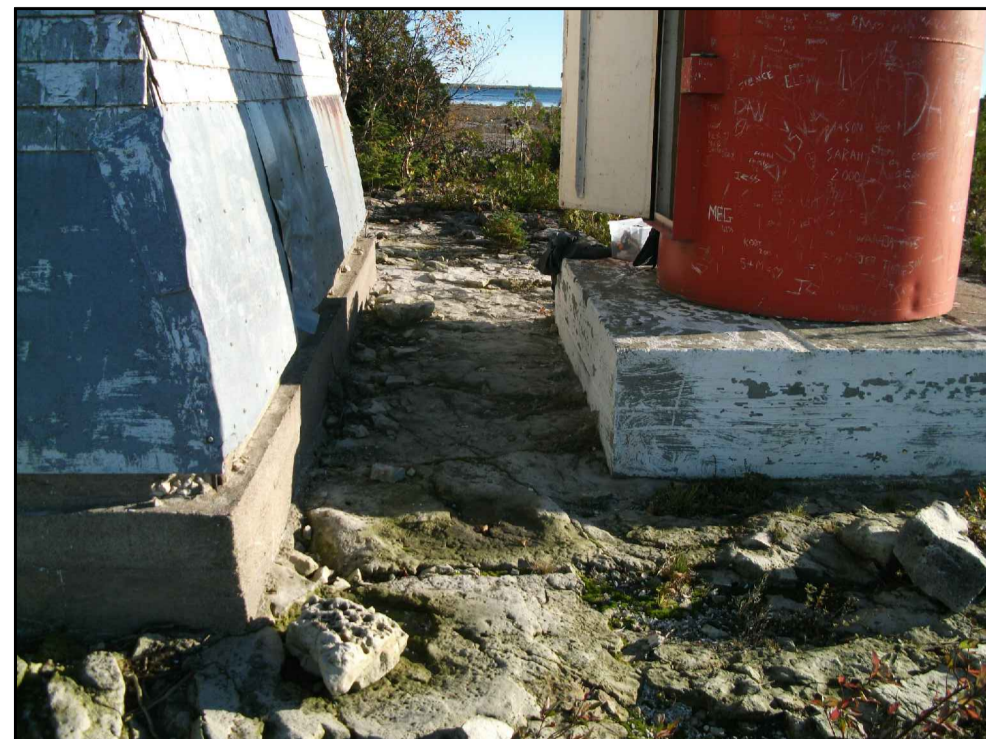
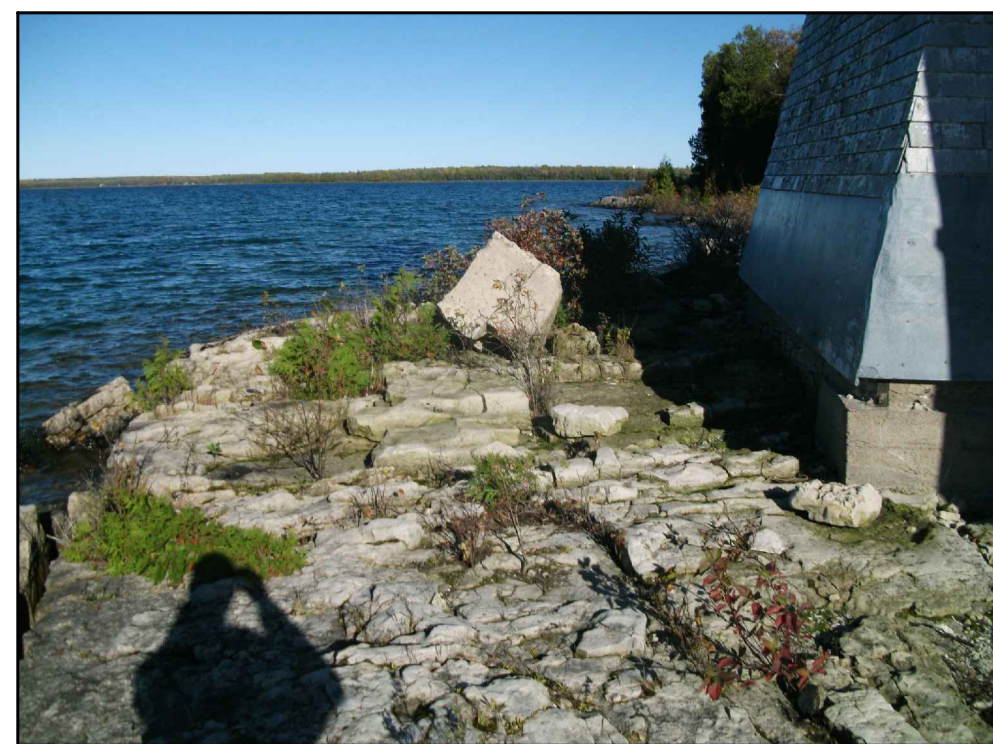
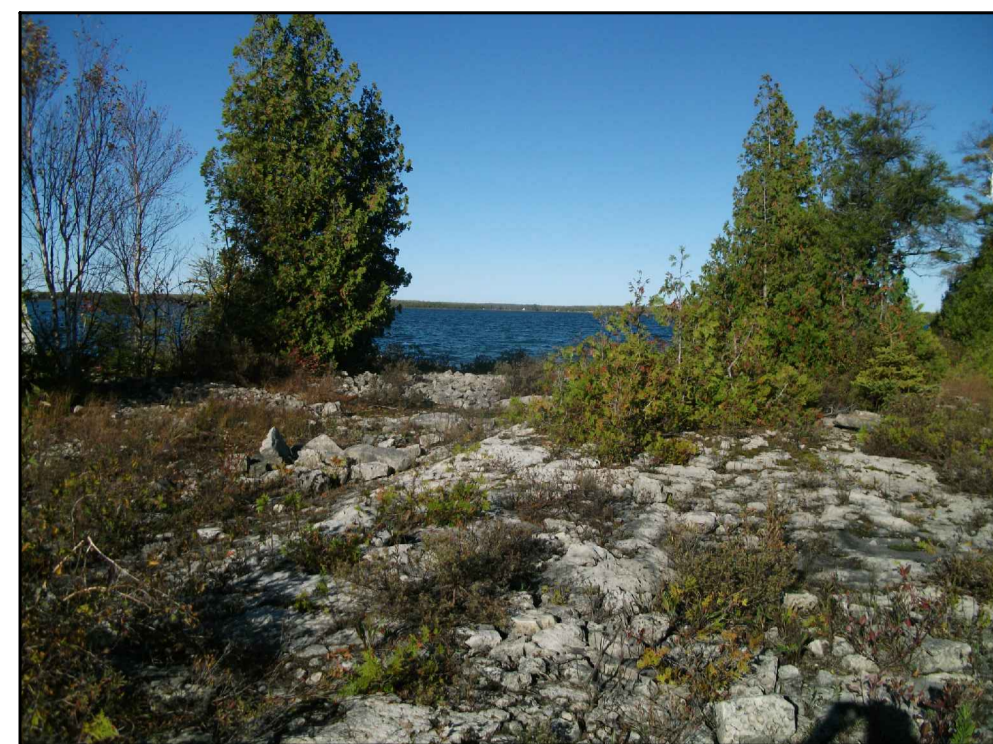
- CONTRACTOR TO FINALIZE MOORING, LAYDOWN AREA AND ACCESS ROUTE LOCATIONS BASED ON SITE CONDITIONS AND WITH APPROVAL FROM THE DEPARTMENTAL REPRESENTATIVE (RELATED COSTS MUST BE INCLUDED IN PROJECT LUMP SUM QUOTE)
- AREA 2: TO BE CONFIRMED BASED ON ADDITIONAL FIELD SAMPLING BY DEPARTMENTAL REPRESENTATIVE. ASSUMED 2m<sup>3</sup> OF NON-HAZARDOUS SOIL REQUIRING DISPOSAL FOR BUDGET PURPOSES
- REFER TO SNC-LAVALIN (2015) REPORT IN APPENDIX A OF THE SPECIFICATION FOR ADDITIONAL DETAILS

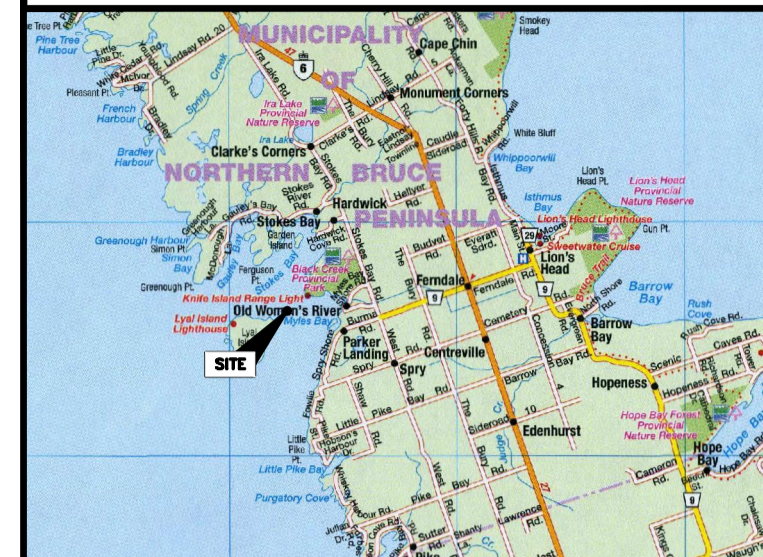
KEY PLAN NOT TO SCALE

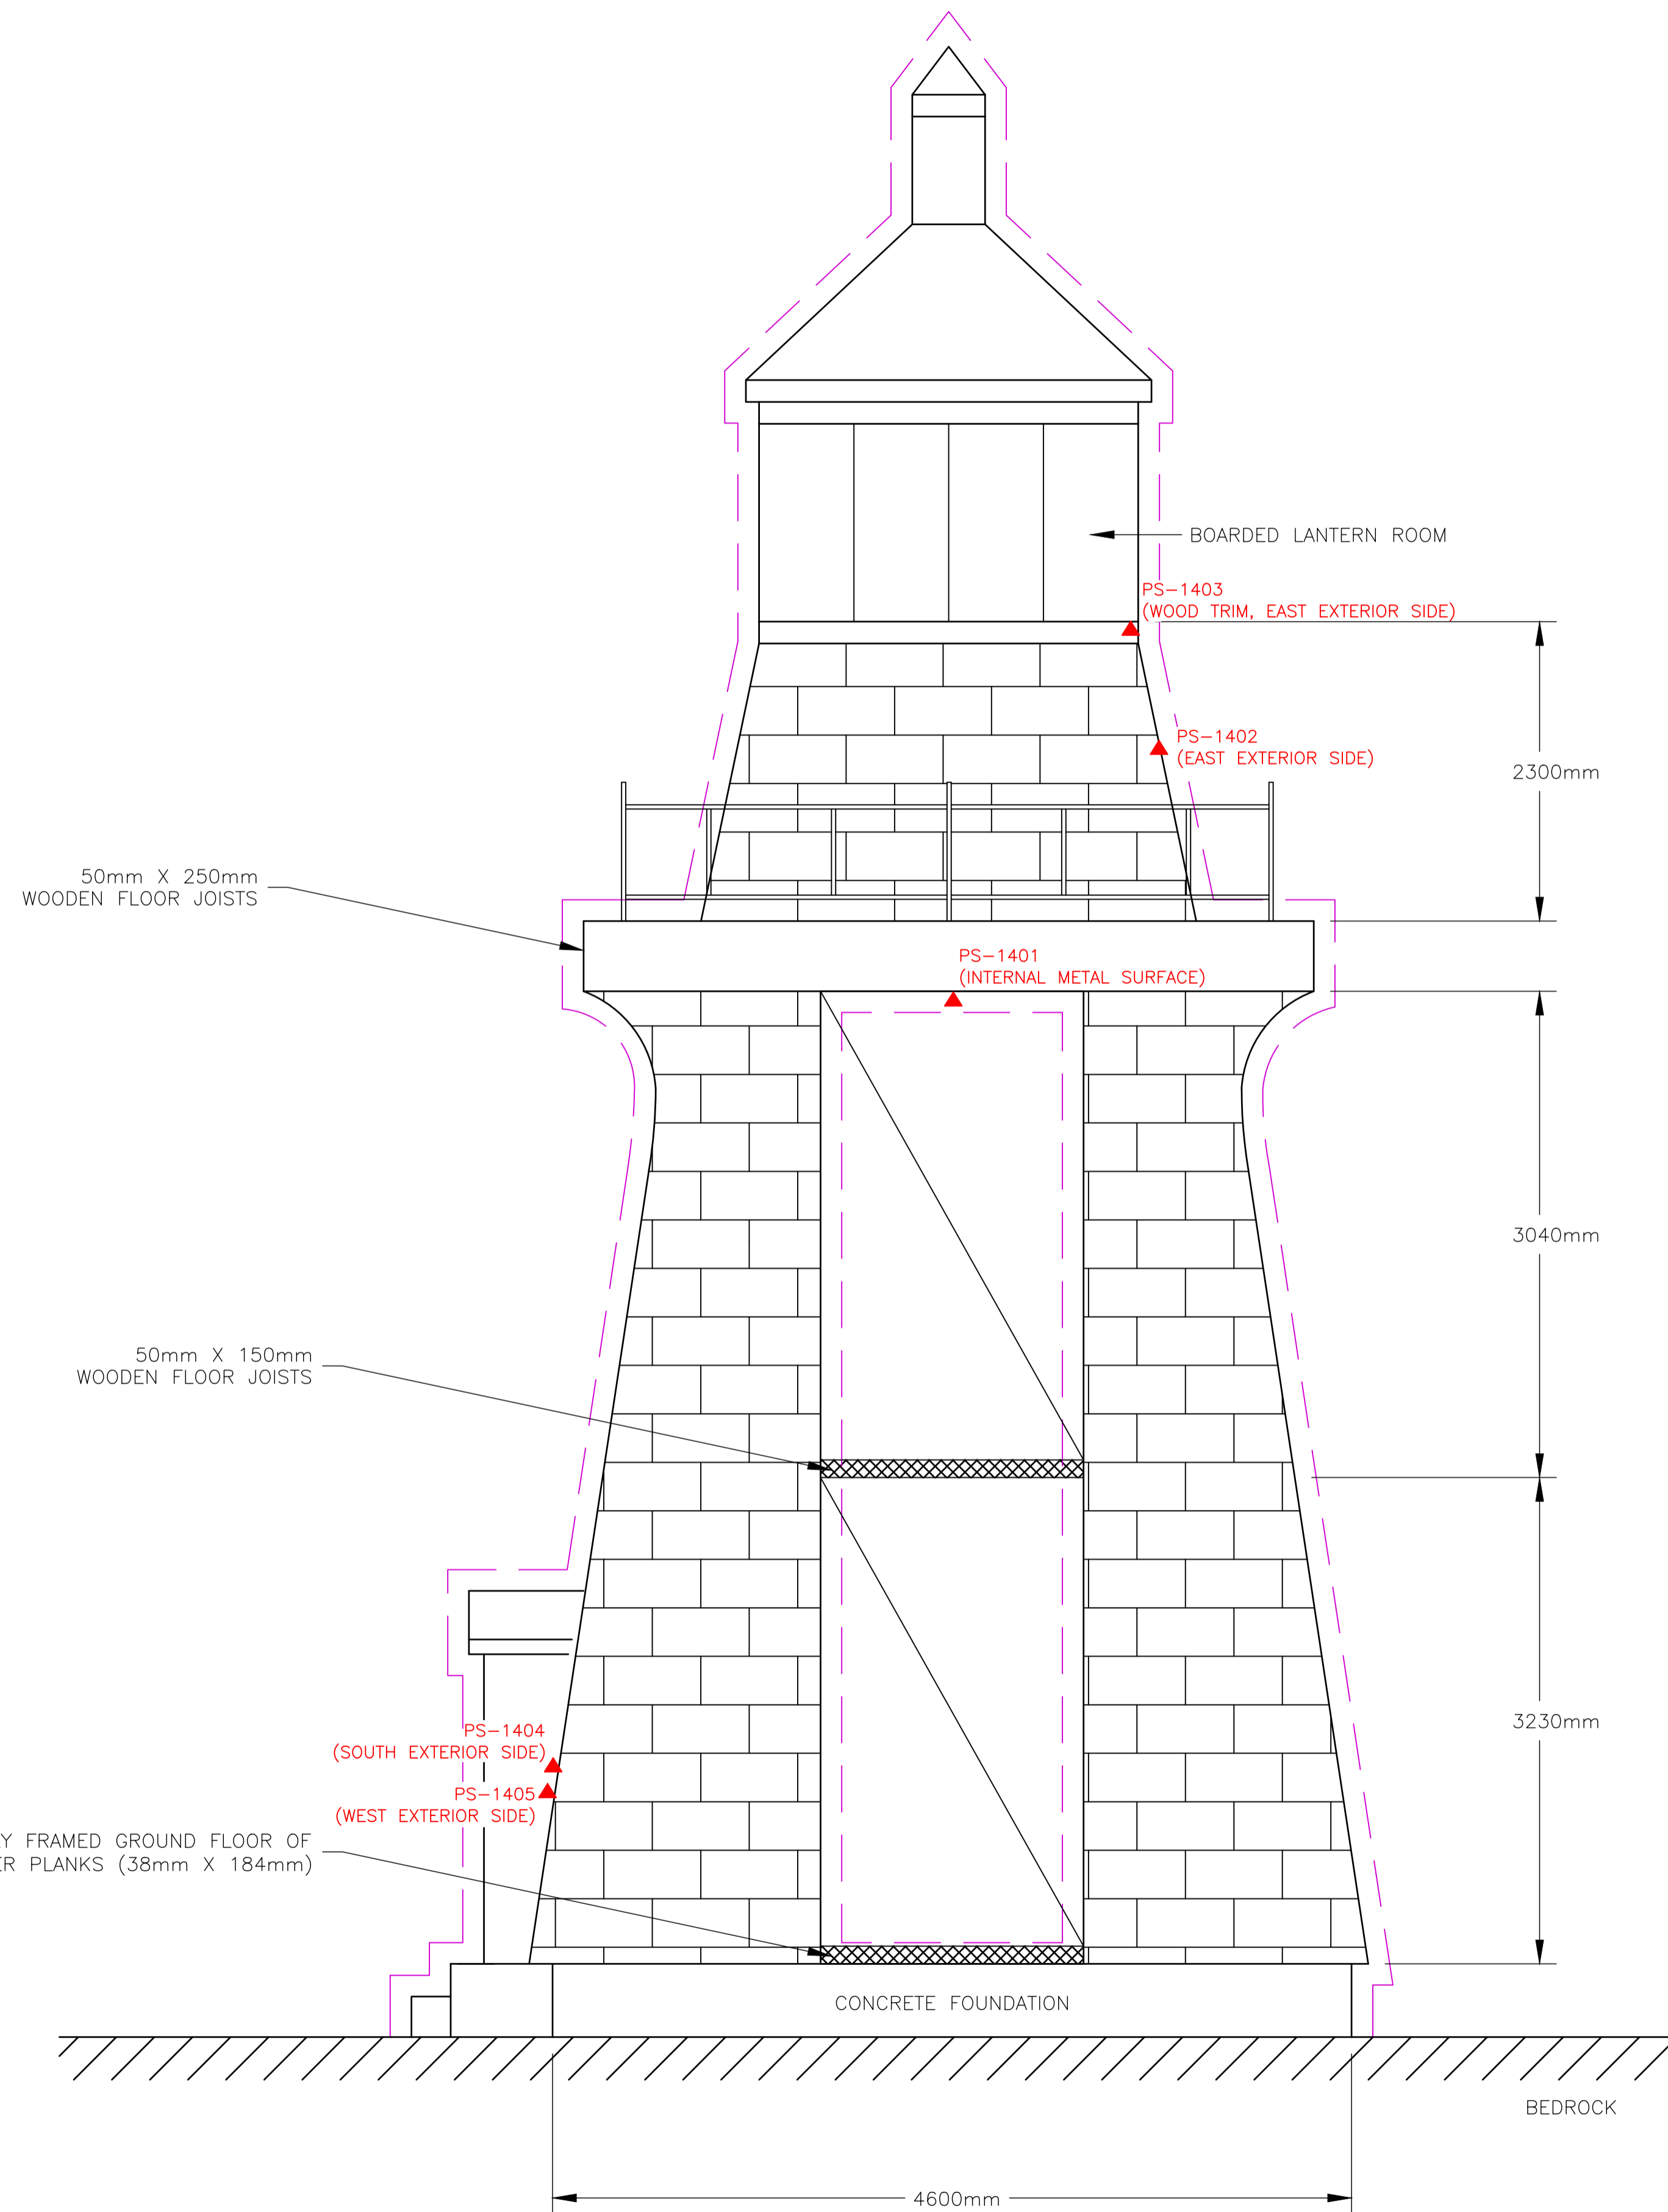
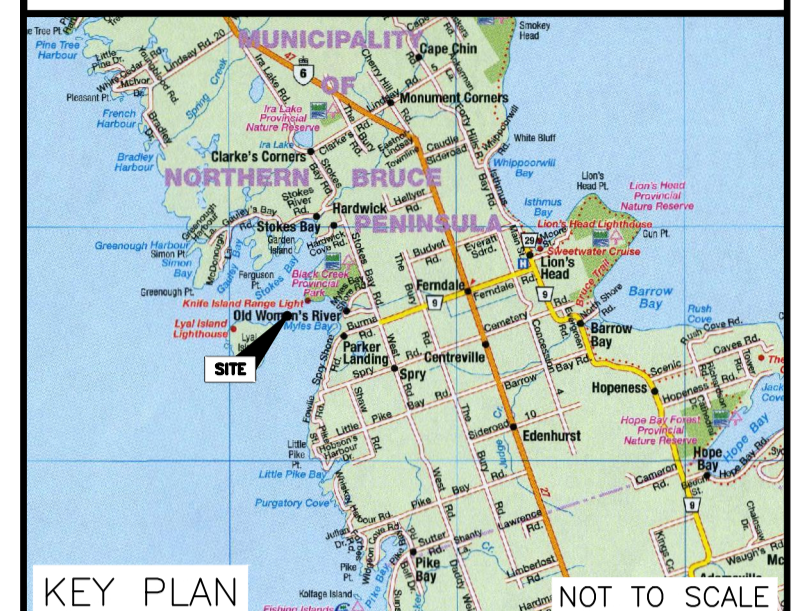
KEY PLAN NOT TO SCALE
