Title - Sujet CCTV FOR CBSA LACOLLE	
Solicitation No. - N° de l'invitation 47446-166562/A	Amendment No. - N° modif. 001
Client Reference No. - N° de référence du client 47446-166562	Date 2015-12-04
GETS Reference No. - N° de référence de SEAG PW-\$\$HN-324-68337	
File No. - N° de dossier hn324.47446-166562	CCC No./N° CCC - FMS No./N° VME
Solicitation Closes - L'invitation prend fin at - à 02:00 PM on - le 2015-12-22	Time Zone Fuseau horaire Eastern Standard Time EST
F.O.B. - F.A.B. Plant-Usine: <input type="checkbox"/> Destination: <input checked="" type="checkbox"/> Other-Autre: <input type="checkbox"/>	
Address Enquiries to: - Adresser toutes questions à: Theriault, Joelle	Buyer Id - Id de l'acheteur hn324
Telephone No. - N° de téléphone (819) 956-3484 ()	FAX No. - N° de FAX (819) 953-4944
Destination - of Goods, Services, and Construction: Destination - des biens, services et construction:

Amendment 001 is issued to provide Questions and Answers and to extend the solicitation close date.

Summary of the Inspection Visit to the St-Bernard de Lacolle

Underground Conduits

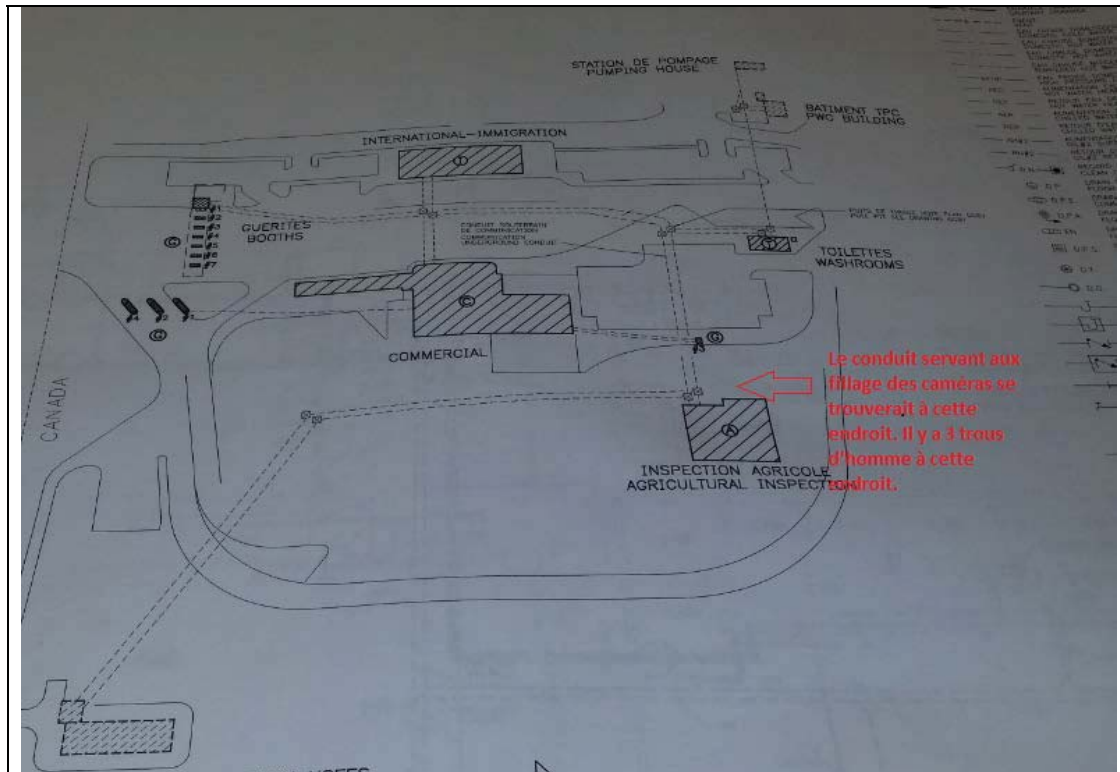
Image translation: The conduit containing the camera wiring would be found at this location. There are three manholes at this location.

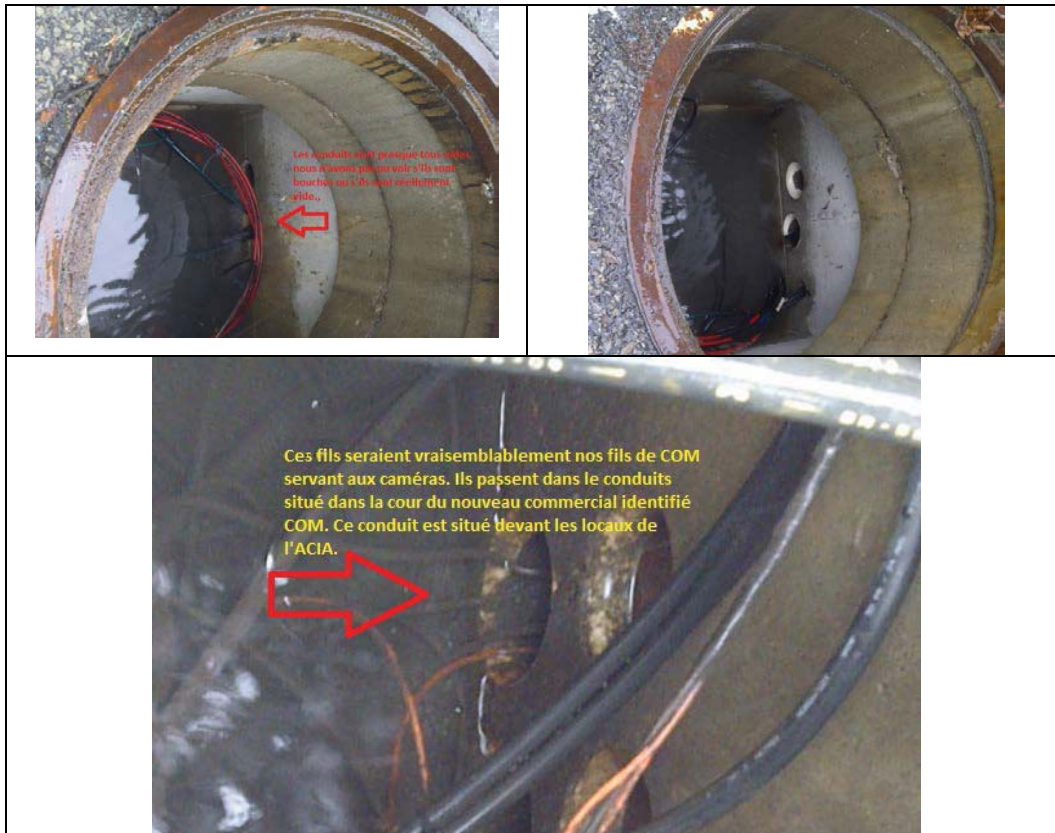
The inspection of this conduit was mainly focused on the camera currently on the corner of the building. The conduit containing the wiring for the cameras and computers is under the first cover in the disabled parking area located in front of the CFIA offices. It connects the wires to the new COM commercial yard conduit. The conduits are practically empty, which corresponds to the situation at CFIA, which is not part of the CBSA IT network.

Image 1 translation: The conduits are almost all empty. We were not able to see whether they are blocked or actually empty.

Image 3 translation: These are likely our COM wires for the cameras. They go through the conduit located in the new commercial yard identified as COM. The conduit is located in front of the CFIA facility.

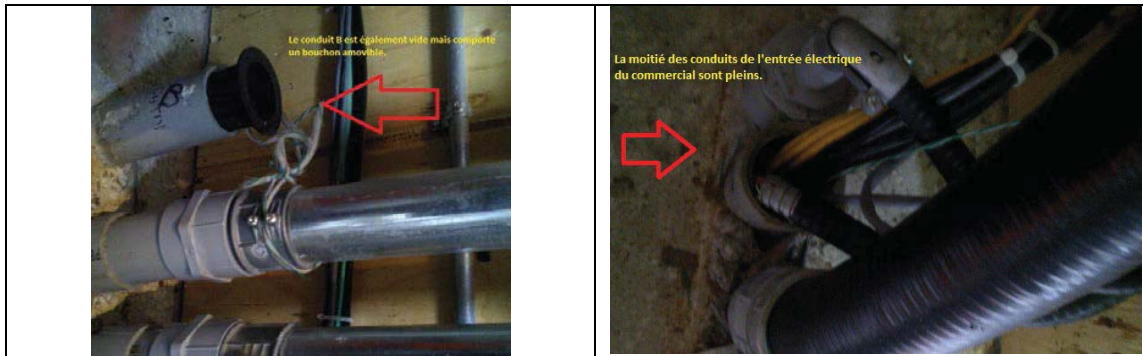
The electrical input of the commercial booths has several outlets that are mostly full, but there is still enough space for future wiring out of conduits B and/or A. The outlet at the main building was not identified because we are concerned there is not enough space for the outlet.

Image 1 translation: Conduit B is also empty, but has a removable plug.

Image 2 translation: Half of the electrical input conduits of the commercial booth are full.

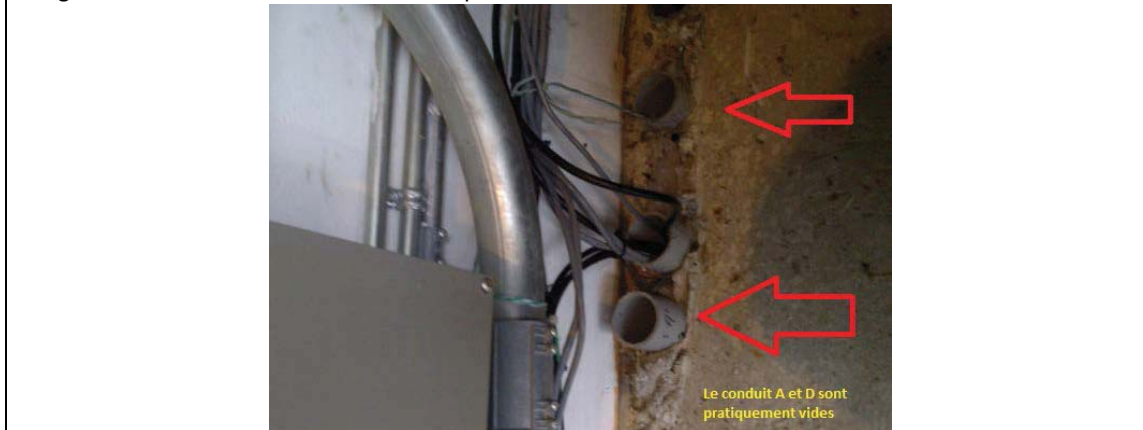
Image 3 translation: Conduits A and D are practically empty.

Certain conduits still have transit lines, but some do not.

Based on what we can see, there is sufficient space for the camera wiring. Installation of the wiring could be problematic. Some of the conduit elbows were very tight, and the camera could not get through.

It would be important to confirm where the empty conduits at the electrical input of the commercial booths lead to ensure that the empty conduits do in fact go under the booths.
