Project Description / Description de projet HFX - Nitrogen Generation System		
Solicitation No./ No de sollicitation 15-22193	Project No./N ^o de projet HFX-5142	W.O. No./N ^o d'ordre de travail
Project Engineer / Ingénieur de projet Nadine Merkley		Date March 30 th , 2016
<p>Notice: This addendum shall form part of the tender documents and all conditions shall apply and be read in conjunction with the original plans and specifications.</p>		<p>Nota: Cet addenda fait partie intégrale des dossiers d'appel d'offres; toutes les conditions énoncées doivent être lues et appliquées en conjonction avec les plans et les devis originaux.</p>

PROJECT: NRC Nitrogen Generation System (Solicitation 15-22193)
PROJECT #: HFX-5142
ISSUED BY: Stantec
DATE: March 29, 2016

**NATIONAL RESEARCH COUNCIL OF CANADA
ASBESTOS SURVEY
1411 OXFORD STREET, HALIFAX, NS**

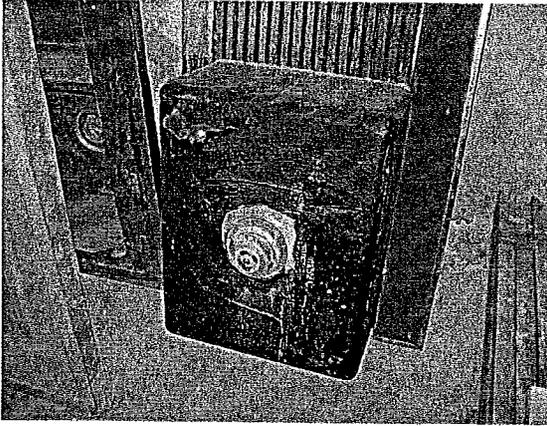
Photo 01 – Thermal sink insulation on the underside of a sink, basement storage room (location 001, sample 01-02-67-S002).

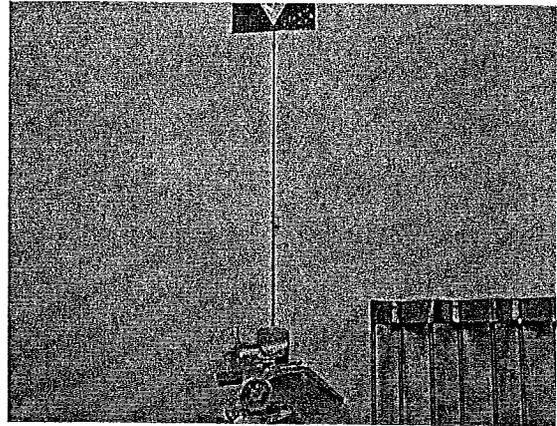
Photo 02 – Transite panels on the walls, basement machine shop (location 003, sample 01-02-67-S004).

Use Type 1 asbestos procedures to repair approximately 9 ft² of "Transite" panelling in POOR condition throughout the building. If power tools are to be used or if significant breakage of the panels is anticipated then Type 2 asbestos procedures should be used.

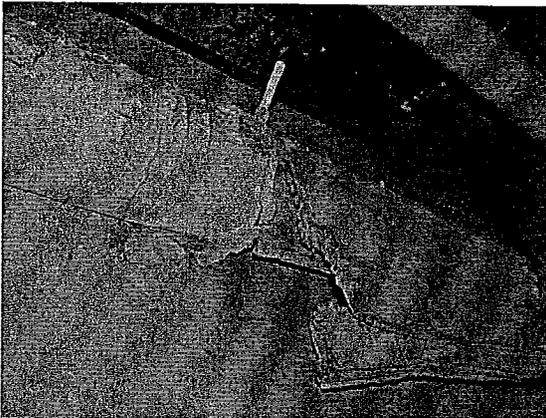
- The following friable asbestos-containing materials were identified within the building.
 - Canvas-covered "Aircell" pipe insulation identified on condensate return, domestic water ("DW"), and steam supply lines contains >75% chrysotile asbestos. Aircell insulation was noted in FAIR and POOR condition throughout the building.

Canvas-covered "Aircell" pipe insulation was sampled from a steam supply line in the basement machine shop (location 003). Analysis of this insulation identified the presence of >75% chrysotile asbestos (sample 01-02-67-S005). This insulation was visually identified on condensate return, domestic water ("DW"), and steam supply lines. Aircell pipe insulation is present in the following locations. Approximate quantities of Aircell pipe insulation in FAIR and POOR condition are noted in parentheses:

Photo 03 – Aircell pipe insulation on a steam supply line, basement machine shop (location 003, sample 01-02-67-S005).

Use Type 2 asbestos procedures to repair approximately 8 ft of "Aircell" insulation in FAIR condition throughout the building. Alternatively glove-bag procedures may be used for repair of the pipe insulation.

Use Type 2 asbestos procedures to remove approximately 10 ft of "Aircell" insulation in POOR condition throughout the building. Alternatively glove-bag procedures may be used for removal of the pipe insulation.

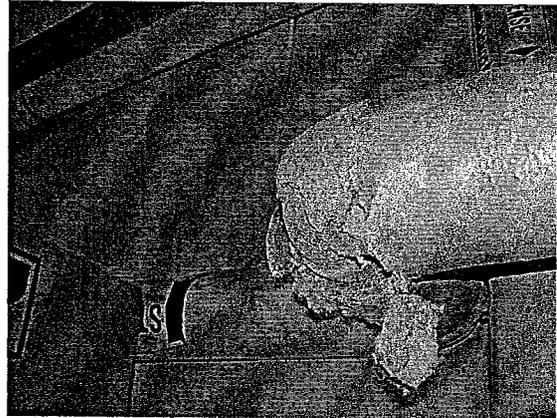
- Parging cement identified on fittings (elbows, valves, etc) on the steam supply, drain, DW, and condensate return lines contains >50% chrysotile asbestos. Parging cement was noted in FAIR and POOR condition throughout the building.

Photo 04 – Parging cement on steam supply fittings, basement machine shop (location 003, sample 01-02-67-S006).

Use Type 2 or Type 3 asbestos procedures to remove approximately sixty-five (65) parging cement fittings in FAIR condition and thirty-two (32) parging cement fittings in POOR condition throughout the building. Determination of the asbestos procedures depends on the number of fittings in each room (greater than ten (10) fittings requires Type 3 asbestos procedures). Alternatively glove-bag procedures may be used for removal of parging cement fittings.

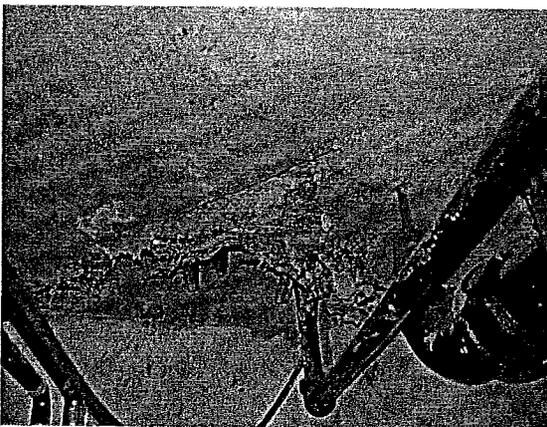
Based on the inconstancy of the sample results and the visual observations, all walls with plaster finishes in the building should be considered asbestos-containing unless sampling within specific locations proves otherwise. Exposed plaster base coat was noted on walls and ceilings throughout the building rating these areas in FAIR condition.

Photo 05 – Plaster on ceiling, basement west corridor (location 004, sample 01-02-67-S009).

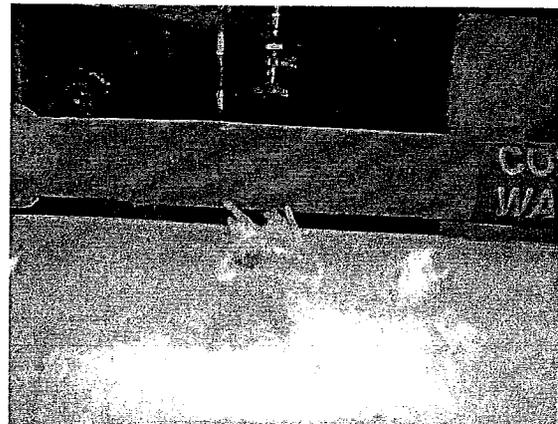
Layer paper and tar insulation was sampled from a condensate return line in the basement hallway (location 004). Analysis identified the presence of 1-5% chrysotile asbestos in the tar and no asbestos in the covering paper (sample 01-02-60-S010). This tar was visually identified on steam supply, DW, and condensate return lines, and is present in the following locations. Approximate quantities of tar in POOR condition are noted in parentheses:

Photo 06 – Paper covering tar on condensate return line, basement west corridor (location 004, sample 01-02-67-S010).

Use Type 1 (low risk) asbestos procedures to repair approximately 169 ft of Layer paper and tar insulation in POOR condition throughout the building.

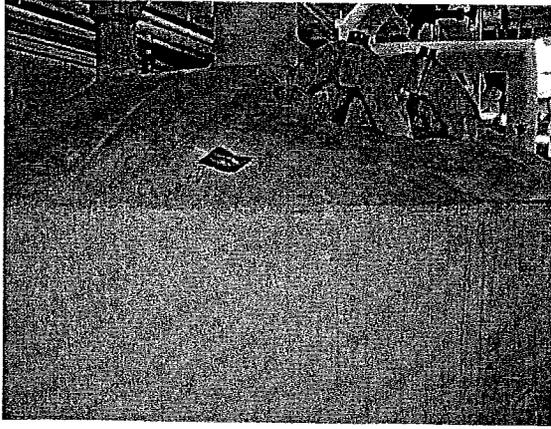
Canvas-covered parging cement was sampled from a steam pressure tank in the basement tank room (location 017). Analysis of the parging cement identified the presence of 50-75% chrysotile asbestos (sample 01-02-67-S017). All of the parging cement insulation was in GOOD condition.

Photo 07 – Parging cement on steam pressure tank, tank room (location 017, sample 01-02-67-S017).

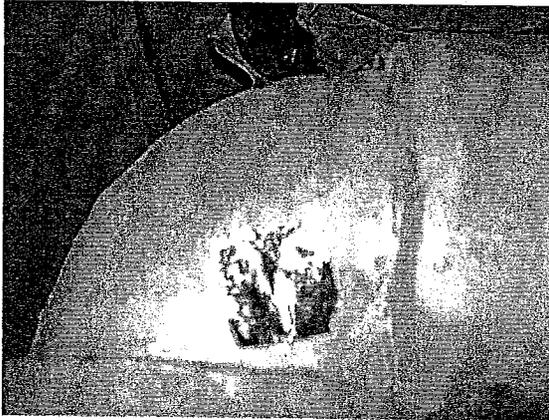
Photo 09 – Parging cement on drain line elbow, basement east hallway (location 024, sample 01-02-67-S020).

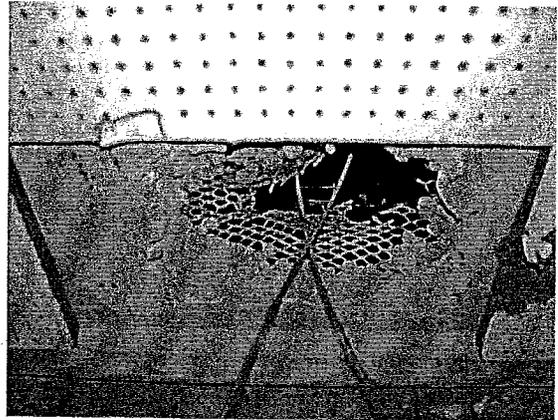
Photo 10 – Plaster on ceiling, 2nd floor west corridor (location 083, sample 01-02-67-S032).

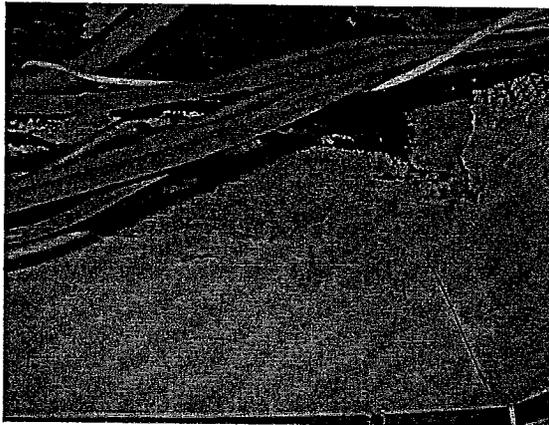
Photo 11 – Plaster on wall, 2nd floor west corridor (location 083, sample 01-02-67-S033).

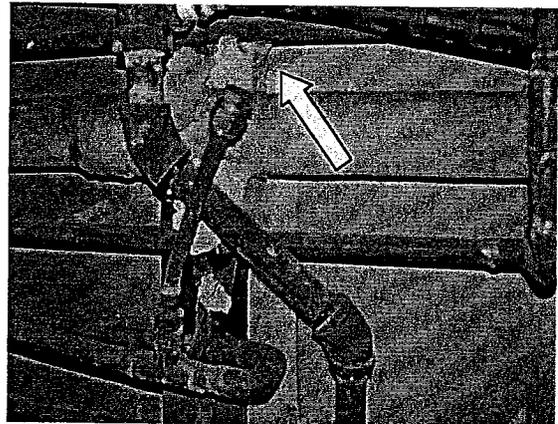
White fibrous paper debris was sampled in the pipe chase of Room 235, marine bio-actives lab (location 235). Analysis of the paper debris identified the presence of 50-75% chrysotile asbestos (sample 01-02-67-S037). There is approximately 2 ft² of this material in POOR condition. Concealed fibrous paper is expected in the pipe chases throughout the building.

Photo 12 – Fibrous paper debris in pipe chase, Room 235 (location 100, sample 01-02-67-S037).
