RS 2.2.3 Feasibility Study

GoCB Windsor
441 University Avenue, Windsor, ON

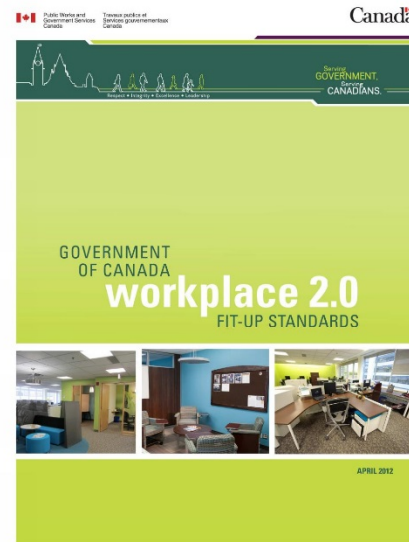
Office & Workstation Area

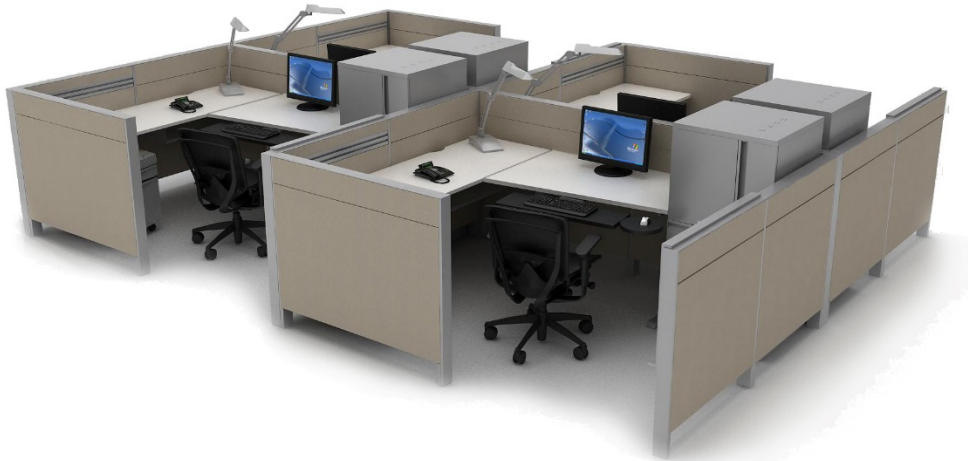
Figure 1a Typical grouping of 4.5m² workstations (Source: Office Works LLC)

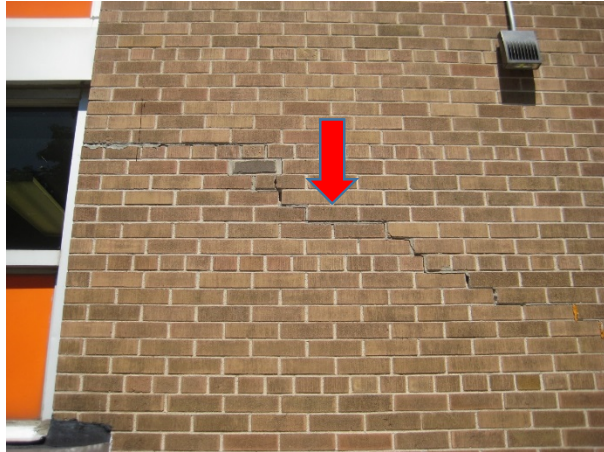
Figure 6 Cracking of Brick Veneer (Photo: DIALOG 07-15-15)

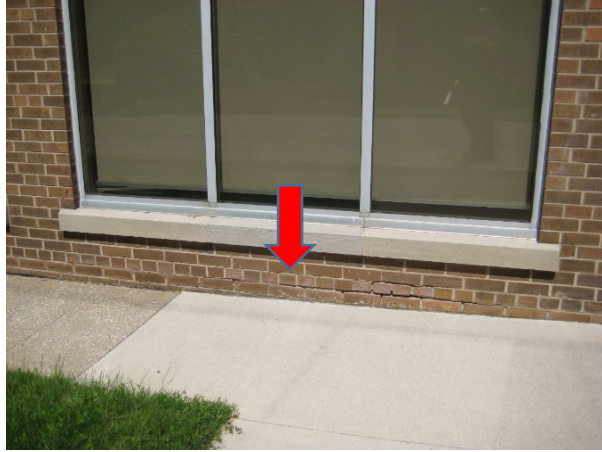
Figure 7 Spalling of Brick Veneer (Photo: DIALOG 07-15-15)

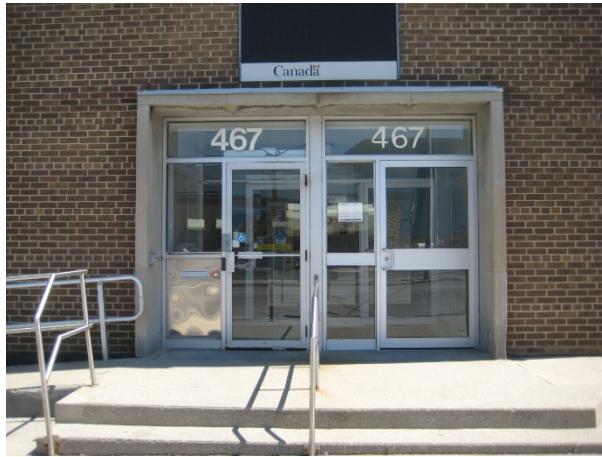
Figure 10 Main Entrance Doors (Photo: DIALOG 07-15-15)

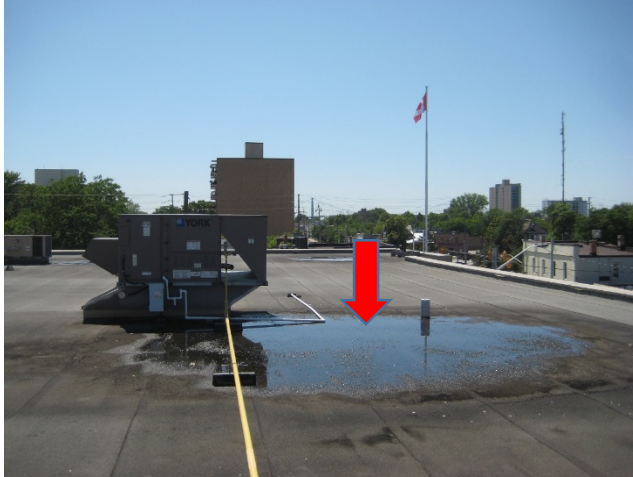
Figure 12 Standing Water (Photo: DIALOG 07-15-15)

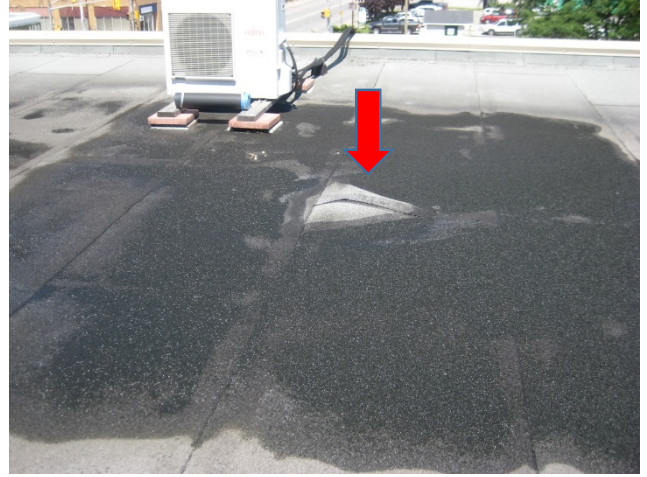
Figure 13 Delaminating Roof Membr. (Photo: DIALOG 07-15-15)

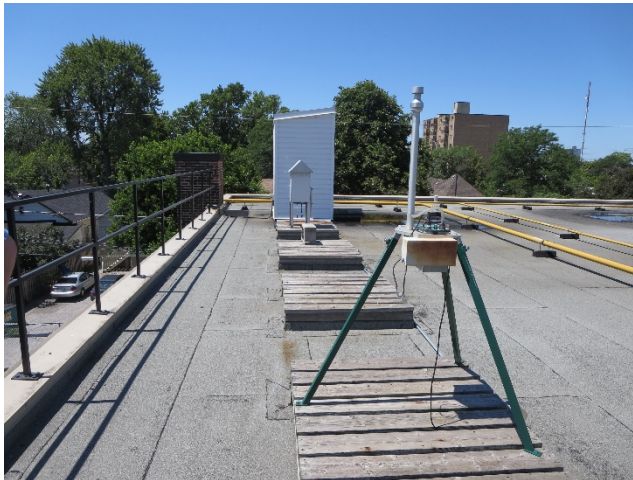
Figure 14 Guardrail on South Elevation (Photo: DIALOG 07-15-15)

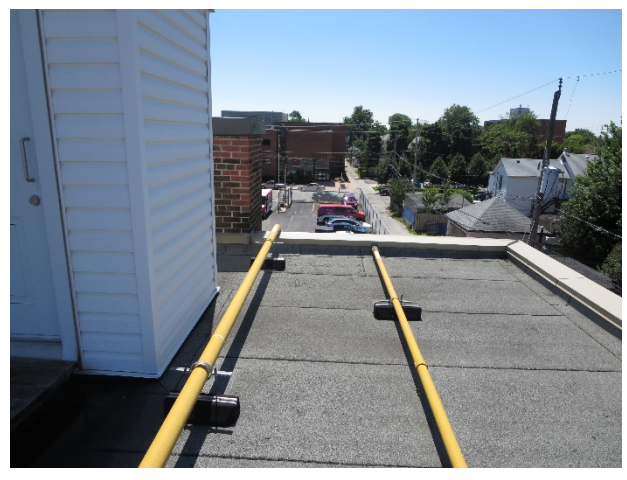
Figure 15 Typical Roof Curb/Parapet (Photo: DIALOG 07-15-15)

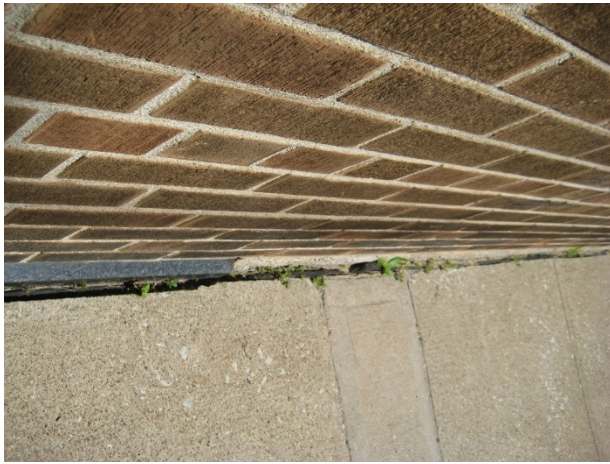
Figure 16 Foundation/Sidewalk (Photo: DIALOG 07-15-15)

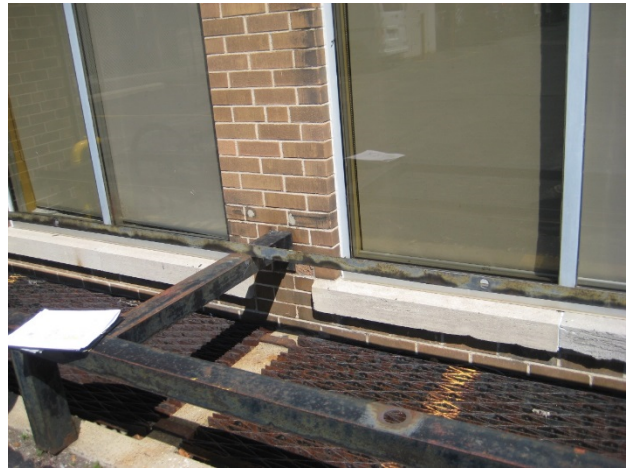
Figure 17 Areaway & Grating (Photo: DIALOG 07-15-15)

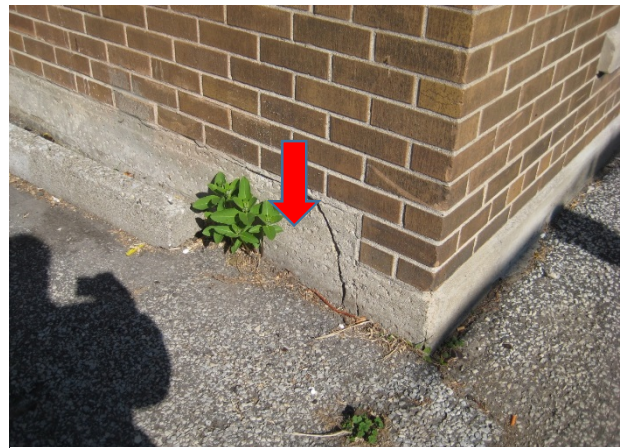
Figure 19 Foundation Cracking S/E Corner (Photo: DIALOG 07-15-15)

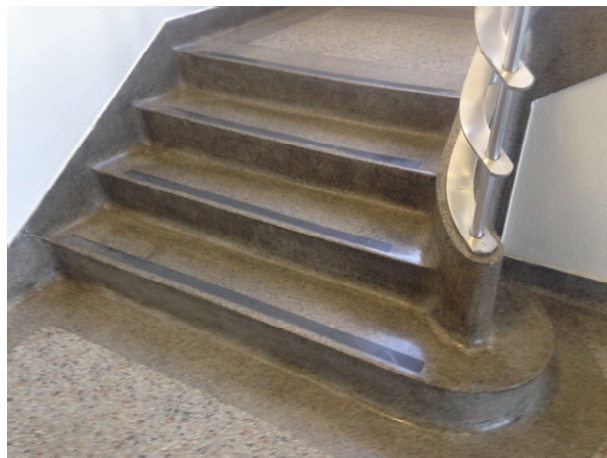
Figure 29 A & B – N-E Stair Treads. (Photo DIALOG 07-15-15)

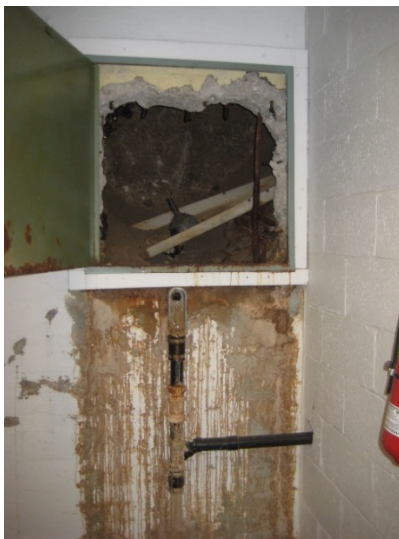
Figure S-1 (left): Existing access hole cut in foundation wall at water leak from storm drain

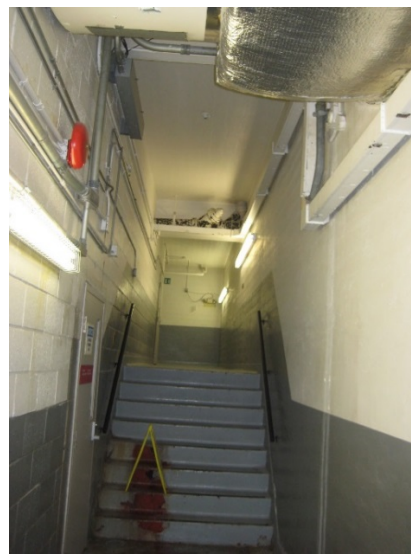
Figure S-2 (right): Signs of water leak in basement corridor stairs

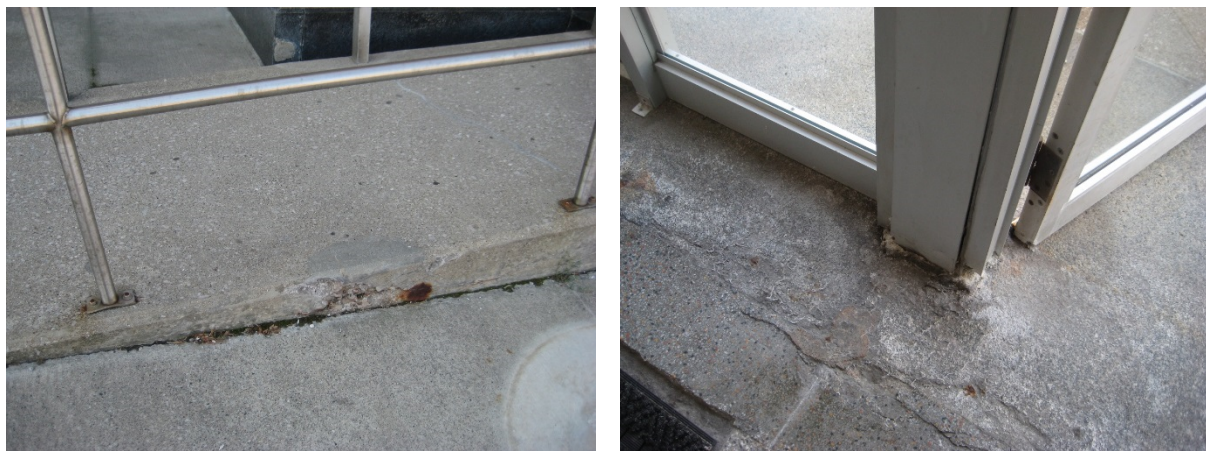
Figure S-3 A&B: Signs of concrete spalling at north-west main entrance

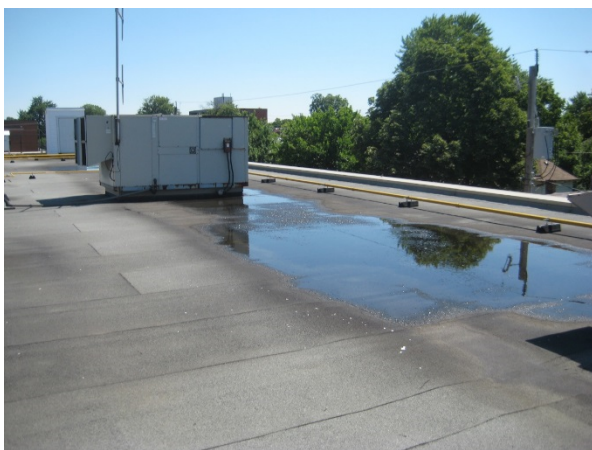
Figure S-6: Sagging of roof deck and water ponding

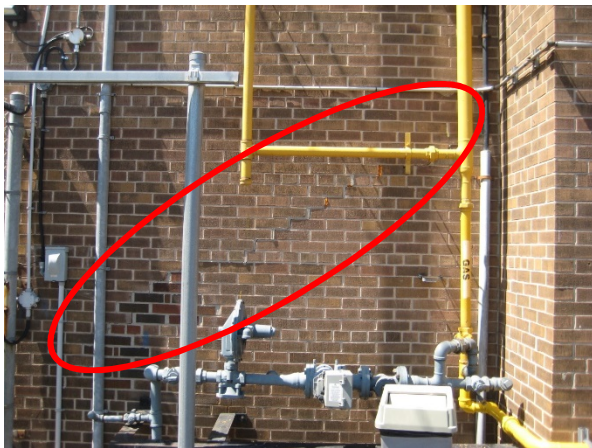
Figure S-7: Cracking in existing exterior brick veneer at south-west elevation

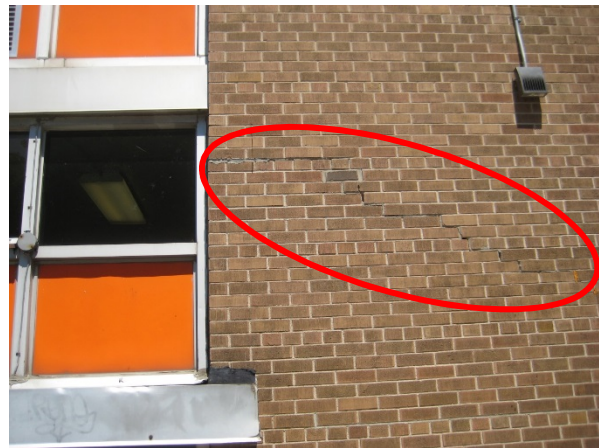
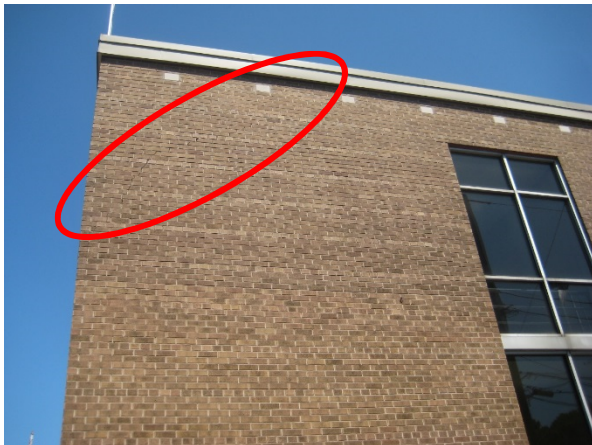
Figure S-8: Cracking at top in existing exterior brick veneer at north-west elevation

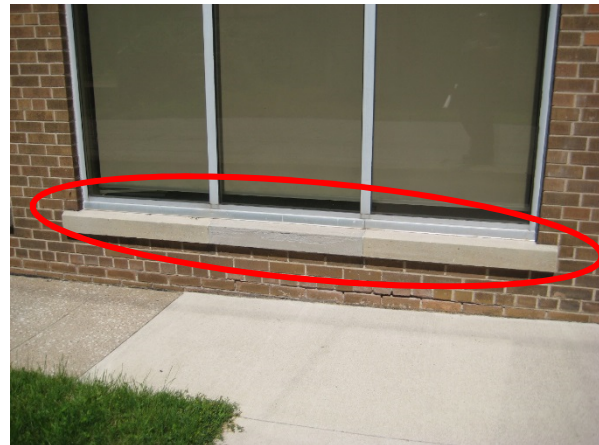
Figure S-9: Spalling of exterior brick face

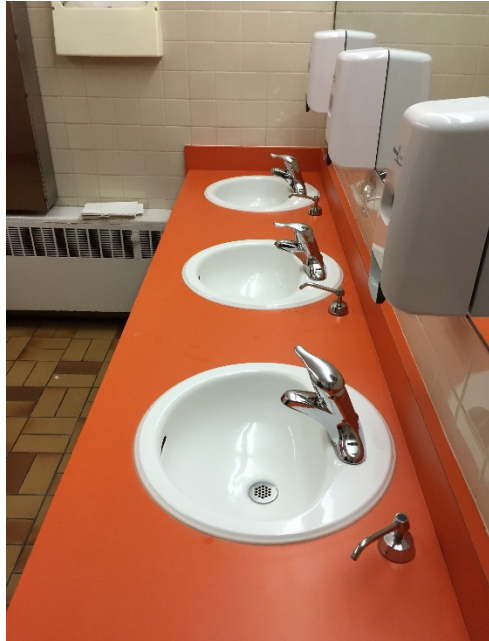
M-Figure 1 Existing Lavatories

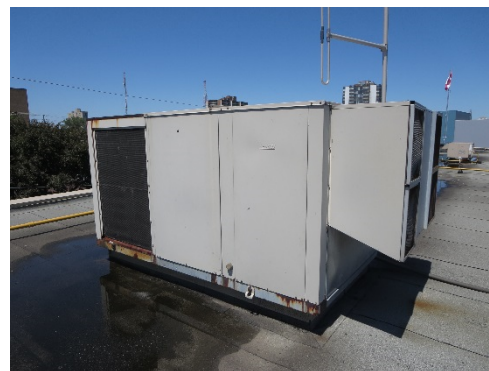
M-Figure 4 Existing Janitor Sink

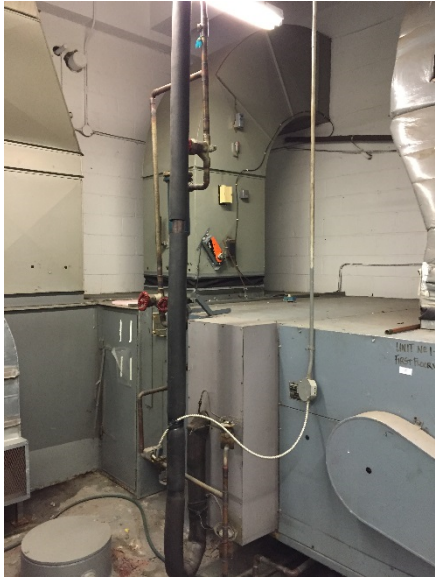
M-Figure 1 Existing Indoor AHU

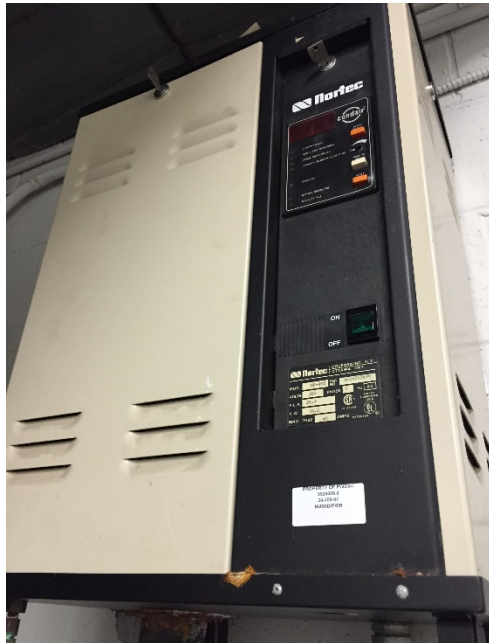
M-Figure 3 Existing Humidifier

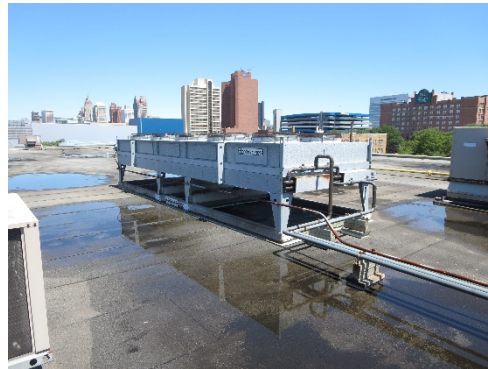
M-Figure 4 Existing Air Cooled Condenser

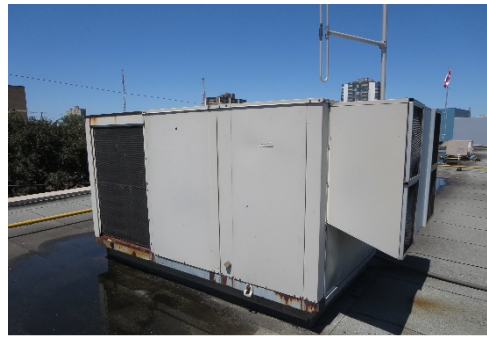
M-Figure 6 Existing Rooftop Units

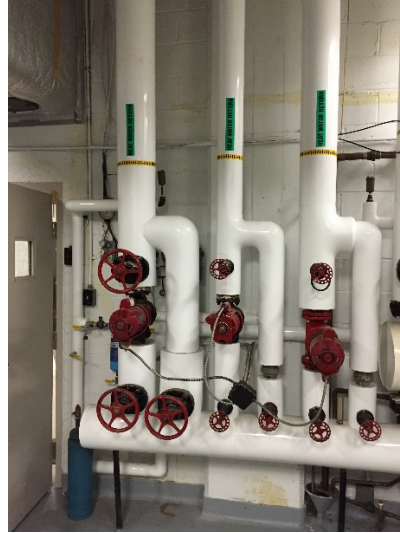
M-Figure 8 Existing Heating Loops

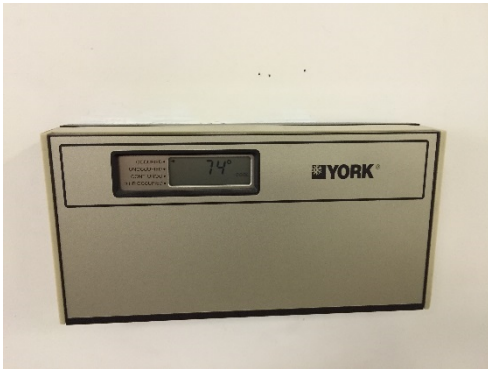
M-Figure 9 Existing Thermostat

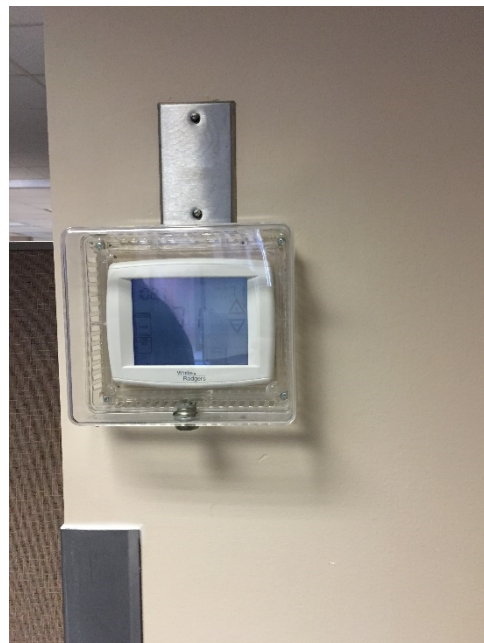
M-Figure 10 Existing Thermostat

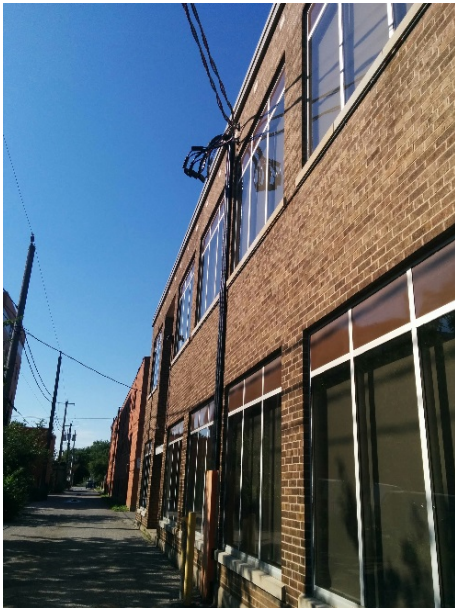
E-Figure 1 Incoming Service and pole mounted transformers in background

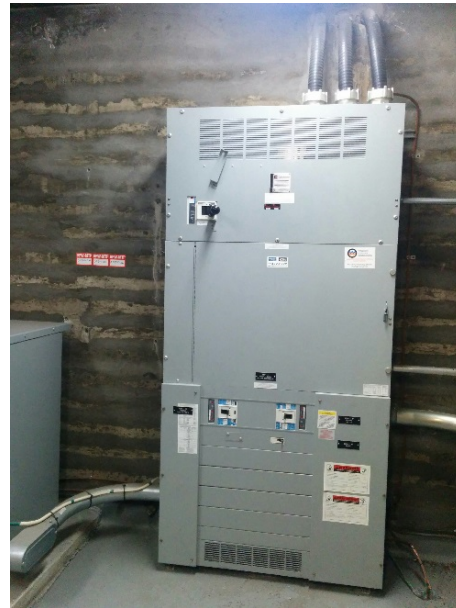
E-Figure 2 Main Incoming Switchboard – Good condition

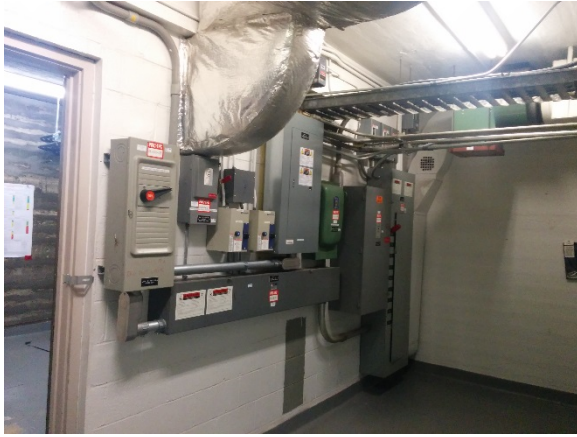
E-Figure 3 600V Splitter and Disconnects – Recommended for replacement

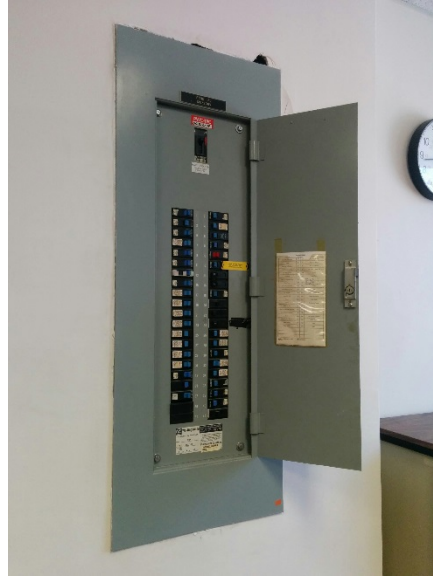
E-Figure 4 Typical 120/208V panelboard

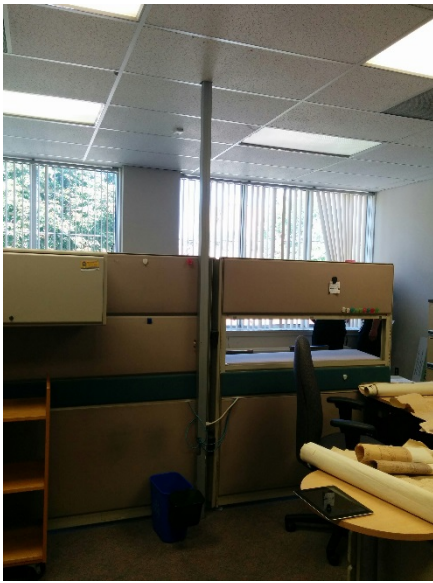
E-Figure 5 Typical Office Fluorescent Troffer

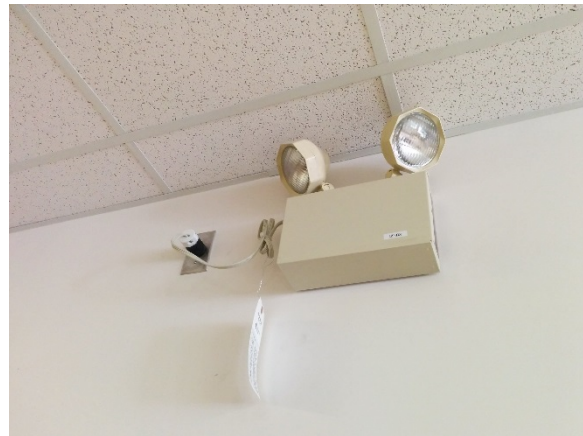
E-Figure 8 Typical emergency battery unit with lamp heads

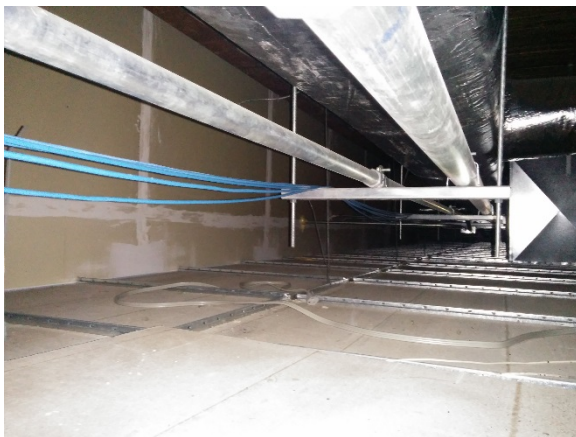
E-Figure 9 Typical Loose Horizontal Communications Wiring

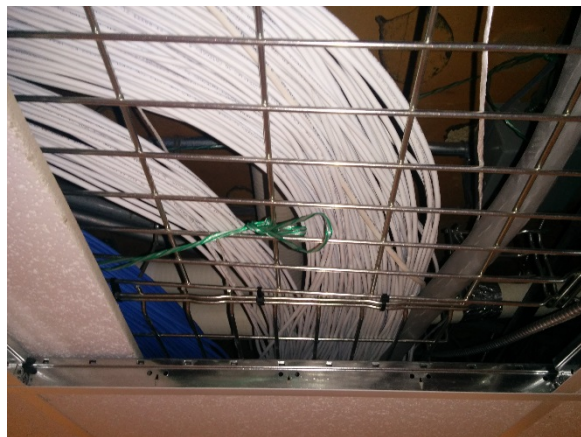
E-Figure 10 Atypical Cable Tray in CRA Space Only

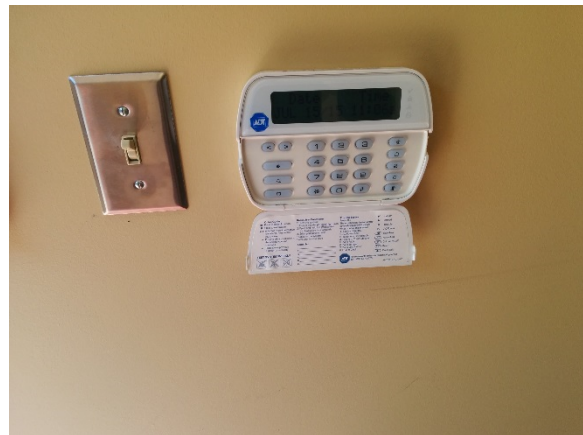
E-Figure 12 Tenant-owned security keypad; not in operation

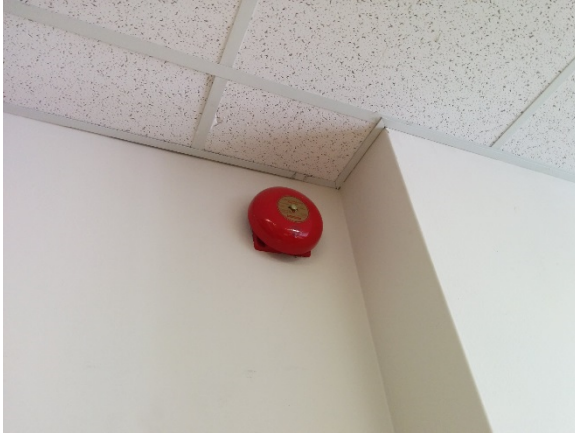
E-Figure 15 Non-conformant bells, typical

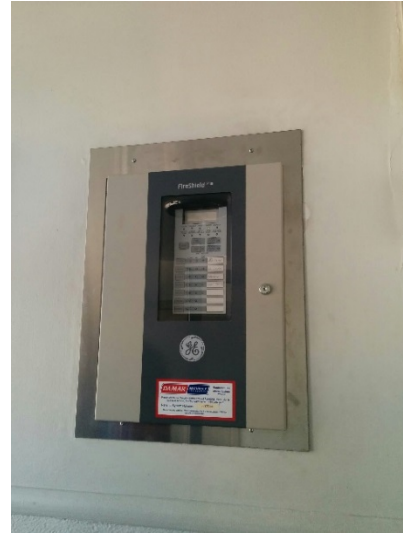
E-Figure 16 Recently replaced main fire alarm panel, good condition

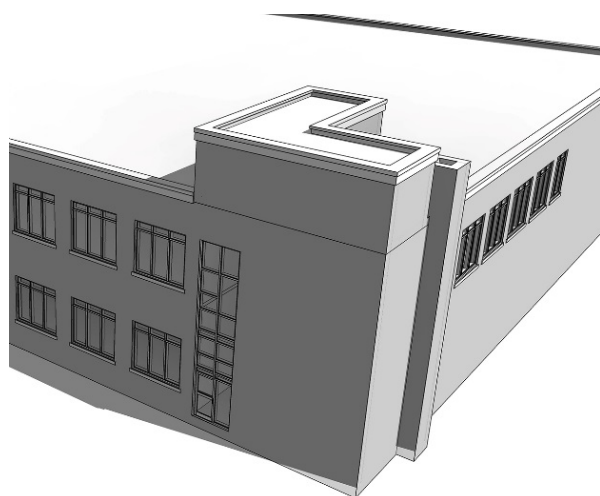
The mandate to establish Environment Canada's monitoring station on the building's roof calls for the provision of a safe, internal pathway to the roof from the building interior. Specifically this would involve extending the S-W stairwell up to the roof level, and in turn removing the precarious exterior roof access stair on the building's south wall.

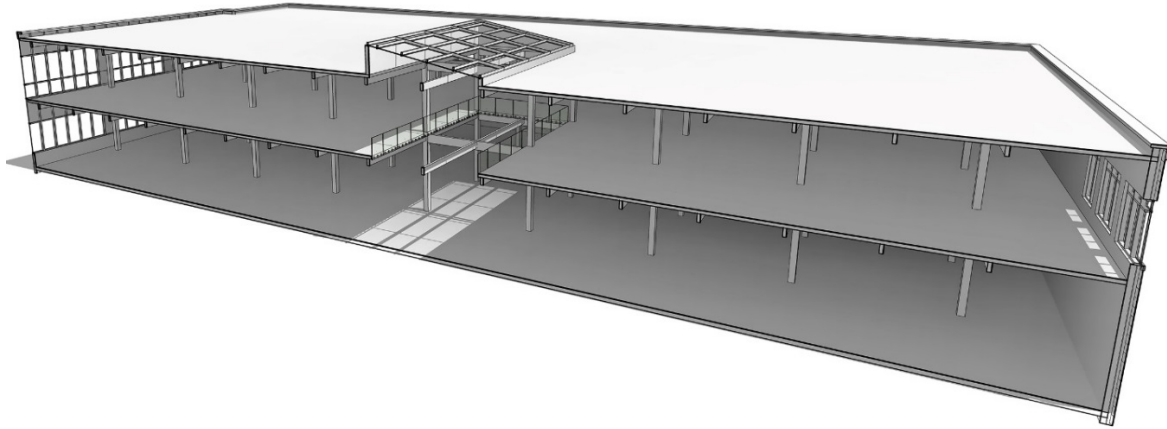
Figure 30 - Section Perspective of Skylight and Floor Opening

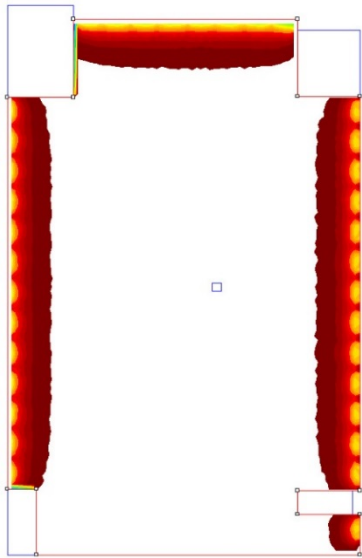
Figure 31 - Daylighting Analysis, Existing Ground FL

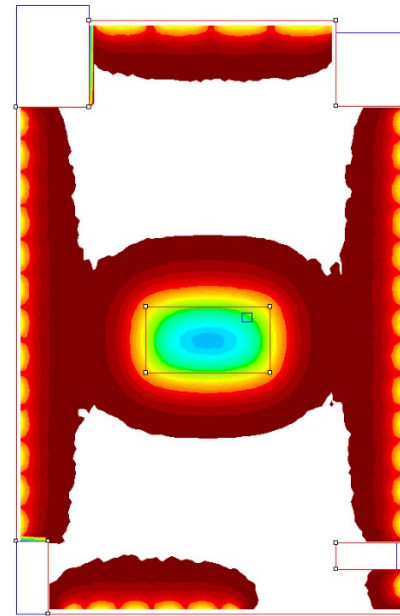
Figure 34 - Daylighting Analysis, Existing Second FL

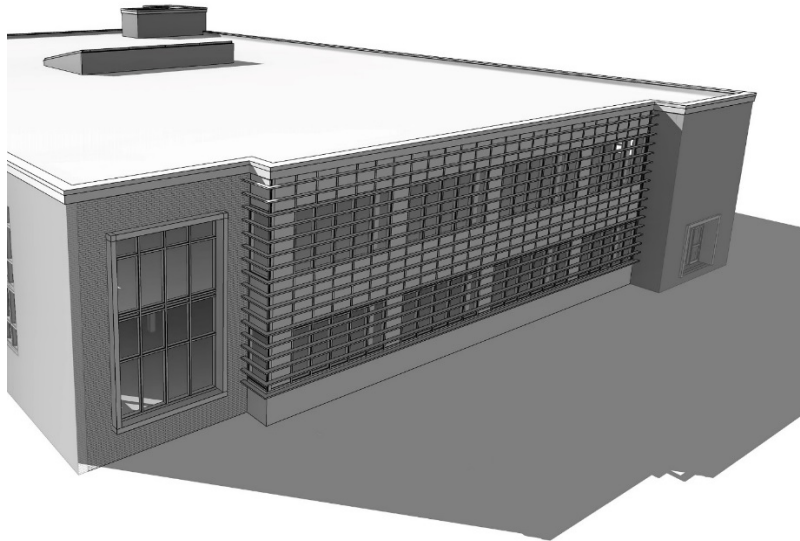
Option 3 includes demolition and reinstatement of the north façade with a modern wall system that could implement the latest standards in sustainable design and building science. This revision would appropriately communicate the investment being made in the building's extensive renovation, and in so doing establish a new public face for the building that would last for its 25 year life cycle. This refurbishment would cost approximately \$390,000, under 4% of Option 3's total cost of \$10,289,800. Refer to Section 7 *Feasibility Budget for the GoCB Windsor* and Appendix B for more
