Metchosin BC
William Head Institution

Fire Alarm Replacement

Project No. R.071314.001
May 2016

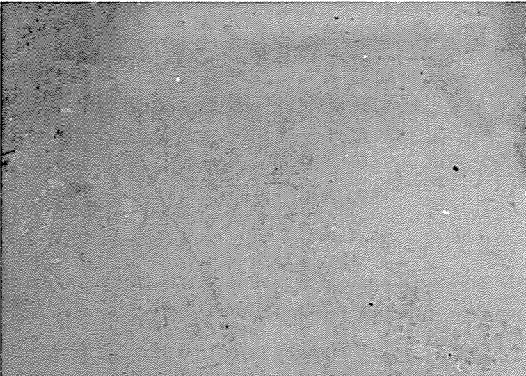
<p>Grey coloured paint on the concrete floor in room 106. This paint was observed to be generally in good condition with areas where paint is worn away (not bubbling, flaking, or peeling).</p>

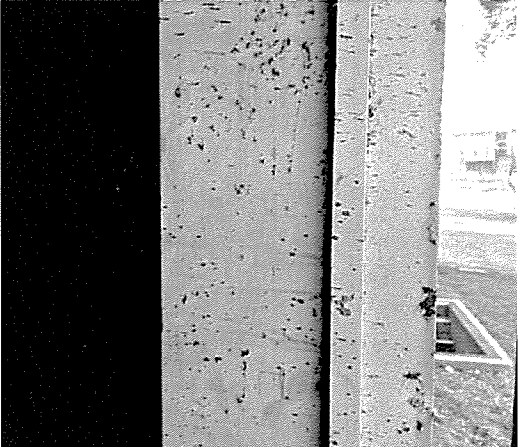
<p>Yellow coloured paint on the metal flammable storage door trim. This paint was observed to be in poor condition (bubbling, flaking, or peeling).</p>

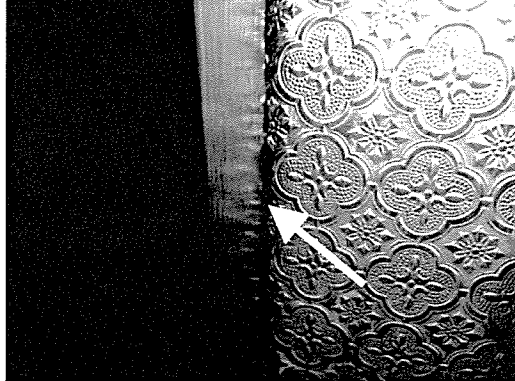
Friability	Non-friable	
Condition	Good	
Content	0.62% Chrysotile	
Black window pane caulking applied to windows throughout the subject area.

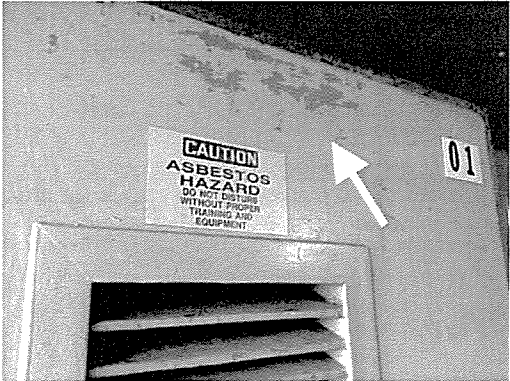
Identified LCP Description	Photo
<p>Grey coloured paint (over orange paint) on the metal door to the basement.</p> <p>This paint was observed to be generally in good condition (not bubbling, flaking, or peeling), with localized areas where paint was worn away.</p>

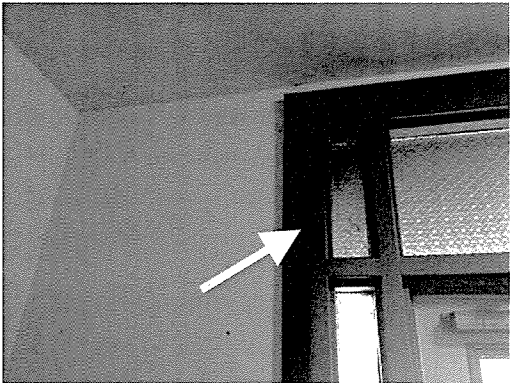
<p>Brown coloured paint on trim within the entrance (107).</p> <p>This paint was observed to be in good condition (not bubbling, flaking, or peeling).</p>

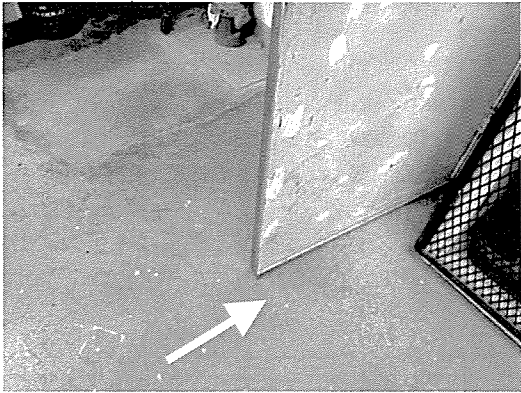
Identified LCP Description	Photo
<p>Grey coloured paint on concrete floors. This paint was observed to be in generally good condition with localized areas where paint has worn from surface (not bubbling, flaking, or peeling).</p>

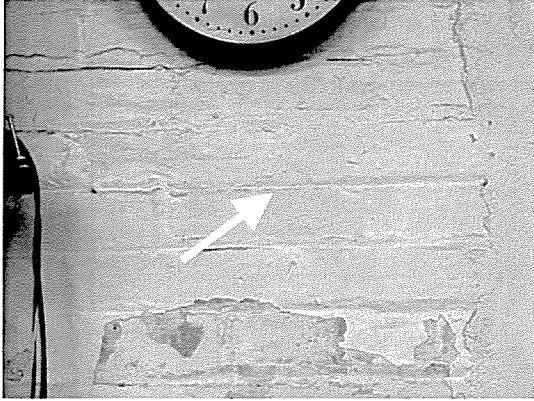
Identified LCP Description	Photo
<p>Off-white coloured paint on brick walls. This paint was observed to be in poor condition (bubbling, flaking, or peeling).</p>

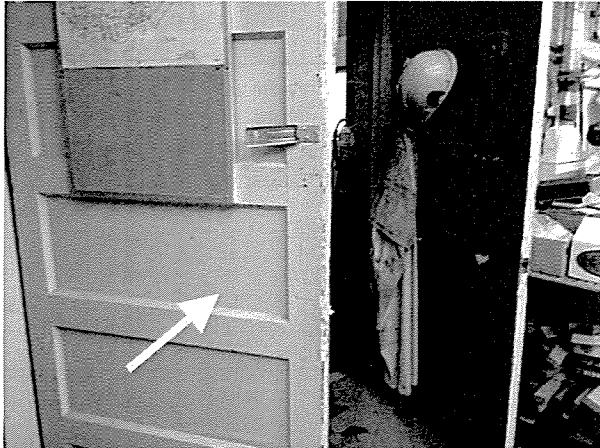
<p>Light blue coloured paint on doors and trim within room 114. This paint was observed to be in good condition (not bubbling, flaking, or peeling).</p>

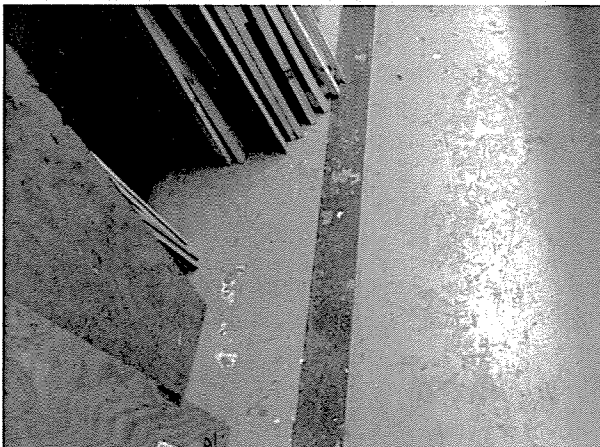
<p>Blue, red, and yellow coloured paint on the concrete floor within room 114. This paint was observed to be in generally good condition with localized areas where paint has worn from surface (not bubbling, flaking, or peeling).</p>

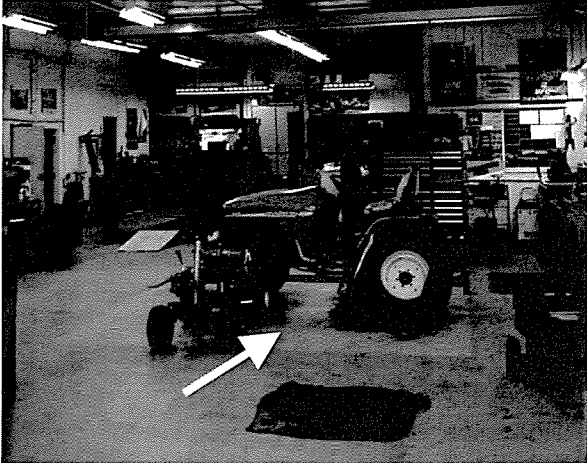
Identified LCP Description	Photo
<p>Bright yellow coloured paint on the concrete floor within room 100.</p> <p>This paint was observed to be in good condition (not bubbling, flaking, or peeling).</p>

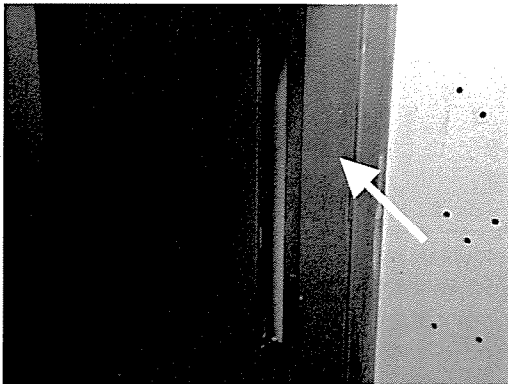
Identified LCP Description	Photo
Dark grey colored paint on doors and trim. This paint was observed to be in good condition (not bubbling, flaking, or peeling).

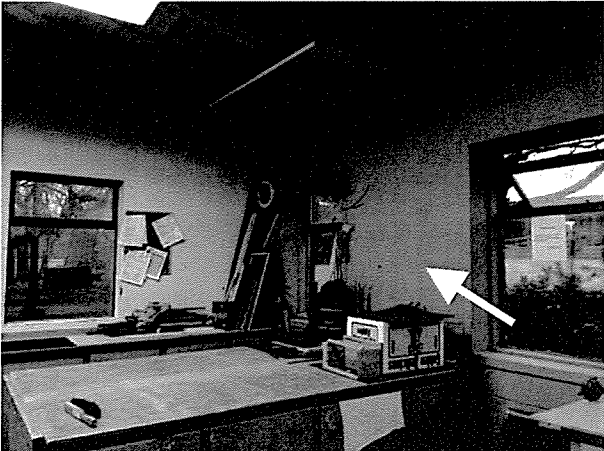
Identified LCP Description	Photo
<p>Beige coloured paint on block walls. This paint was observed to be in good condition (not bubbling, flaking, or peeling).</p>

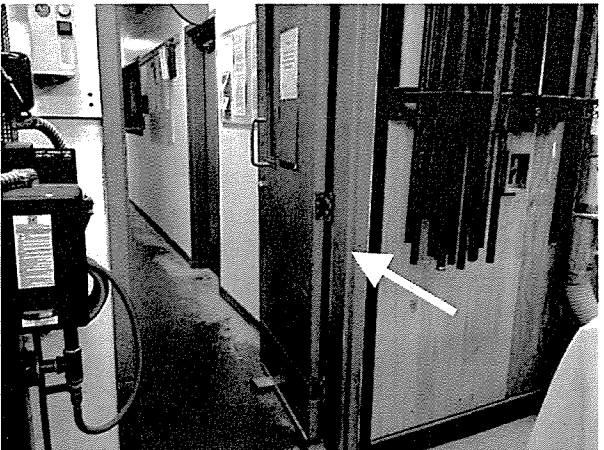
<p>Dark teal colored paint on doors and trim. This paint was observed to be in good condition (not bubbling, flaking, or peeling).</p>

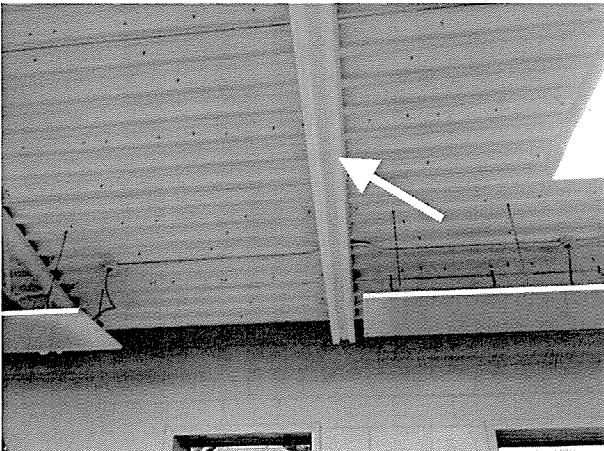
<p>Cream coloured paint (red coloured paint beneath) on steel beams. This paint was observed to be in good condition (not bubbling, flaking, or peeling).</p>

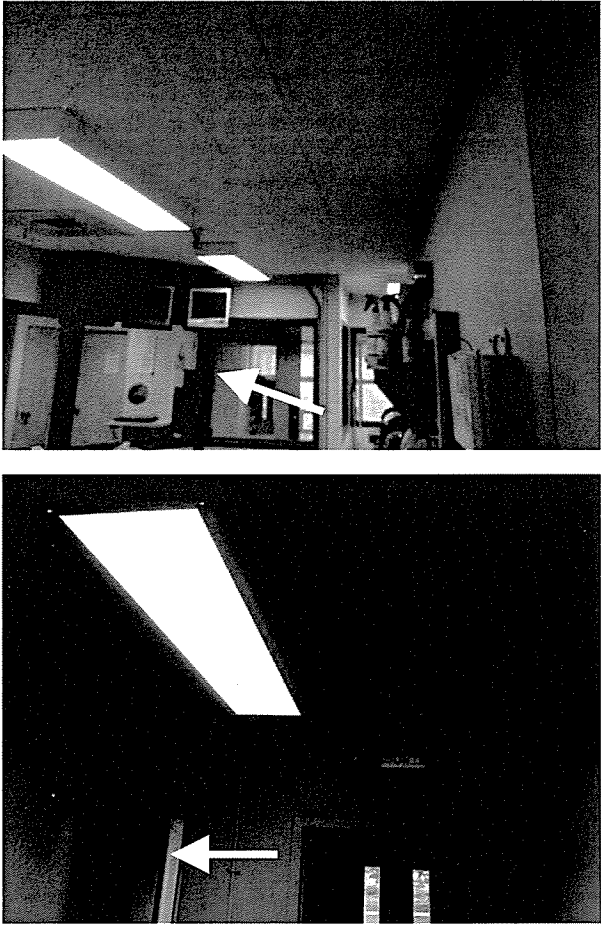
Identified ACM Description and Condition Information		Photo
Black window pane caulking on both partition and perimeter windows throughout.

Friability	Non-friable	
Condition	Good	
Content	1.4% Chrysotile

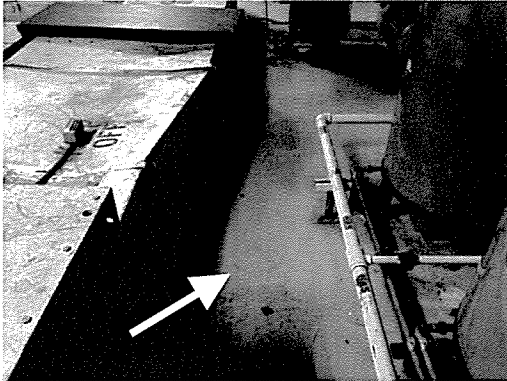
Identified LCP Description	Photo
<p>Grey colored paint on the concrete floor of the mechanical room (300).</p> <p>This paint was observed to be in generally good condition with localized areas where paint is worn from the surface (not bubbling, flaking, or peeling).</p>

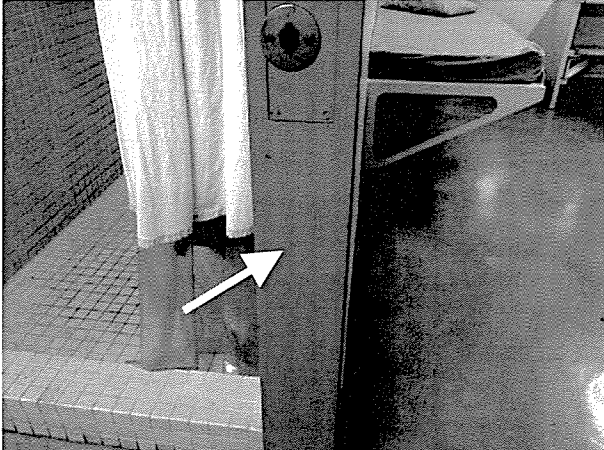
<p>Orange colored paint on metal trim.</p> <p>This paint was observed to be in good condition (bubbling, flaking, or peeling).</p>

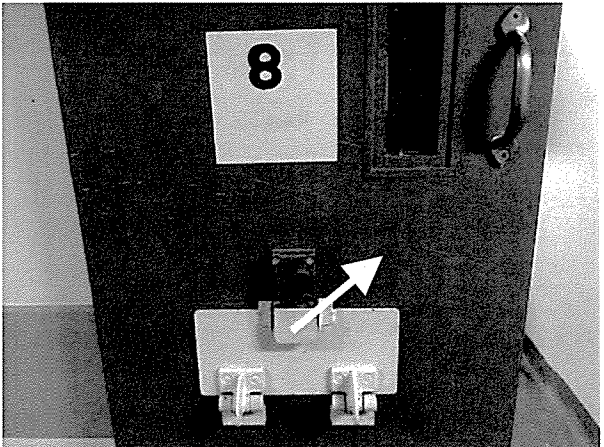
<p>Red colored paint on doors.</p> <p>This paint was observed to be in good condition (bubbling, flaking, or peeling).</p>

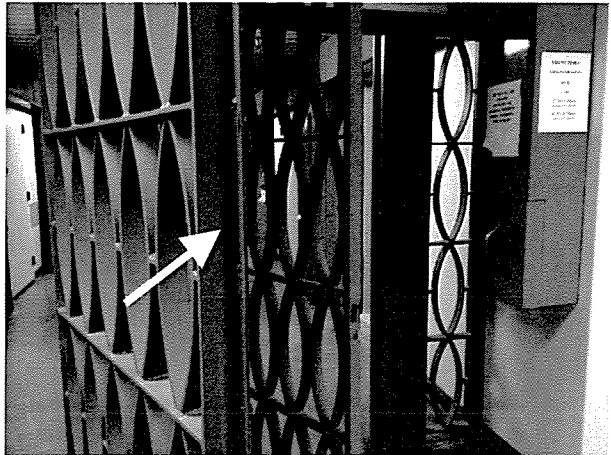
Identified LCP Description	Photo
Dusty rose colored paint on metal doors. This paint was observed to be in good condition (not bubbling, flaking, or peeling).

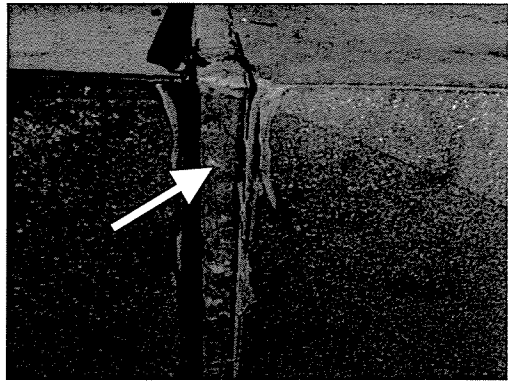
Identified ACM Description and Condition Information		Photo
Olive green mastic on duct seams throughout.

Friability	Non-friable	
Condition	Good	
Content	1.4% Chrysotile

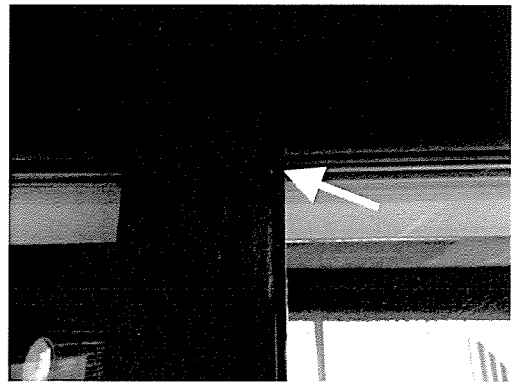
Identified ACM Description and Condition Information		Photo
Black window pane caulking on partition windows throughout.

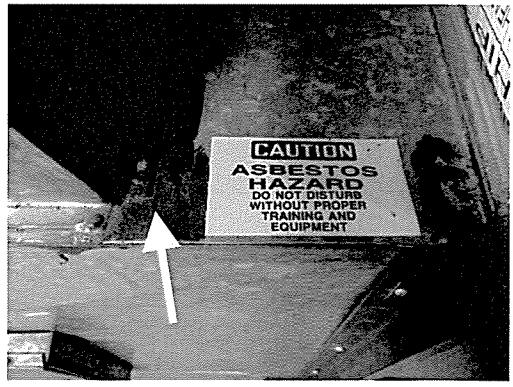
Friability	Non-friable	
Condition	Good	
Content	8.4% Chrysotile	
Brown duct mastic throughout.

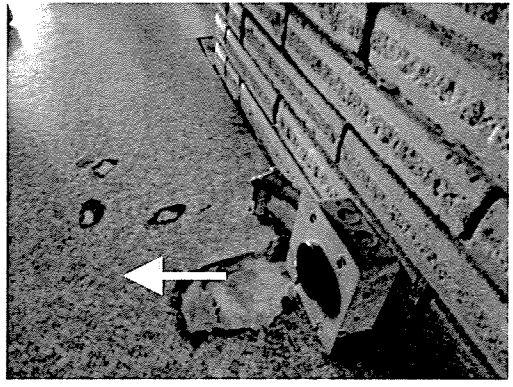
Friability	Non-friable	
Condition	Good	
Content	1-10% Chrysotile Note that this material was sampled during this assessment and results indicated no asbestos detected. Previous sampling results indicate 1-10% Chrysotile, therefore this material should still be considered asbestos-containing.	
Beige/brown/white multi-sized cube pattern vinyl sheet flooring present in room 119 and 115.

Friability	Non-friable	
Condition	Good – In general Poor – Behind the bar in room 119	
Content	1-10% Chrysotile Note that this material was sampled during this assessment and results indicated no asbestos detected. Previous sampling results indicate 1-10% Chrysotile, therefore this material should still be considered asbestos-containing.

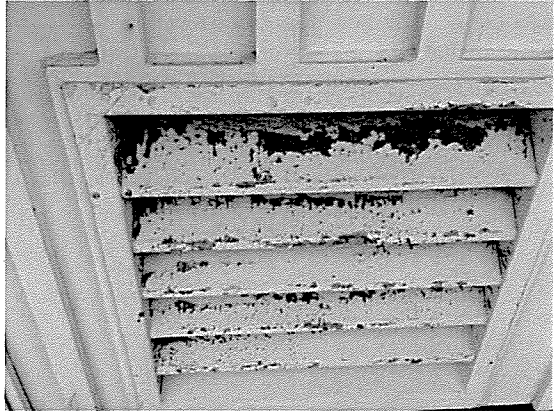
Identified LCP Description	Photo
<p>White colored paint on the exterior of the attic. This paint was observed to be in poor condition (bubbling, flaking, or peeling).</p>

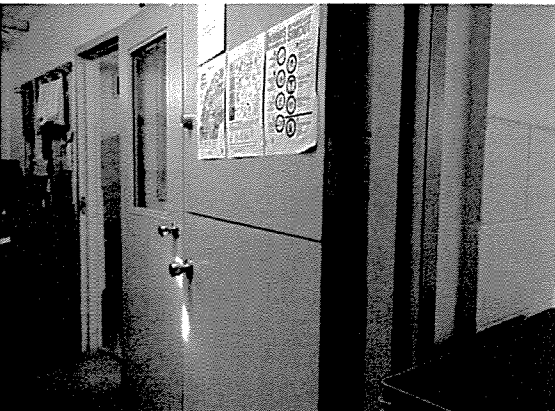
<p>Teal colored paint on the interior doors and trim. This paint was observed to be in good condition (not bubbling, flaking, or peeling).</p>

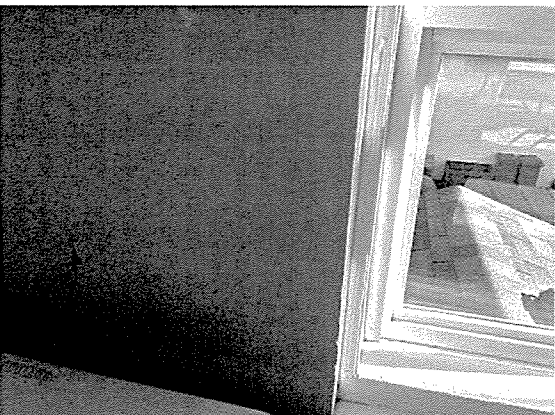
<p>Light grey colored paint on walls in room 114. This paint was observed to be in good condition (not bubbling, flaking, or peeling).</p>

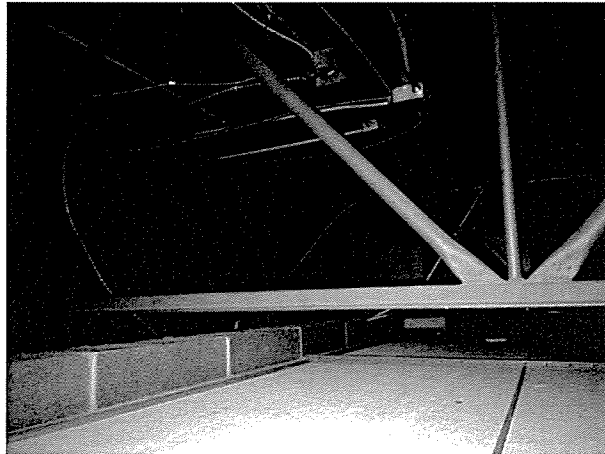
Identified LCP Description	Photo
<p>Red colored paint on steel beams within the ceiling spaces.</p> <p>This paint was observed to be in good condition (not bubbling, flaking, or peeling).</p>

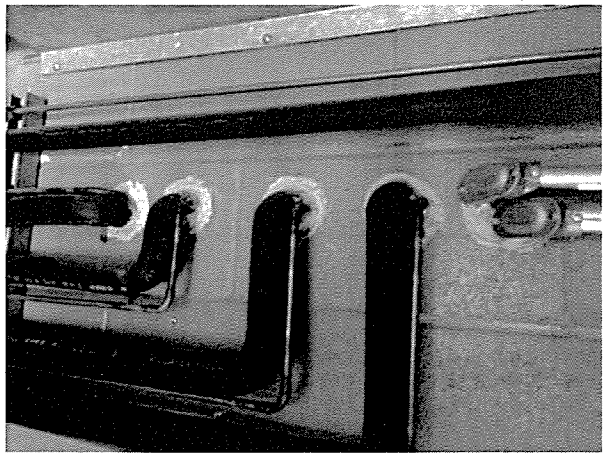
<p>Orange colored paint on the block walls within room 100.</p> <p>This paint was observed to be in good condition (not bubbling, flaking, or peeling).</p>

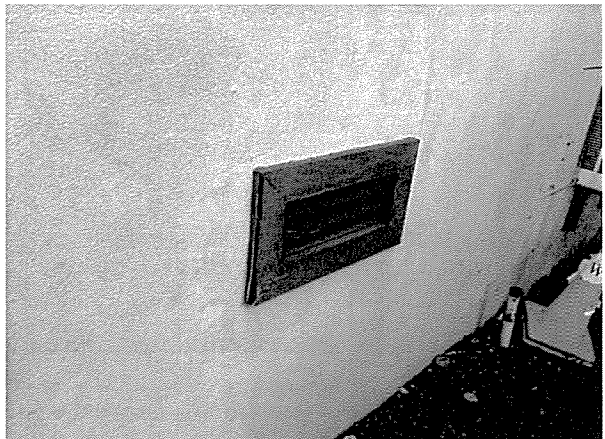
<p>Burgundy coloured paint on exterior vent covers.</p> <p>This paint was observed to be in poor condition (bubbling, flaking, or peeling).</p>

Lead-containing paint observed in poor condition should be cleaned-up and/or addressed during the renovation project, and to mitigate potential for additional deterioration and dispersal of lead-containing paint chips/dust. Consideration should be given to re-painting surfaces to mitigate the potential for additional deterioration and hazards associated with the lead-containing paint chips/dust that may be created. If re-painting is completed, appropriate precautions to protect workers and work areas from exposure to lead will be required during painting preparation activities.

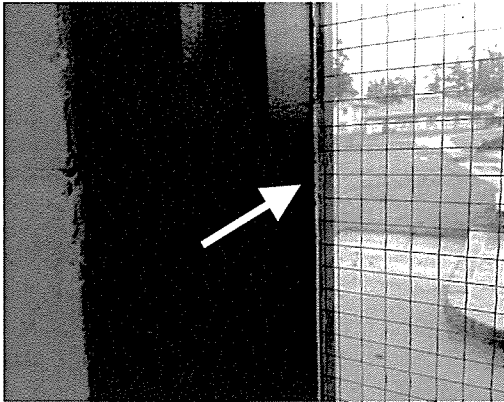
Identified ACM Description and Condition Information		Photo
Black window pane caulking throughout.

Friability	Non-friable	
Condition	Good	
Content	3.9% Chrysotile

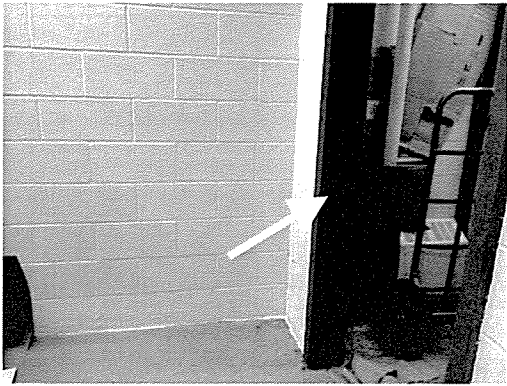
Identified LCP Description	Photo
Brown coloured paint on trim throughout. This paint was observed to be in good condition (not bubbling, flaking, or peeling).

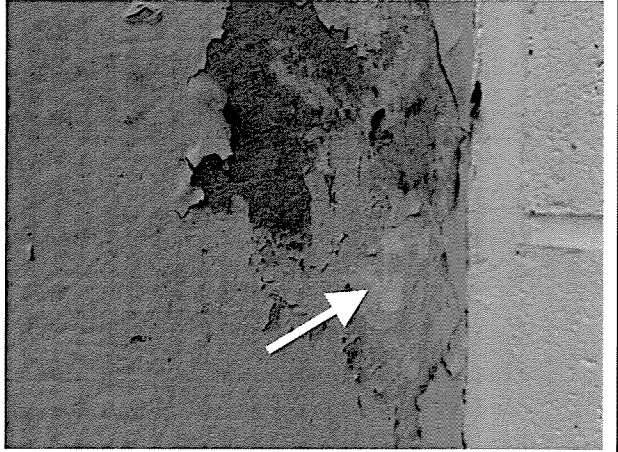
Identified ACM Description and Condition Information		Photo
Skim coat applied to concrete columns in Room 105.

Friability	Non-friable	
Condition	Good (overlying paint beginning to peel/flake in locations)	
Content	2.0% Chrysotile

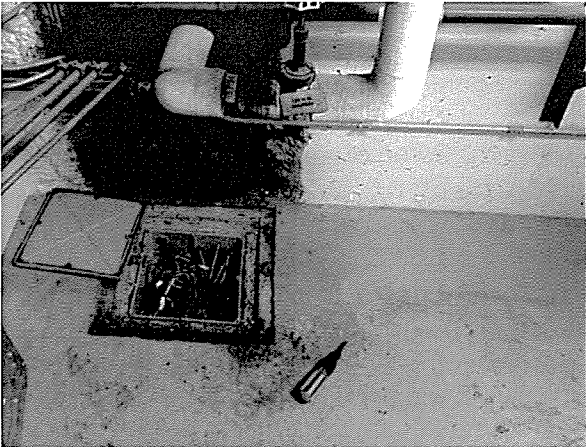
Identified LCP Description	Photo
<p>Grey colored paint on the concrete floor of the mechanical room (potential LCP – additional sampling may indicate otherwise). This paint was observed to be in poor condition (bubbling, flaking, or peeling).</p>

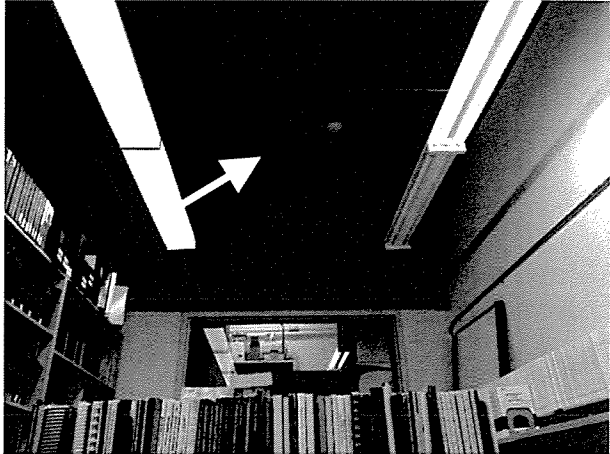
Identified LCP Description	Photo
<p>Black colored paint on the ceiling. This paint was observed to be in good condition (not bubbling, flaking, or peeling).</p>

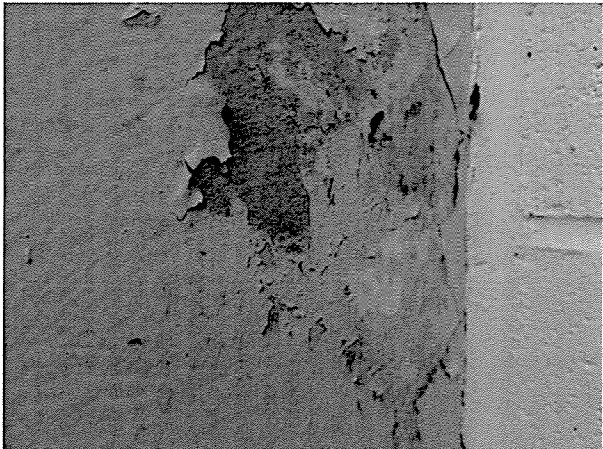
<p>Cream/yellow colored paint on the walls. This paint was observed to be in poor condition (bubbling, flaking, or peeling).</p>

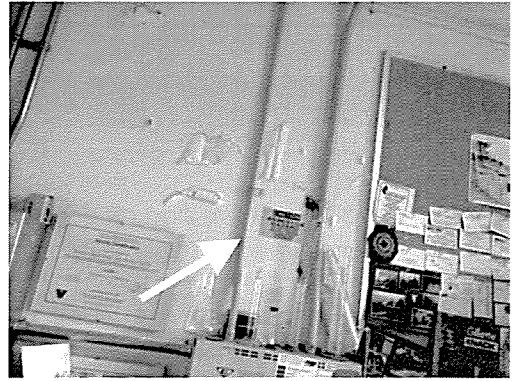
Identified ACM Description and Condition Information		Photo
Plaster walls and ceilings throughout.

Friability	Non-friable	
Condition	Good	
Content	<p><1.0% Chrysotile</p> <p>Note that this material was sampled during this assessment and results indicated no asbestos detected. Previous sampling results indicate that the texture coat applied to the plaster walls contains <1.0% chrysotile asbestos, therefore this material should still be considered asbestos-containing.</p>
