Project No.: 219.05112
Client Reference No.: DFRP # 16096, ARMS # 00394, FCSI # 16096079

**RE: CONCEPTUAL APPROACH -PROPOSED REMEDIATION PROGRAM
UPLANDS TRAIL AREA, HISTORIC DUMP SITE, WILMER MARSH UNIT
COLUMBIA NATIONAL WILDLIFE AREA, NEAR WILMER, BC**

This report presents the findings of a subsurface investigation, an excavation feasibility assessment, a slope stability assessment, and recommendations for the historic dump site located within the Wilmer Marsh Unit of the Columbia National Wildlife Refuge in Wilmer, BC.

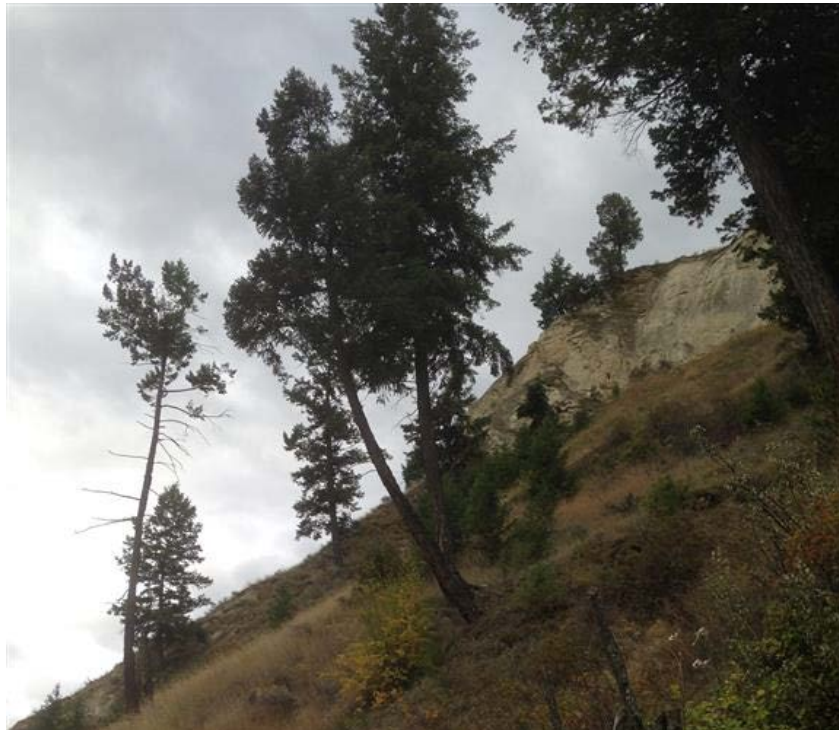
Photo 1: View of natural analogs next to marsh north of the site.

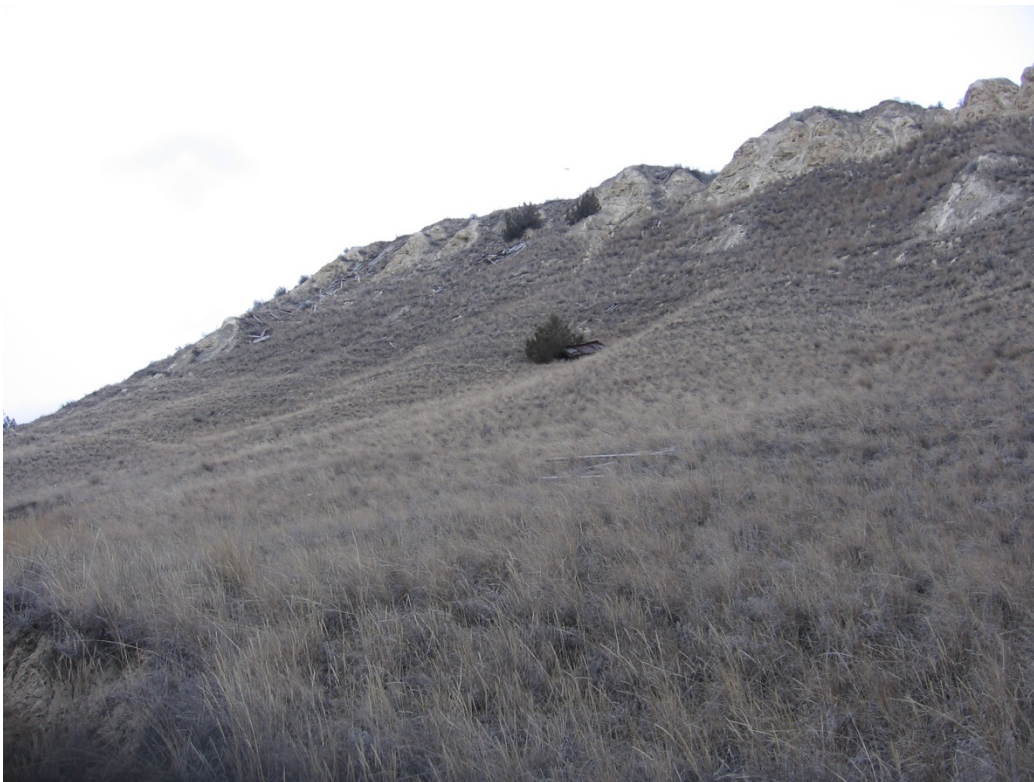
Photo 2: View of natural analog to southeast of proposed work area.

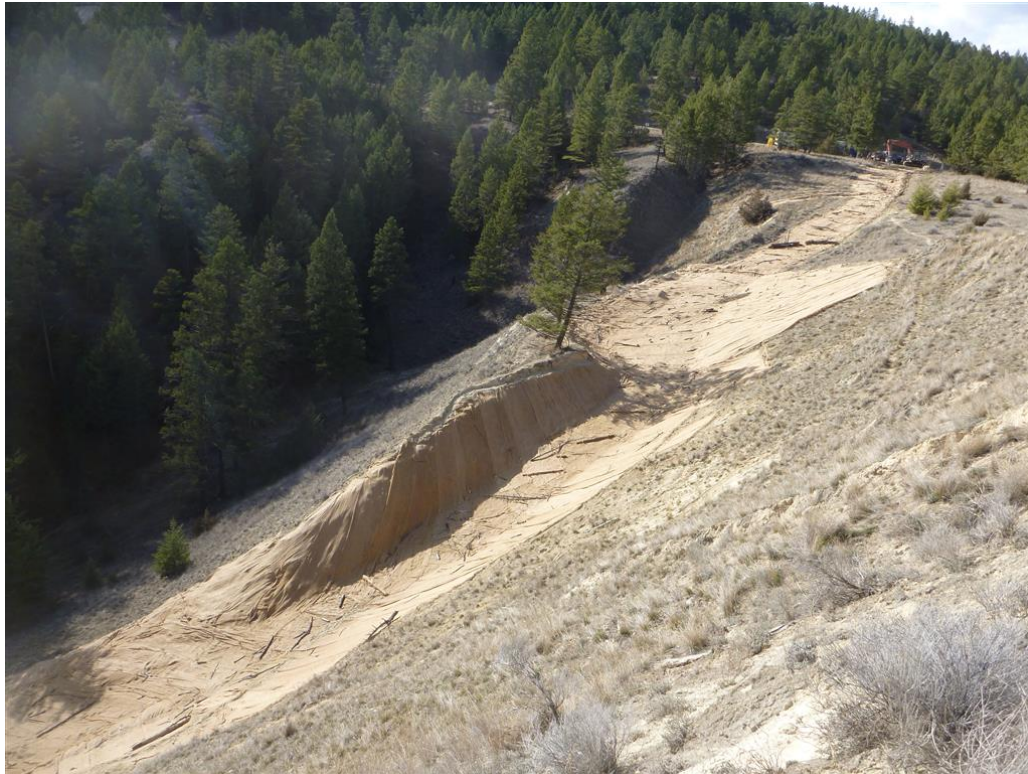
Photo 3: View of extensive erosion control blanket installation in March 2015.

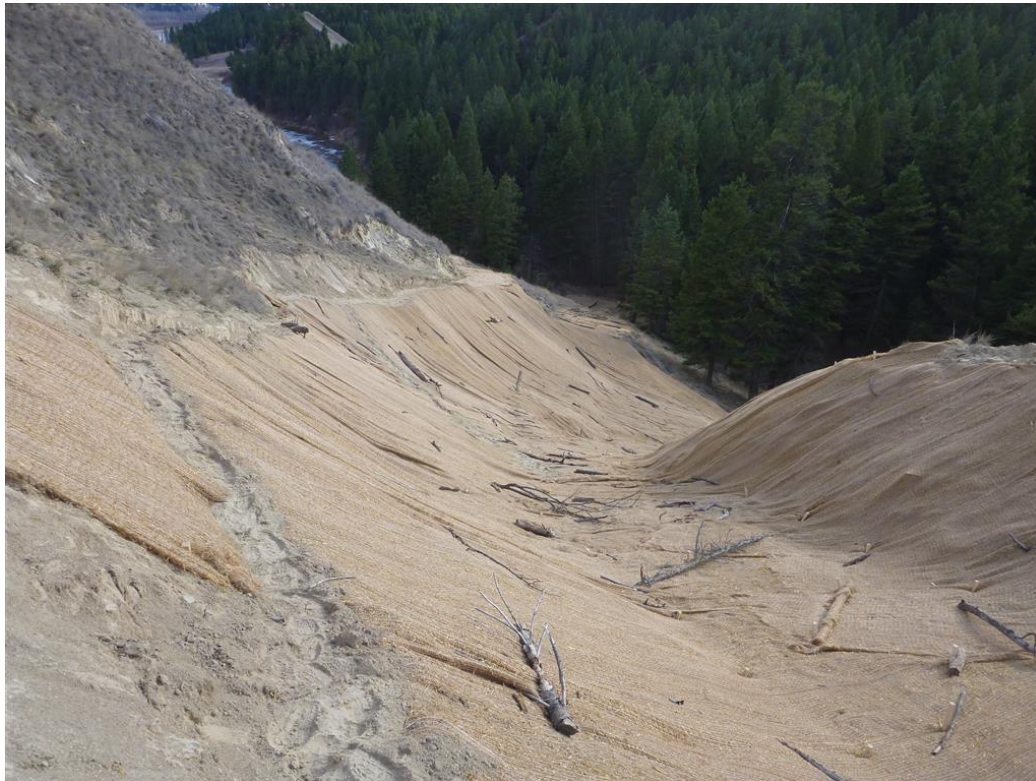
There may also be the opportunity to incorporate the construction of narrow terraces for wildlife movement within the above options. Following the previous remediation activities, narrow terraces were created in select locations to facilitate installation of the erosion control blanket and to serve as access trails for wildlife. Subsequent site visits by SLR's Environmental Monitor confirmed the use of these terraces/trails by wildlife (e.g. deer). It is noted that the construction of these features may or may not be achievable based on observed site conditions at the time of construction.

Photo 4: View of narrow wildlife path within blanketed areas in March 2015.

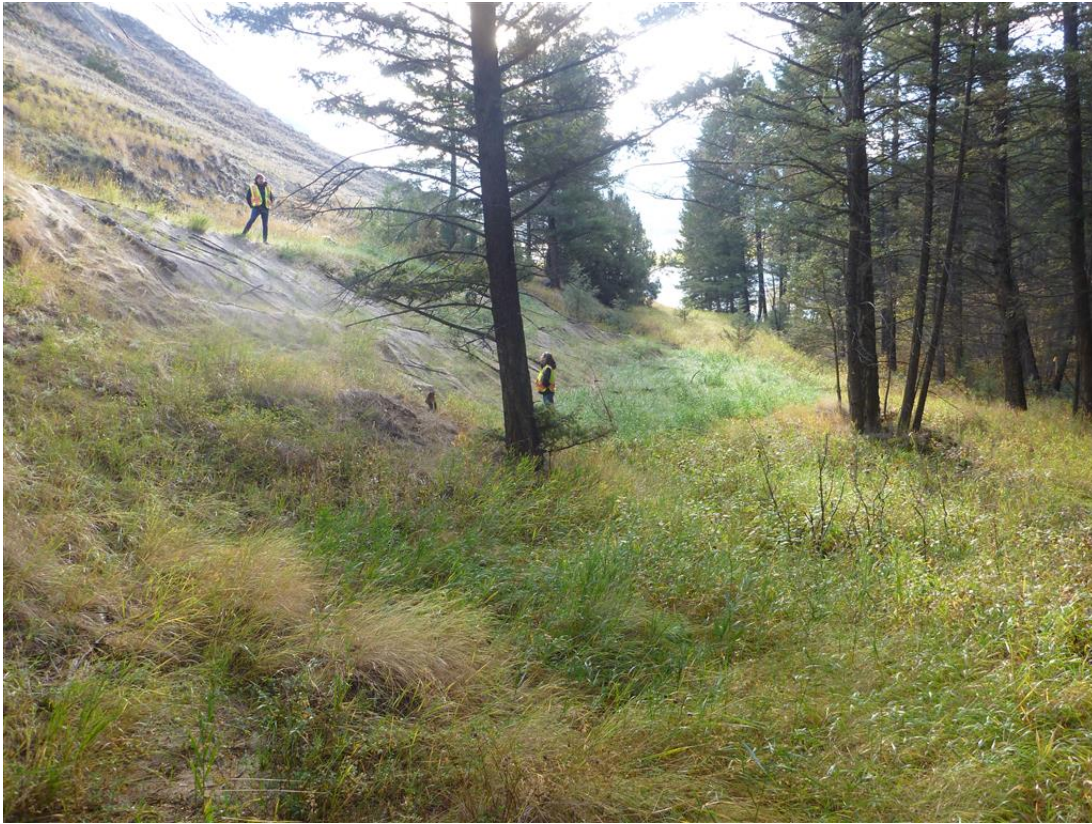
Photo 5: View of gully below remediation work area looking toward marsh.

Finally, the installation of erosion and sediment control measures within the gully at the base of the slope (installation of waddles, construction of cross ditches) is recommended to mitigate overland flow of sediments into the marsh. It is noted that these are conservative precautions given that the distance from the base of the slope where work will be occurring and the marsh is 200 m and the gully is relatively flat-lying and well vegetated. A photo of the gully between the work area and the marsh has been included for reference.

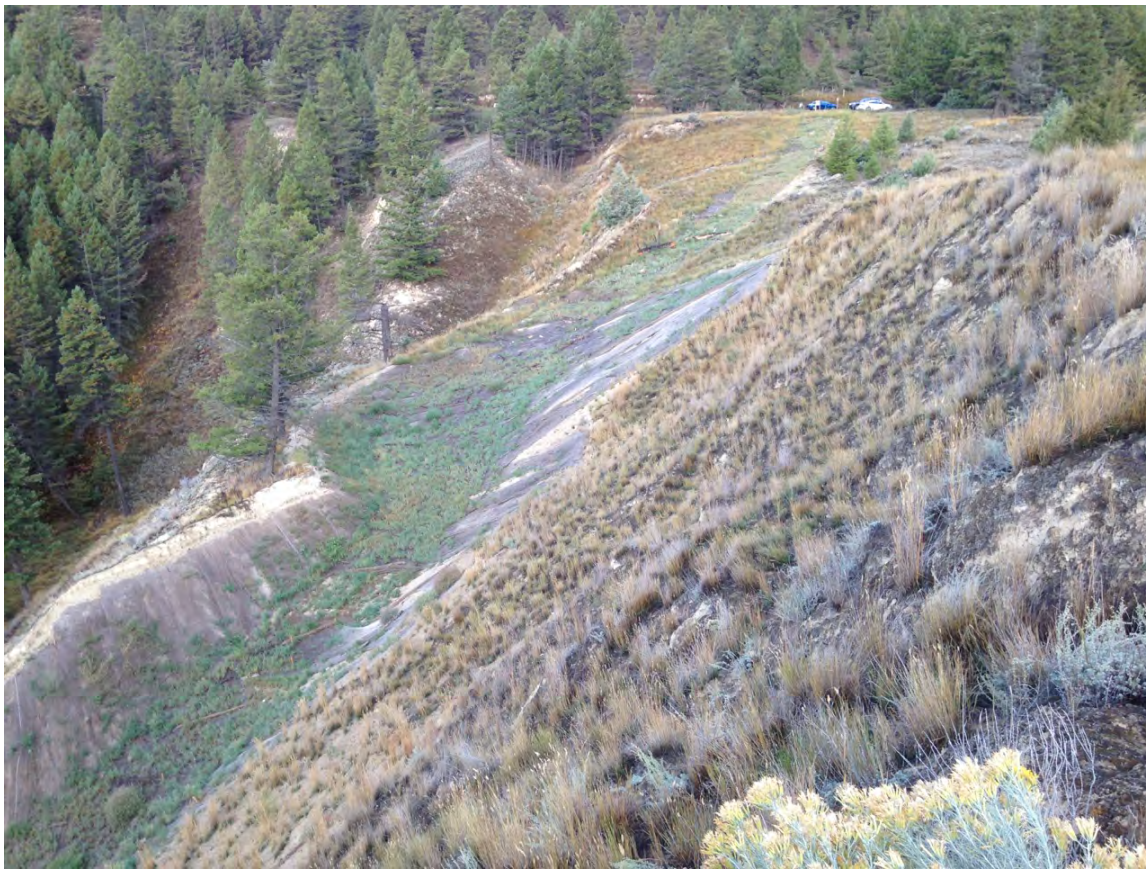
- Based on observed slope instability (tension cracks in north wall of excavation) there is a concern that additional excavation will destabilize the slope;
- To access buried debris along, and at the toe of, the north slope the excavation would likely entail working from the top-down in benches. To access material at the toe, the benches would extend into the top of the slope, resulting in a partial loss of the upper plateau. Detailed excavation planning will be required to ensure site safety and long-term geotechnical stability;

Photo 1: View of Main Debris Zone to the west from the top of the slope (Sept. 21, 2015)

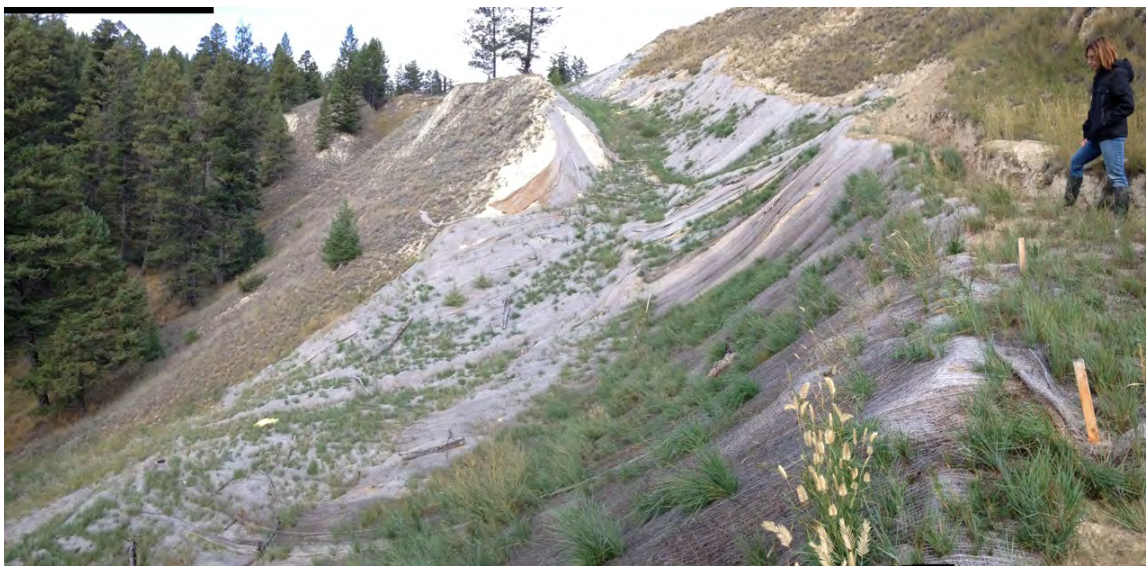
- It was observed that several panels of erosion control fabric were wind blown, exposing small areas of bare soil. Additional staking on the affected panels, and on panels that appear vulnerable to wind exposure, is recommended to provide additional support; and,

Photo 2: View of the Main Debris Zone to the west from the bottom of the slope. Note panels of fabric on the south side of the slope that have been wind blown (Sept. 21, 2015)
