DESIGNATED SUBSTANCES SURVEY

**Duplex Residence Structure
66 & 68 Alder Drive
Inuvik, Northwest Territories**

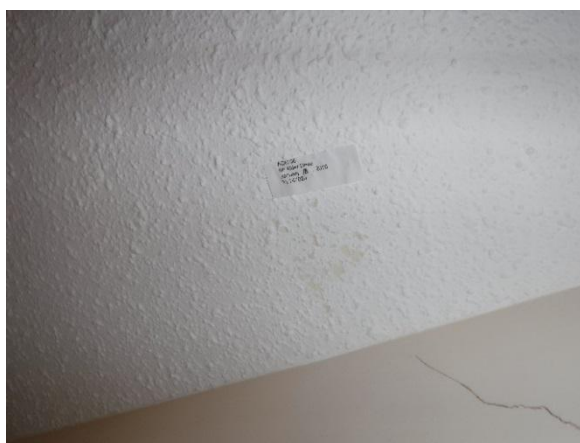
Photo 12: Sample ACM-06 – 66 Alder; Texture finish (stipple) on ceiling in kitchen. No asbestos fibres observed.

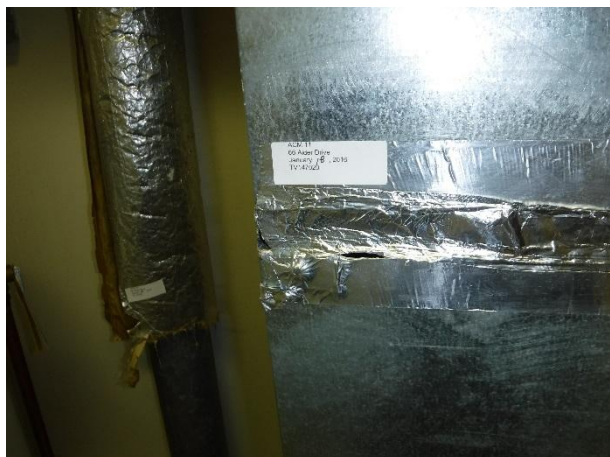
Photo 13: Samples ACM-10 and ACM-11 – 66 Alder; pipe insulation and duct tape, respectively, associated with the furnace. No asbestos fibres detected.

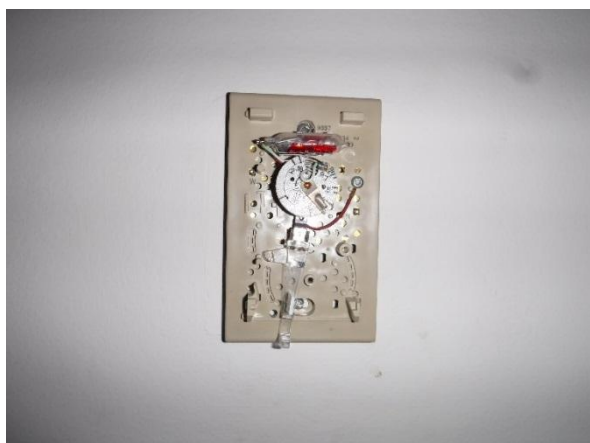
Photo 21: View of mercury containing thermostat observed in the living room of 68 Alder Drive.

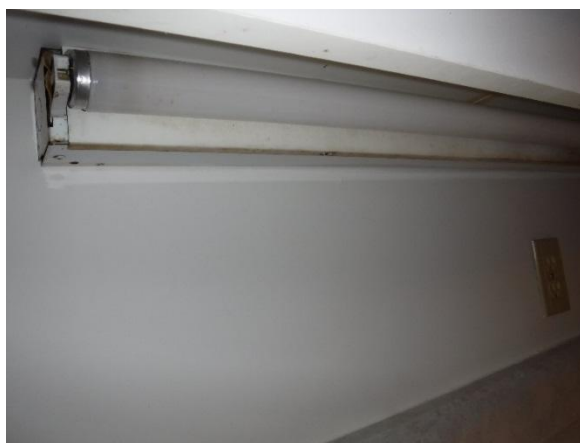
Photo 22: View of typical fluorescent light fixture located beneath kitchen cabinets, note the mercury containing light tube.

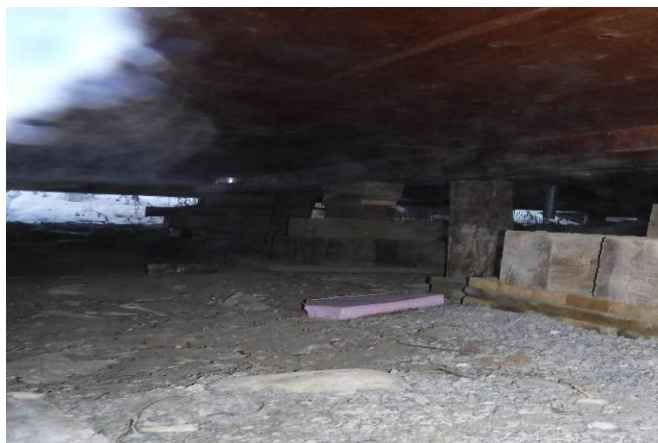
Photo 24: View of the crawlspace and foundation beneath the building.

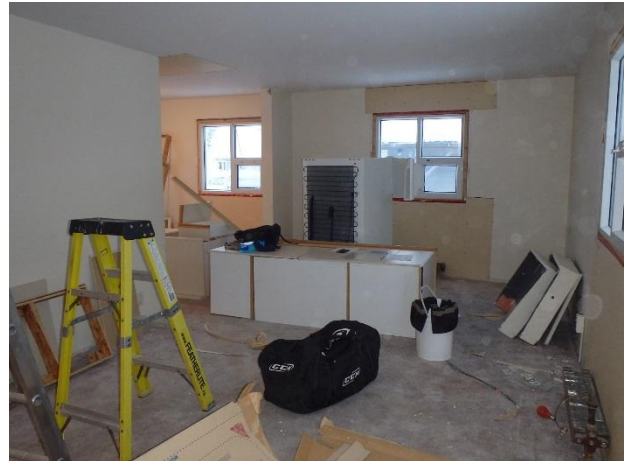
Photo 2: Living room, showing general state of building and repairs.

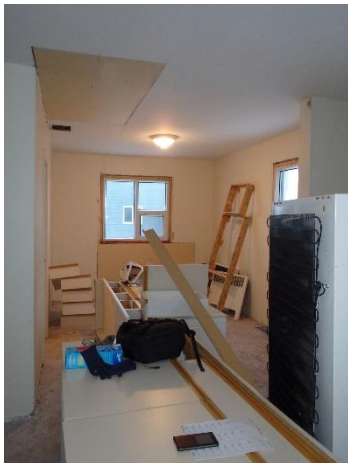
Photo 3: Dining room, wall and ceiling repairs visible.

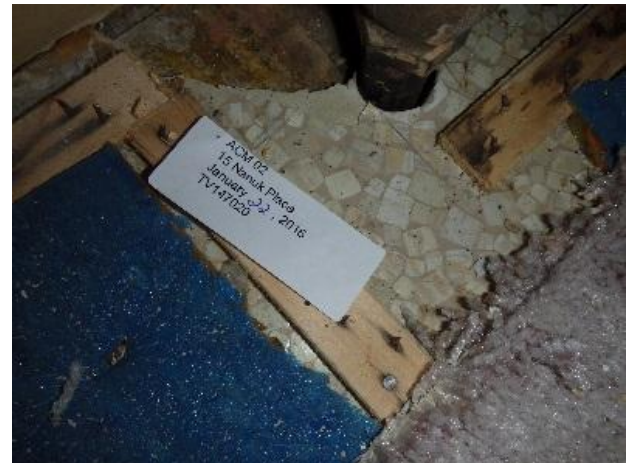
Photo 4: Sample ACM-02, vinyl roll flooring (VRF), dining room (and lower level landing) was determined to **contain 20% Chrysotile asbestos fibres.**

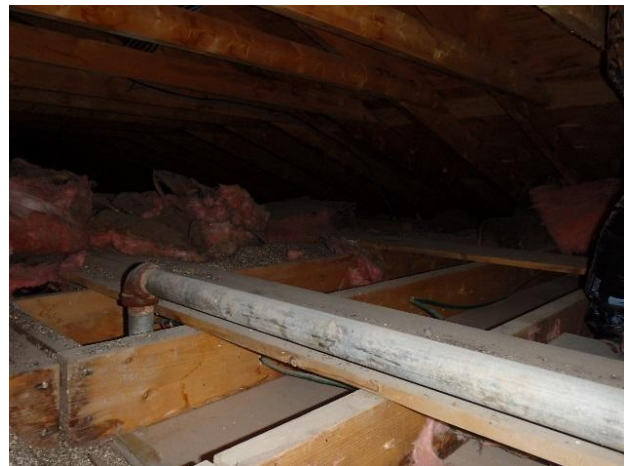
Photo 12: Vermiculite was observed to have been placed above (with traces below) pink fibreglass insulation.

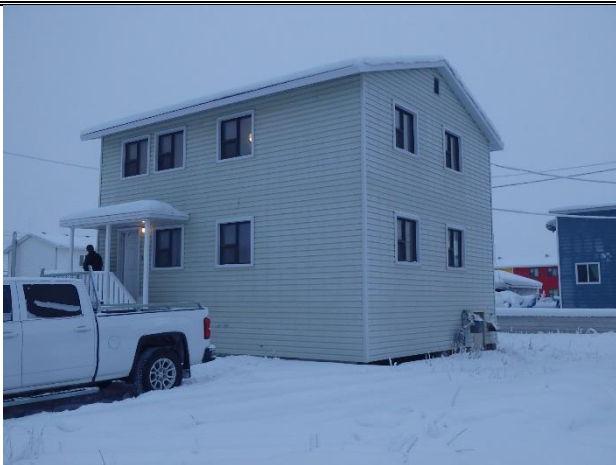
Photo 13: Sample PB02 - collected from the decking on the front deck, was determined to contain **38,900 mg/kg lead**.

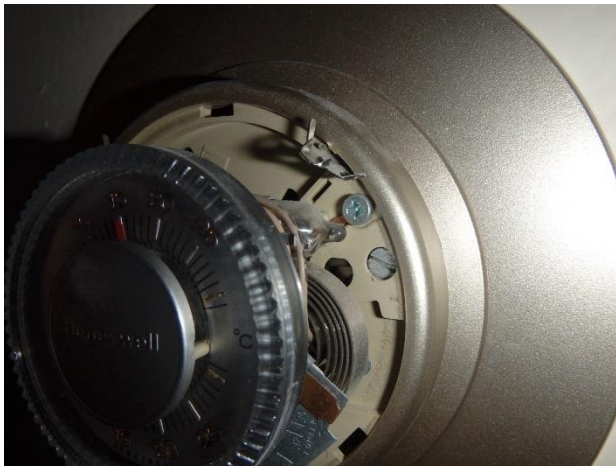
Photo 15: Mercury-containing thermostat observed on lower level.

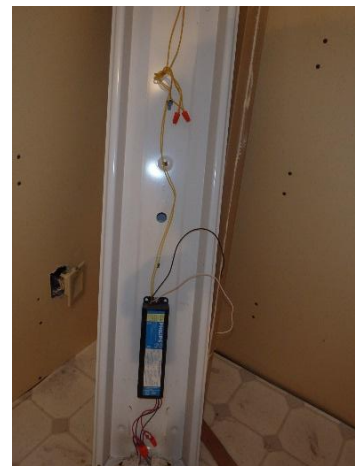
Photo 16: Ballast labelled "No PCBs" observed in fixture on floor in kitchen.

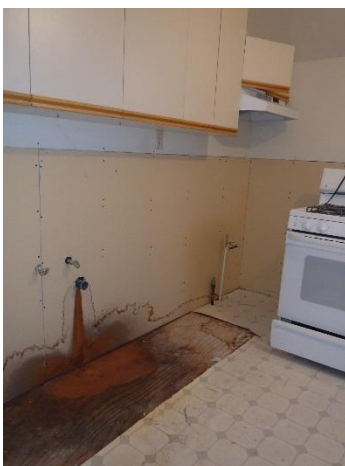
Photo 17: Water damage and SVG observed in kitchen.

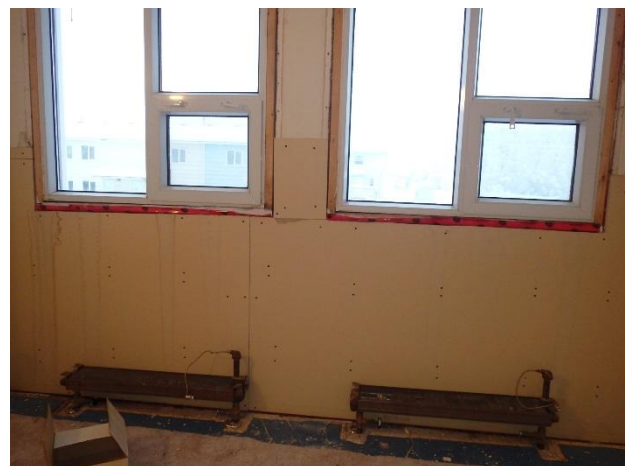
Photo 18: Water damage observed below bedroom windows on repaired sections of gypsum board.

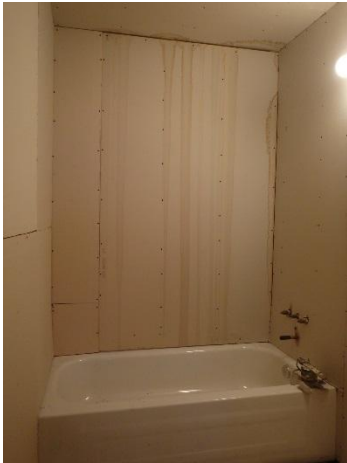
Photo 19: Water damage observed on walls and ceiling surrounding tub in bathroom.

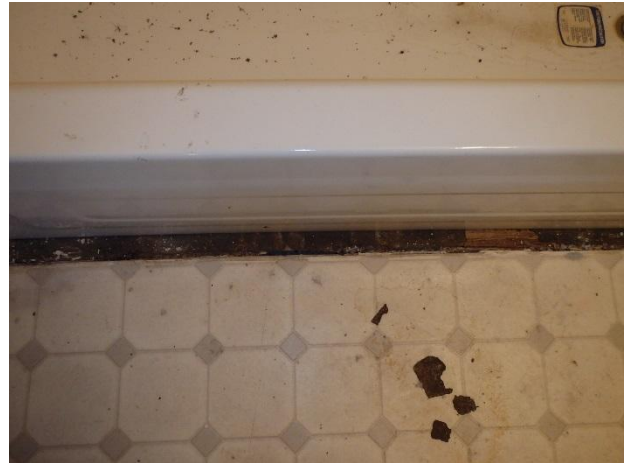
Photo 20: Water intrusion observed on sub-floor along tub in bathroom.

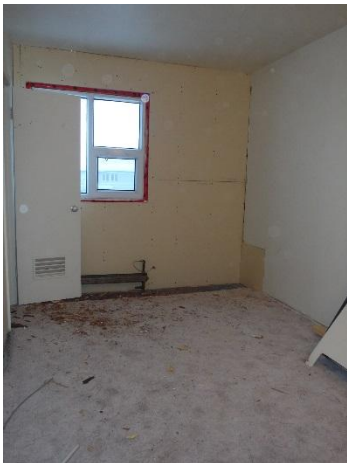
Photo 21: Gypsum board replaced in several areas, including areas around windows.

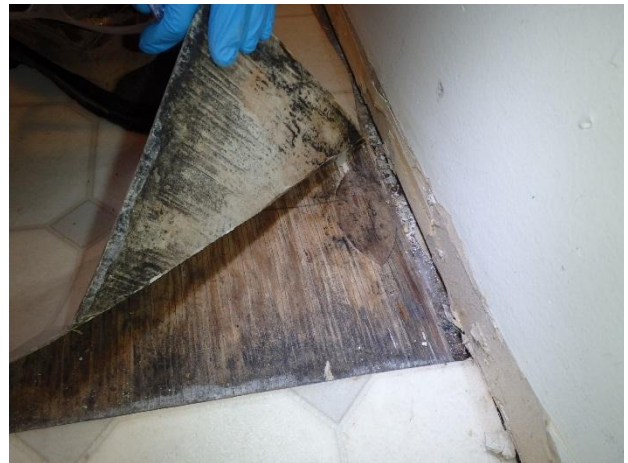
Photo 22: SVG observed on underside of flooring in side entrance.

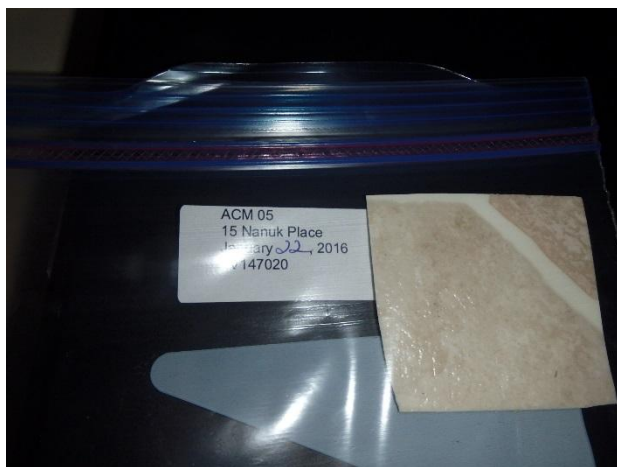
Photo 23: ACM-05, VRF, laundry room. No asbestos fibres detected.

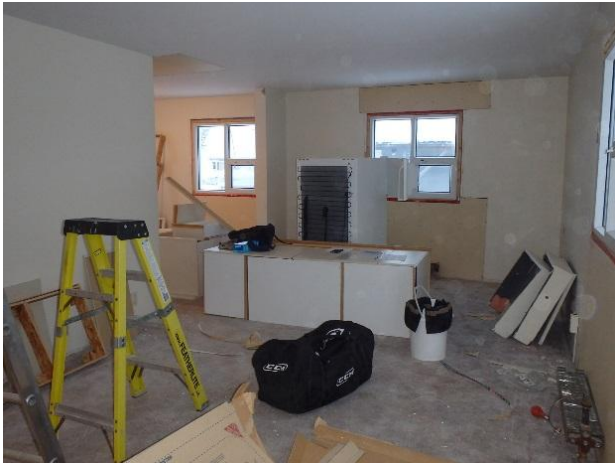
Photo 25: One refrigerator observed on Site suspected to contain ODS.

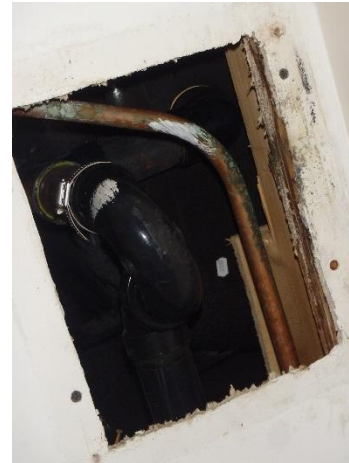
Photo 26: View of indoor piping included both PVC and copper.

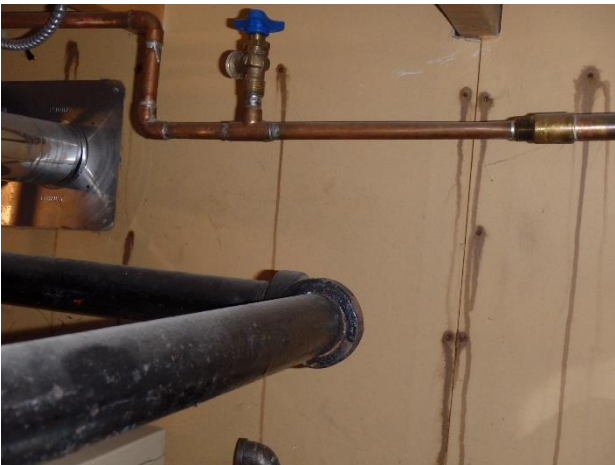
Photo 27: Cast iron piping observed in crawl space.

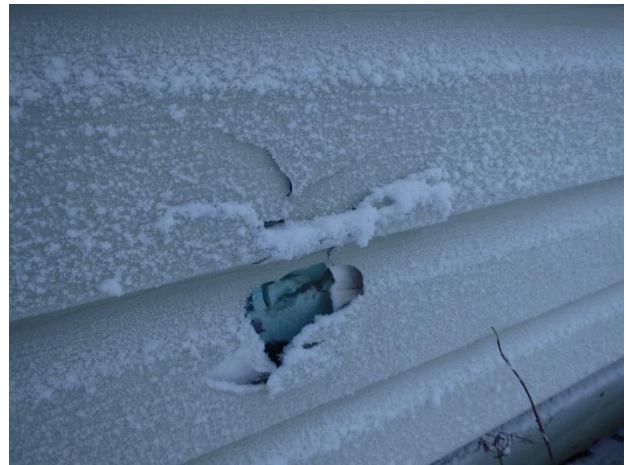
Photo 28: Damaged exterior siding, paper wrap house wrap Sample ACM-19, no asbestos fibres detected.

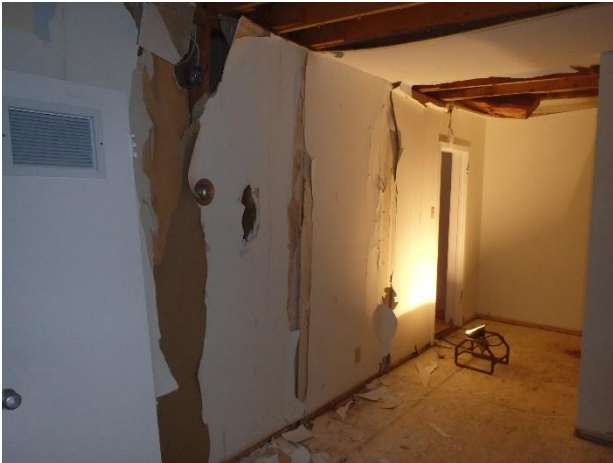
Photo 7: View of living room/dining room wall and ceiling. Site has had no heat and minimal electrical supply since water damage event in 2010.

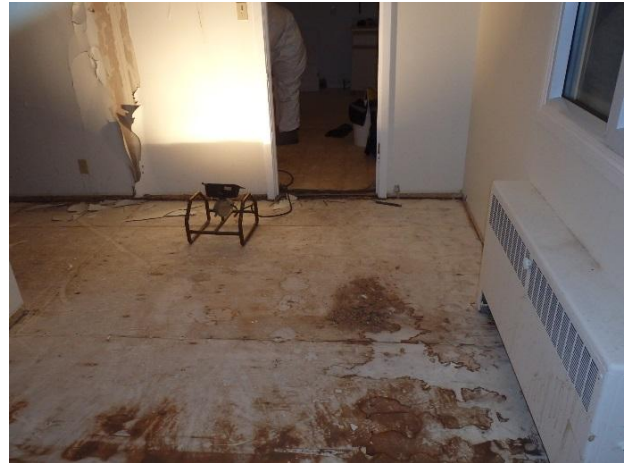
Photo 8: Most floors in building were observed to be have been stripped to the subfloor.

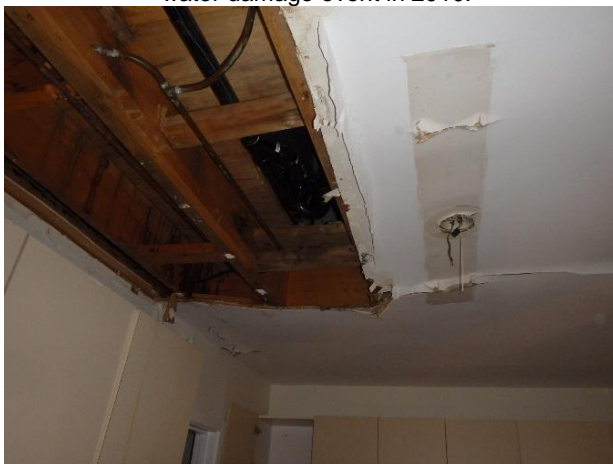
Photo 9: View of kitchen ceiling. Water damage in the building was a result of a leaking toilet on the second level.

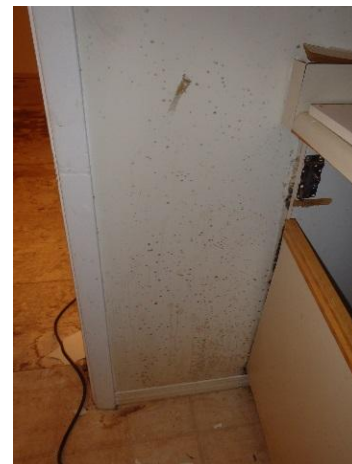
Photo 10: View of surface visible growth (SVG) adjacent to kitchen cabinetry.

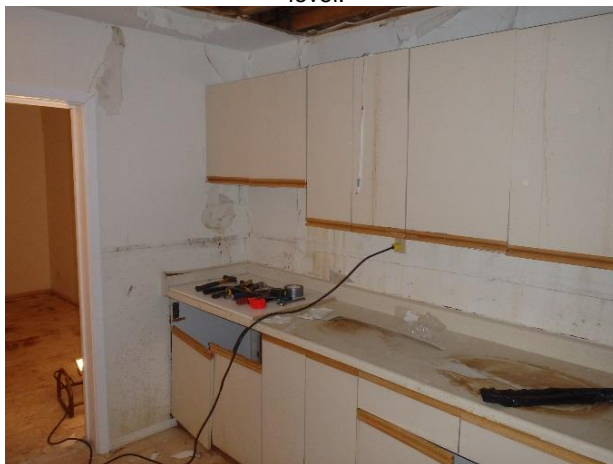
Photo 11: Water staining and SVG observed to extend throughout kitchen.

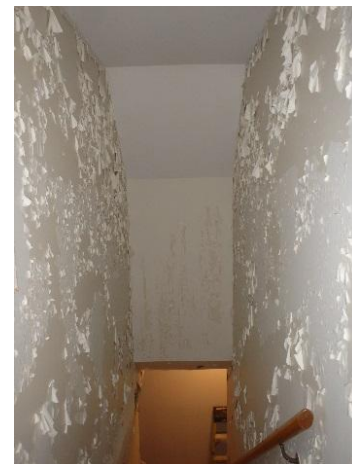
Photo 12: View of staircase walls showing extensive paint damage.

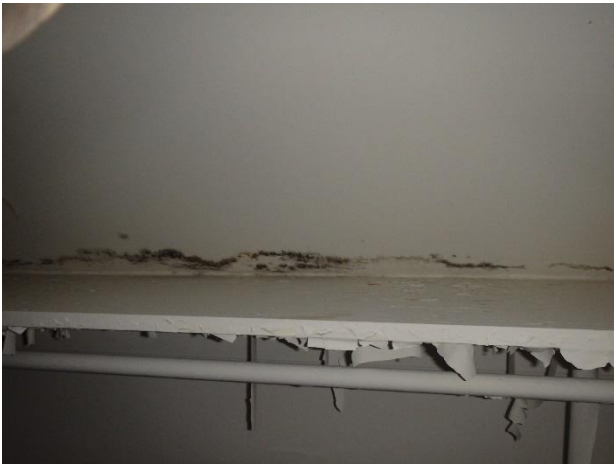
Photo 13: SVG observed in the master bedroom closet.

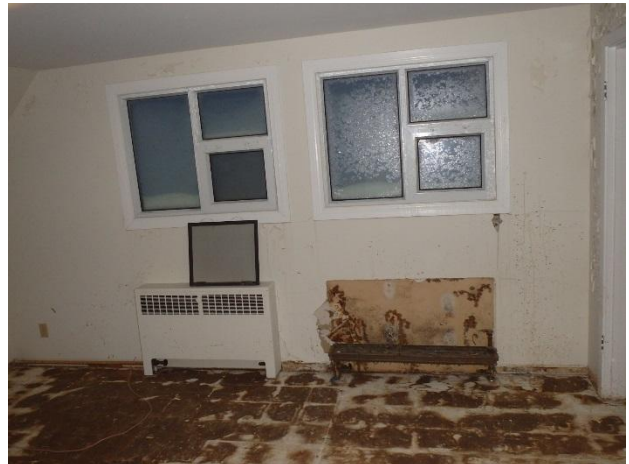
Photo 14: SVG and water damage observed to extend over most of the exterior master bedroom wall.

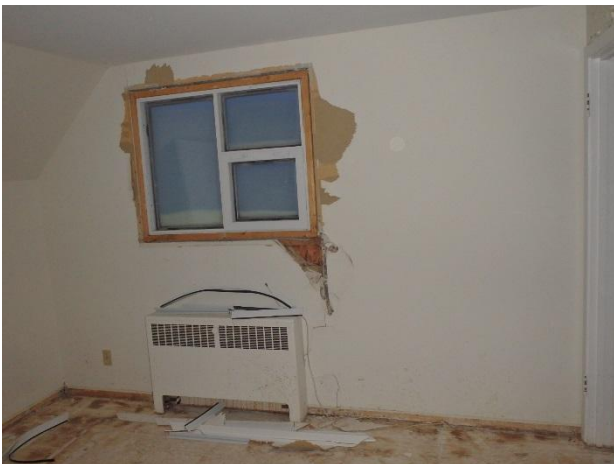
Photo 15: SVG and water damage observed to extend over most of the exterior wall in smaller bedroom on second level.

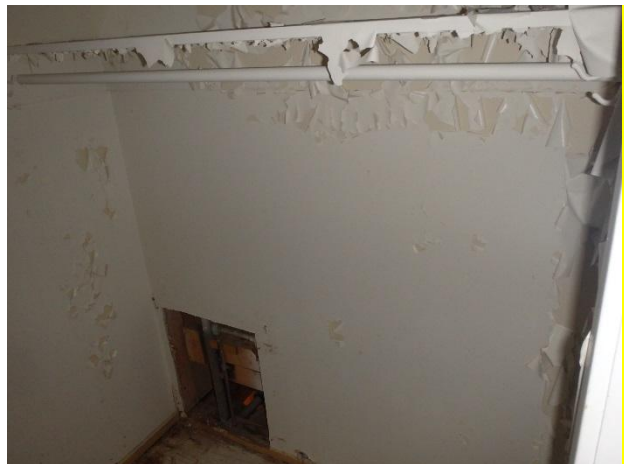
Photo 16: View of extensive paint damage in closet smaller bedroom on second level.

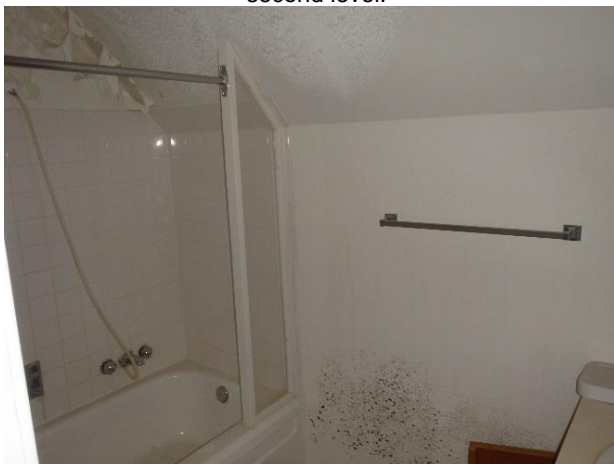
Photo 17: SVG observed to cover lower portion of wall in bathroom in former location of toilet.

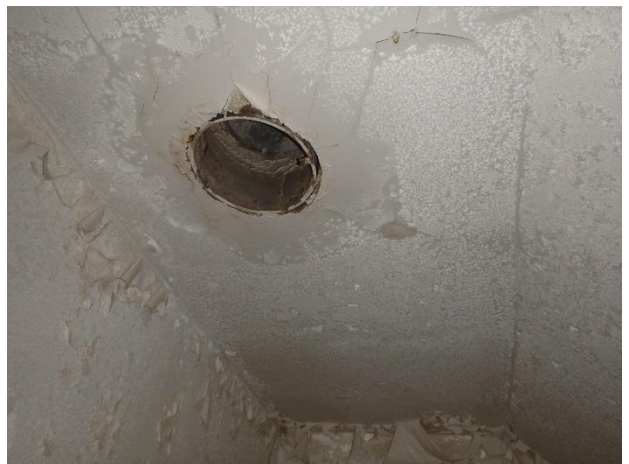
Photo 18: View of bathroom ceiling showing damaged paint and the presence on frost on the ceiling.

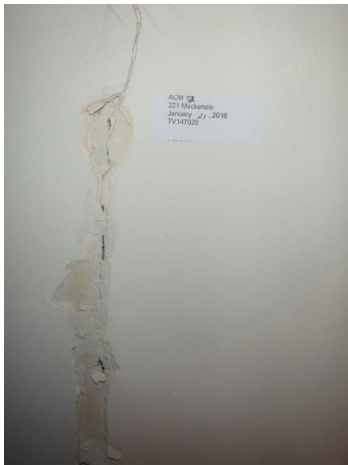
Photo 7: Sample ACM-12, GBJC along cracking joint on the living room wall, opposite stairway was determined to contain **10% Chrysotile asbestos fibres.**

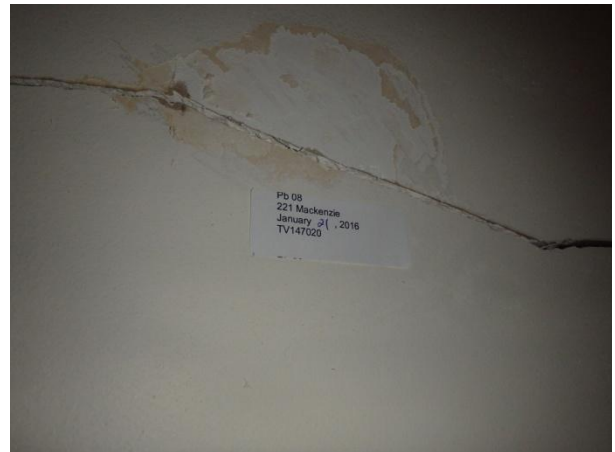
Photo 8: Sample ACM-13 GBJC from crack in stairway wall opposite lower level bedroom was determined to contain **2% Chrysotile asbestos fibres.**

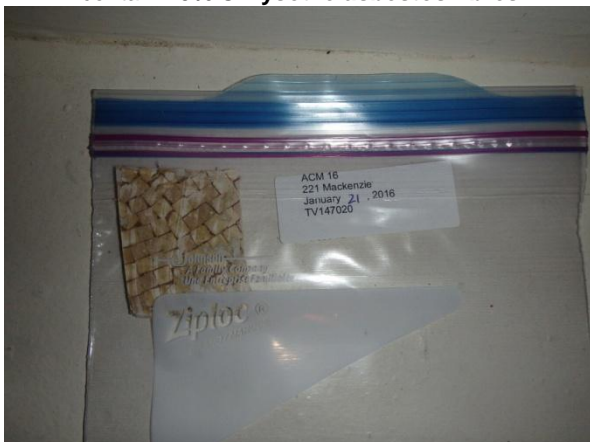
Photo 9: Sample ACM-16, brown mosaic vinyl roll flooring (VRF) in bathroom on second floor was determined to contain **25% Chrysotile asbestos fibres.**

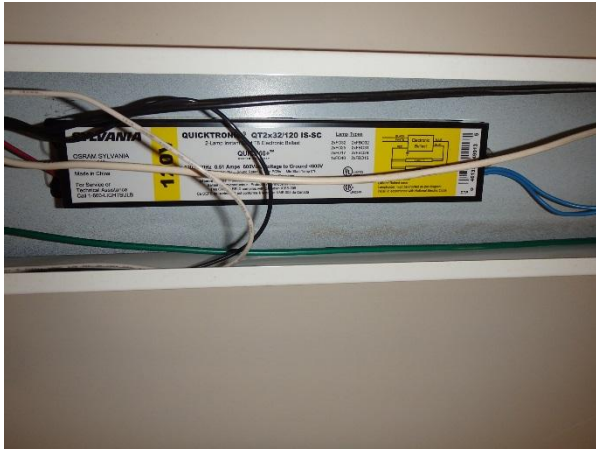
Photo 25: View of a typical fluorescent light ballast observed at the site with a manufacturer’s label noting “no-PCB”.

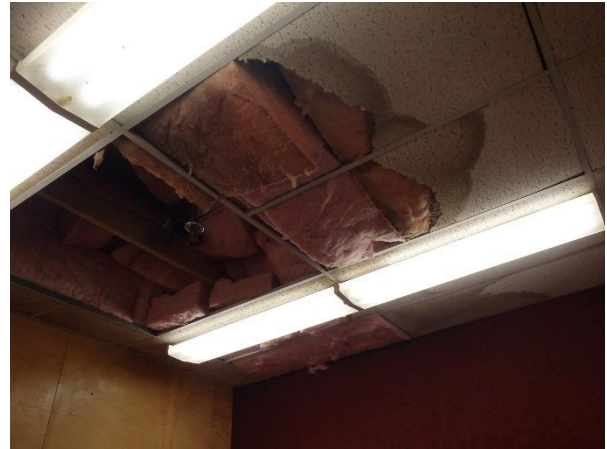
Photo 26: View of water damaged suspended ceiling tiles in the northeast office. Note the fluorescent light tubes suspected to contain mercury.

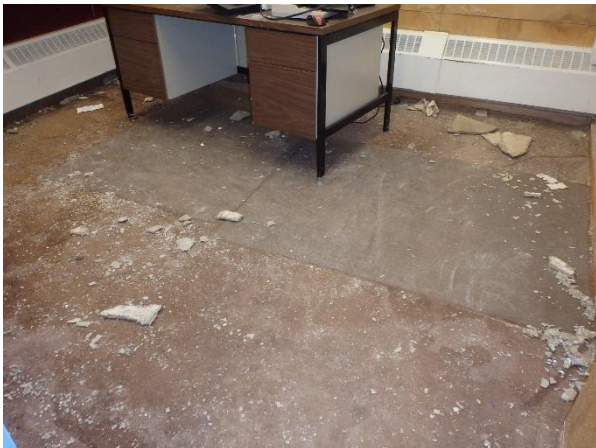
Photo 27: View of water damaged materials on the floor in the back office area.

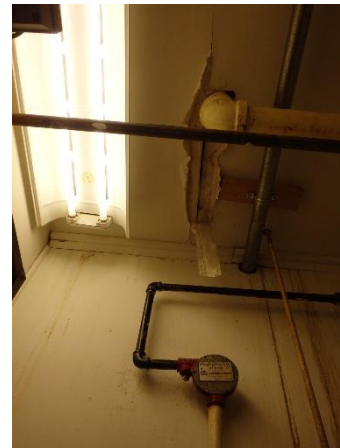
Photo 28: View of water damaged gypsum board ceiling the in boiler room.

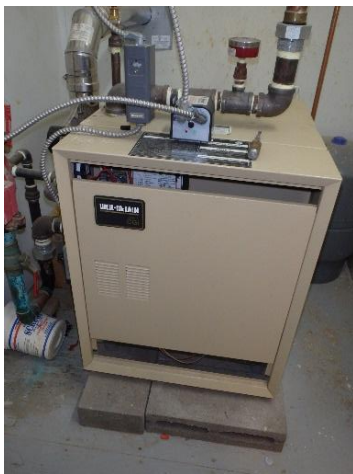
Photo 29: View of the gas fired boiler.
