Title - Sujet Turbine Installation	
Solicitation No. - N° de l'invitation F1700-164035/A	Amendment No. - N° modif. 002
Client Reference No. - N° de référence du client F1700-164035	Date 2017-01-17
GETS Reference No. - N° de référence de SEAG PW-\$PWY-019-7943	
File No. - N° de dossier PWY-6-39253 (019)	CCC No./N° CCC - FMS No./N° VME
Solicitation Closes - L'invitation prend fin at - à 02:00 PM on - le 2017-01-25	
F.O.B. - F.A.B. Plant-Usine: <input type="checkbox"/> Destination: <input checked="" type="checkbox"/> Other-Autre: <input type="checkbox"/>	
Address Enquiries to: - Adresser toutes questions à: Ngan, Ken (PWY)	Buyer Id - Id de l'acheteur pwy019
Telephone No. - N° de téléphone (604) 658-2755 ()	FAX No. - N° de FAX (604) 775-6633
Destination - of Goods, Services, and Construction: Destination - des biens, services et construction: DFO - Puntledge Hatchery - Courtenay, BC

This Solicitation Amendment 002 is raised to incorporate Addendum #2 and the referenced Asbestos Survey.

LOWER PUNTLEDGE HATCHERY

**ASBESTOS SURVEY AND ASSESSMENT
(PK 90160)**

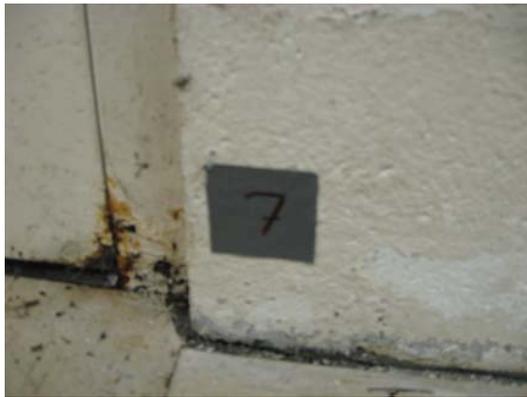
Four (4) samples of suspect asbestos-containing floor tiles were collected. Where possible a portion of the underlying mastic was collected and submitted with the floor tile sample. One (1) sample was found to contain asbestos (Aeration Tower). This sample was found to be in FAIR

condition at the time of the survey.

DFO Sample ID	Building	Type of Material Sampled	Location of Sample	Asbestos (% & type)	Condition	Access-ibility	Friability	Recom-mended Action	Quantity	Cost
PK90160-0801-BM008	Aeration Tower	Floor Tile	Aeration Tower	5 Chrysotile	FAIR	A	Non-friable	3	200 sf	\$1,000.00

Photo 1 – BM008 - Aeration Tower – Floor Tile

- 1) Provide copies of this report, or a summary thereof, to site personnel as per the asbestos management plan.
- 2) Label all identified ACM.
- 3) ACM in good condition should be controlled through the implementation of the DFO Asbestos Management Plan designed to meet the requirements of the Canada Labour Code, PWGSC Deputy Minister Directive 057, and WorkSafe BC.
- 4) Inspect all identified asbestos containing materials annually to identify any damage and ensure proper labeling is present.

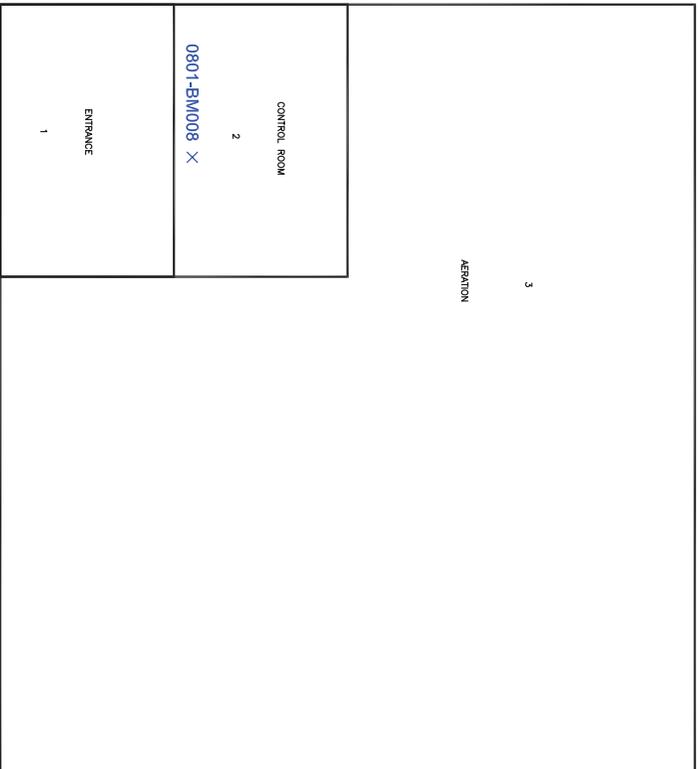
DRAWING TITLE		PROJECT TITLE	
PUNTLIDGE AERATION TOWER SAMPLING LOCATIONS		ASBESTOS SURVEYS AND RISK ASSESSMENTS	
DRAWN BY	DATE	ISSUED BY	DATE
IES	28/03/08	RC	01/08
PROJECT NO.		FIGURE	
PC0906		FIGURE 6

Summary of ACM Survey Findings and Recommendations		
Building	Finding and Condition	Recommendations
Aeration Building	Asbestos containing vinyl floor tiles are present in the control room. Some damage has occurred and further damage is likely. This material is in FAIR condition	<p>All asbestos work must be undertaken in accordance with procedures outlined in Part 6 of the BC Occupational Health and Safety Regulation 301/2004. These procedures satisfy the federal Department of Labour and PWGSC requirements pertinent to asbestos work.</p> <p>Remove all ACM materials in FAIR condition.</p>
