<b>Title - Sujet</b> Turbine Installation	
<b>Solicitation No. - N° de l'invitation</b> F1700-164035/A	<b>Amendment No. - N° modif.</b> 002
<b>Client Reference No. - N° de référence du client</b> F1700-164035	<b>Date</b> 2017-01-17
<b>GETS Reference No. - N° de référence de SEAG</b> PW-\$PWY-019-7943	
<b>File No. - N° de dossier</b> PWY-6-39253 (019)	<b>CCC No./N° CCC - FMS No./N° VME</b>
<b>Solicitation Closes - L'invitation prend fin</b> <b>at - à 02:00 PM</b> <b>on - le 2017-01-25</b>	
<b>Time Zone</b> Fuseau horaire Pacific Standard Time PST	
<b>F.O.B. - F.A.B.</b> <b>Plant-Usine:</b> <input type="checkbox"/> <b>Destination:</b> <input checked="" type="checkbox"/> <b>Other-Autre:</b> <input type="checkbox"/>	
<b>Address Enquiries to: - Adresser toutes questions à:</b> Ngan, Ken (PWY)	<b>Buyer Id - Id de l'acheteur</b> pwy019
<b>Telephone No. - N° de téléphone</b> (604) 658-2755 ( )	<b>FAX No. - N° de FAX</b> (604) 775-6633

## ADDENDUM #2

**LOWER PUNTLEDGE HATCHERY**

**ASBESTOS SURVEY AND ASSESSMENT  
(PK 90160)**

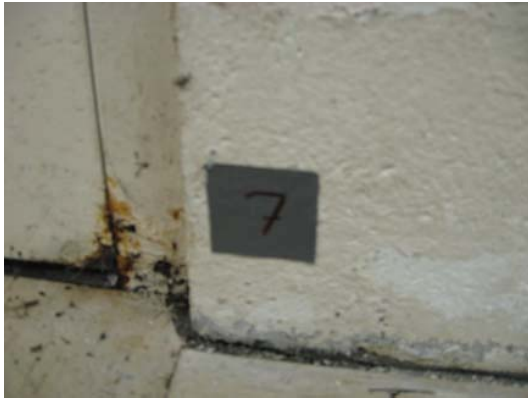
**Photo 1 – BM008 - Aeration Tower – Floor Tile**

Summary of ACM Survey Findings and Recommendations		
Building	Finding and Condition	Recommendations
Aeration Building	Asbestos containing vinyl floor tiles are present in the control room. Some damage has occurred and further damage is likely. This material is in FAIR condition	<p>All asbestos work must be undertaken in accordance with procedures outlined in Part 6 of the BC Occupational Health and Safety Regulation 301/2004. These procedures satisfy the federal Department of Labour and PWGSC requirements pertinent to asbestos work.</p> <p>Remove all ACM materials in FAIR condition.</p>

Four (4) samples of suspect asbestos-containing floor tiles were collected. Where possible a portion of the underlying mastic was collected and submitted with the floor tile sample. One (1) sample was found to contain asbestos (Aeration Tower). This sample was found to be in FAIR

condition at the time of the survey.

1.3	01 11 00 Summary of Work	<b>Removal of Asbestos-containing Floor Tiles.</b>  Add to Clause 1.3.1 - The control room tiles are to be removed as part of this project. Approximate area tiled is 7.5 m <sup>2</sup> . Existing control room tiles have asbestos content. See attached Asbestos Report. The Work will be completed in accordance with all applicable WCB-BC (Worksafe BC) regulations relating to safe handling of asbestos.
	01 33 00 Submittal Procedures	Add Clause 1.5 Asbestos Removal Plan Submittal  1.5 Contractor to provide a plan for approval that identifies proposed method for removal of asbestos tiles, worker safety provisions, and method of disposal. The plan will demonstrate compliance with WCB regulations. No work to be completed

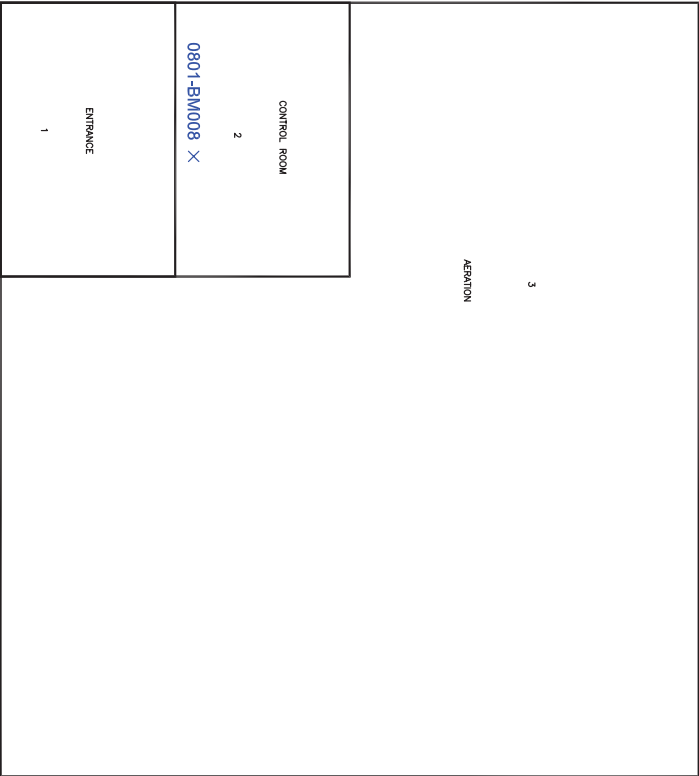
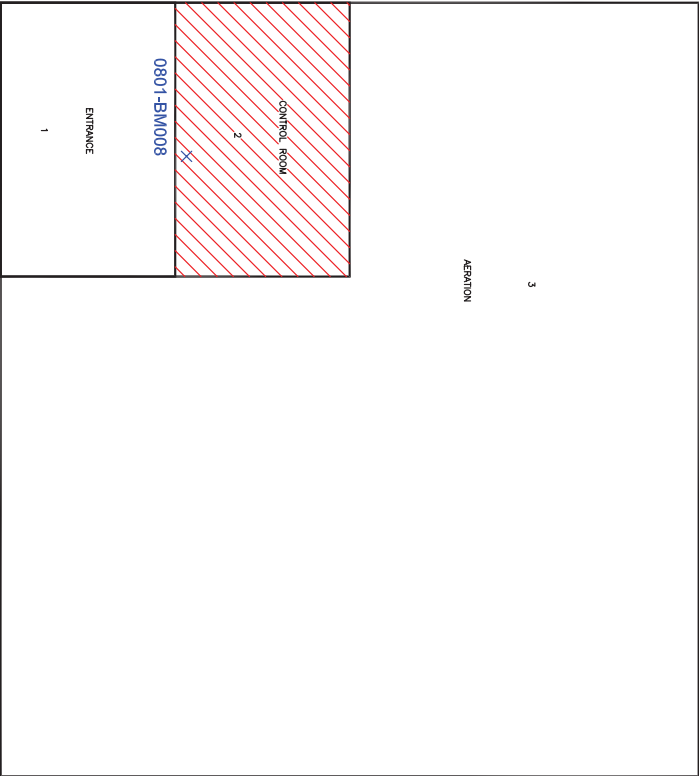
CONSULTANT					
DRAWING TITLE					
PLANTFORAGE AERATION TOWER					
LOCATIONS OF IDENTIFIED ACM					
PROJECT TITLE					
ASBESTOS SURVEYS AND RISK ASSESSMENTS					
DRAWN BY	DATE	SIGNED BY	DATE	PROJECT NO.	FIGURE
IES	28/03/08	RC	04/08	PC0060	FIGURE 6A

ACM
