**SOLICITATION AMENDMENT
MODIFICATION DE L'INVITATION**

Title - Sujet Roof Replacements	
Solicitation No. - N° de l'invitation EZ899-172611/A	Amendment No. - N° modif. 001
Client Reference No. - N° de référence du client	Date 2017-02-09
GETS Reference No. - N° de référence de SEAG PW-\$PWY-026-7985	
File No. - N° de dossier PWY-6-39309 (026)	CCC No./N° CCC - FMS No./N° VME
Solicitation Closes - L'invitation prend fin at - à 02:00 PM on - le 2017-02-24	Time Zone Fuseau horaire Pacific Standard Time PST
F.O.B. - F.A.B. Plant-Usine: <input type="checkbox"/> Destination: <input checked="" type="checkbox"/> Other-Autre: <input type="checkbox"/>	
Address Enquiries to: - Adresser toutes questions à: Yi (PWY), Patty	Buyer Id - Id de l'acheteur pwy026
Telephone No. - N° de téléphone (778) 919-2578 ()	FAX No. - N° de FAX (604) 775-6633
Destination - of Goods, Services, and Construction: Destination - des biens, services et construction: CSC - Mountain Institution - Agassiz, BC

Hazardous Building Materials Assessment

Power House Roof Replacement at Mountain Medium Institution,
Agassiz, BC

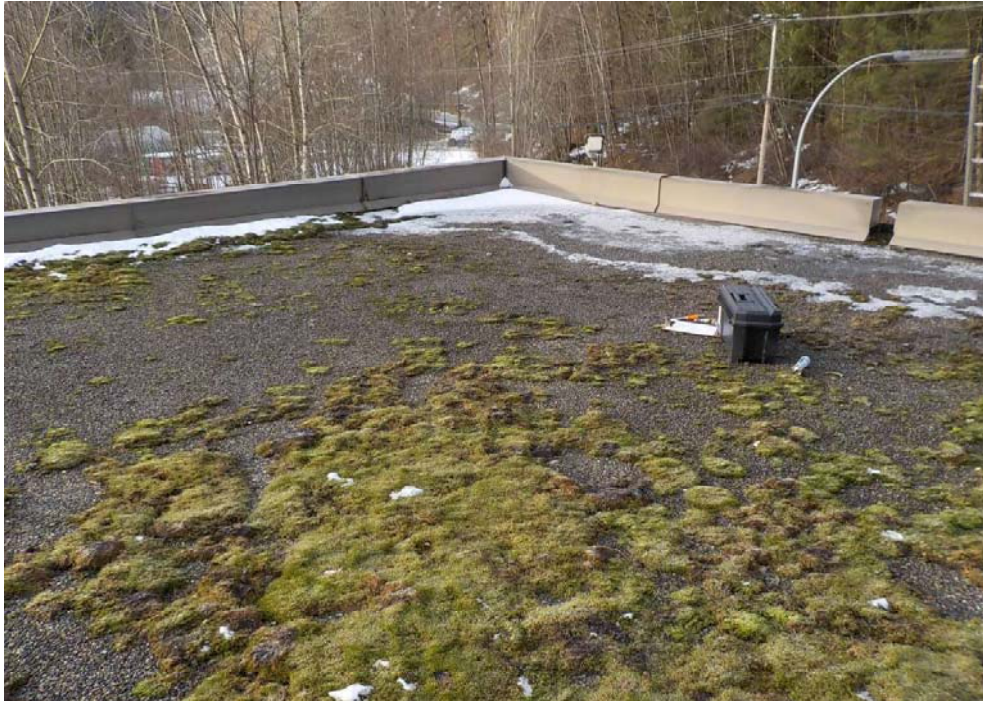
Photograph 1: Power House roof looking southwest from the northeast corner.

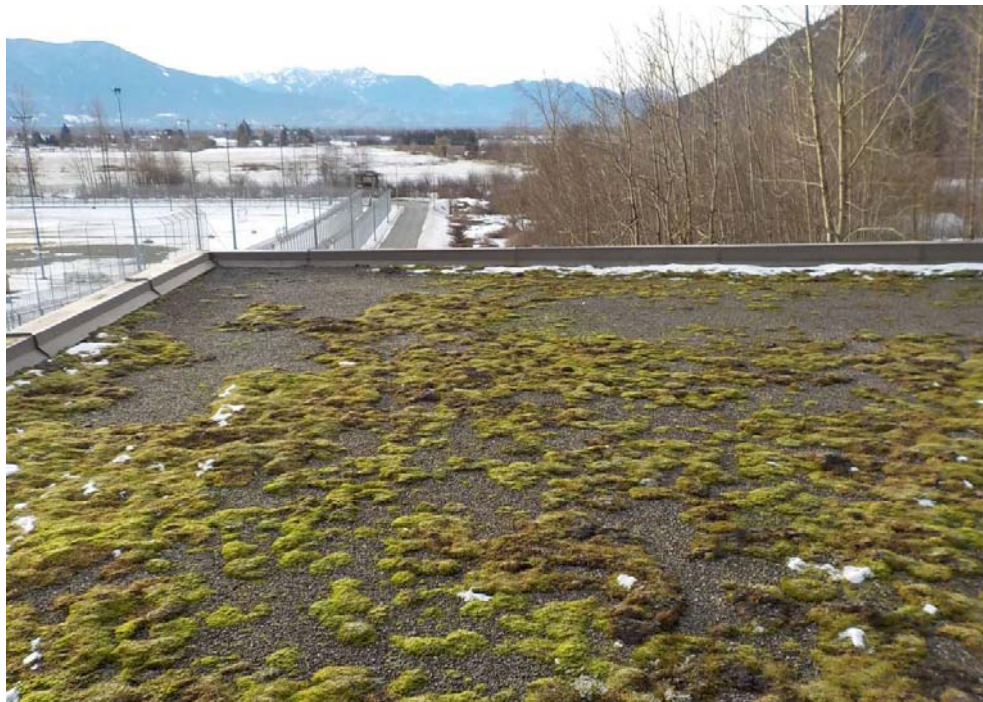
Photograph 2: Power House roof looking south from the northeast corner.
