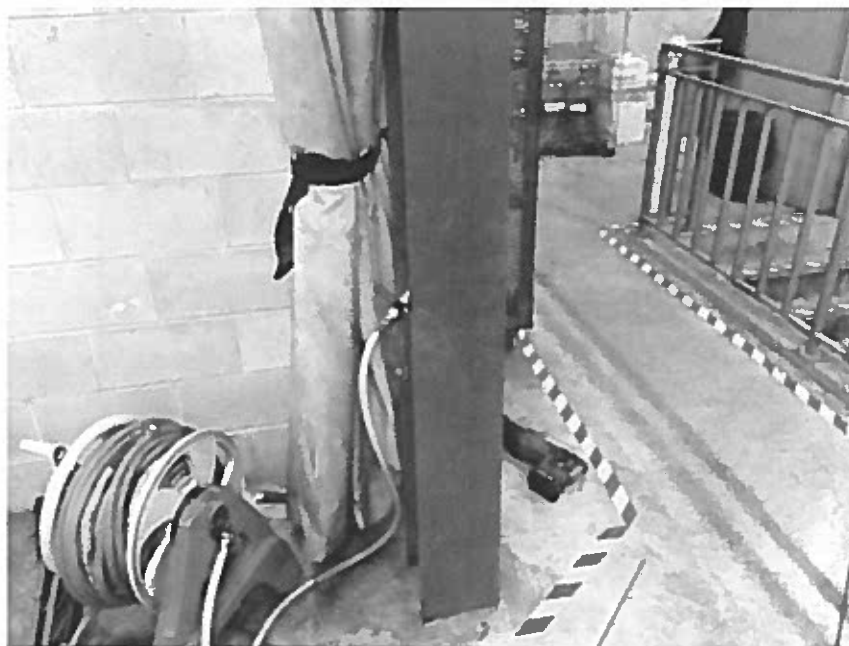
Photo 63 – Sous-sol, garage – Colonne métallique recouverte d'une peinture rouge au plomb  
(échantillon P-4)

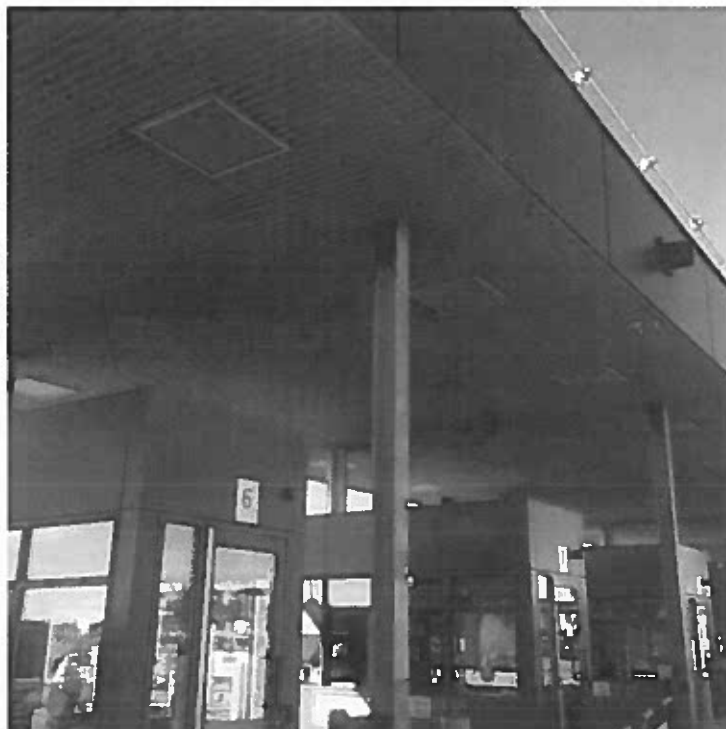
Photo 83 – Extérieur – Colonne métallique recouverte d'une peinture grise au plomb  
(échantillon P-5)

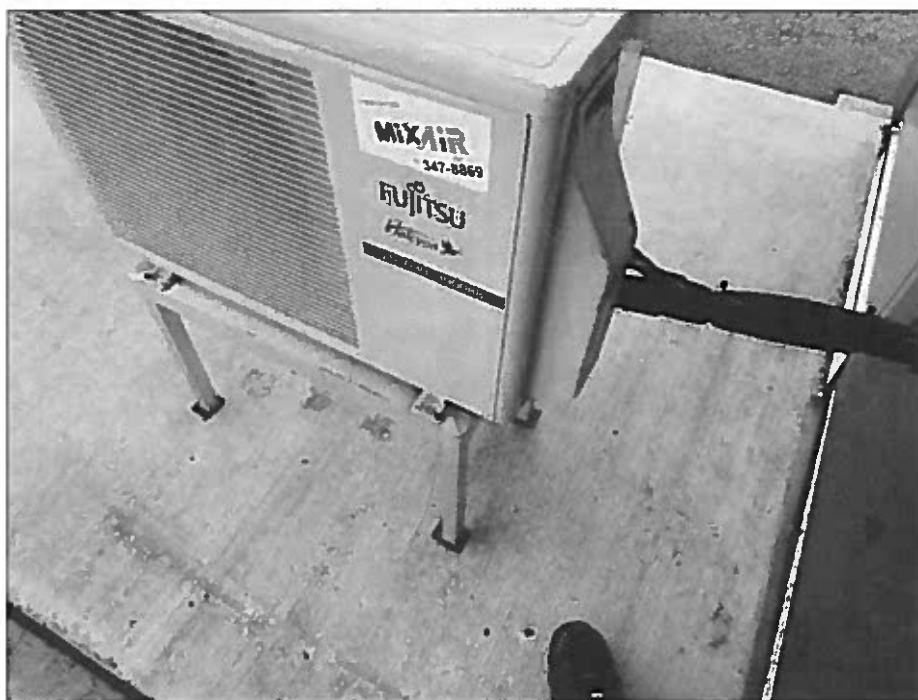
Photo 97 – Toit du bâtiment – Unité de condensation de type « split » contenant un réfrigérant de type R-410A, un halocarbure
