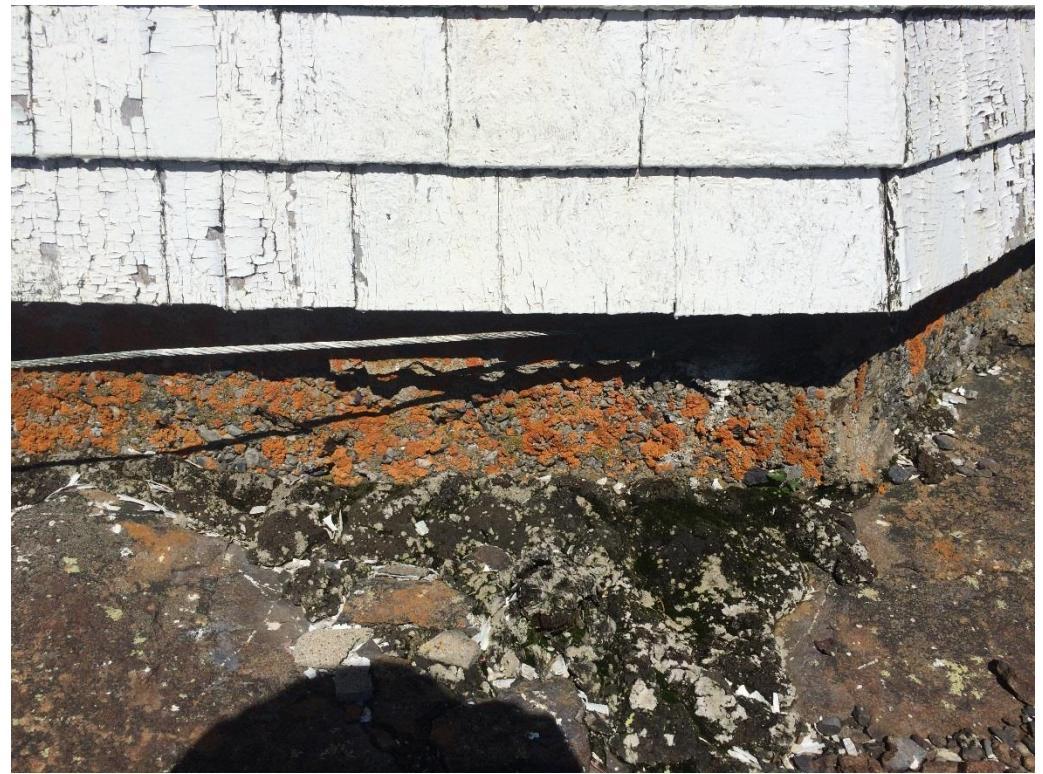
Photo 2: Severe spalling and vegetative growth at foundation.

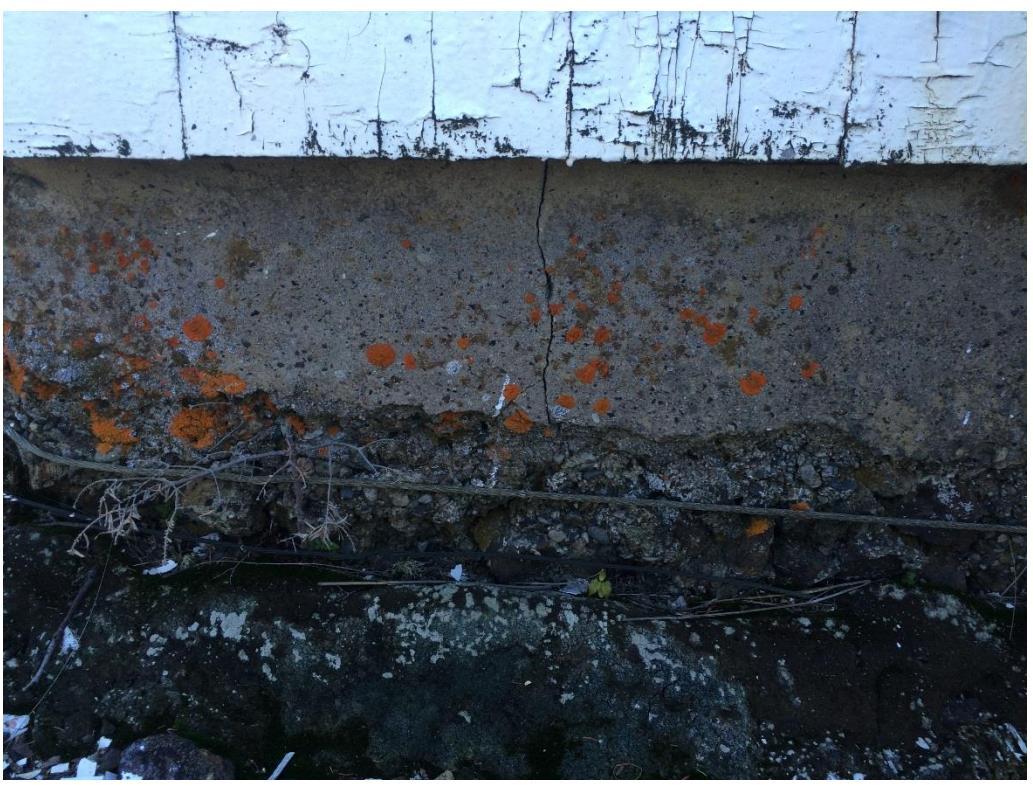
Photo 3: Wide crack at foundation.

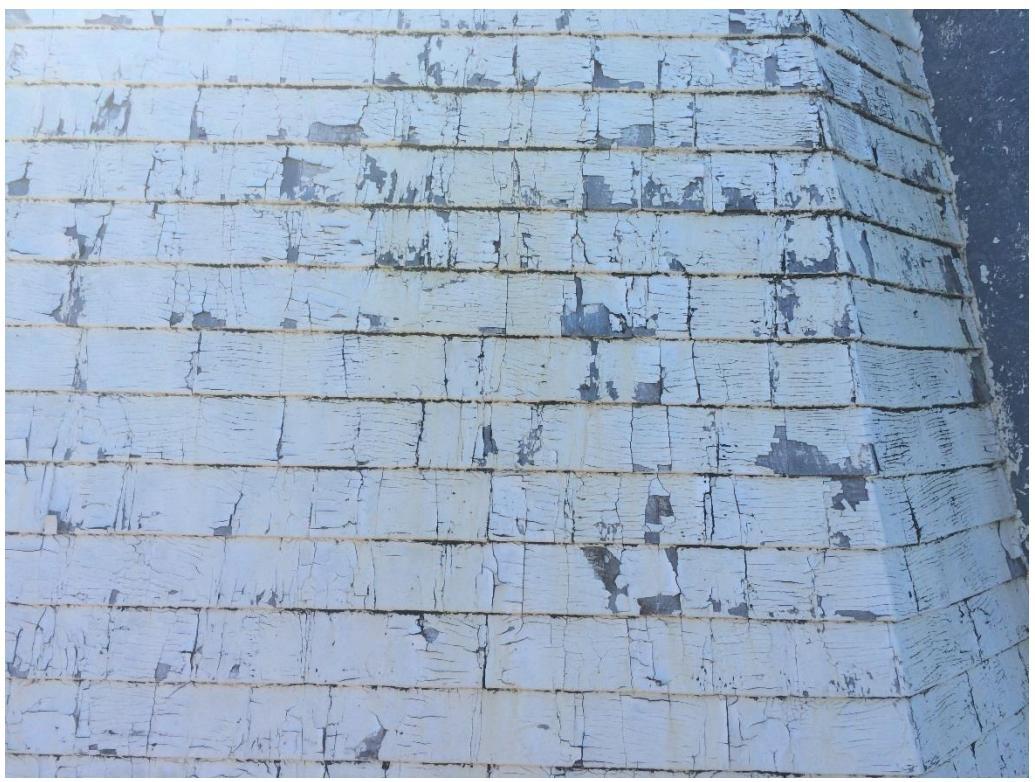
Photo 5: Cracked and peeling paint at exterior siding.

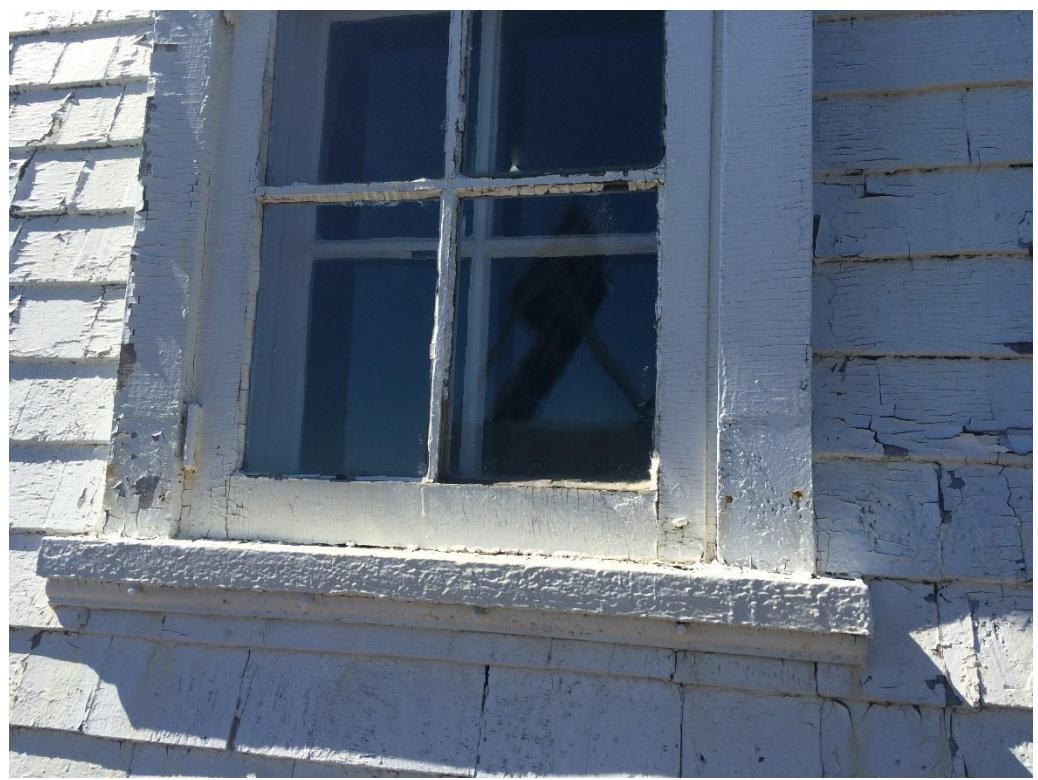
Photo 8: Peeling paint and missing sealants at Lighthouse wall window.

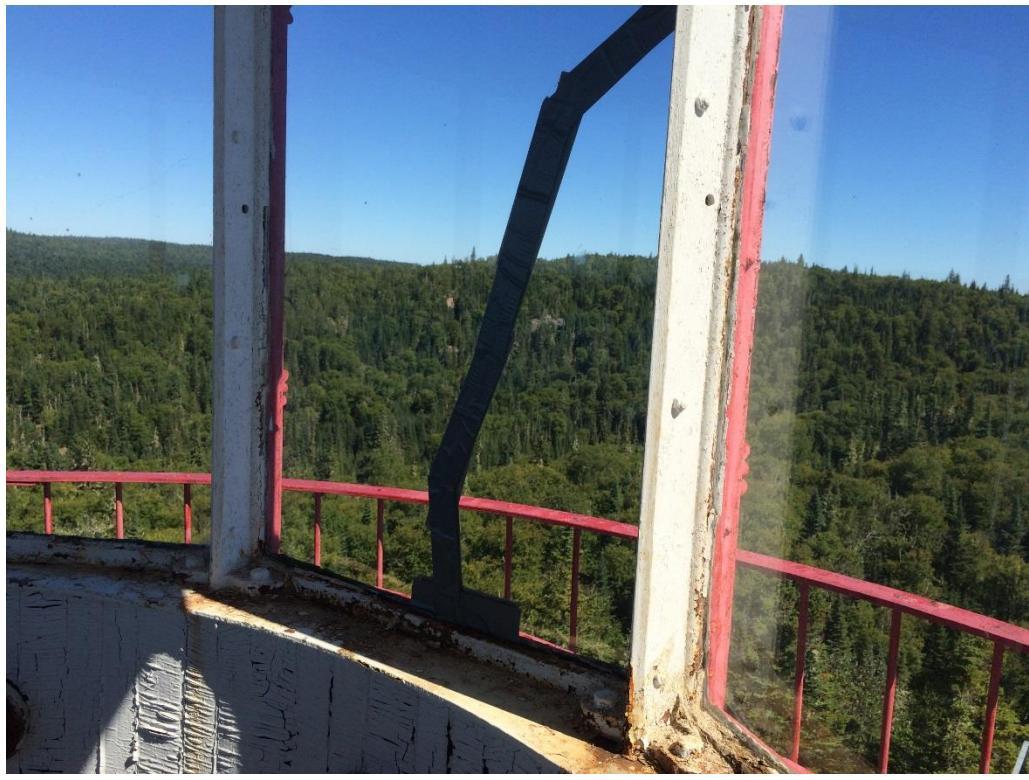
Photo 9: Cracked window at lantern.

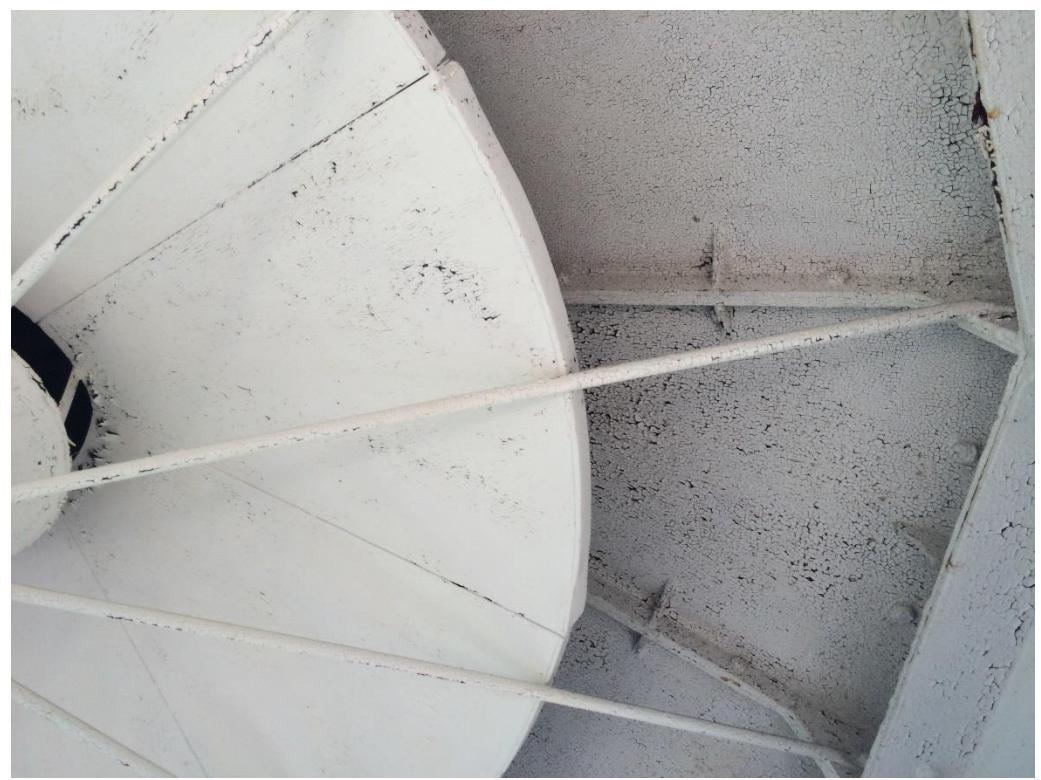
Photo 10: Peeling paint and light corrosion at lantern.

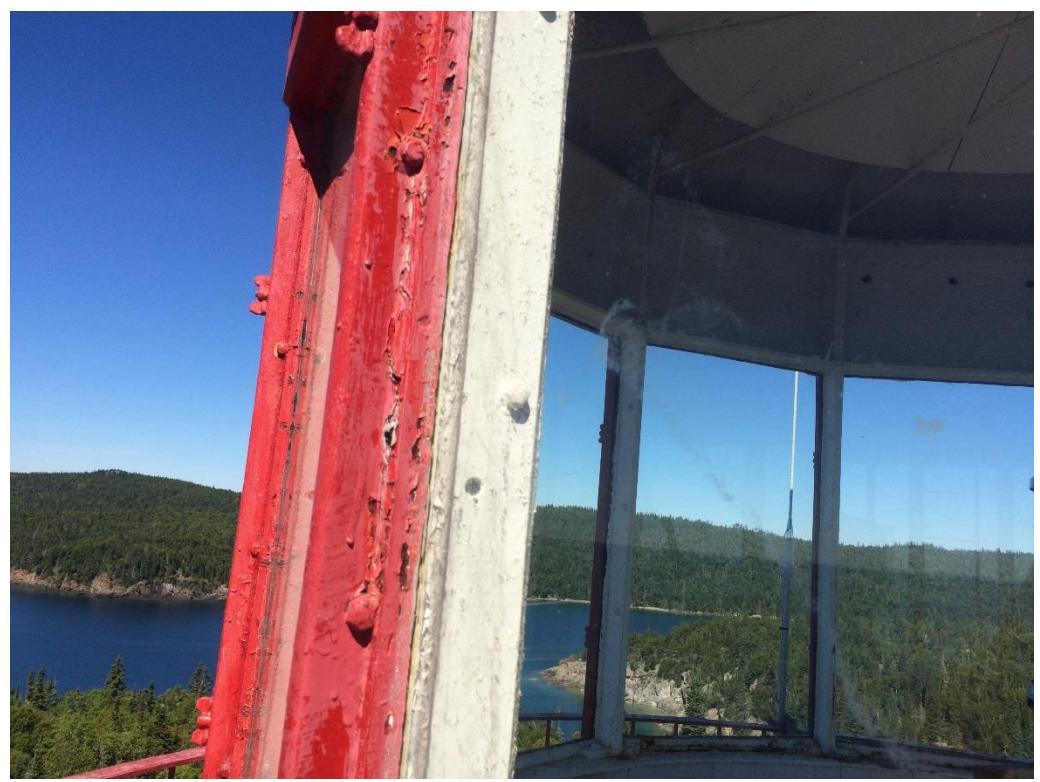
Photo 12: Peeling paint and light corrosion at lantern.

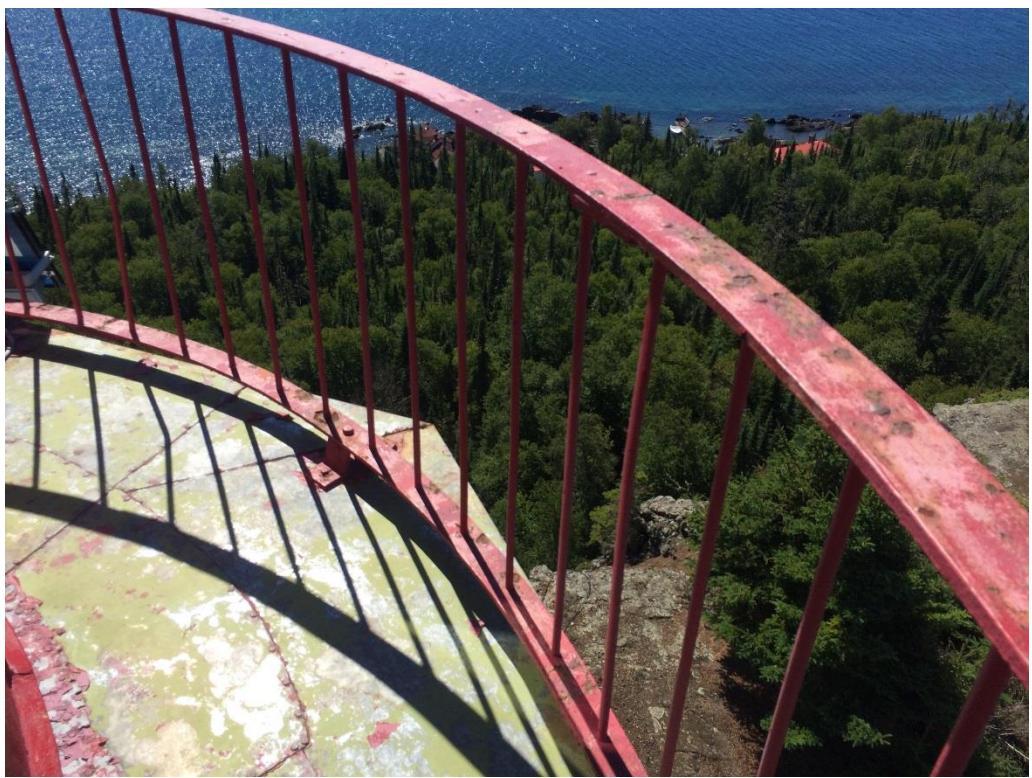
Photo 13: Peeling paint and light corrosion at lantern.

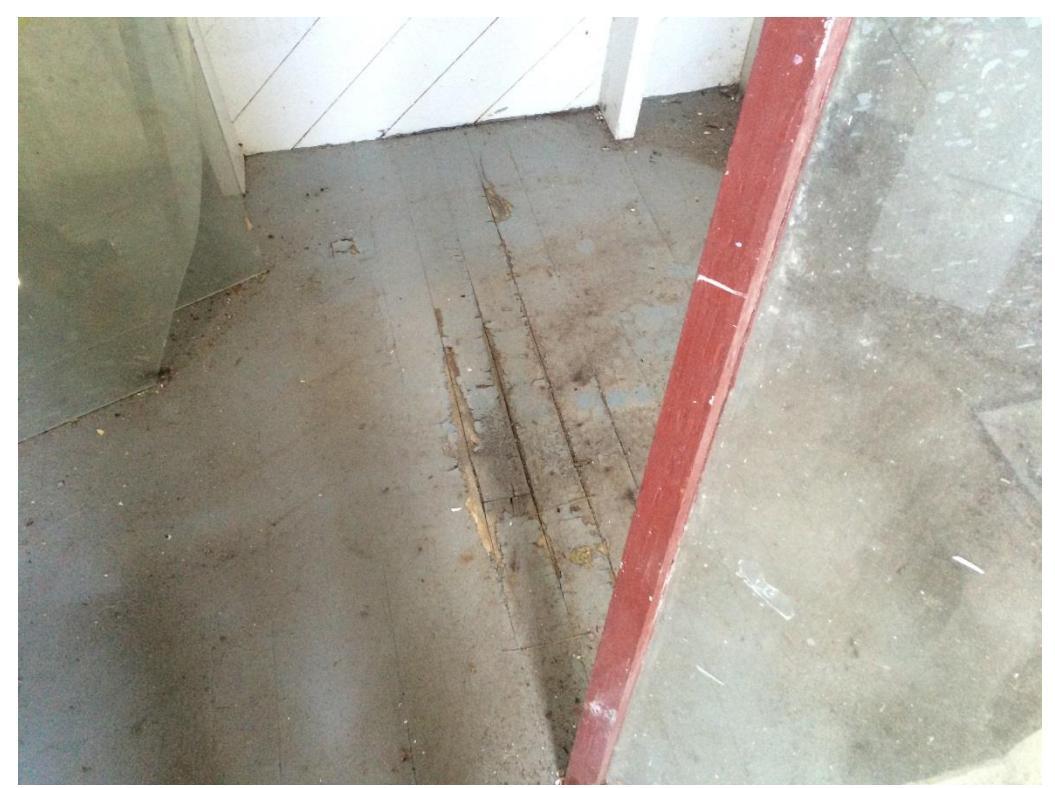
Photo 14: Water damage and medium rot at wood flooring.

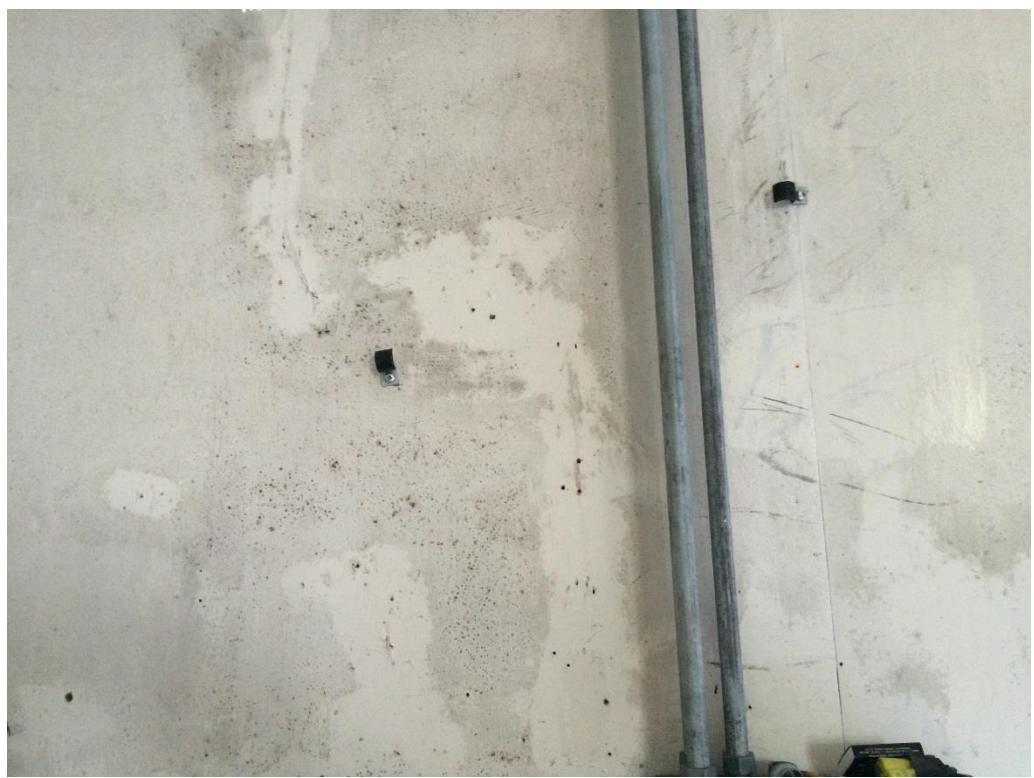
Photo 16: Mold and mildew at wood walls.

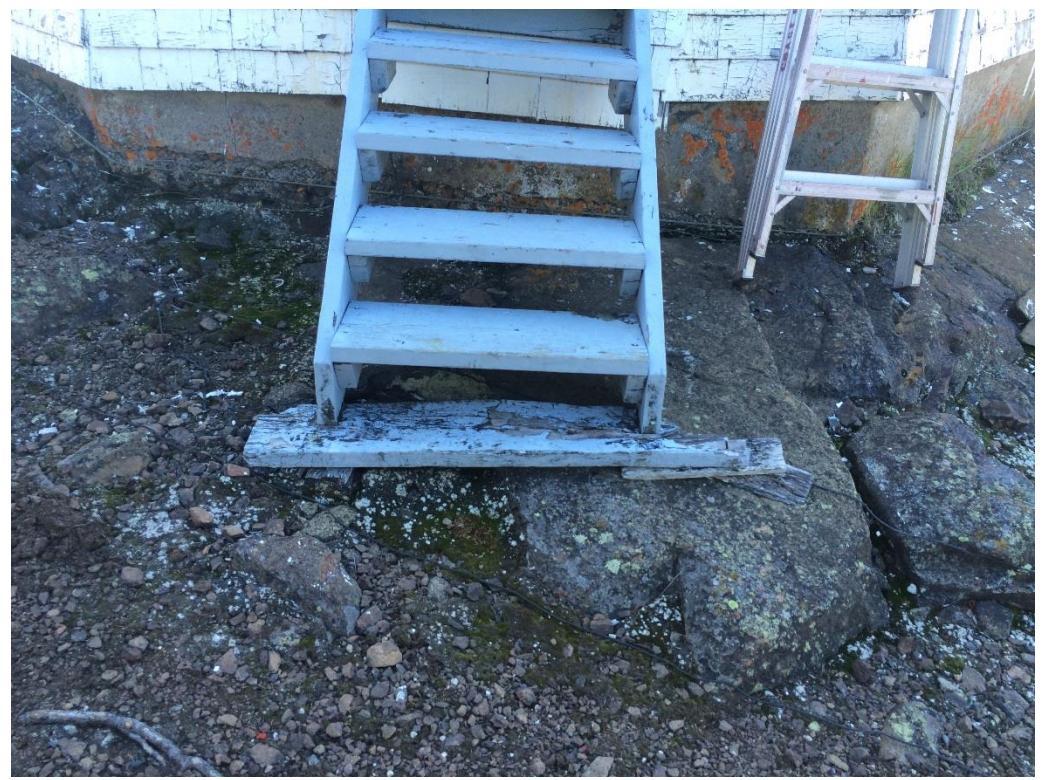
Photo 18: Severe rot at stair bearing timber.

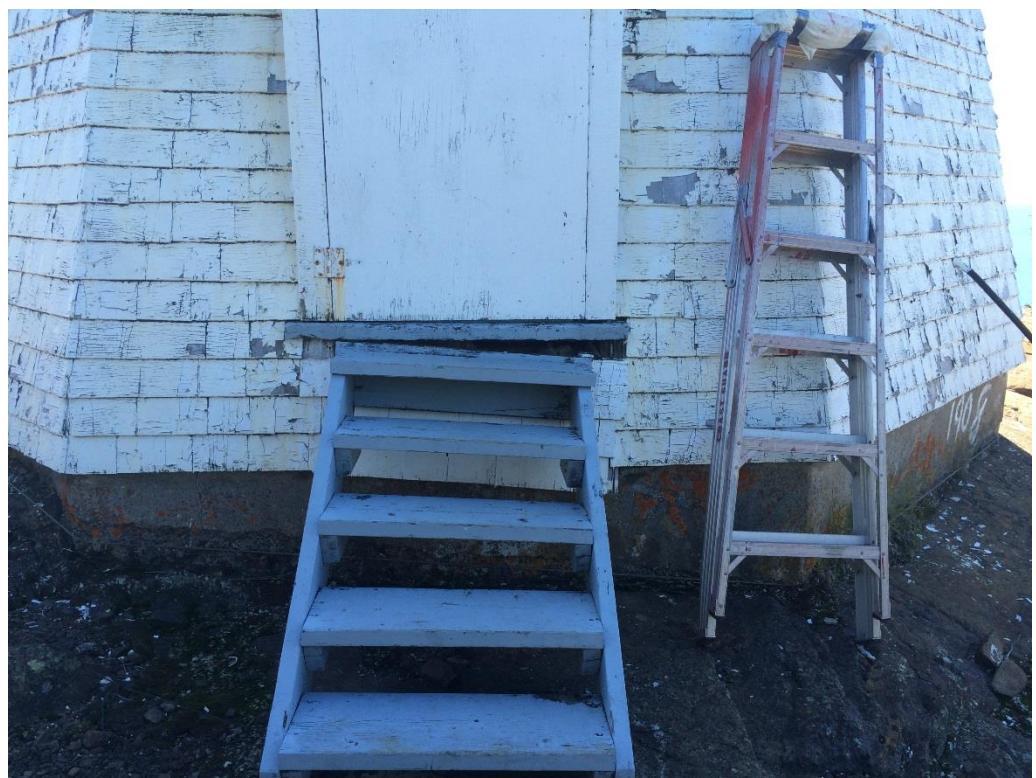
Photo 19: Out of level stair without handrail.

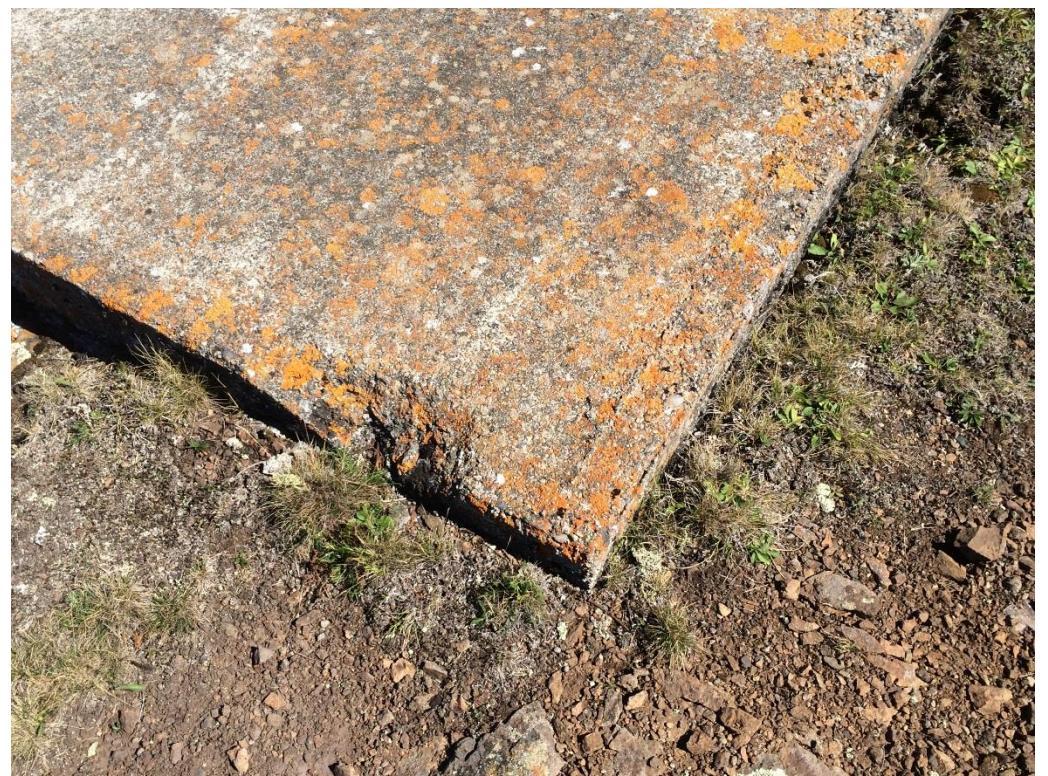
Photo 4: Spall at west edge of slab.

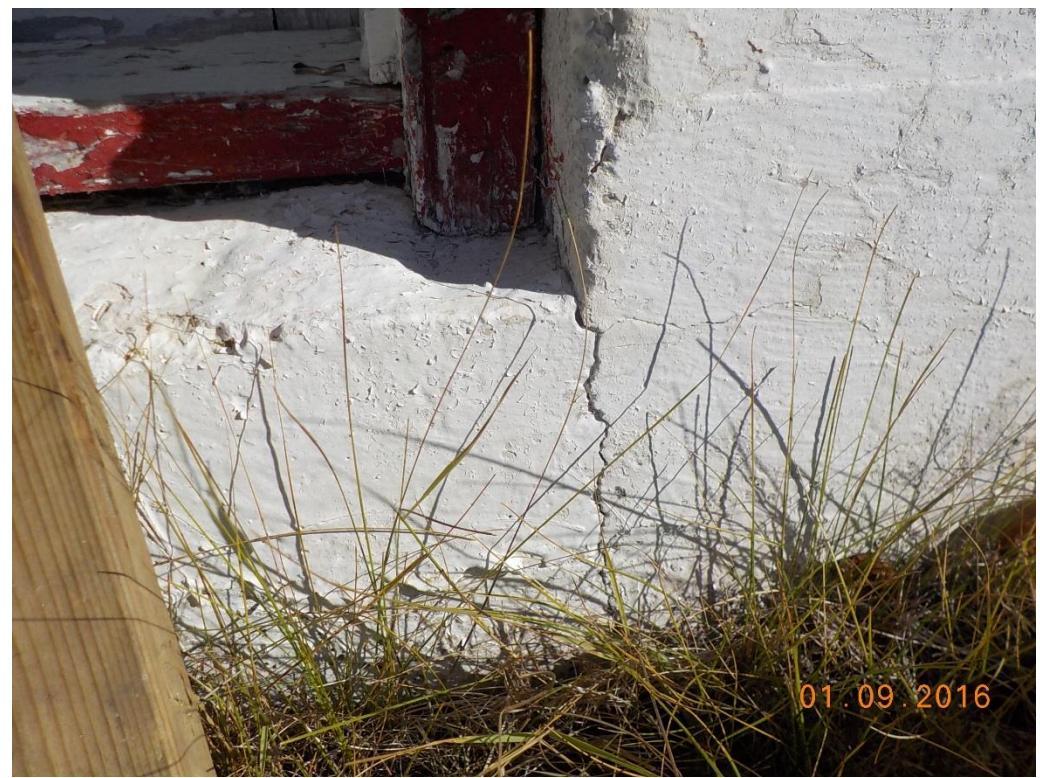
Photo 5: Typical foundation crack at exterior.

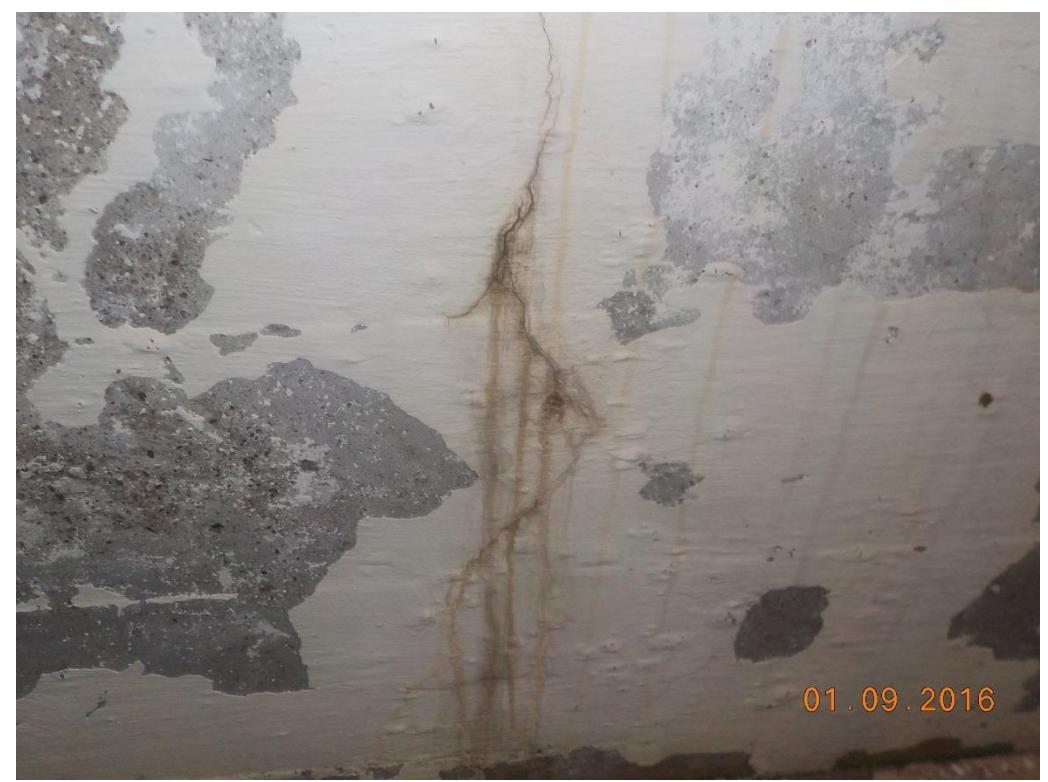
Photo 6: Typical foundation crack at interior indicating leaks.

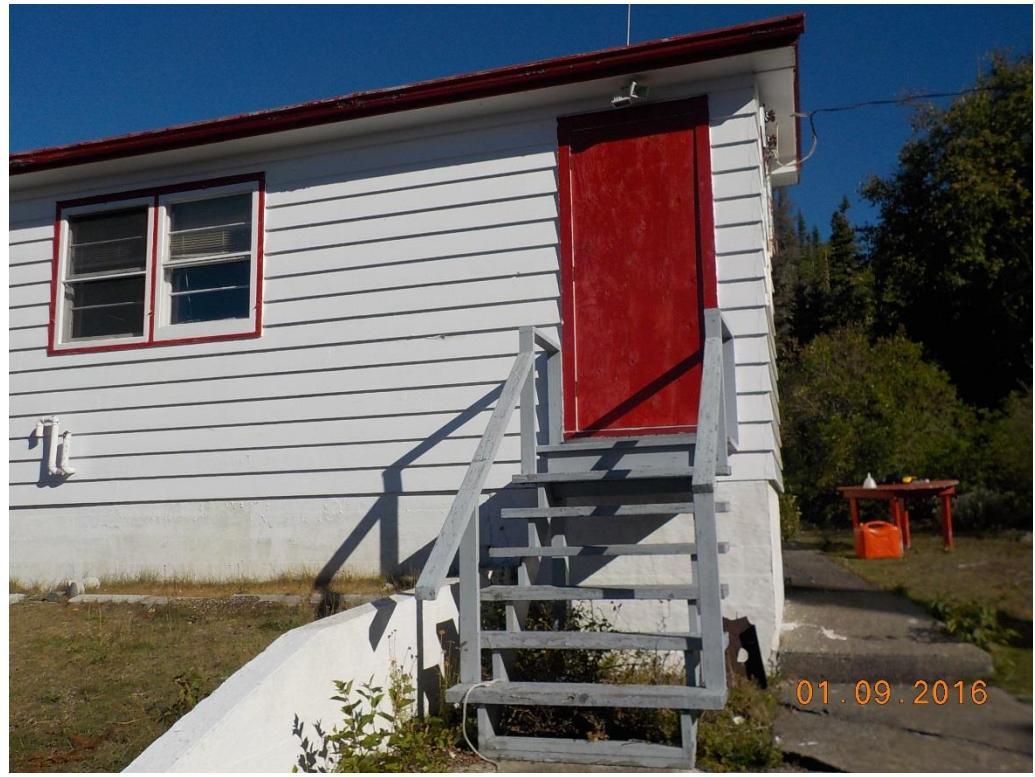
Photo 13: Southern door closed off by plywood. Paint peeling at staircase.

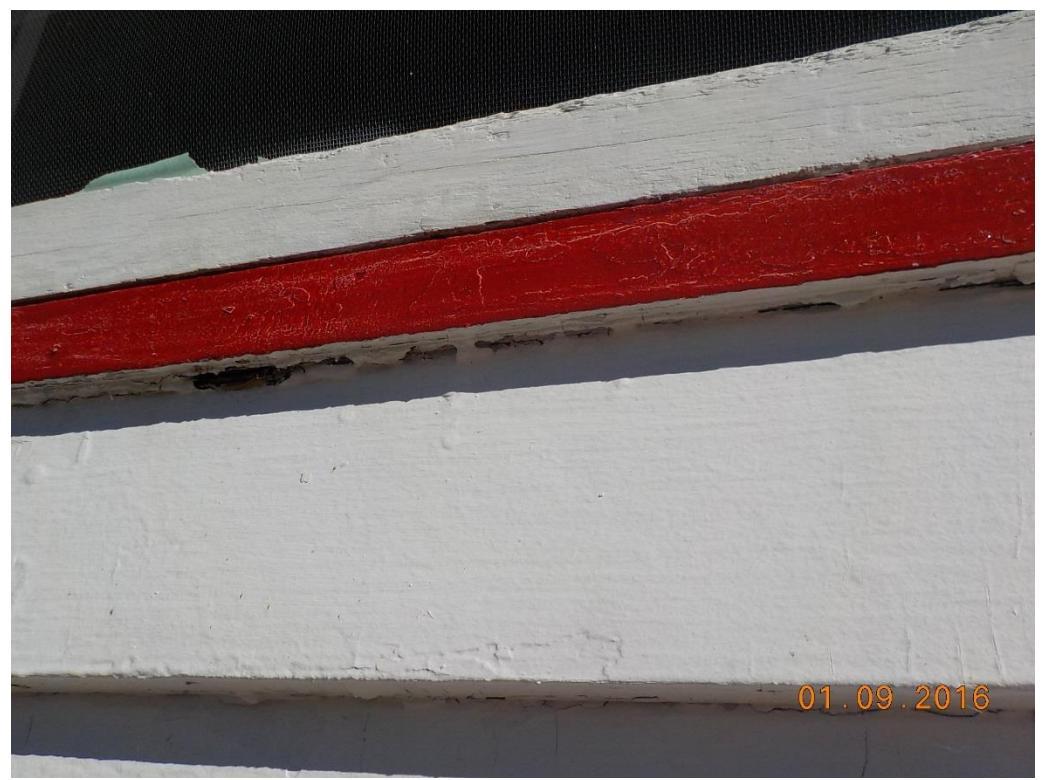
Photo 14: Failed caulking at window.

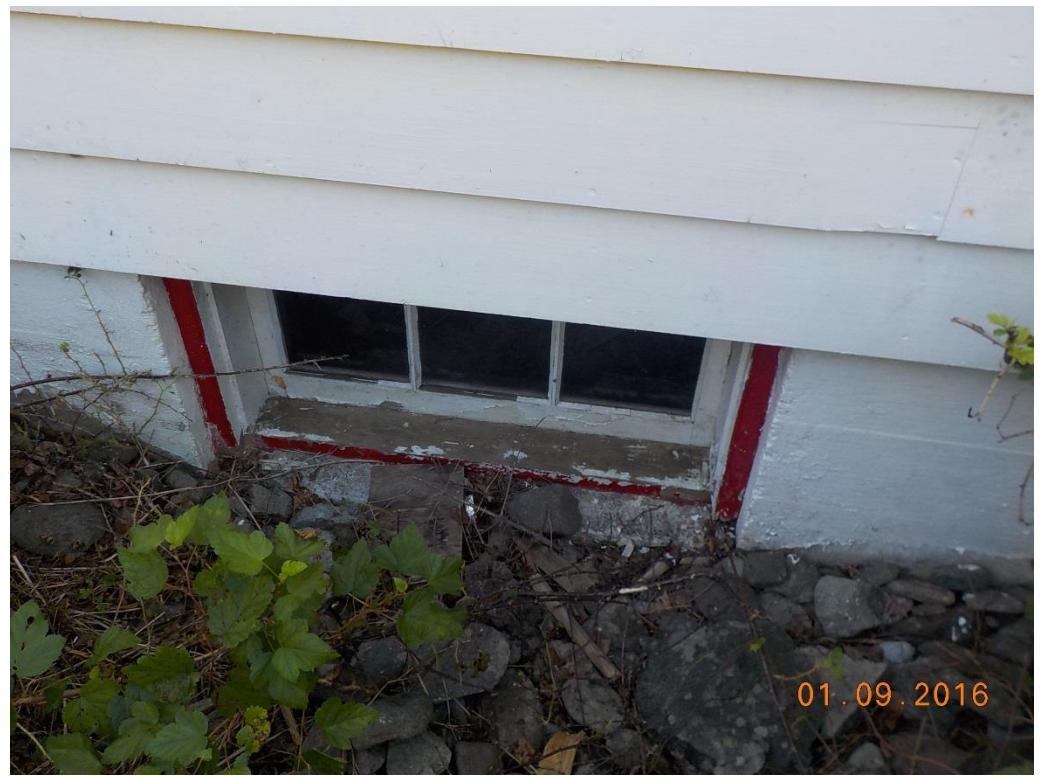
Photo 15: Peeling paint and weathered window frame at foundation walls.

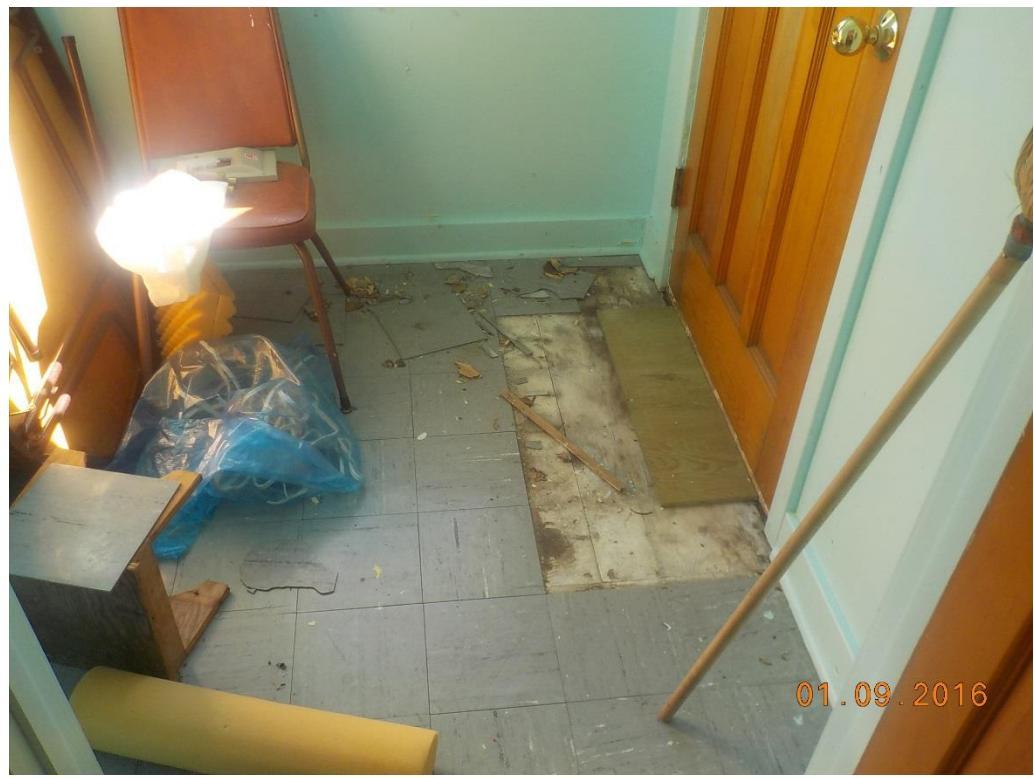
Photo 18: Vinyl flooring removed exposing water damaged subfloor at southern entrance.

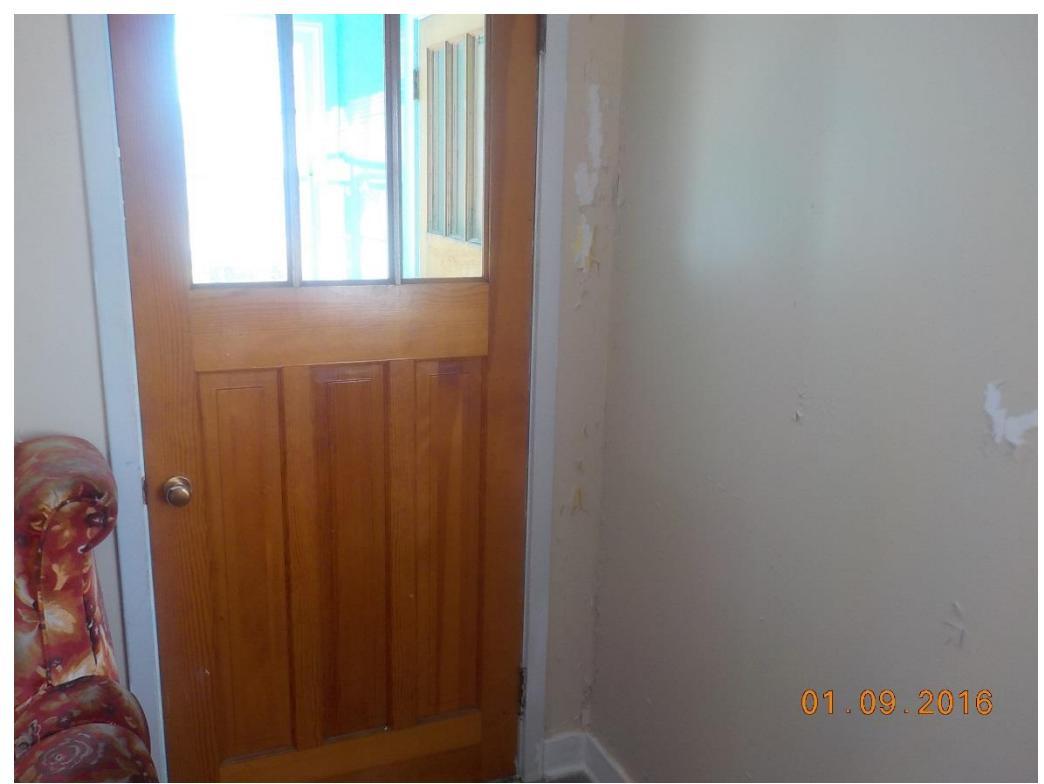
Photo 19: Paint peeling at interior wall at northern entrance.

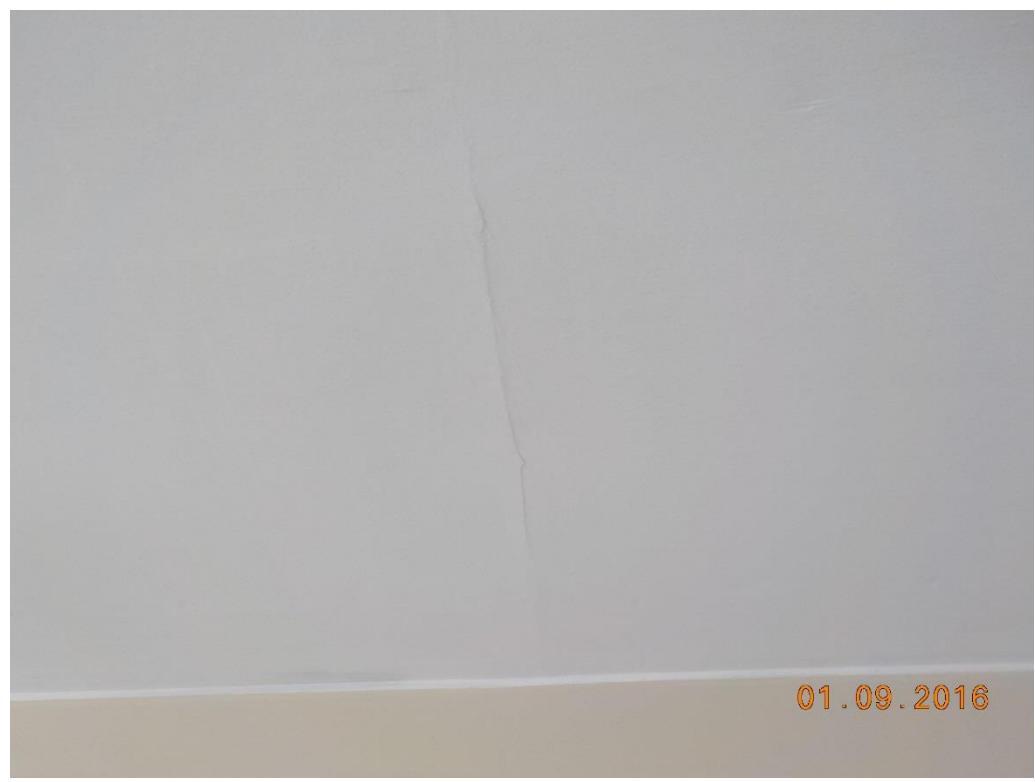
Photo 20: Crack at ceiling at northern entrance.

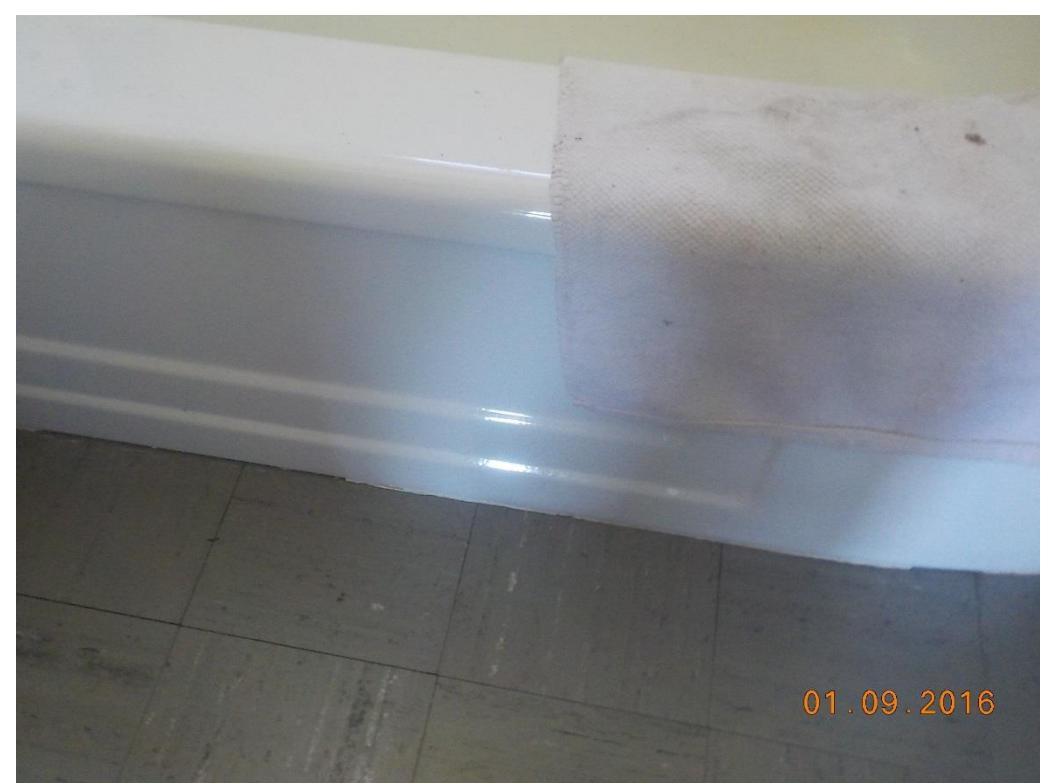
Photo 26: Failed sealant at bathtub within bathroom.

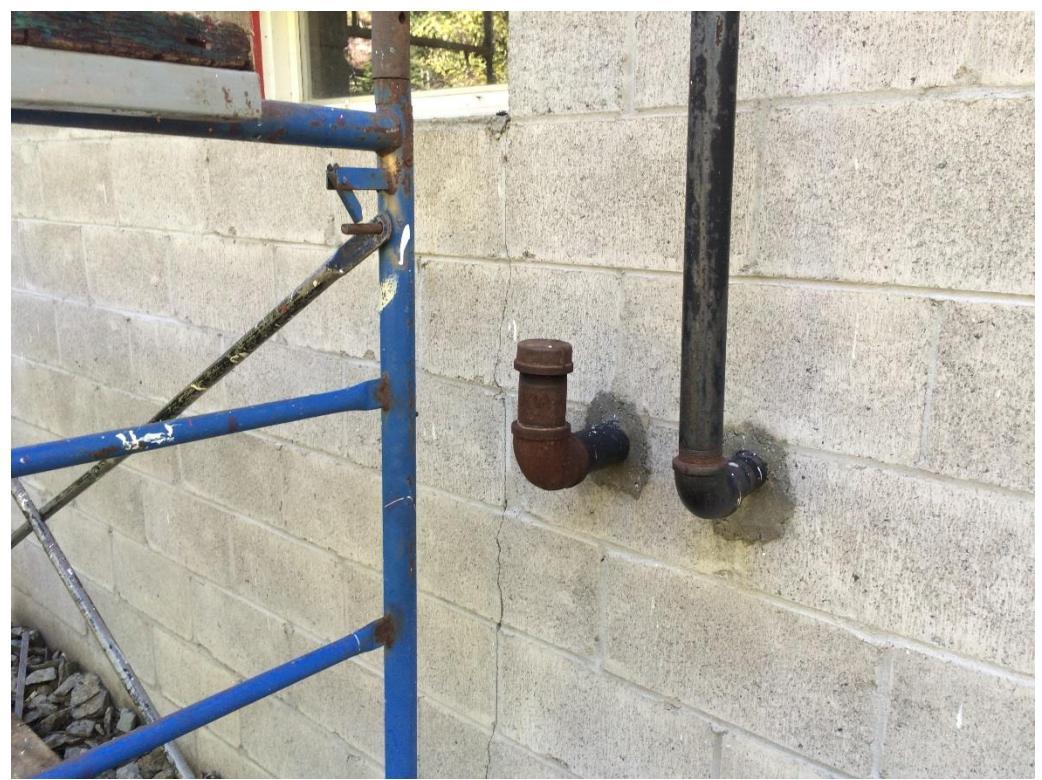
Photo 4: Typical splitting failure cracking at foundation wall.

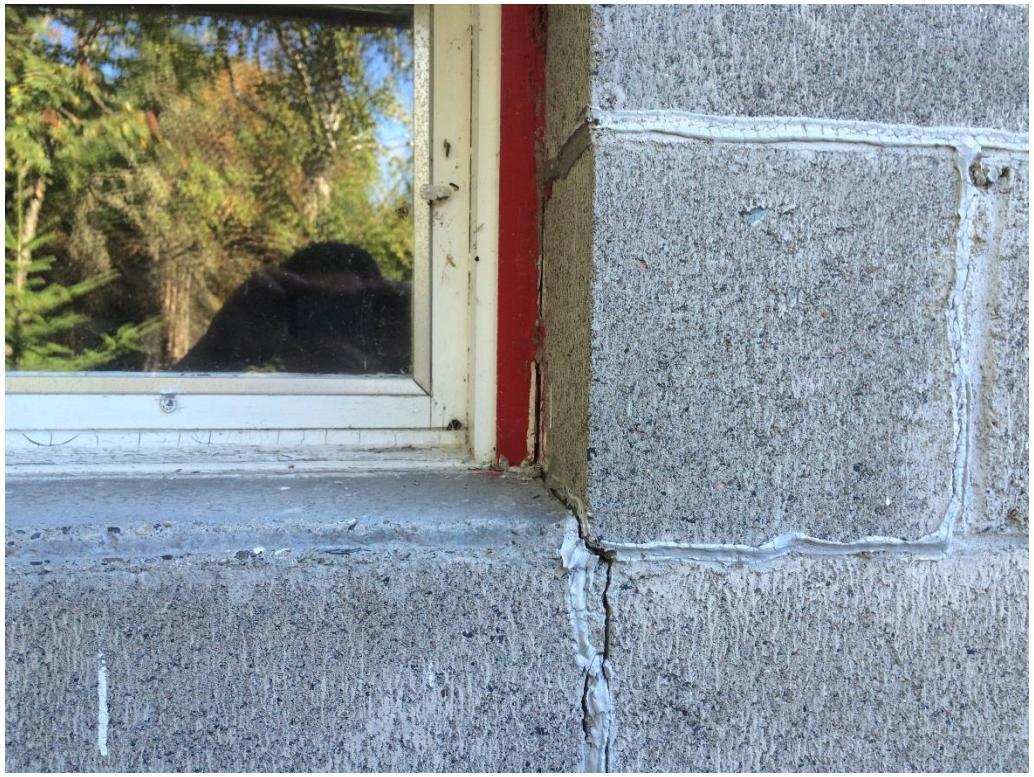
Photo 9: Typical sealant failure and paint peeling at windows.

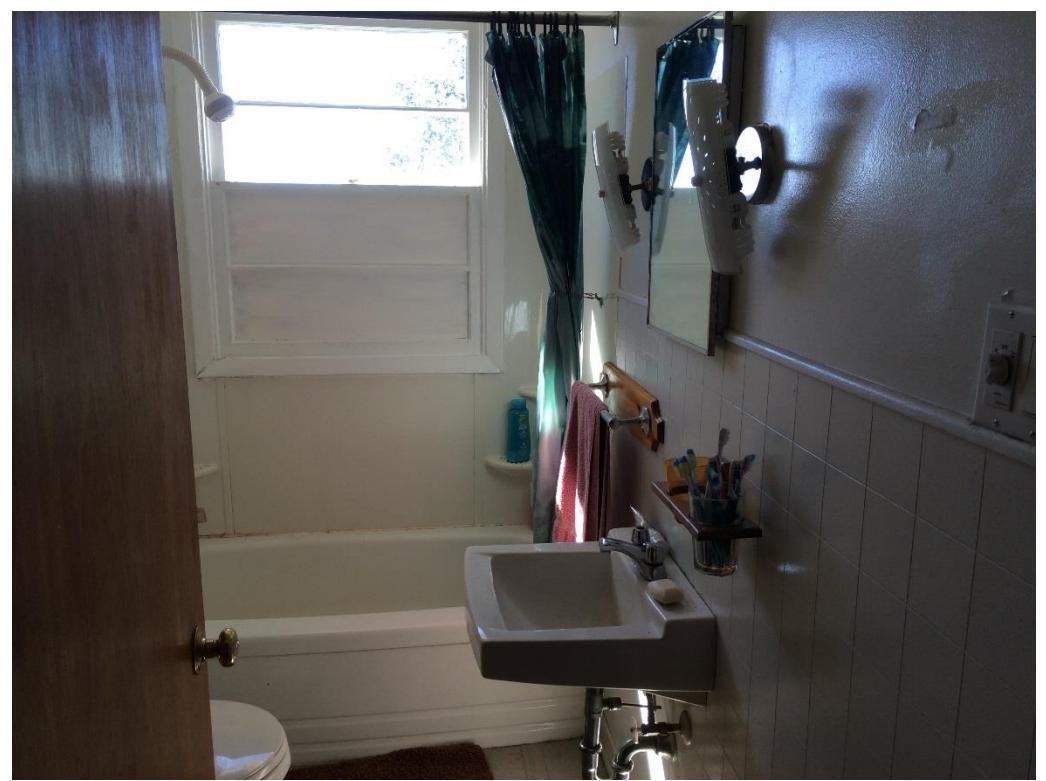
Photo 15: Typical bathroom. Failed sealant at bathtub.

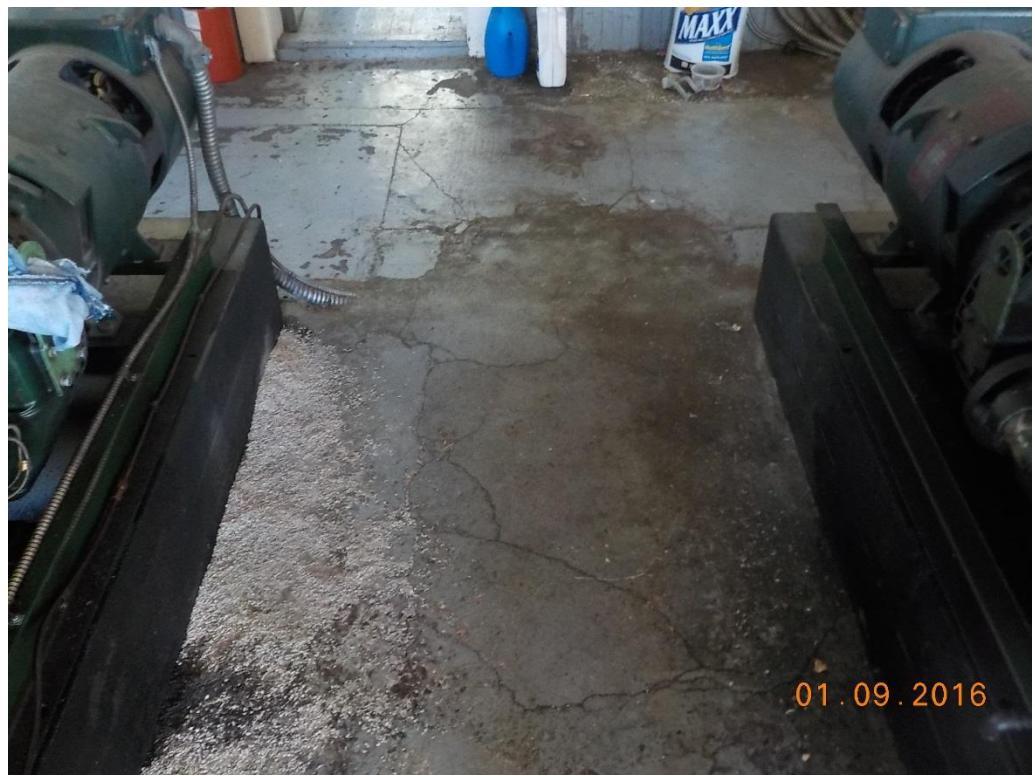
Photo 4: Cracks at concrete slab.

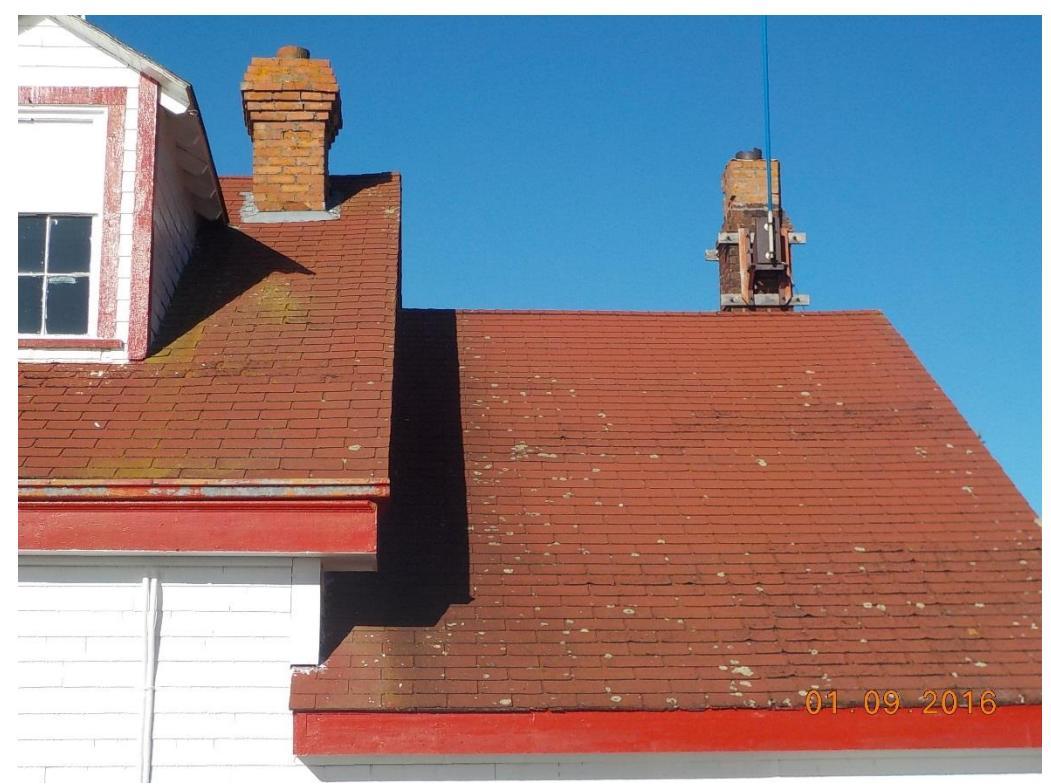
Photo 12: Typical fishmouthing, curling and moss growth at shingles.

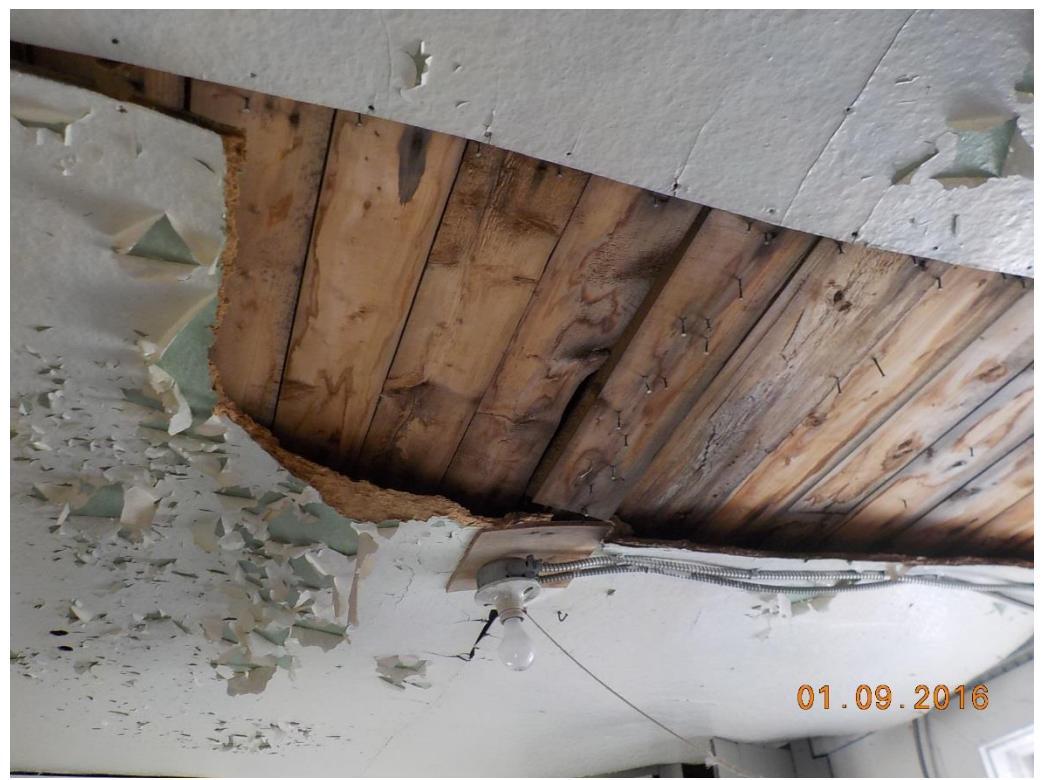
Photo 17: Water damage at ceiling at second level.
