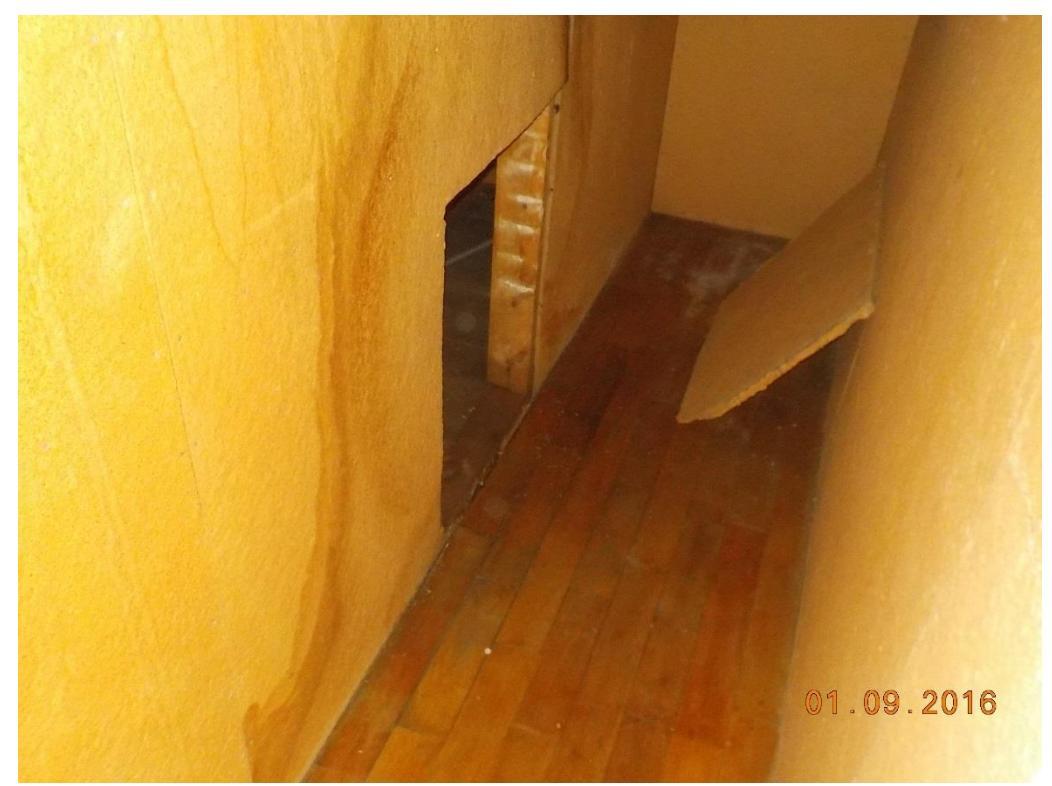
Photo 18: Water damage at walls at second level.

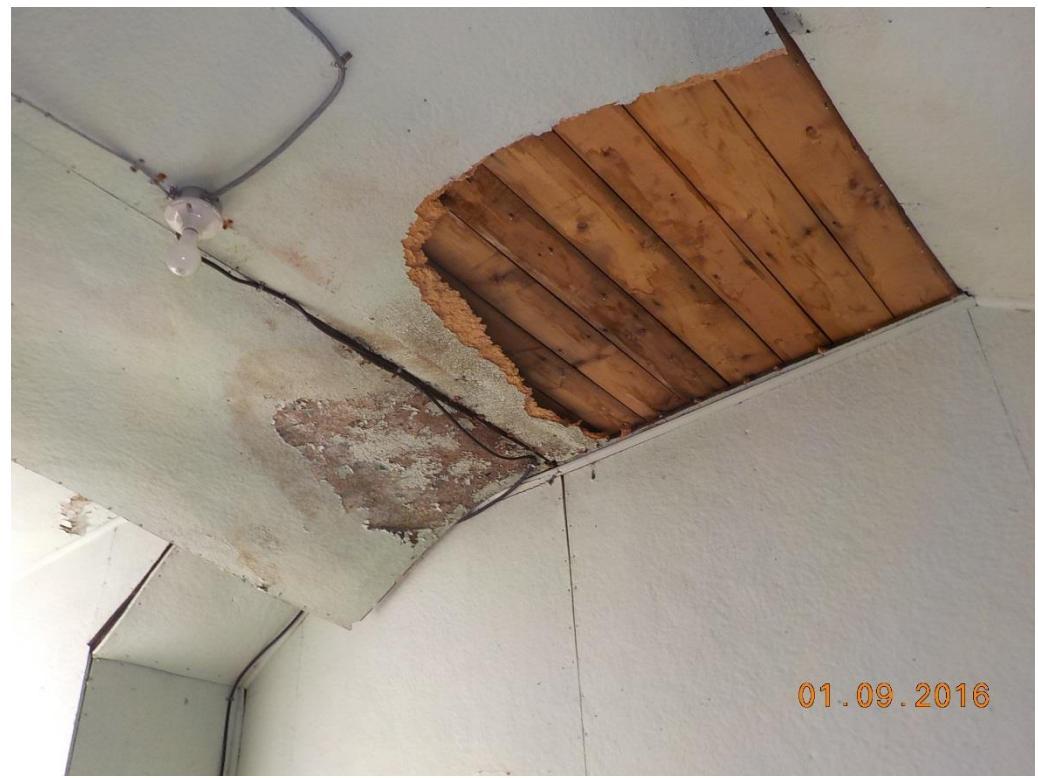
Photo 19: Water damage at ceiling at second level.

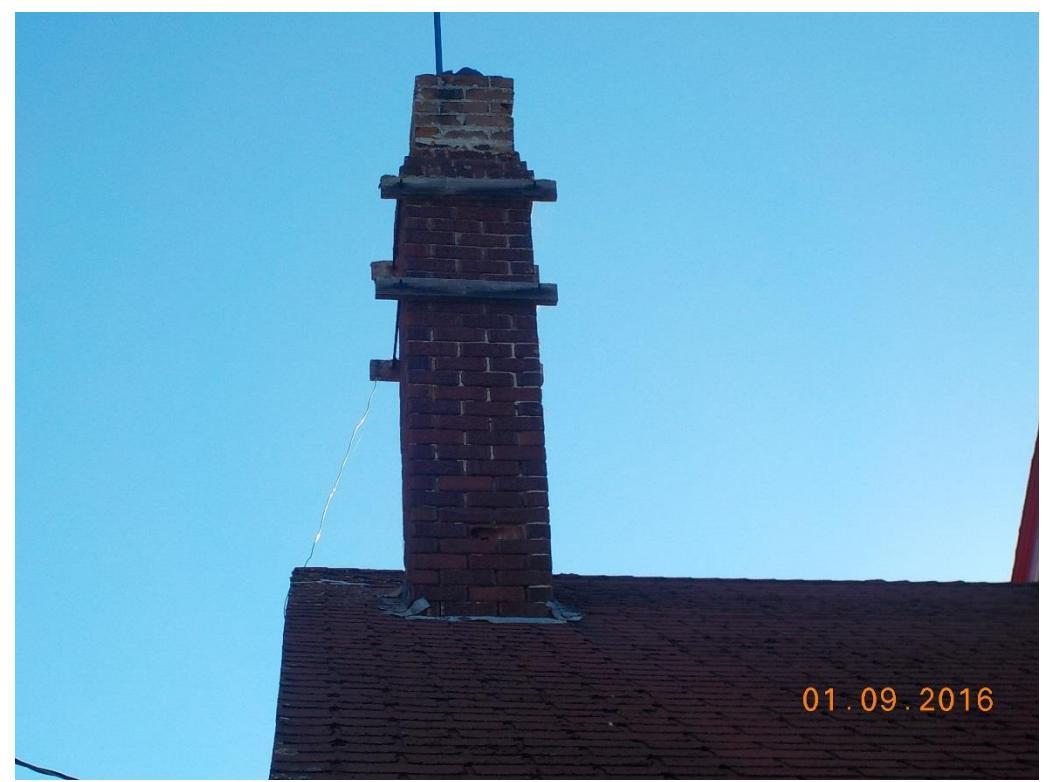
Photo 24: Missing brick, broken brick, and poor flashing at chimney.

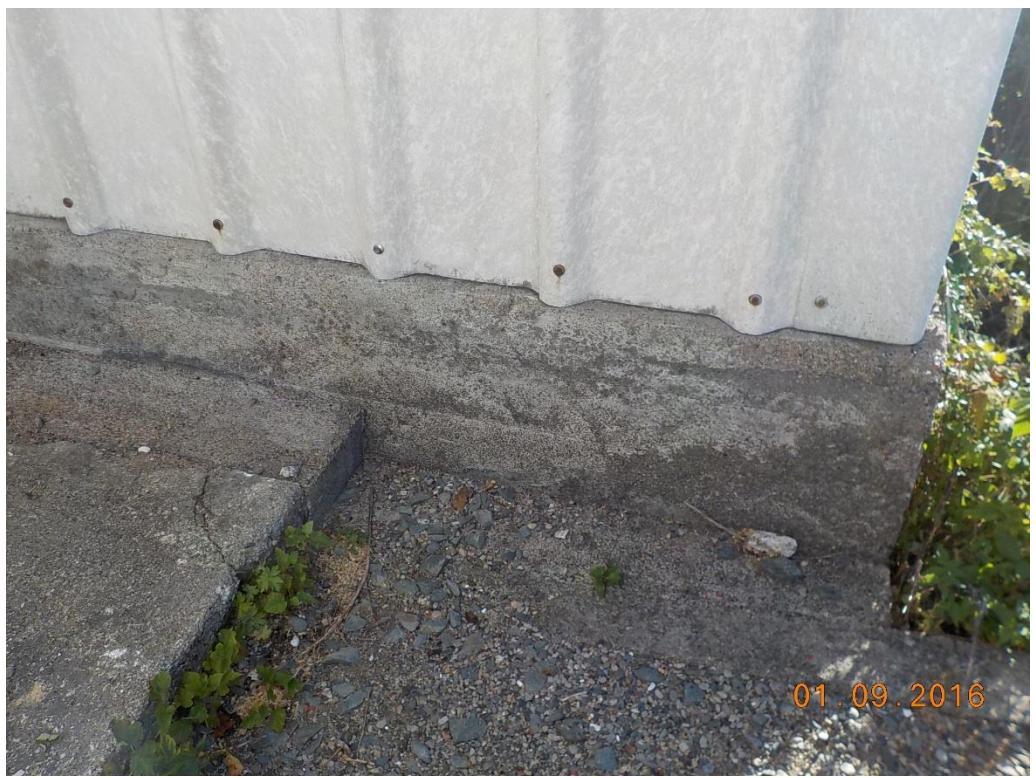
Photo 4: Missing sealant between wall and foundation. Light corrosion at fasteners.

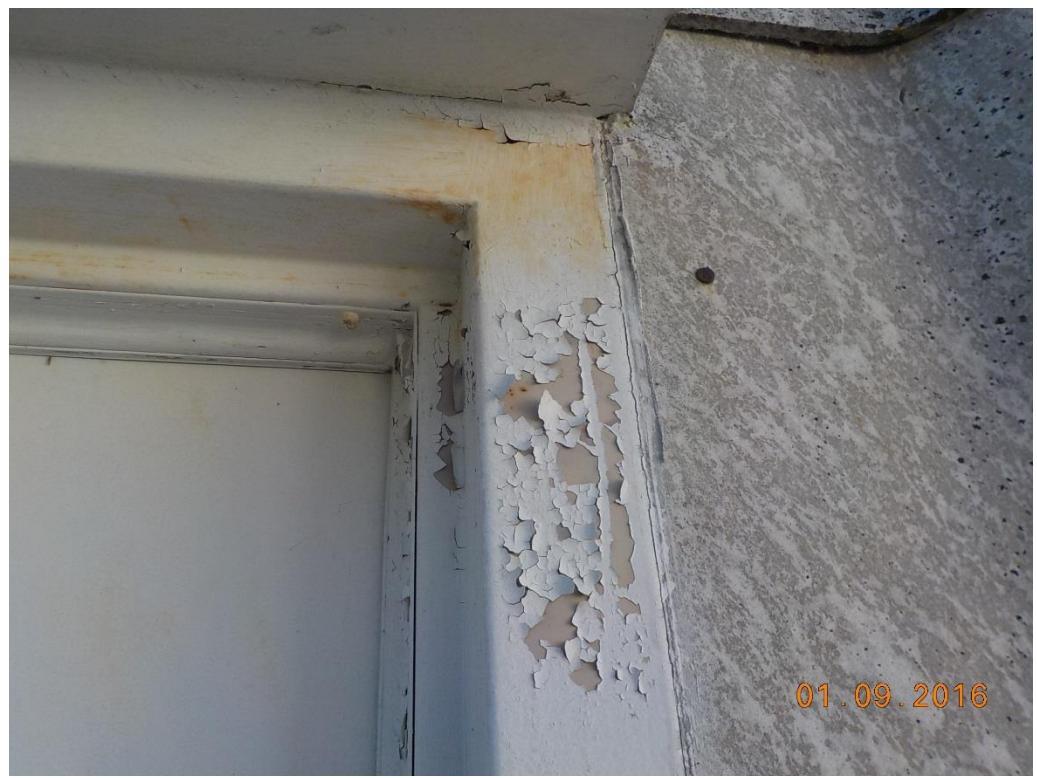
Photo 6: Cracked sealant, ineffective weather stripping, and peeling paint at door frame.

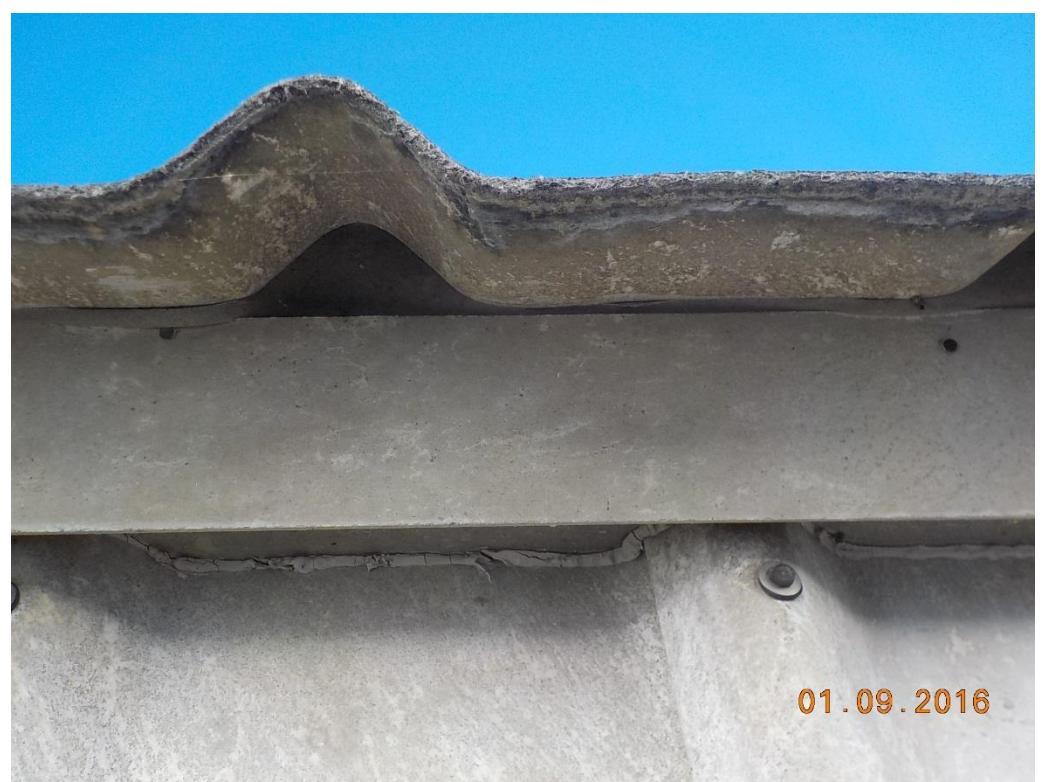
Photo 7: Failed closer strip below roof.

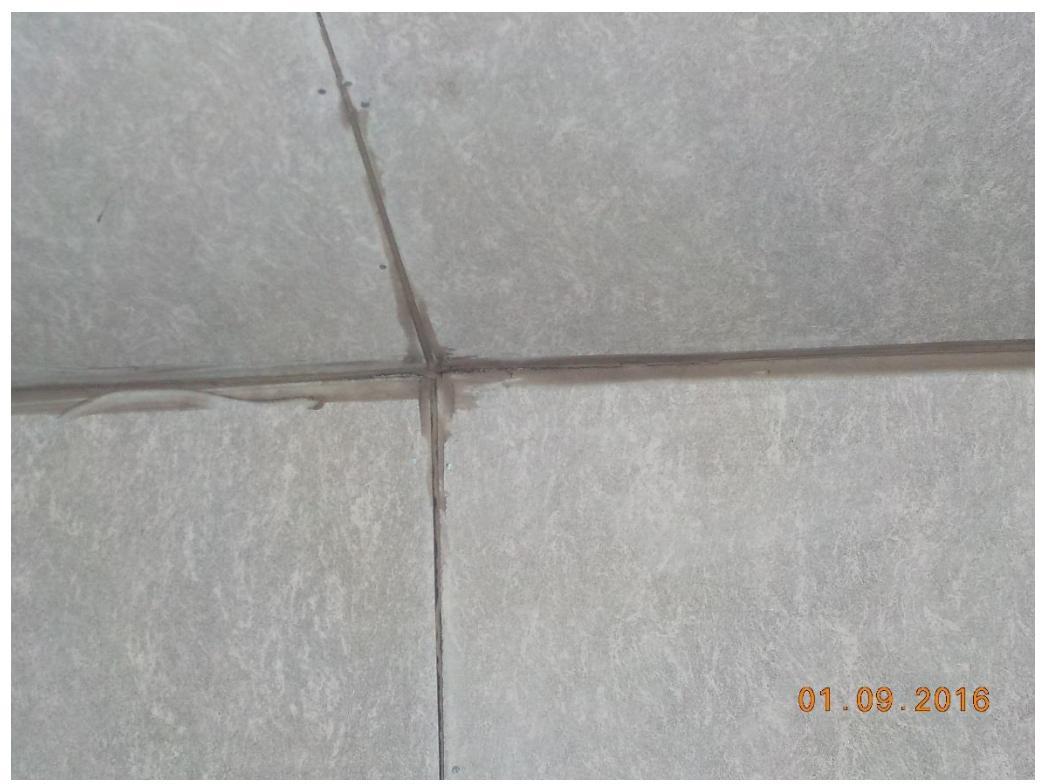
Photo 8: Cracked sealant at interior panels.

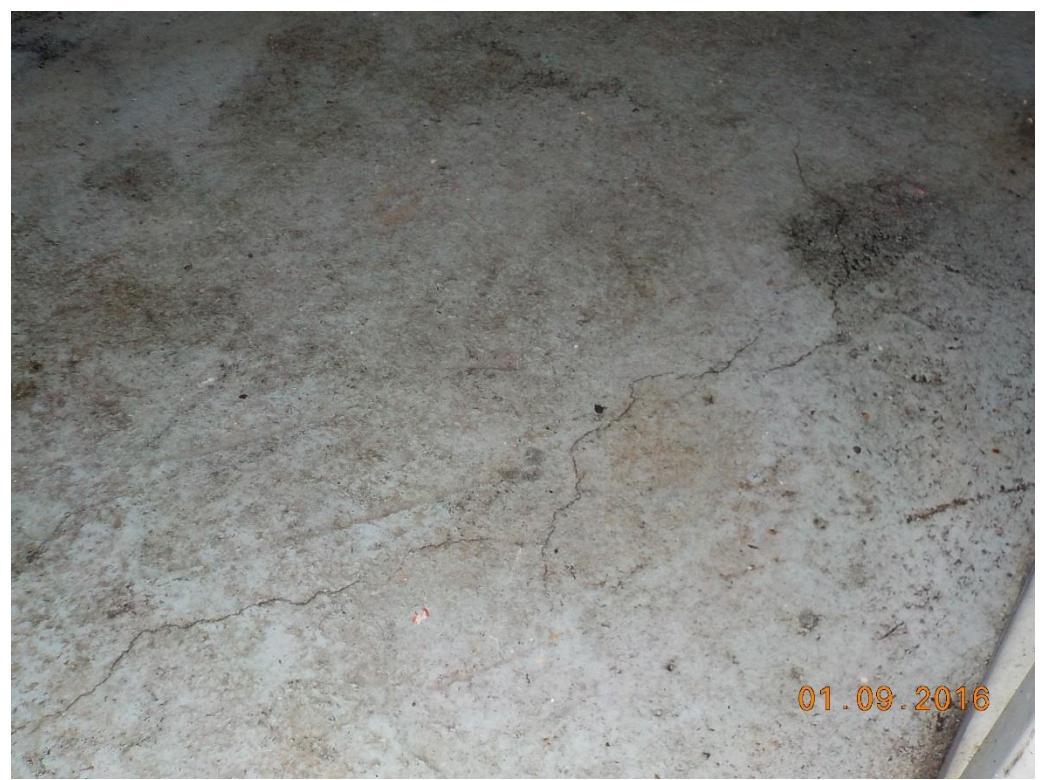
Photo 4: Cracks at foundation slab.

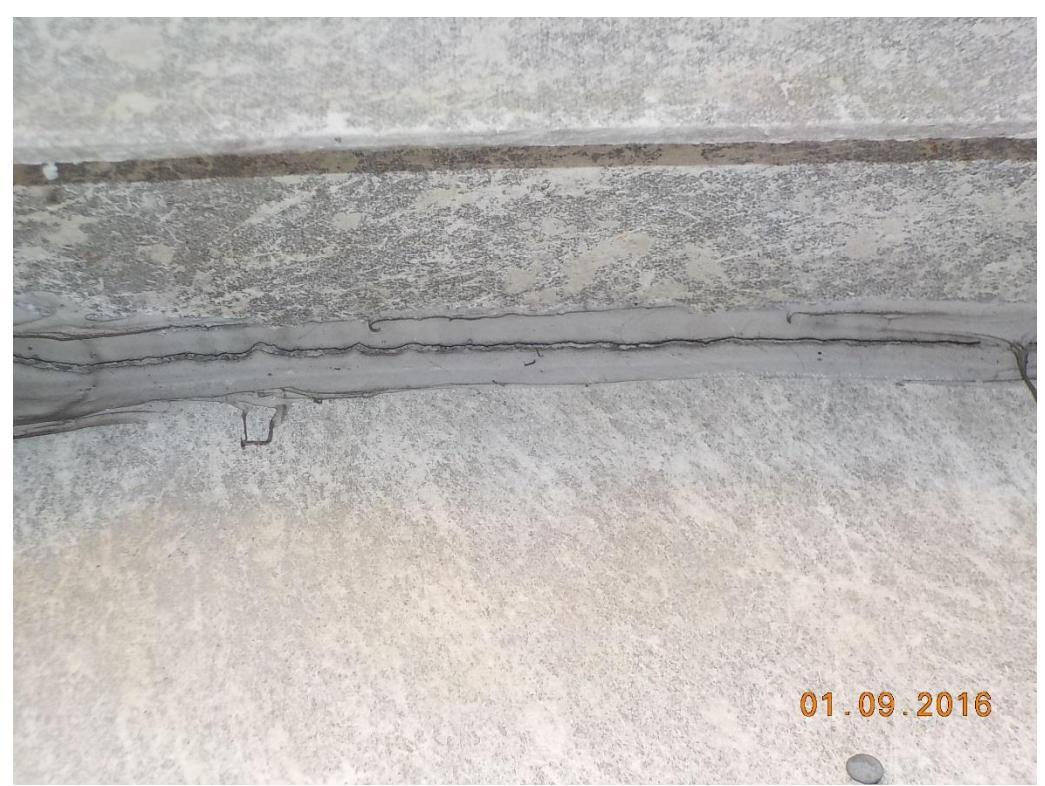
Photo 6: Cracked sealant between wall and roof.

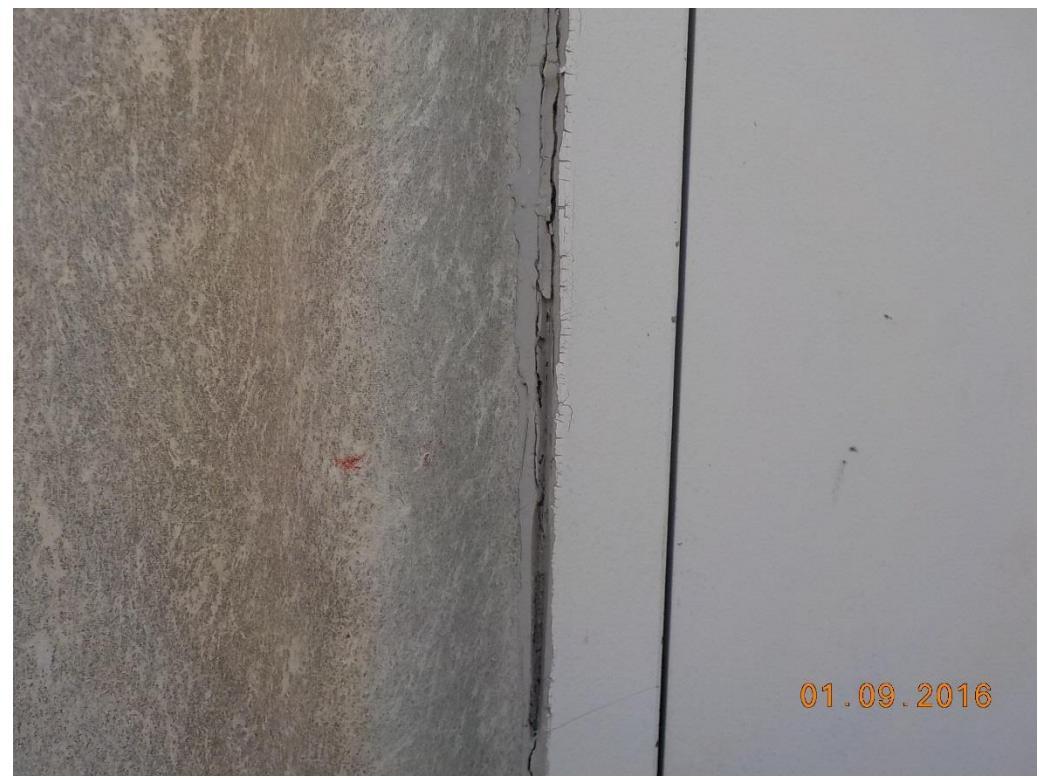
Photo 8: Cracked sealant at door frame.

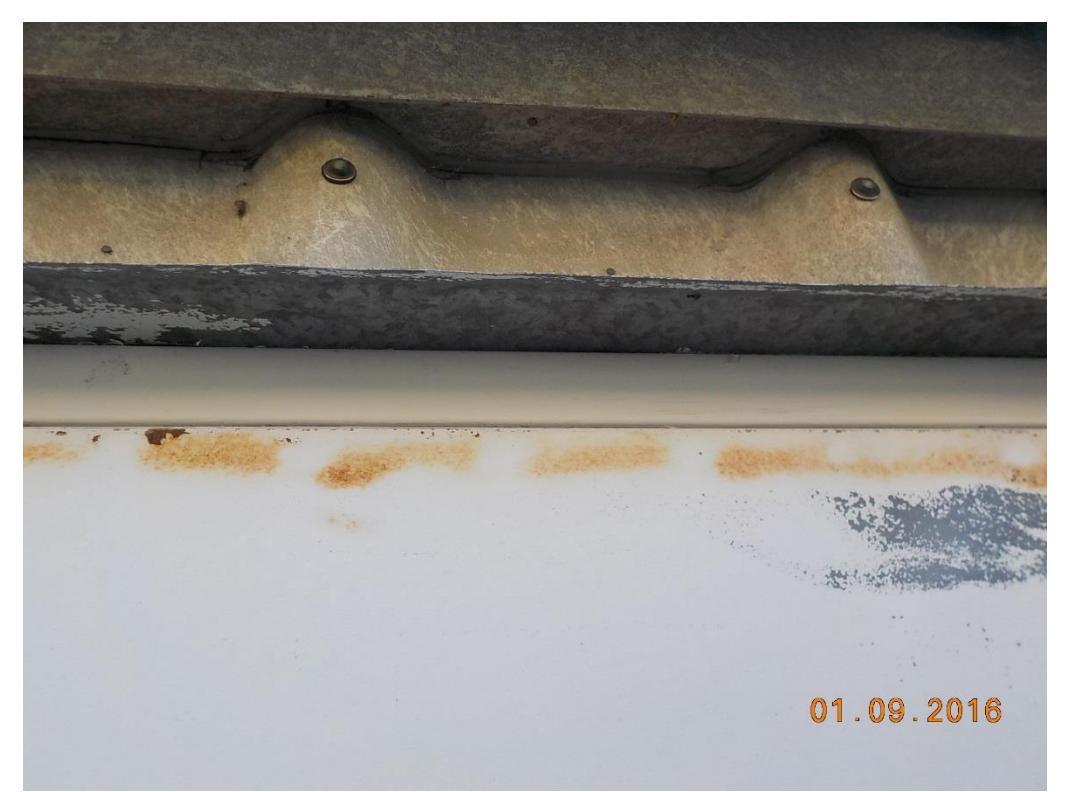
Photo 9: Paint peeling and light corrosion at door.

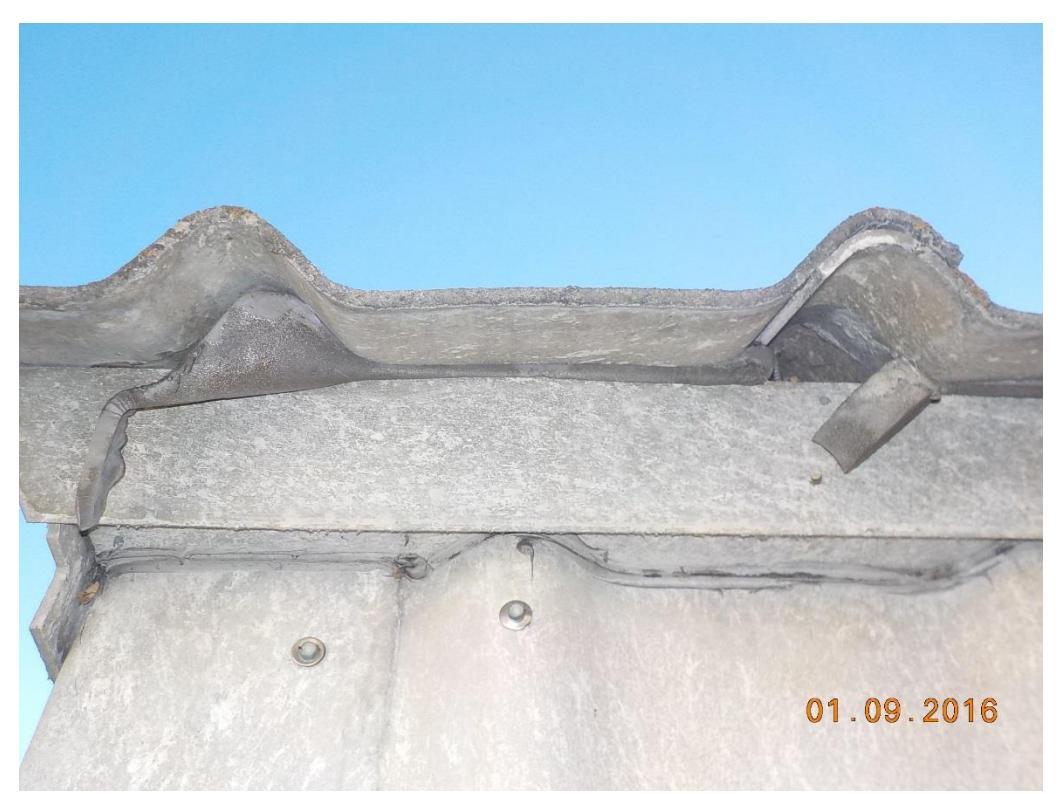
Photo 10: Failed closer strip below roof.

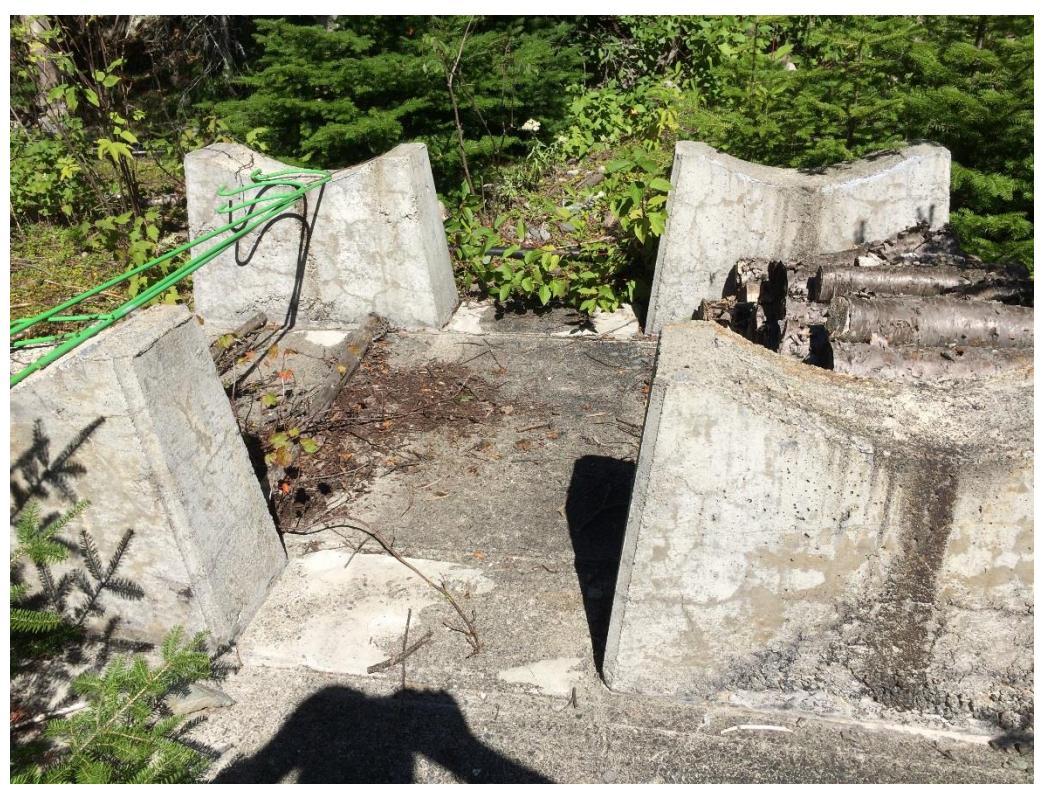
Photo 3: Typical scaling and cracking at concrete cradles.

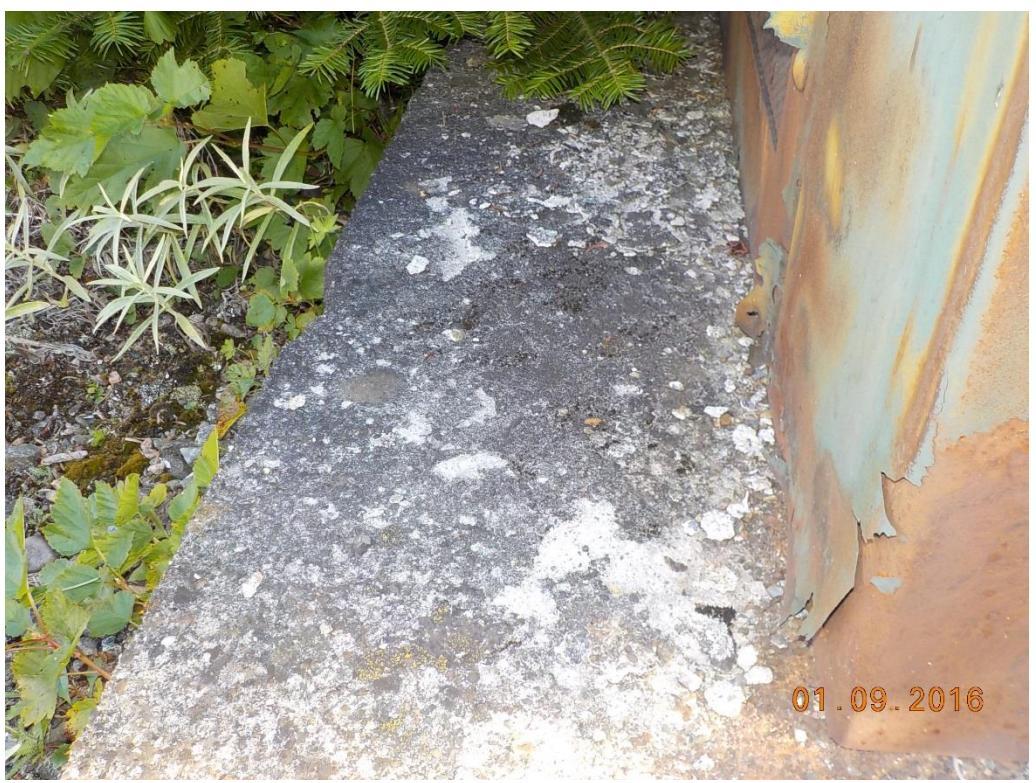
Photo 3: Light corrosion and paint peeling at steel box. Medium scaling at concrete slab.

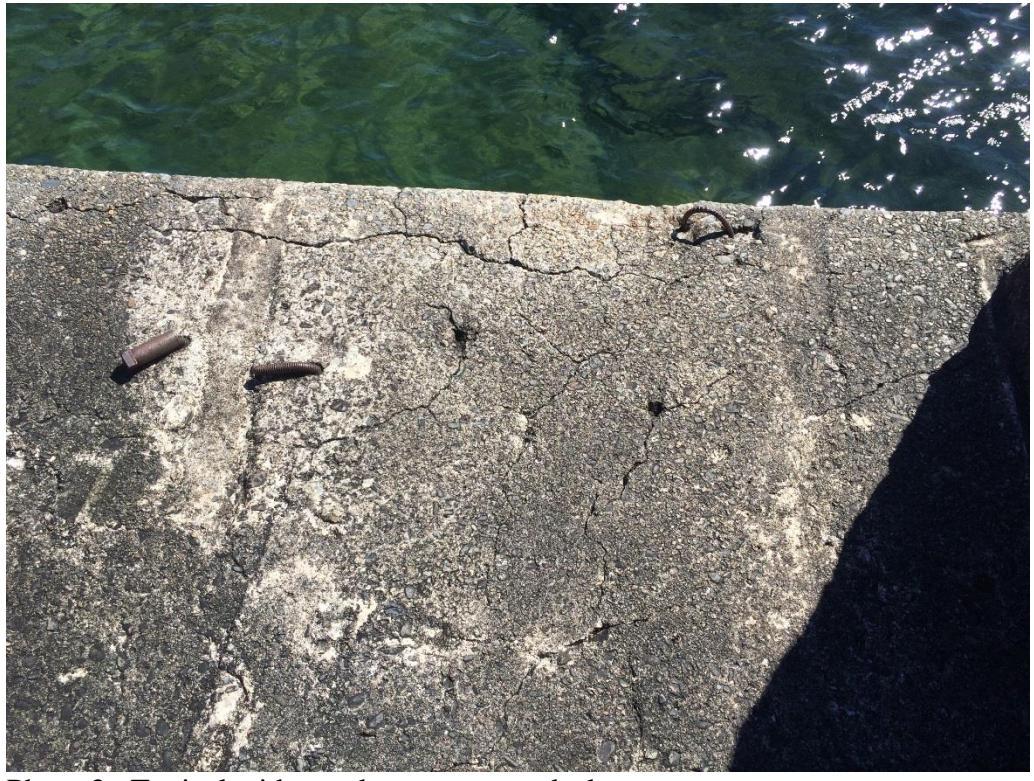
Photo 3: Typical wide cracks at concrete deck.

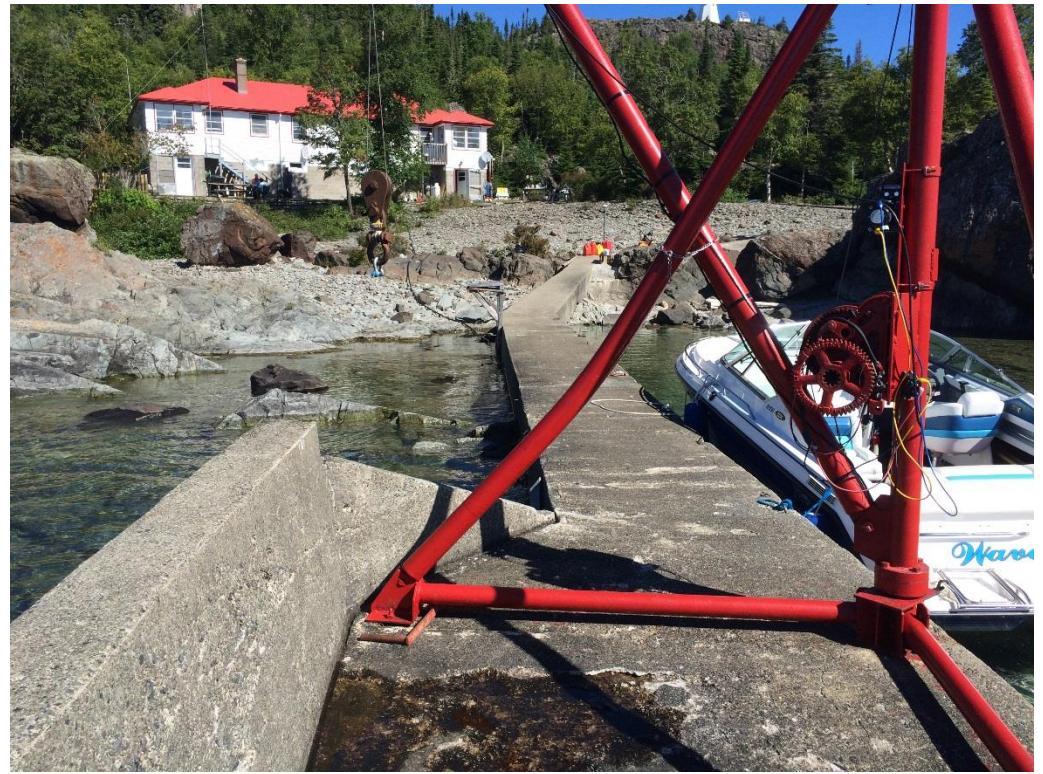
Photo 4: Spalling at concrete deck.

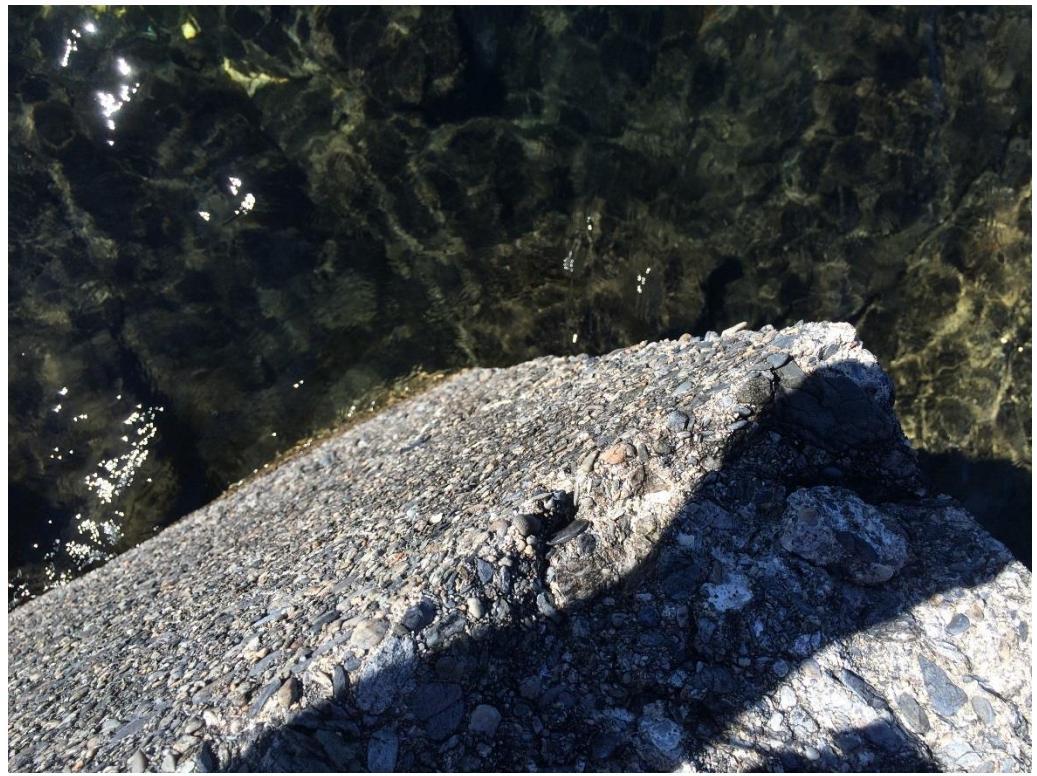
Photo 6: Light to medium scaling at concrete walls.

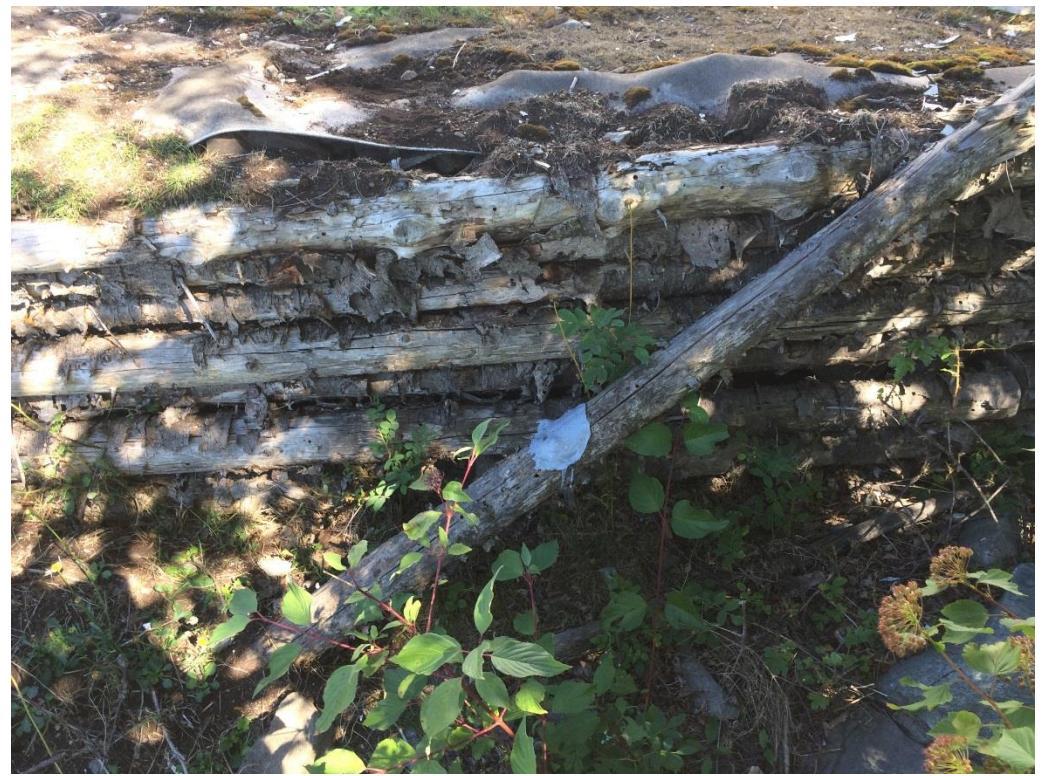
Photo 2: Medium to severe rot at logs.

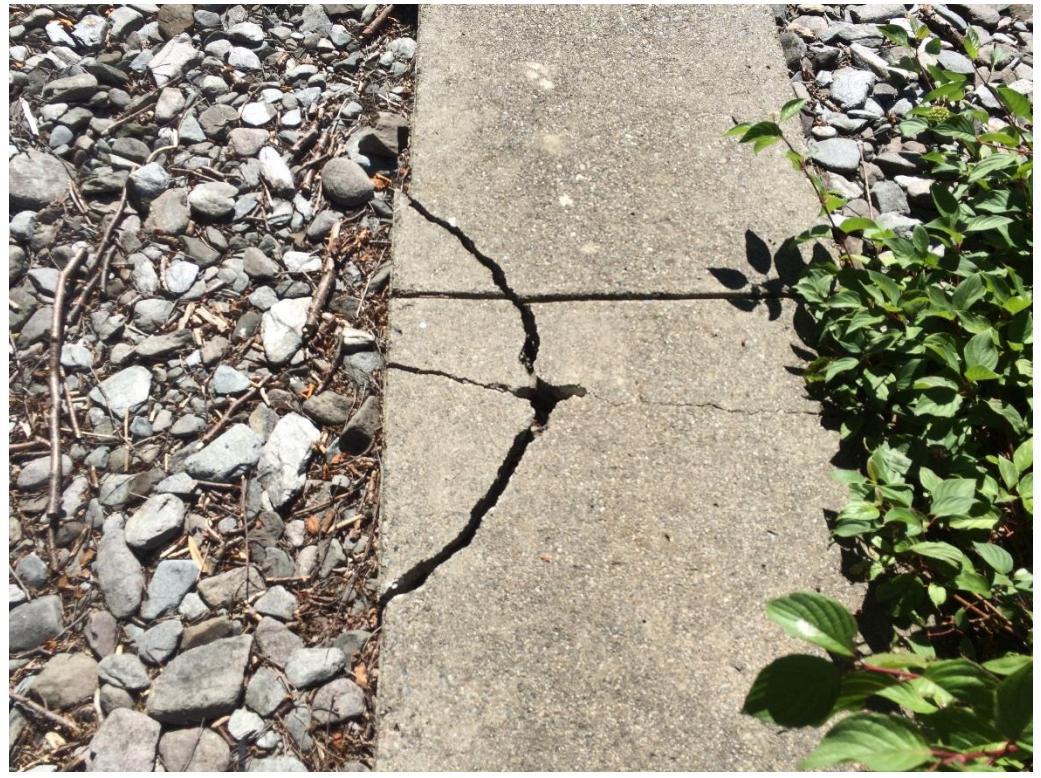
Photo 4: Cracked and broken Sidewalk panel.

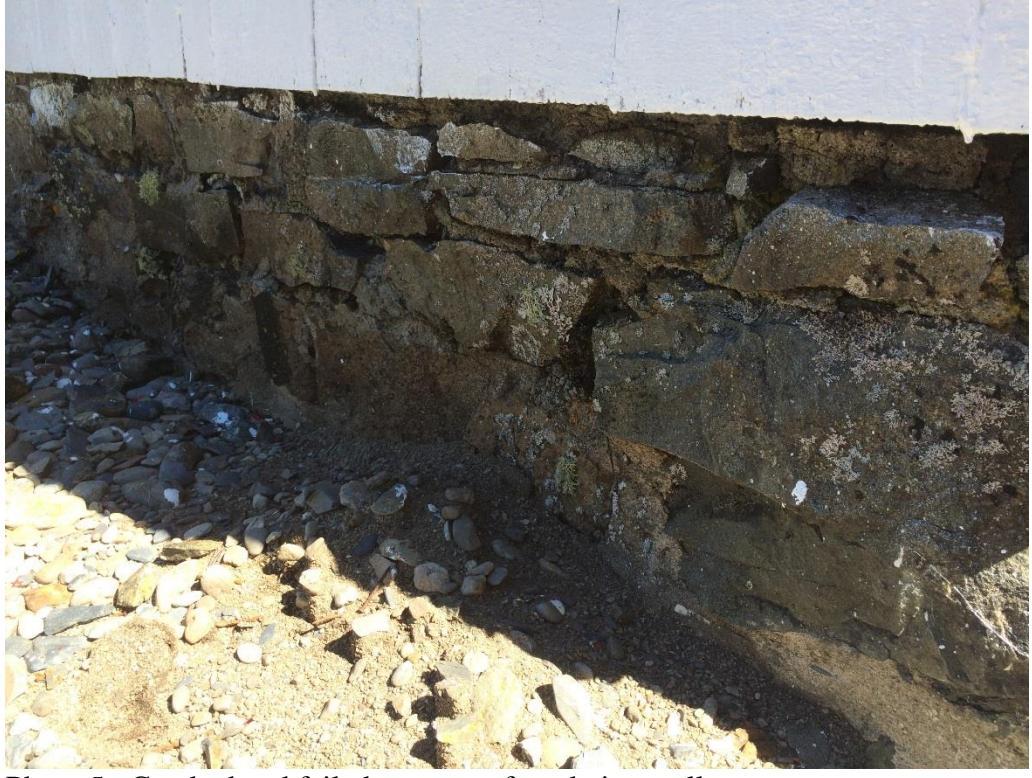
Photo 5: Cracked and failed mortar at foundation wall.

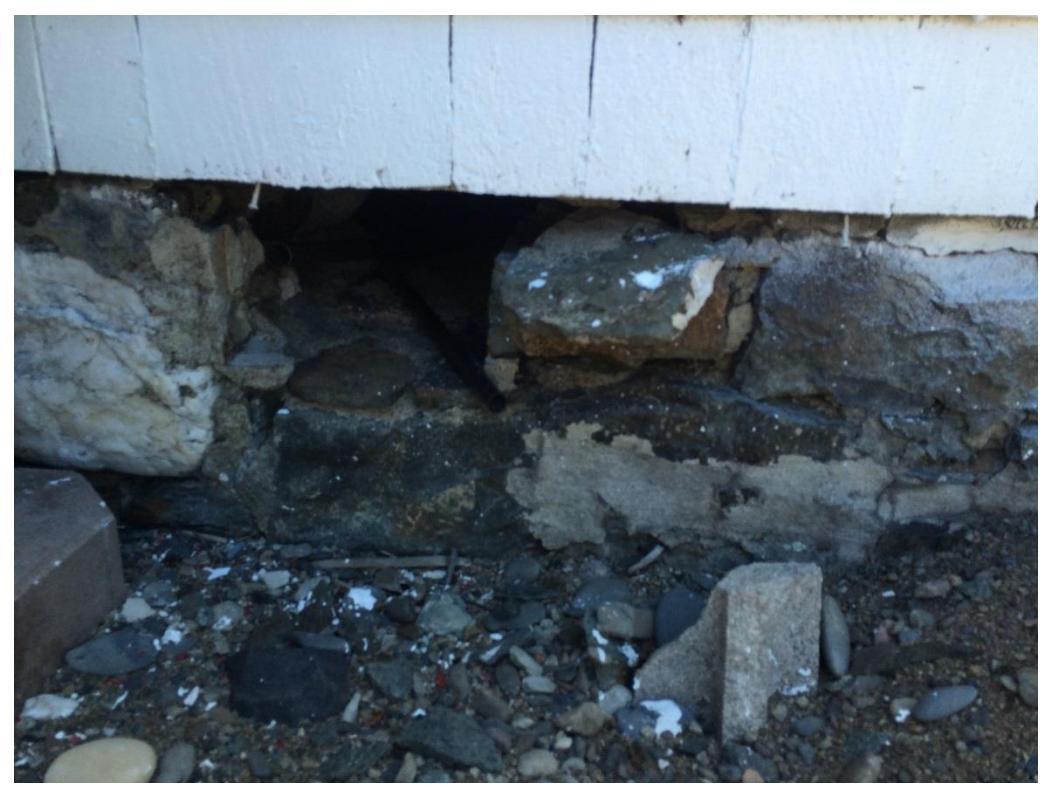
Photo 6: Missing stone at foundation wall.

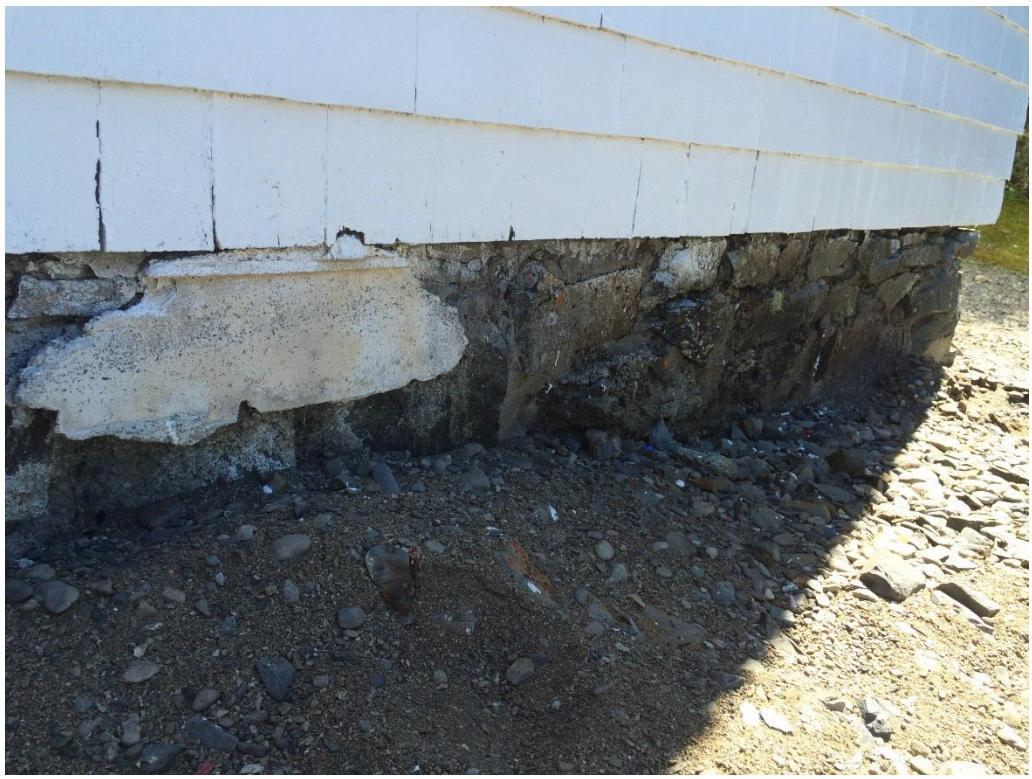
Photo 7: Previous repair at foundation wall.

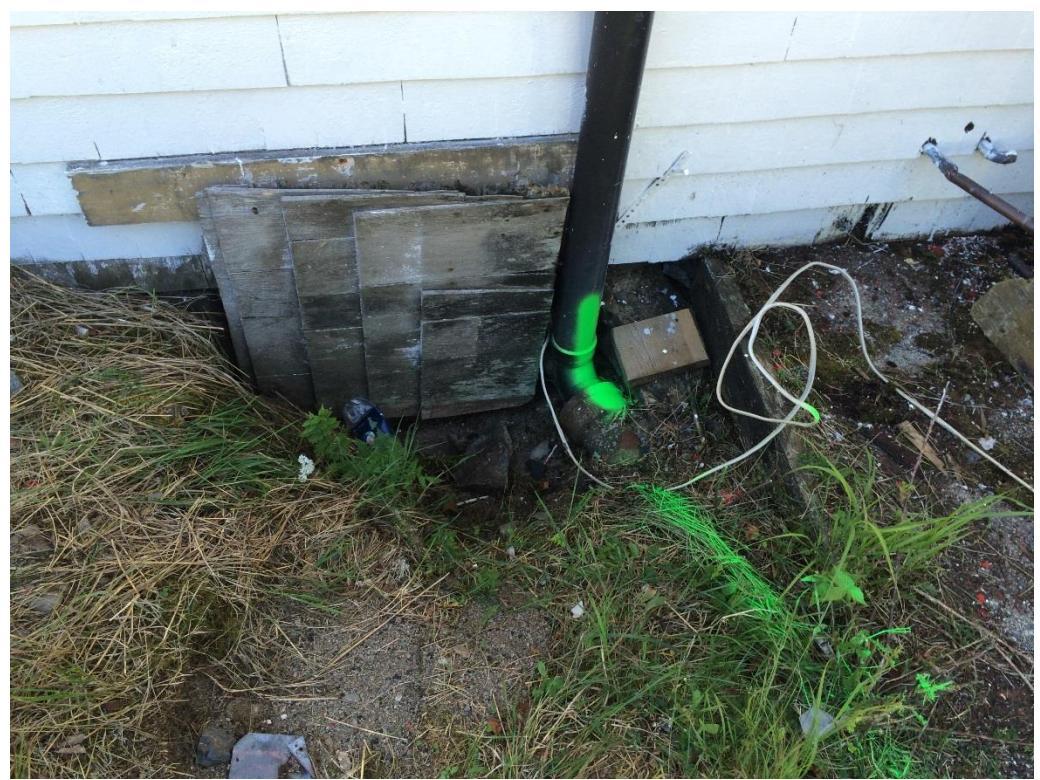
Photo 8: Void in foundation wall covered by plywood.

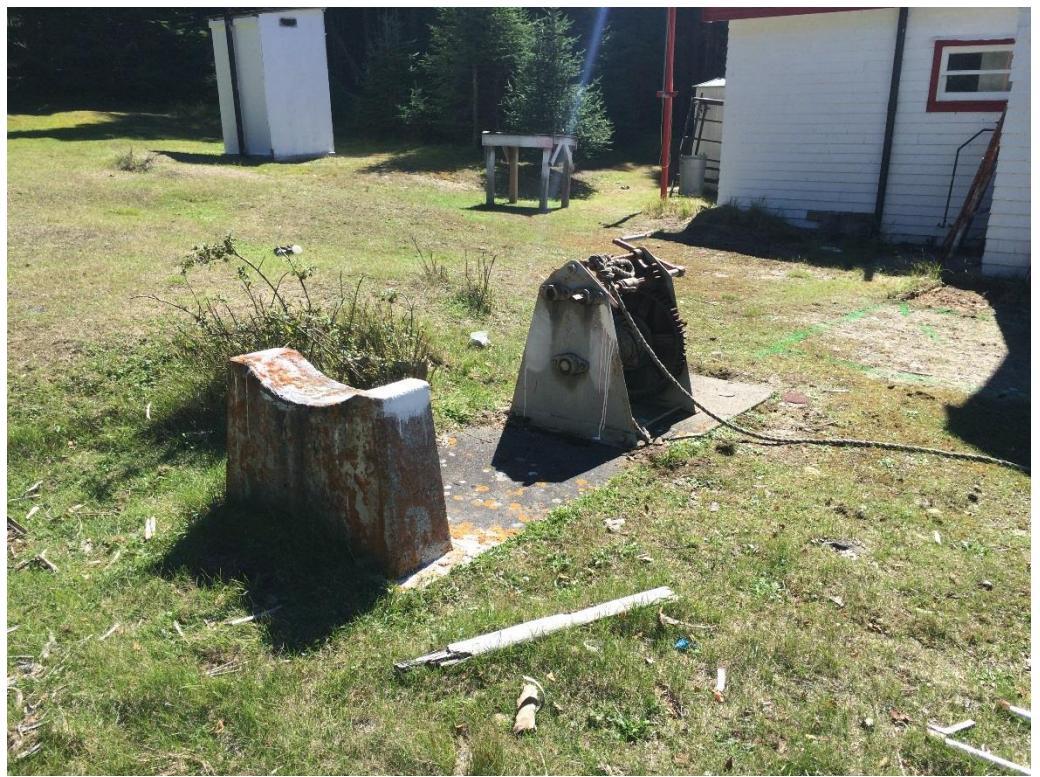
Photo 3: Vegetative growth at cradle and slab.

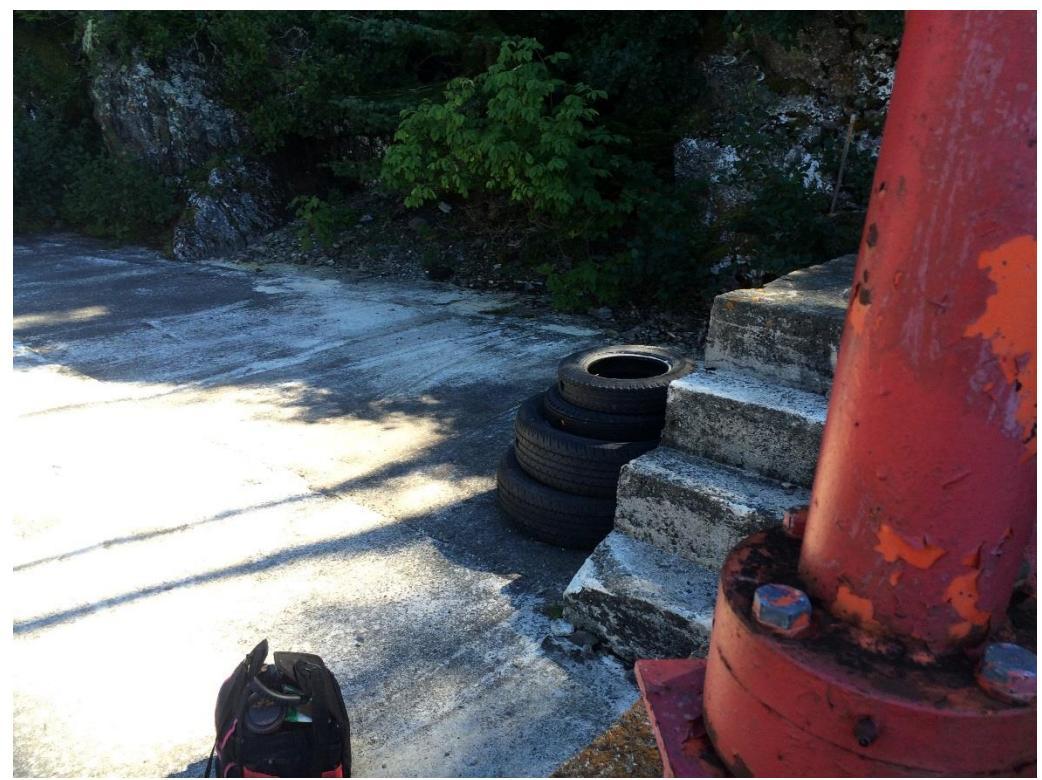
Photo 4: Paint peeling at steel hoist.
