**BABINE HOUSING DEMOLITION**  
**SUMMARY OF WORK**

**Picture of the Atco Trailer to be demolished**

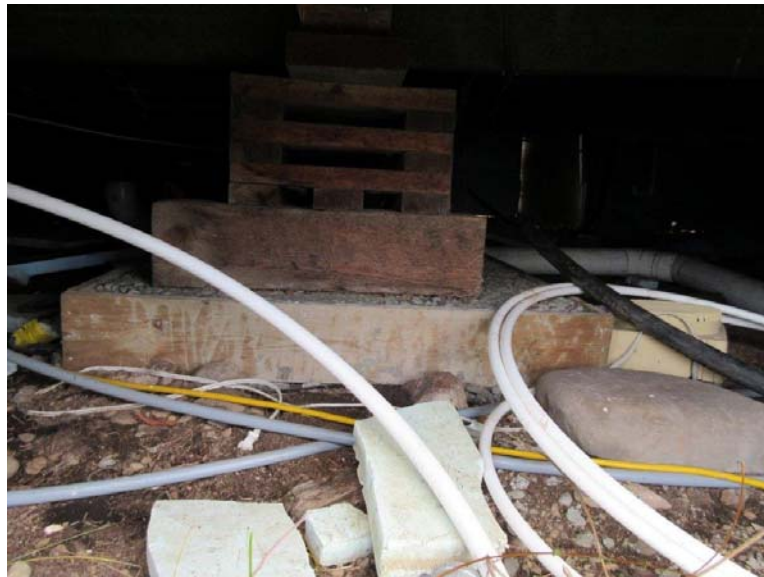
***Building Foundation***

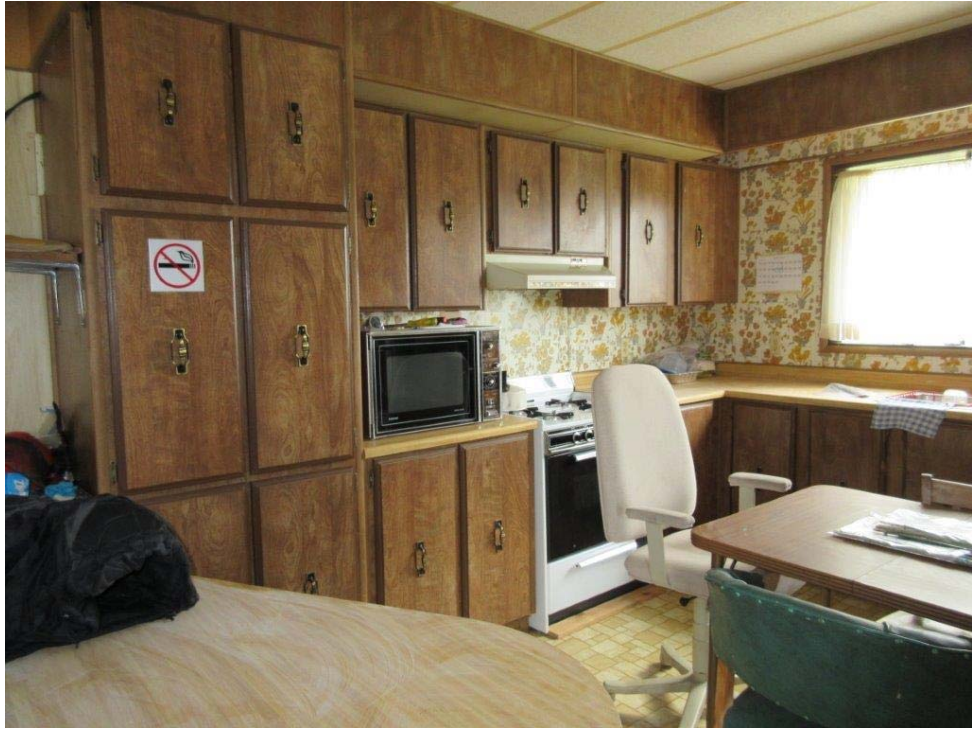
***Building Interior***

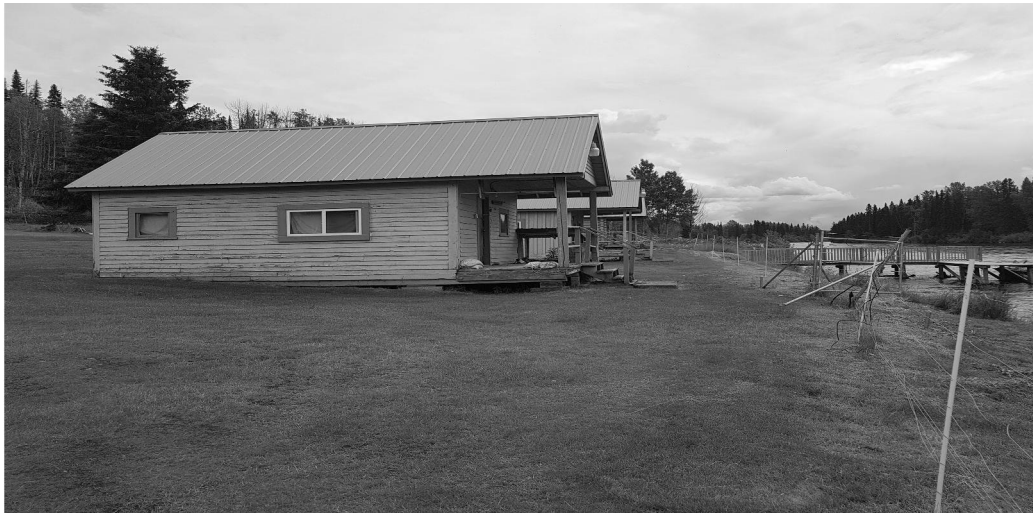
**Pre-renovations Hazardous Materials  
Inventory and Risk Assessment  
of the  
Babine Fish Fence Campsite  
Kilometer 60, FSR4000  
Regional District Bulkley Nechako, BC**

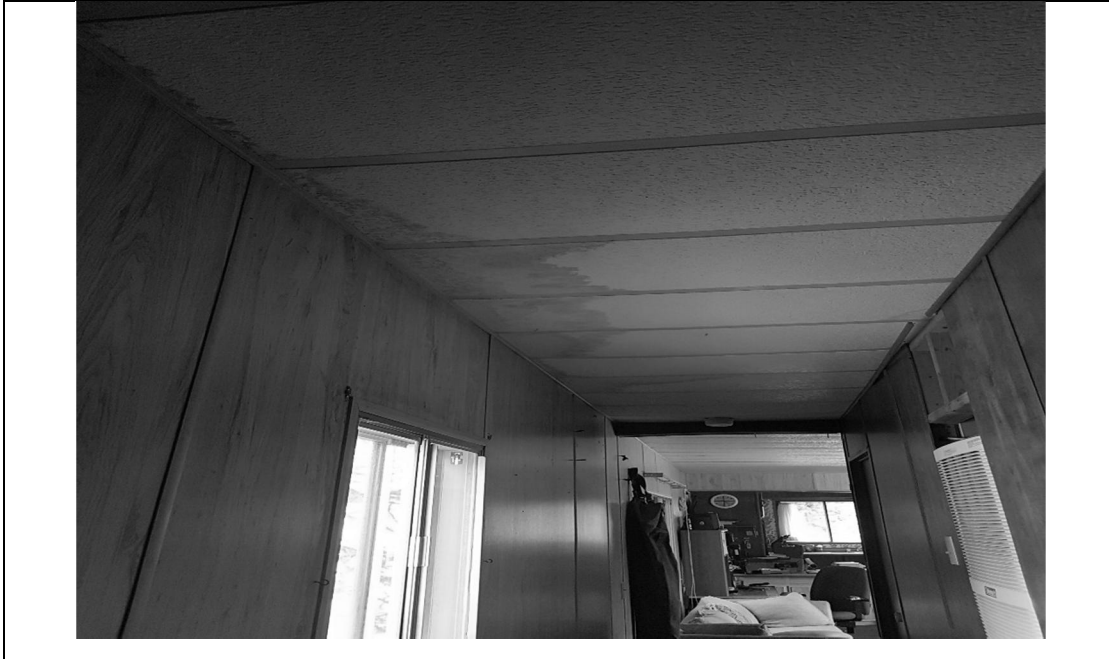
<b>Photo 5</b>	<b>Date:</b> July 13, 2017	<b>Location:</b> BFF Campsite - Trailer
<b>Description:</b> View of the perimeter surface staining of the ceiling. Cause is water seepage through the roof.

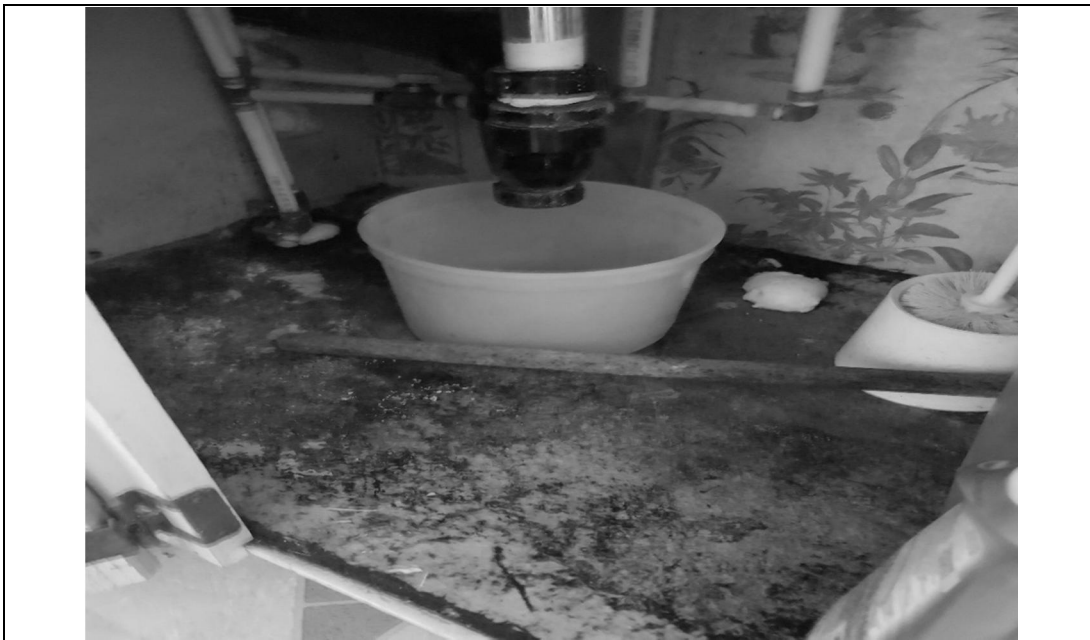
<b>Photo 6</b>	<b>Date:</b> July 13, 2017	<b>Location:</b> BFF Campsite - Trailer
<b>Description:</b> View of the bathroom sink cabinet; suspect fungal growth on surface of cabinet.

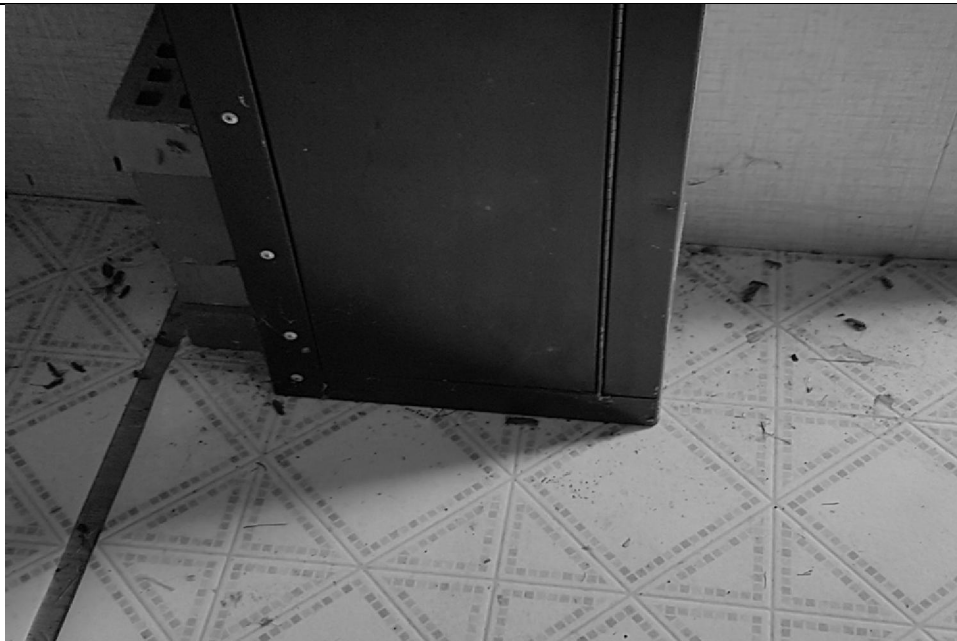
<b>Photo 10</b>	<b>Date:</b> July 13, 2017	<b>Location:</b> BFF Campsite - Cabins
<b>Description:</b> Typical view of the living and dead stoneflies found inside of the cabins.

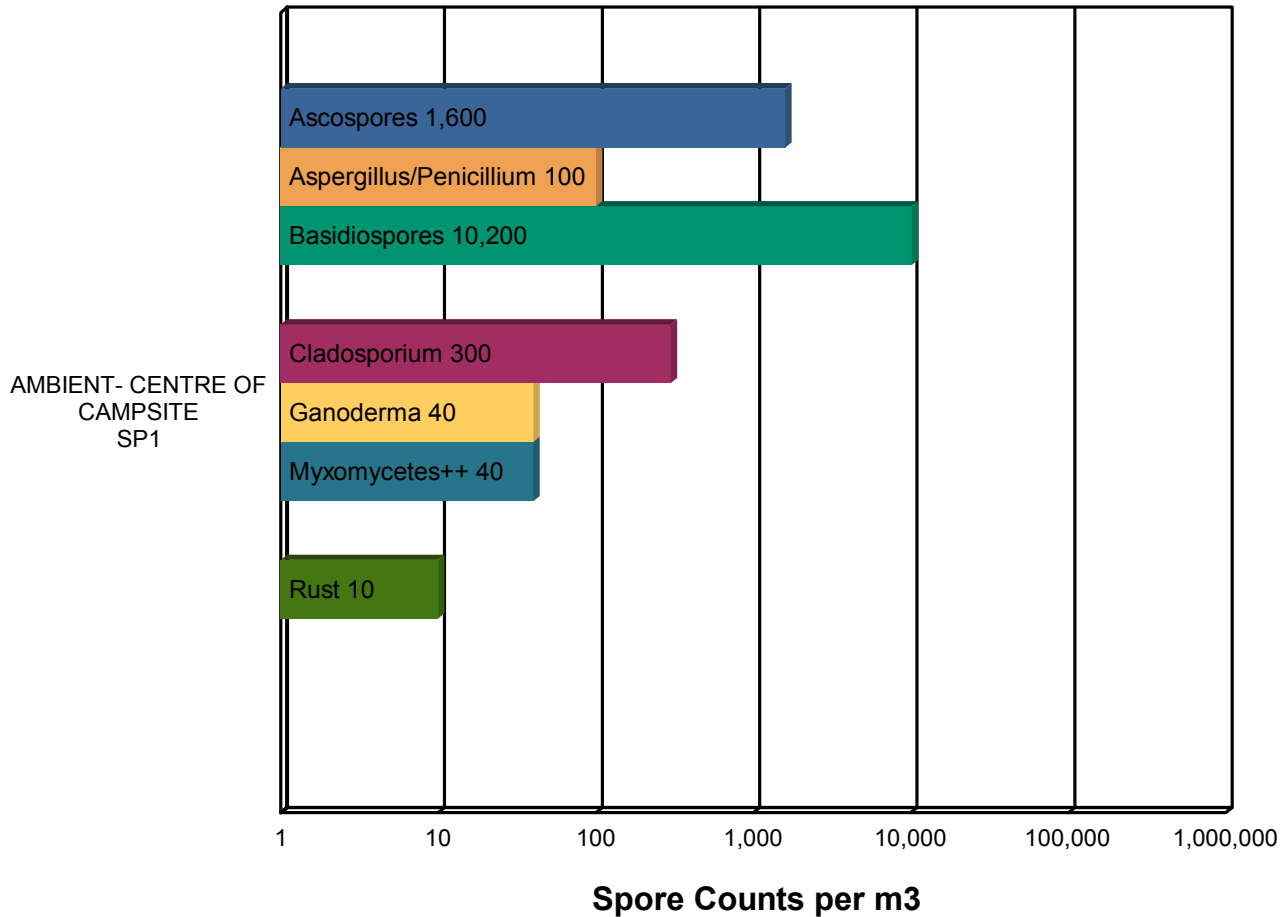
\* The chart is displayed using a logarithmic scale. Bar size is not directly proportional to the number of spores.

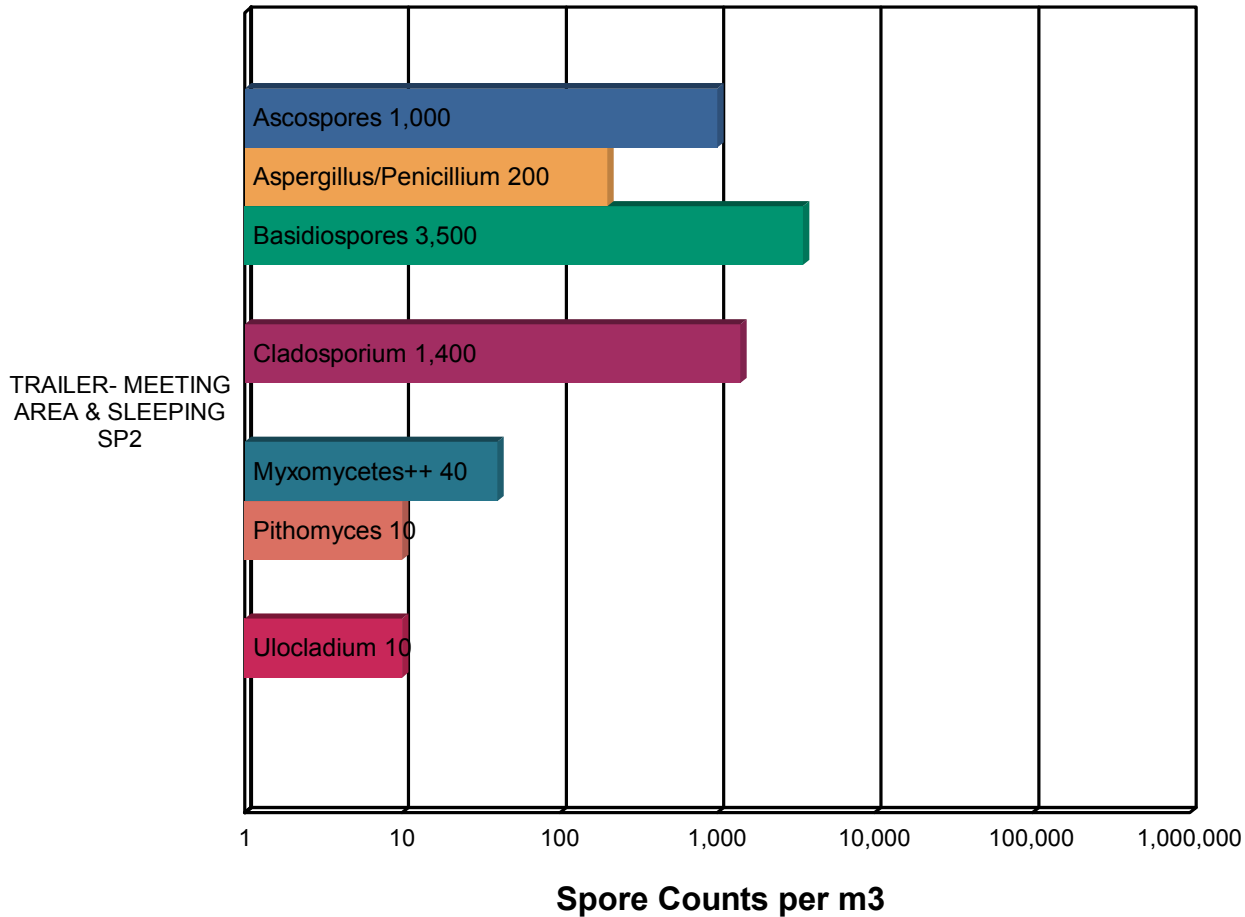
\* The chart is displayed using a logarithmic scale. Bar size is not directly proportional to the number of spores.

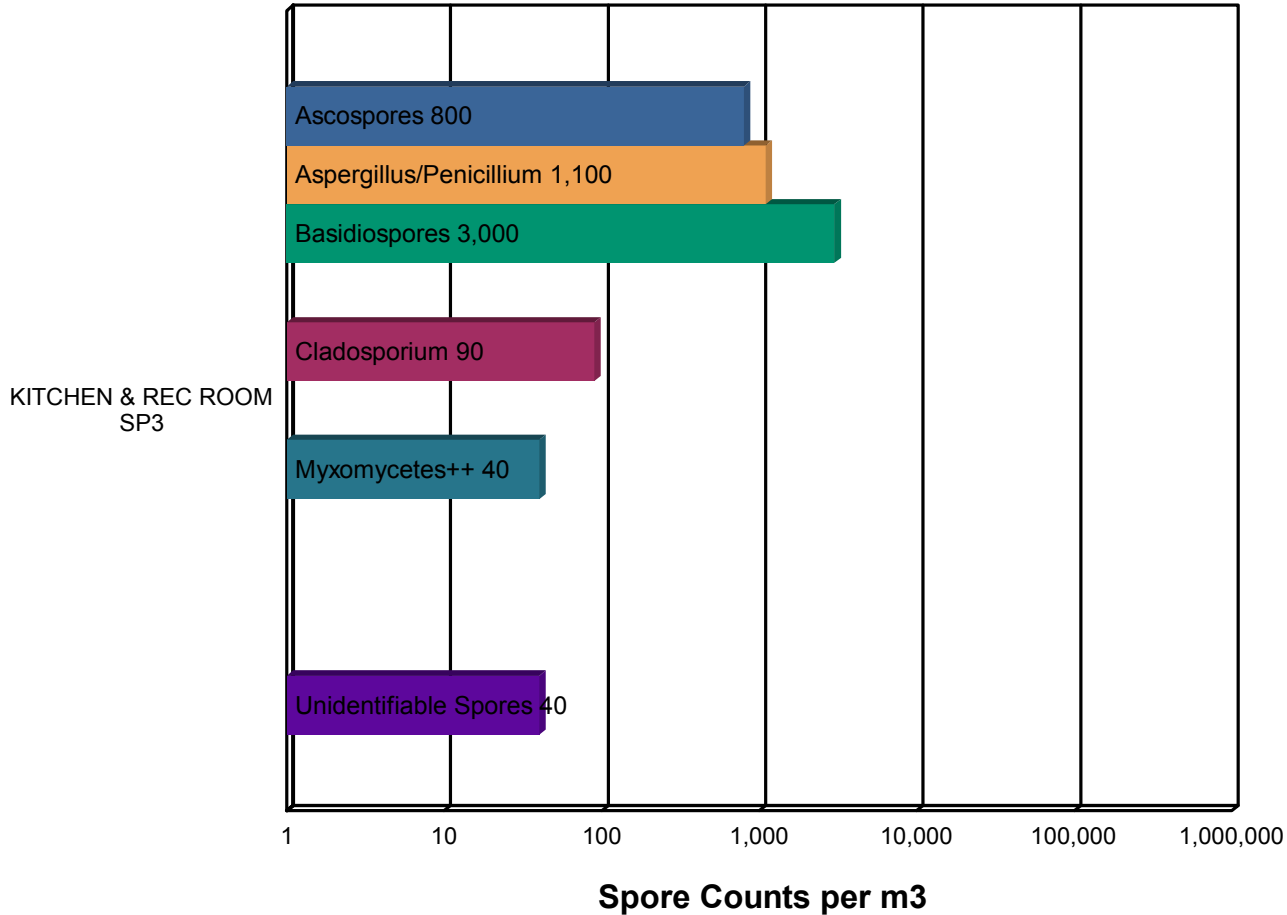
\* The chart is displayed using a logarithmic scale. Bar size is not directly proportional to the number of spores.

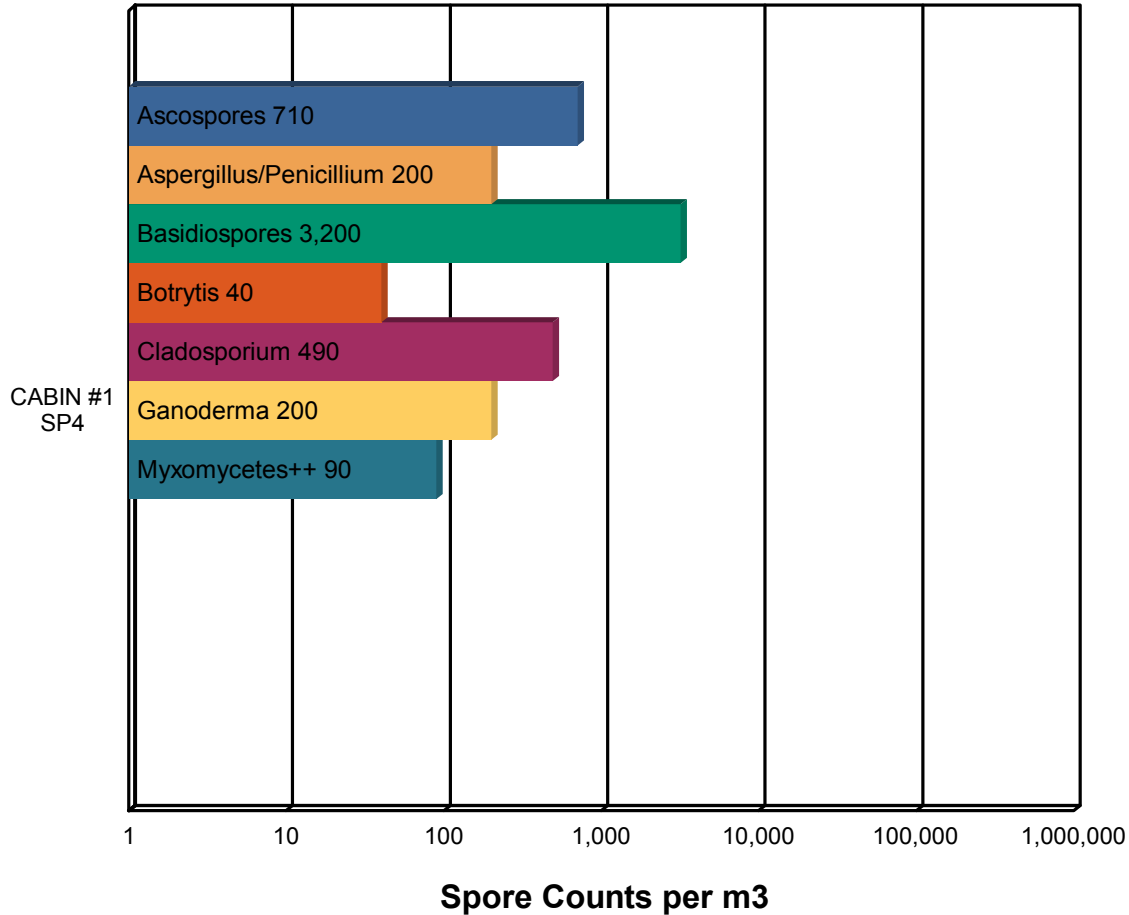
\* The chart is displayed using a logarithmic scale. Bar size is not directly proportional to the number of spores.

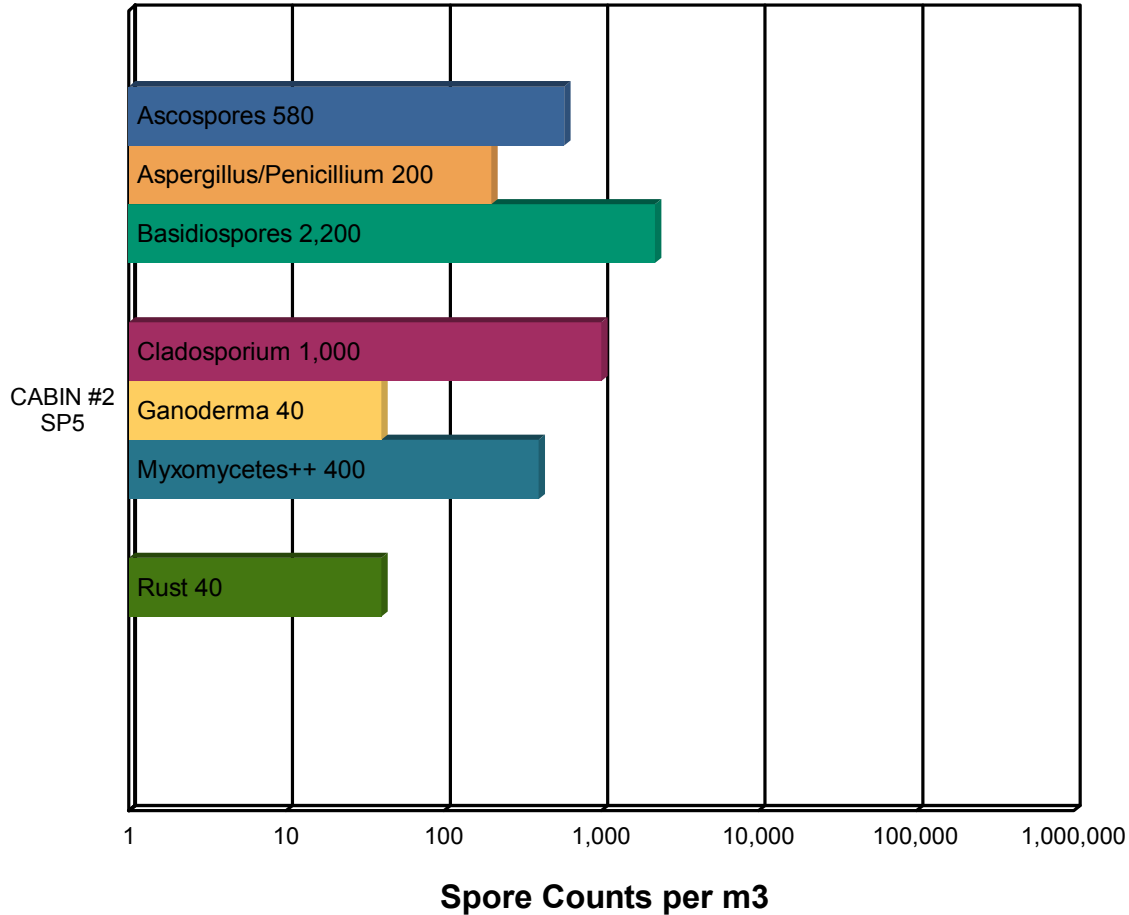
\* The chart is displayed using a logarithmic scale. Bar size is not directly proportional to the number of spores.

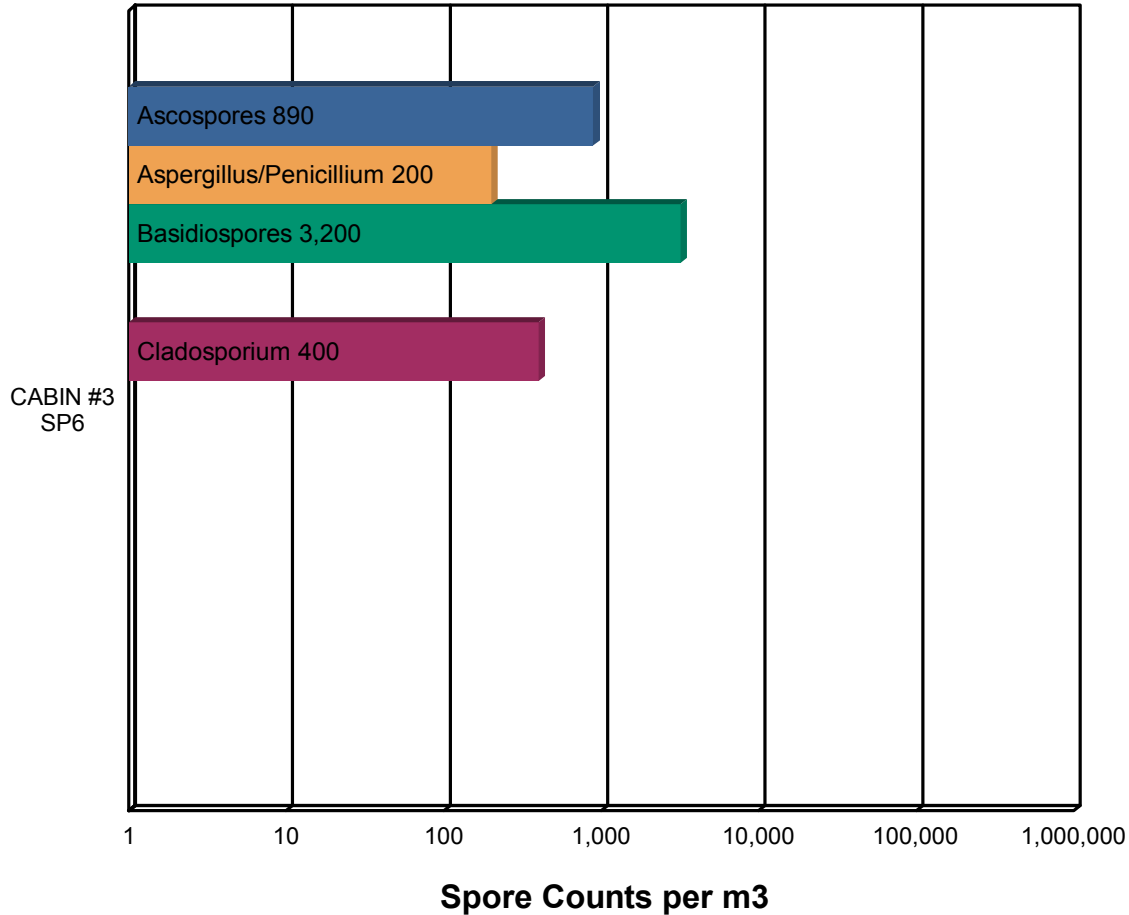
Ascospores	Aspergillus/Penicillium	Basidiospores
Botrytis	Cladosporium	Ganoderma
Myxomycetes++	Pithomyces	Rust
Ulocladium	Unidentifiable Spores

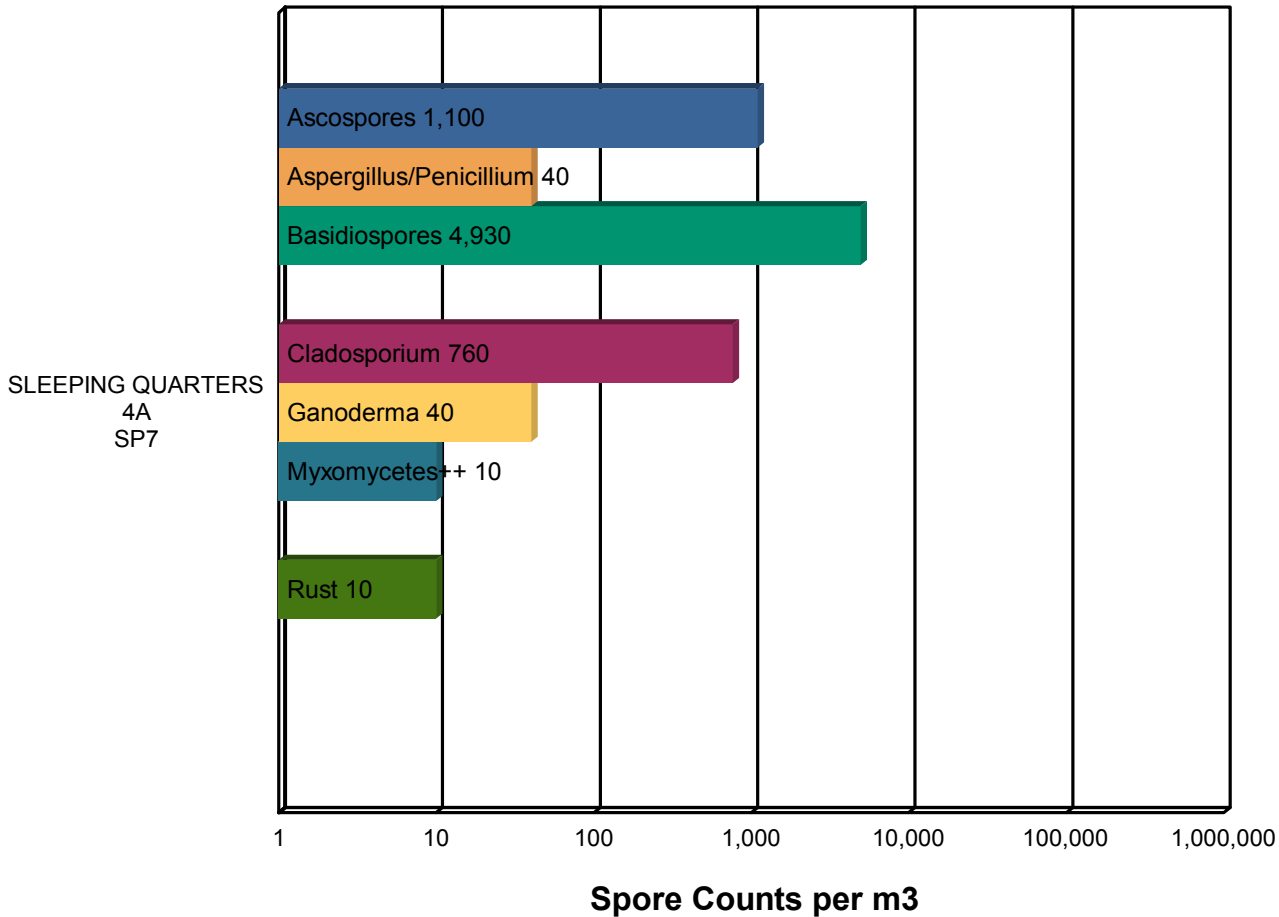
\* The chart is displayed using a logarithmic scale. Bar size is not directly proportional to the number of spores.

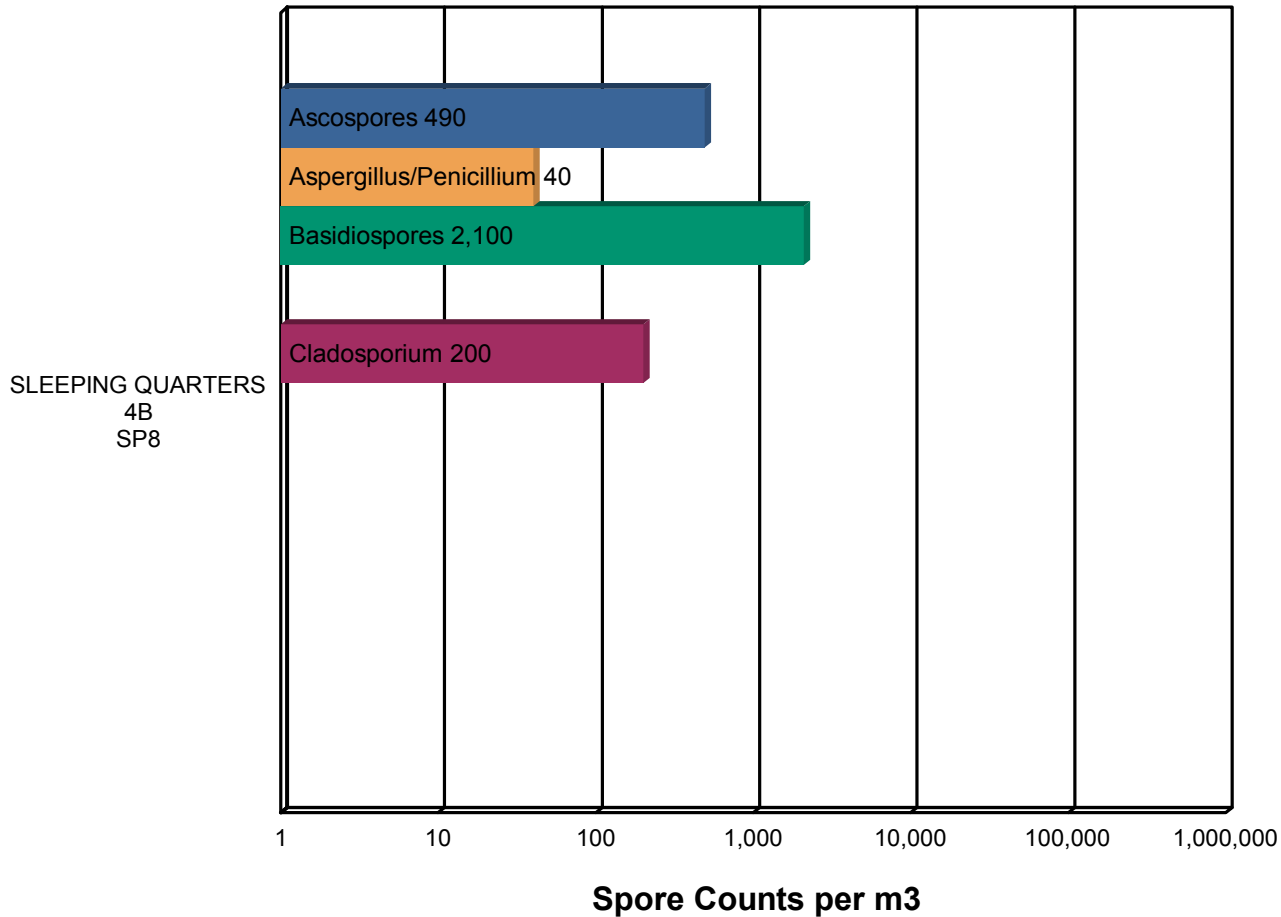
Ascospores	Aspergillus/Penicillium	Basidiospores
Botrytis	Cladosporium	Ganoderma
Myxomycetes++	Pithomyces	Rust
Ulocladium	Unidentifiable Spores
