Public Services Procurement Canada – Alaska Highway

Concrete Repairs Action Plan:

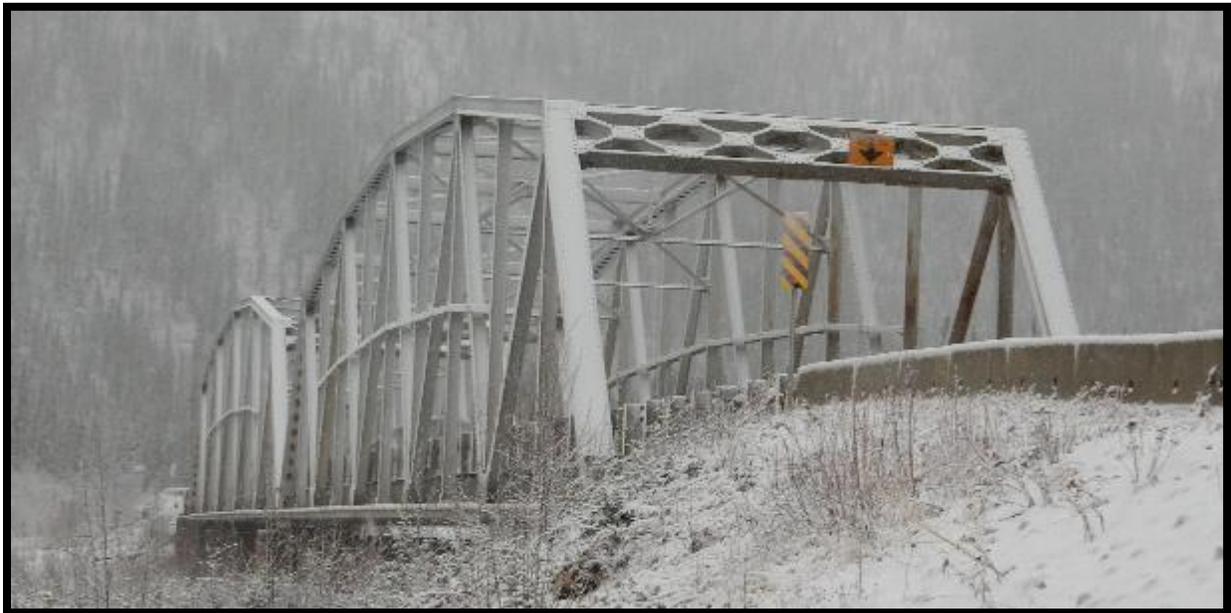
- Tetsa River Bridge No. 1 – km 584.6
- MacDonald Creek Bridge – km 628.0
- Racing River Bridge – km 641.1

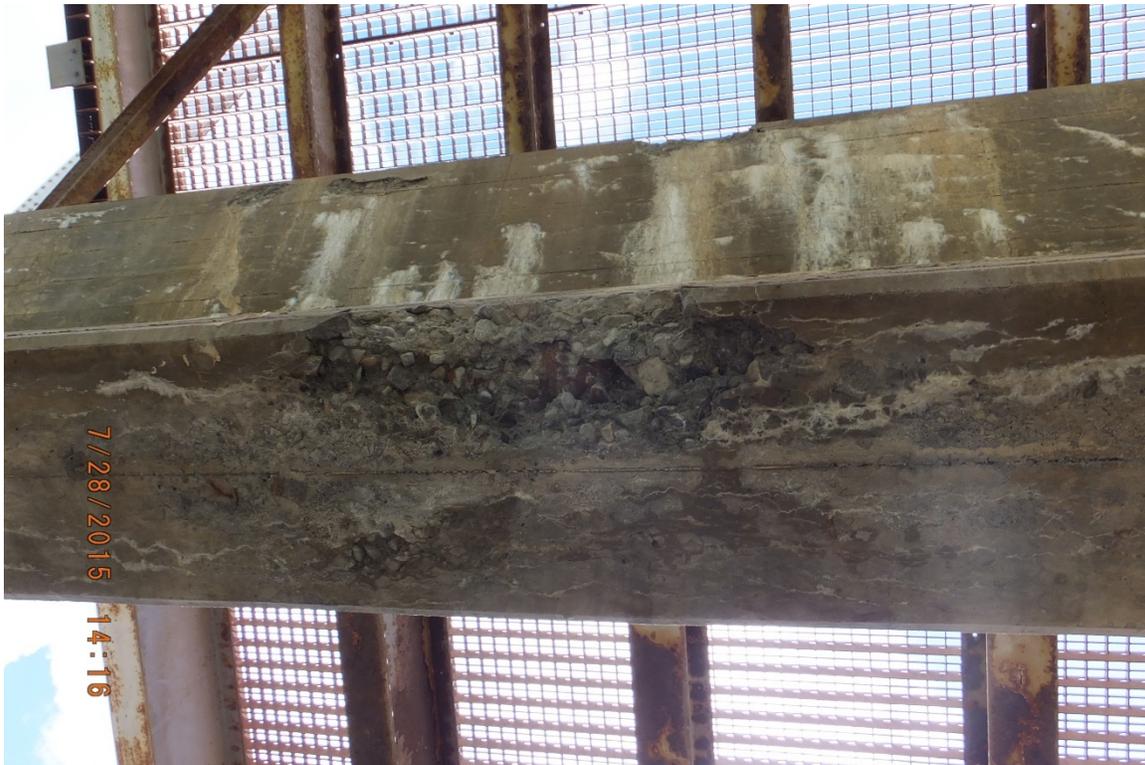
Photo 1 – MacDonald Bridge, Underside of south pier cap, spall with exposed stirrups.

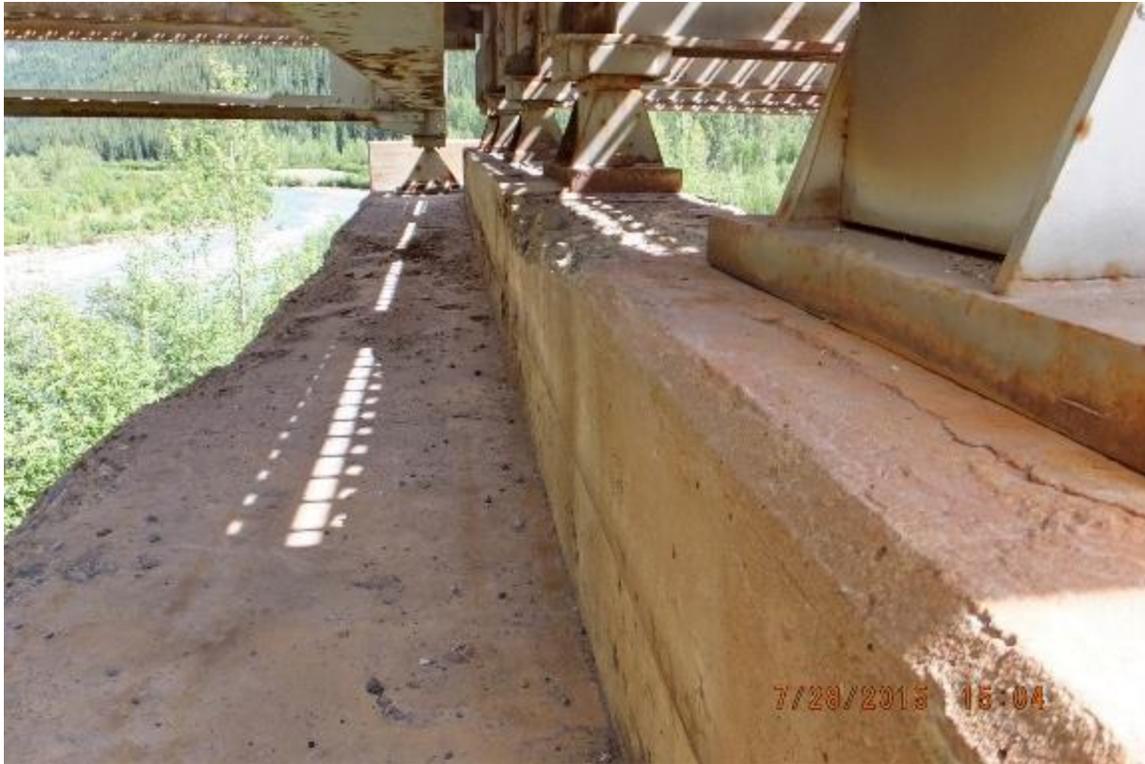
Photo 2 – MacDonald Bridge, south pier cap, spalls near bearings.

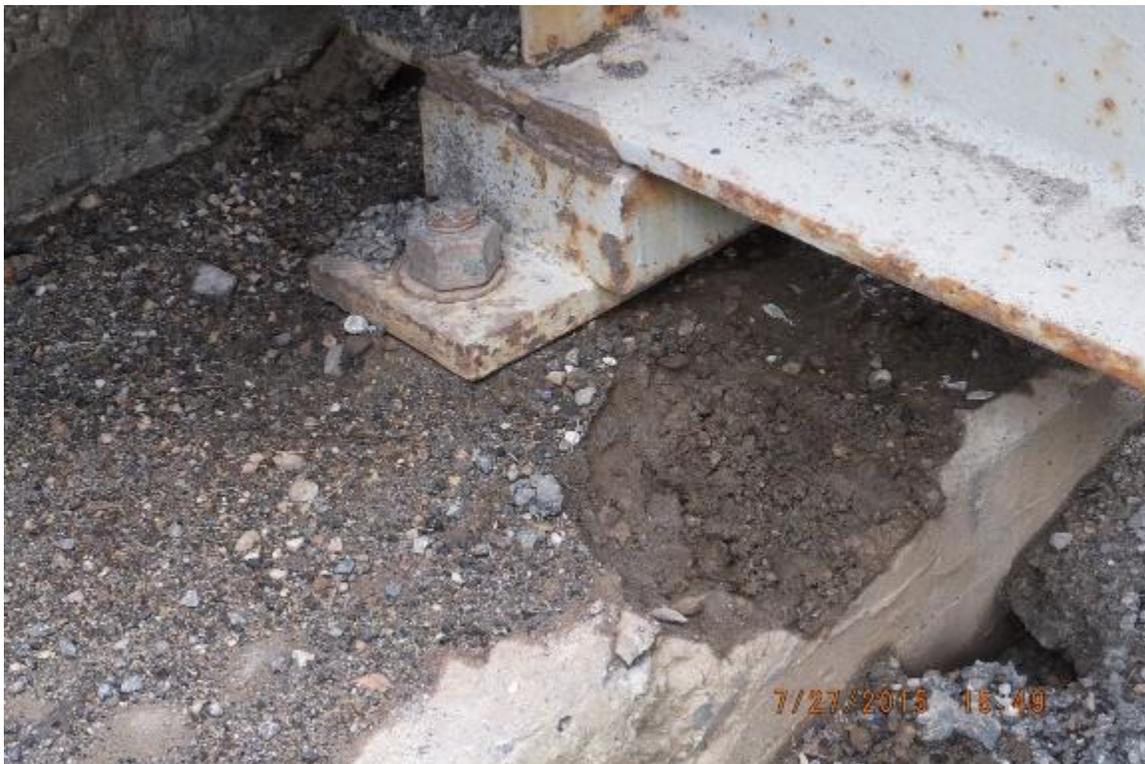
Photo 3 – Tetsa Bridge, south abutment, spall near bearing 1.

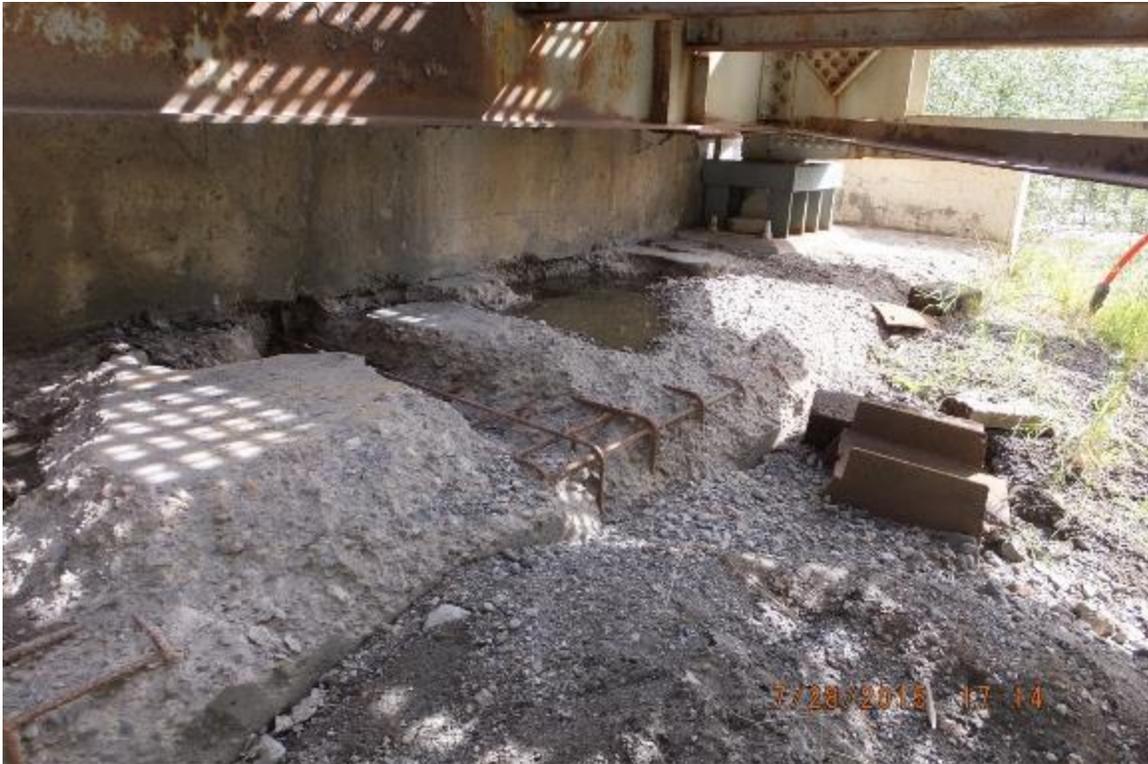
Photo 4 – South abutment bearing seat of the Racing River structure. Severe scaling with exposed rebar

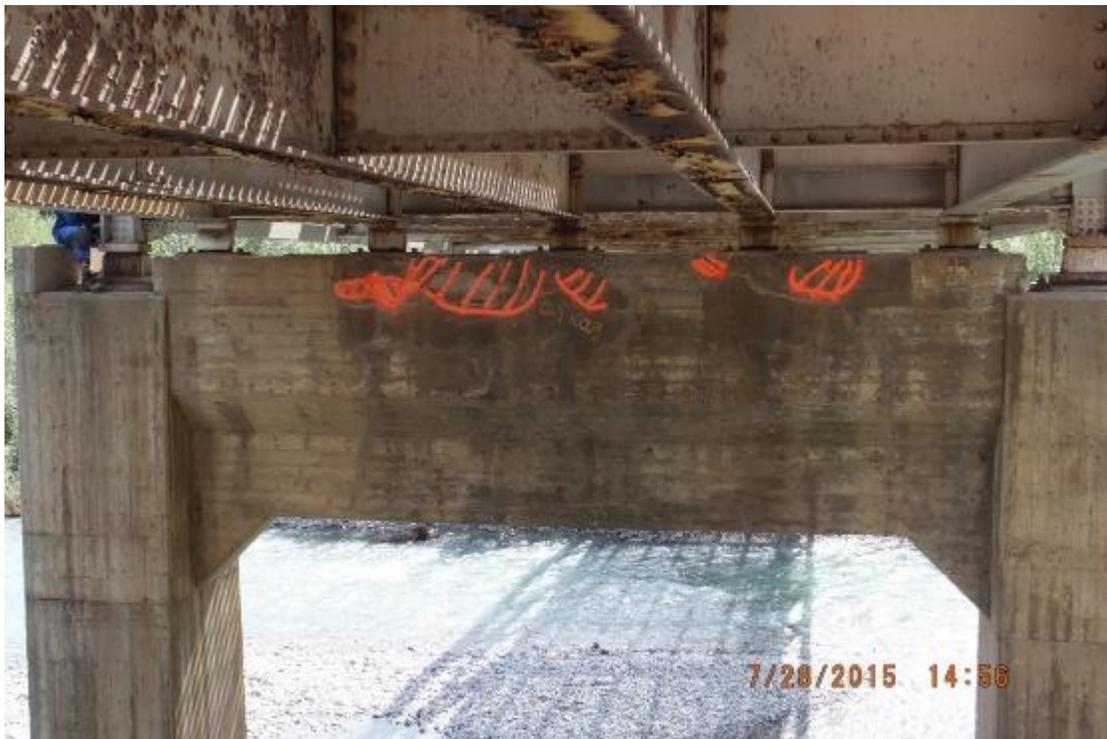
Photo 5 – Delaminated concrete patch repairs in the pier cap of the MacDonald bridge. exposed rebar.

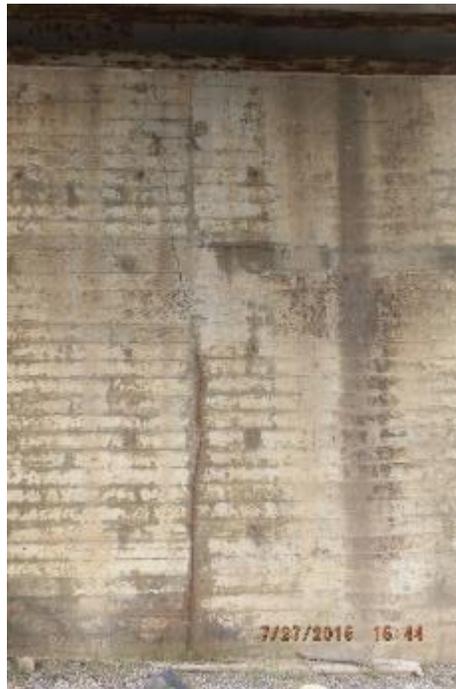
Photo 6 – Wide vertical crack pier 2 of the Tetsa structure, with rust staining from corroded rebar within.

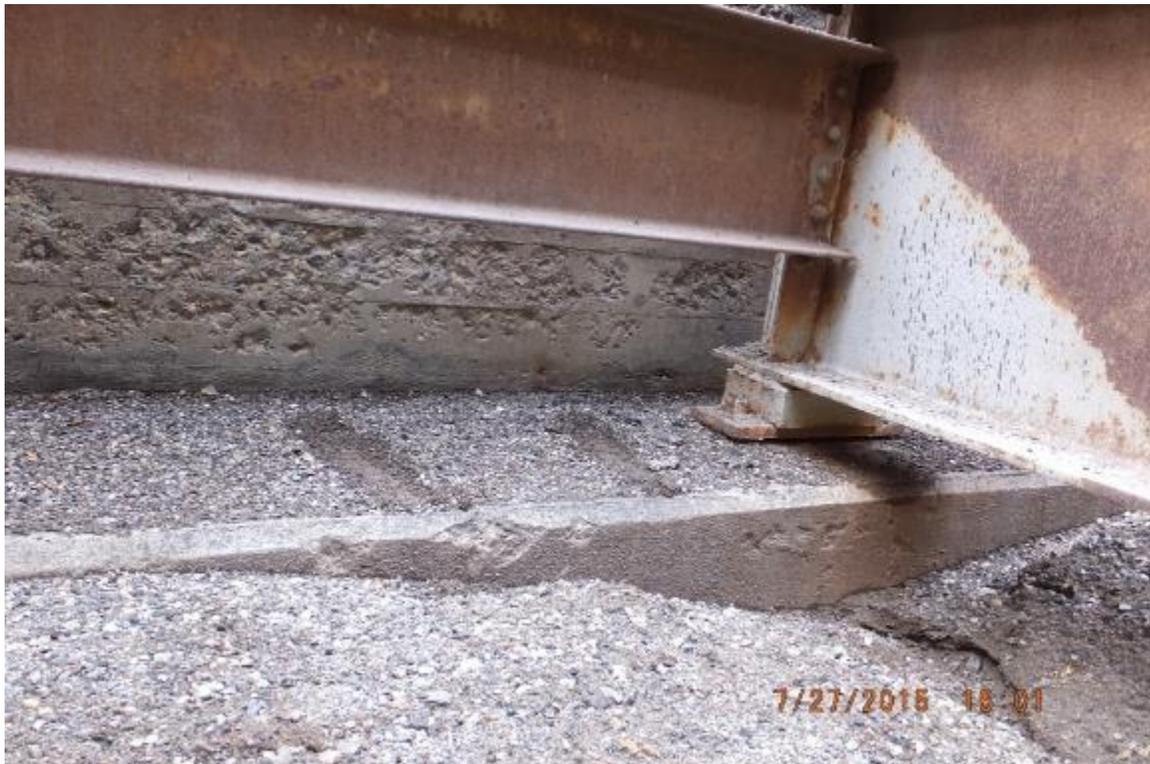
Photo 7 – North abutment of Tetsa structure with scaling in the backwall.
