The Tla-O-Qui-Aht First Nation

## Tofino Water Supply Upgrades – Phase 3

Geotechnical Assessment

July 10, 2015  
Levelton File # R715-0161-00

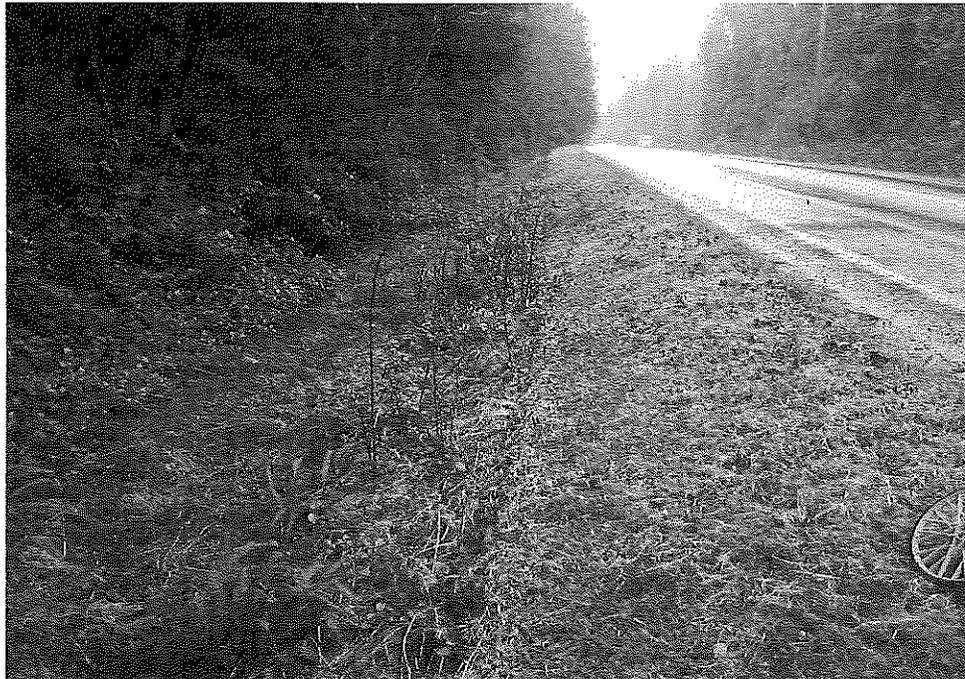
Photo1: Photo take near Lost Shoe Creek showing typical alignment conditions in Waterline Segment C.

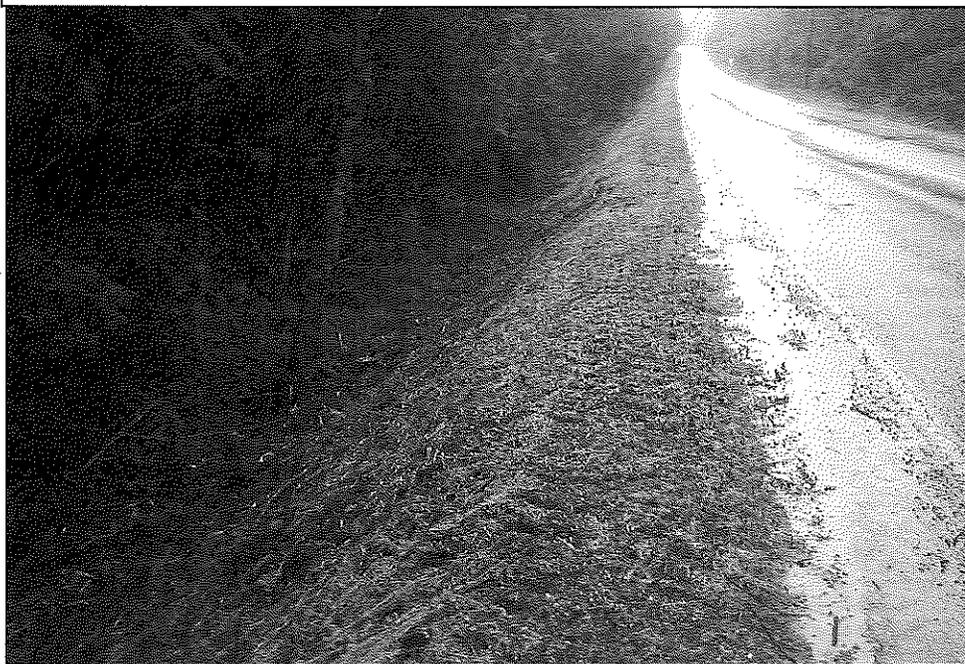
Photo 2: Conditions looking north near ravine/creek crossing near Station 18+000. Note the pylon from Photo 3 in the background.

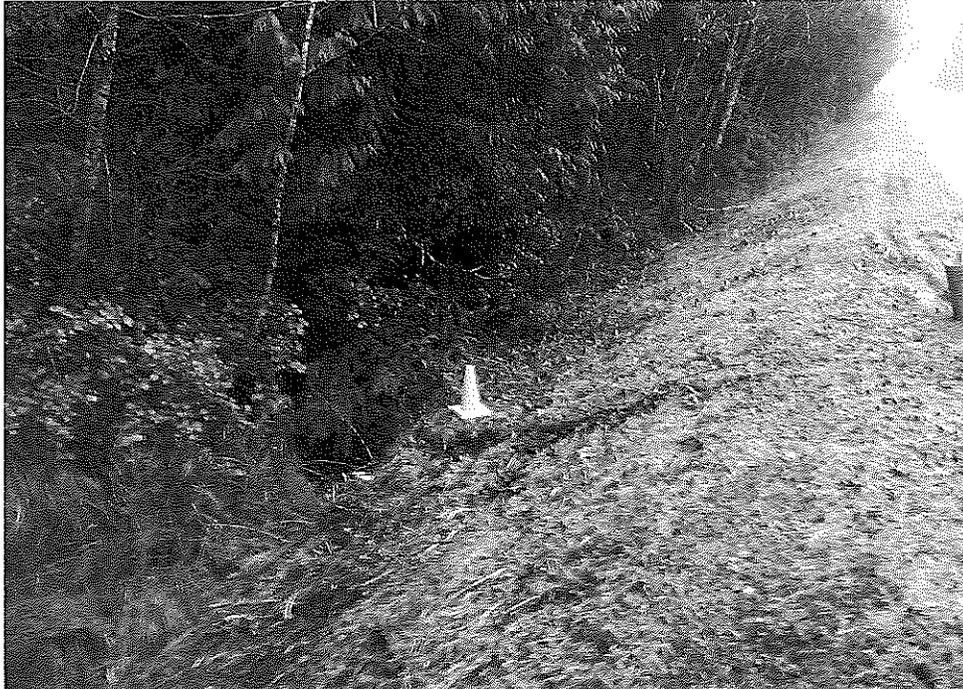
Photo 3: Erosion conditions at discharge of culvert at crossing near Station 18+000.

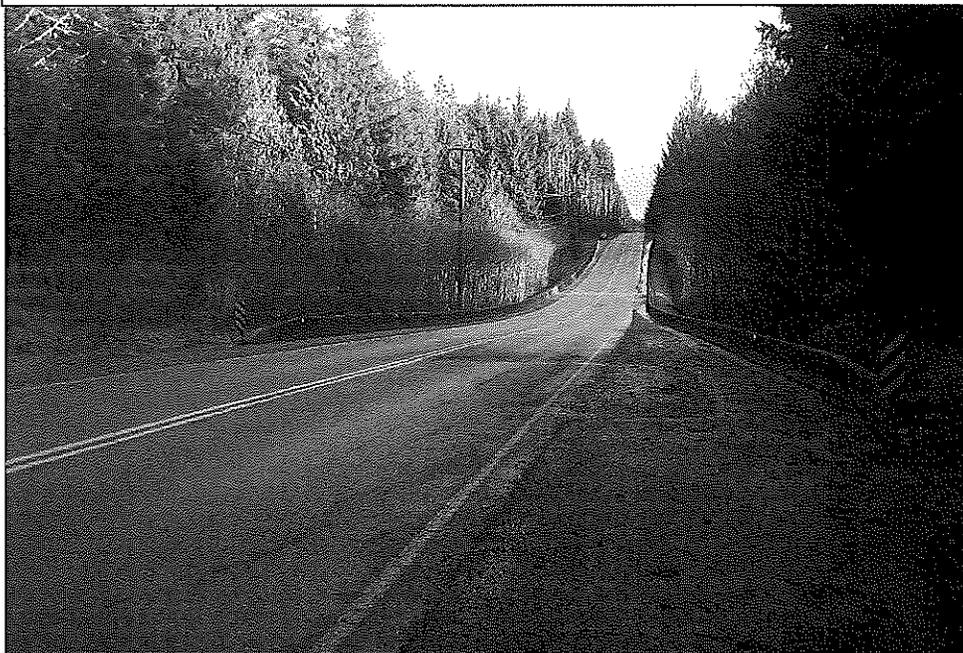
Photo 4: Current conditions at "Devil's Dip" at approximate Station 12+760 in Waterline Segment C.

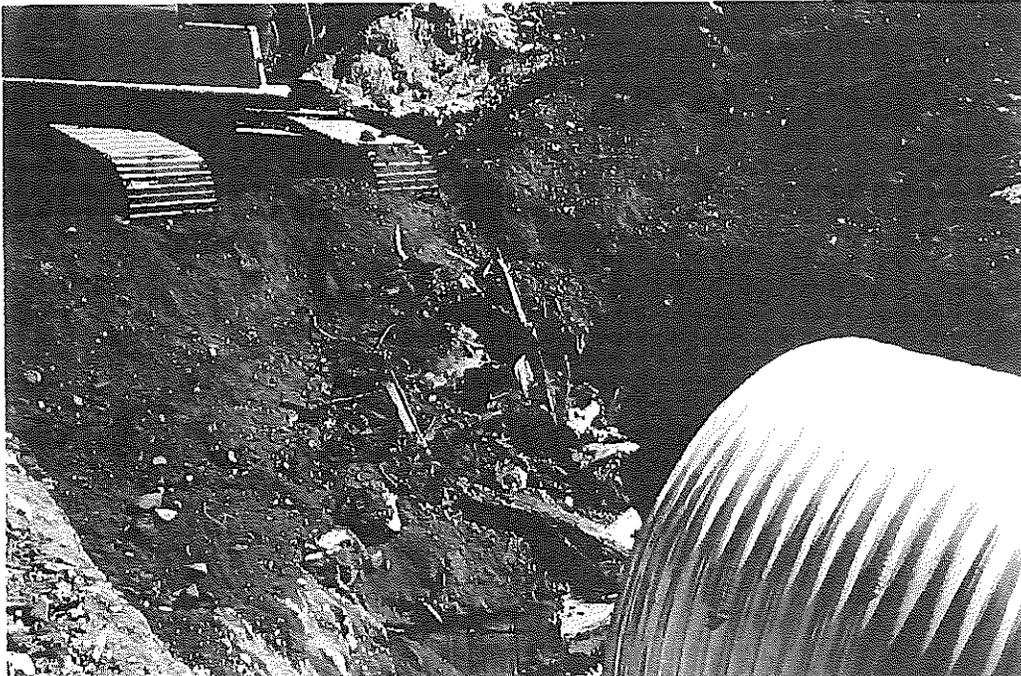
Photo 5: Historical Photo #127 – August 10, 1997 – Excavation conditions at base of Devil's Dip illustrating removal of organics and wood debris to expose underlying clay.

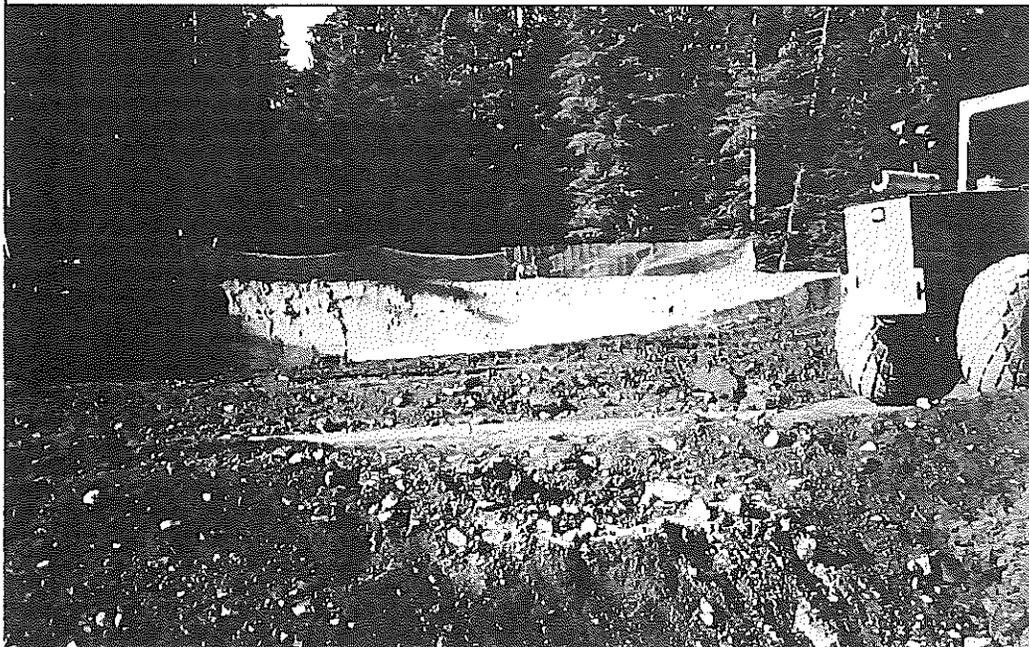
Photo 6: Historical Photo #131 – August 11, 1997 – Placement and compaction of embankment material at Devil's Dip near top of culvert elevation.

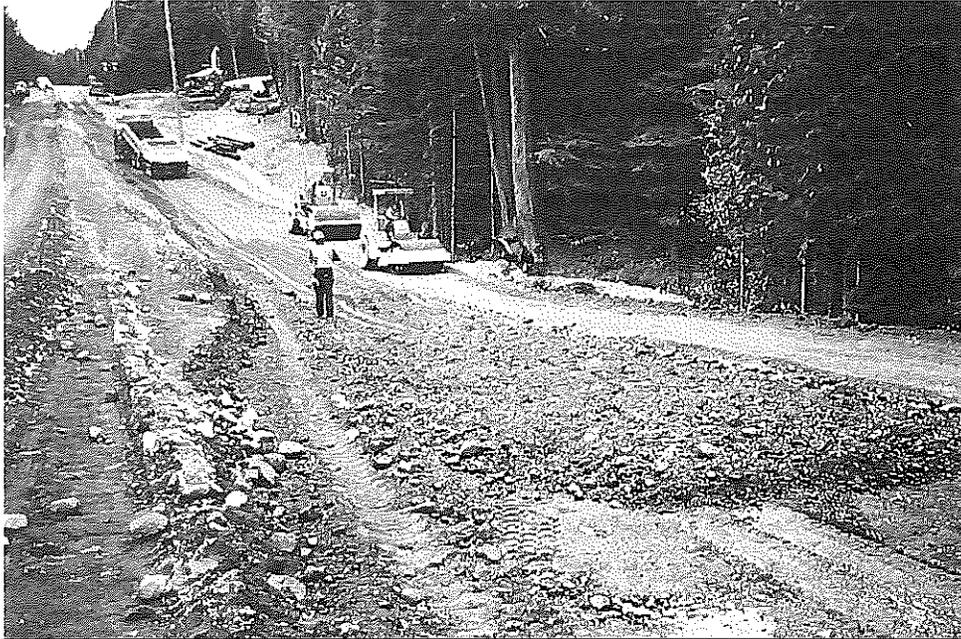
Photo 7: Historical Photo #152 – 18 August 1997 – Placement and compaction of engineered fill at Devil's Dip. Note the relatively coarse nature of material, limited lift thickness and heavy compaction equipment in the background

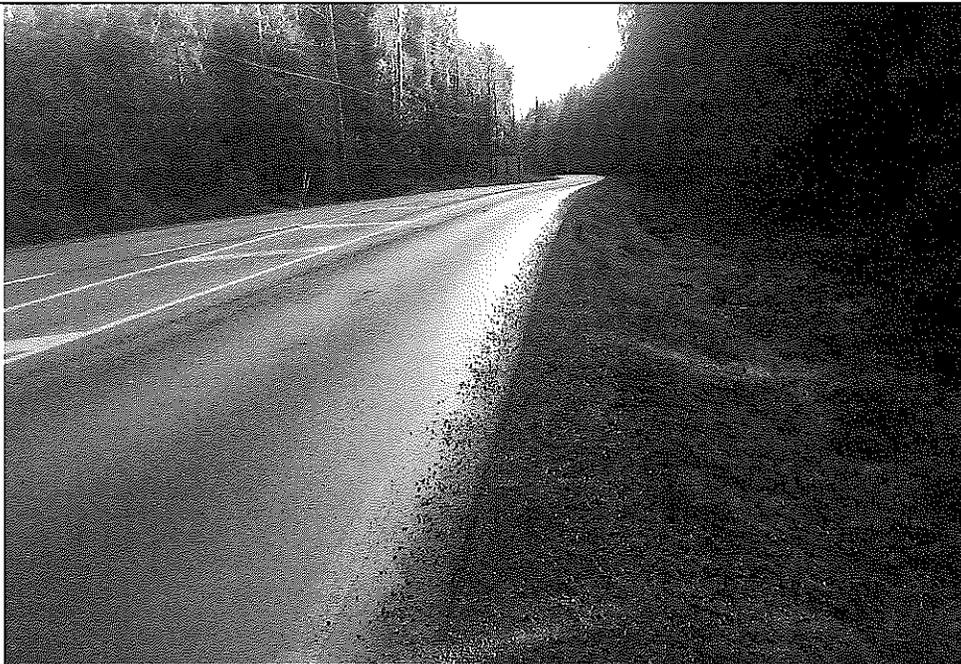
Photo 8: Conditions at tie-in to previous phase at north end of Waterline Segment C facing southeast.

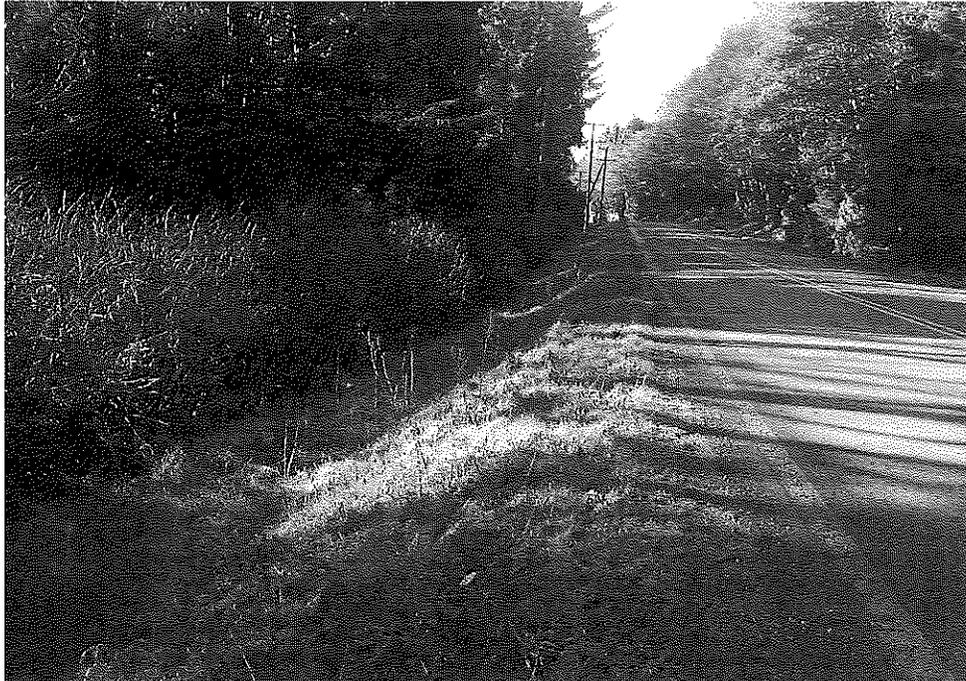
West of Incinerator Rock (Waterline Segment A), the south (ocean) side of the road appeared to be performing poorly, with signs of settlement, alligator cracking, patching, and longitudinal cracking. The worst area appeared at the westernmost part of this section near the Esowista Reserve. This area was a curved and sloped section of road where the terrain sloped down towards the ocean with a drop of about 6 m.

Photo 9: Conditions on ocean side of road in Waterline Segment A (Esowista).

- West of Incinerator Rock (2+000 to 3 +275, Segment A) poor ground conditions (variable fill over organics and wood debris) were encountered and design should be based on a pipe invert elevation deeper than 2 m to avoid these materials. Specific geotechnical review should be requested if localized areas of organics or logs are encountered below this depth during installation. Geotextiles and “corduroy road logs” have been encountered in previous boreholes in this section and the contractor should be made aware of the presence of those materials;

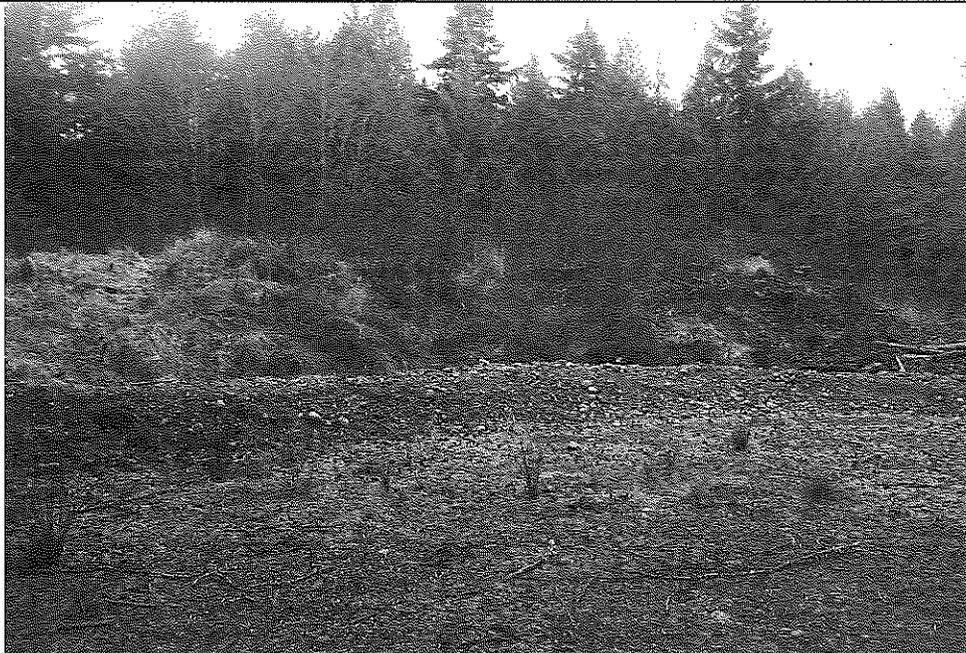
Photo 10: Conditions at proposed High Point Reservoir.

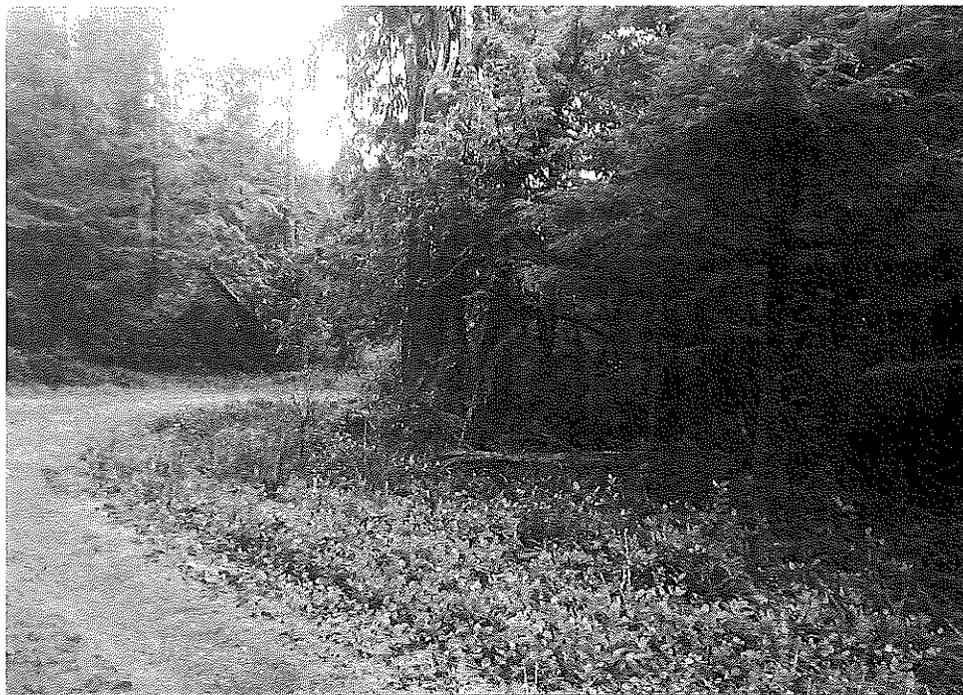
Photo 11: Conditions at proposed Wick Road Reservoir.

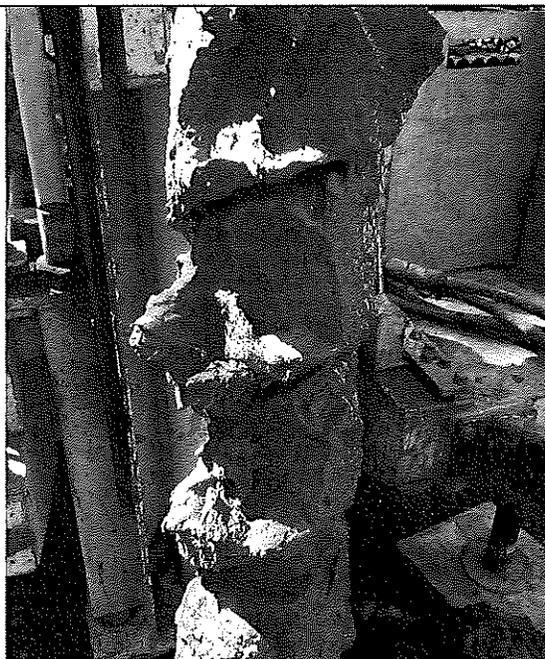
Photo 12: View of typical normally consolidated clay on auger encountered at depth of Wick Road and High Point reservoir sites.

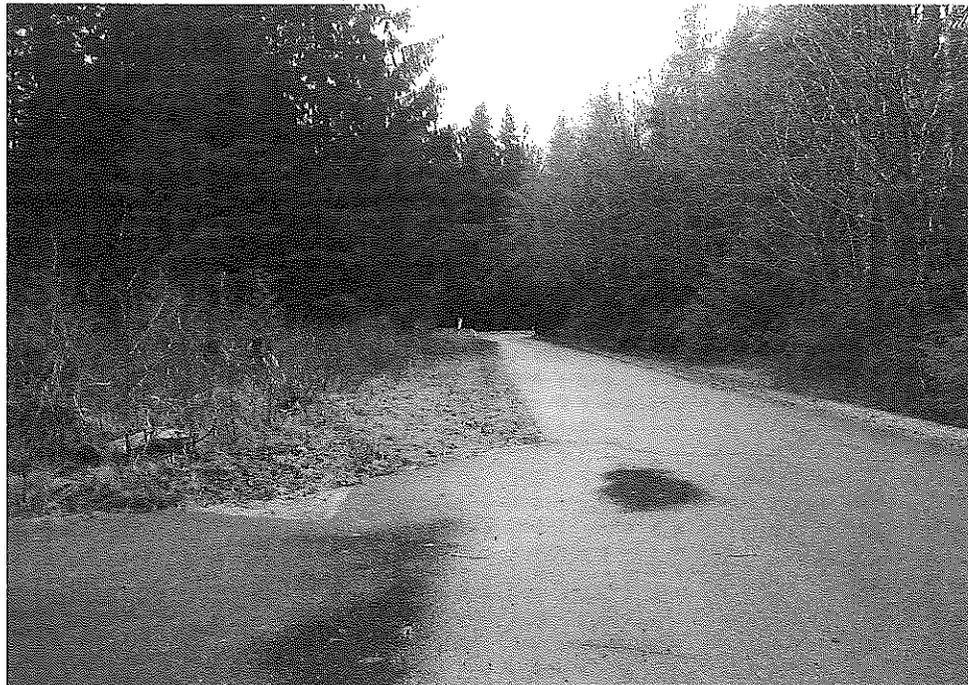
Photo 13: Conditions at proposed chlorination building at Lost Shoe Creek  
– Note Highway 4 in the background.

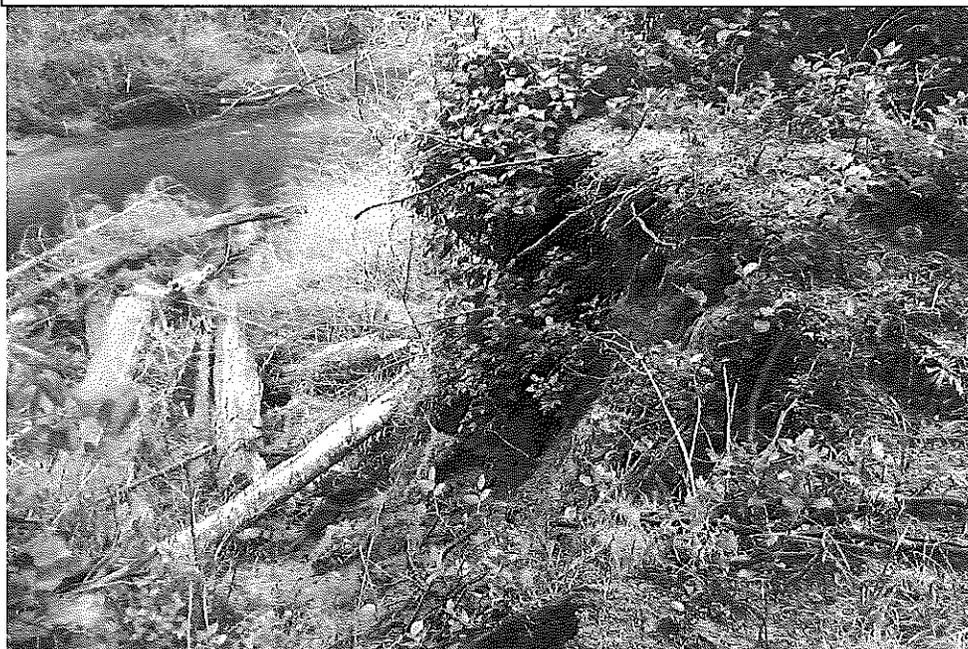
Lost Shoe Creek was approximately 60 m south east of the proposed treatment building site. The creek bank was approximately 10 m high and an existing well and pump house were present near the crest of this slope. We understand the existing well and pump house are being replaced as part of this project.

Photo 14: Over-steepened slope along Lost Shoe Creek near to existing well.
