*Public Services Procurement Canada – Alaska Highway*

**Concrete Repairs Action Plan:**

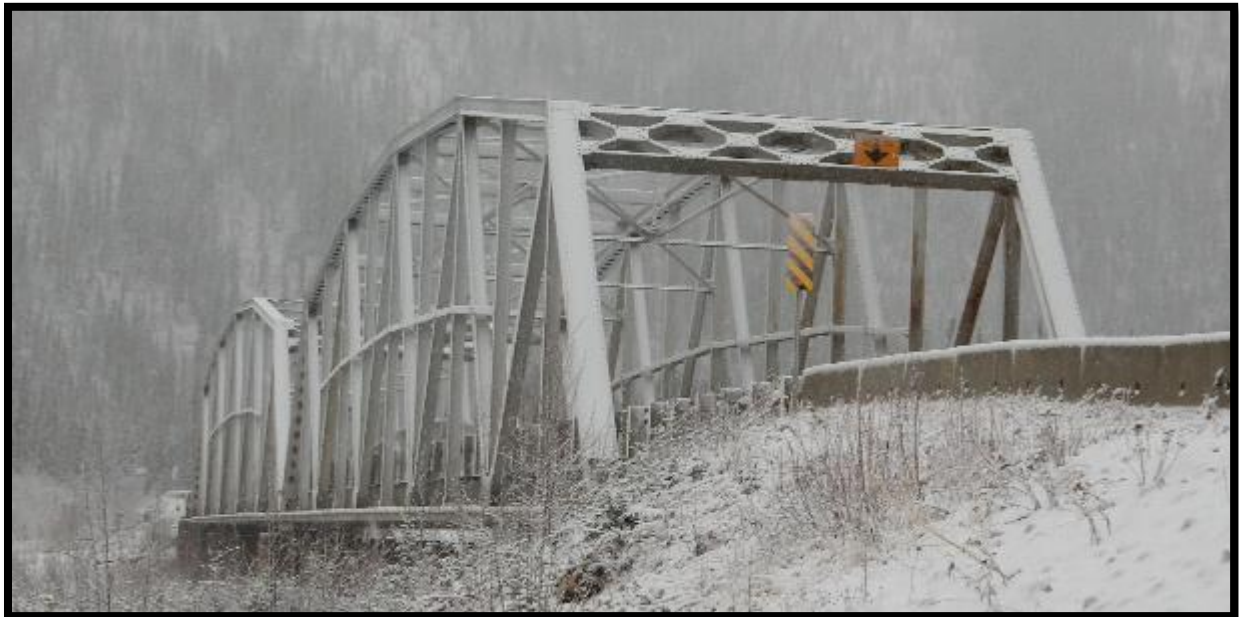
- Tetsa River Bridge No. 1 – km 584.6
- MacDonald Creek Bridge – km 628.0
- Racing River Bridge – km 641.1

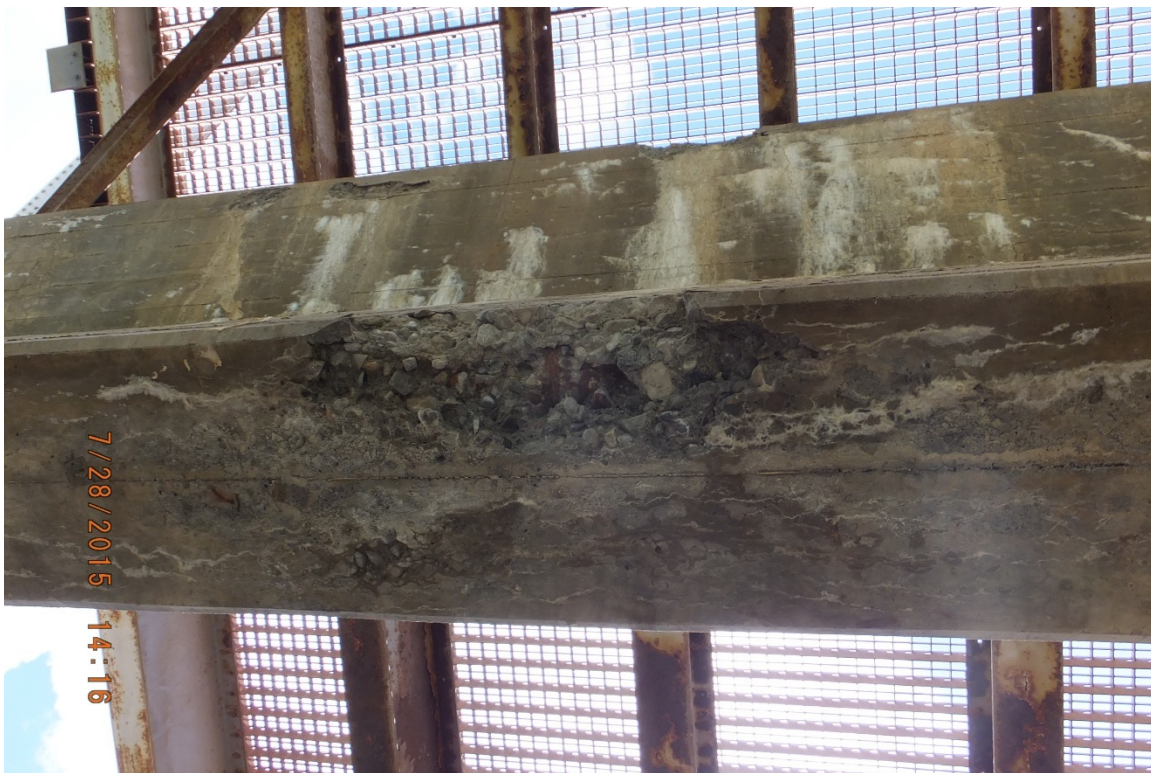
**Photo 1** – MacDonald Bridge, Underside of south pier cap, spall with exposed stirrups.

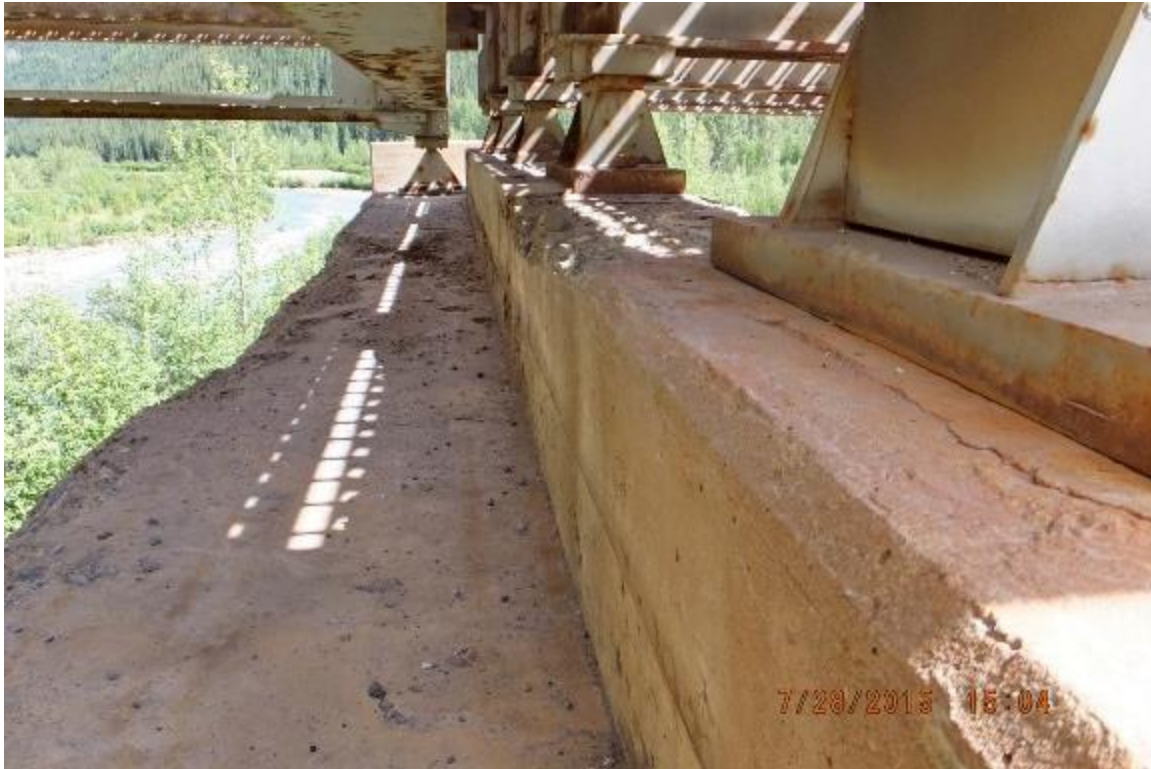
**Photo 2** – MacDonald Bridge, south pier cap, spalls near bearings.

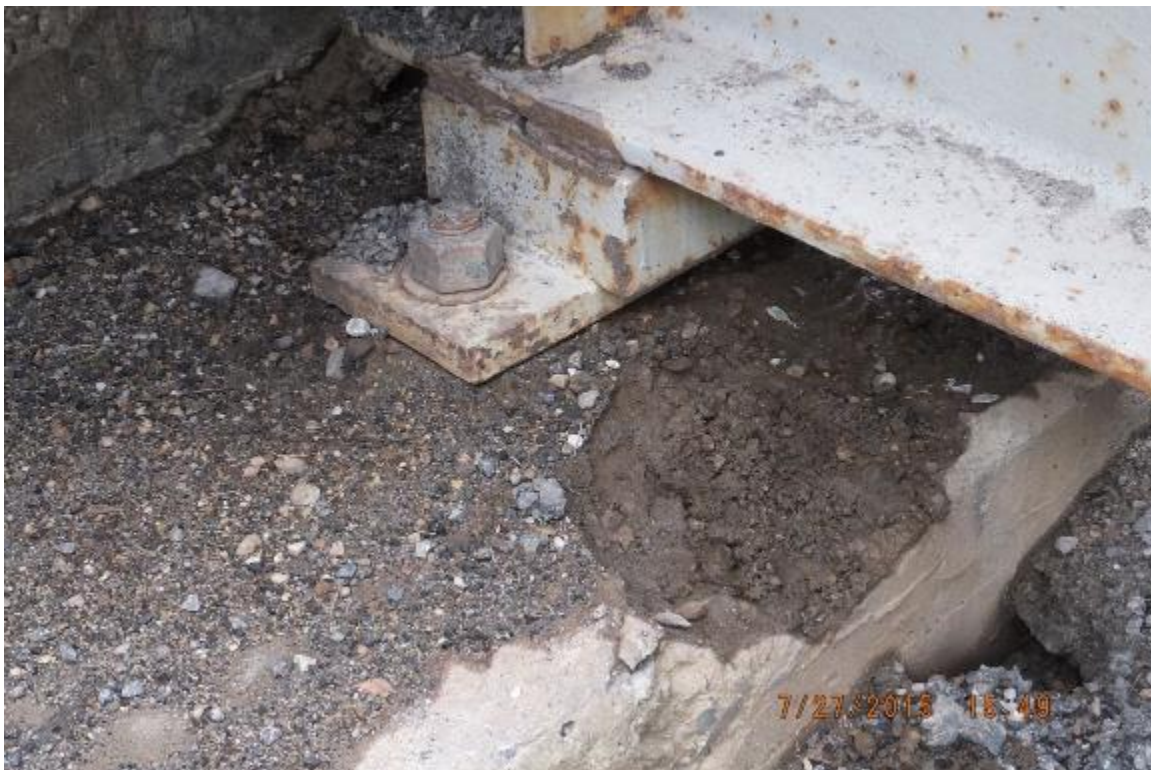
**Photo 3** – Tetsa Bridge, south abutment, spall near bearing 1.

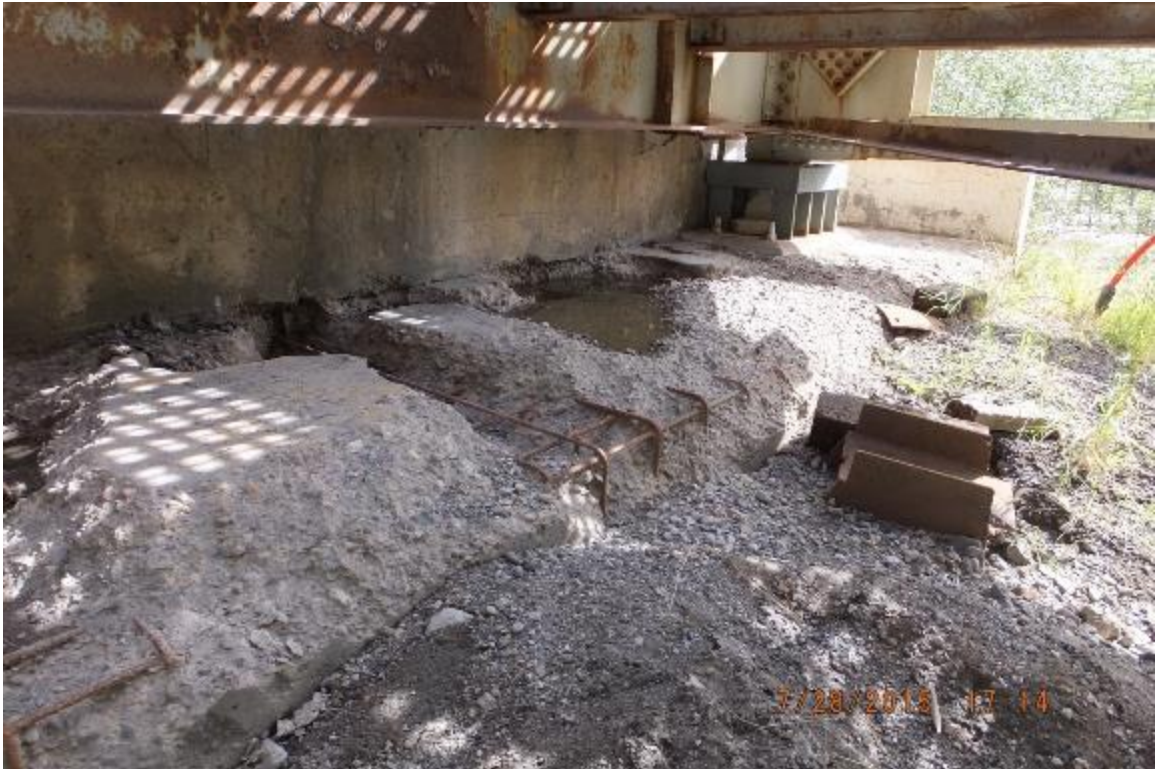
**Photo 4** – South abutment bearing seat of the Racing River structure. Severe scaling with exposed rebar

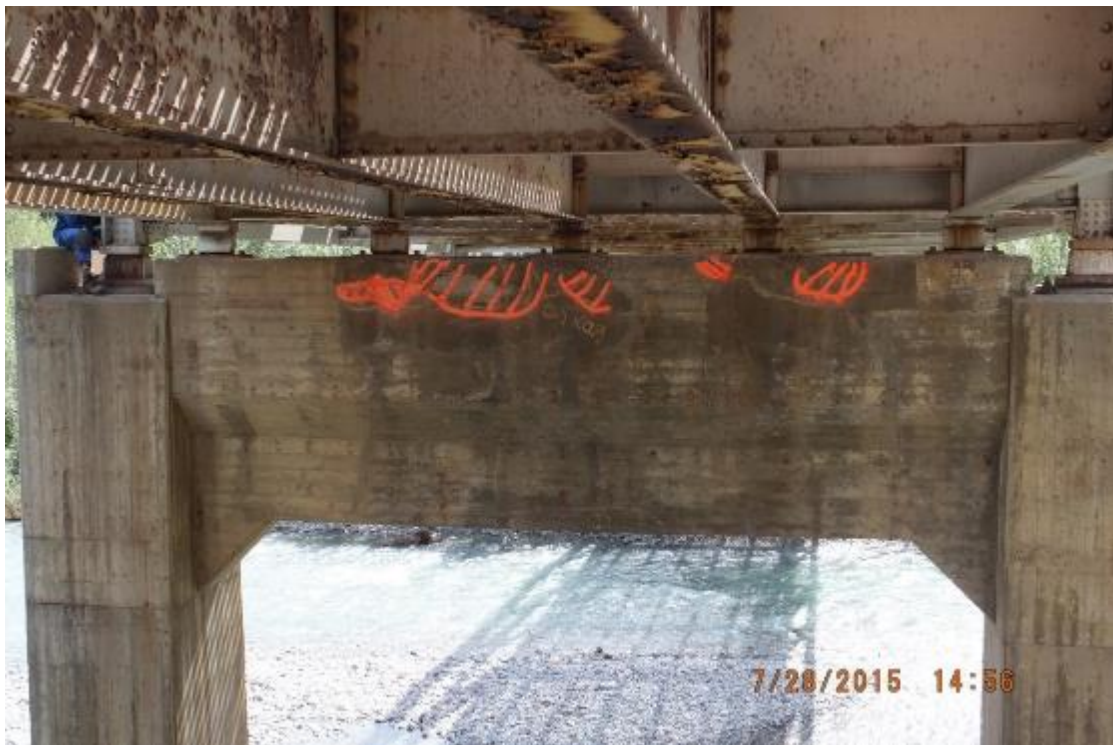
**Photo 5** – Delaminated concrete patch repairs in the pier cap of the MacDonald bridge. exposed rebar.

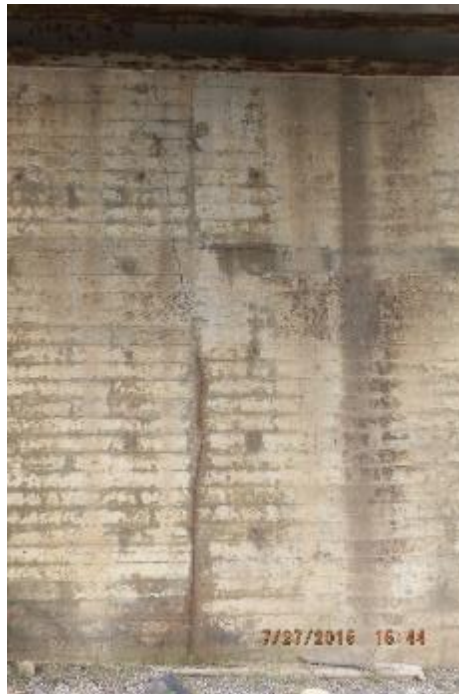
**Photo 6** – Wide vertical crack pier 2 of the Tetsa structure, with rust staining from corroded rebar within.

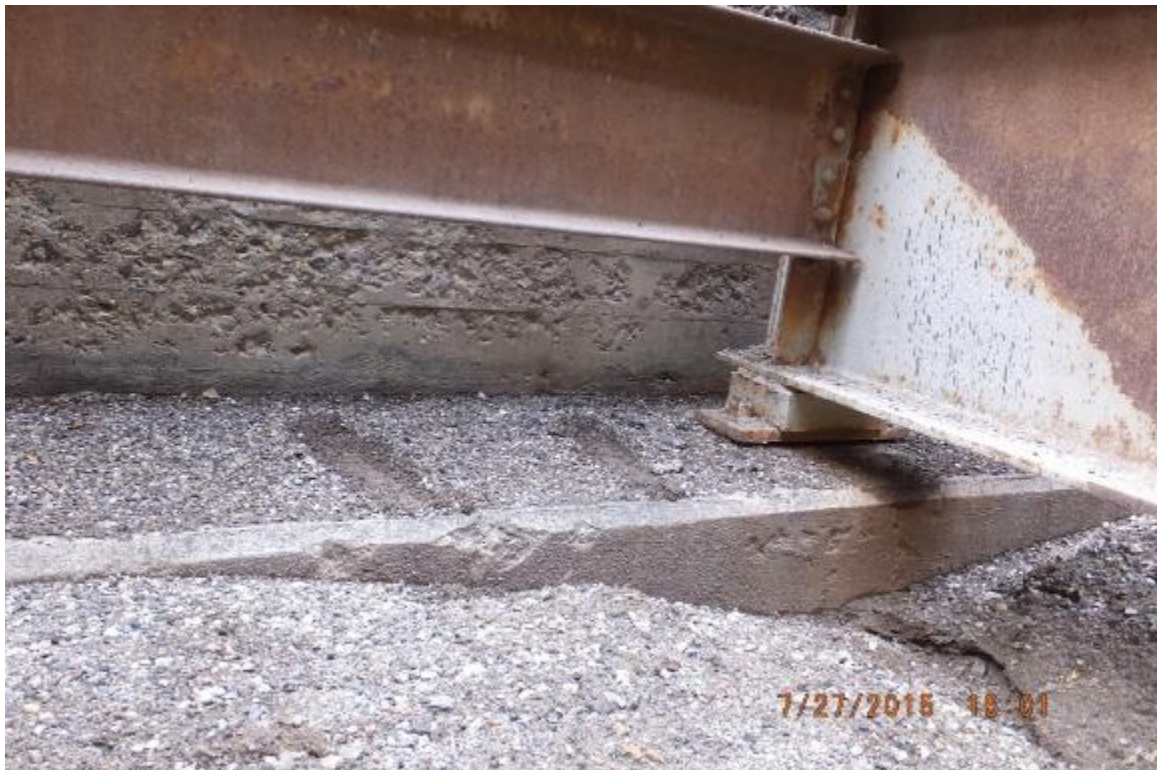
**Photo 7** – North abutment of Tetsa structure with scaling in the backwall.

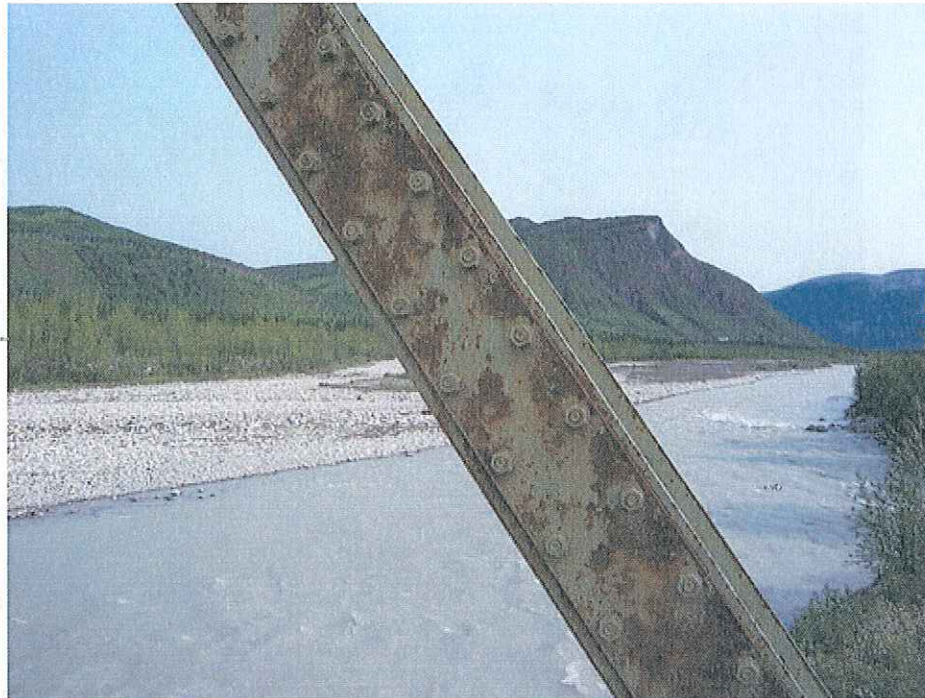
**Photo 4 – Corroded Diagonal**

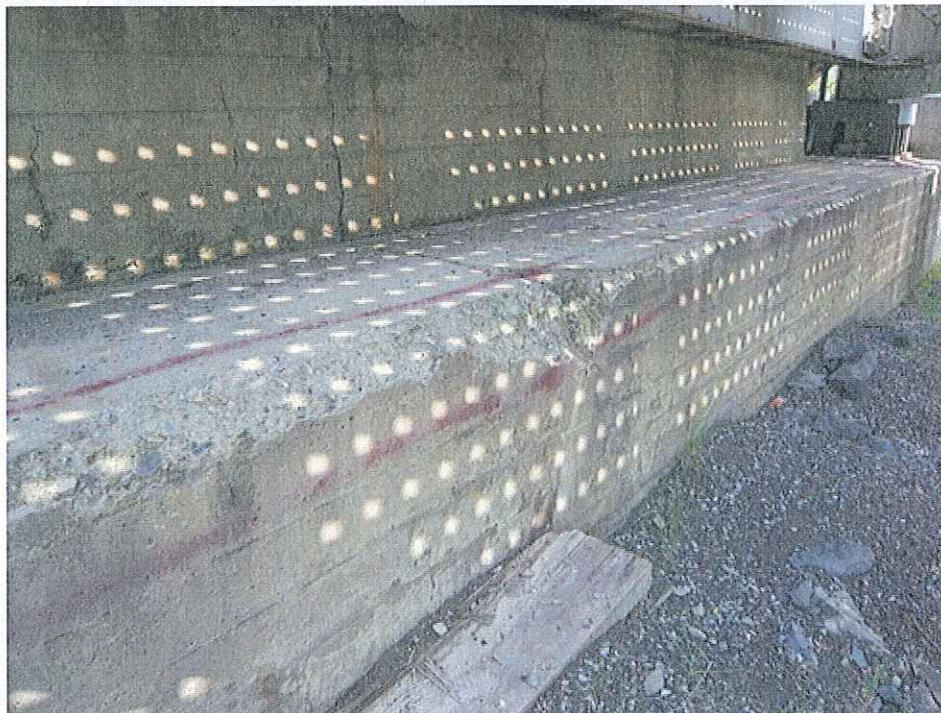
**Photo 8 – Spalls on North Abutment**

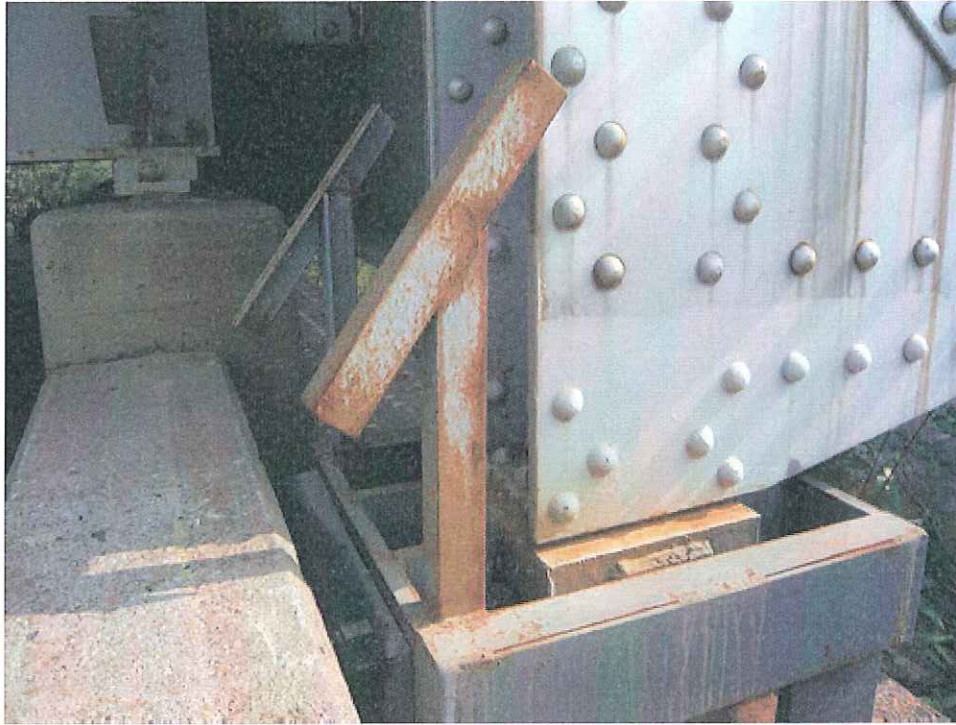
**Photo 13 – Limiter and Debris Prevention Plate (missing)**

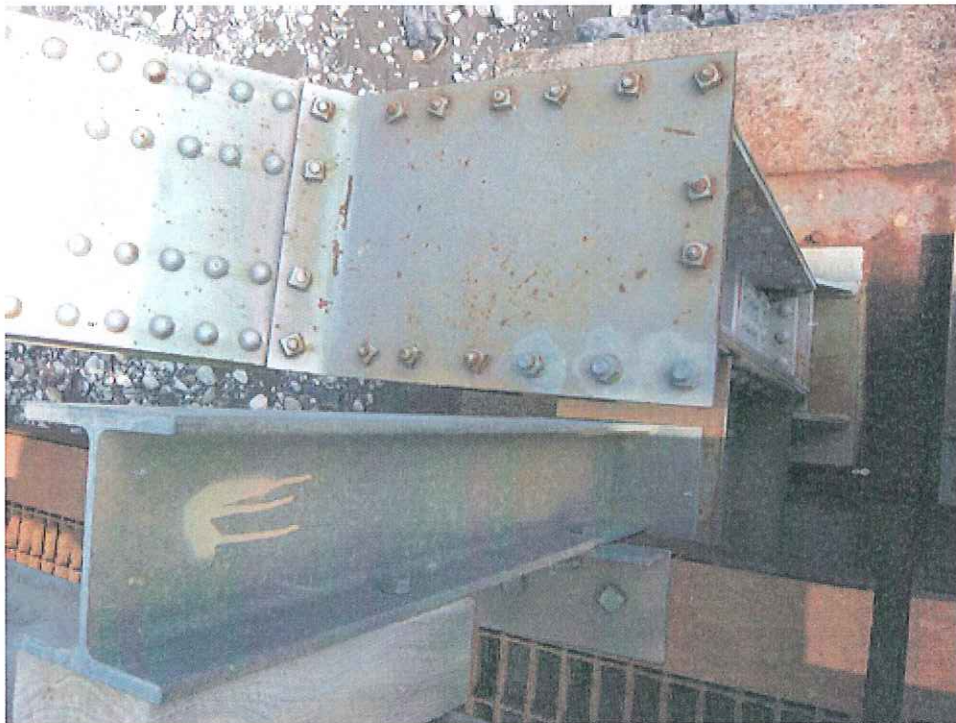
**Photo 14 – Vertical Post – Missing Bolts Installed on Top Plate**

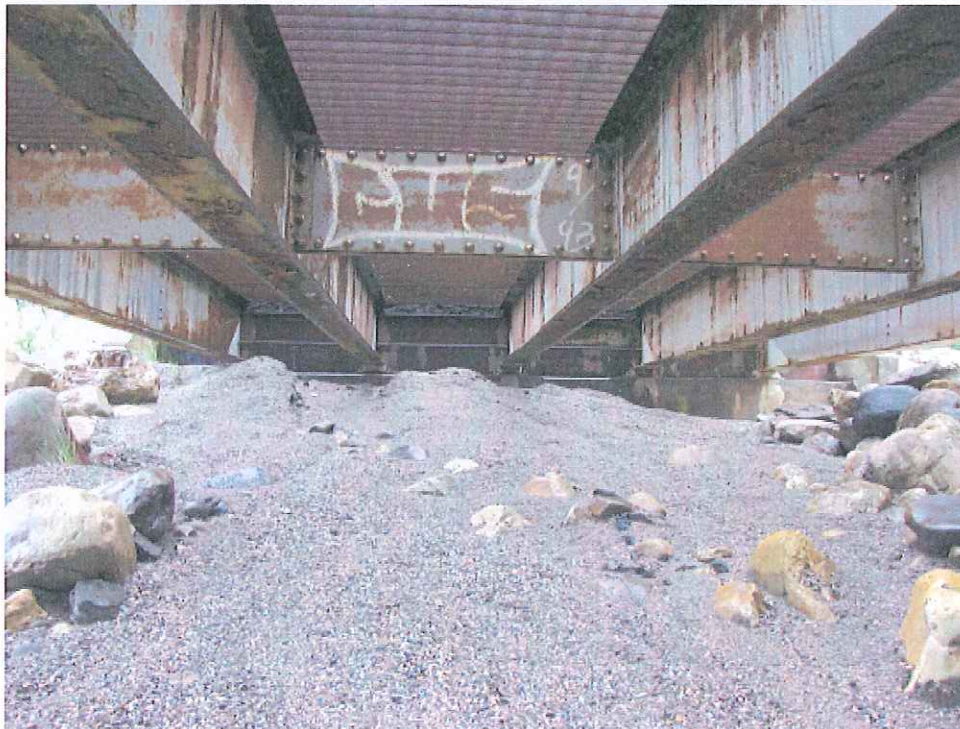
**Photo 6 – Corroded Steel I Girder – Approach Span**

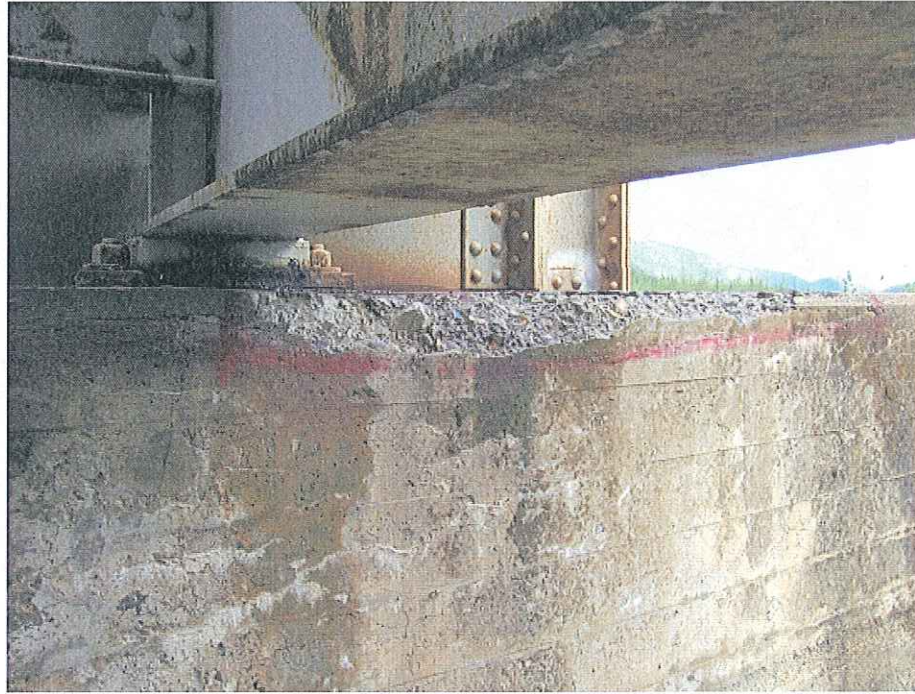
**Photo 7 – Concrete Spalling at Pier**

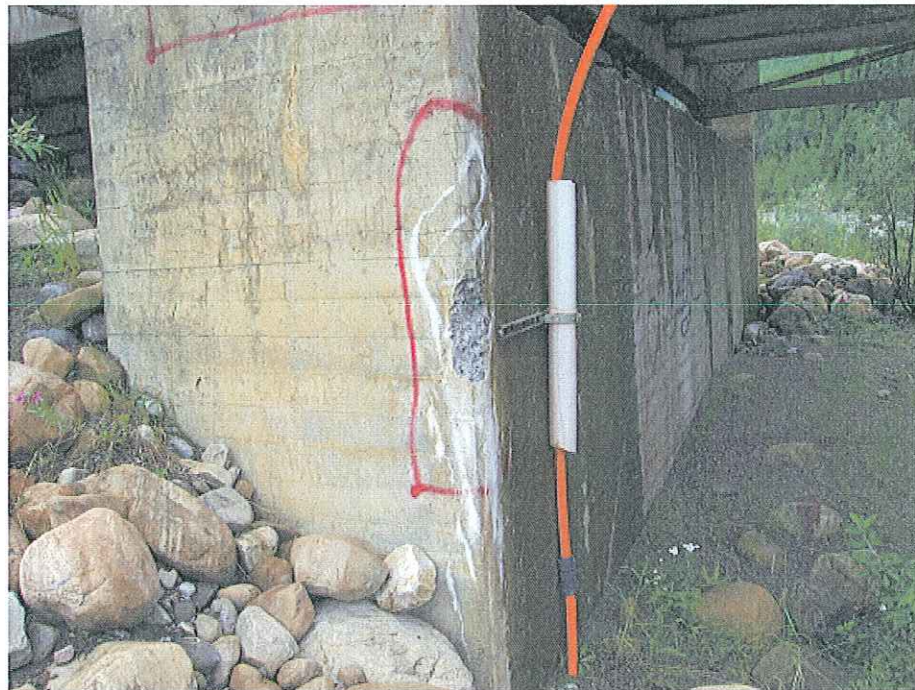
**Photo 8 – Pier – Concrete Spalling**

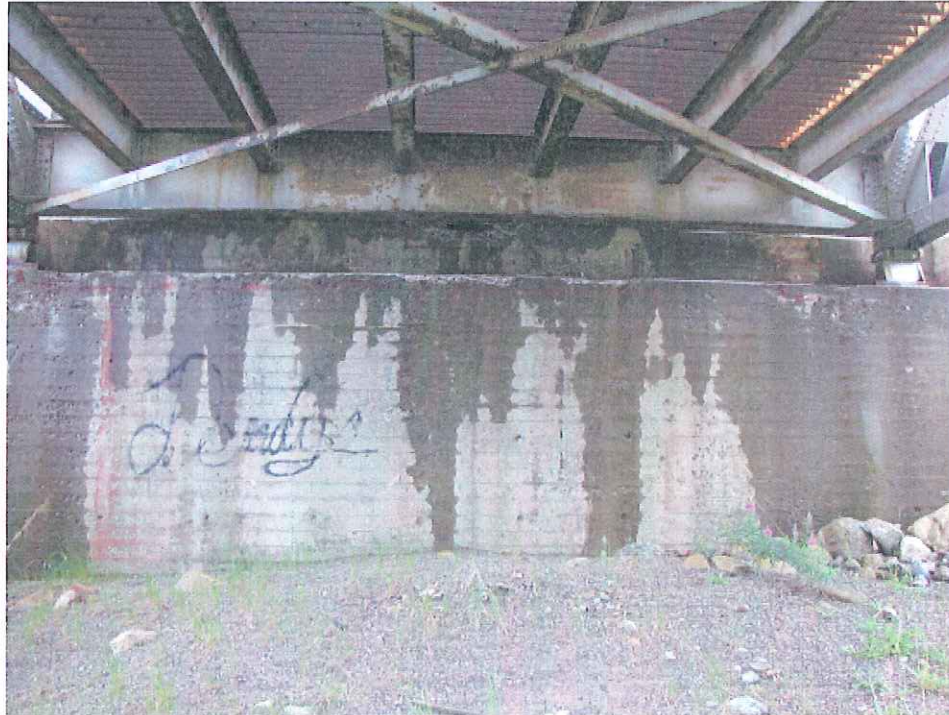
**Photo 9 – Condition of Floor Beam and Stringers at Pier**

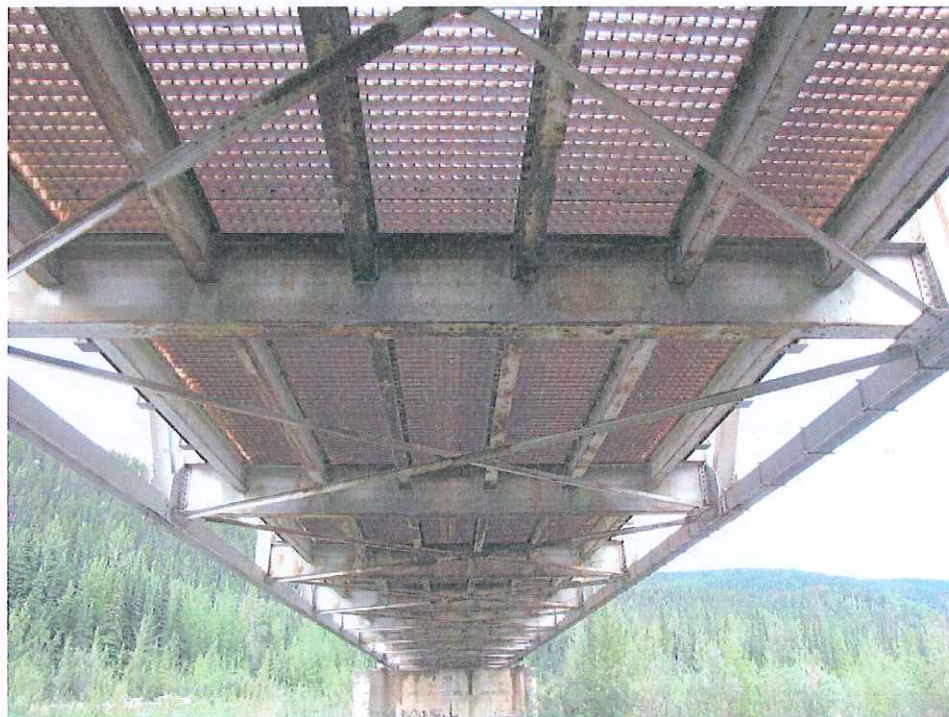
**Photo 10 – Condition of Floor Beams, Stringers and Bracing**

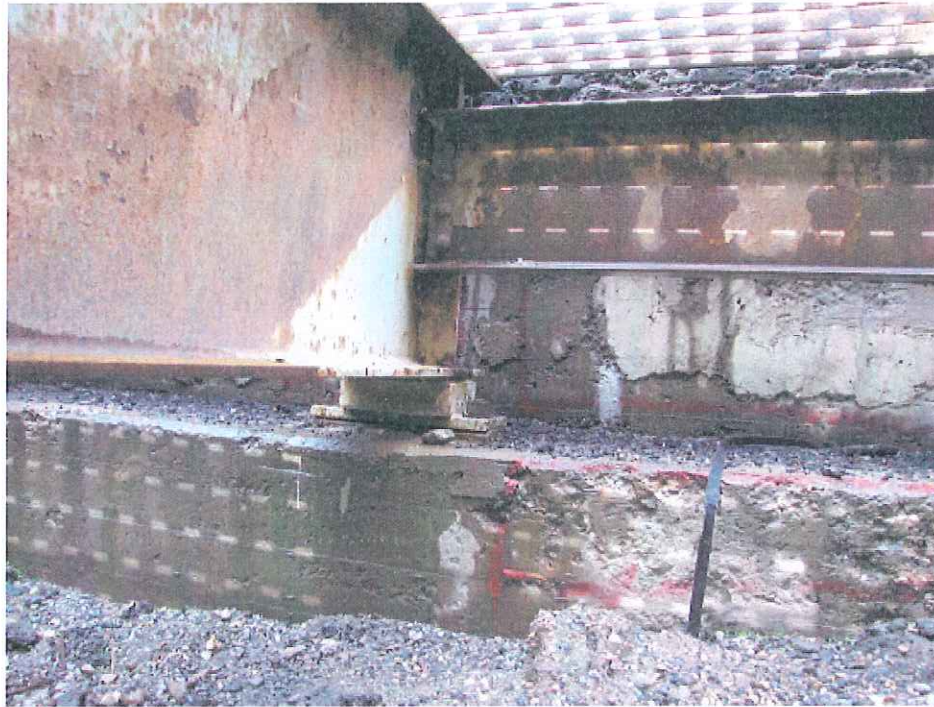
**Photo 13 – Spalling at South Abutment**

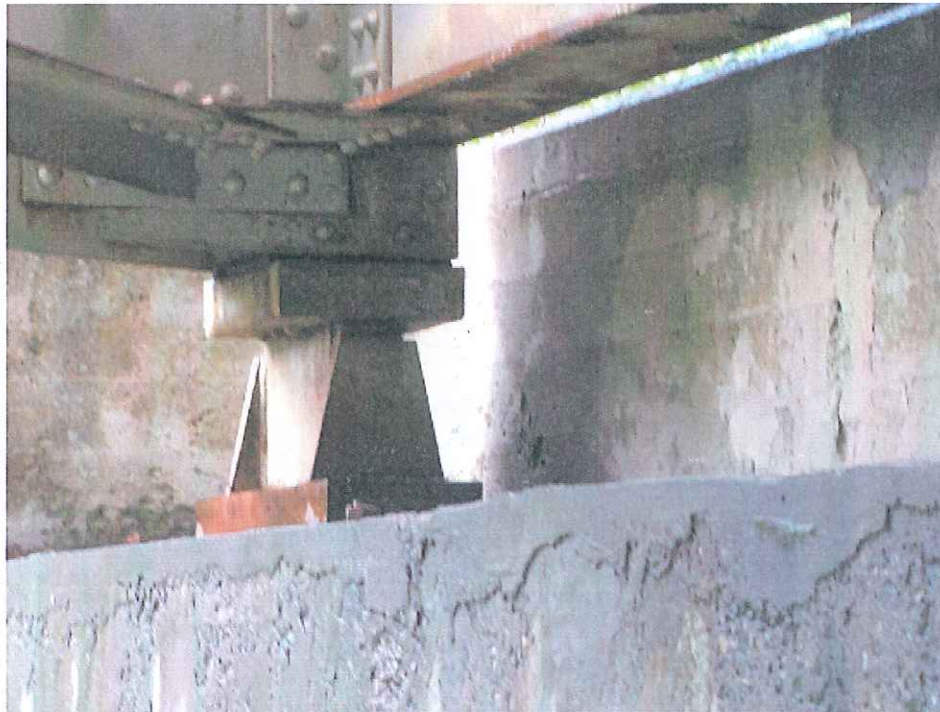
**Photo 14 – Bearing**

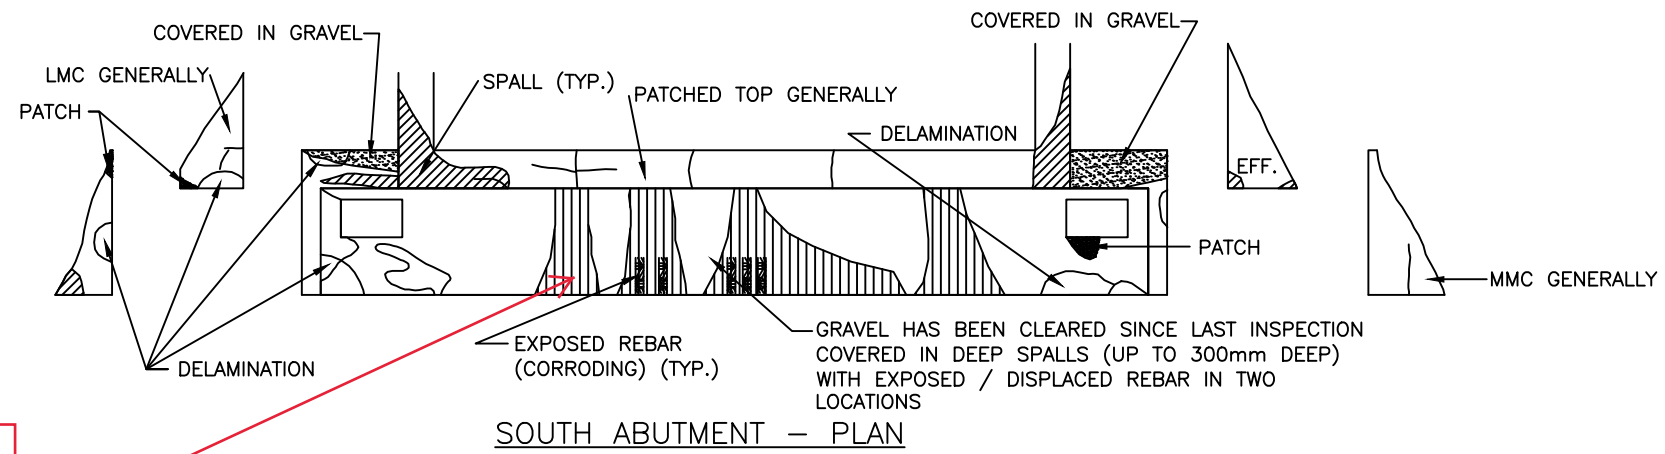
Abutment bearing seat has been repaired since the time of this inspection

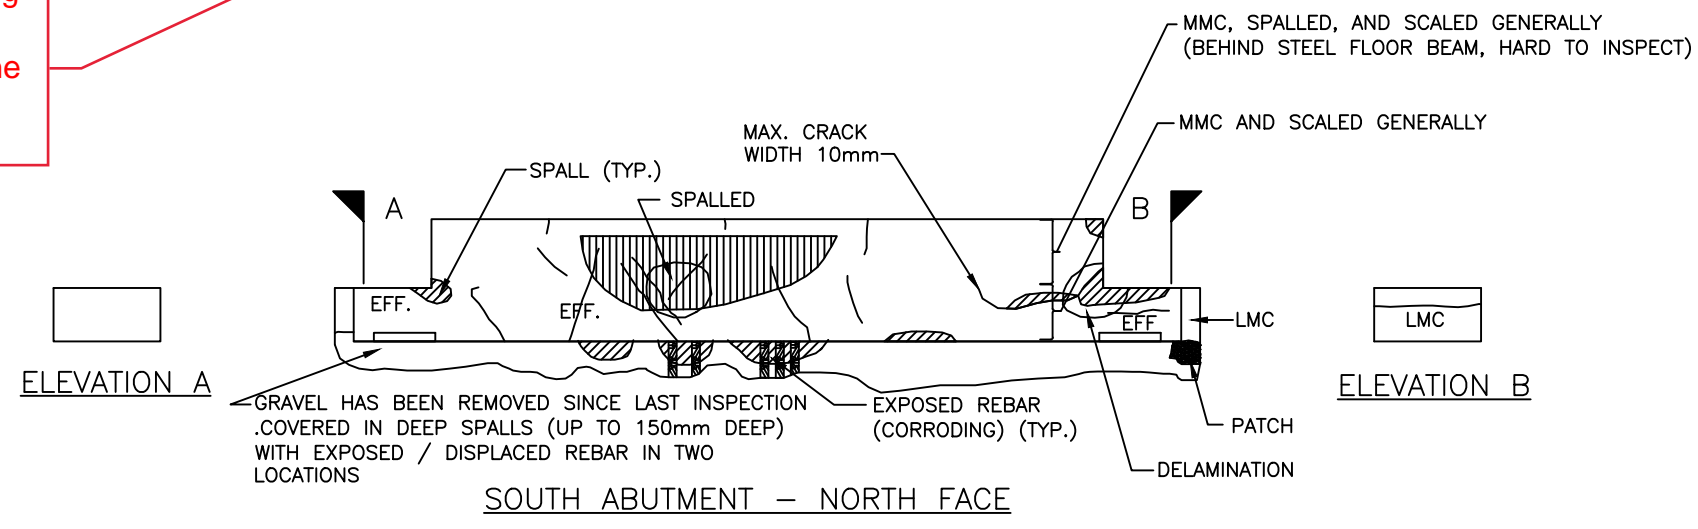
**NOTE:**  
CRACK DIMENSIONS ARE IN MILLIMETRES.

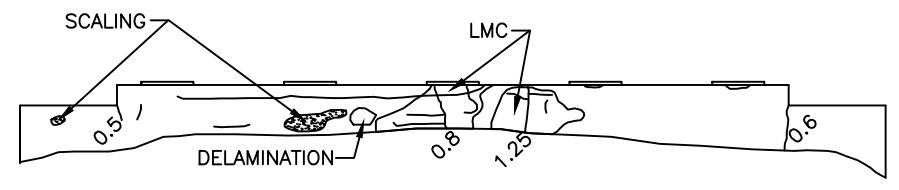
NORTH PIER - NORTH FACE

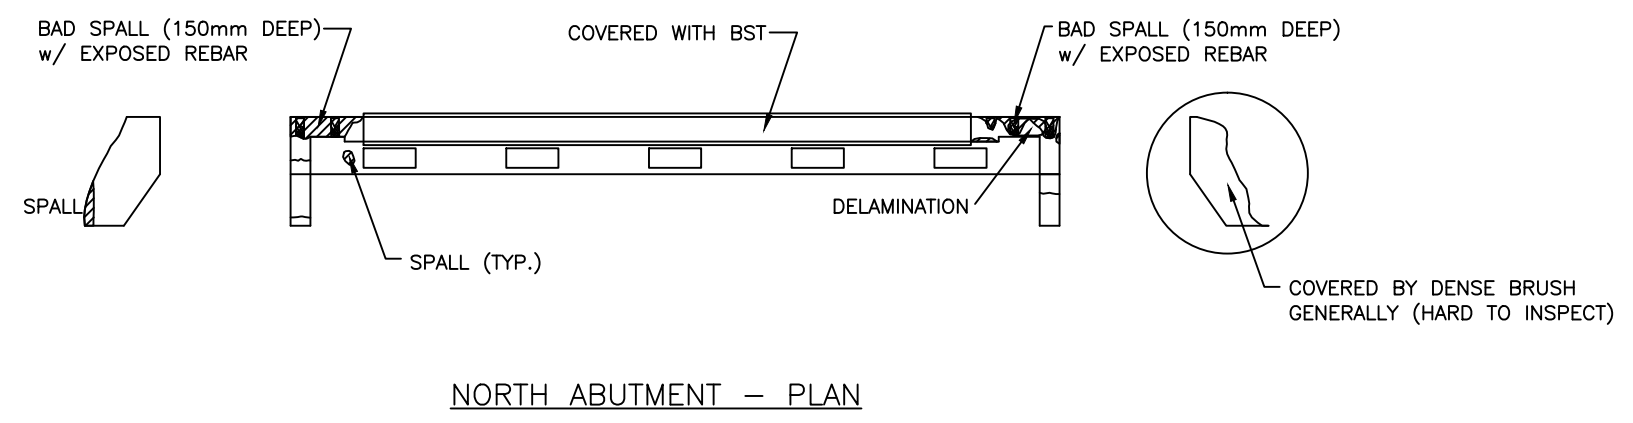
NORTH ABUTMENT - PLAN

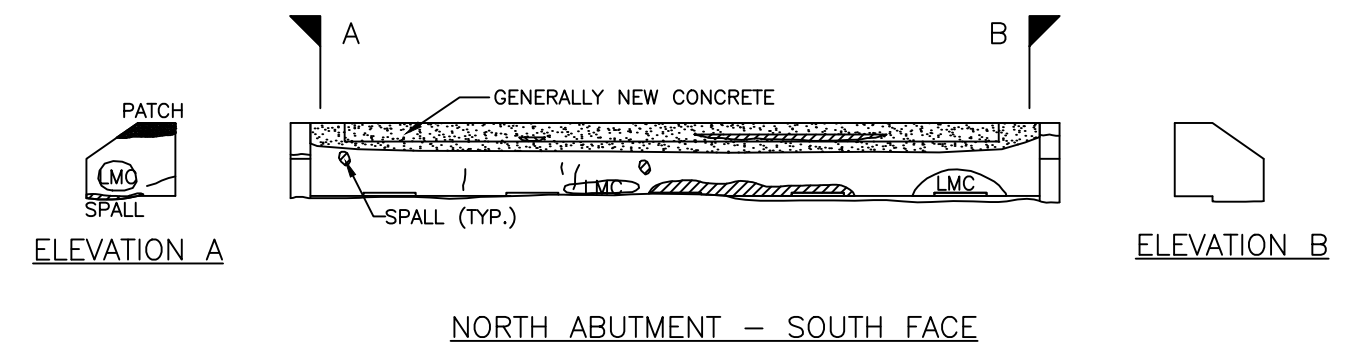
NORTH ABUTMENT - SOUTH FACE

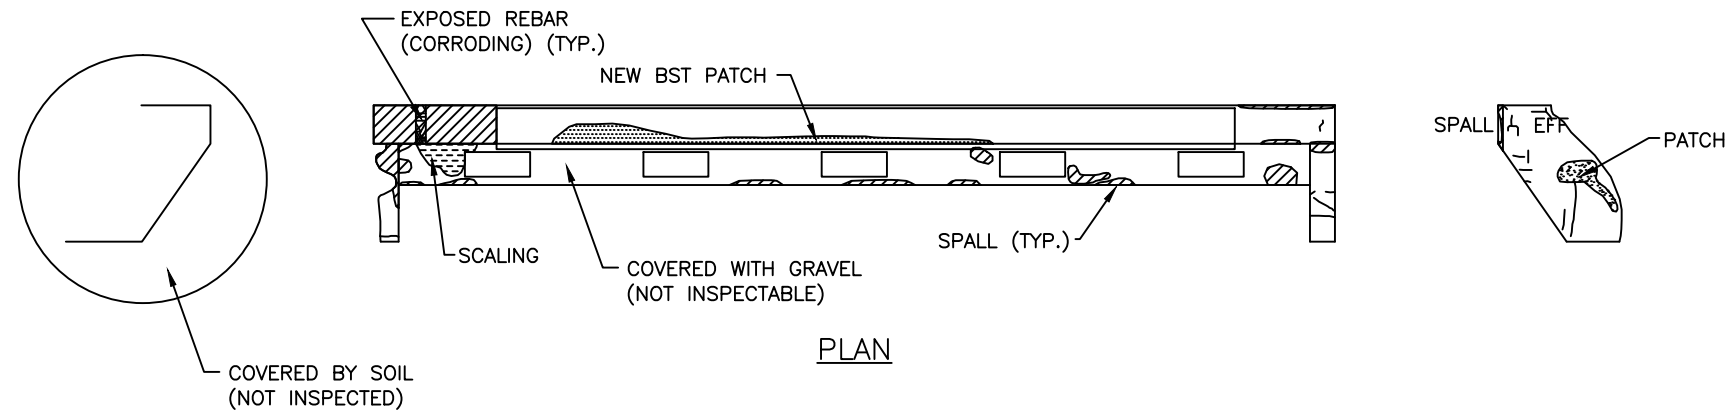
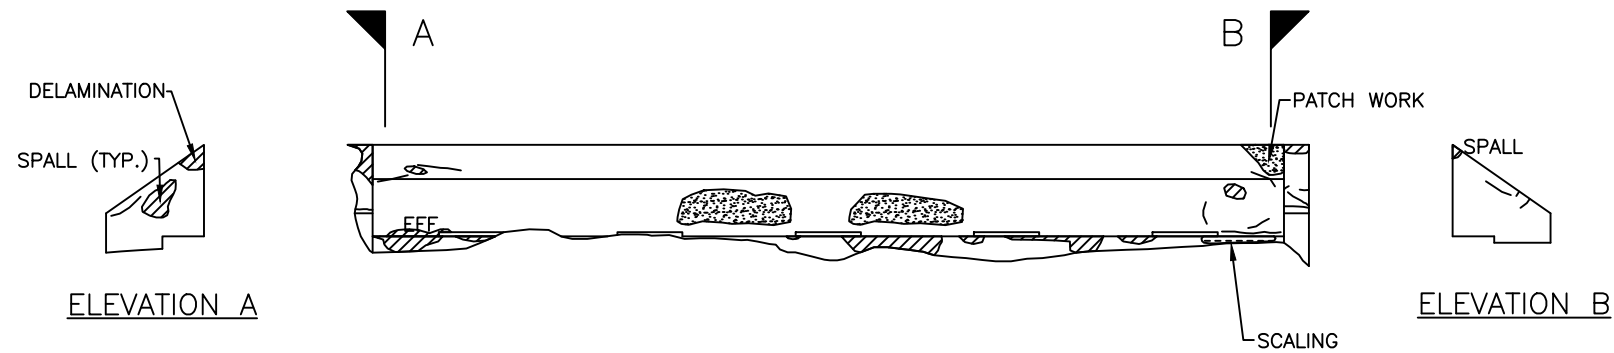
ABUTMENT 1 - (SOUTH ABUTMENT)

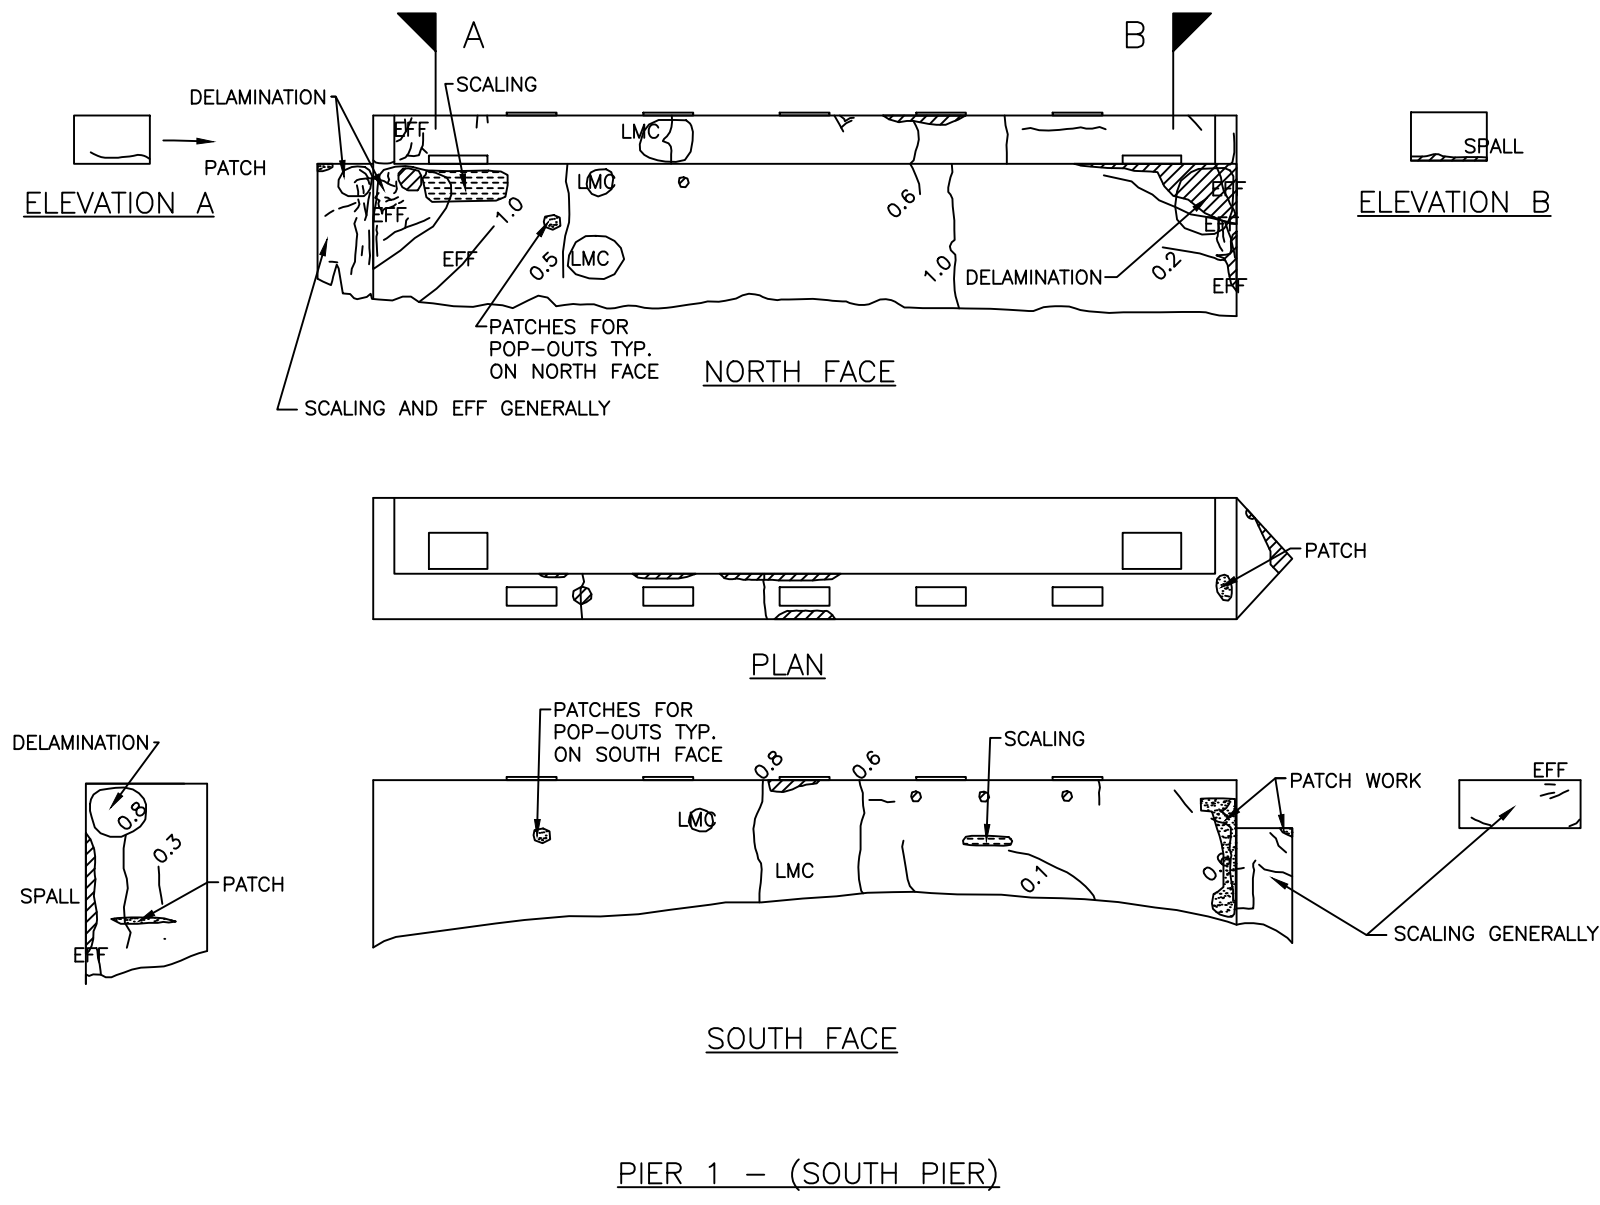
**NOTE:**  
 CRACK DIMENSIONS ARE IN MILLIMETRES.  
 EFF. DENOTES EFFLORESCENCE  
 LMC. DENOTES LIGHT MAP CRACKING  
 MMC. DENOTES MEDIUM MAP CRACKING

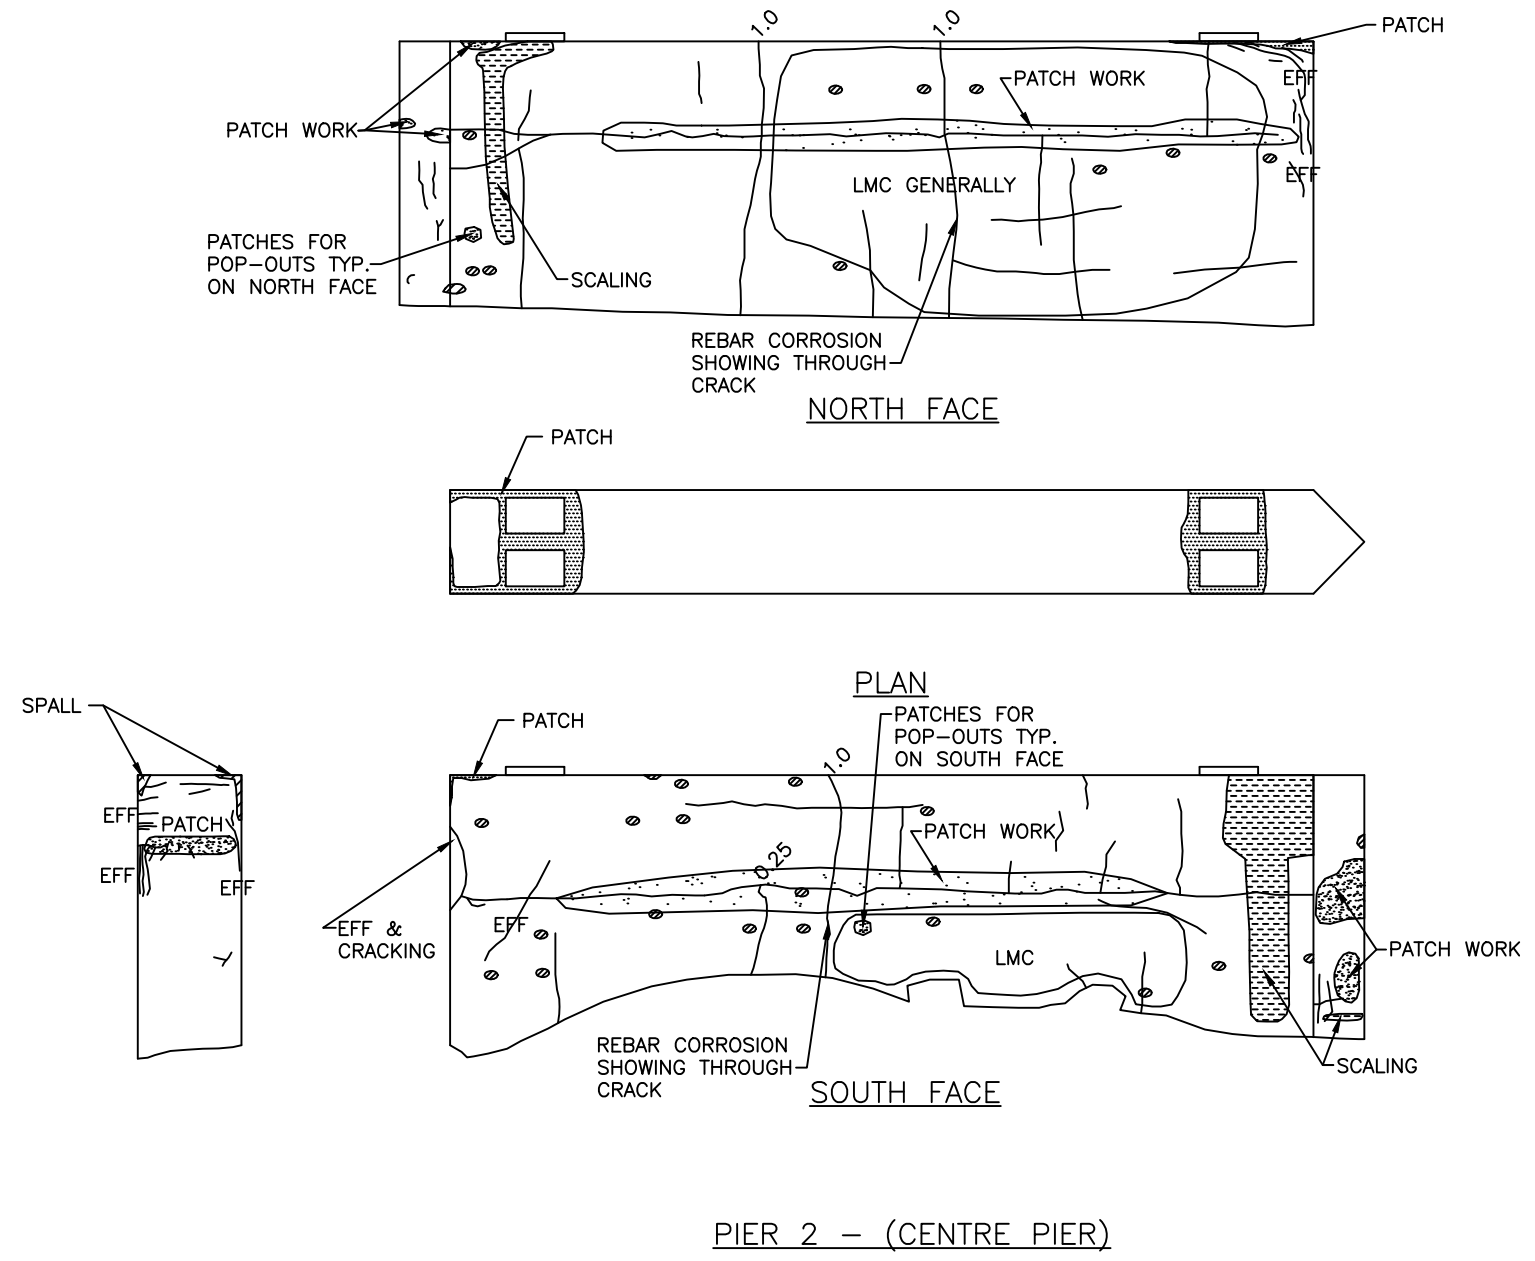
ACAD006 B015/10/06 1008 0100 ALASKA HIGHWAY 07 SEPTEMBER 2015 SUBSTRUCTURE DEFECTS AUTODRAW/TETS. LDVG PLOTTED ON 2015/10/13 14:15
