*Public Services Procurement Canada – Alaska Highway*

**Concrete Repairs Action Plan:**

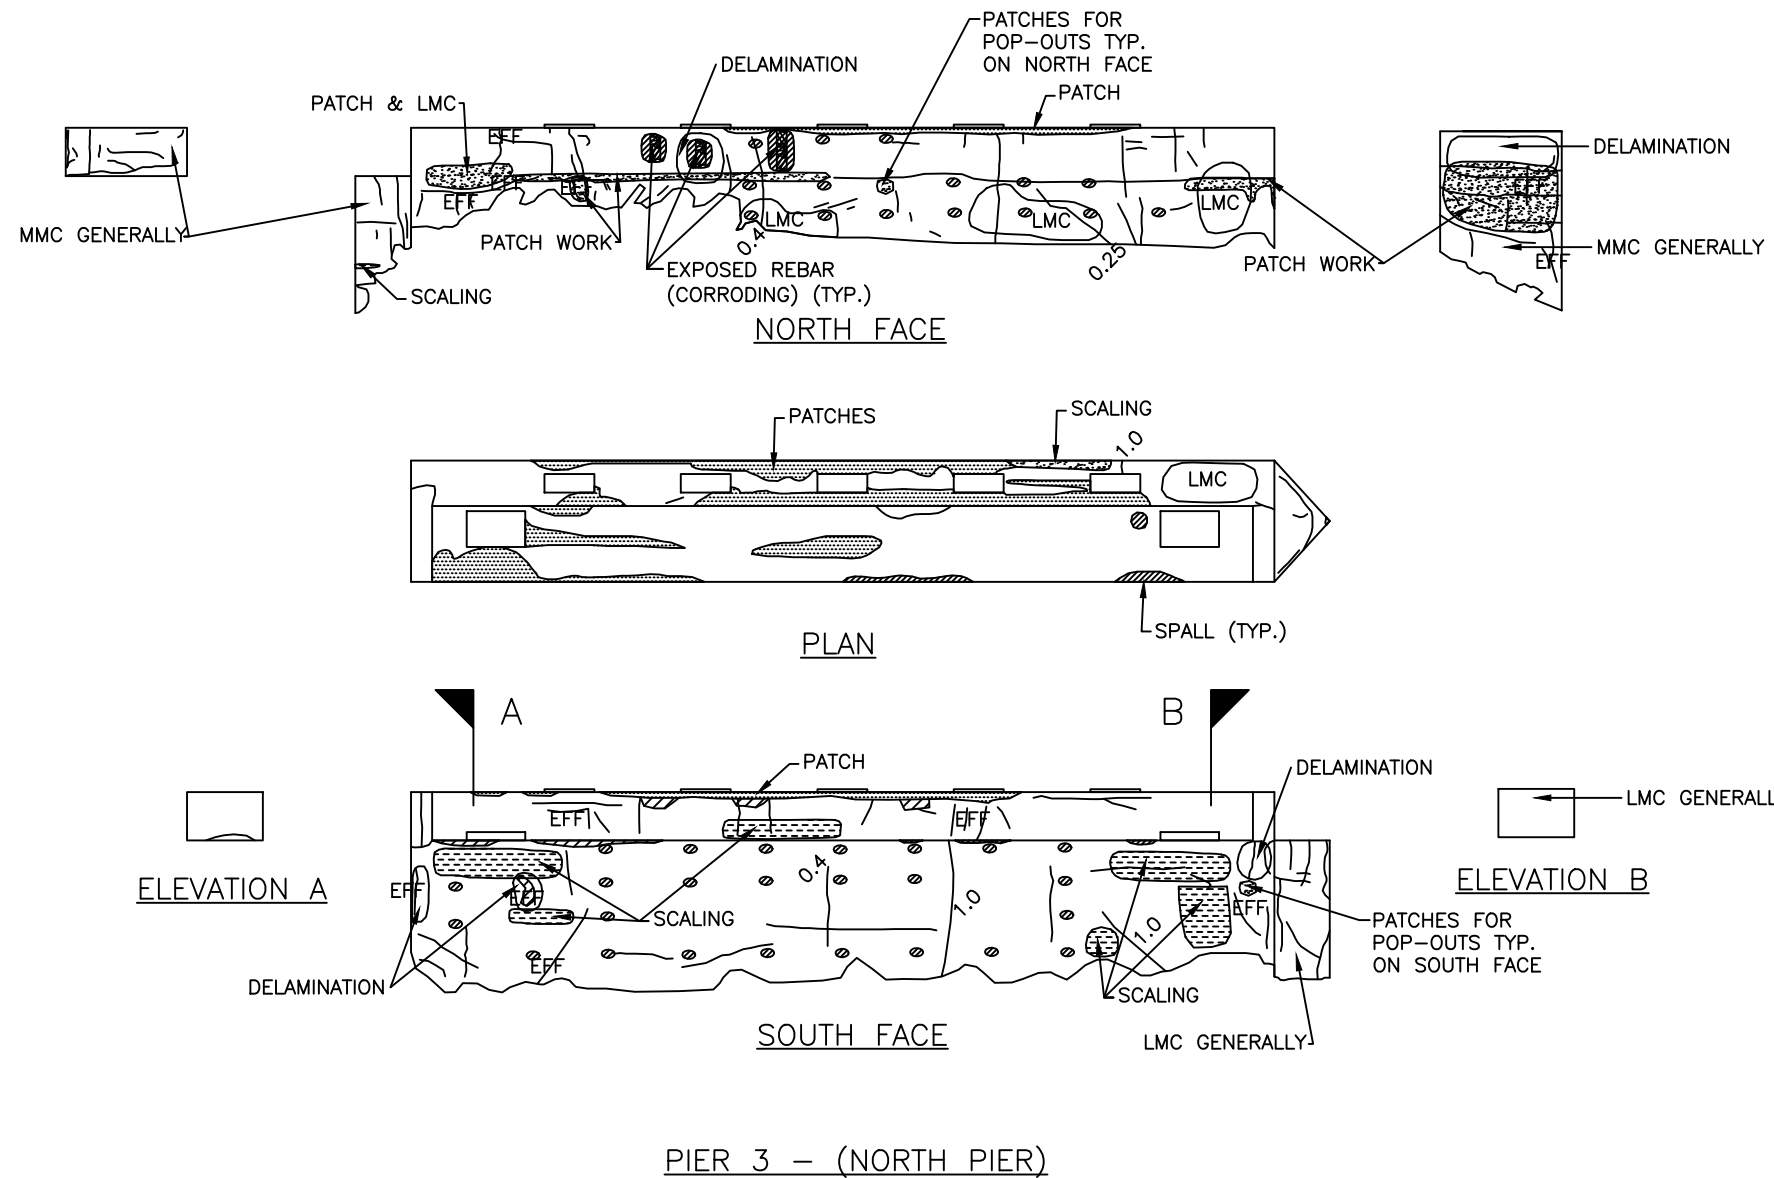
ACAD0006 BRIS/10/06 1008 @/N/A ALASKA HIGHWAY/07 SEPTEMBER BRIS/SUBSTRUCTURE DEFECTS AUTODRAW/TETSA.LDW PLOTTED ON 2015/10/13 14:15

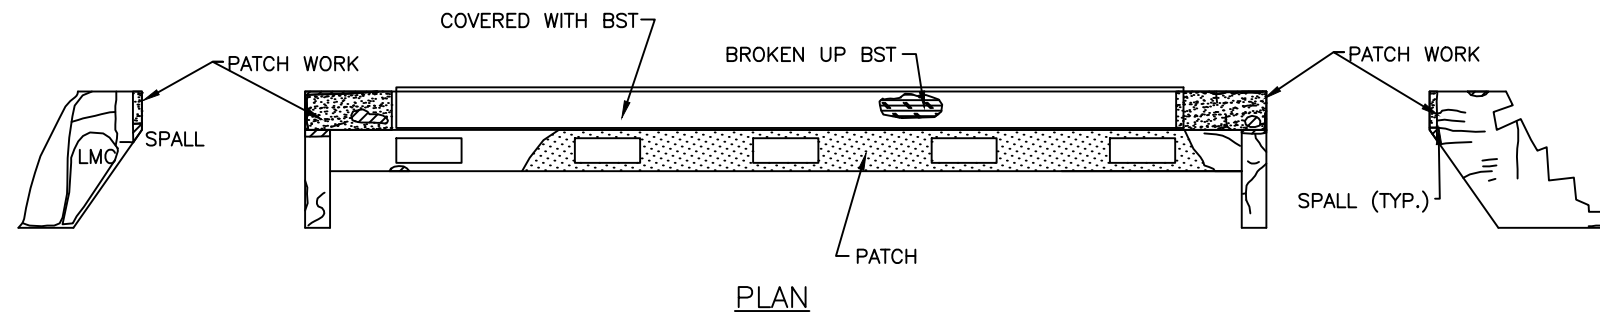
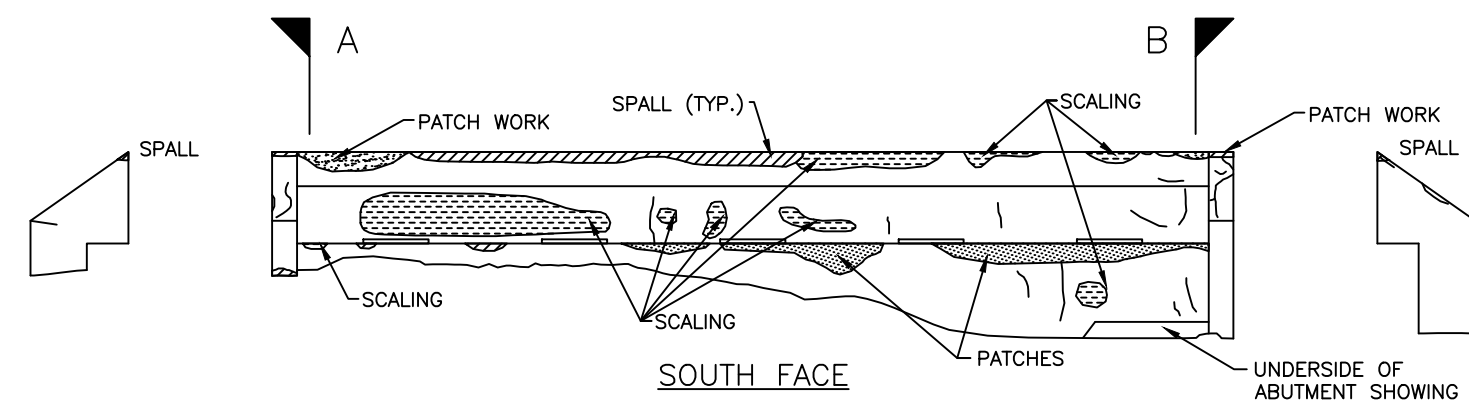
ABUTMENT 2 - (NORTH ABUTMENT)
