MEP Installation Best Practices

PROJECT TITLE: HVAC REFURBISHMENT

CLIENT: DEPUTY HIGH COMMISSION OF CANANDA,

DOCUMENT TITLE: MECHANICAL GOOD PRACTICE

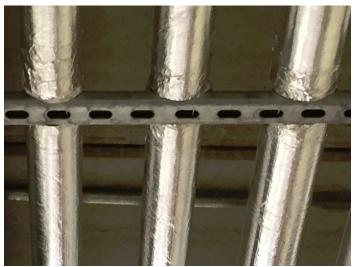
Thermal bridge broken as lagging not carried through, hence pipe in contact with steel bracket directly.

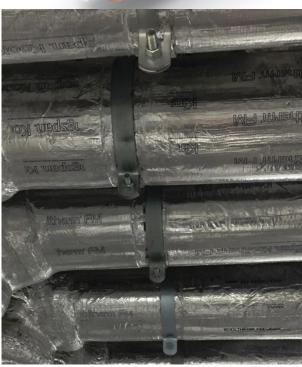
Phenolic block used at pipe bracket, with insulation connected with vapour barrier seal to ensure no thermal bridge

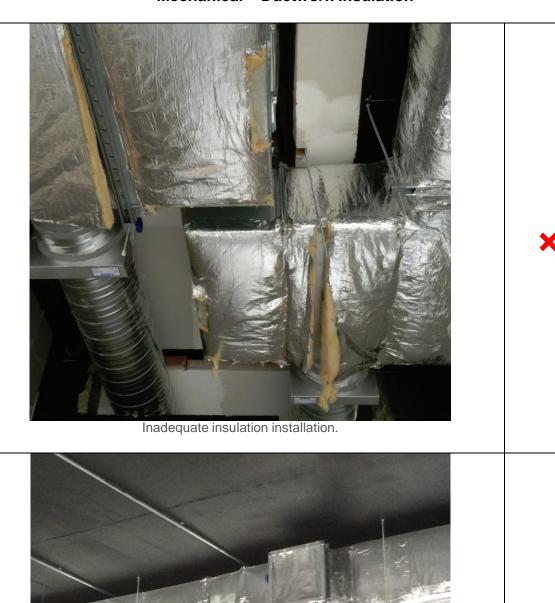
Insulation to have complete coverage and be vapour sealed. Thermal bridge between the ductwork support and the duct must also be separated – insulation must be installed between the duct and support.

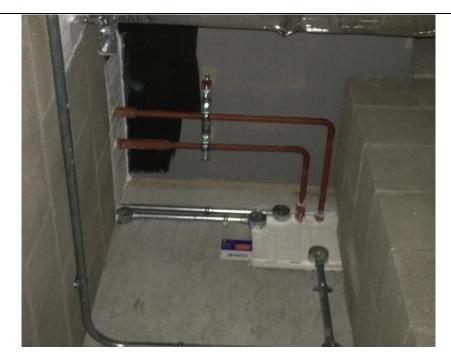
Fire stopping completely sealing up opening, and pipework sleeves installed to protect pipework.

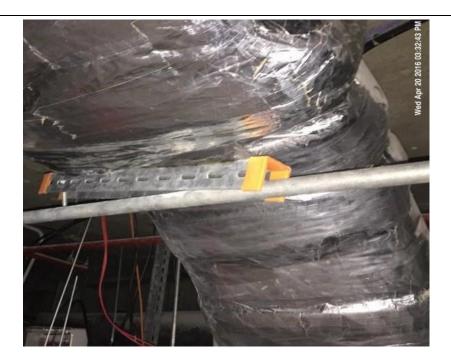
Duct support poorly installed leading to separation from threaded rod.
