Parks Canada Agency

# **GRAND-PRÉ NATIONAL HISTORIC SITE MEMORIAL CHURCH AND MONUMENTS REPOINTING**

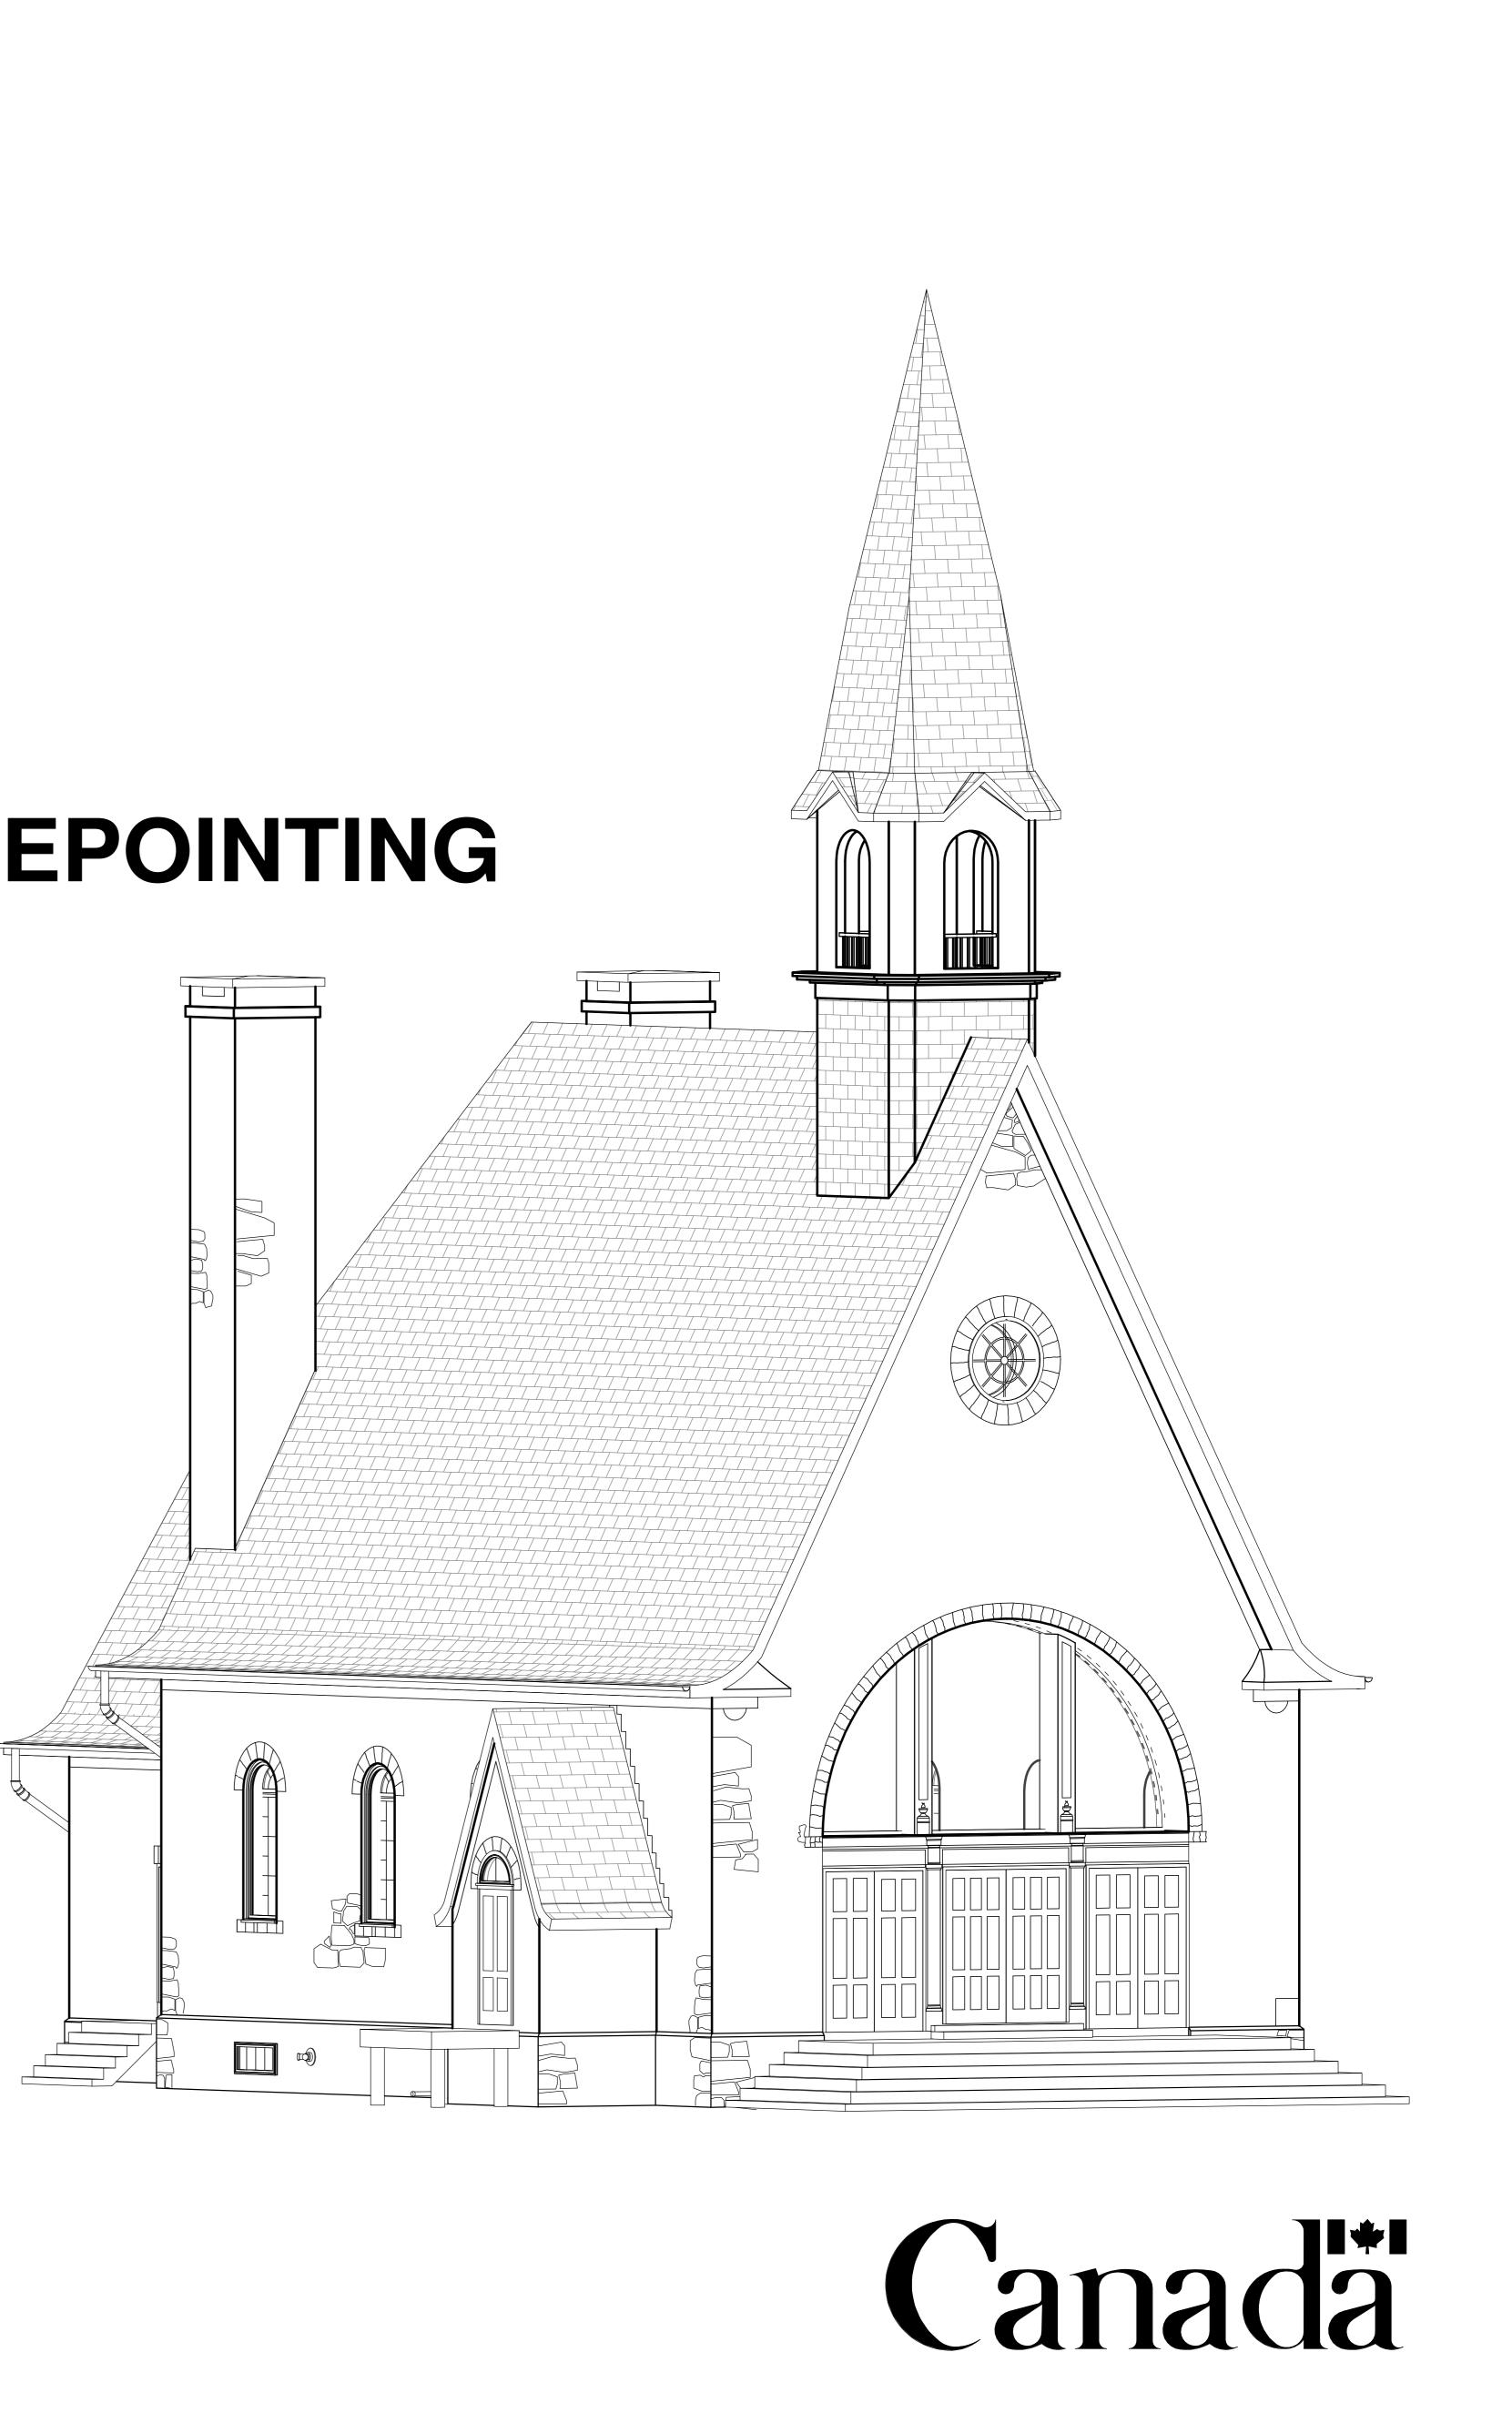
**RS & INTERIOR - PHOTOS**

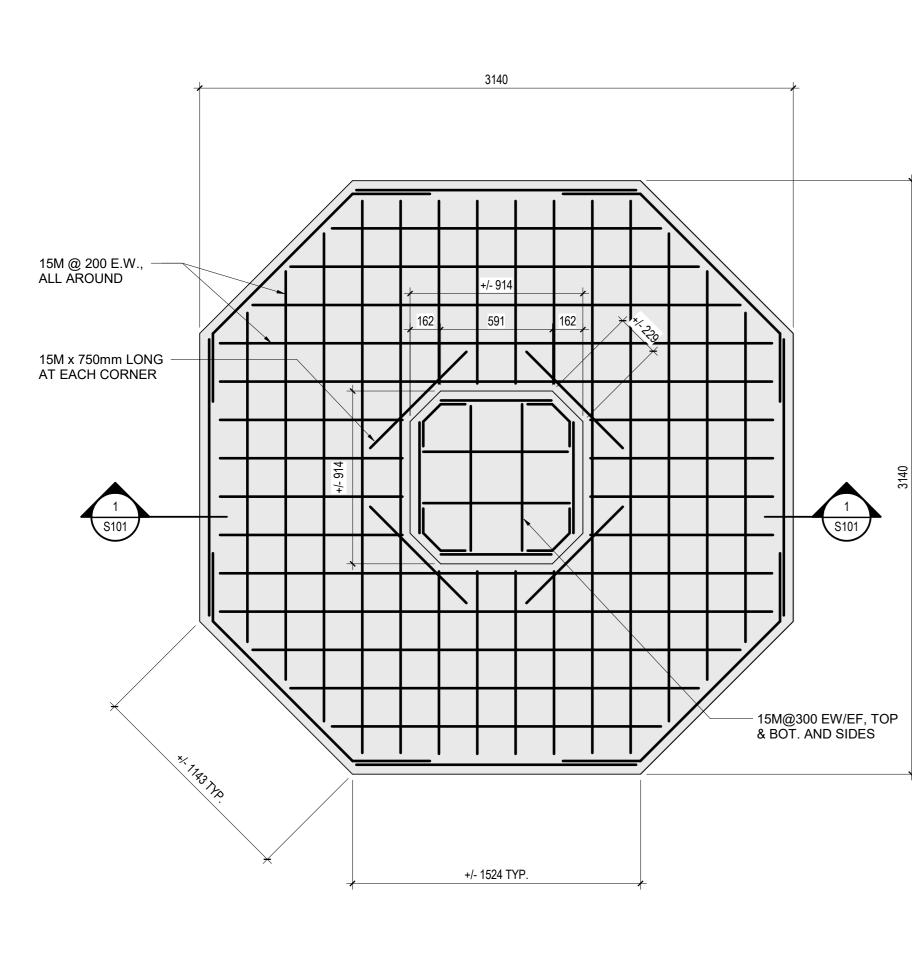
4 EVANGELINE FOUNDATION PLAN S101 1:20

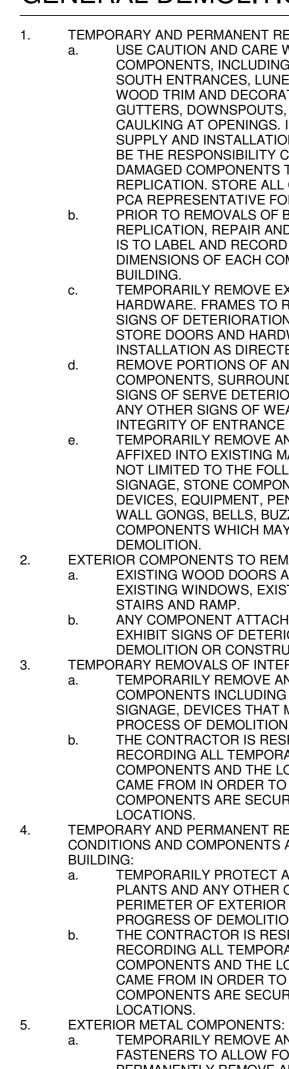
INCLUDE BUT ARE
		COMPONENTS; SOU
		BUILDING SIGNAGE
		COMPONENTS, ELE
		DEVICES, EQUIPME
		SERVICES, WALL G
		ANY OTHER PREVIO
		EQUIPMENT AND S
		BACK TO THEIR OR
		COMPLETE AND FU

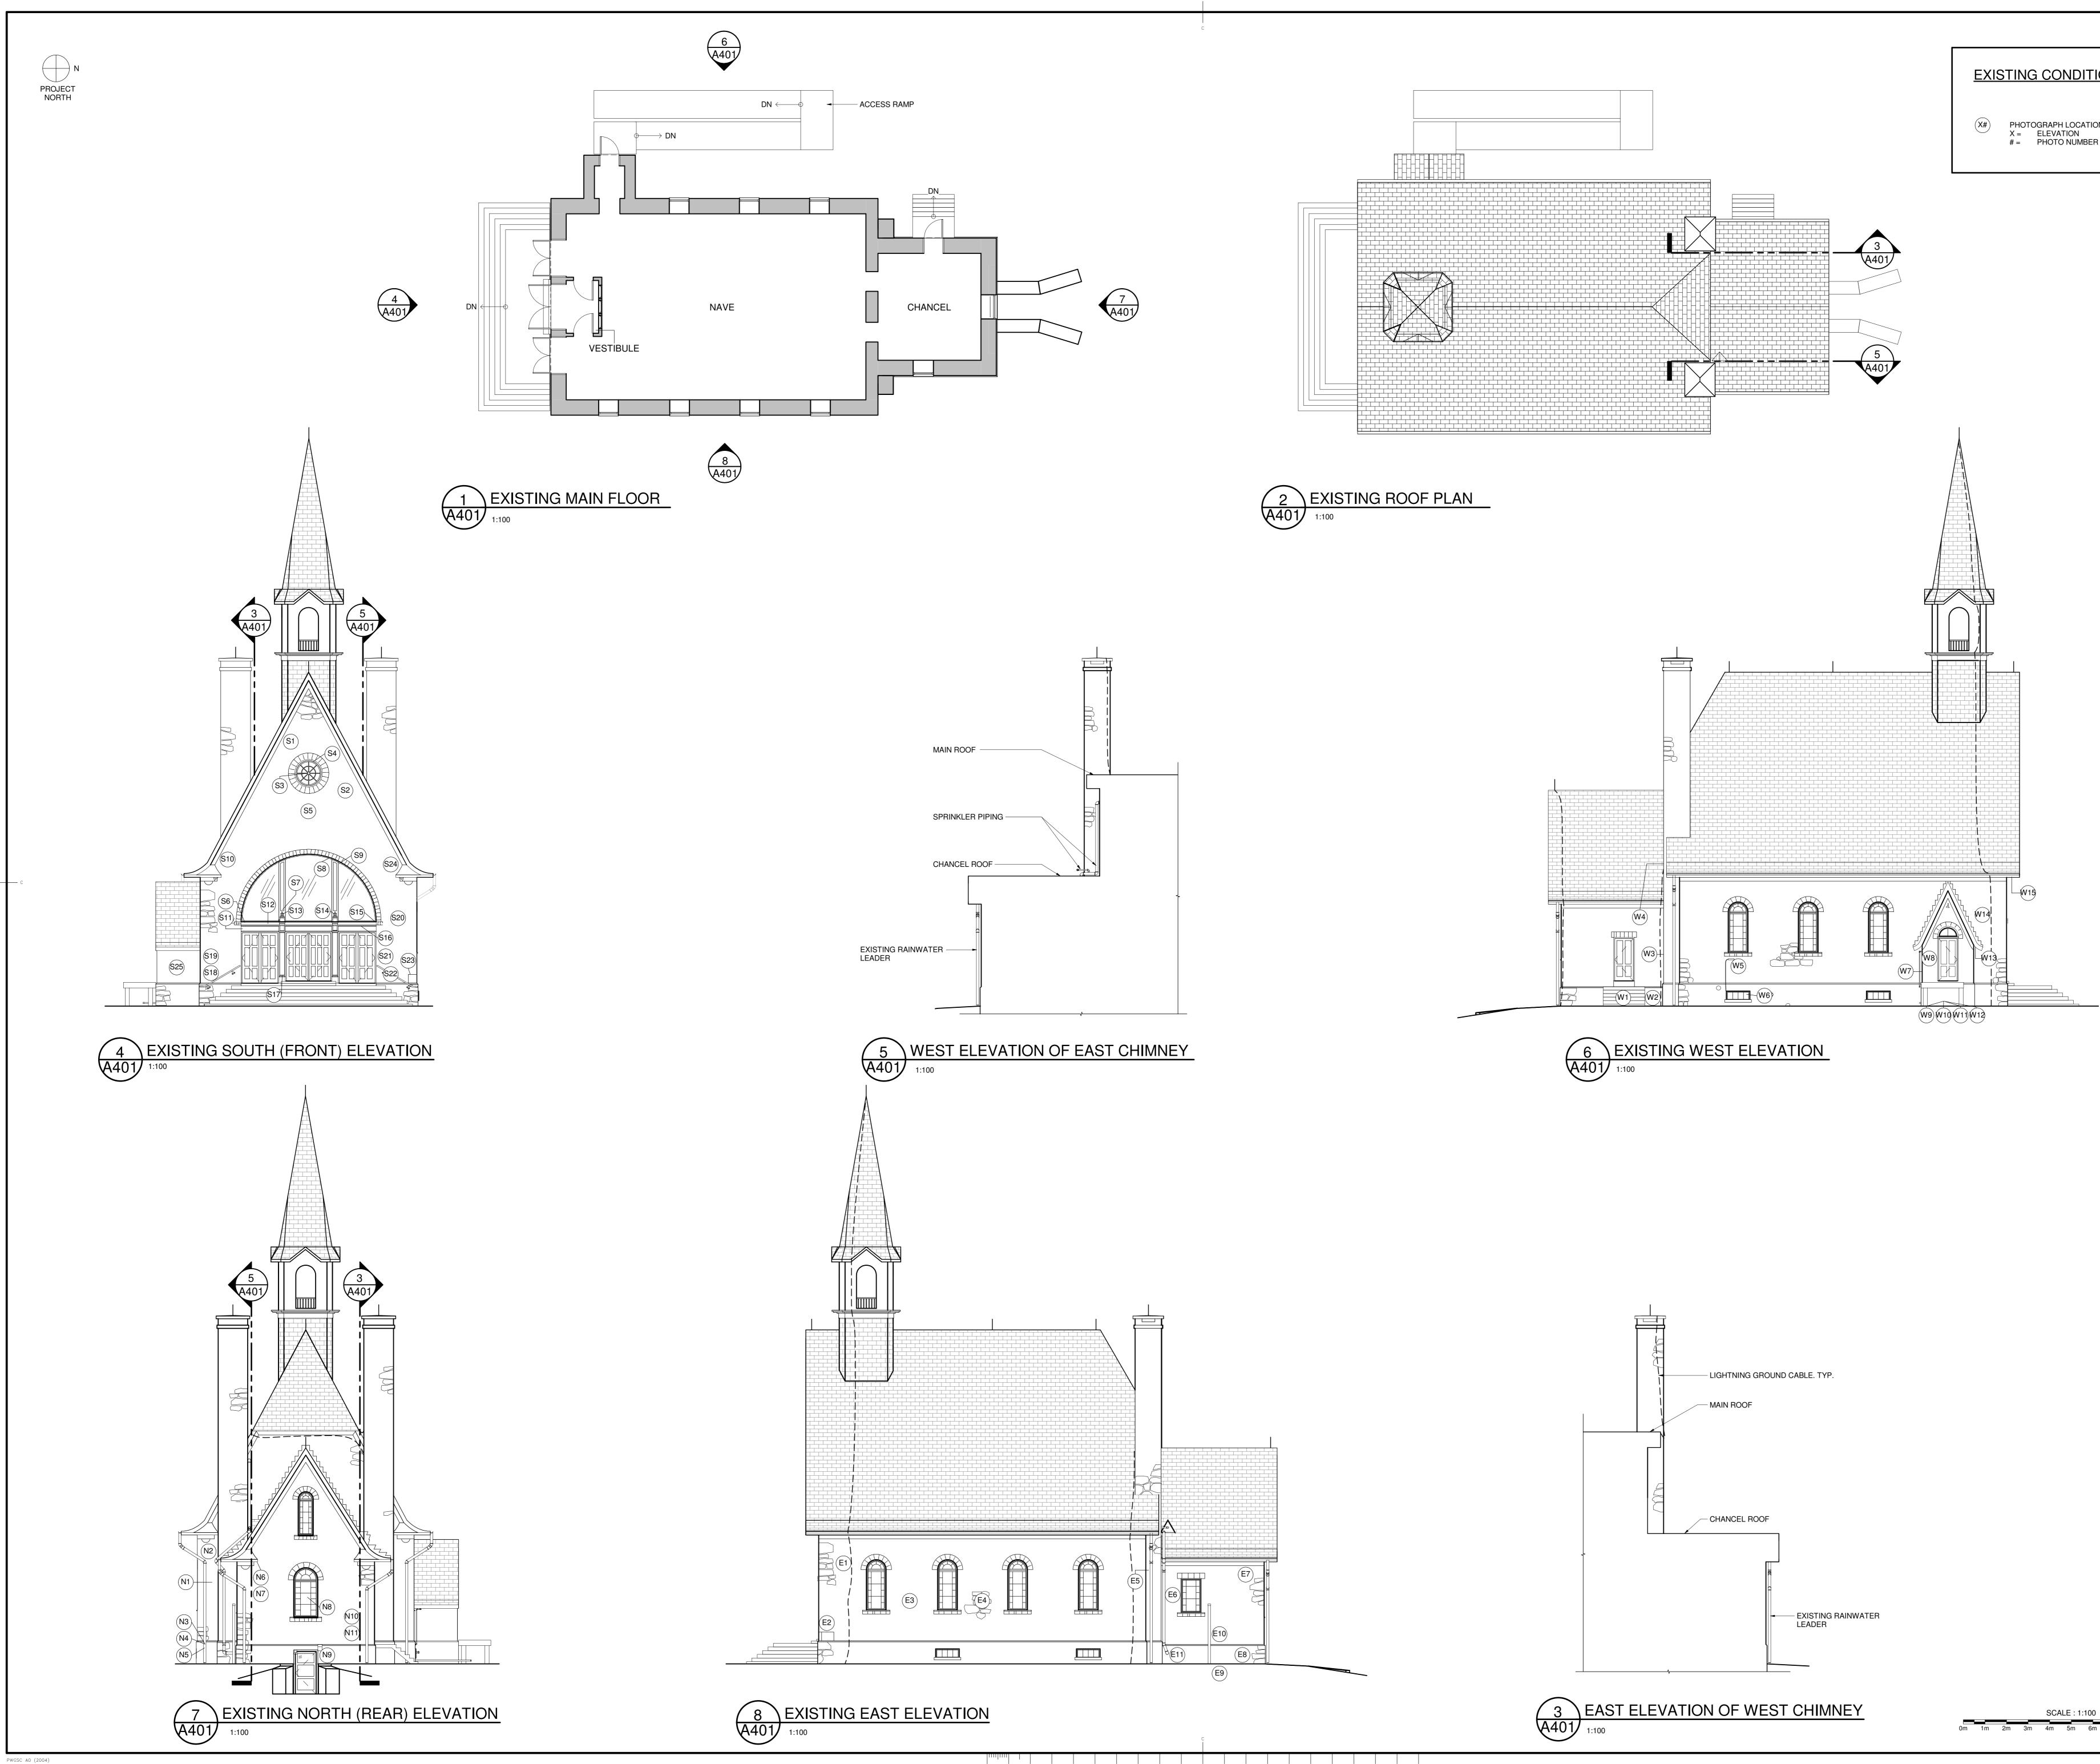
10
 10
 20mm
 40
 60
 80
 100
 120
 140
 160
 180
 200mm

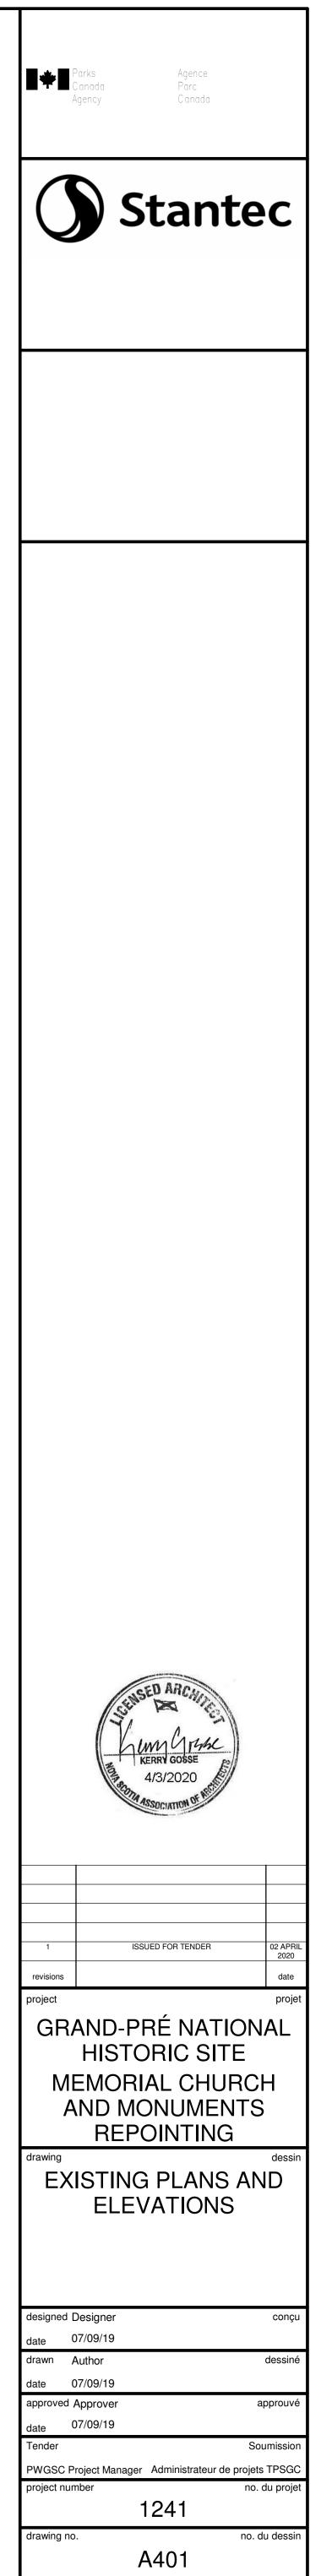
(X#) PHOTOGRAPH LOCATION. SEE DRAWINGS A901-A903
 X = ELEVATION
 # = PHOTO NUMBER

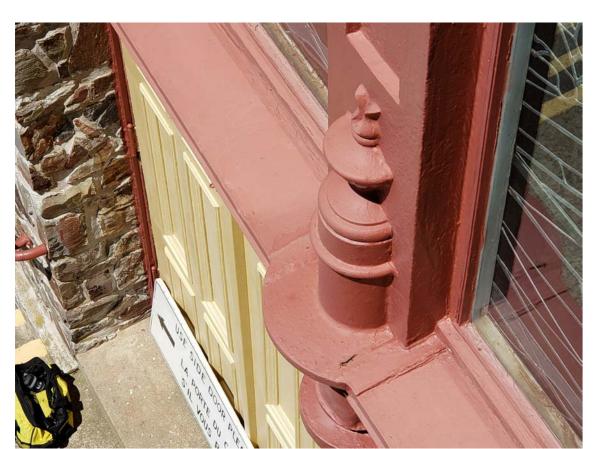
(S7) MINOR DAMAGE TO LEDGE OF CAST IRON PILASTER

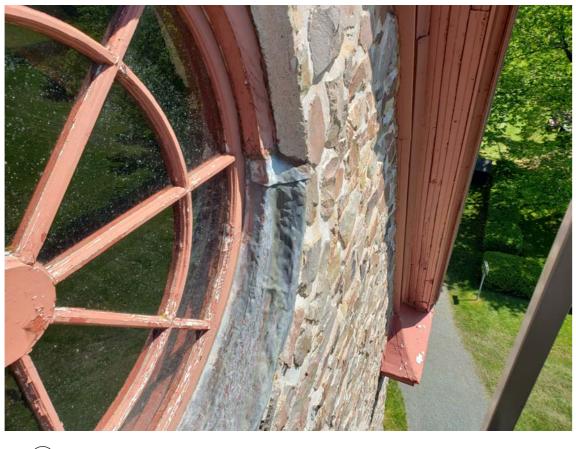
S2 PEELING PAINT, ROTTEN AND WEATHERED WOOD ON LUNETTE WINDOW, SOFFIT AND RAKE RETURN. LUNETTE WINDOW INSTALLED BACKWARDS

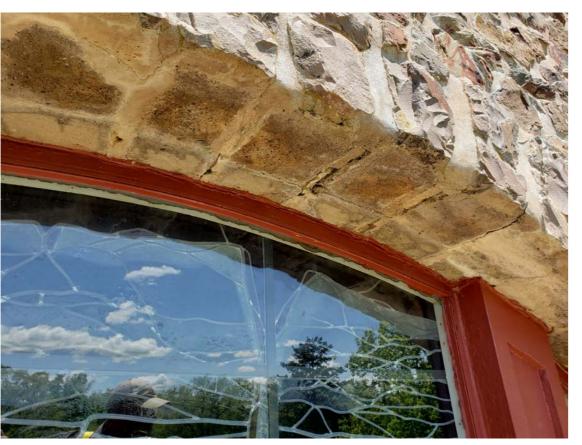
(S8) DETERIORATION OF CONCRETE BLOCK ARCH INCLUDING EFFLORESCENCE, WEATHERING AND OPEN JOINTS

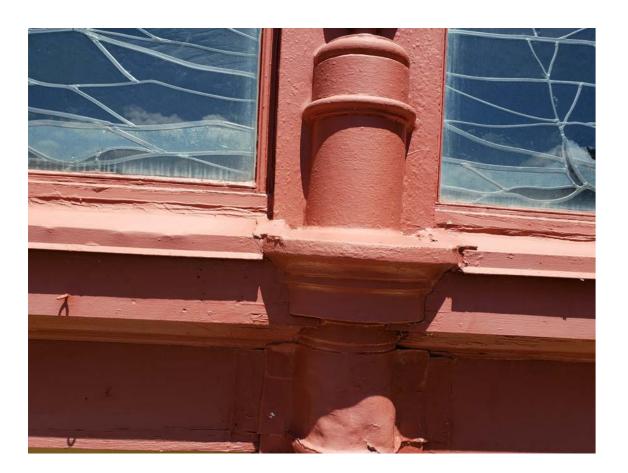
(\$13) PEELING PAINT, ROTTEN AND WEATHERED WOOD ADJACENT CAST IRON PILASTER

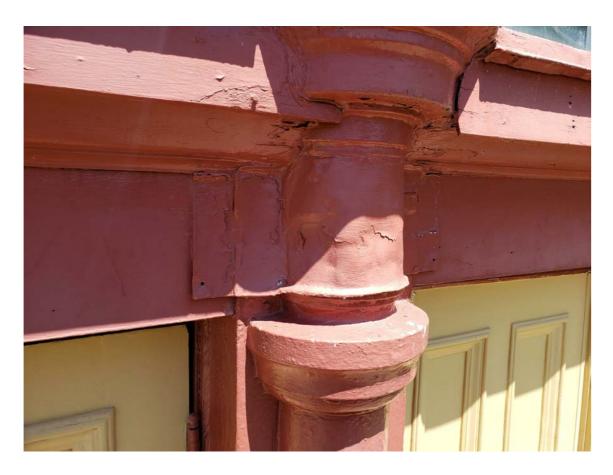
(\$14) PEELING PAINT, AND MISSING FASTENERS ON LEAD FLASHING AT PILASTER

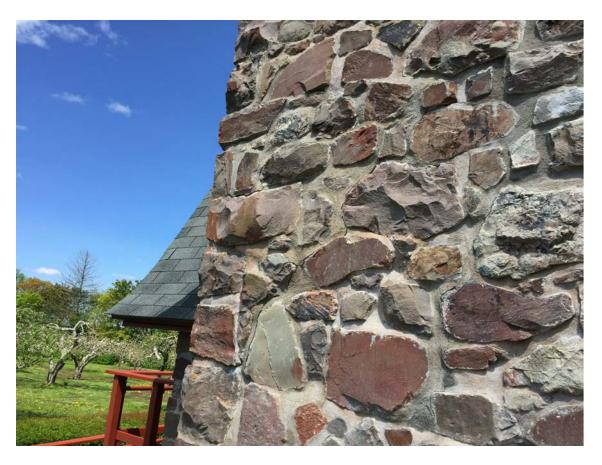
(\$19) PANEL TO SOUTHWEST OF DOOR HAS CRACKED MORTAR, OPEN JOINTS AND PREVIOUS MORTAR REPAIRS

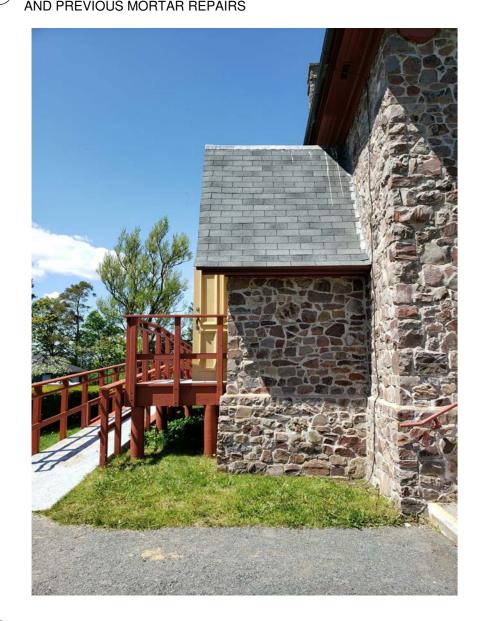
(\$25) SOUTH ELEVATION OF SOUTHWEST PORCH

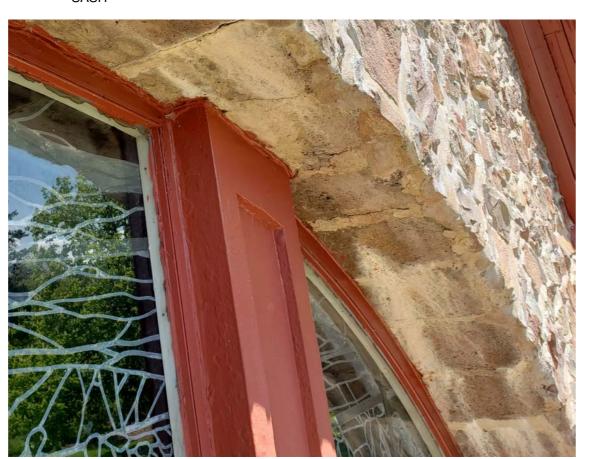
(S9) DETERIORATION OF CONCRETE BLOCK ARCH INCLUDING EFFLORESCENCE, WEATHERING AND OPEN JOINTS

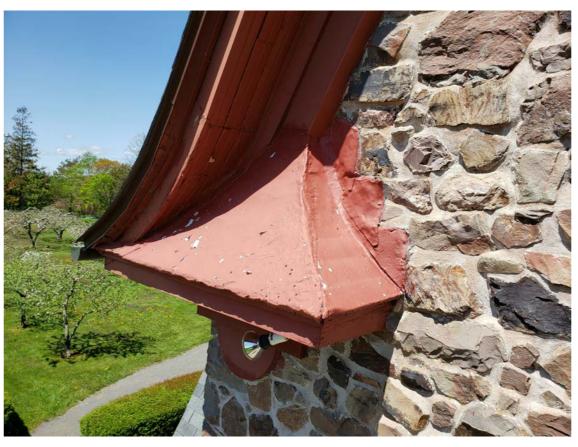
(\$10) PEELING PAINT ON RAKE RETURN, ROTTED WOOD SOFFIT

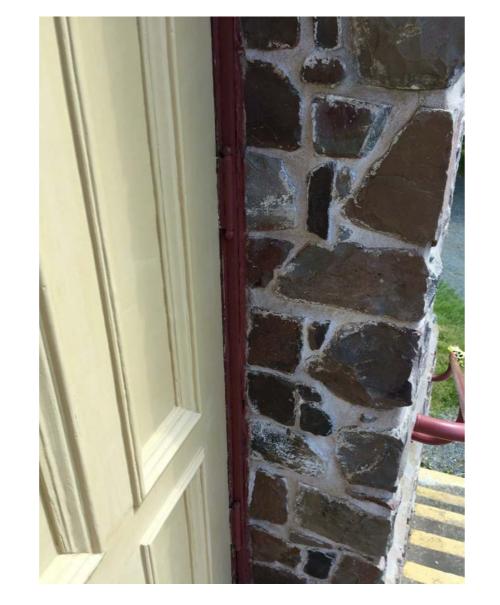
S21) PANEL TO SOUTHWEST OF DOOR HAS CRACKED MORTAR AND EFFLORESCENCE IN JAMB

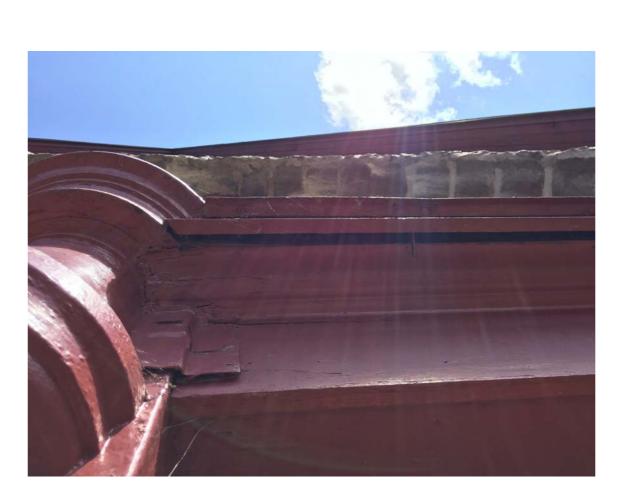
(\$16) WOOD AND FLASHING DETACHMENT

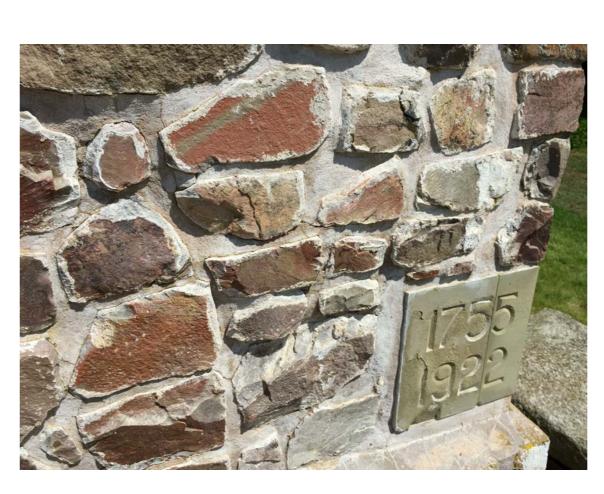
S22 PANEL TO SOUTHEAST OF DOOR HAS CRACKED MORTAR, OPEN JOINTS AND PREVIOUS MORTAR REPAIRS

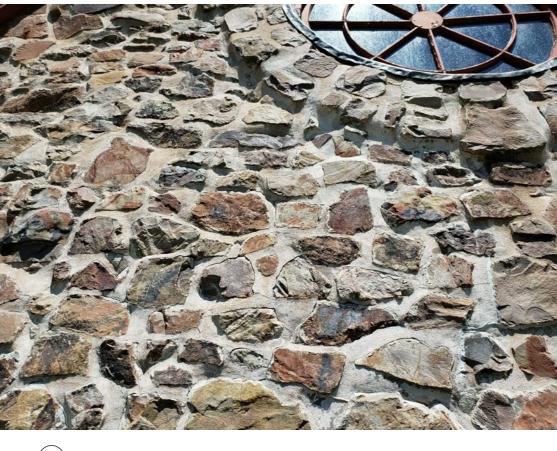
(S5) CRACKED MORTAR, OPEN JOINTS AND PREVIOUS MORTAR REPAIRS

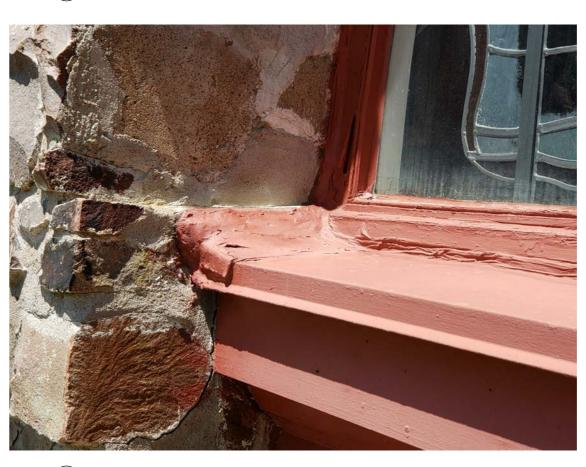
(S11) PEELING PAINT, ROTTEN AND WEATHERED WOOD ON WINDOW FRAME, FAILED CAULKING

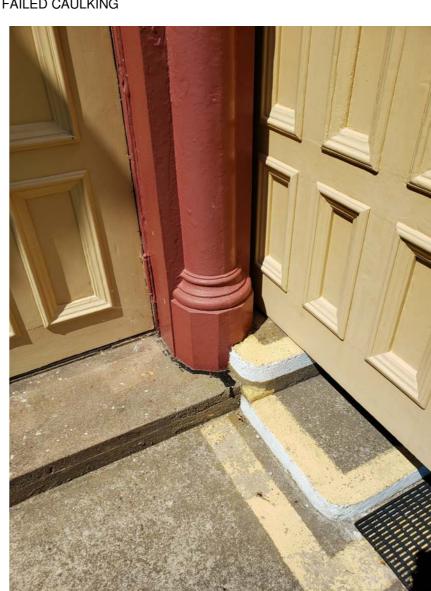
(\$17) PEELING PAINT, ROTTEN AND WEATHERED WOOD ON DOOR FRAMES

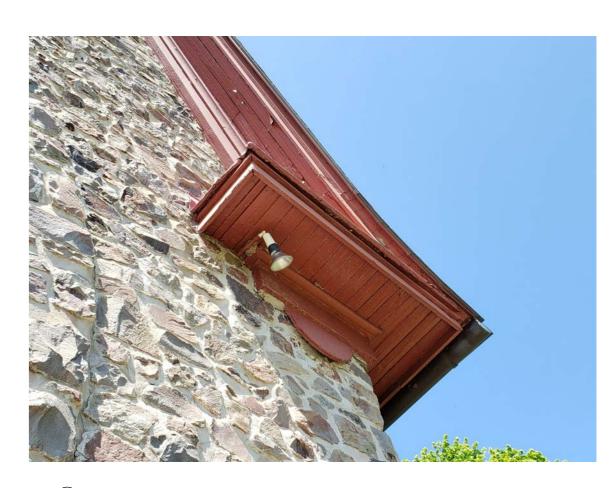
S24 CRACK AT OUTSIDE EDGE OF ARCH, GAP BEHIND WOOD MEDALLION, PEELING PAINT, ROTTEN AND WEATHERED WOOD ON SOFFIT

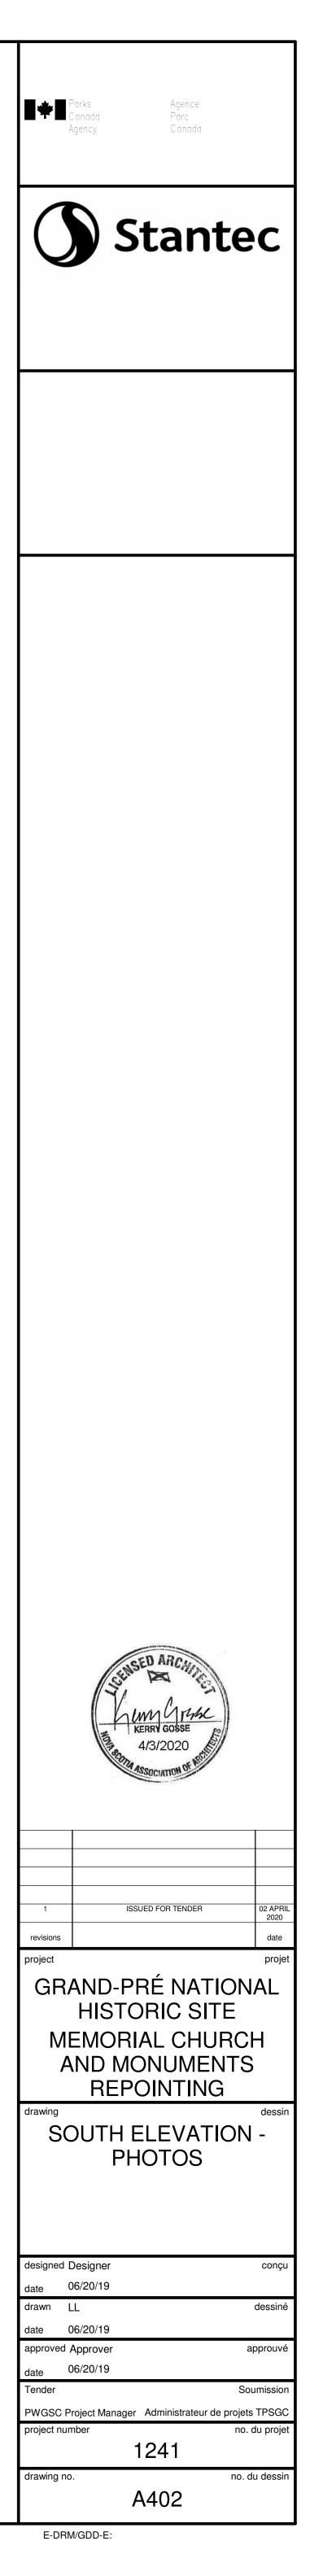
(S12) PEELING PAINT, ROTTEN AND WEATHERED WOOD ON WINDOW FRAME, FAILED CAULKING

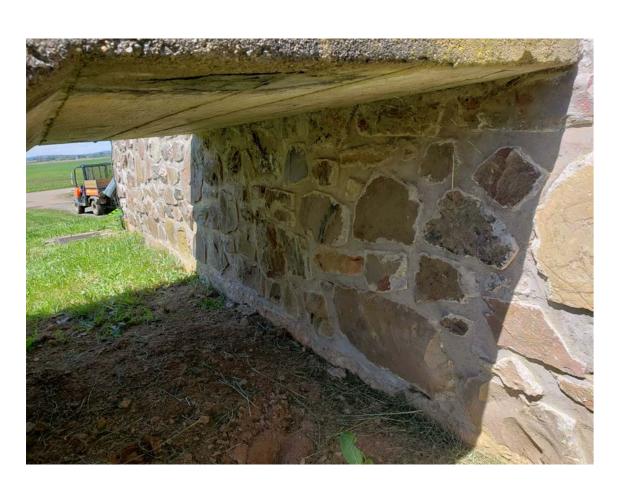
(W1) MORTAR IN GOOD CONDITION BELOW NORTHWEST CONCRETE STAIR

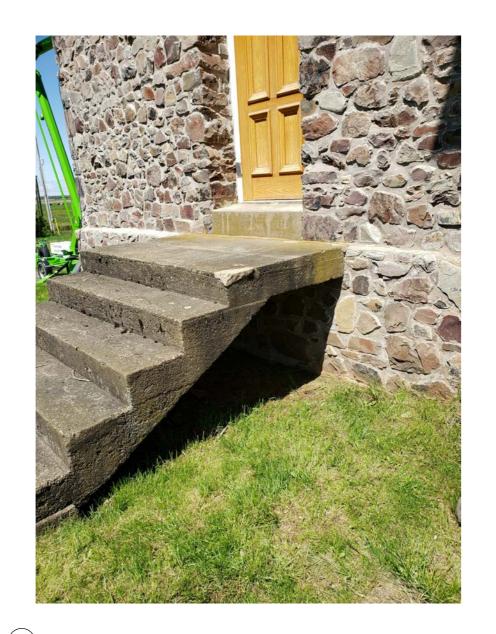
W2 PREVIOUS CONCRETE REPAIR AND ORGANIC GROWTH ON CONCRETE STAIR AND SILL

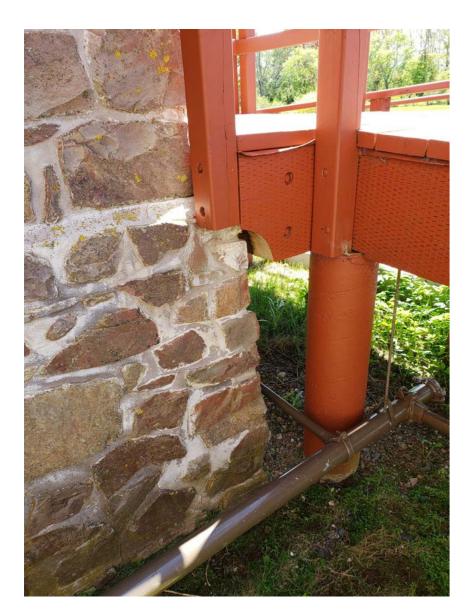
W7 CRACKED MORTAR, OPEN JOINTS, ORGANIC GROWTH AND PREVIOUS W8 SOUTHWEST PORCH MORTAR REPAIRS AT CORNER OF SOUTHWEST PORCH

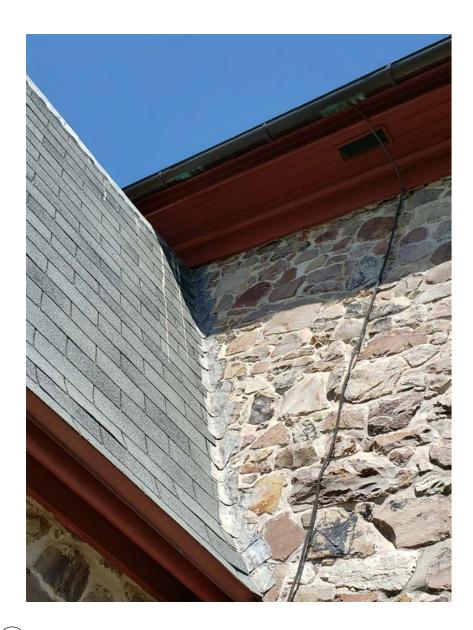
W14 STAINING ON ROOF SHINGLES, LEAKING COPPER GUTTER

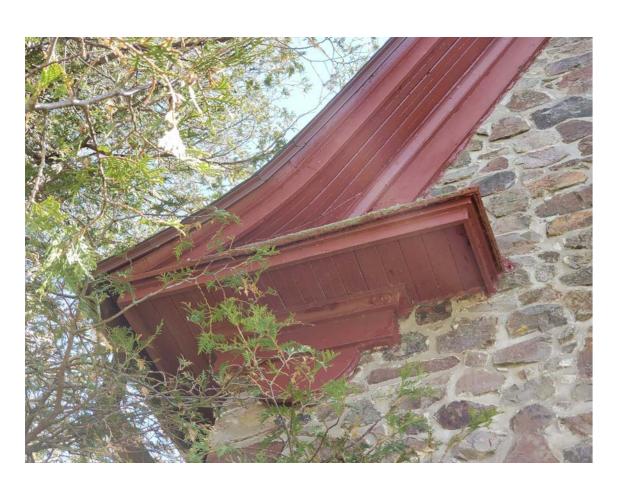
N6) GAP BEHIND WOOD MEDALLION, ORGANIC GROWTH ON ROTTEN WOOD

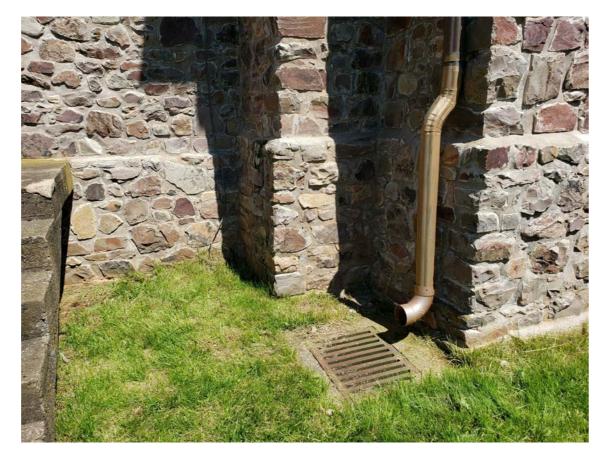
W3 CRACKED MORTAR AND OPEN JOINTS AT CORNERS, VARIOUS MATERIALS AND COLOURS ON DOWNSPOUT

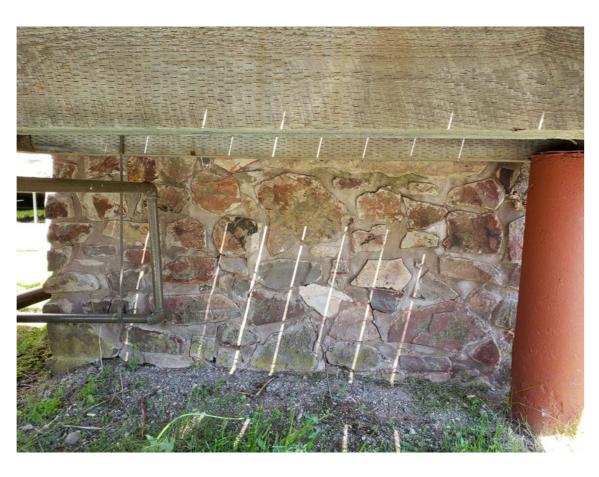
W9 CRACKED MORTAR, OPEN JOINTS, ORGANIC GROWTH AND PREVIOUS MORTAR REPAIRS BELOW LANDING AT SOUTHWEST PORCH

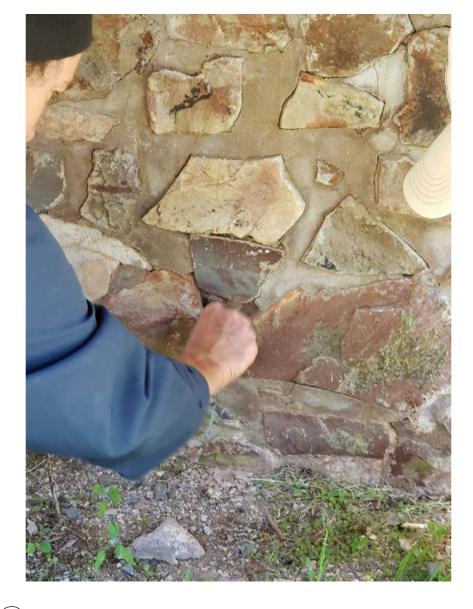
(W10) LOSS OF BINDER FROM MORTAR AND MISSING STONE LANDING AT SOUTHWEST PORCH

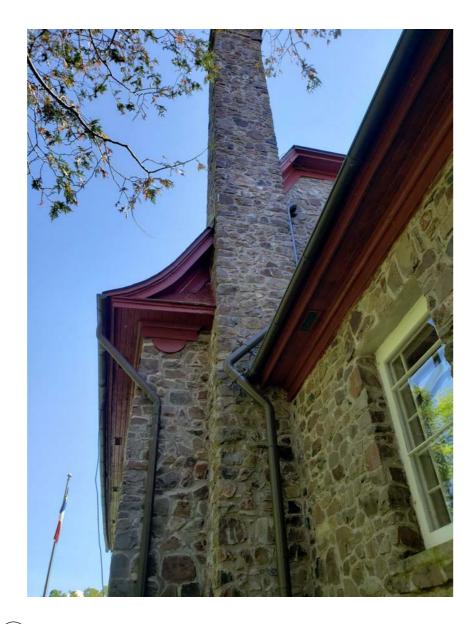
CRACKING AND OPEN JOINTS AT CORNER, CRACKED MORTAR AT JOINT (N1) EFFLORESCENCE ON BACKSIDE OF CHIMNEY, PEELING PAINT ON RAKE BELOW PROFILED FRIEZE

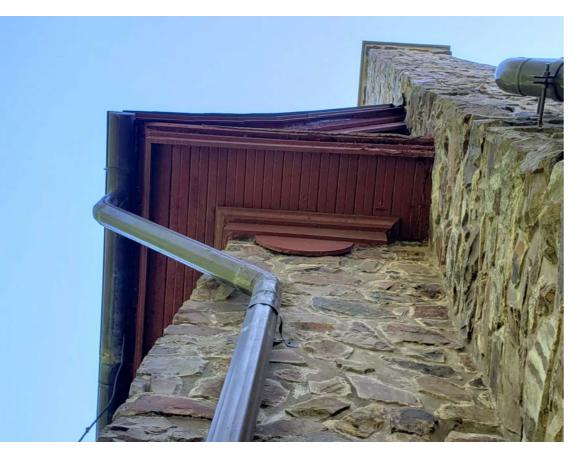
(N2) GAP BEHIND WOOD MEDALLION, ROTTEN WOOD ADJACENT CHIMNEY, LEAKING COPPER GUTTER, DETACHED RAINWATER LEADER STRAP

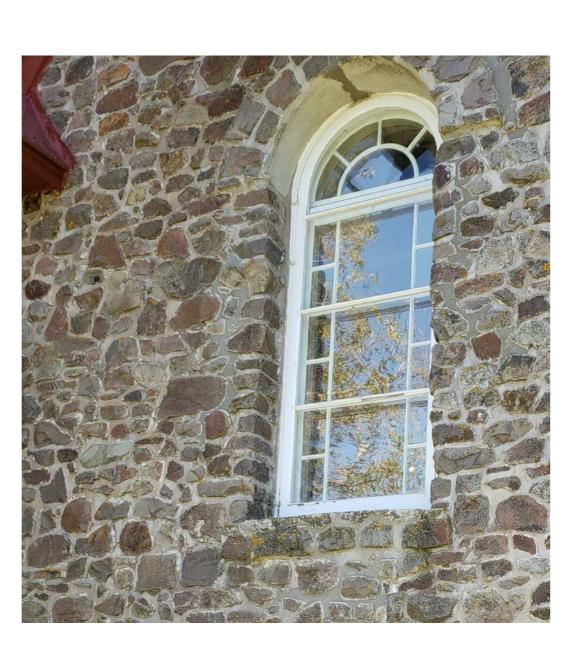
N8 PREVIOUS MORTAR REPAIRS AROUND WINDOW, CRACK AND PREVIOUS REPAIR AT HEAD OF ROUGH OPENING

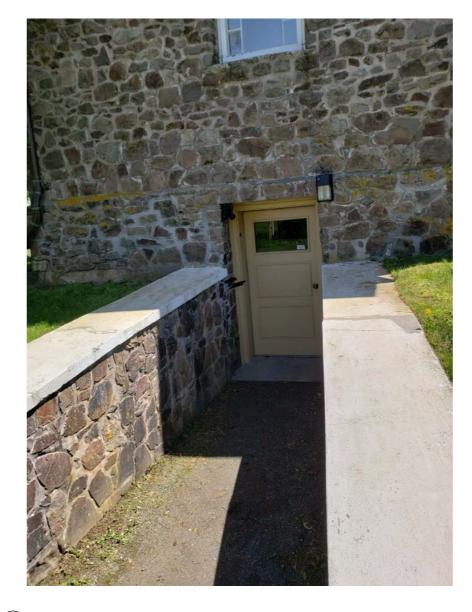
N9 NORTH CHANCEL BASEMENT ENTRANCE, SATURATED BRICK AND MORTAR BELOW END OF WINDOWSILL, ORGANIC GROWTH ON PLINTH

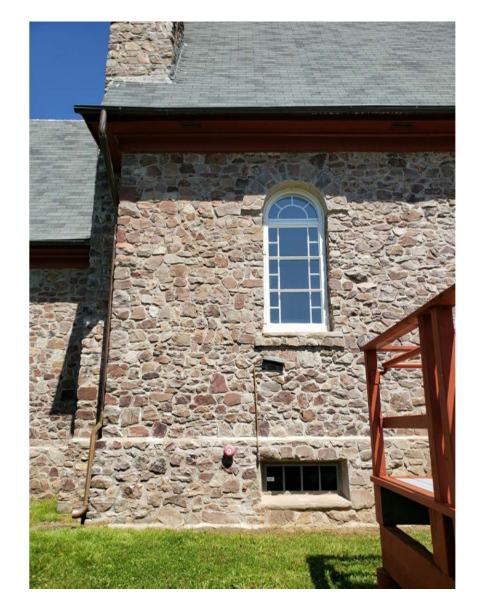
W5 CRACKING AND OPEN JOINTS AT CORNER, MORTAR CAP ON PLINTH DAMAGED

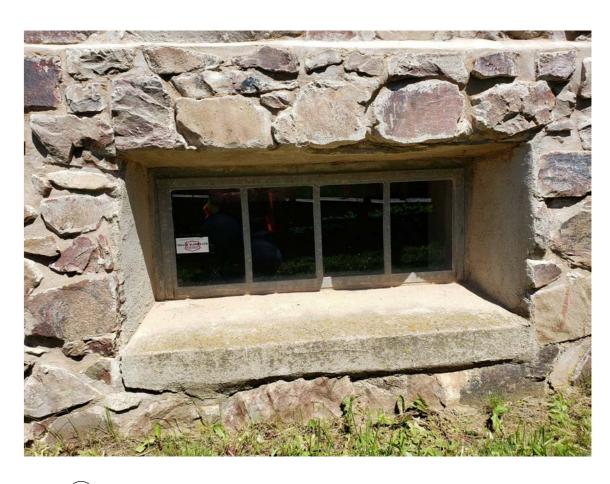
W11 SAND (LOSS OF BINDER) FROM MORTAR JOINT BELOW LANDING AT SOUTHWEST PORCH

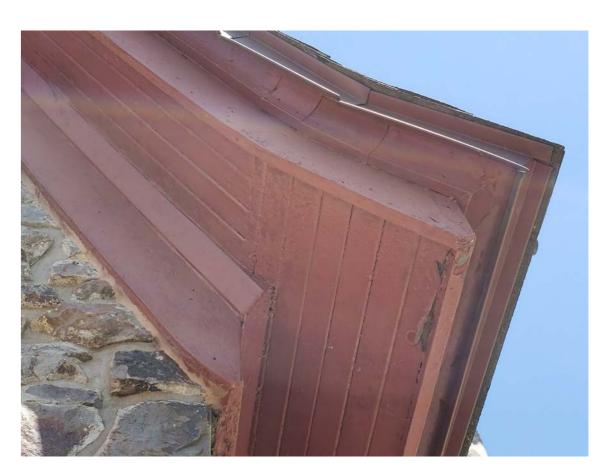
W12 SAND (LOSS OF BINDER) FROM MORTAR JOINT BELOW LANDING AT SOUTHWEST PORCH

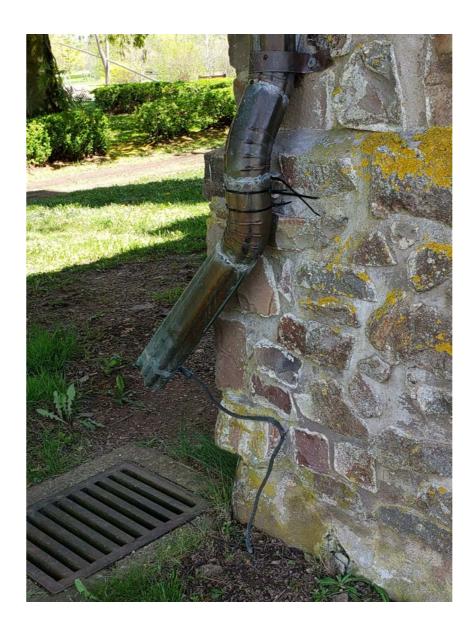
N3 DAMAGED AND CORRODED COPPER RAINWATER LEADER, MAKESHIFT (N4) CORRODED COPPER RAINWATER LEADER, CORRODED MISCELLANEOUS (N5) MAKESHIFT REPAIR WITH ZIP TIES FASTENERS

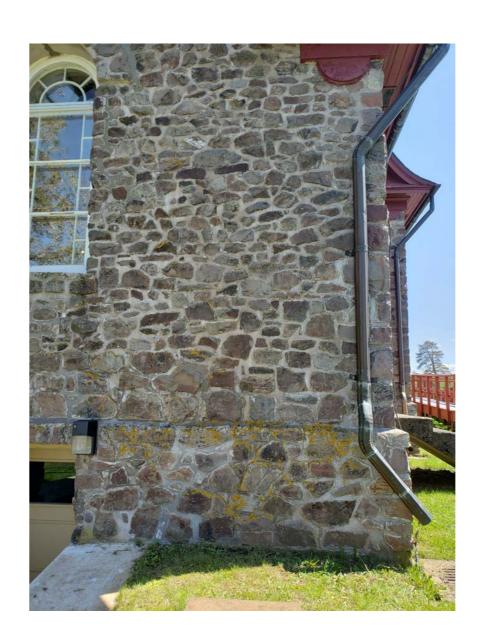
N10 CRACKING AND OPEN JOINTS AT CORNER, ORGANIC GROWTH ON PLINTH

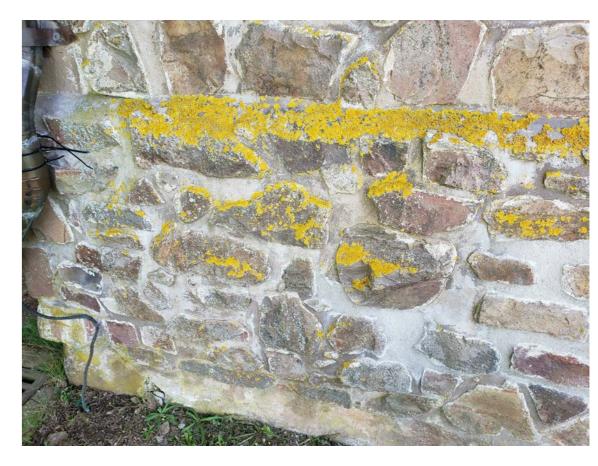
(N11) ORGANIC GROWTH ON PLINTH, PREVIOUS MORTAR REPAIR, CRACKED MORTAR AND MISSING STONE AT BASE OF PLINTH

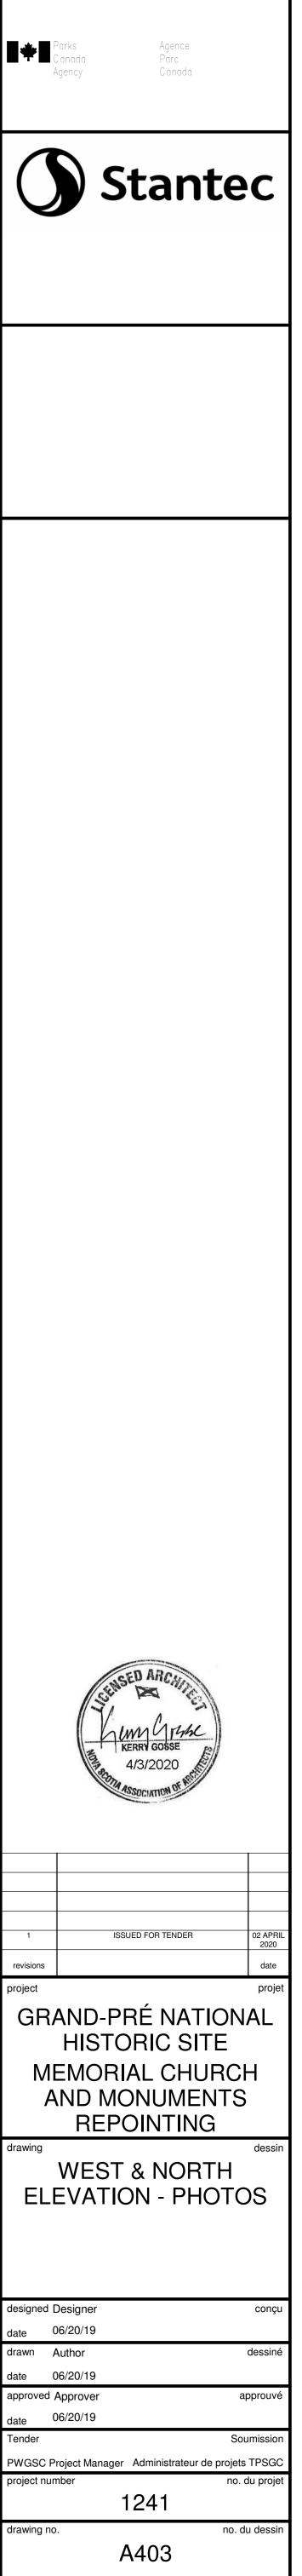
W13 PEELING PAINT, ROTTEN AND WEATHERED WOOD ON SOUTHWEST PORCH SOFFIT AND FACIA

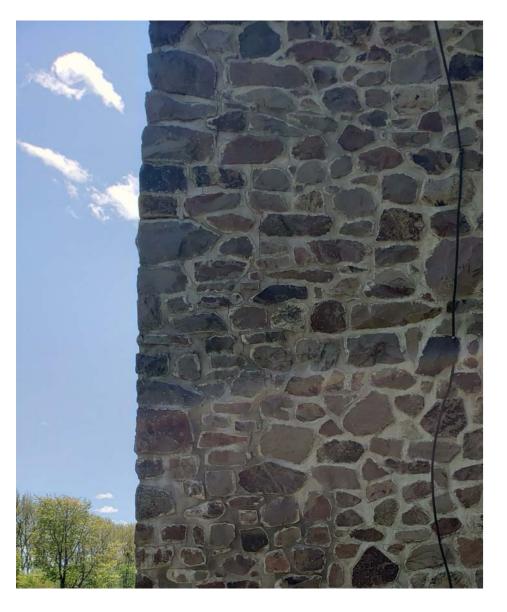
(E1) CRACKED MORTAR, OPEN JOINTS AND PREVIOUS MORTAR REPAIRS AT SOUTHEAST CORNER OF NAVE

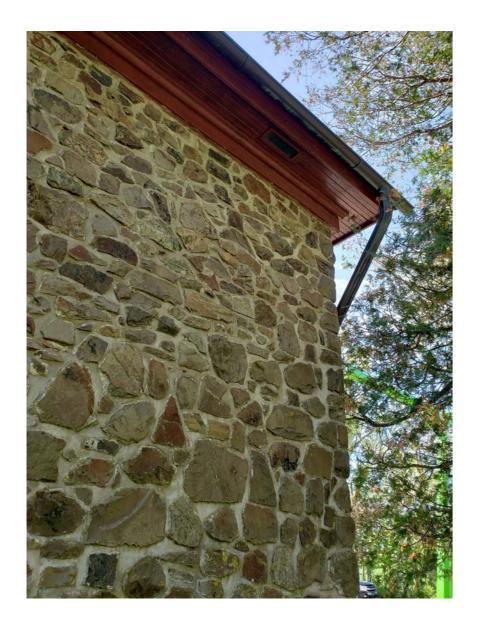
(E7) CRACKED MORTAR, OPEN JOINTS EFFLORESCENCE AND PREVIOUS MORTAR REPAIRS AT NORTHEAST CORNER OF CHANCEL

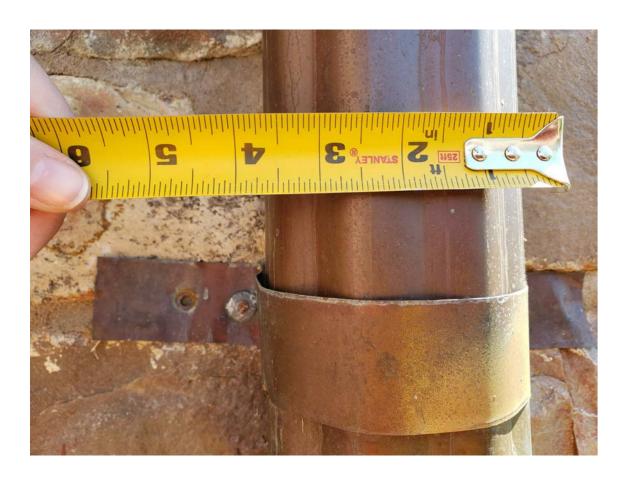
RL1) 4" DIAMETER COPPER RAINWATER LEADER

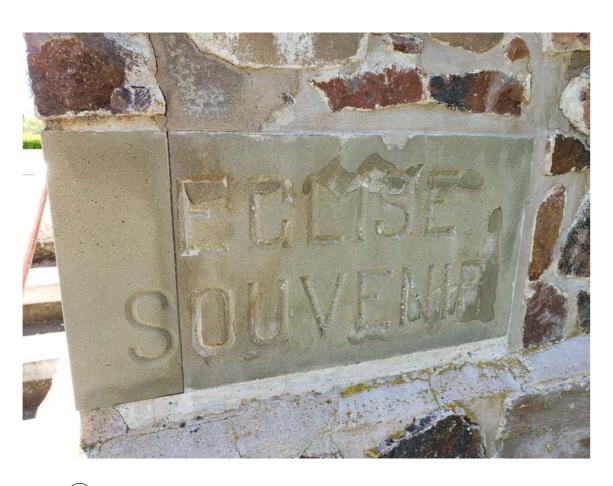
(E2) SANDSTONE CORNER STONE IS CHIPPED AND EXFOLIATING, OPEN AND CRACKED MORTAR JOINTS, PREVIOUS MORTAR REPAIR
