Parks Canada Agency

# **GRAND-PRÉ NATIONAL HISTORIC SITE MEMORIAL CHURCH AND MONUMENTS REPOINTING**

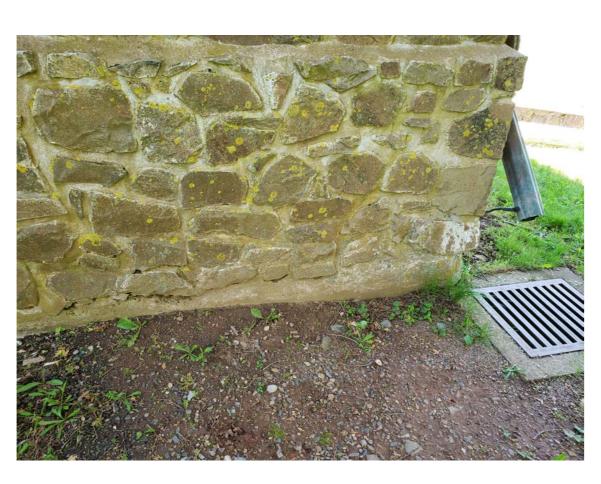
E8 CRACKED MORTAR, EFFLORESCENCE, OPEN JOINTS AND ORGANIC GROWTH AT NORTHEAST CORNER OF CHANCEL

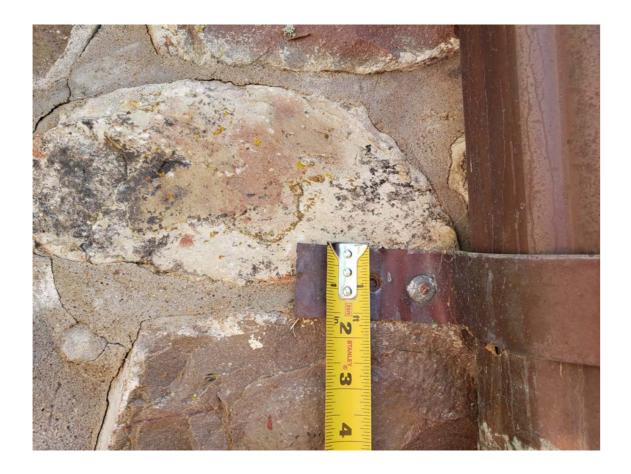
RL2 1 1/2" WIDE COPPER RAINWATER LEADER STRAP

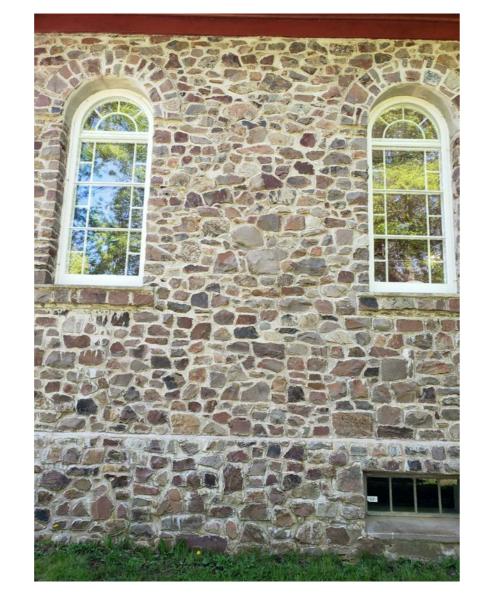
(E3) EFFLORESCENCE, CRACKED MORTAR, OPEN JOINTS AND PREVIOUS MORTAR REPAIRS BELOW WINDOWS AND AT TOP OF PLINTH

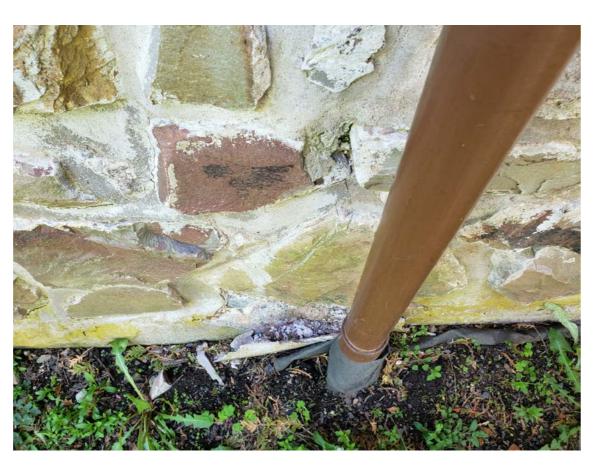
(E9) CRACKED MORTAR, EFFLORESCENCE, AND OPEN JOINTS BEHIND OIL TANK VENT PIPE

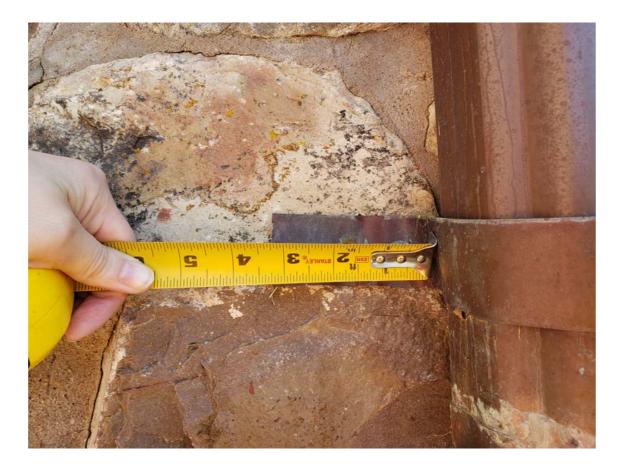
(RL3) 3 1/4" LEG ON COPPER RAINWATER LEADER STRAP

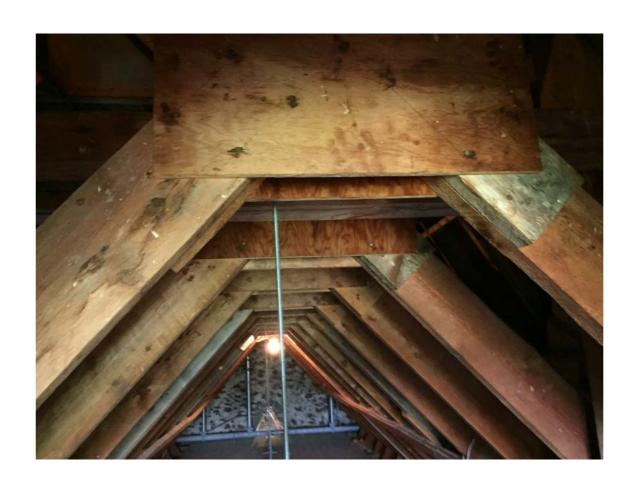
(14) NAVE ROOF RAFTERS AND GUSSET PLATES

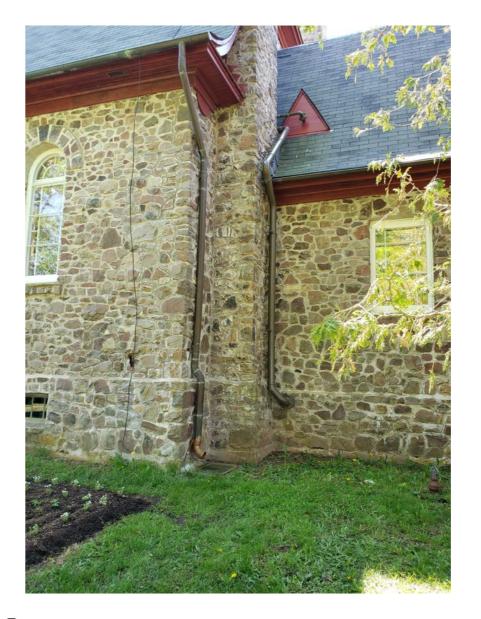
(E5) CRACKED MORTAR, OPEN JOINTS AND PREVIOUS MORTAR REPAIRS AT NORTHEAST CORNER OF NAVE, ORGANIC GROWTH ON CHIMNEY

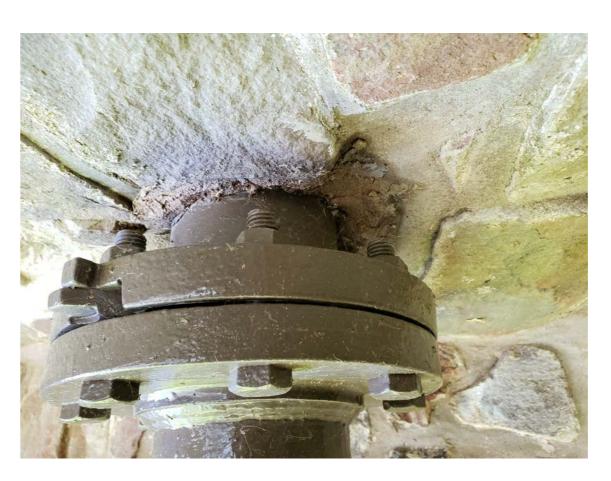
(E11) POOR MORTAR REPAIR AT THROUGH WALL PENETRATION

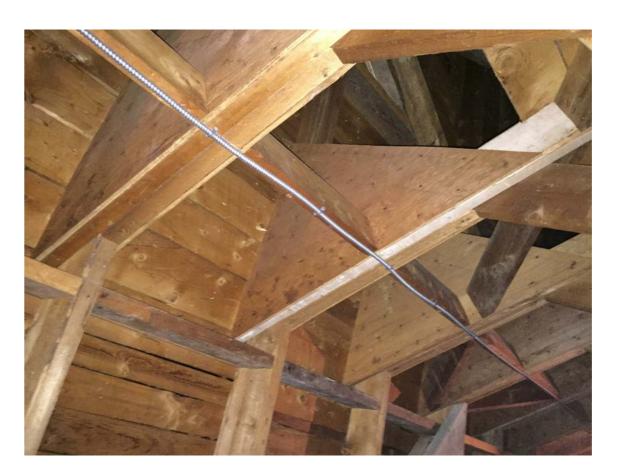
(15) NAVE ROOF RAFTERS AND GUSSET PLATES

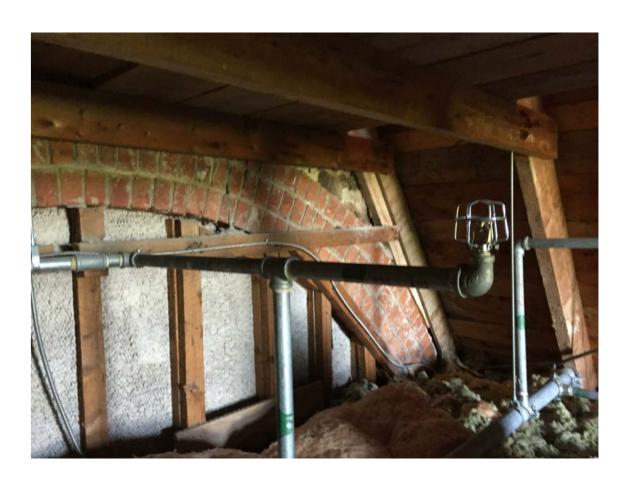
(E6) CRACKED MORTAR, OPEN JOINTS EFFLORESCENCE AND PREVIOUS MORTAR REPAIRS BELOW WINDOW AND AT BASE OF PLINTH

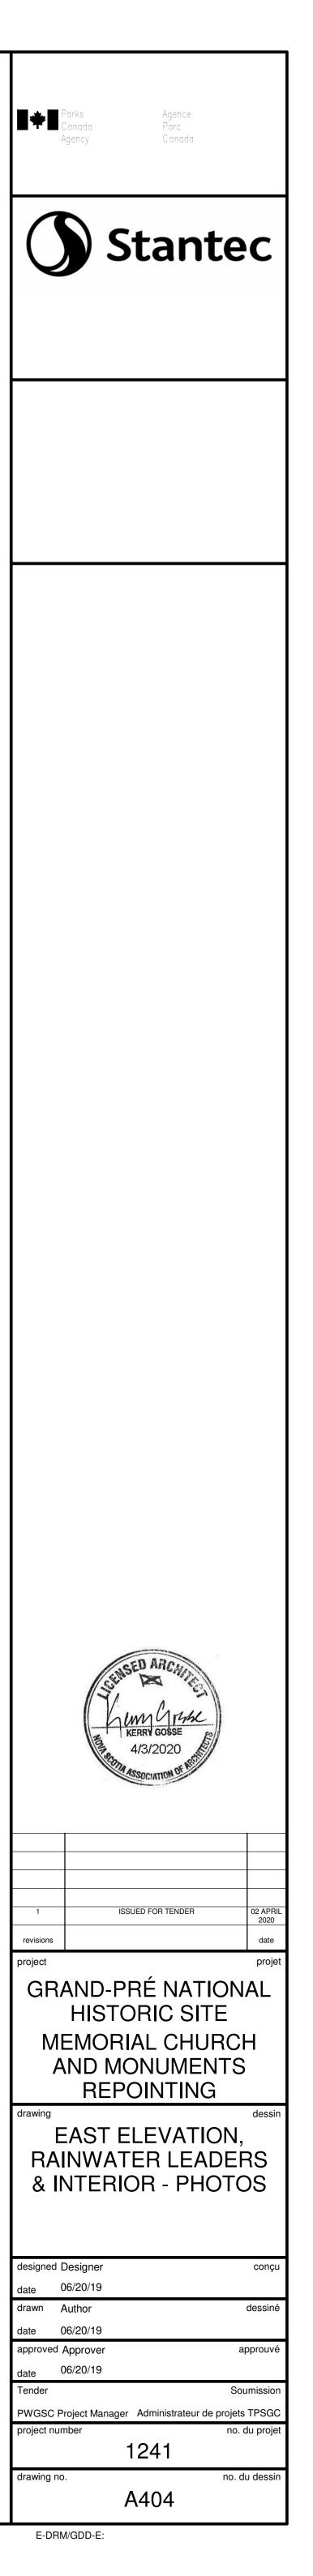
(16) INTERIOR FACE OF SOUTH NAVE WALL, BRICK ARCH WITH LATCH AND PLASTER INFILL

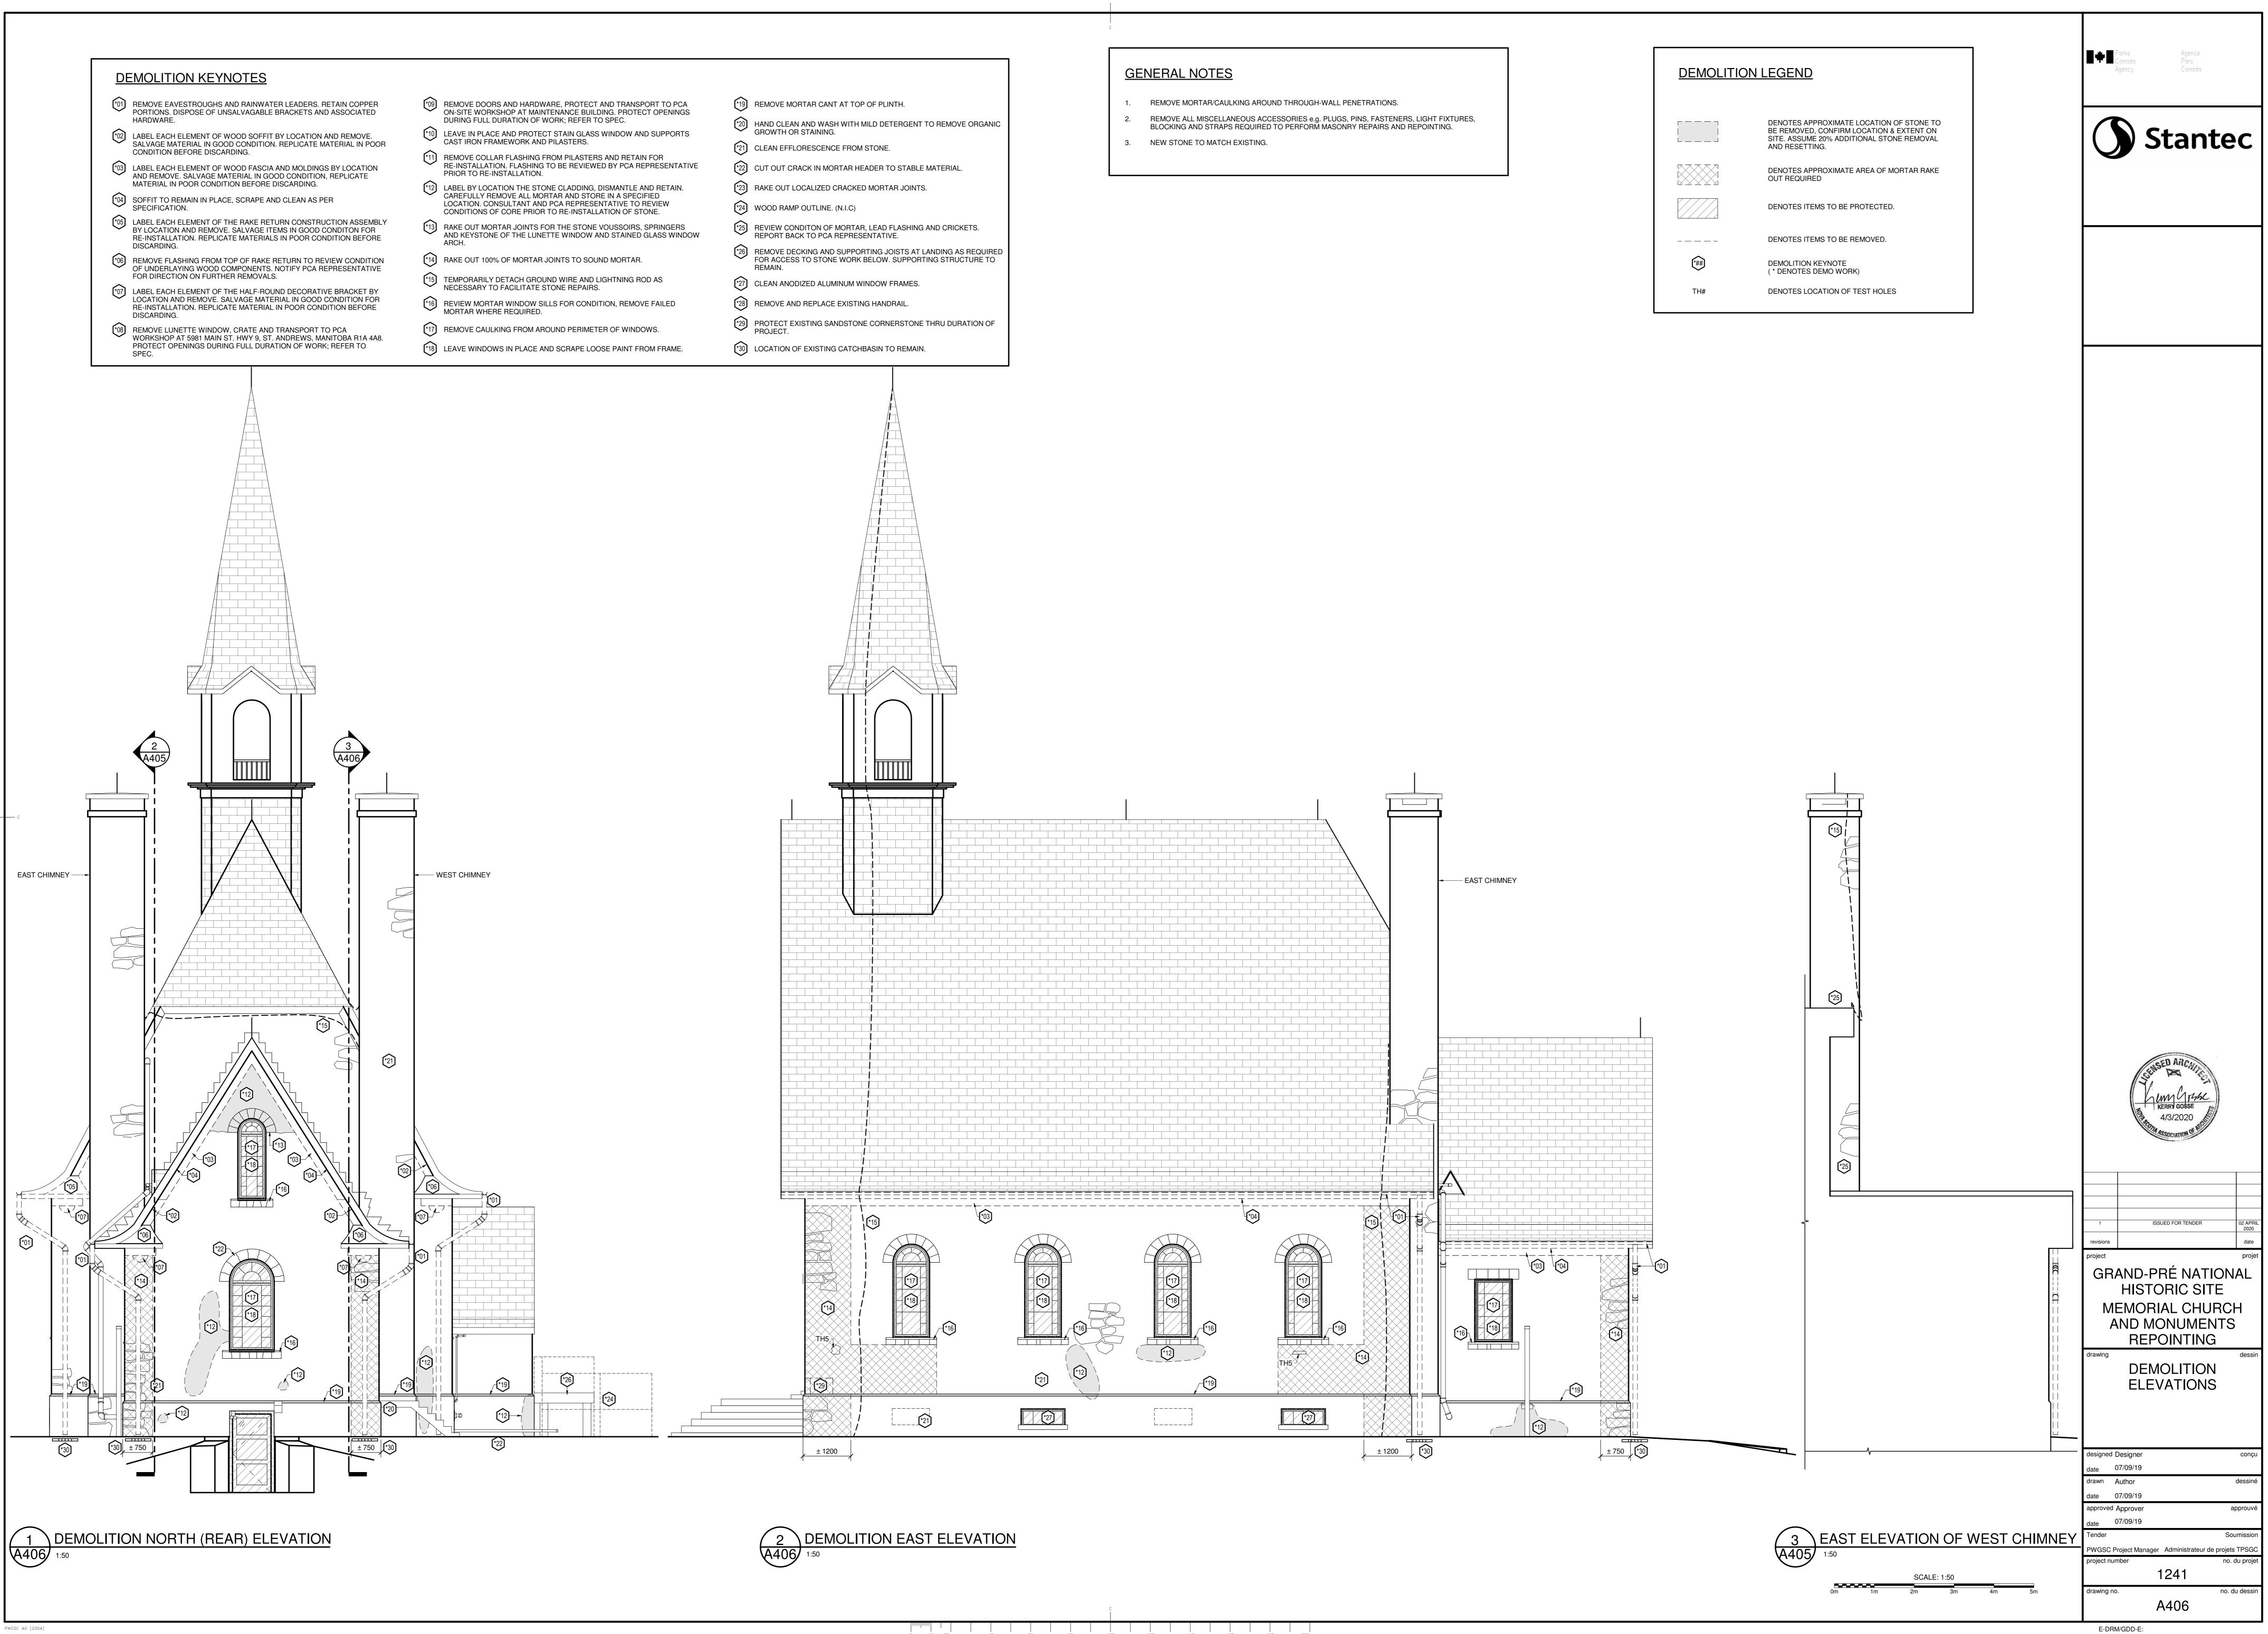
<u>DEMOLITIO</u>	<u>N LEGEND</u>
	DENOTES APF BE REMOVED, SITE. ASSUME AND RESETTII
	DENOTES APF OUT REQUIRE
	DENOTES ITEI
	DENOTES ITE
*##	DEMOLITION F (* DENOTES D
TH#	DENOTES LOC

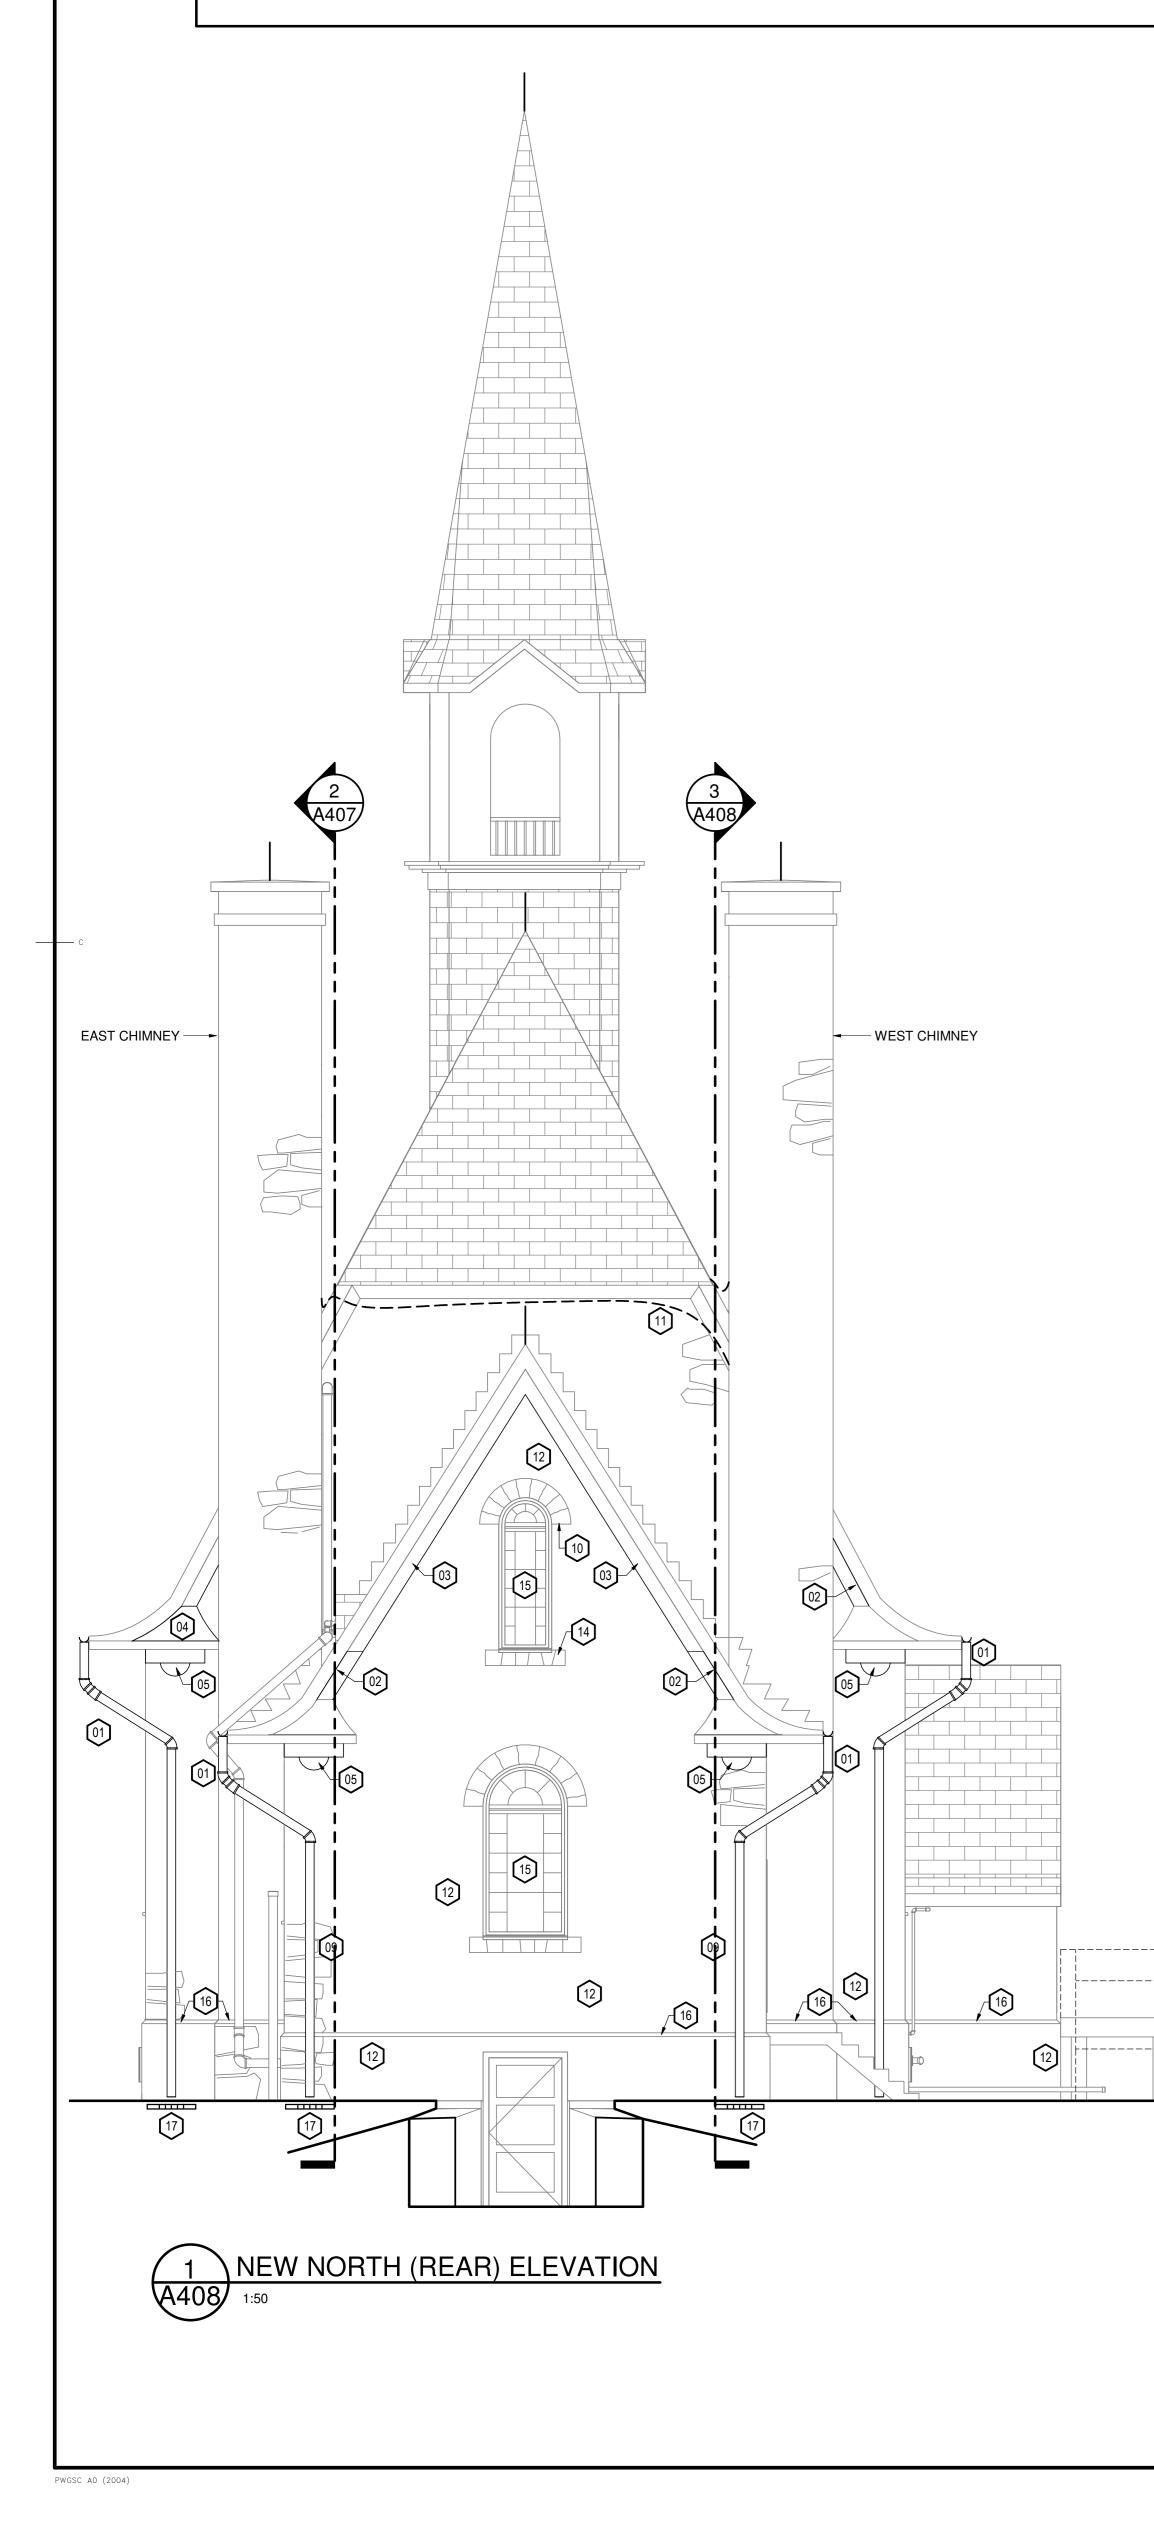
13 LIGHT DRESS SANDSTONE CORNERSTONES AND RETOOL EDGES OF NUMBERS. TREAT WITH STONE CONSOLIDATION PRODUCT.

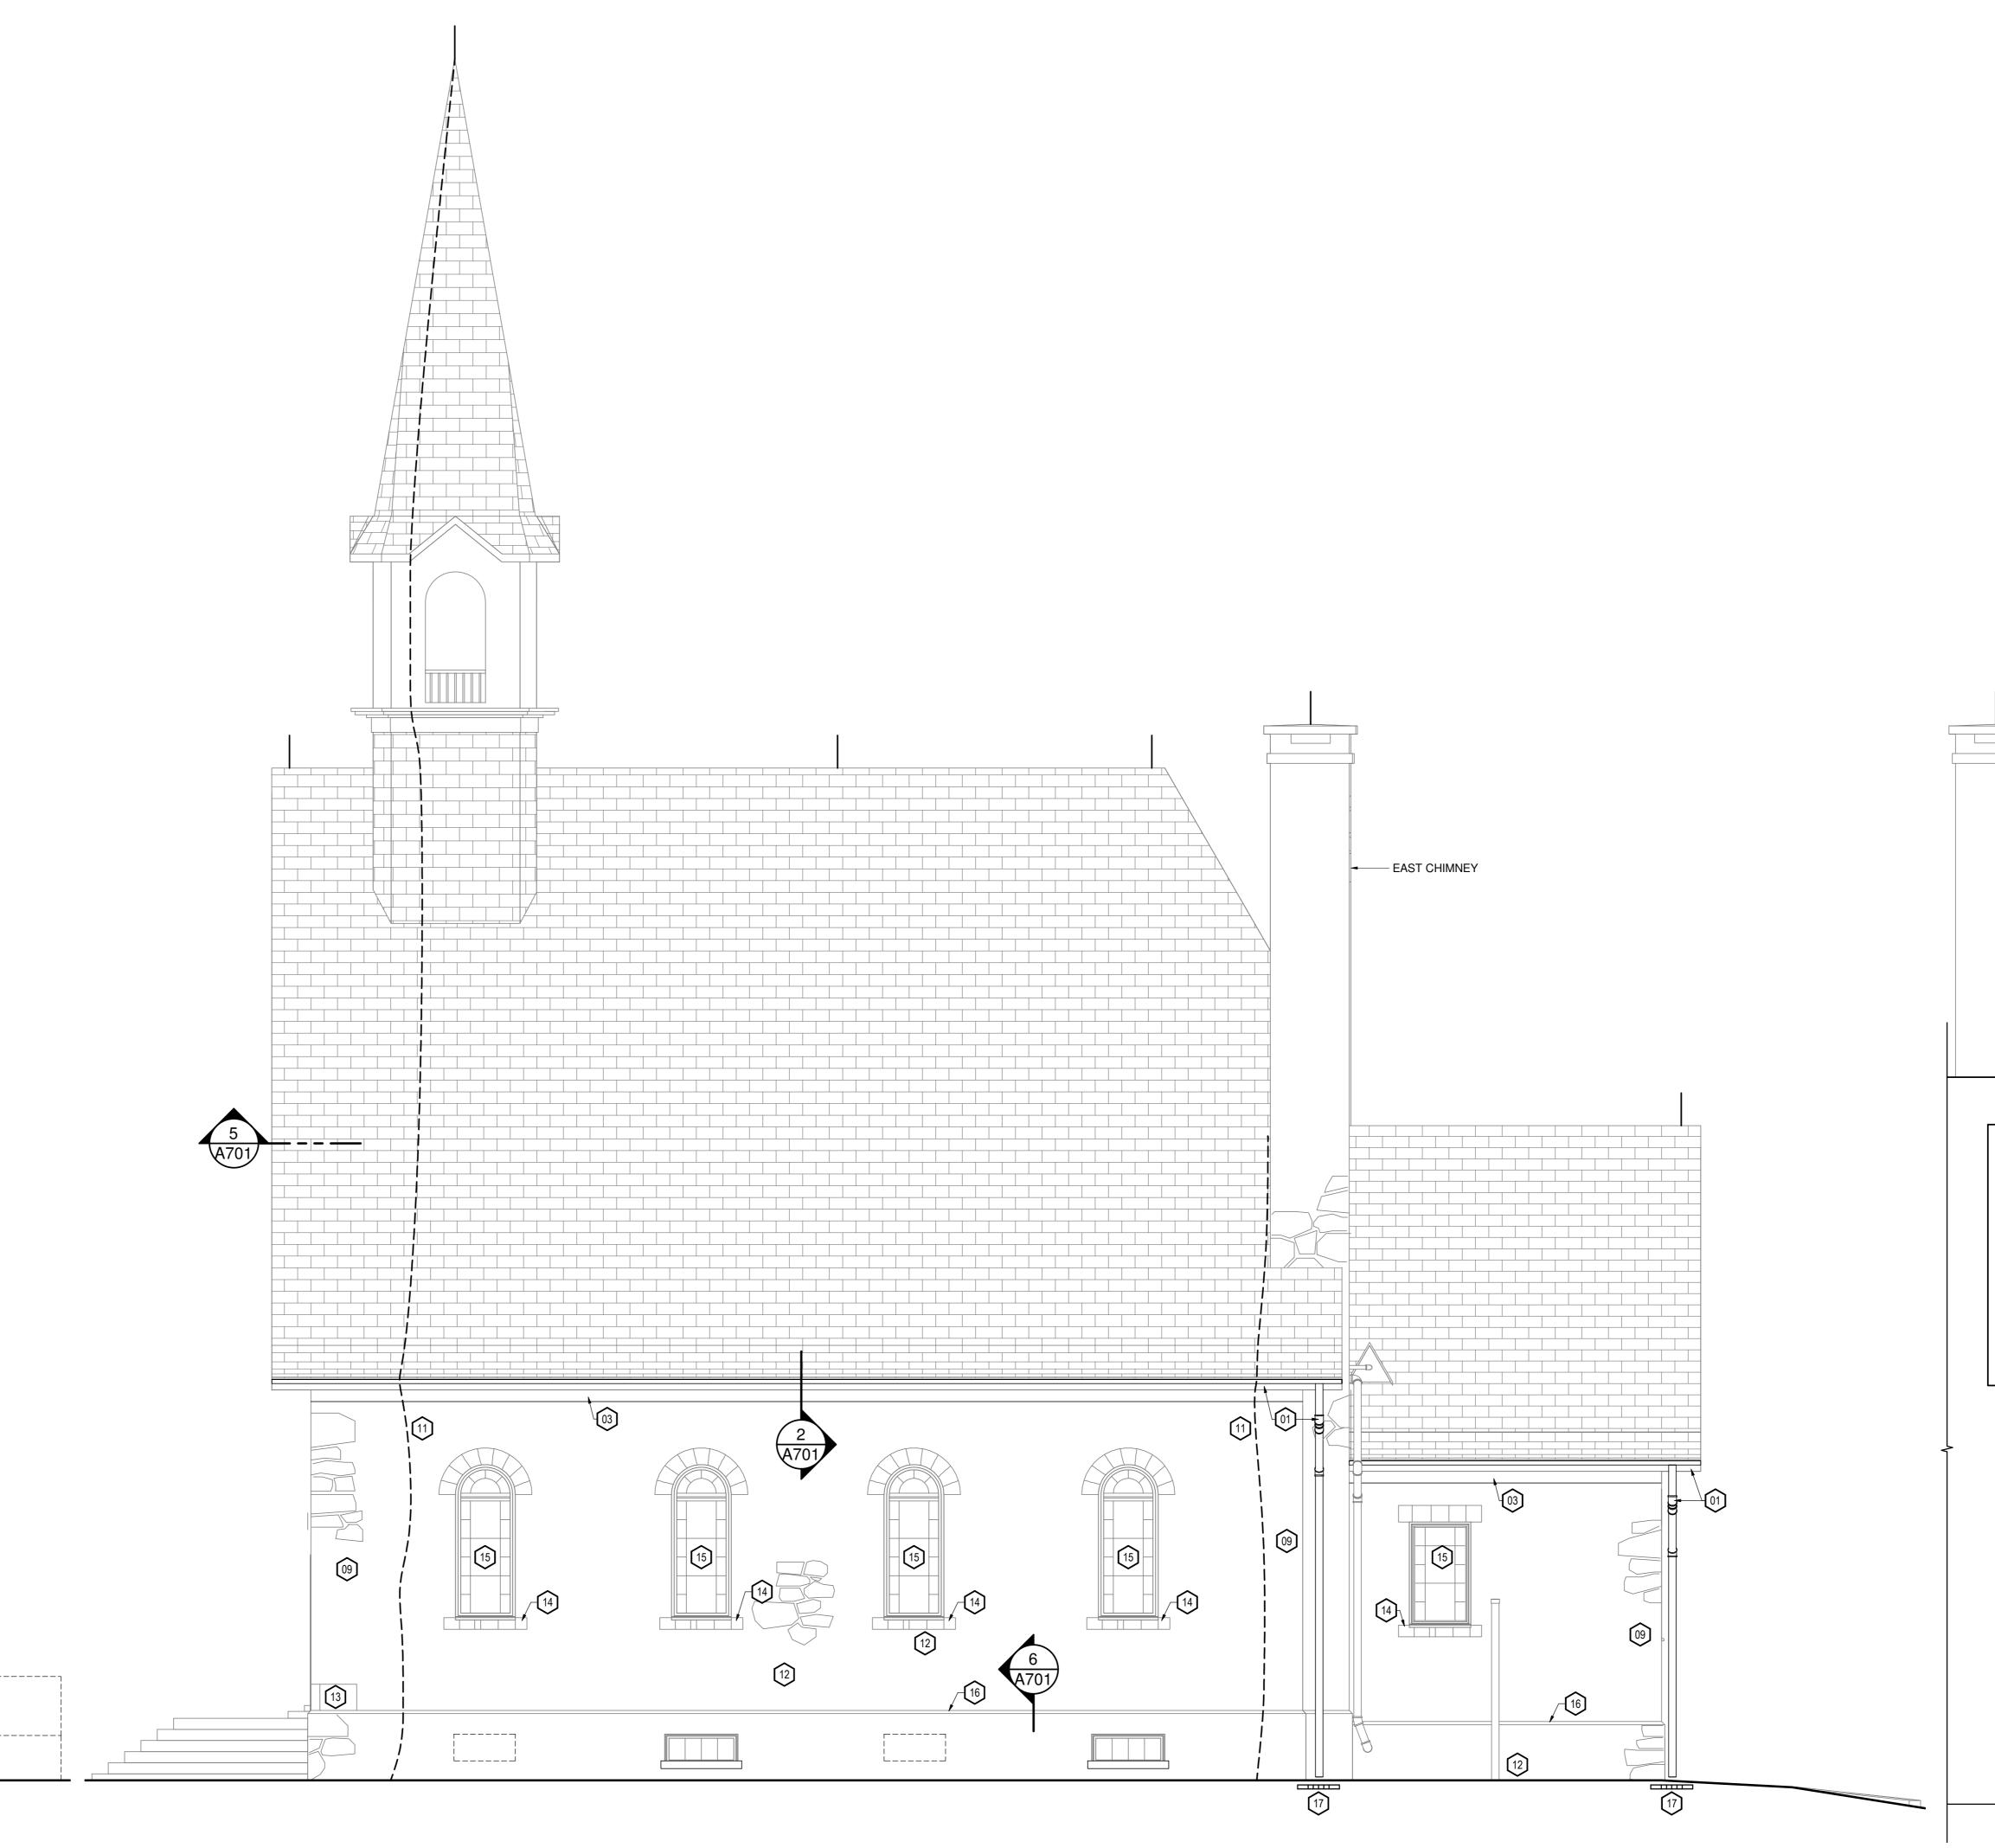
2 NEW EAST ELEVATION A408 1:50

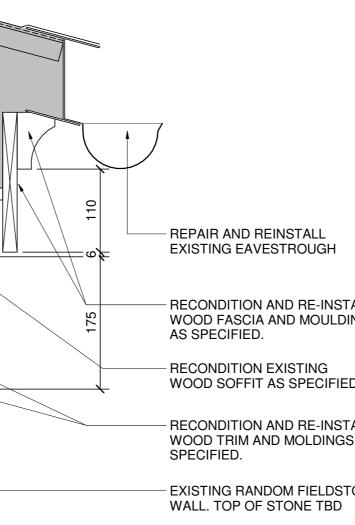
- REPAIR AND REINSTALL EXISTING EAVESTROUGH - RECONDITION AND RE-INSTALL WOOD FASCIA AND MOULDING AS SPECIFIED. - RECONDITION EXISTING WOOD SOFFIT AS SPECIFIED. RECONDITION AND RE-INSTALL WOOD TRIM AND MOLDINGS AS SPECIFIED. - EXISTING RANDOM FIELDSTONE

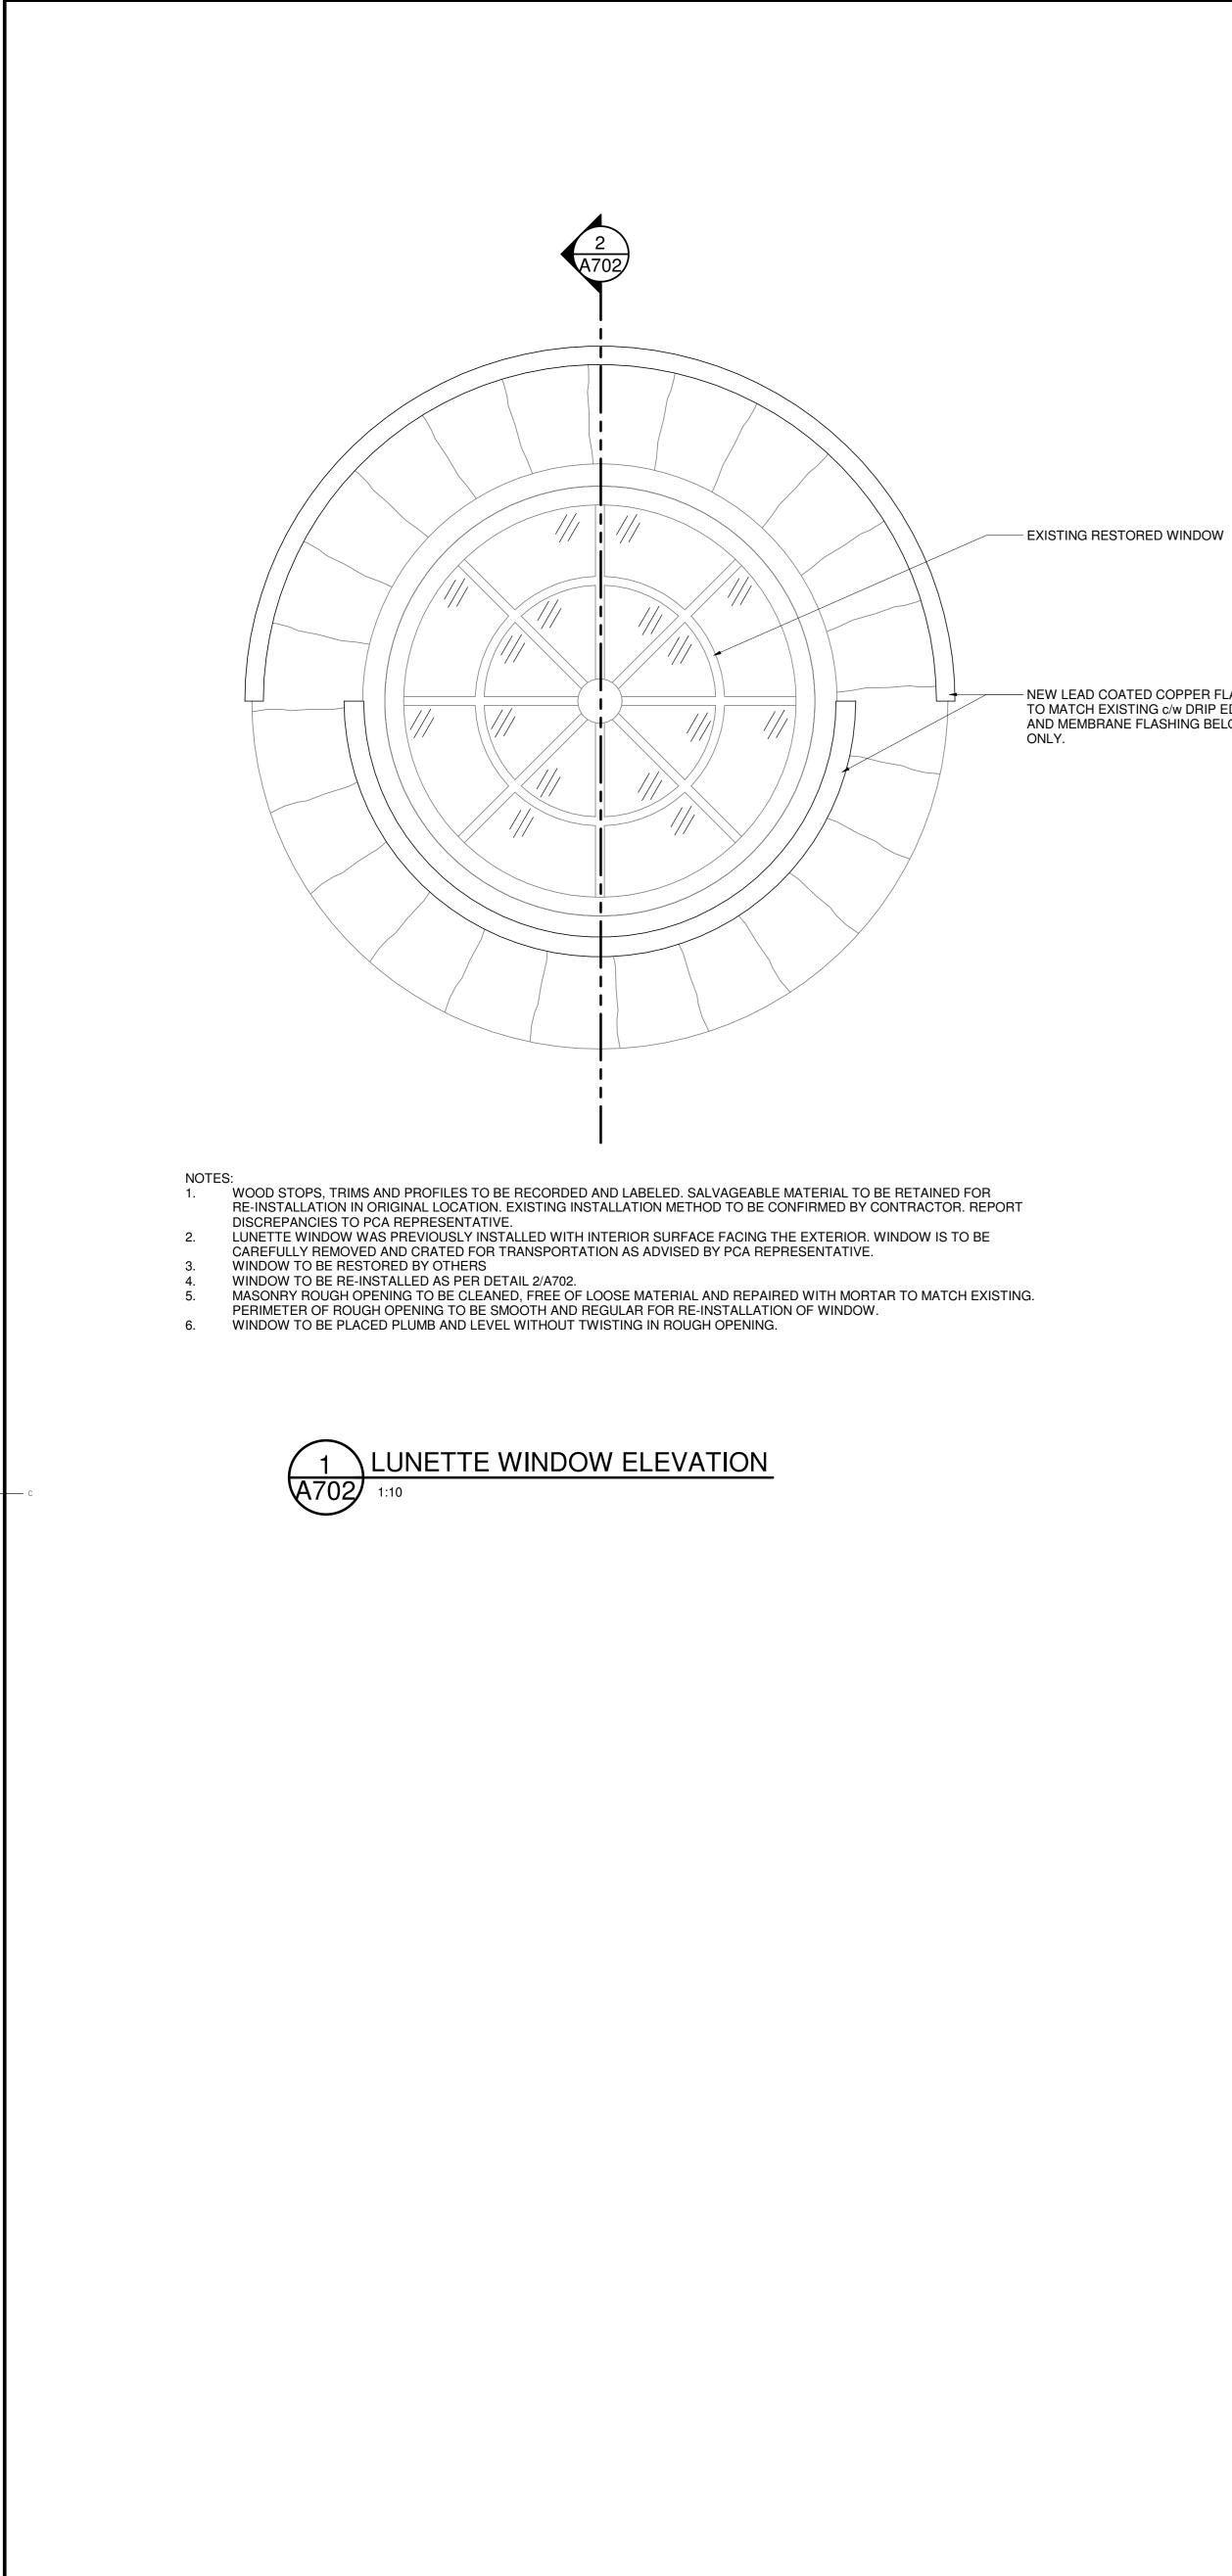
- EXISTING FIELDSTONES

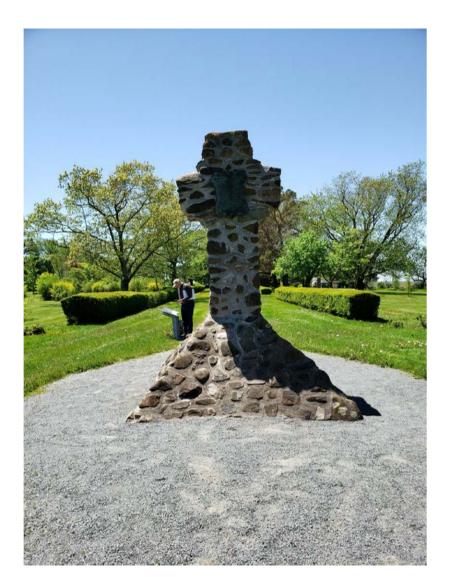
# 2 WEST (FRONT) ELEVATION A903 1:20

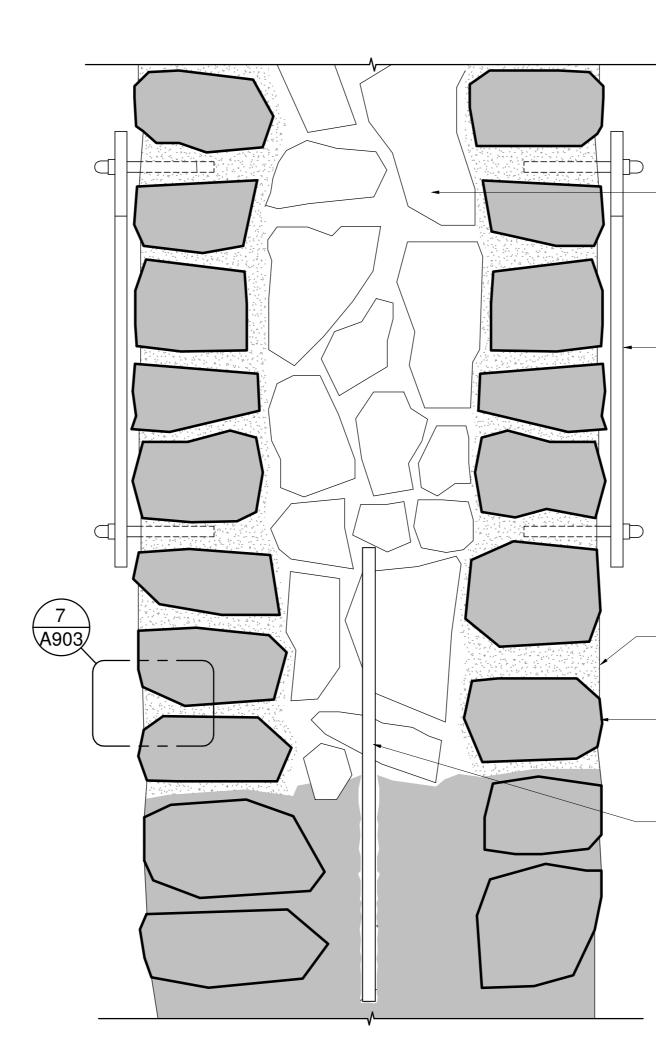
SOUTH ELEVATION <u> 606A</u> 1:20

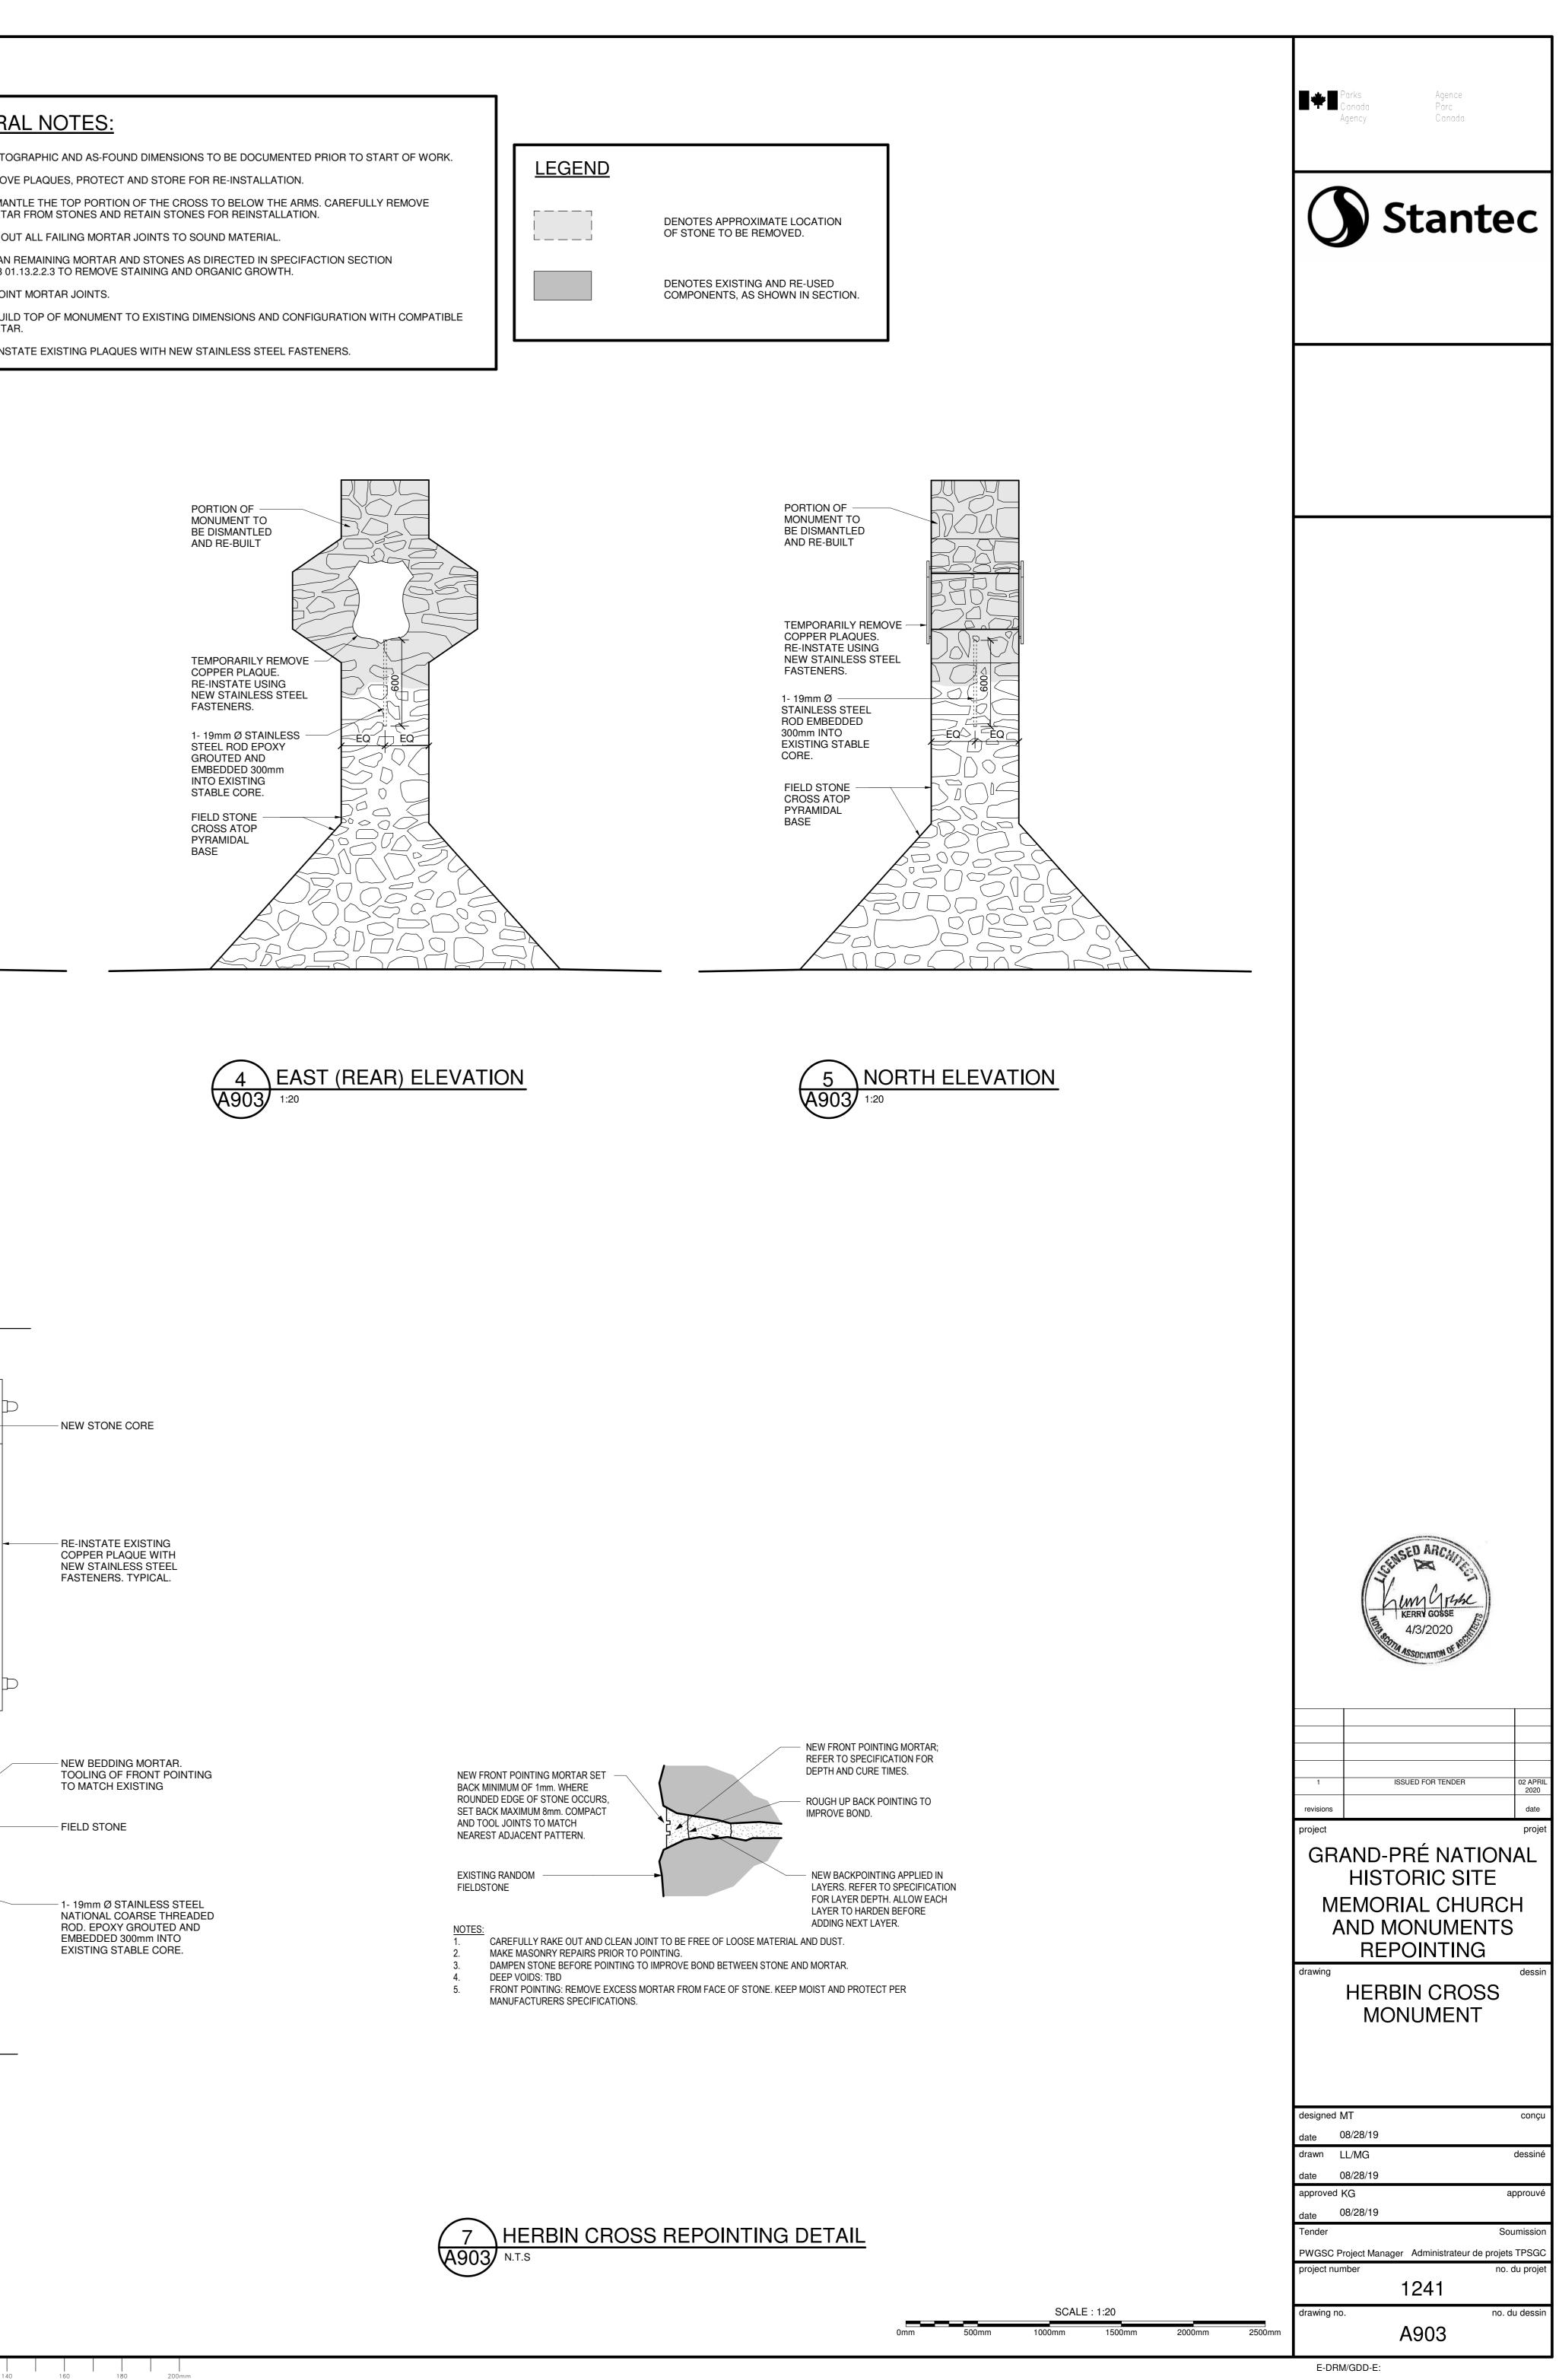
- TOGRAPHIC AND AS-FOUND DIMENSIONS TO BE DOCUMENTED PRIOR TO START OF WORK. OVE PLAQUES, PROTECT AND STORE FOR RE-INSTALLATION.
- IANTLE THE TOP PORTION OF THE CROSS TO BELOW THE ARMS. CAREFULLY REMOVE TAR FROM STONES AND RETAIN STONES FOR REINSTALLATION.
- OUT ALL FAILING MORTAR JOINTS TO SOUND MATERIAL. AN REMAINING MORTAR AND STONES AS DIRECTED IN SPECIFACTION SECTION
- DINT MORTAR JOINTS.
- UILD TOP OF MONUMENT TO EXISTING DIMENSIONS AND CONFIGURATION WITH COMPATIBLE TAR.
- 8. RE-INSTATE EXISTING PLAQUES WITH NEW STAINLESS STEEL FASTENERS.
