Geotechnical Engineering Review and Assessment: (Mountain Institution)

Client: CWMM  
Date: November 30, 2018  
Our File No.: 218C555B

### **PROPOSED PERIMETER FENCE AND GATES UPGRADES MOUNTAIN INSTITUTION 4732 CEMETERY ROAD, AGASSIZ, BC**

### **GATES NO. 7, 8, 9 & 10 PLAN AND DETAIL (MOUNTAIN INSTITUTION)**

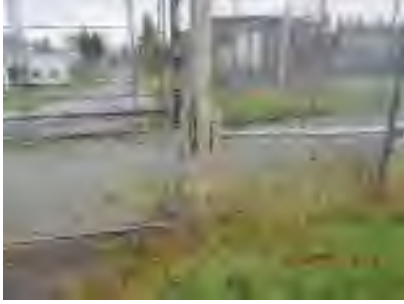
Paint Colour	Light Grey	
Substrate	Metal	
Location & Extent	Gate 13	
Lead Content (ppm)	1,500	
Condition	Fair	
Access	A	
Identified Lead Paint Description		Photograph
Light Grey Paint on gate structure
