LaSalle Causeway

Deck Grating Inspection and Repair Report

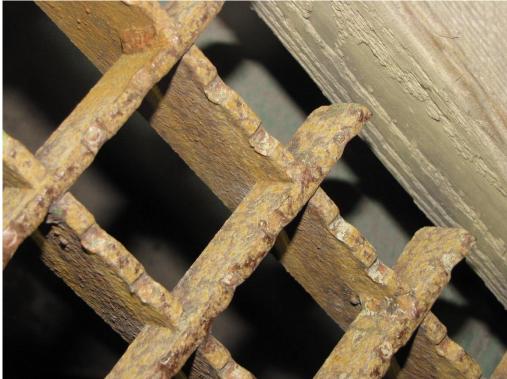
Photo 3: Light to medium corrosion of cross bars and bearing bars at the north curb by the west abutment.

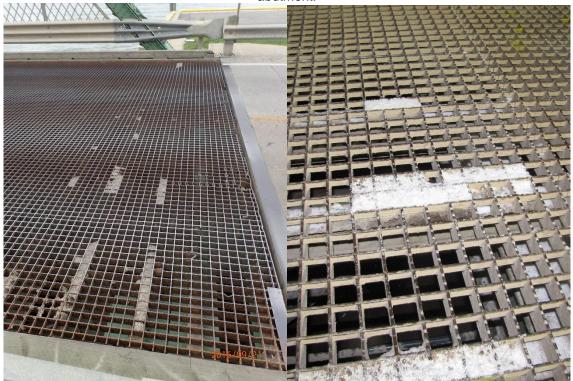
Photo 4: Debris in the grating at the east abutment (Photo on left taken in September 2015)

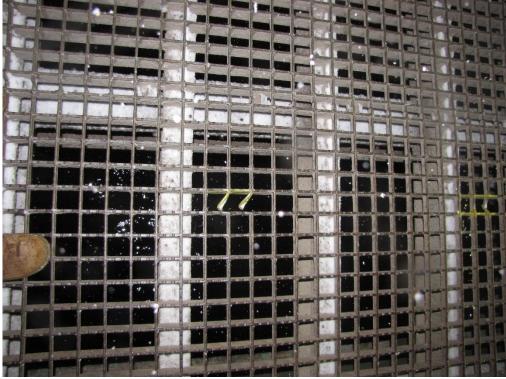
Photo 7: Broken Bars at (D14-15 at row 4)

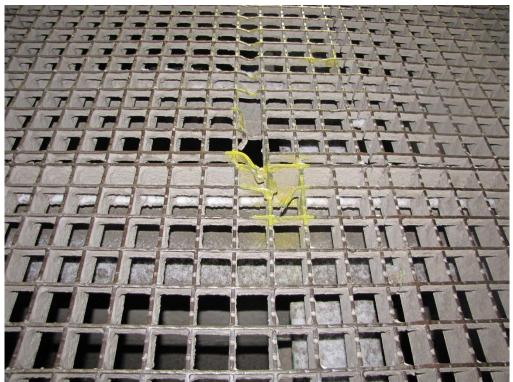
Photo 8: Broken and Bent Transverse Cross-Bars (12-14 at 1-13)

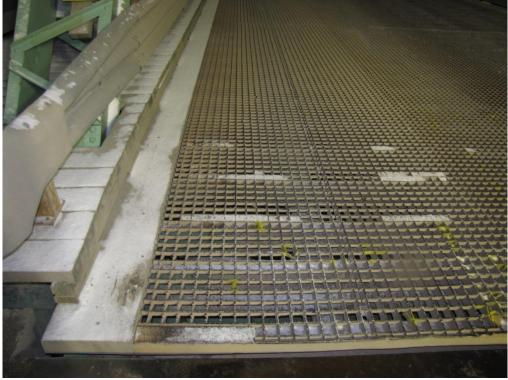
Photo 9: Armouring at south side at east abutment.

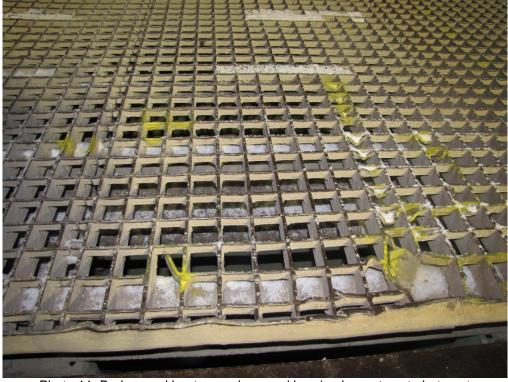
Photo 11: Broken and bent cross-bars and bearing bars at east abutment

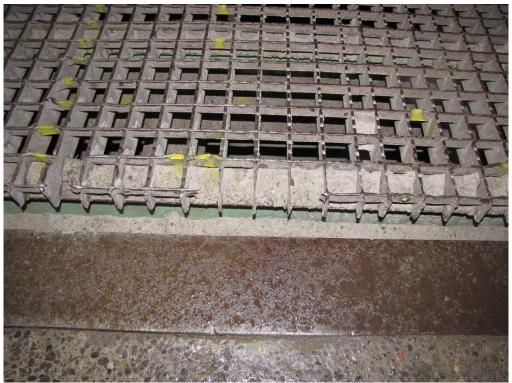
Photo 12: Condition of grating at east abutment prior to temporary repair.

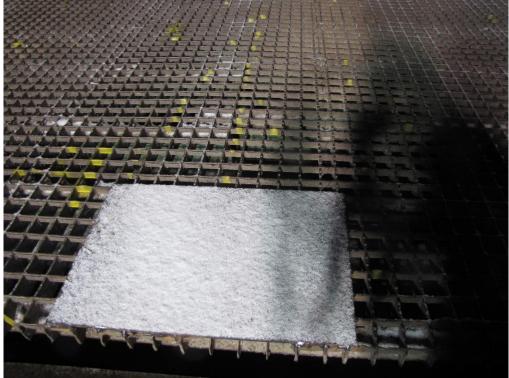
Photo 13: Temporary steel plate repair at east abutment.

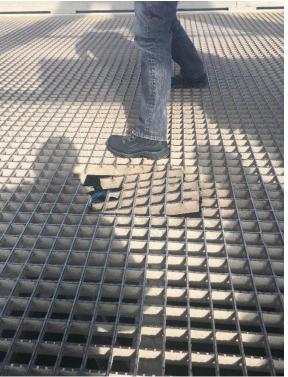
Photo 14: Broken piece of grating at the center of the bridge in the eastbound lane.

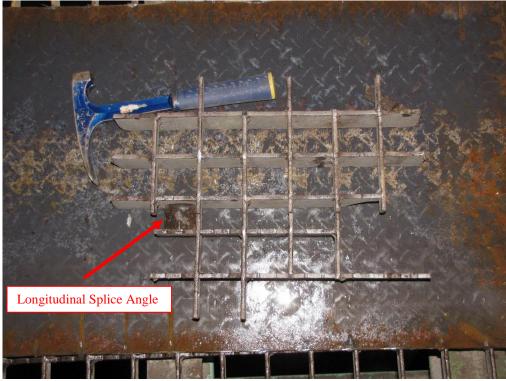
Photo 15: Piece of grating that broke loss.

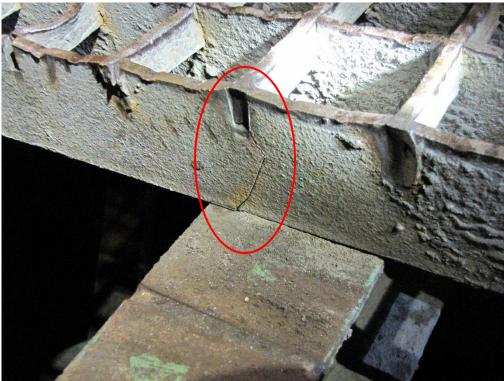
Photo 17: Crack in bearing bar propagating from notch for cross bar at sill. Adjacent to piece that was broken off.

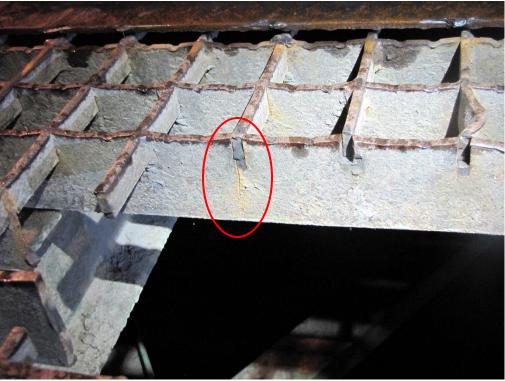
Photo 18: Crack in Bearing bar propagating from cross bar notch.

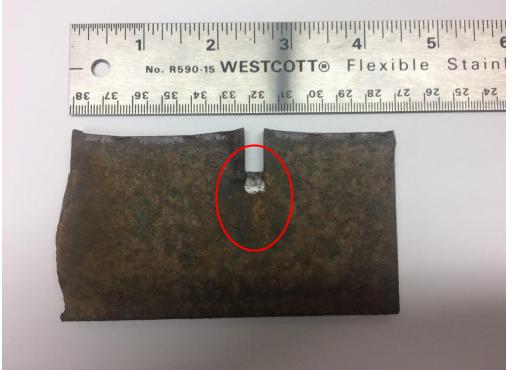
Photo 19: Crack in bearing bar propagating from notch in sample taken from piece that failed.

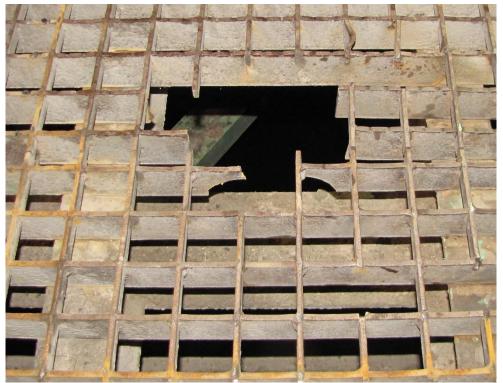
Photo 20: Crack in bearing bar propagating from cross bar notch.

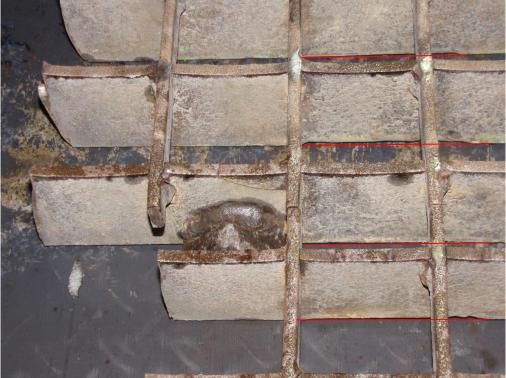
Photo 21: Wearing of base of bearing bars at sill location.

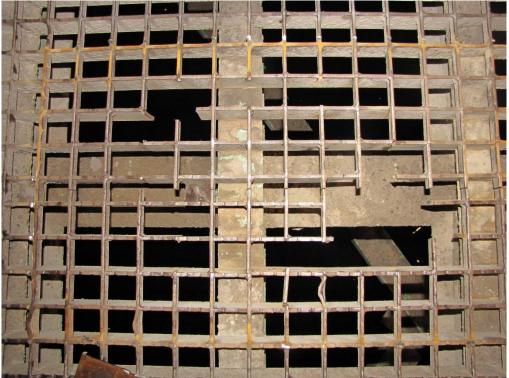
Photo 22: Piece of grating that broke off in opening.

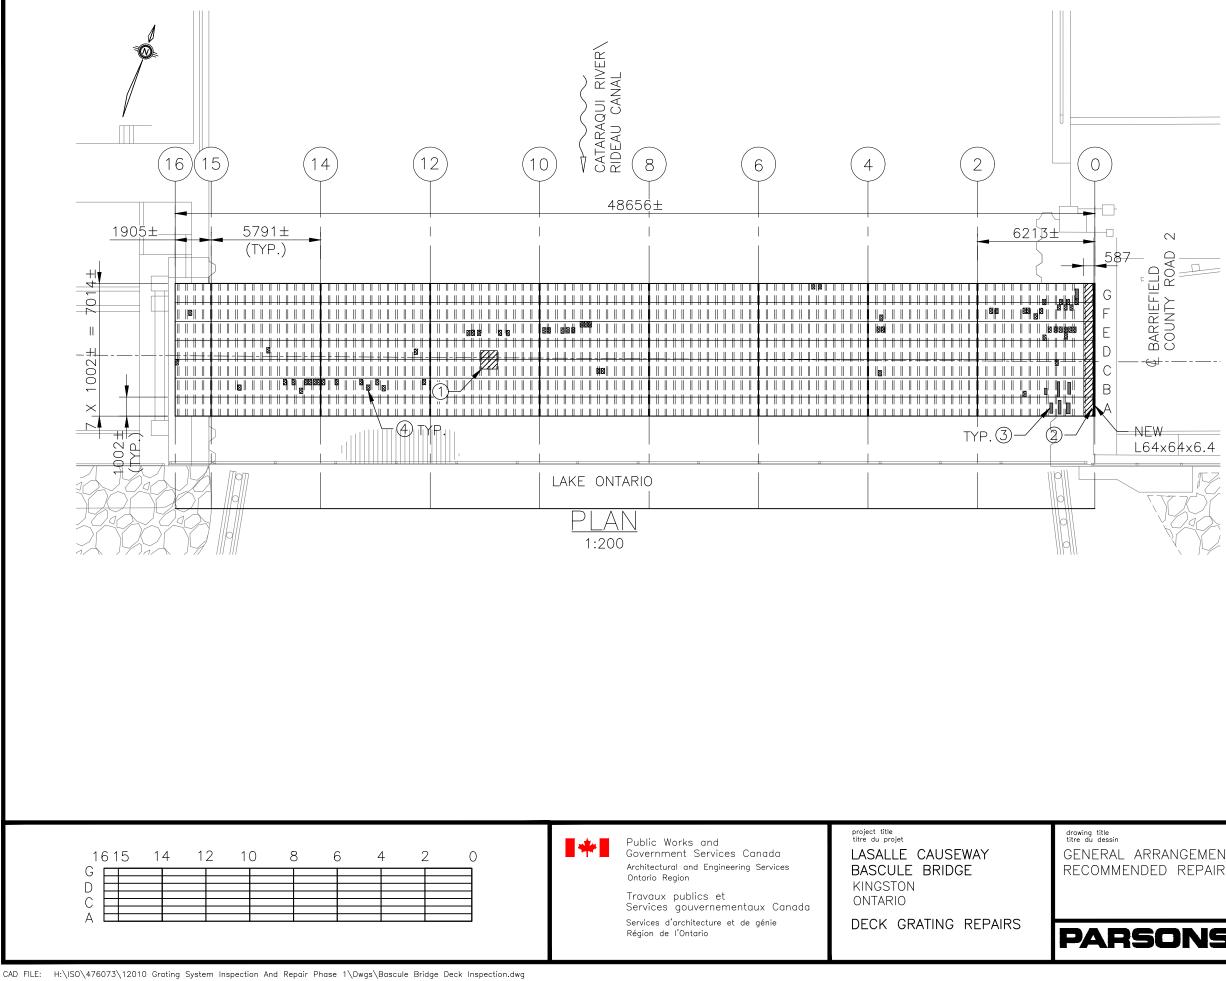
RECOMMENDED REPAIRS:

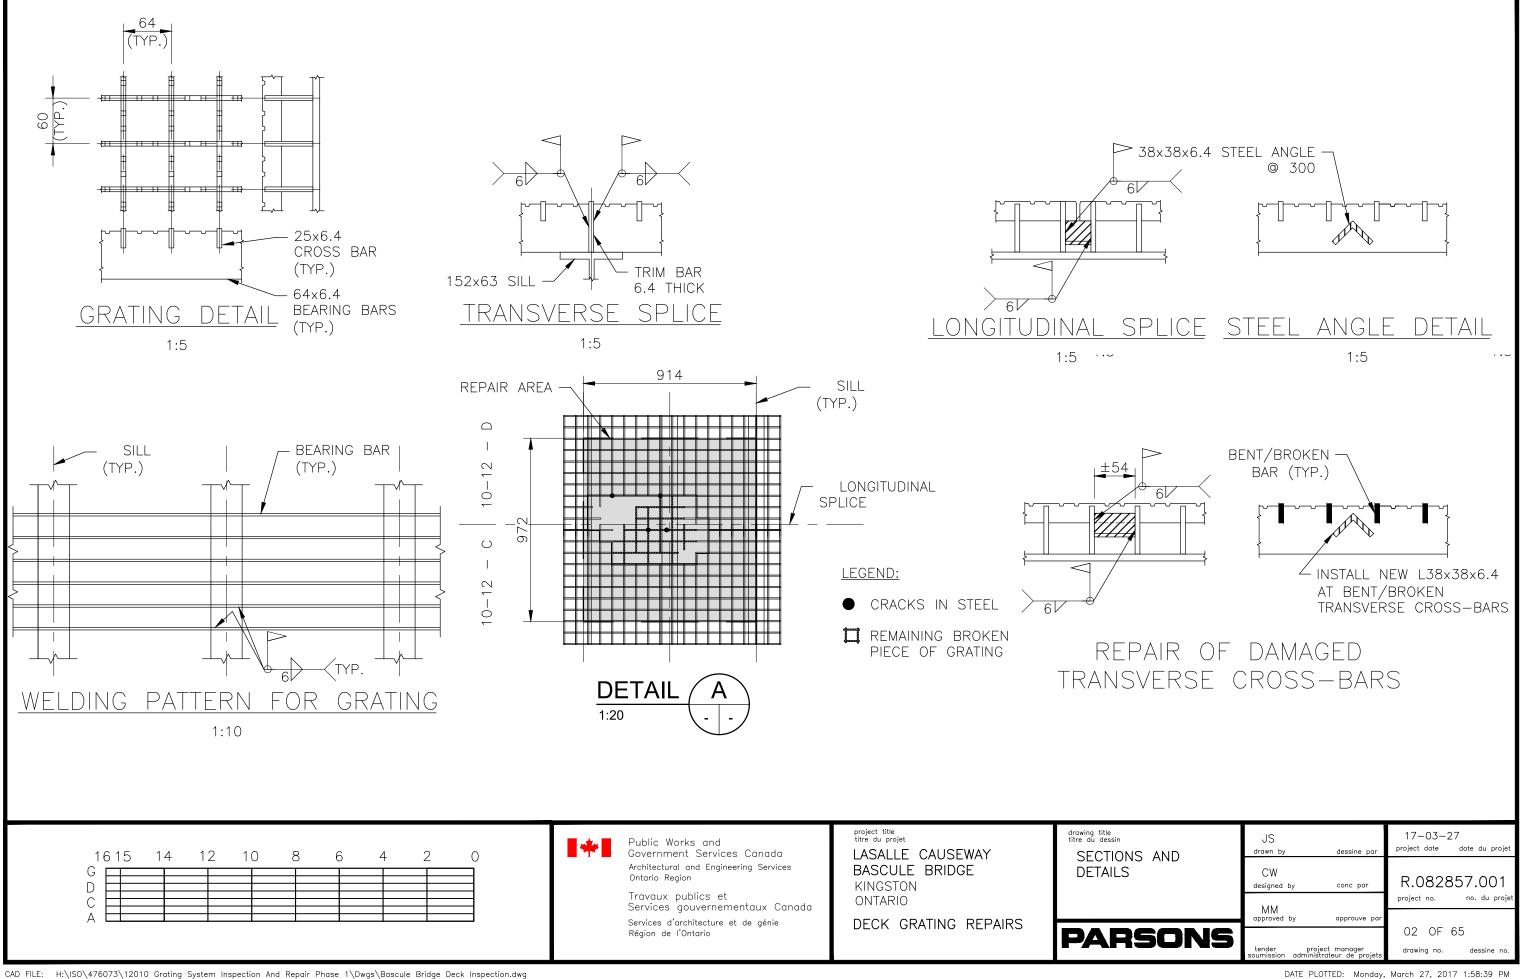
CAD FILE: H:\ISO\476073\12010 Grating System Inspection And Repair Phase 1\Dwgs\Bascule Bridge Deck Inspection.dwg

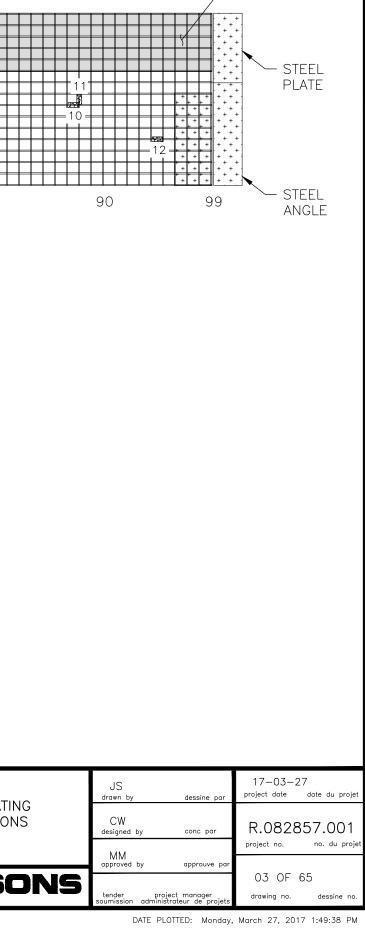
CAD FILE: H:\ISO\476073\12010 Grating System Inspection And Repair Phase 1\Dwgs\Bascule Bridge Deck Inspection GRATING 0-2.dwg

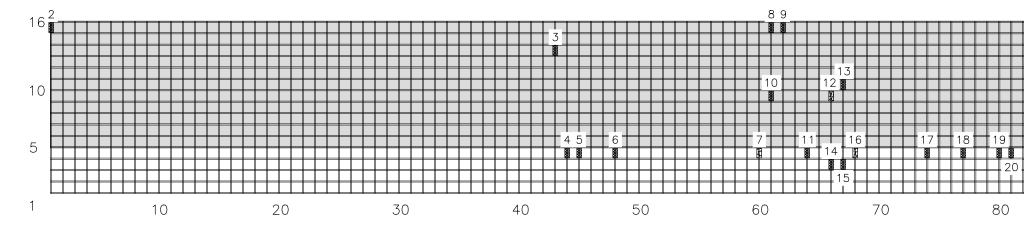
DEFECT No.	DESCRIPTION	DEFECT No.	DESCRIPTION
1	ABRASION	17	BENT TRANSVERSE BAR
2	BENT TRANSVERSE BAR	18	BENT TRANSVERSE BAR
3	BENT TRANSVERSE BAR	19	BENT TRANSVERSE BAR
4	BENT TRANSVERSE BAR	20	BENT TRANSVERSE BAR
5	BENT TRANSVERSE BAR	21	BENT TRANSVERSE BAR
6	BENT TRANSVERSE BAR	22	BROKEN LONGITUDINAL BAR
7	BROKEN TRANSVERSE BAR	23	BROKEN LONGITUDINAL BAR
8	BENT TRANSVERSE BAR	24	BROKEN TRANSVERSE BAR
9	BENT TRANSVERSE BAR	25	BROKEN TRANSVERSE BAR
10	BENT TRANSVERSE BAR	26	BENT TRANSVERSE BAR
11	BENT TRANSVERSE BAR	27	BROKEN TRANSVERSE BAR
12	BROKEN TRANSVERSE BAR	28	BENT TRANSVERSE BAR
13	BENT TRANSVERSE BAR	29	BROKEN TRANSVERSE BAR
14	BENT TRANSVERSE BAR	30	BENT TRANSVERSE BAR
15	BENT TRANSVERSE BAR	31	AREA OF BROKEN TRANSVERSE BARS
16	BROKEN TRANSVERSE BAR

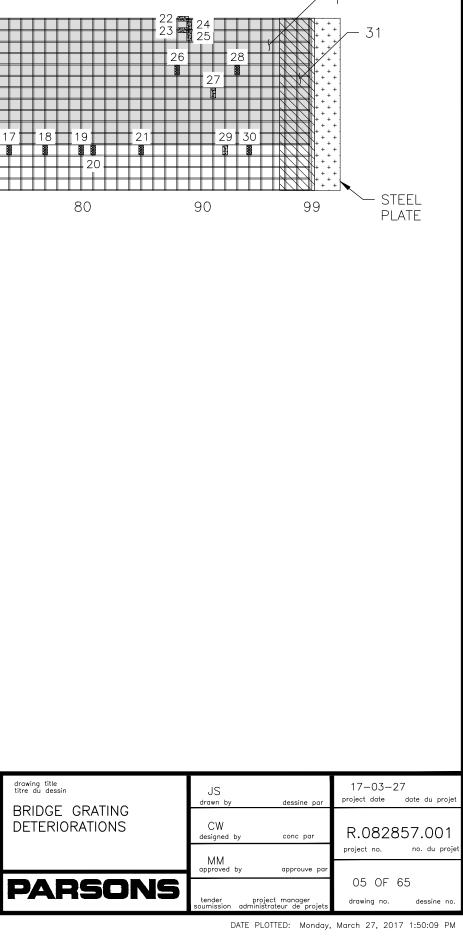
CAD FILE: H:\ISO\476073\12010 Grating System Inspection And Repair Phase 1\Dwgs\Bascule Bridge Deck Inspection GRATING 0-2.dwg

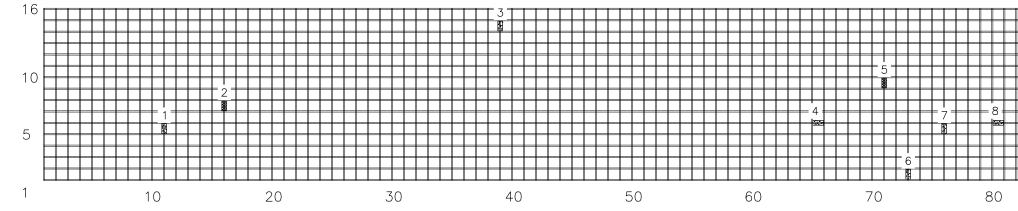
$\frac{O-2 - D}{1:20}$

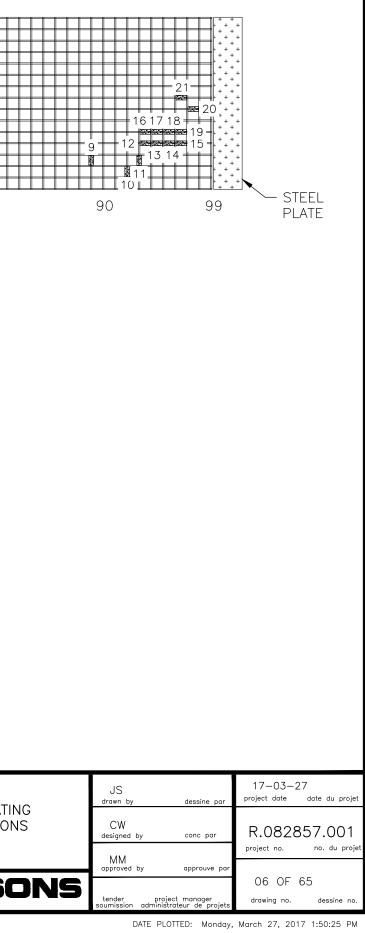
CAD FILE: H:\ISO\476073\12010 Grating System Inspection And Repair Phase 1\Dwgs\Bascule Bridge Deck Inspection GRATING 0-2.dwg

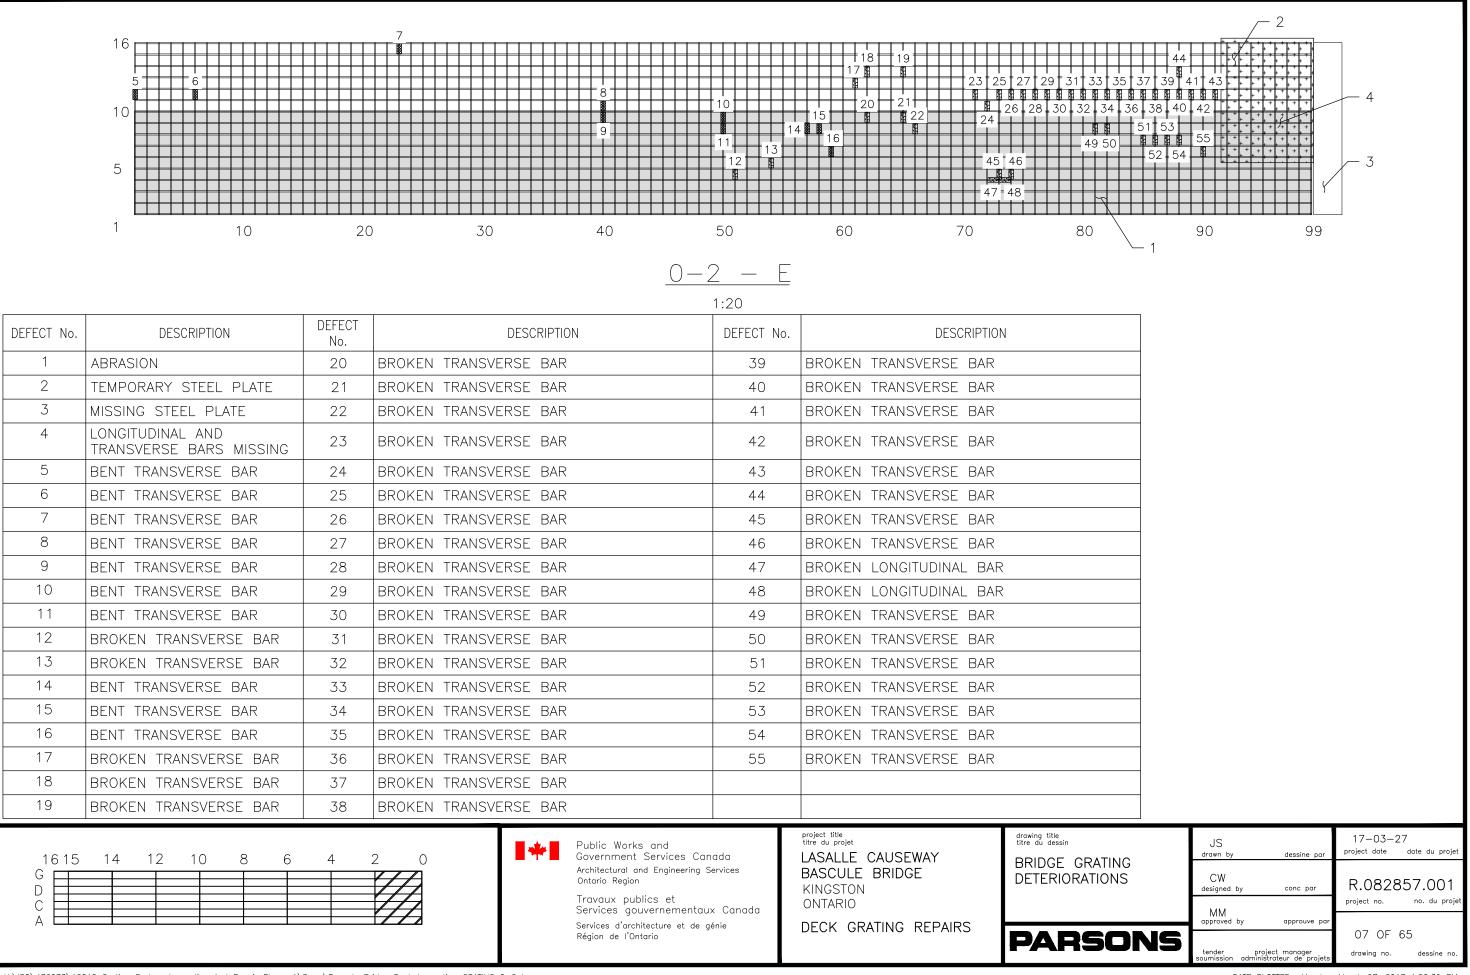
CAD FILE: H:\ISO\476073\12010 Grating System Inspection And Repair Phase 1\Dwgs\Bascule Bridge Deck Inspection GRATING 0-2.dwg

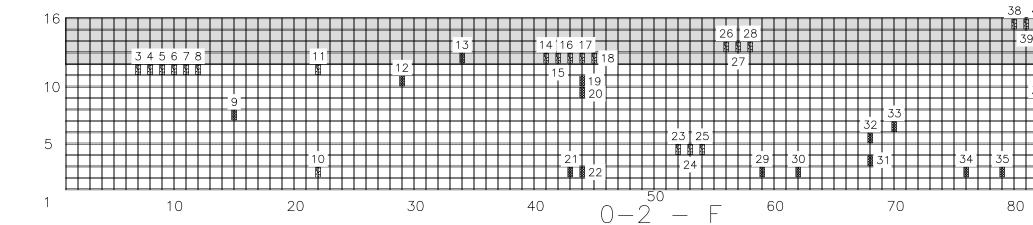
DATE PLOTTED: Monday, March 27, 2017 1:50:39 PM

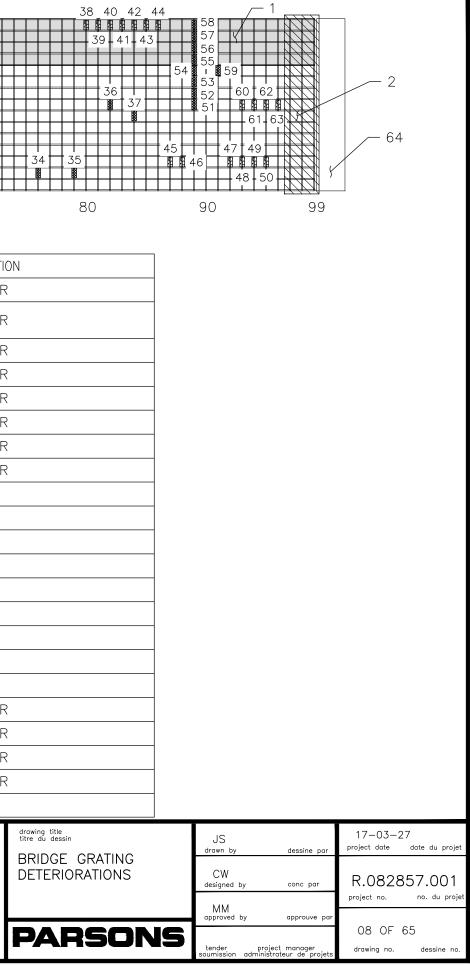
DATE PLOTTED: Monday, March 27, 2017 1:50:53 PM

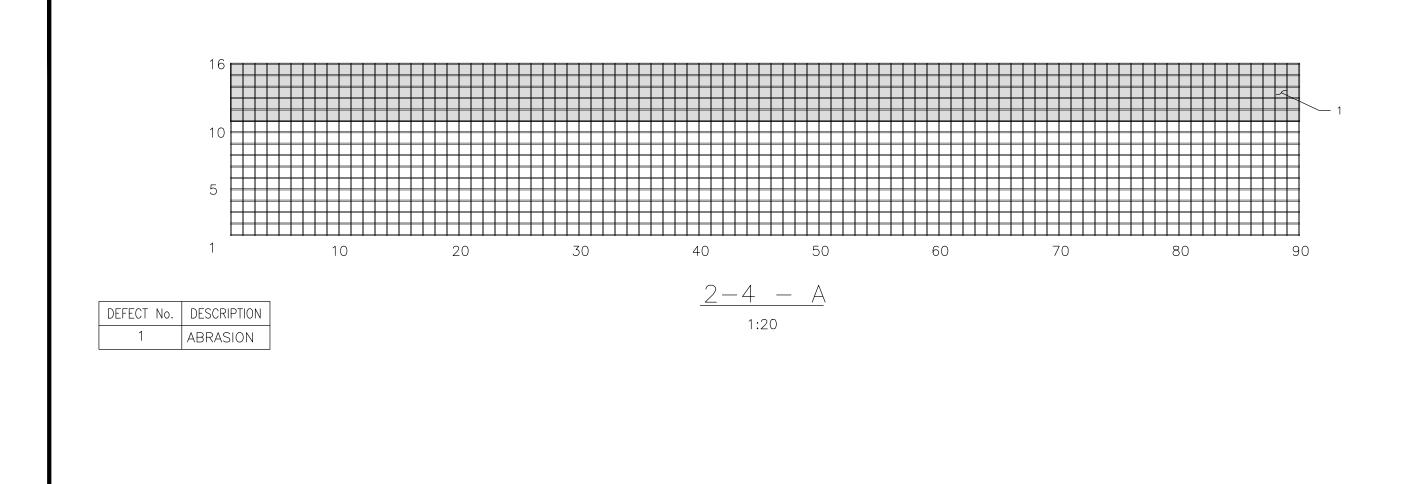
1615 14 12 10 8 6 4 2 0 G D C	Public Works and Government Services Canada Architectural and Engineering Services Ontario Region Travaux publics et Services gouvernementaux Canada	project title titre du projet LASALLE CAUSEWAY BASCULE BRIDGE KINGSTON ONTARIO	drawing title titre du dessin BRIDGE GRATING DETERIORATIONS	JS drawn by dessine par CW designed by conc par	17-03-27 project date du projet R.082857.001 project no. no. du projet
	Services gouvernementaux contradu Services d'architecture et de génie Région de l'Ontario	DECK GRATING REPAIRS	PARSONS	MM approved by approuve par tender project manager soumission administrateur de projets	10 OF 65 drawing no. dessine no.

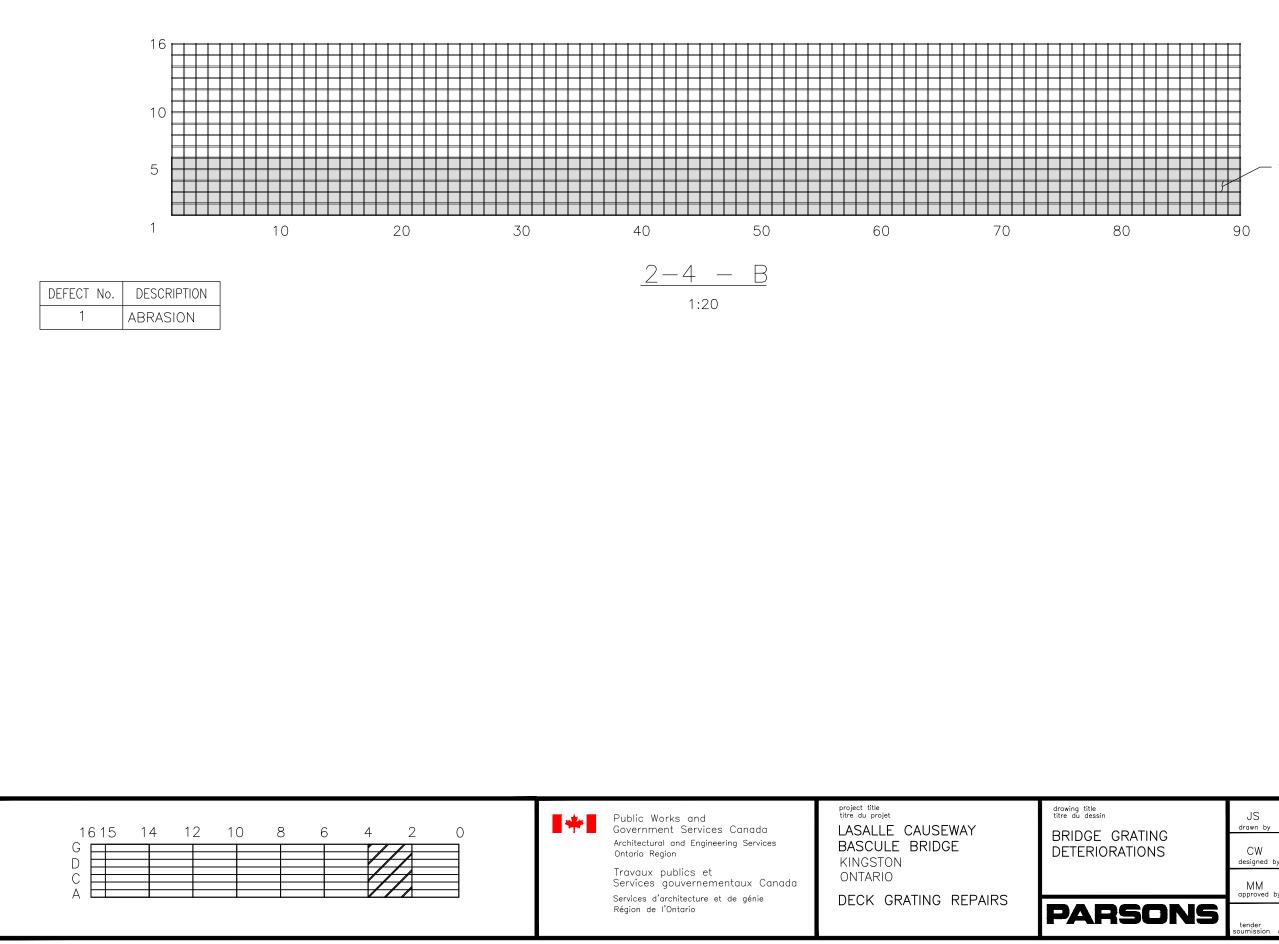
CAD FILE: H:\ISO\476073\12010 Grating System Inspection And Repair Phase 1\Dwgs\Bascule Bridge Deck Inspection GRATING 2-4.dwg

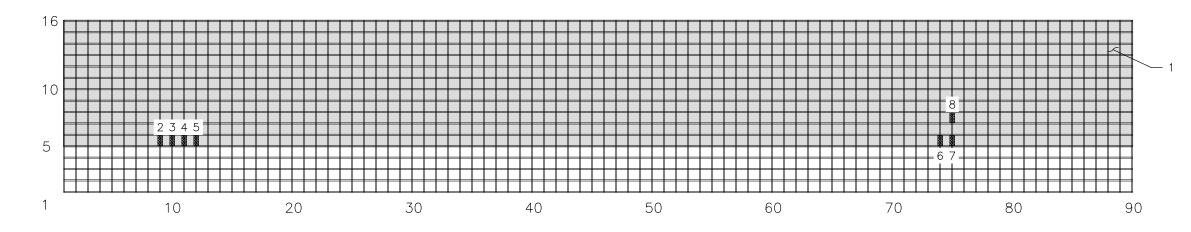
DATE PLOTTED: Monday, March 27, 2017 12:18:32 PM

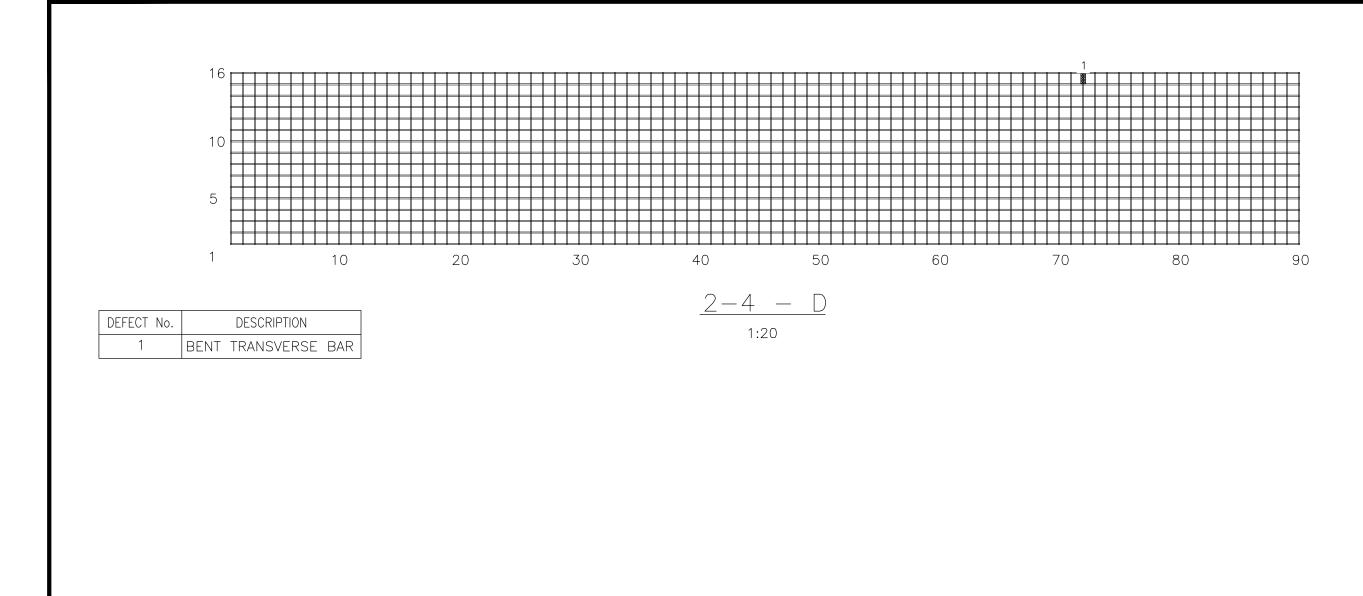
1615 14 12 10 8 6 4 2 0 G G G G G G G G G G G G G G G G G G G	Public Works and Government Services Canada Architectural and Engineering Services Ontario Region Travaux publics et Services gouvernementaux Canada Services d'architecture et de génie Région de l'Ontario	project title titre du projet LASALLE CAUSEWAY BASCULE BRIDGE KINGSTON ONTARIO DECK GRATING REPAIRS	drawing title titre du dessin BRIDGE GRATII DETERIORATION
--	---	---	--

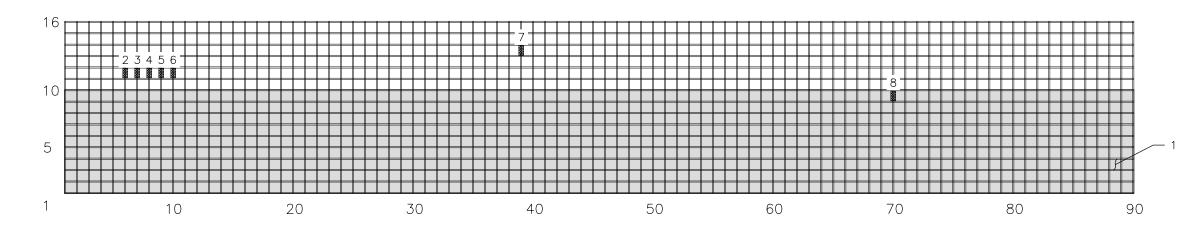
DATE PLOTTED: Monday, March 27, 2017 12:18:35 PM

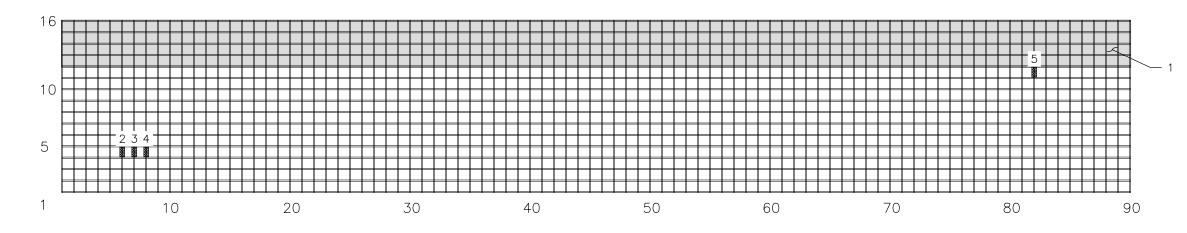
DATE PLOTTED: Monday, March 27, 2017 12:18:36 PM

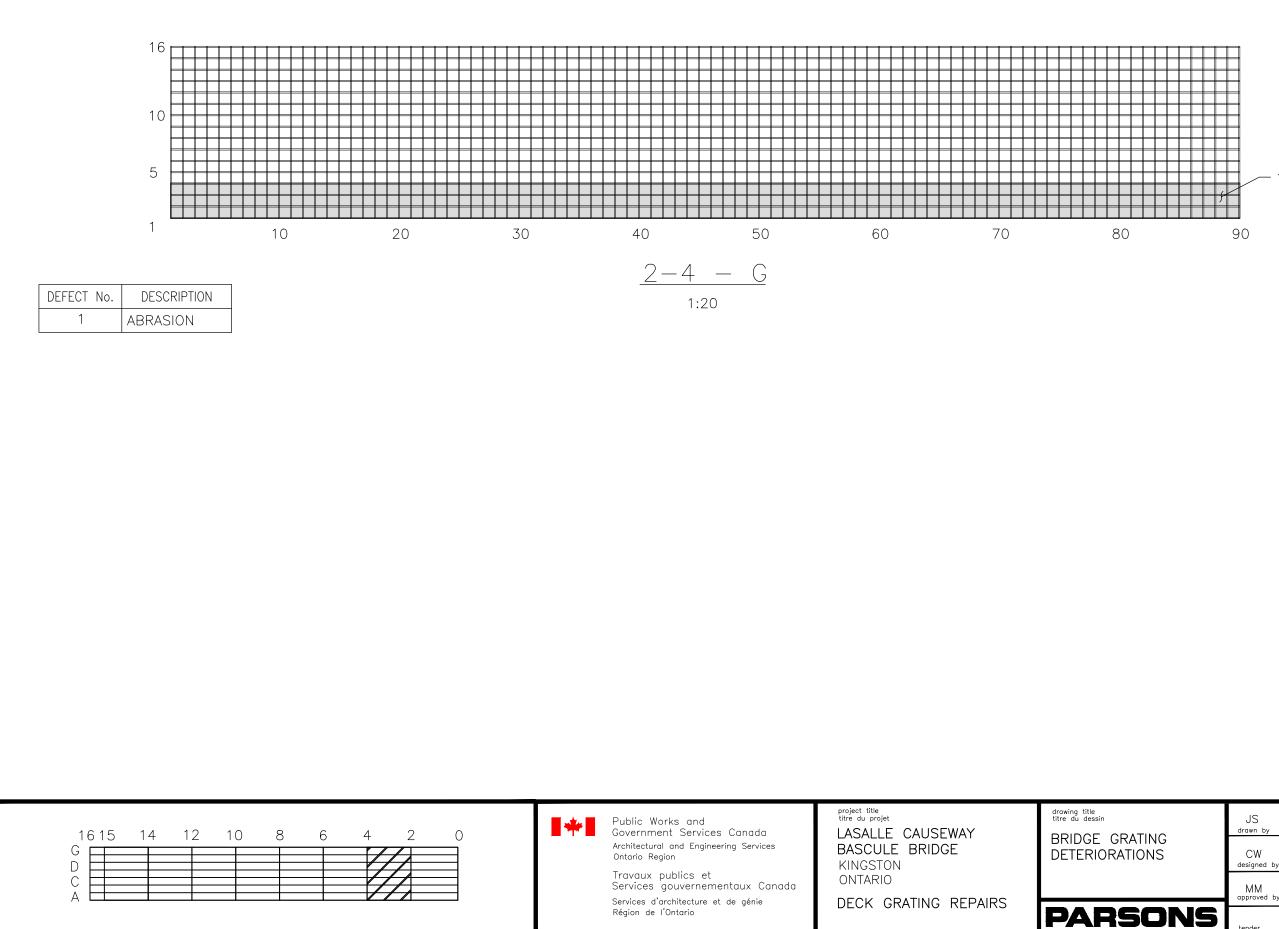
DATE PLOTTED: Monday, March 27, 2017 12:18:39 PM

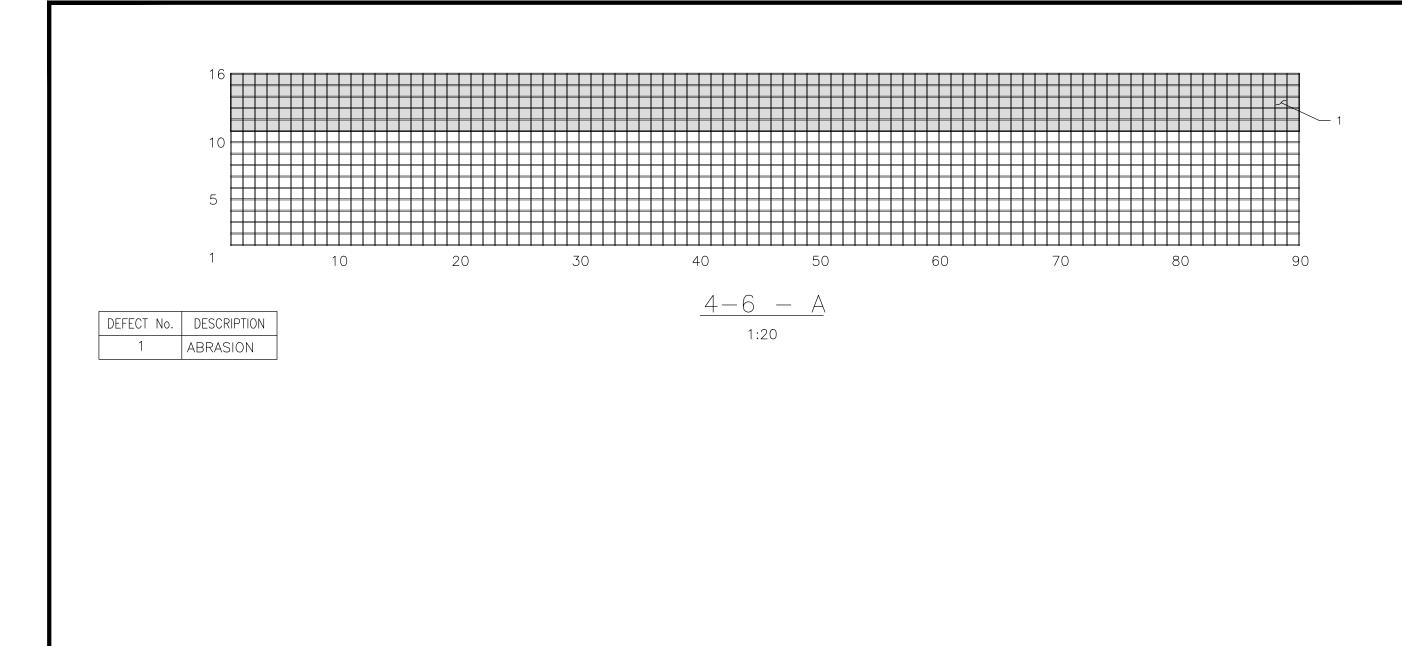
Public Works and Government Services Canada Architectural and Engineering Services	project title titre du projet LASALLE CAUSEWAY BASCULE BRIDGE	drawing title titre du dessin BRIDGE GRATING DETERIORATIONS	JS drawn by dessine par CW	17-03-27 project date du projet
Ontario Region Travaux publics et Services gouvernementaux Canada	KINGSTON ONTARIO	DETENIONATIONS	designed by conc par	R.082857.001 project no. no. du projet
Services d'architecture et de génie Région de l'Ontario	DECK GRATING REPAIRS	PARSONS	approved by approuve par	18 OF 65 drawing no. dessine no.

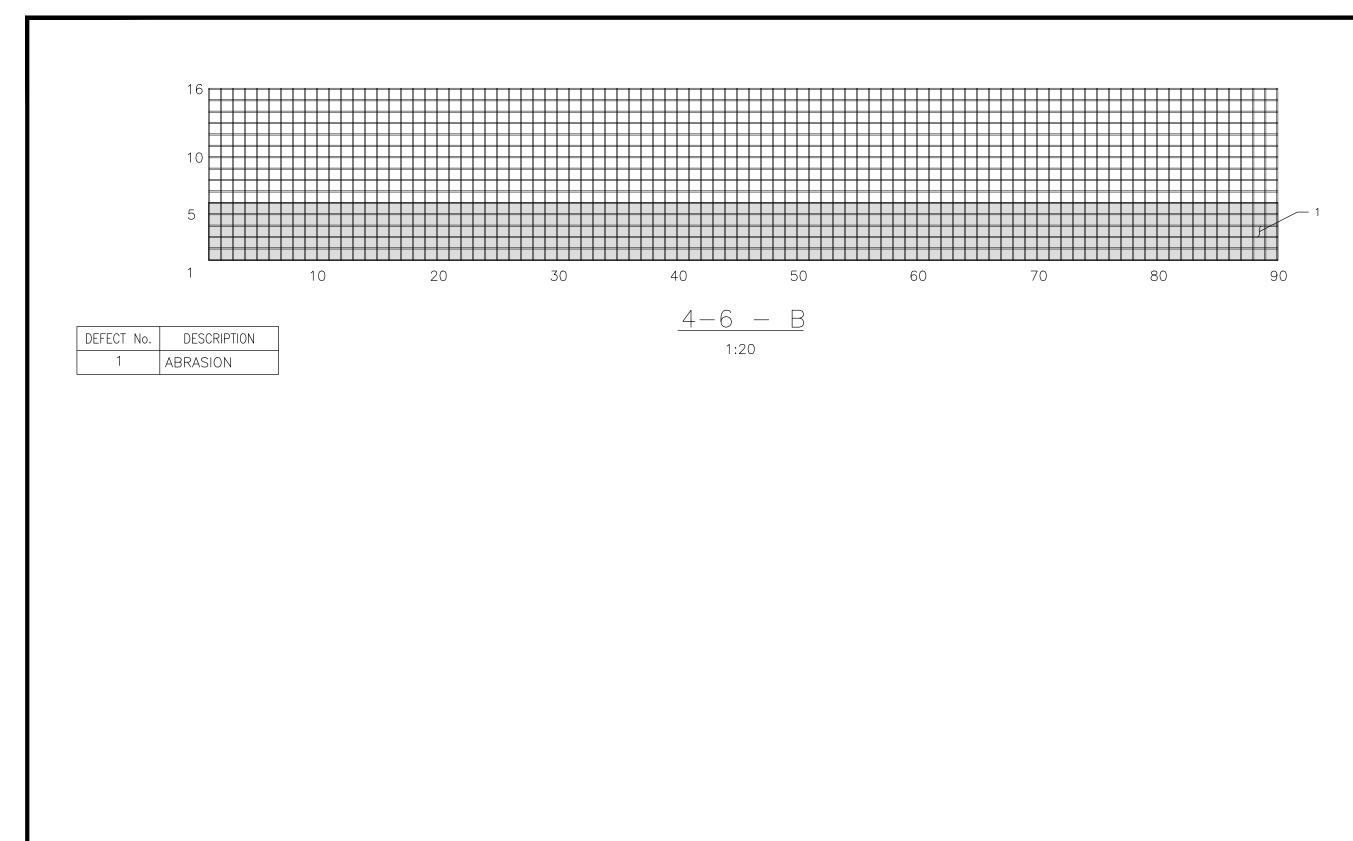
1615 14 12 10 8 6 4 2 0	Public Works and Government Services Canada	project title titre du projet LASALLE CAUSEWAY	drawing title titre du dessin BRIDGE GRATING	JS drawn by dessine par	17-03-27 project date date du projet
G D C	Architectural and Engineering Services Ontario Region Travaux publics et Services gouvernementaux Canada	BASCULE BRIDGE KINGSTON ONTARIO	DETERIORATIONS	CW designed by conc par MM	R.082857.001 project no. no. du projet
	Services gouvernementaux oundau Services d'architecture et de génie Région de l'Ontario	DECK GRATING REPAIRS	PARSONS	approved by approuve par	18 OF 65 drawing no. dessine no.

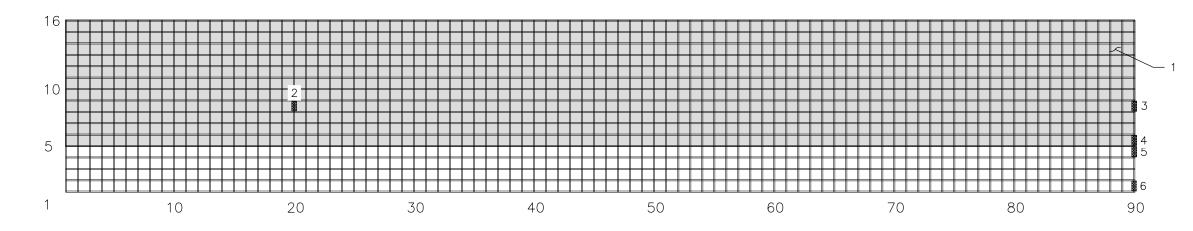
DATE PLOTTED: Monday, March 27, 2017 12:18:43 PM

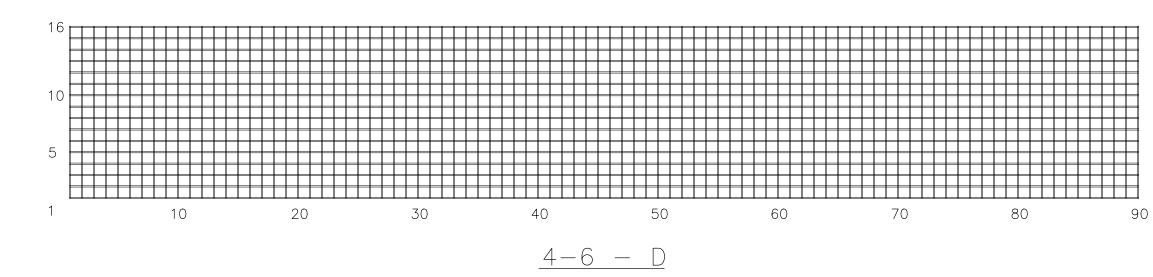
DATE PLOTTED: Monday, March 27, 2017 12:18:45 PM

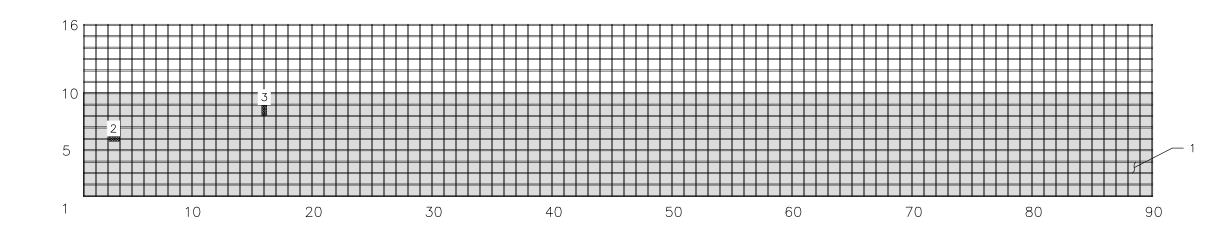
DATE PLOTTED: Monday, March 27, 2017 12:18:47 PM

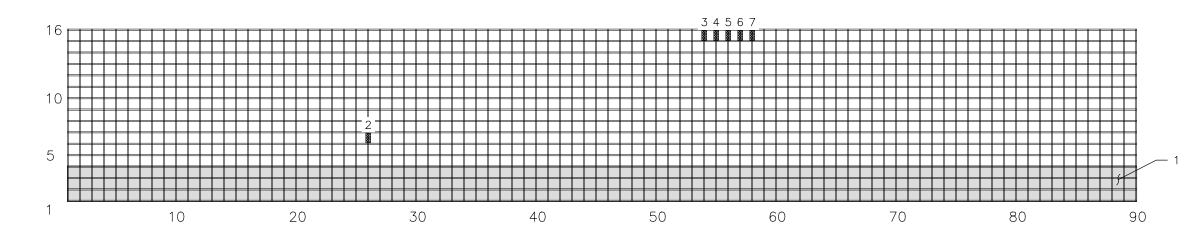
DATE PLOTTED: Monday, March 27, 2017 12:18:51 PM

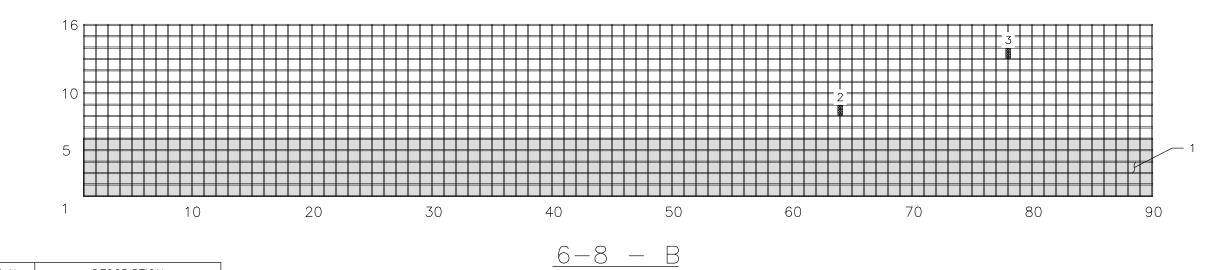
DEFECT No.	DESCRIPTION		
1	ABRASION		
4	BENT TRANSVERSE BAR		
5	BENT TRANSVERSE BAR

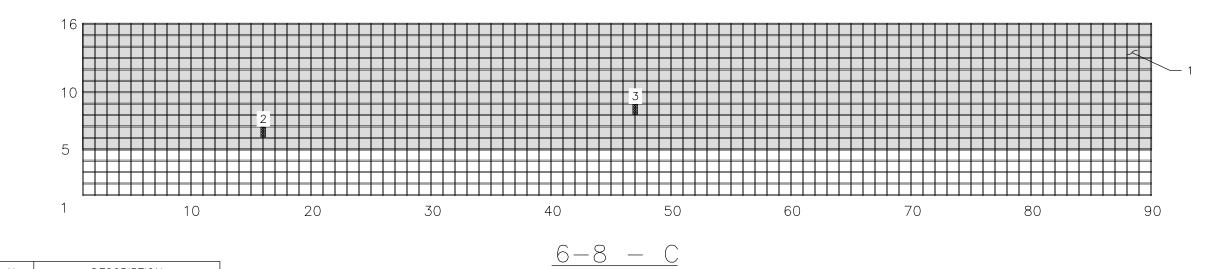
DEFECT No.	DESCRIPTION		
1	ABRASION		
2	BENT TRANSVERSE BAR		
3	BENT TRANSVERSE BAR

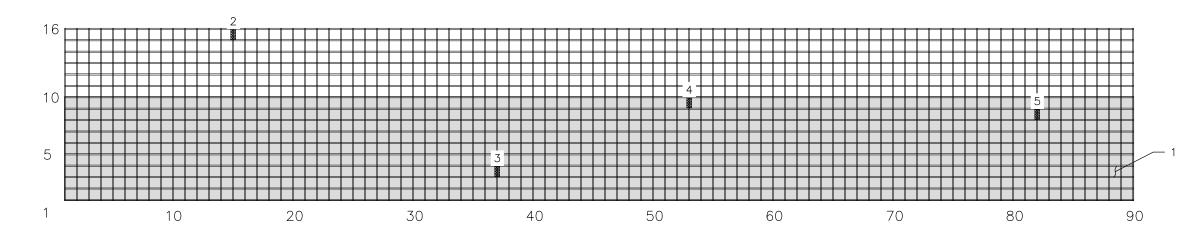
DATE PLOTTED: Monday, March 27, 2017 12:19:00 PM

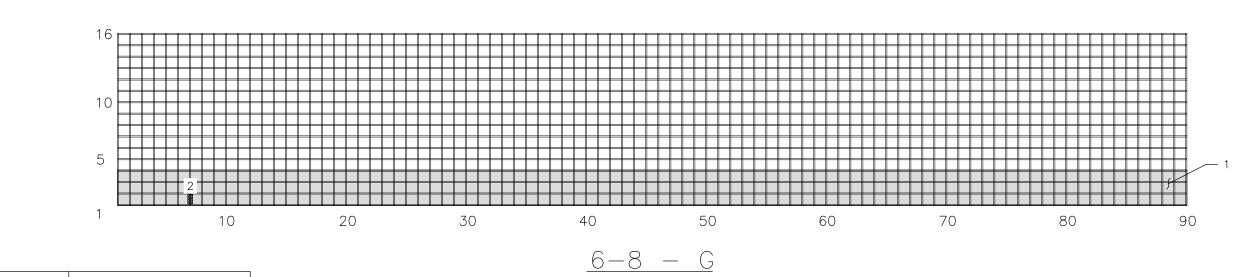
DEFECT No.	DESCRIPTION	
1	ABRASION	
2	BENT TRANSVERSE BAR

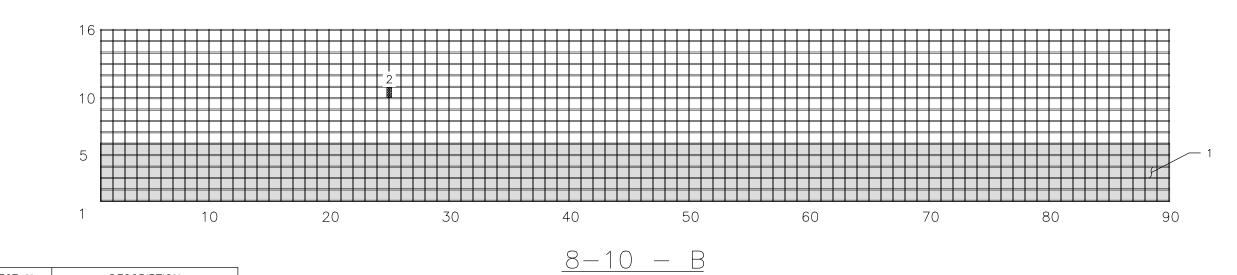
DEFECT No.	DESCRIPTION		
1	ABRASION		
4	BENT TRANSVERSE BAR

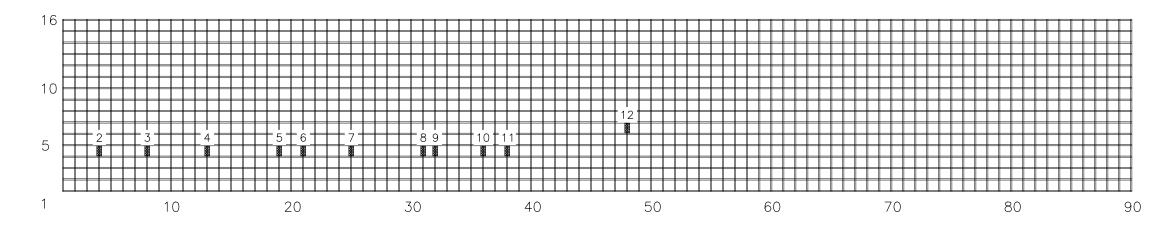
DATE PLOTTED: Monday, March 27, 2017 12:19:09 PM

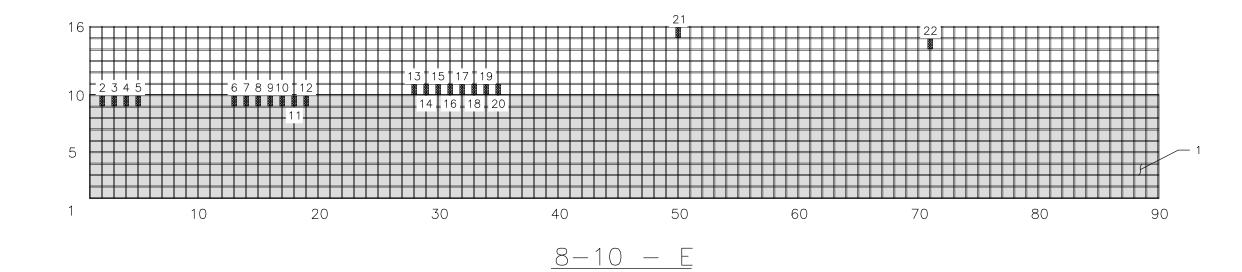
DEFECT No.	DESCRIPTION	DEFECT No.	DESCRIPTION
1	ABRASION	13	BENT TRANSVERSE BAR
2	BENT TRANSVERSE BAR	14	BENT TRANSVERSE BAR
3	BENT TRANSVERSE BAR	15	BENT TRANSVERSE BAR
4	BENT TRANSVERSE BAR	16	BENT TRANSVERSE BAR
5	BENT TRANSVERSE BAR	17	BENT TRANSVERSE BAR
6	BENT TRANSVERSE BAR	18	BENT TRANSVERSE BAR
7	BENT TRANSVERSE BAR	19	BENT TRANSVERSE BAR
8	BENT TRANSVERSE BAR	20	BENT TRANSVERSE BAR
9	BENT TRANSVERSE BAR	21	BENT TRANSVERSE BAR
10	BENT TRANSVERSE BAR	22	BENT TRANSVERSE BAR
11	BENT TRANSVERSE BAR		
12	BENT TRANSVERSE BAR

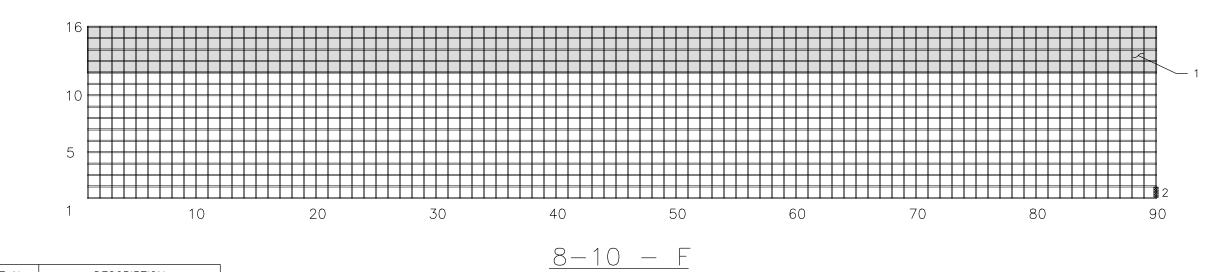
DEFECT No.	DESCRIPTION		
1	ABRASION		
2	BENT TRANSVERSE BAR

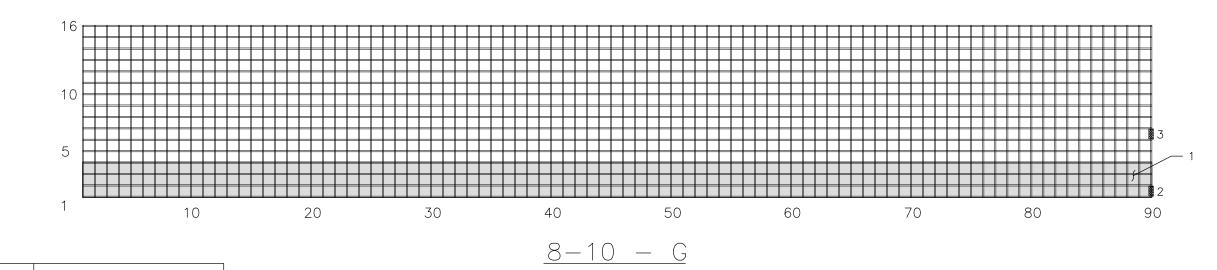
DEFECT No.	DESCRIPTION		
1	ABRASION		
2	BENT TRANSVERSE BAR		
3	BENT TRANSVERSE BAR

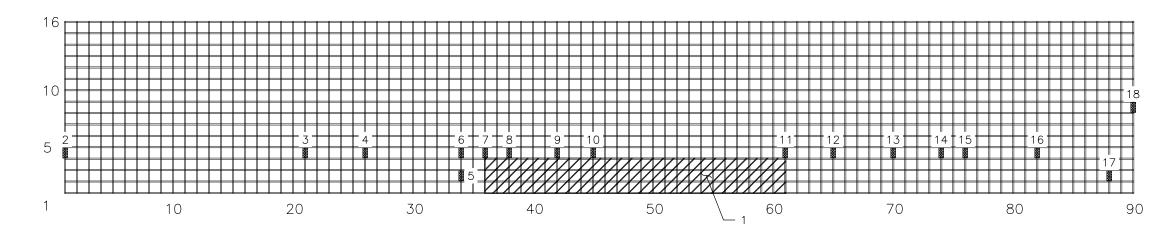
DATE PLOTTED: Monday, March 27, 2017 12:19:22 PM

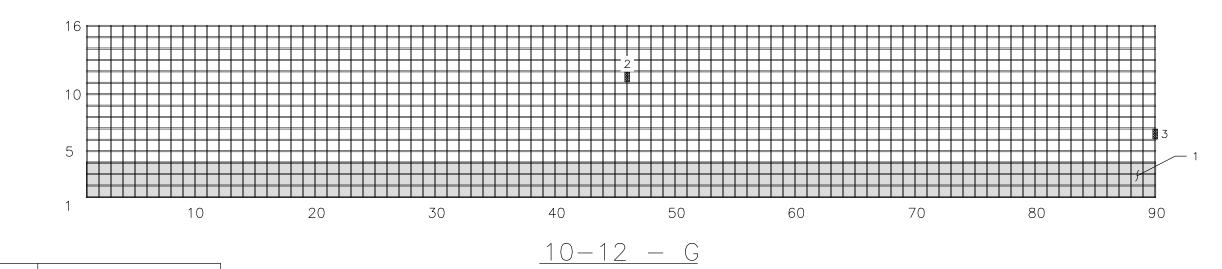
DEFECT No.	DESCRIPTION
1	ABRASION
2	BENT TRANSVERSE BAR
3	BENT TRANSVERSE BAR

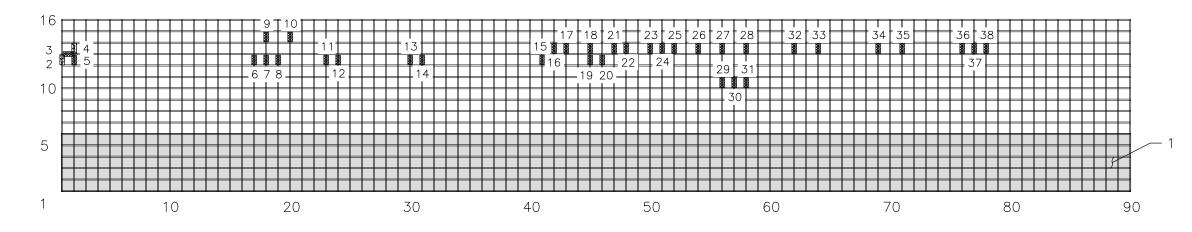
DATE PLOTTED: Monday, March 27, 2017 12:19:27 PM
