LaSalle Causeway

Deck Grating Inspection and Repair Report

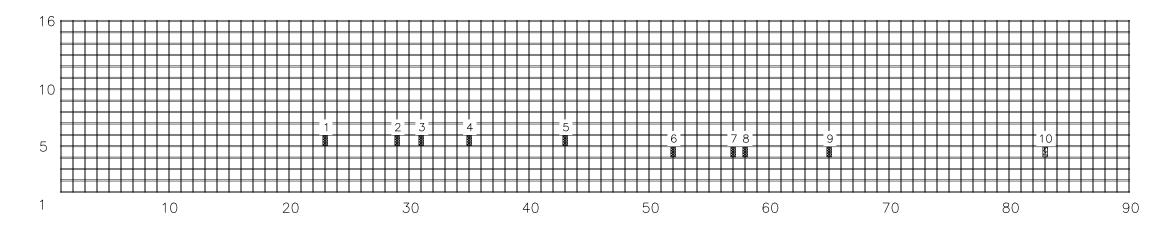
DATE PLOTTED: Monday, March 27, 2017 12:19:31 PM

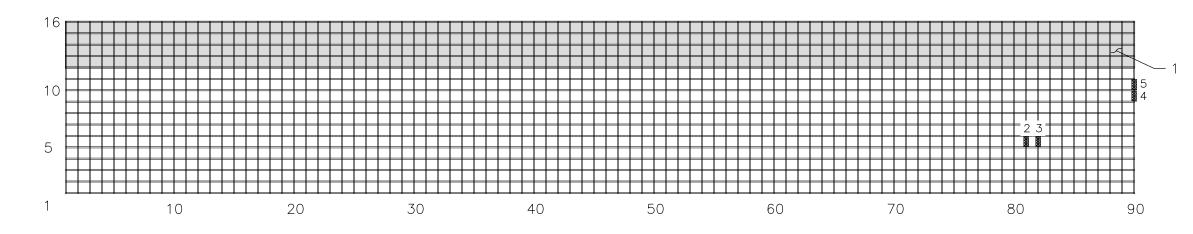
DATE PLOTTED: Monday, March 27, 2017 12:19:34 PM

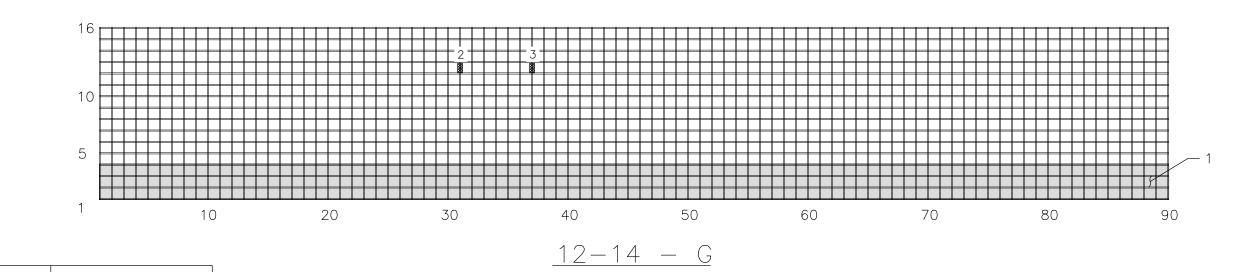
DATE PLOTTED: Monday, March 27, 2017 12:19:35 PM

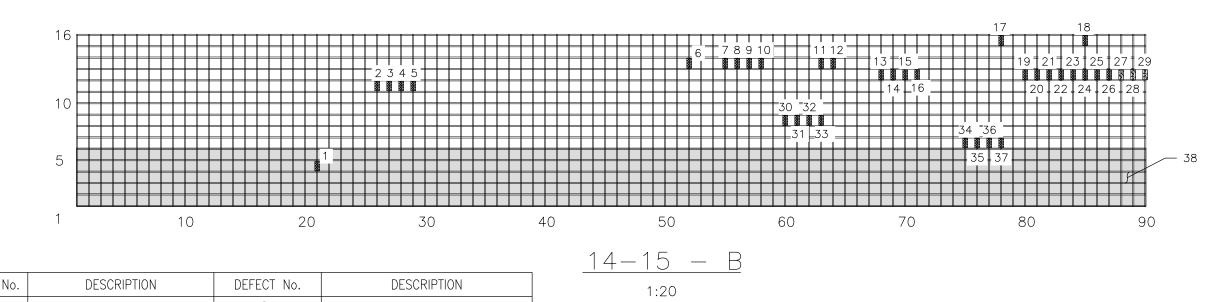
DATE PLOTTED: Monday, March 27, 2017 12:20:02 PM

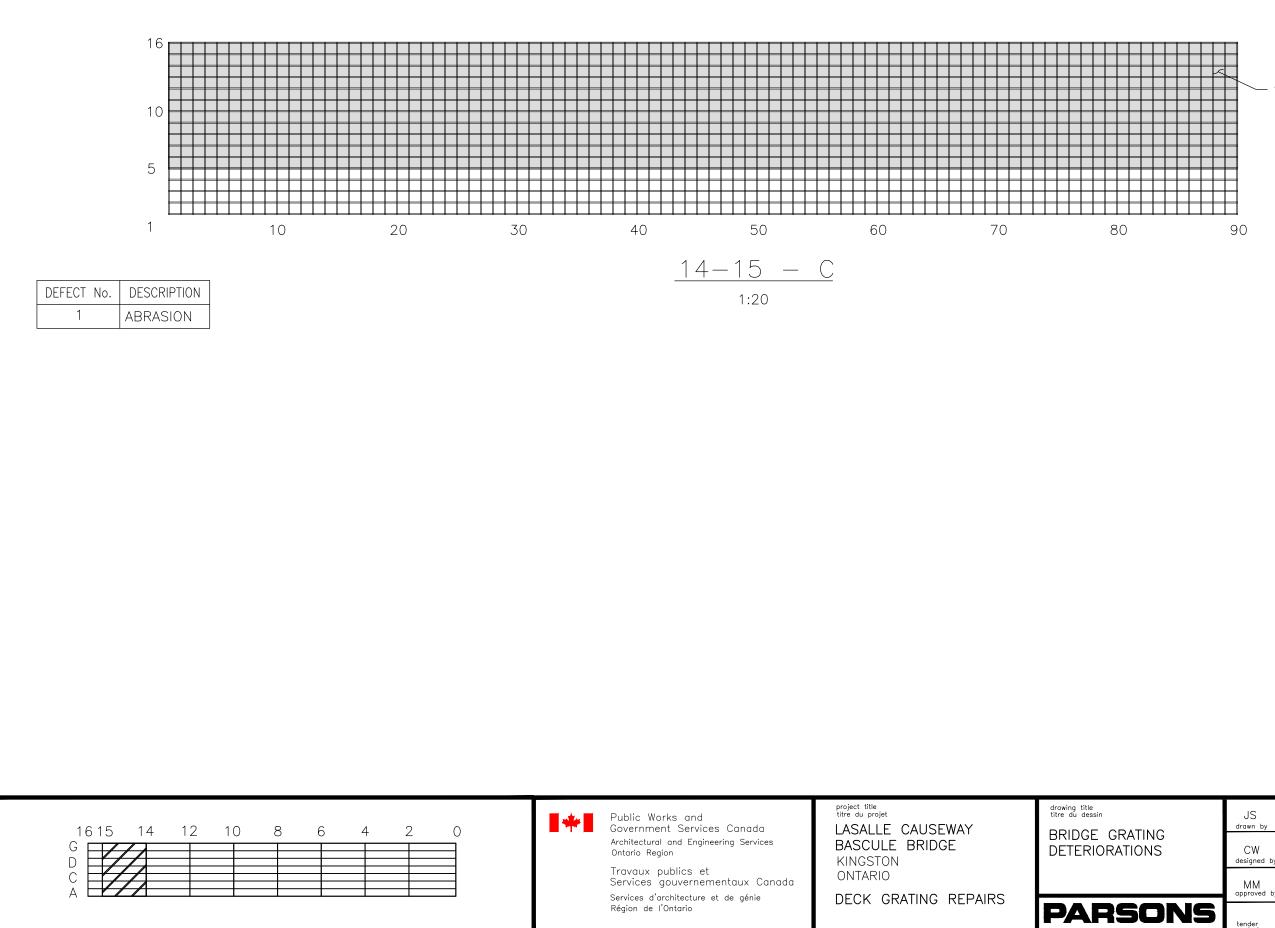
DATE PLOTTED: Monday, March 27, 2017 12:20:03 PM

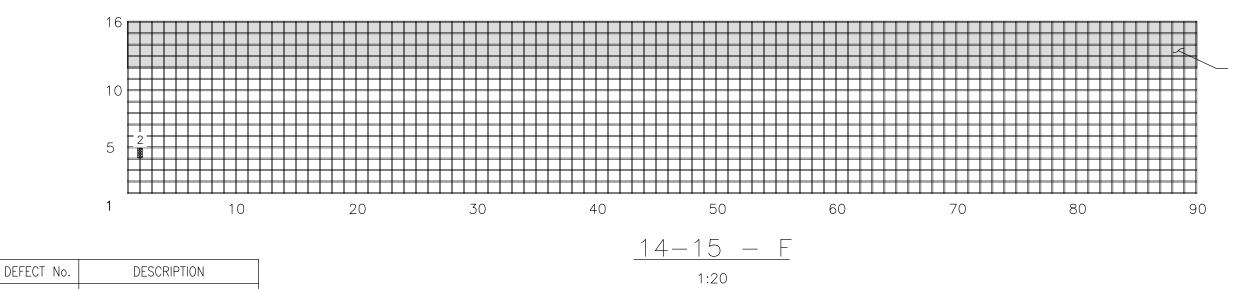
DEFECT No.	DESCRIPTION		
1	ABRASION		
2	BENT TRANSVERSE BAR

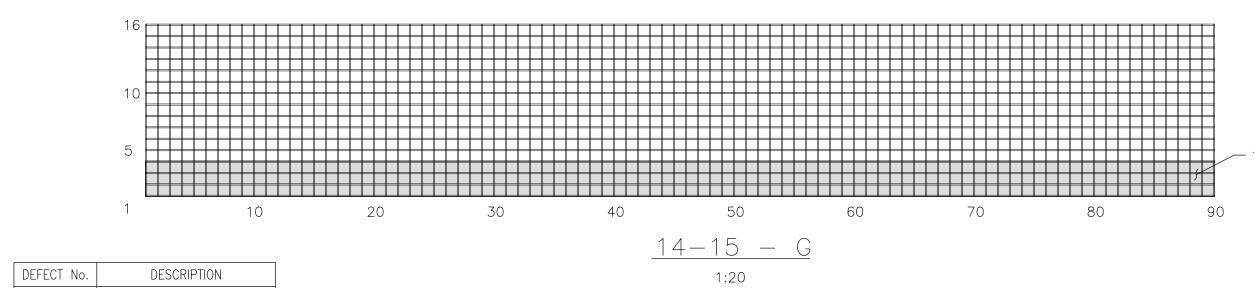
DEFECT No.	DESCRIPTION
1	ABRASION
2	BENT TRANSVERSE BAR

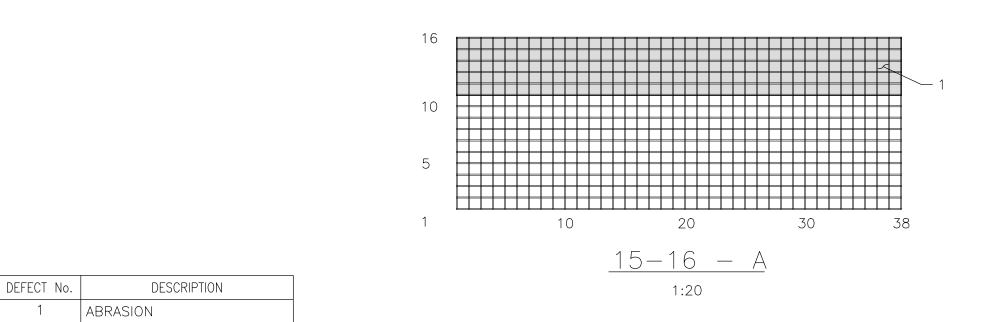
Public Works and	project title titre du projet	drawing title titre du dessin
1615 14 12 10 8 6 4 2 0 G C A A A A A A A A A A A A A A A A A A	Public Works and Government Services Canada Architectural and Engineering Services Ontario Region Travaux publics et Services gouvernementaux Canada Services d'architecture et de génie Région de l'Ontario	LASALLE CAUSEWAY BASCULE BRIDGE KINGSTON	BRIDGE GRATII DETERIORATION

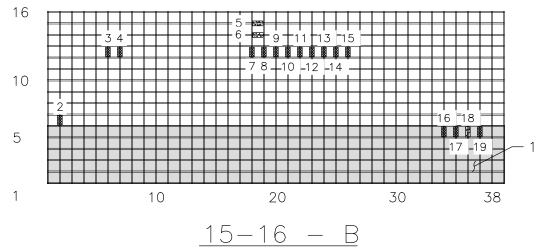
DATE PLOTTED: Monday, March 27, 2017 12:20:20 PM

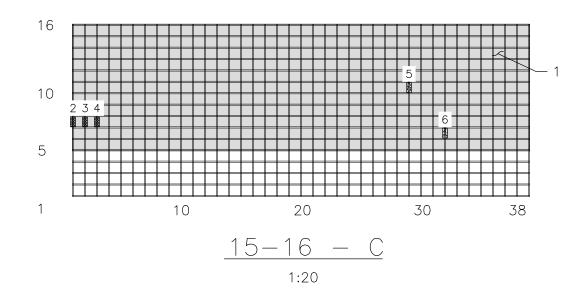
DEFECT No.	DESCRIPTION		
1	ABRASION		
2	BENT TRANSVERSE BAR		
3	BENT TRANSVERSE BAR		
4	BENT TRANSVERSE BAR		
5	BROKEN TRANSVERSE BAR		
6	BROKEN TRANSVERSE BAR

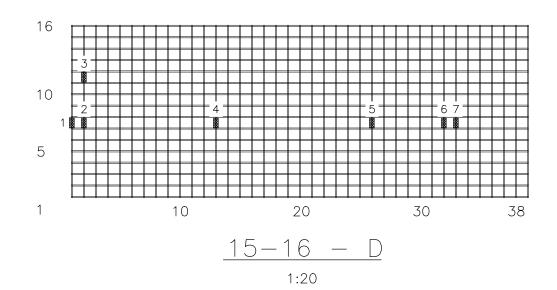
DEFECT No.	DESCRIPTION
1	BENT TRANSVERSE BAR
2	BENT TRANSVERSE BAR
3	BENT TRANSVERSE BAR
4	BENT TRANSVERSE BAR
5	BENT TRANSVERSE BAR
6	BENT TRANSVERSE BAR
7	BENT TRANSVERSE BAR

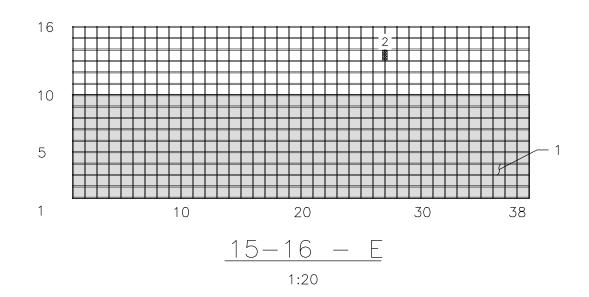
DEFECT No. DESCRIPTION		DESCRIPTION
1 ABRASION		
	2	BENT TRANSVERSE

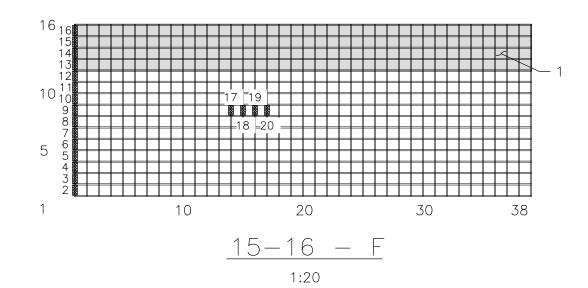
DEFECT No.	DESCRIPTION		
1	ABRASION		
2	BENT TRANSVERSE		
3	BENT TRANSVERSE		
4	BENT TRANSVERSE		
5	BENT TRANSVERSE		
6	BENT TRANSVERSE		
7	BENT TRANSVERSE		
8	BENT TRANSVERSE		
9	BENT TRANSVERSE		
10	BENT TRANSVERSE		
11	BENT TRANSVERSE		
12	BENT TRANSVERSE		
13	BENT TRANSVERSE		
14	BENT TRANSVERSE		
15	BENT TRANSVERSE		
16	BENT TRANSVERSE		
17	BENT TRANSVERSE		
18	BENT TRANSVERSE		
19	BENT TRANSVERSE		
20	BENT TRANSVERSE

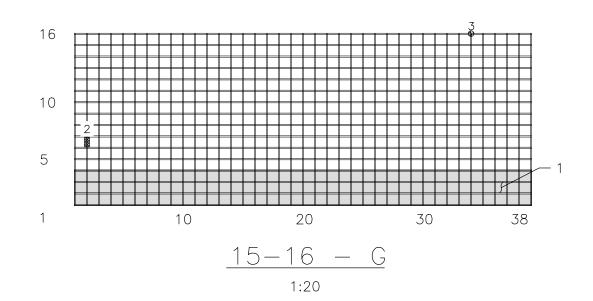
DEFECT No.	DESCRIPTION		
1	ABRASION		
2	BENT TRANSVERSE		
3	BENT TRANSVERSE
