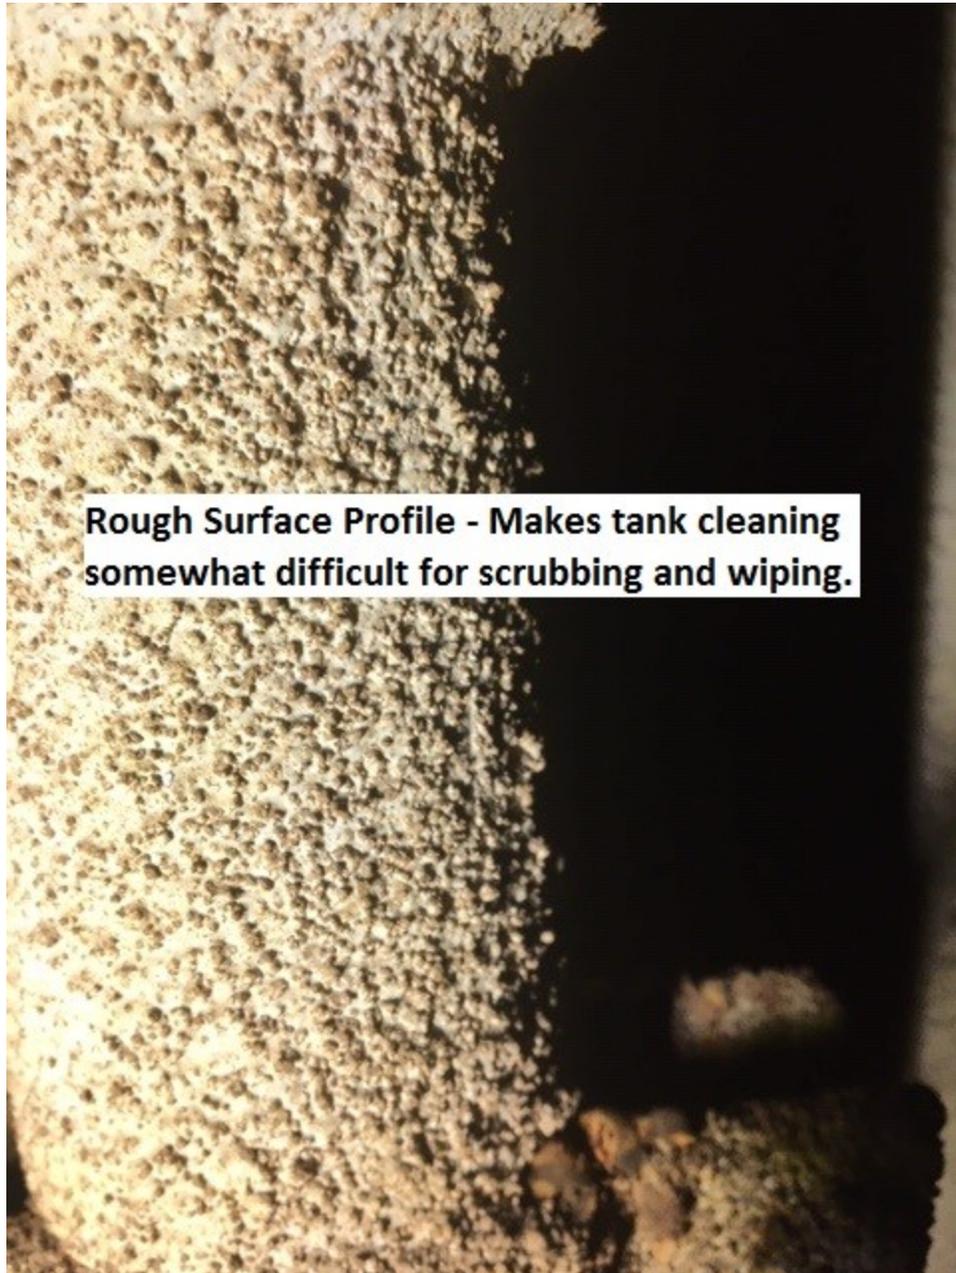
Rough Surface Profile - Makes tank cleaning somewhat difficult for scrubbing and wiping.
