MEMORANDUM

Subject: Summary of Environment Assessment, Nanaimo Bunker, Nanaimo Lakes Road,
Nanaimo BC

Surveys and Mitigation Recommendations for Western Painted Turtle on DND Lands Subjected to Soil Remediation at Nanaimo Bunker Property, Vancouver Island

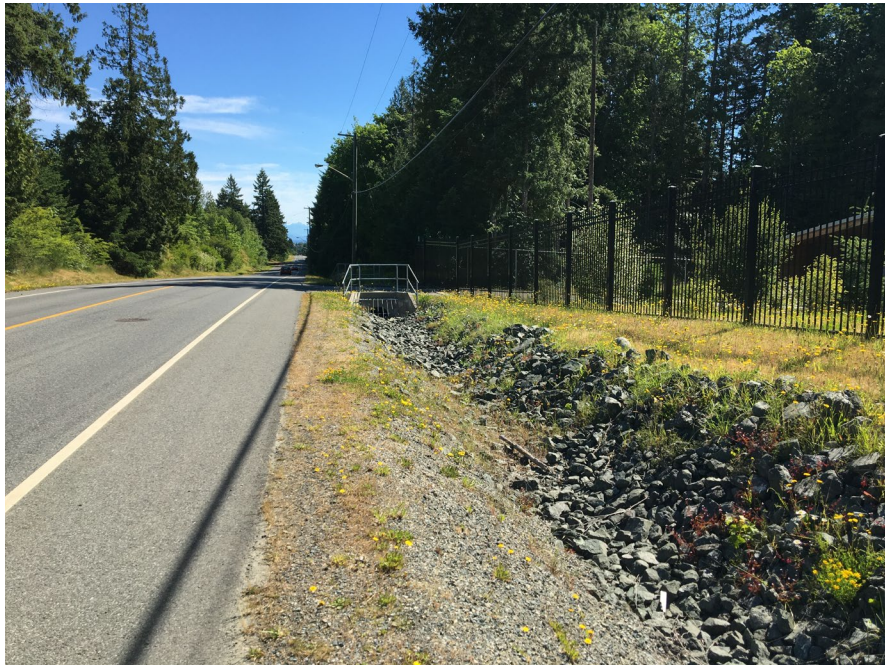
Photograph 2: Paved road and riprap ditch.

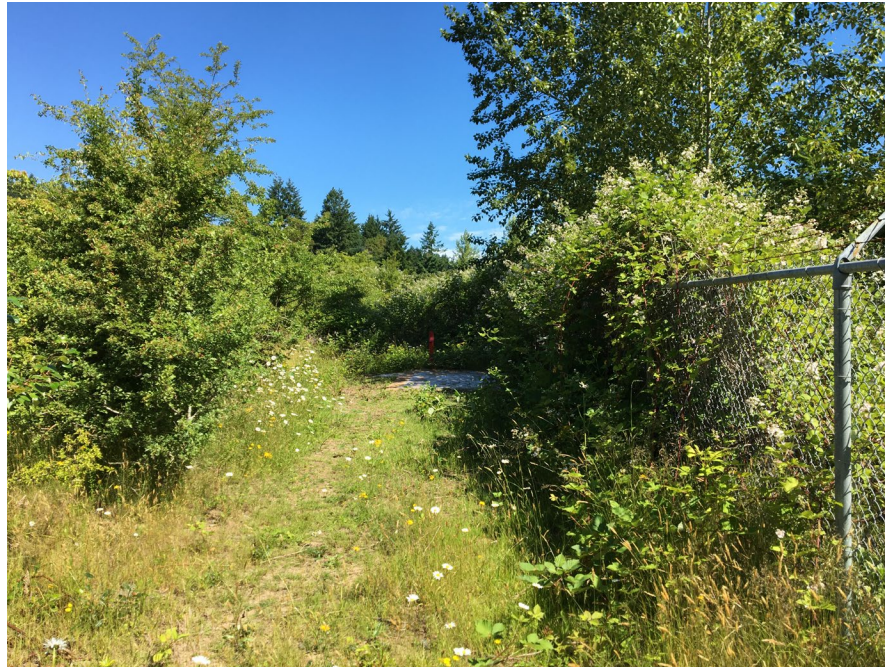
Photograph 3: Dense vegetation and chain-link fence at margin of Site.

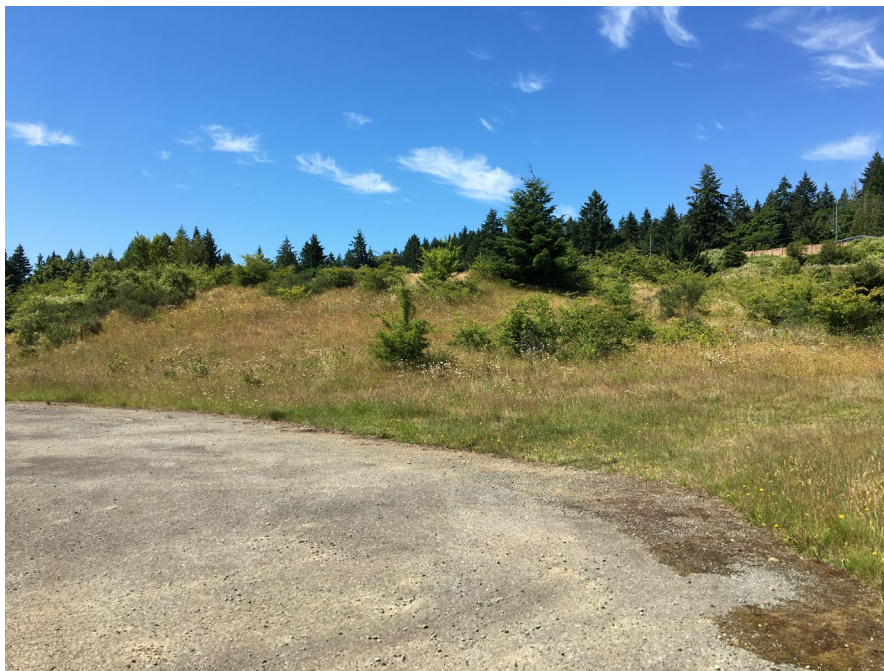
Photograph 4: Paved area and typical vegetation at the Site.

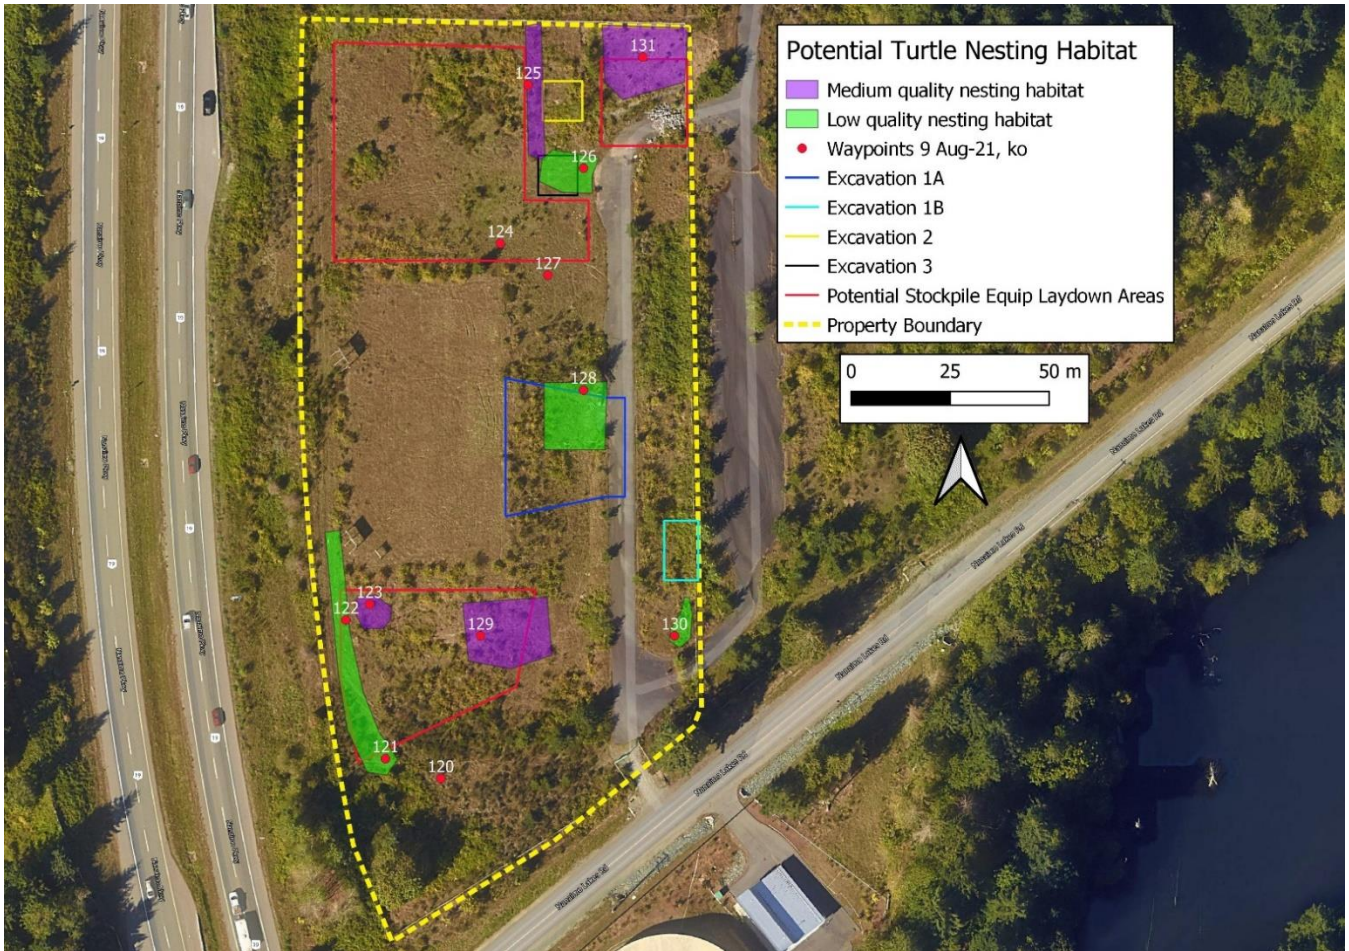
Most of the study area was covered by dense shrubs or grass, unsuitable for turtle nesting. However, we identified several sites that contained potentially suitable patches with bare ground and suitable substrate and exposure (Figure 3; see Appendix 1 for field notes and Appendix 2 for images). These were rated either as medium or low quality. The best habitat occurred in the northeast corner and in the south-central and southwest parts of the study area. In these areas, the potential nesting habitat overlapped with the proposed equipment and stockpile laydown areas (Figure 3).

Figure 3. Turtle nesting habitat assessment within the Nanaimo Bunker study area. Reference numbers match those in the appendices.

- Avoid soil disturbance in areas rated as medium suitability for the species (see Figure 3). This may include re-routing of access roads and turn-around areas in the soil remediation area, if required; avoid widening existing access roads into the site; all new roads should be restored after completion of remediation activities. Avoid using those portions of equipment and stockpile laydown areas that overlap with medium quality nesting habitat.

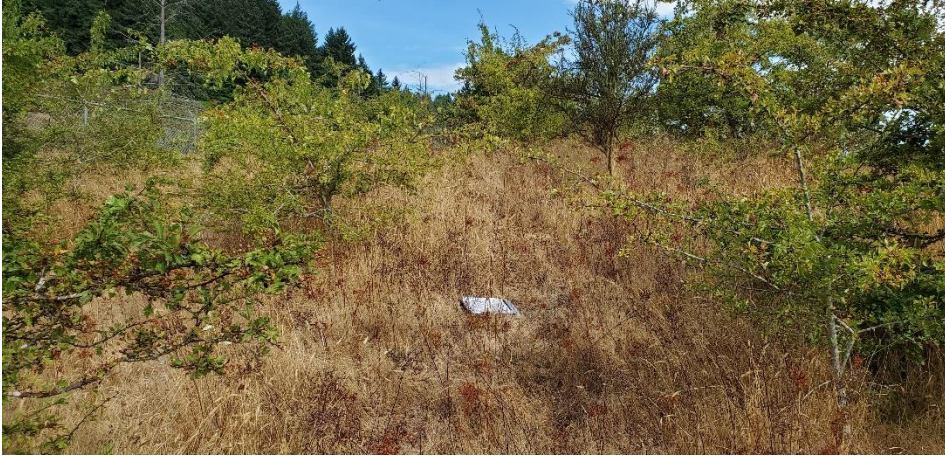
Site 123

Appendix 2. Images of potential turtle nesting habitat rated as medium suitability within the remediation area and a road that turtles would need to cross to access the sites. Site numbers correspond to those in Figure 3 and Appendix 1.

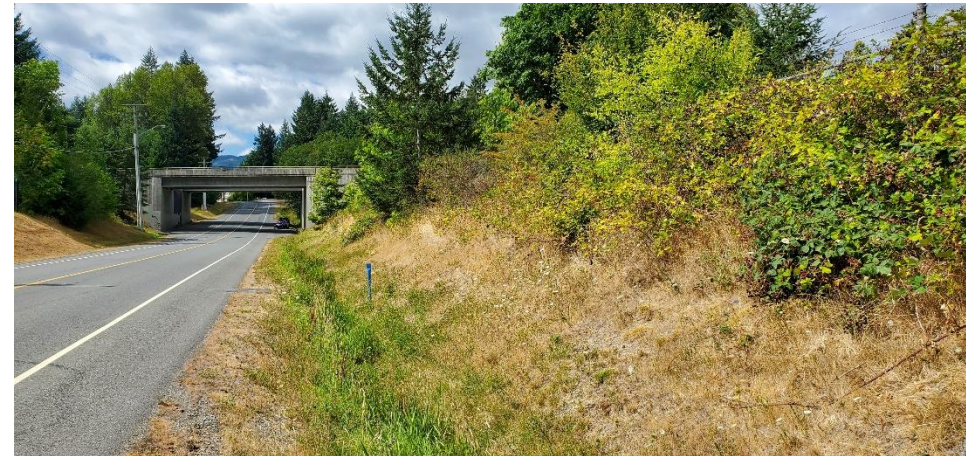
Access to the remediation area by turtles from the nearest wetlands (Colliery Dam Lakes) would necessitate crossing the Nanaimo Lakes Road. The remediation site is on the right, bordered by Himalayan Blackberry bushes and enclosed by a chain link fence.

- Maintain or create gaps (e.g., 10 cm high) at the bottom of the chain link fence surrounding the property on the south side (facing Nanaimo Lakes Road) to allow turtles access to the property.
