Geotechnical Investigation Report
Fire Pump Replacement, St. Anthony, NL
SNC-Lavalin Group Inc.

December 16, 2021

Prepared by: AllRock Consulting Ltd.
19B Union Street
Corner Brook, NL
A2H 5P9

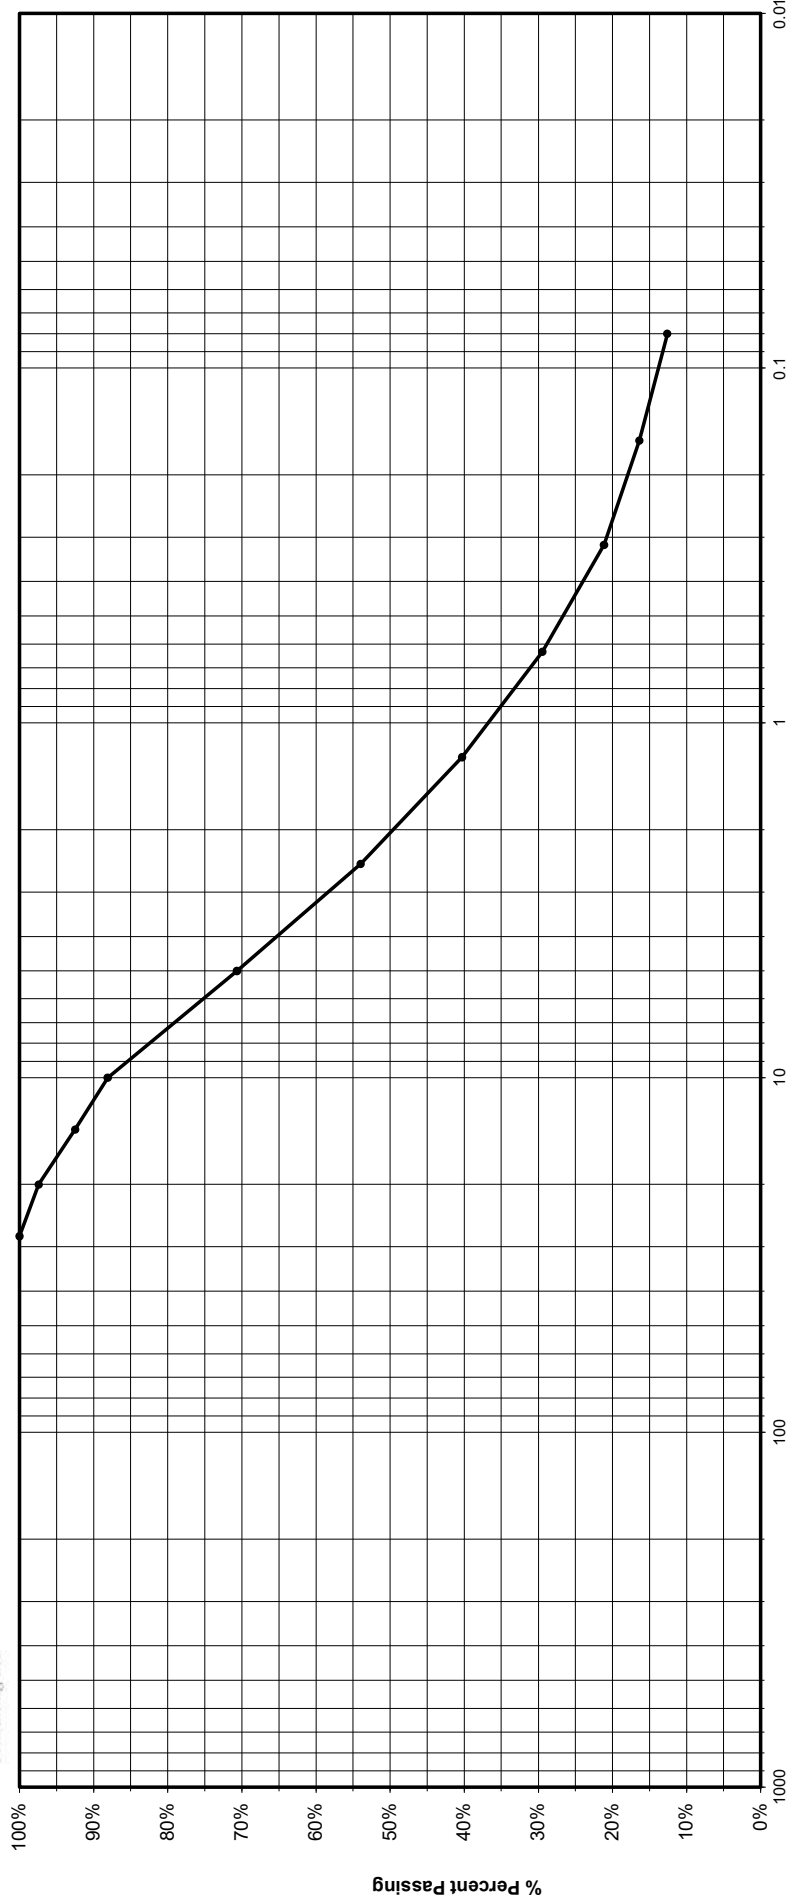
AIIRock Sample Gradation Analysis	
Project:	St. Anthony Fire Pump Replacement
Project #:	21221
Client:	SNC Lavalin
Date:	26-Nov-21
Sample:	Silty Sand with Gravel (SM)
Sample #:	1
Source:	SS #2 2'-4'

Specification		Tested Sample	Remarks
Sieve Size (mm)	Lower % Passing	Upper % Passing	
28		100.0%	No grading specification available for test pits.
20		97.4%	
14		92.5%	
10		88.1%	
5		70.7%	
2.5		54.0%	
1.25		40.3%	
0.63		29.5%	
0.315		21.1%	
0.16		16.4%	
0.08		12.6%	
Moisture Content:		4.1%	
Technician Sampled:		W. Ball	
Technician Tested:		C. Dollard	
Reviewed By:		B. Evans

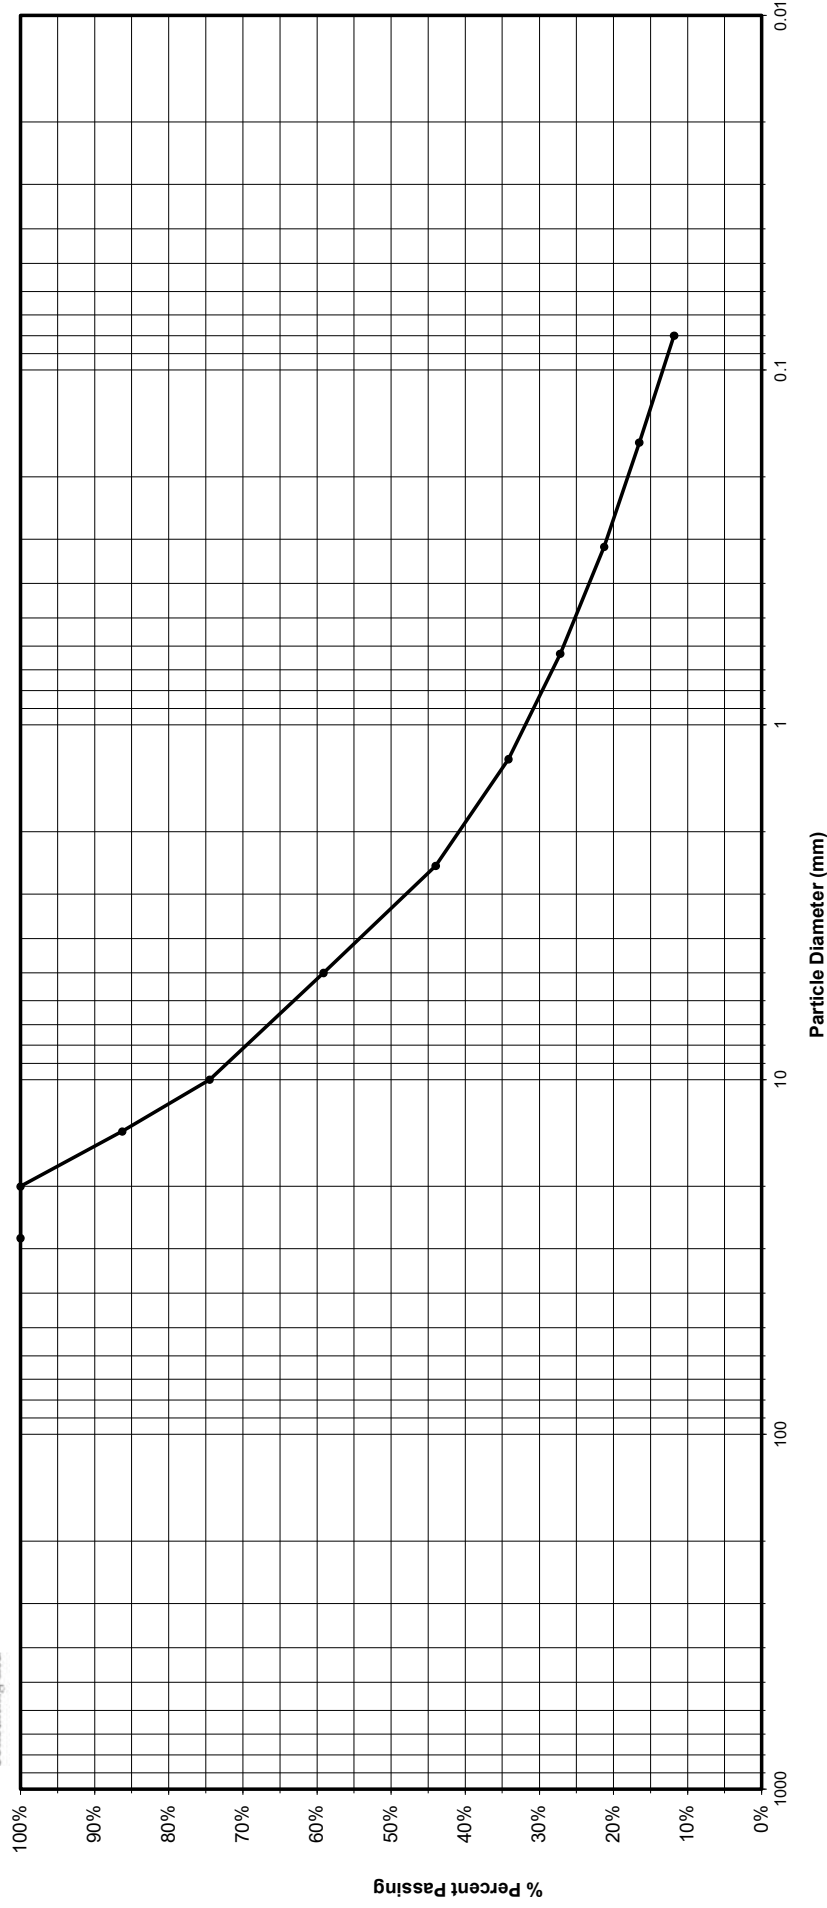
AllRock Sample Gradation Analysis	
Project:	St. Anthony Fire Pump Replacement
Project #:	21221
Client:	SNC Lavalin
Date	26-Nov-21
Sample:	Silty Sand with Gravel (SM)
Sample #:	2
Source:	SS #3 5'-6'4"

Specification				Tested Sample	Remarks
Sieve Size (mm)	Lower % Passing	Upper % Passing	% Passing		
28				100.0%	
20				100.0%	
14				86.3%	
10				74.5%	
5				59.1%	
2.5				44.0%	
1.25				34.2%	
0.63				27.2%	
0.315				21.2%	
0.16				16.5%	
0.08				11.8%	
Moisture Content:				9.9%	
Technician Sampled:			W. Ball		
Technician Tested:			C. Dolland		
Reviewed By:			B. Evans
