Addendum #2.

Project No. R.034893.001
Rehabilitate Runway 11-29, Taxi 'B', Aprons, Maintenance Road,
Airport Access Road, and Parking Lot
Port Hardy Airport, Port Hardy, British Columbia.

**Port Hardy Airport Runway Pavement Rehabilitation
Geotechnical Investigation**

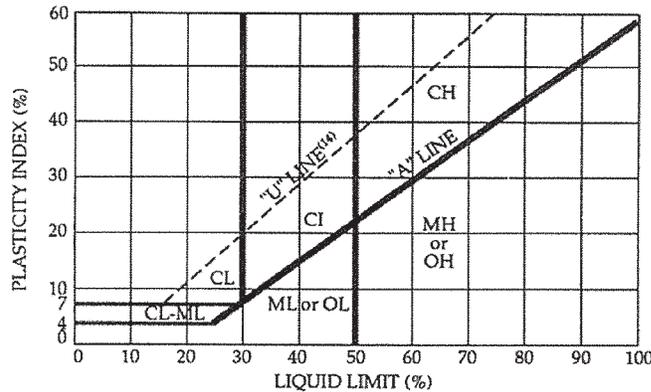
PLASTICITY CHART FOR SOILS PASSING NO. 40 SIEVE⁽¹⁰⁾

(10) This plasticity classification conforms to the Unified Soil Classification System (USCS) and the ASTM D-2487 plasticity chart, except for the addition of an intermediate category for clay, where the liquid limit is between 30% and 50% (CI). Under ASTM and USCS, all clays with a liquid limit less than 50% are classified as low plasticity (CL).

(14) "U" Line marks typical upper limit. "A" Line divides clays from silts and organic soils.

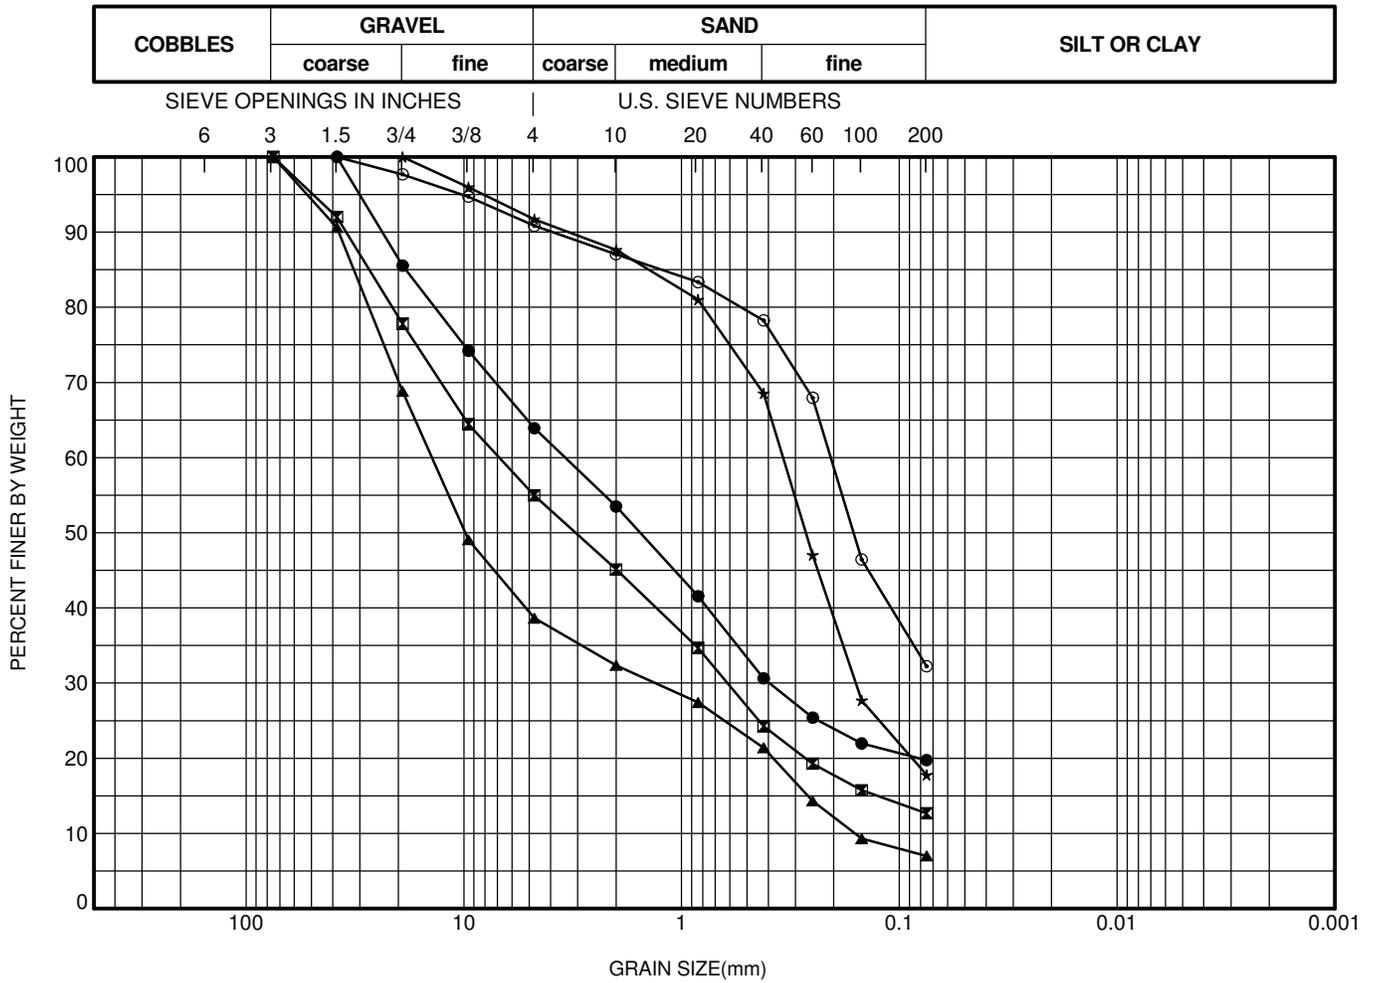
GRAIN SIZE DISTRIBUTION

HOLE	DEPTH (m)	D85	D60	D50	D15	D10	CU	%GRAVEL	%SAND	%FINES
●	AH10-01	0.10	18.474	3.432	1.551				36.1	44.2	19.8
☒	AH10-02	0.10	27.129	6.874	3.071	0.126			45.0	42.3	12.7
▲	AH10-03	0.07	31.959	13.993	9.838	0.263	0.160	87.449	61.4	31.6	7.0
★	AH10-03	0.40	1.416	0.342	0.268				8.3	73.9	17.8
⊙	AH10-03	1.00	1.236	0.206	0.162				9.2	58.6	32.2

The granular layer encountered in AH10-03 along Byng Road consisted of sand or silty sand. The granular layer encountered in all other holes consisted of well graded sand and gravel with fines content (< 0.075 mm) varying from 7% to 20%.

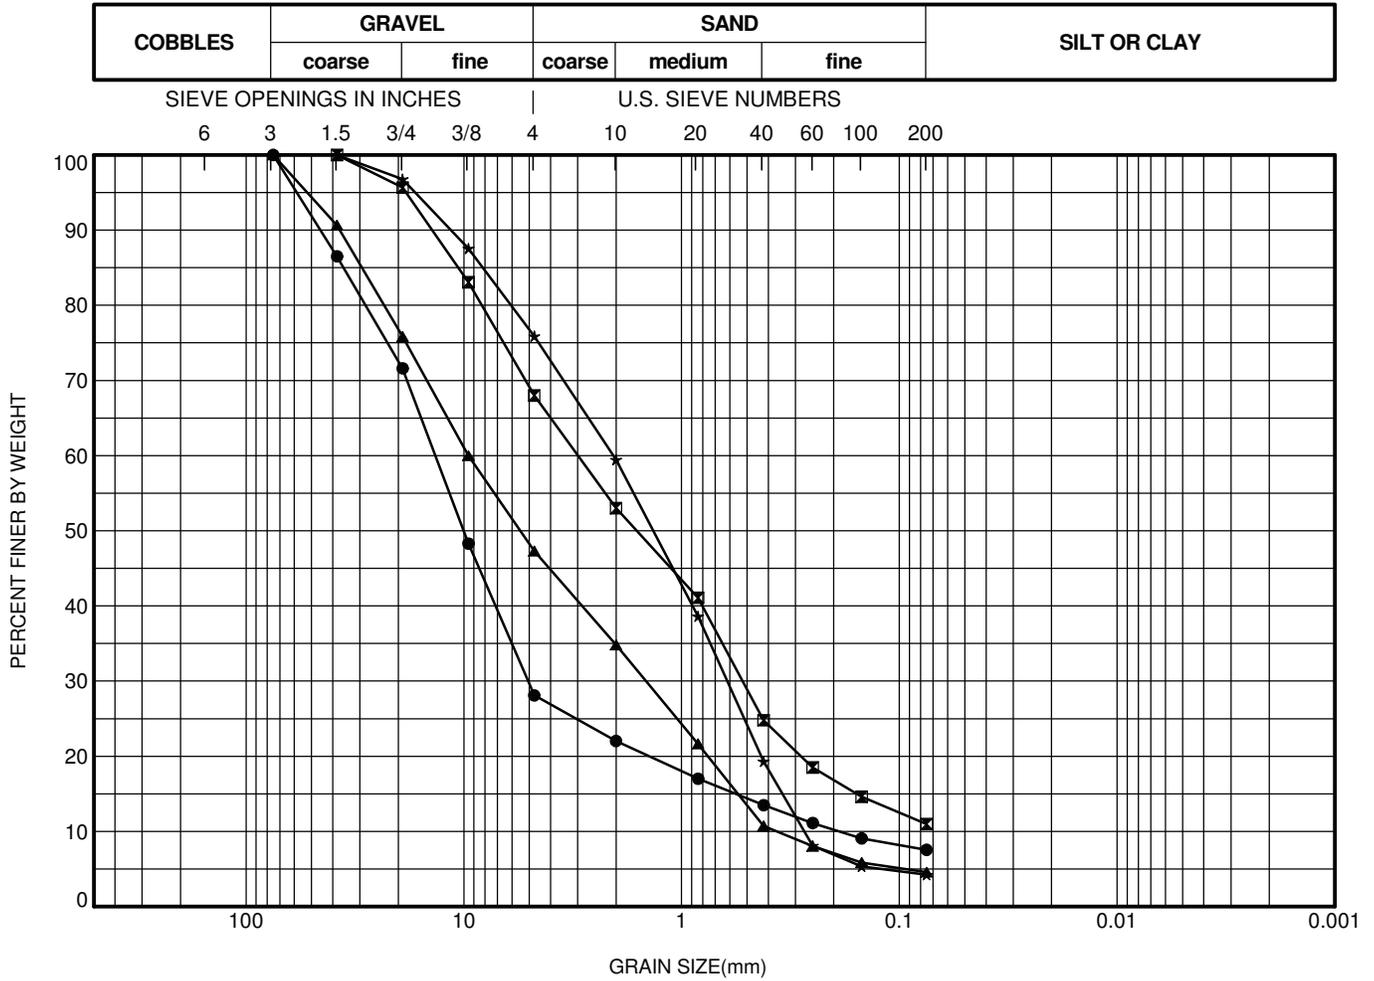
GRAIN SIZE DISTRIBUTION

HOLE	DEPTH (m)	D85	D60	D50	D15	D10	CU	%GRAVEL	%SAND	%FINES
●	AH10-04	0.07	35.619	13.505	10.017	0.565	0.189	71.540	71.9	20.6	7.5
☒	AH10-04a	0.00	10.593	2.993	1.607	0.157		48.130	32.0	57.0	11.0
▲	AH10-05	0.22	29.308	9.524	5.507	0.551	0.365	26.108	52.7	42.7	4.6
★	AH10-07	0.10	8.170	2.059	1.350	0.344	0.273	7.546	24.1	71.7	4.2

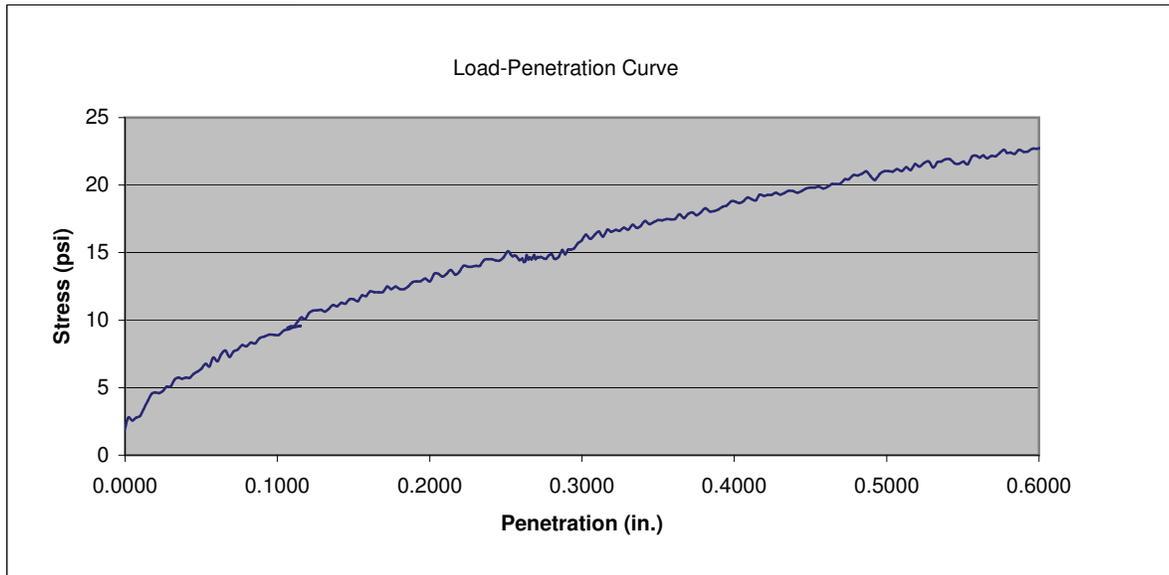
Load-Penetration Curve

Hole Number/Sample Number:	AH10-05			
Depth (m):	1.3-3.3			
Method of Compaction:	Modified Proctor Method C - ASTM D1557 - 6" Mold - 56 Blows/Layer			
Sample Condition:	Soaked			
Surcharge (kg):	4.54 (10 lbs)			
Natural Water Content (%):	20.8		Sample Height After Compaction (mm):	114.68
Water Content Before Compaction (%):	20.2		Sample Diameter (mm):	152.11
Water Content After Compaction (%):	19.7		Sample Weight After Compaction (g):	4443
Water Content Top 1" Layer After Test (%):	21.0		Wet Unit Weight (kg/m ³):	2123
Water Content Bot. 2-4" Layer After Test (%):	20.6		Dry unit Weight (kg/m ³):	1781
Sample Height Before Soaking (mm):	114.68		Note: Moisture content after compaction is used to calculate dry unit weight	
Sample Height After Soaking (mm):	115.74			
Swell (%):	0.93

Adjusted Penetration Depth @ 0.100 in. (in.):	0.100
Adjusted Penetration Depth @ 0.200 in. (in.):	0.200
Stress @ Adjusted 0.100 inch Penetration (psi):	8.91
Stress @ Adjusted 0.200 inch Penetration (psi):	12.87
Standard Stress @ 0.100 in. Penetration (psi):	1000
Standard Stress @ 0.200 in. Penetration (psi):	1500
CBR @ 0.100 in. Penetration:	0.89
CBR @ 0.200 in. Penetration:	0.86

Clay subgrade samples were compacted by Modified Proctor energy (ASTM D1557) using a 150 mm diameter mold with 56 blows per layer. Samples were prepared at the natural water content to reflect existing in-situ conditions.

After compaction, a surcharge of 4.45 kg was applied, and samples were allowed to soak for 96 hours. After soaking, the stress required to push the penetration piston into the sample was recorded.

In all three samples, the recorded CBR value was less than one.

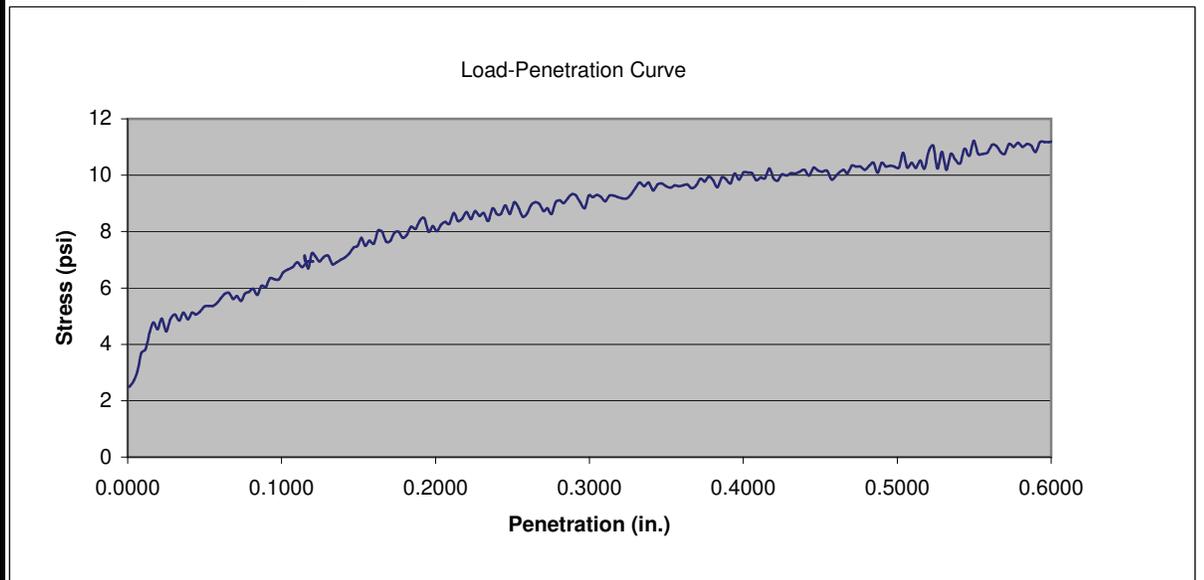
Load-Penetration Curve

Hole Number/Sample Number:	AH10-06			
Depth (m):	0.25-2.0			
Method of Compaction:	Modified Proctor Method C - ASTM D1557 - 6" Mold - 56 Blows/Layer			
Sample Condition:	Soaked			
Surcharge (kg):	4.54 (10 lbs)			
Natural Water Content (%):	16.6		Sample Height After Compaction (mm):	110.08
Water Content Before Compaction (%):	16.5		Sample Diameter (mm):	151.57
Water Content After Compaction (%):	16.2		Sample Weight After Compaction (g):	4480
Water Content Top 1" Layer After Test (%):	15.6		Wet Unit Weight (kg/m ³):	2241
Water Content Bot. 2-4" Layer After Test (%):	16.1		Dry unit Weight (kg/m ³):	1928
Sample Height Before Soaking (mm):	110.08		Note: Moisture content after compaction is used to calculate dry unit weight	
Sample Height After Soaking (mm):	112.61			
Swell (%):	1.62

Adjusted Penetration Depth @ 0.100 in. (in.):	0.100
Adjusted Penetration Depth @ 0.200 in. (in.):	0.200
Stress @ Adjusted 0.100 inch Penetration (psi):	6.56
Stress @ Adjusted 0.200 inch Penetration (psi):	8.02
Standard Stress @ 0.100 in. Penetration (psi):	1000
Standard Stress @ 0.200 in. Penetration (psi):	1500
CBR @ 0.100 in. Penetration:	0.66
CBR @ 0.200 in. Penetration:	0.53

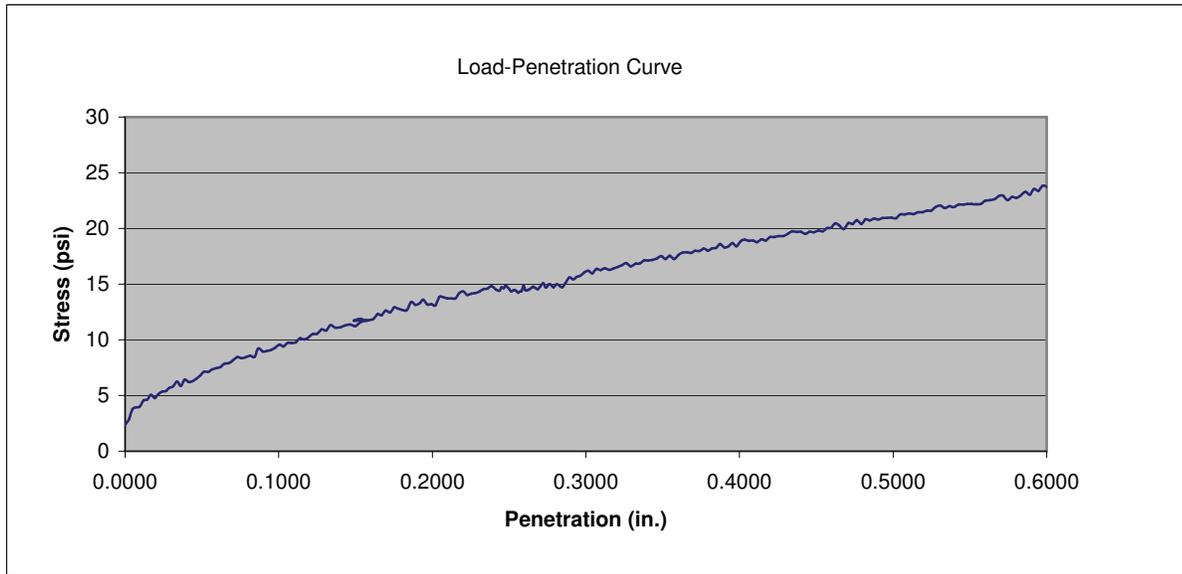
Load-Penetration Curve

Hole Number/Sample Number:	AH10-07			
Depth (m):	1.6-3.3			
Method of Compaction:	Modified Proctor Method C - ASTM D1557 - 6" Mold - 56 Blows/Layer			
Sample Condition:	Soaked			
Surcharge (kg):	4.54 (10 lbs)			
Natural Water Content (%):	22.0		Sample Height After Compaction (mm):	115.49
Water Content Before Compaction (%):	21.1		Sample Diameter (mm):	151.81
Water Content After Compaction (%):	21.7		Sample Weight After Compaction (g):	4328
Water Content Top 1" Layer After Test (%):	22.7		Wet Unit Weight (kg/m ³):	2070
Water Content Bot. 2-4" Layer After Test (%):	21.9		Dry unit Weight (kg/m ³):	1701
Sample Height Before Soaking (mm):	115.49		Note: Moisture content after compaction is used to calculate dry unit weight	
Sample Height After Soaking (mm):	117.18			
Swell (%):	1.46

Adjusted Penetration Depth @ 0.100 in. (in.):	0.100
Adjusted Penetration Depth @ 0.200 in. (in.):	0.200
Stress @ Adjusted 0.100 inch Penetration (psi):	9.57
Stress @ Adjusted 0.200 inch Penetration (psi):	13.07
Standard Stress @ 0.100 in. Penetration (psi):	1000
Standard Stress @ 0.200 in. Penetration (psi):	1500
CBR @ 0.100 in. Penetration:	0.96
CBR @ 0.200 in. Penetration:	0.87

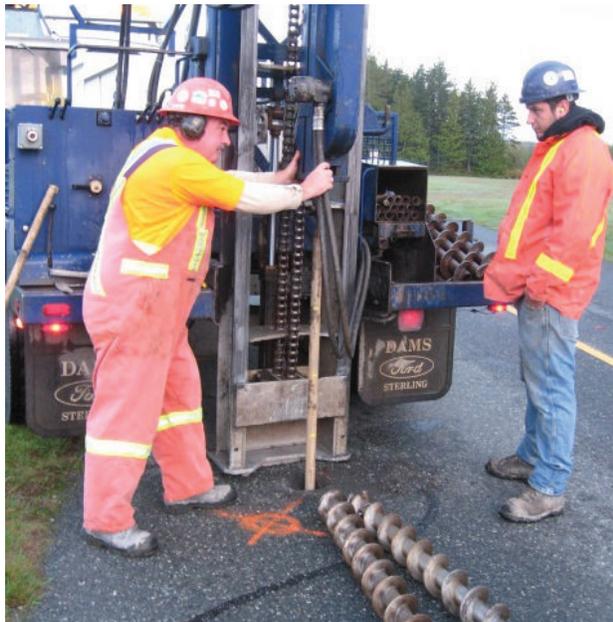
Photo 1: Conducting DCPT at AH10-03.

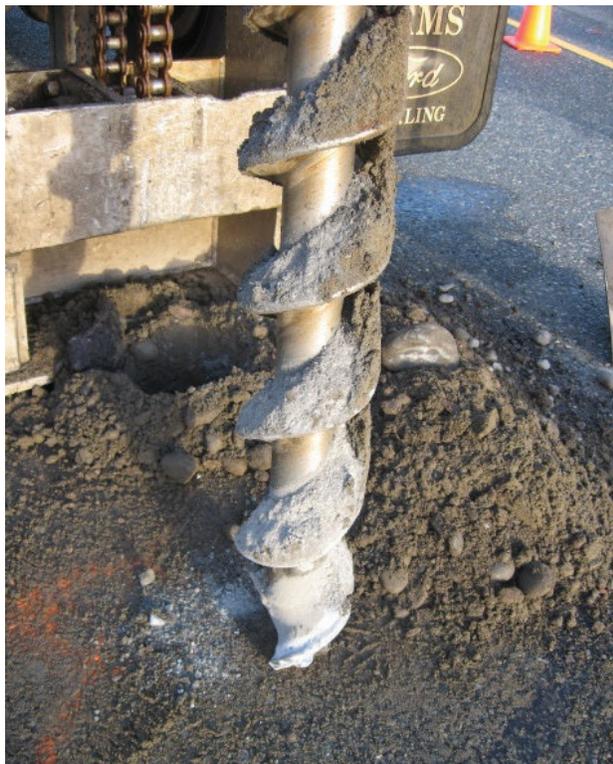
Photo 2: Practical refusal of solid stem auger hole at AH10-03. Cobbles pulverized by drilling (light grey) shown on auger flights.

Auger drill holes along Byng Road to the west of the airport (AH10-03, AH10-04 and AH10-04a) encountered 65 mm thick asphalt underlain by very dense sand and gravel to about 1.5 m depth where the auger drill refused. AH10-04a was drilled following the refusals at AH10-03 and AH10-04 in an attempt to reach the target depth of 2.0 m. The refusal was inferred to be on cobbles or boulders, given the absence of visible bedrock outcrops in the area.

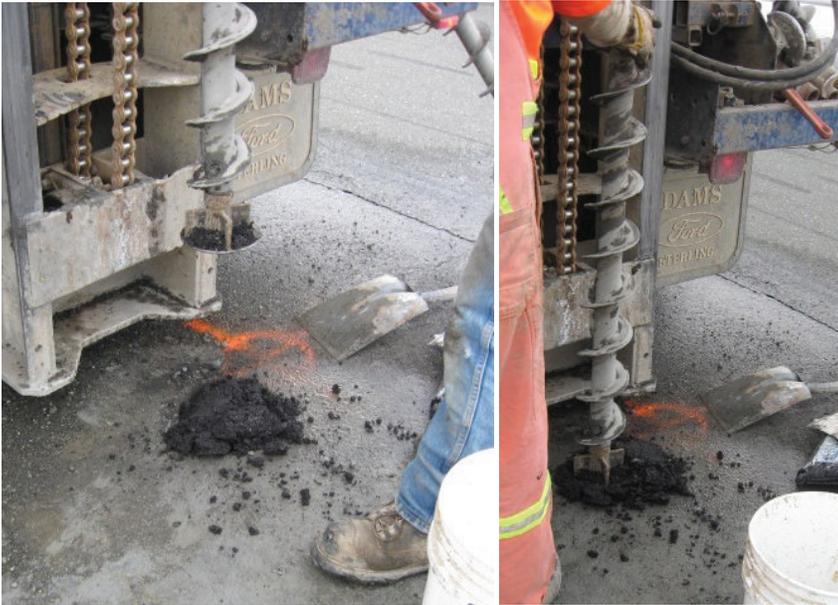
Photo 5: Placing and compacting asphalt patch at AH10-05.
