PHASE II/III ENVIRONMENTAL SITE ASSESSMENT CAMBRIDGE BAY AIRPORT, CAMBRIDGE BAY, NUNAVUT

Project No. 1748-0901
March 2010

**PHASE II/III ENVIRONMENTAL SITE ASSESSMENT
DRAFT FIELD REPORT**

CAMBRIDGE BAY AIRPORT CAMBRIDGE BAY, NUNAVUT

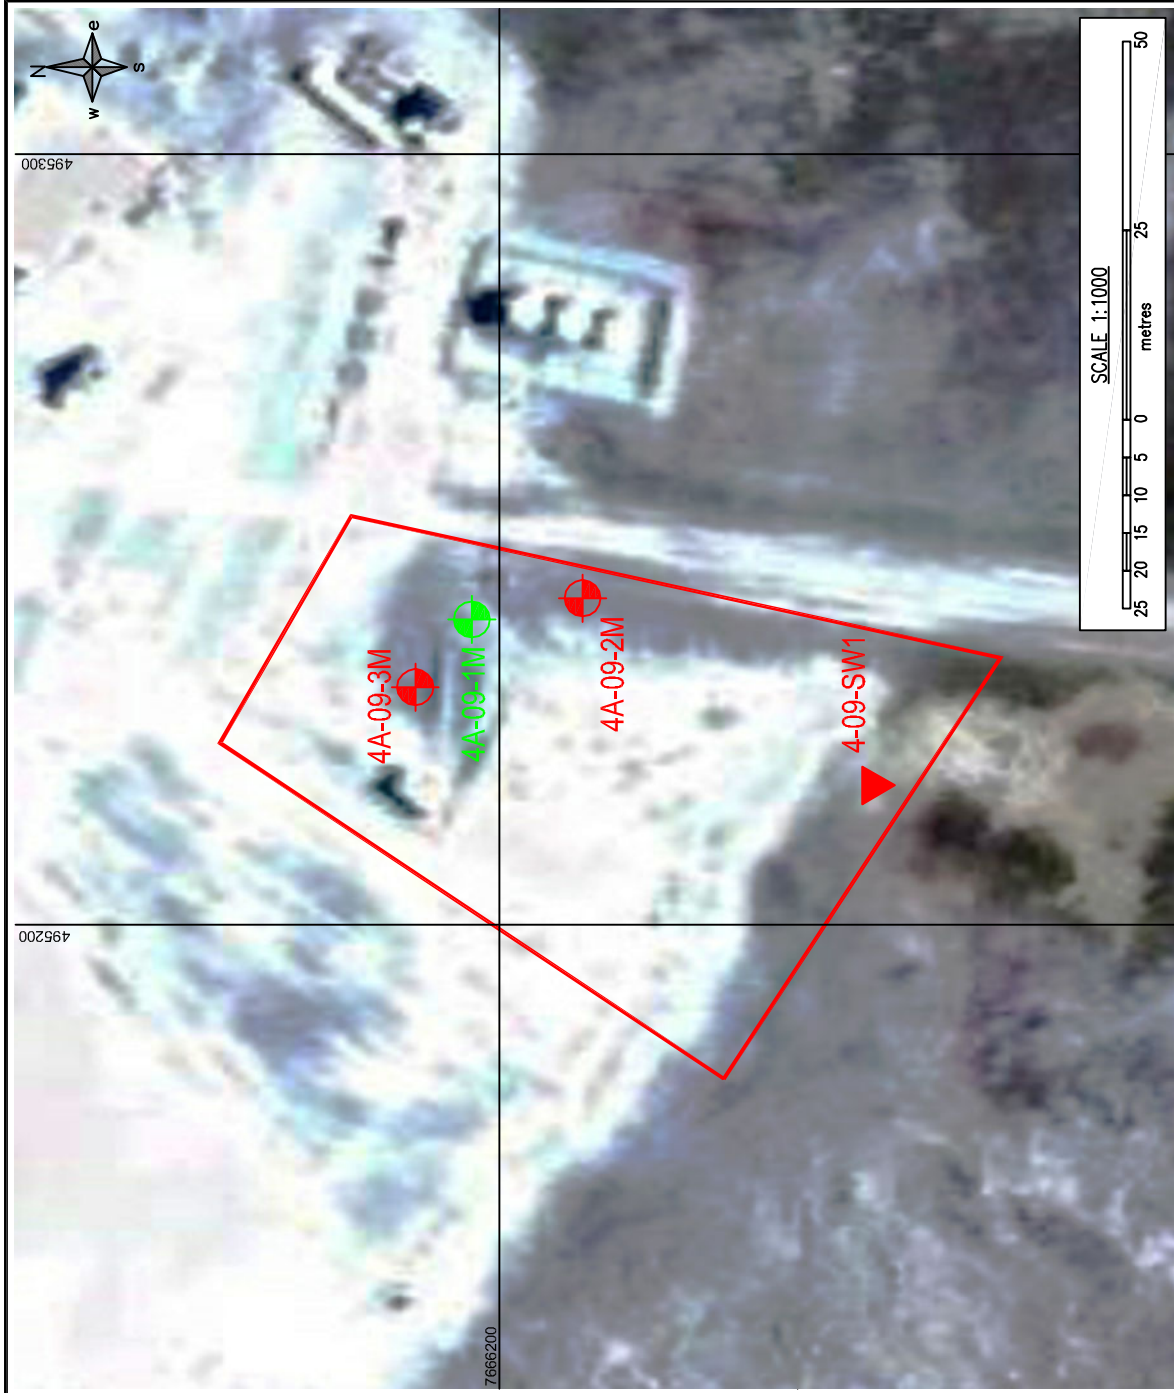
CSR guidelines guidelines guidelines	Title: APEC 4 - Former F.H. Ross Tank Site Sampling Locations and Analytical Results - Groundwater

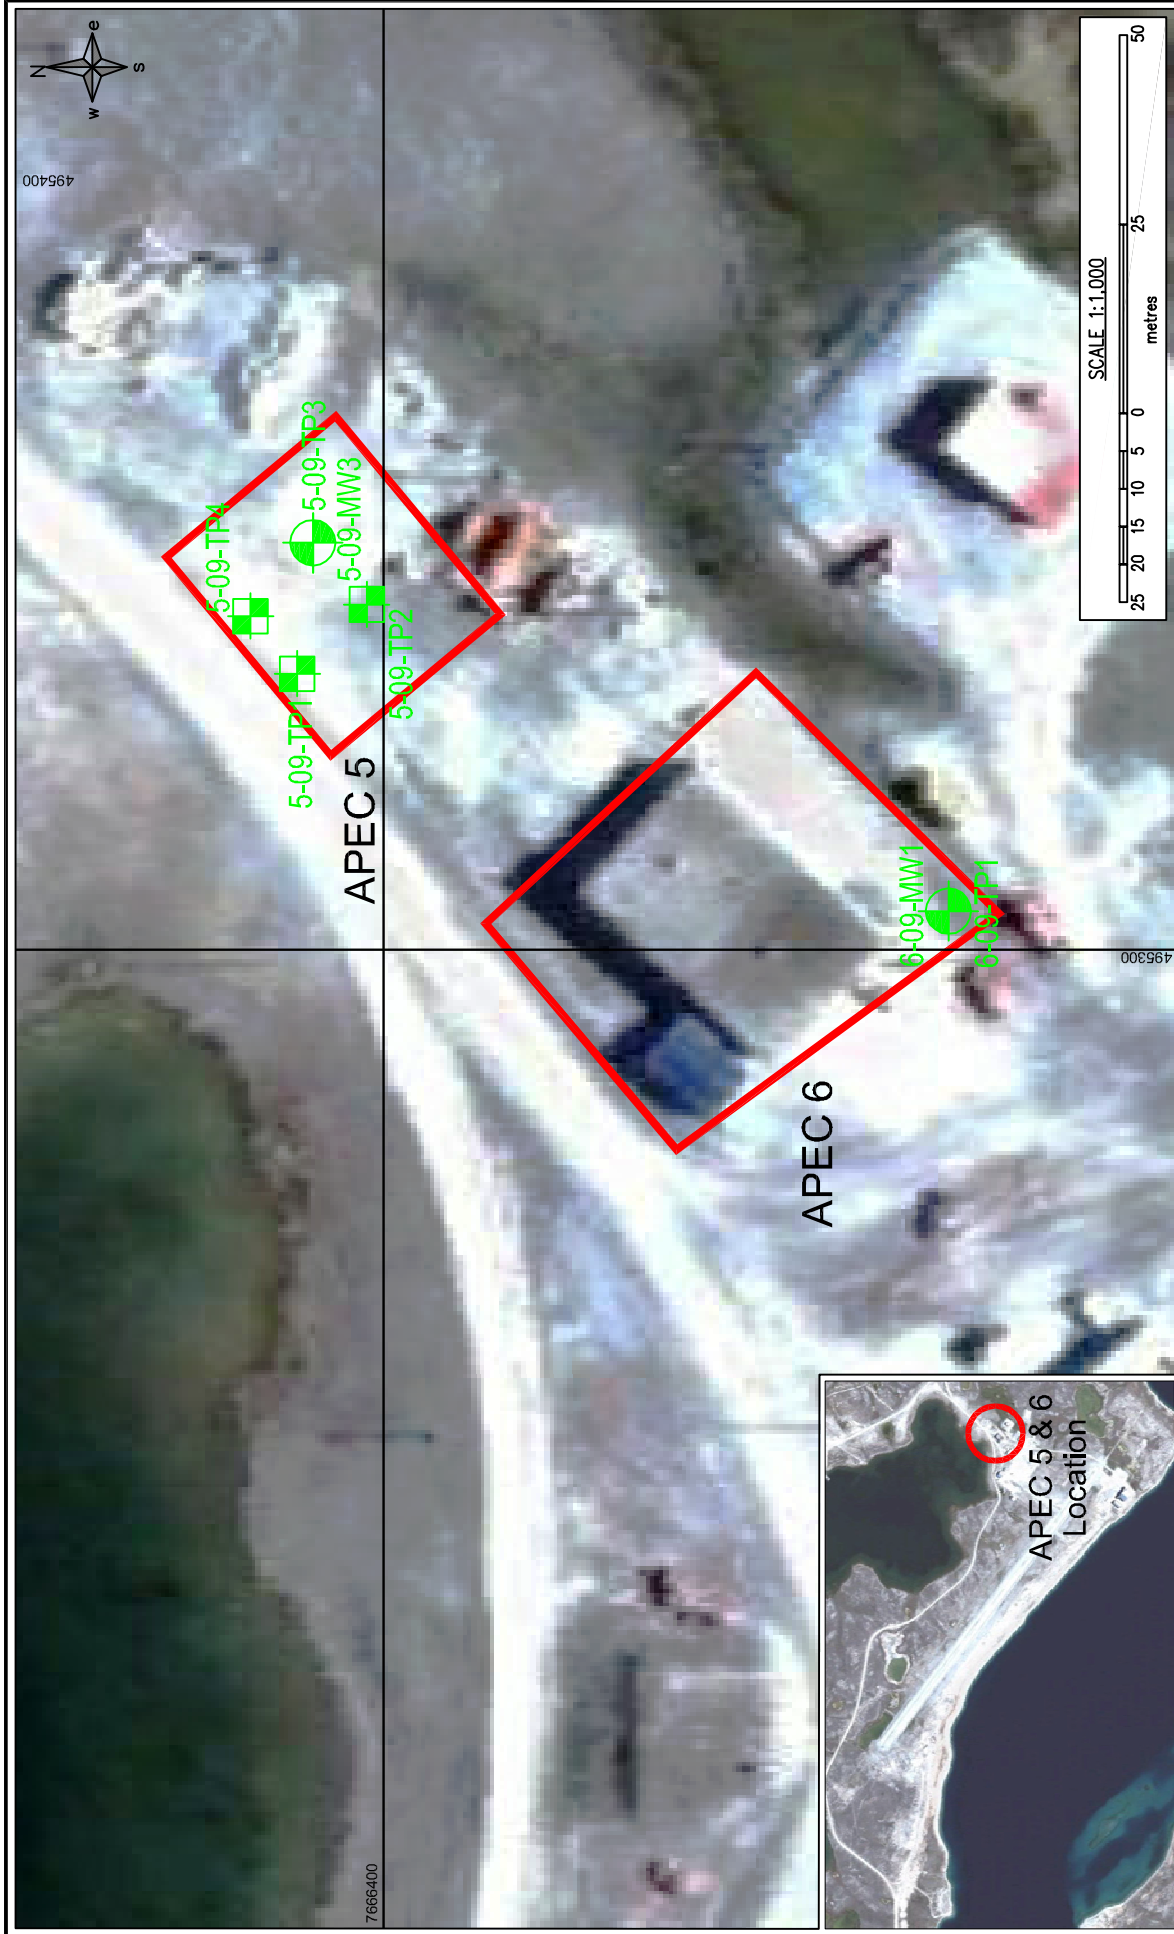
<p>LEGEND</p> <ul style="list-style-type: none"> Extent of APEC Soil Sample; compliant with CCME guidelines Soil sample (TP); compliant with CCME guidelines Groundwater sample (GW); compliant with BC-CSR guidelines 	<p>Title: APECs 5 & 6 Sampling Locations and Analytical Results - Groundwater</p> <p>Project: CAMBRIDGE BAY AIRPORT PHASE II/III ENVIRONMENTAL SITE ASSESSMENT FINAL REPORT</p> <p>Client: PUBLIC WORKS AND GOVERNMENT SERVICES CANADA</p> <p>Date: MARCH 2010</p> <p>Scale: 1 : 1,000</p> <p>Figure 10</p>
--	---

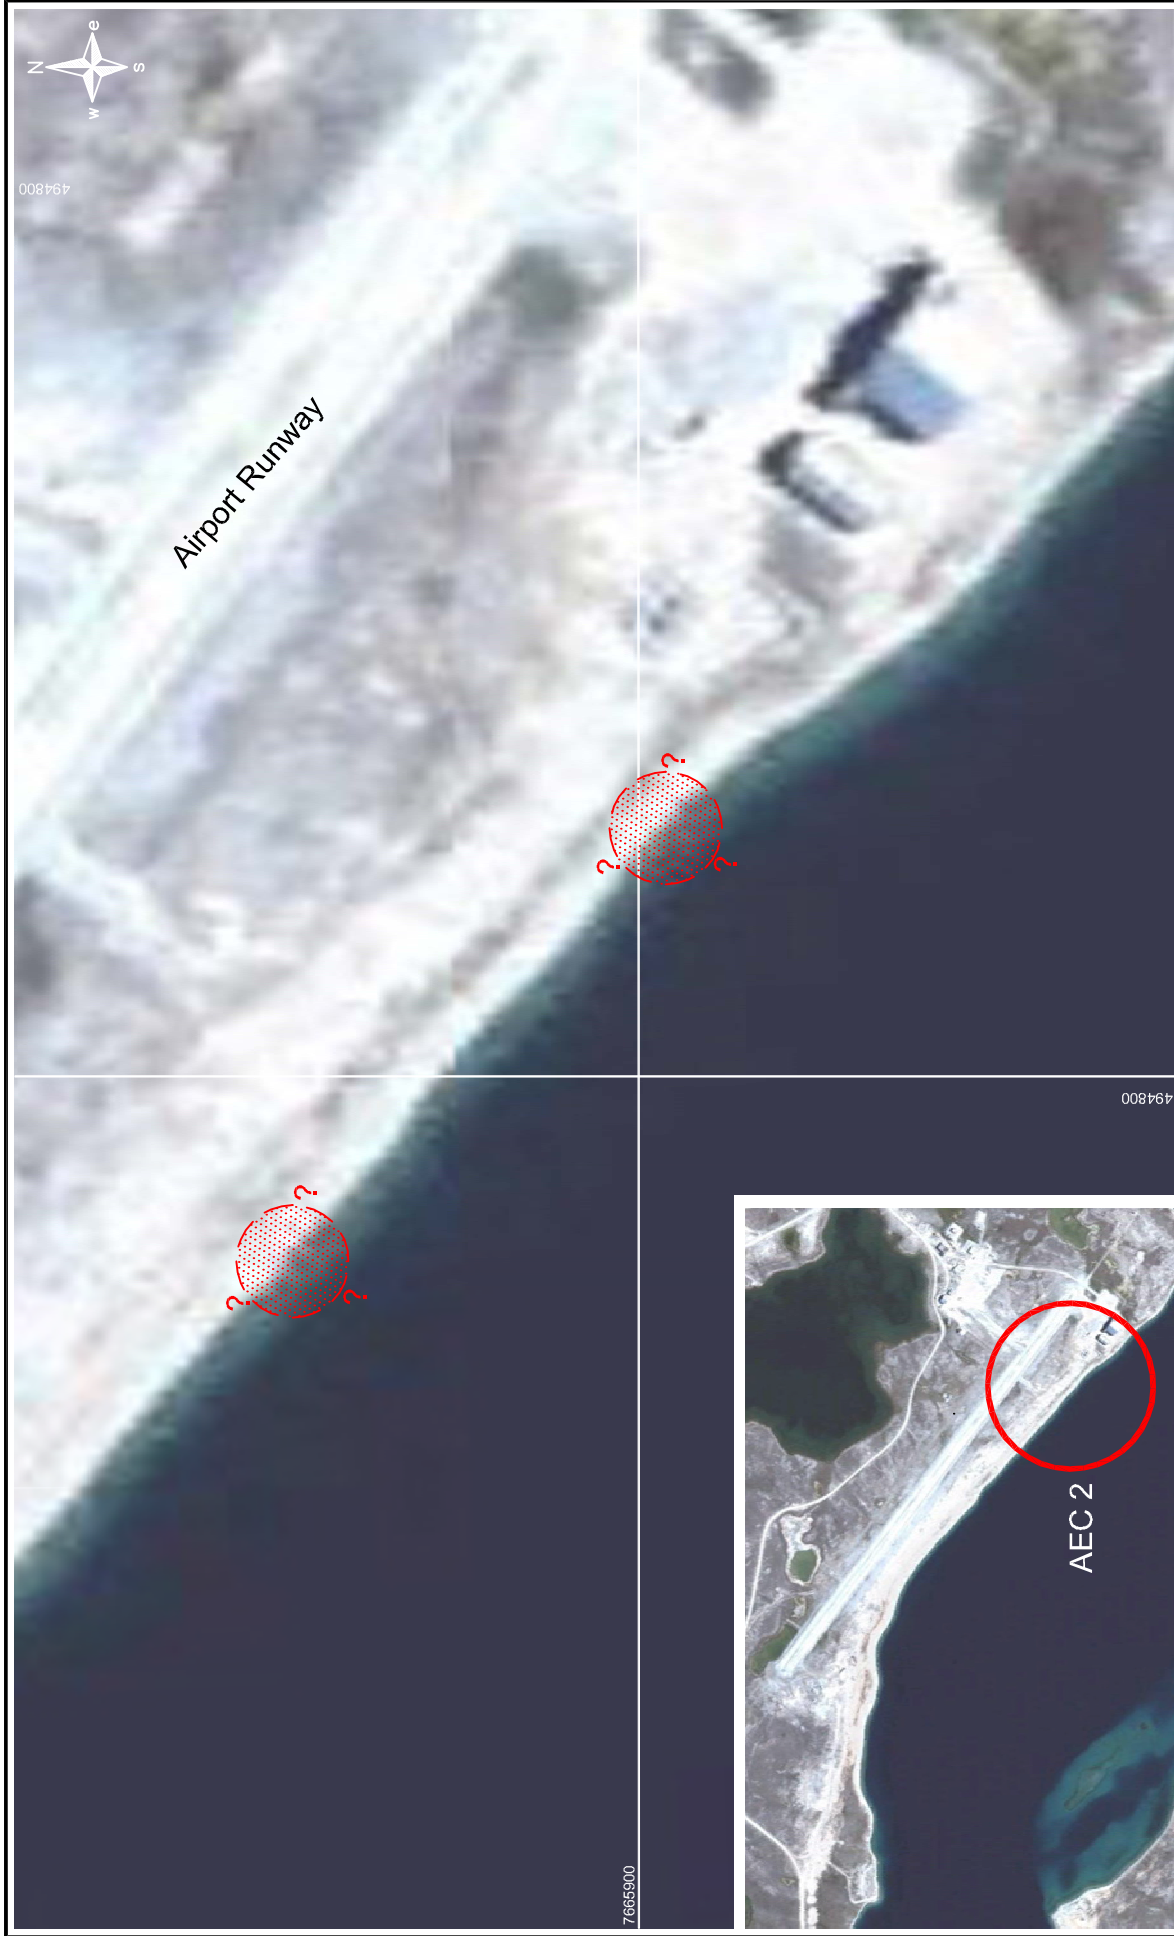
<p>LEGEND</p> <p>Approximate extent of contamination</p> <p>Extent not fully delineated</p>	<p>Title: AEC 2 - Estimated Extent of Contamination</p>	
	<p>Project: CAMBRIDGE BAY AIRPORT PHASE II/III ENVIRONMENTAL SITE ASSESSMENT FINAL REPORT</p>	<p>Client: PUBLIC WORKS AND GOVERNMENT SERVICES CANADA</p>
	<p>Date: MARCH 2010</p>	<p>Scale: See figures for scale</p>
	<p>References: Google Earth satellite image, 2009 Site locations based on dGPS coordinates (UTM - NAD 83)</p>

Copper (Cu) and arsenic (As) were identified as COCs in soil at APEC 2. The depth of metal-impacted soil is 0-0.6m bgs. Cu and As contamination may be from anthropogenic sources from historical metal debris discarded at the site as although naturally occurring sources are not uncommon in the region, noted concentrations are elevated when compared to analyzed background concentrations. This APEC was retained as an AEC and the contamination is expected to be localized (about 50m²- see figure 11). No COCs were identified in groundwater at APEC 2.

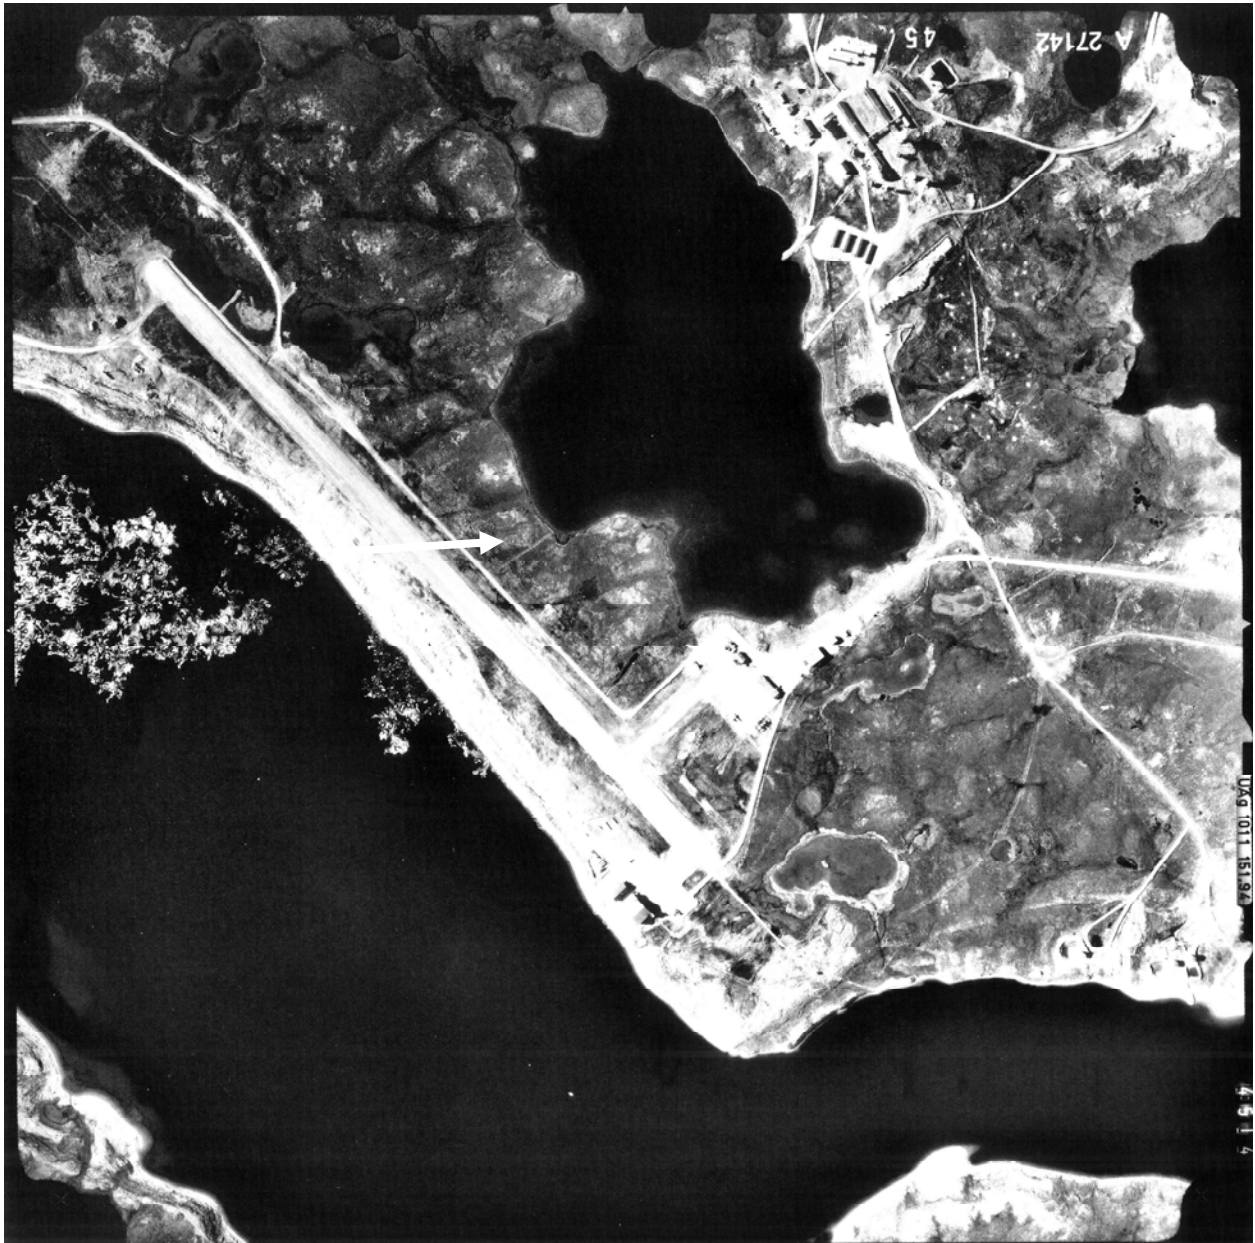
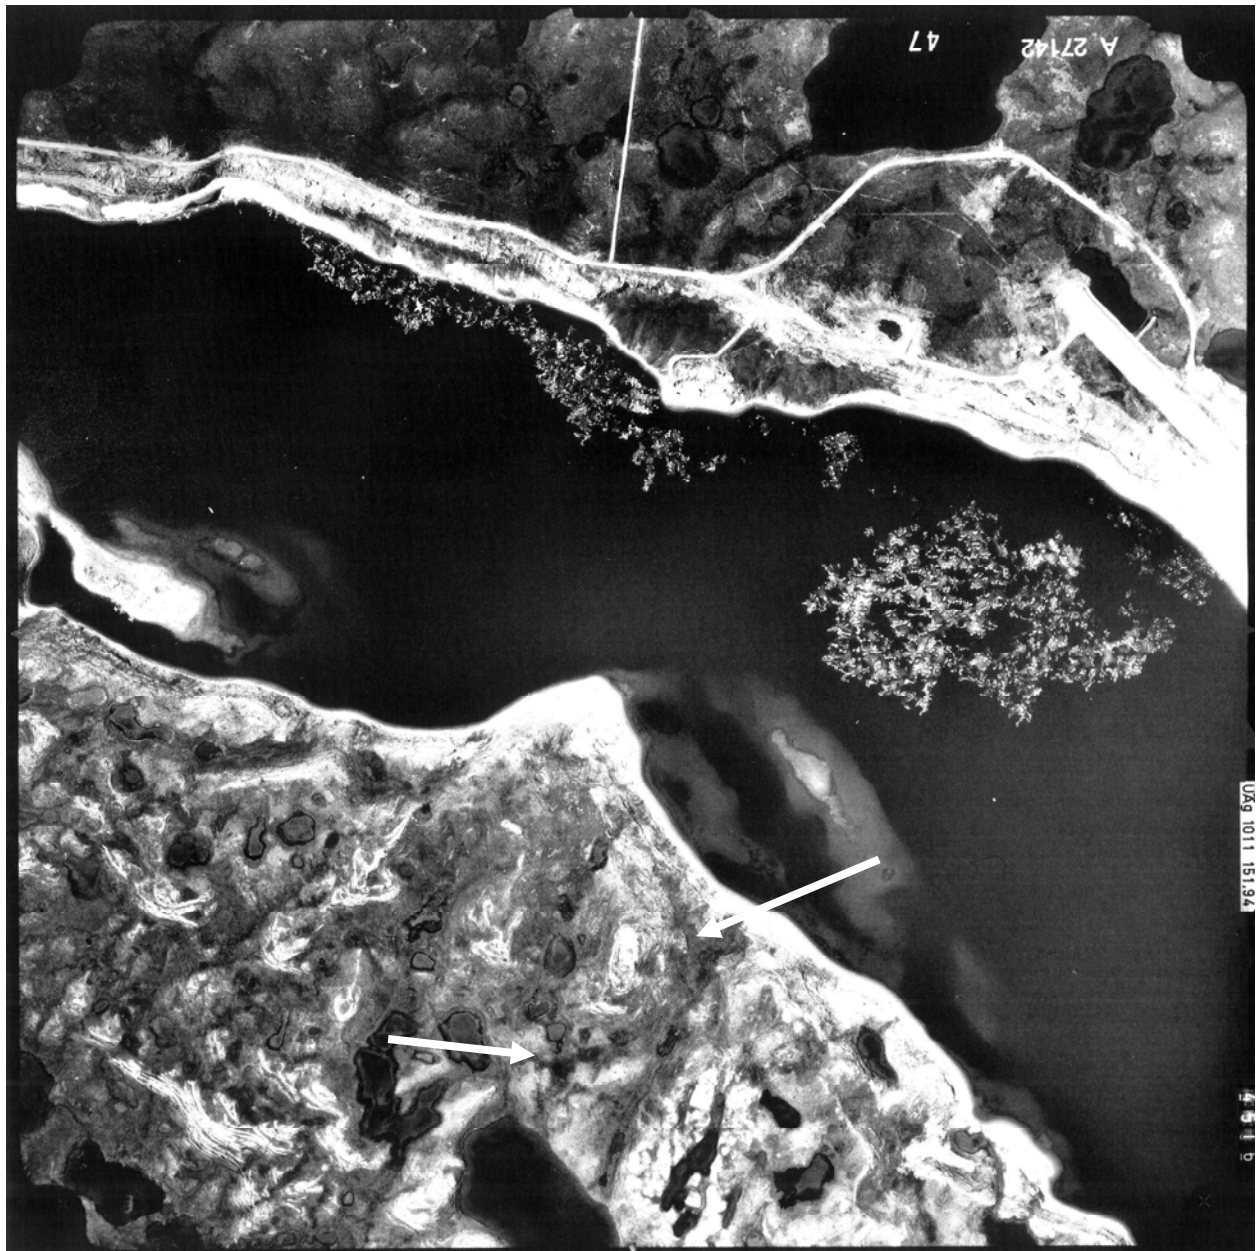
Aerial Photograph Date: 1987
Photo Number: A27142-45
Scale: 1: 12,000

Aerial Photograph Date: 1987
Photo Number: A27142-47
Scale: 1: 12,000

1987	A27142 – 45, 47 (1:12,000)	<p>The area of suspect soil staining at the FTA (APEC 3) has increased to about 1728m², almost reaching the berm on all sides.</p> <p>No other significant changes are observed.</p>

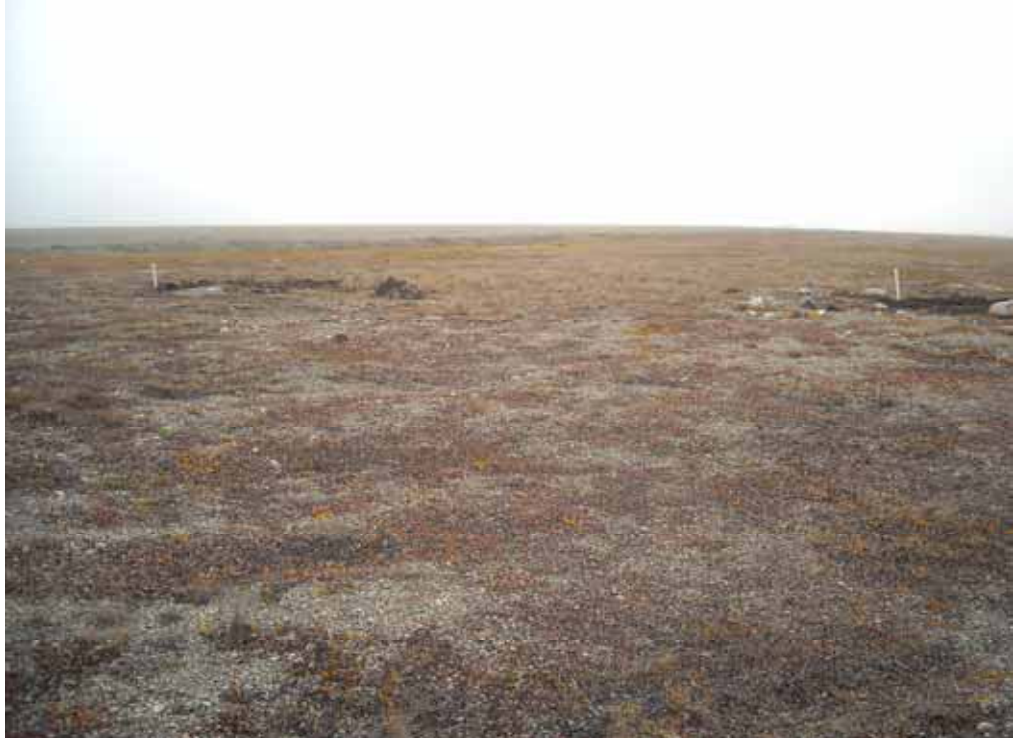
APEC 1 – Screening Plant; Phase I/II ESA Cambridge Bay, Nunavut		1748-0901
Photo ID: 2

Date: August 29, 2009		
Direction: NE		
Description: Monitoring wells 1-09- 2M and 1-093M at APEC 1

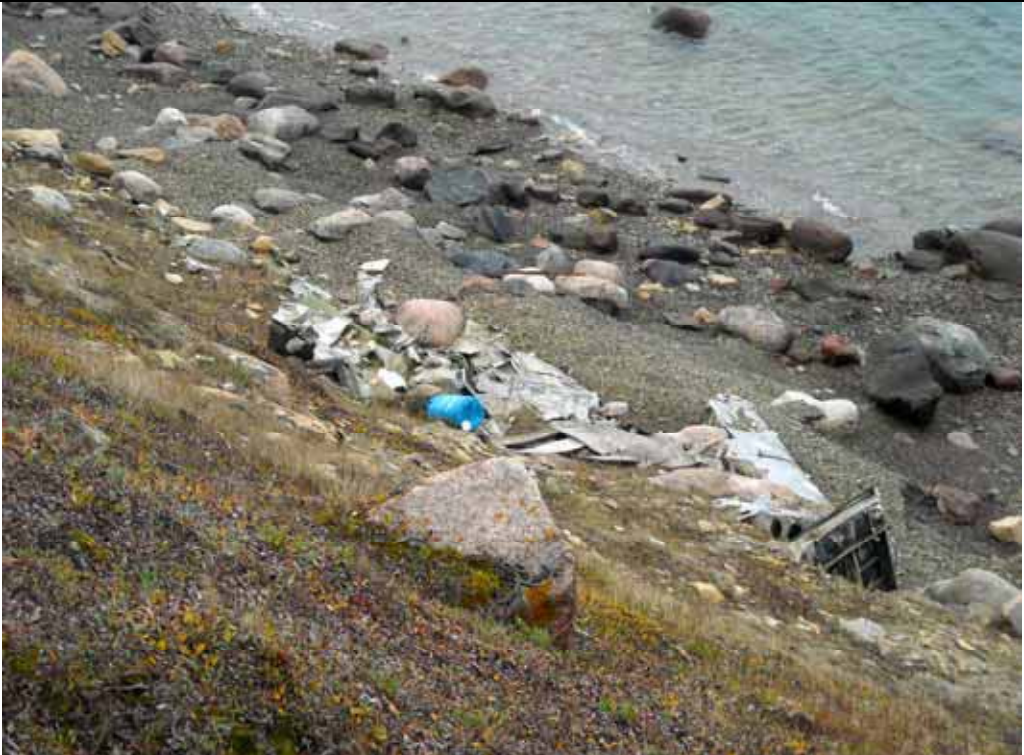
APEC 2 – Shoreline Disposal Area; Phase I/II ESA Cambridge Bay, Nunavut		1748-0901
Photo ID: 3

Date: September 2, 2009		
Direction: S		
<p>Description: Location of test pit 2-09TP-5 at APEC 2.</p>

Chemical analytical results (Figure 5 and Appendix G) indicate copper (Cu) and arsenic (As) in concentrations greater than the CCME guidelines at two test pit locations (2-09-TP5 and 2-09-TP6) along the shoreline between 0-0.6m bgs. Cu and As concentrations greater than the guidelines could be a natural occurrence, and not from anthropogenic activities, as regional geology indicates that there is a potential for base metals deposit on Victoria Island which could cause elevated regional background metal levels.

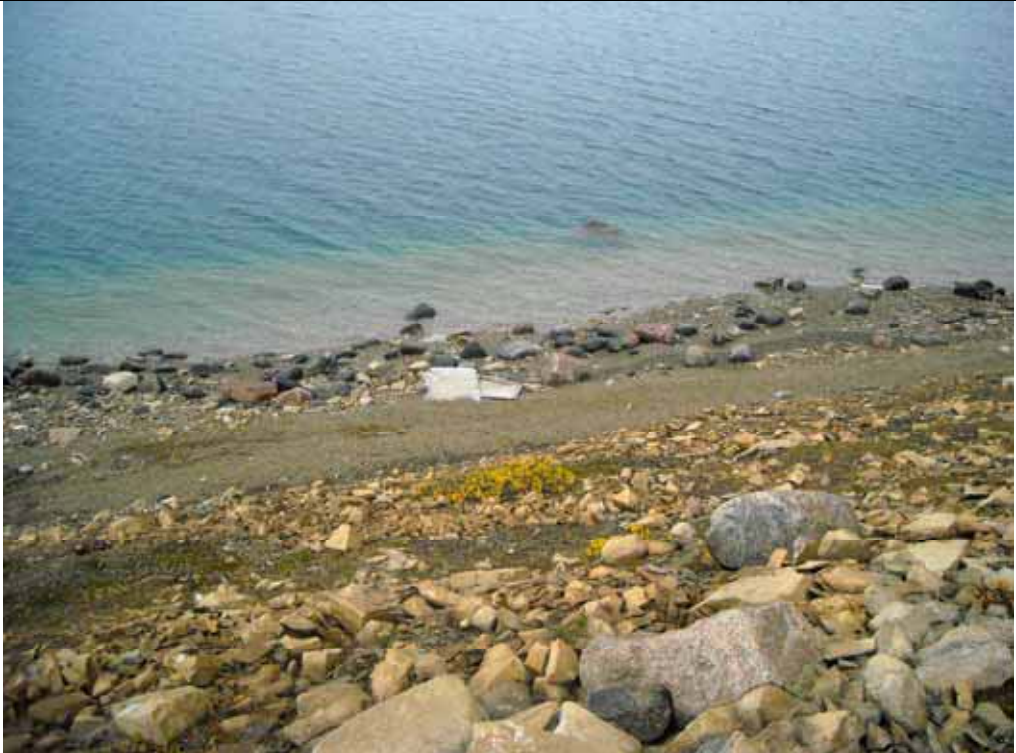
APEC 2 – Shoreline Disposal Area; Phase I/II ESA Cambridge Bay, Nunavut		1748-0901
Photo ID: 4

Date: September 2, 2009		
Direction: S		
<p>Description: Location of test pit 2-09TP-5 at APEC 2.</p>

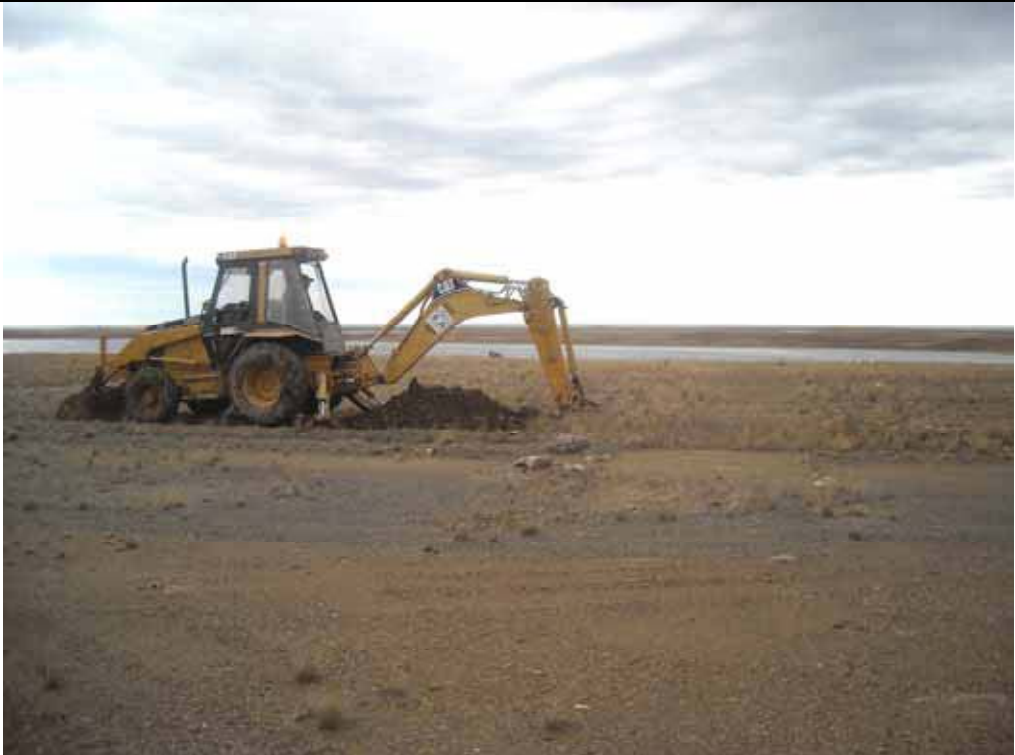
APEC 3 – Former Fire Training Area; Phase I/II ESA Cambridge Bay, Nunavut		1748-0901
Photo ID: 5

Date: August 29, 2009		
Direction: S		
Description: Excavation of test pit 3-09-2 at APEC 3

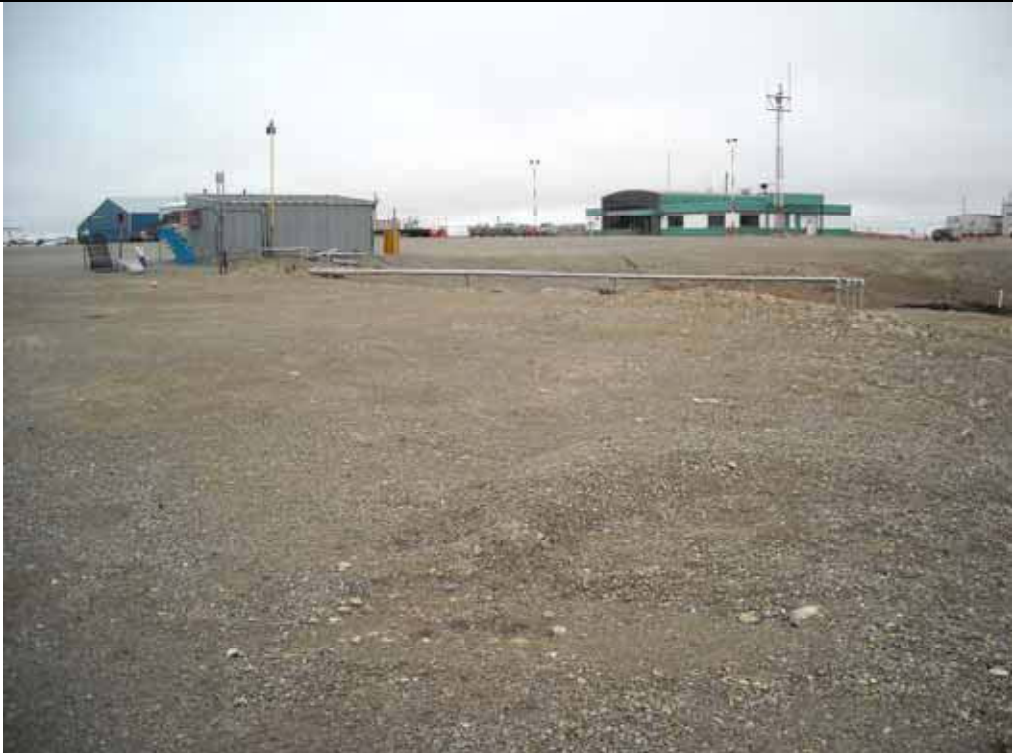
APEC 4 – Former F.H. Ross Tank Farm; Phase I/II ESA Cambridge Bay, Nunavut		1748-0901
Photo ID: 7

Date: August 30, 2009		
Direction: N		
<p>Description: View of APEC 4, with the airport terminal building in the background</p>

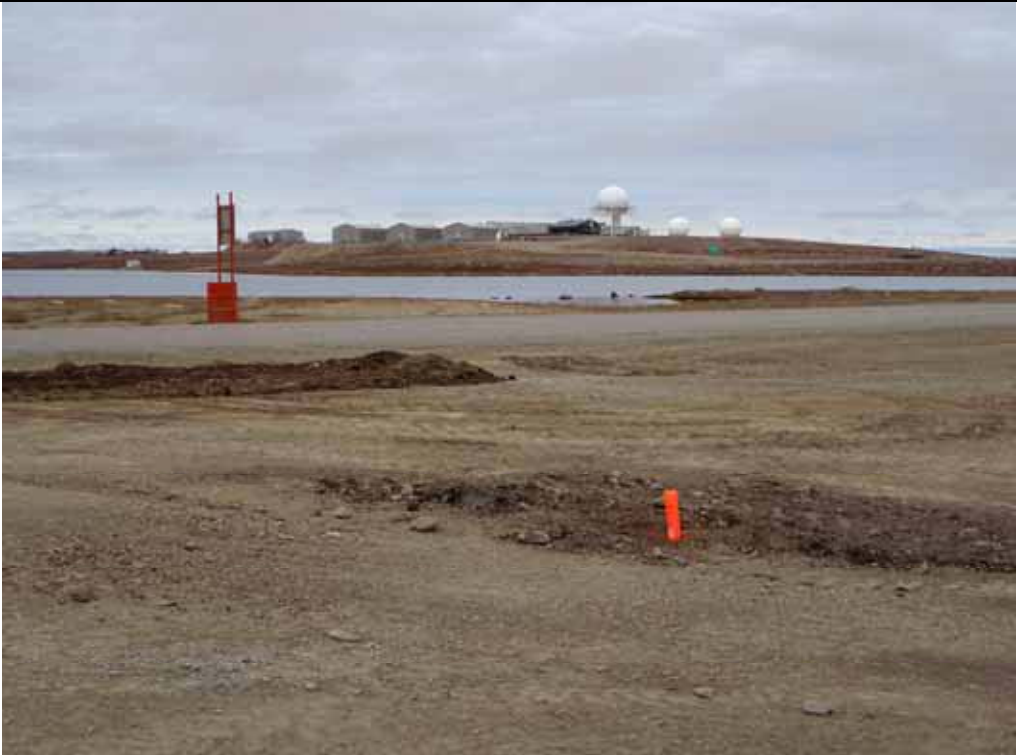
APEC 5 – Former AST north of T-5; Phase I/II ESA Cambridge Bay, Nunavut		1748-0901
Photo ID: 9

Date: August 30, 2009		
Direction: NE		
Description: Monitoring well 5-09-MW3 at APEC 5

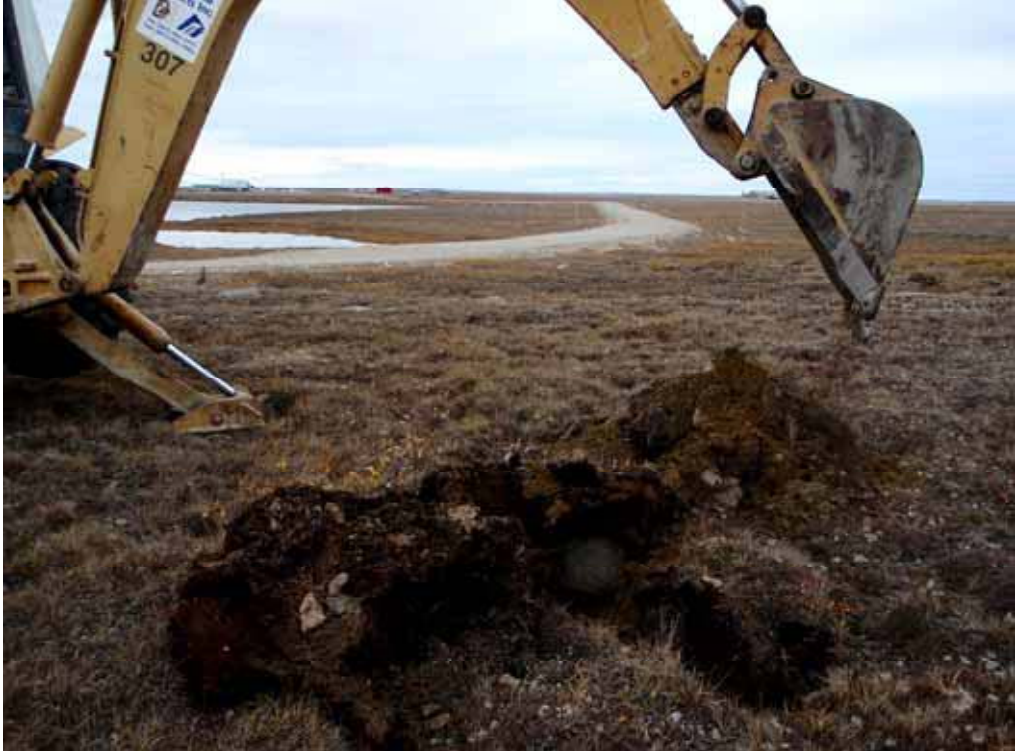
Background Sampling ; Phase I/II ESA Cambridge Bay, Nunavut		1748-0901
Photo ID: 10

Date: August 30, 2009		
Direction: E		
Description: Test pit at background location BG-1
