**Correctional Services Canada (CSC) – Drumheller Institution No. 530  
Landfill Remediation**

**Environmental Assessment Report  
*Submitted to the Public Works and Government Services Canada (PWGSC)*  
Pursuant to the *Canadian Environmental Assessment Act (CEA Act)***

Project No. 2026-1102  
May 2012

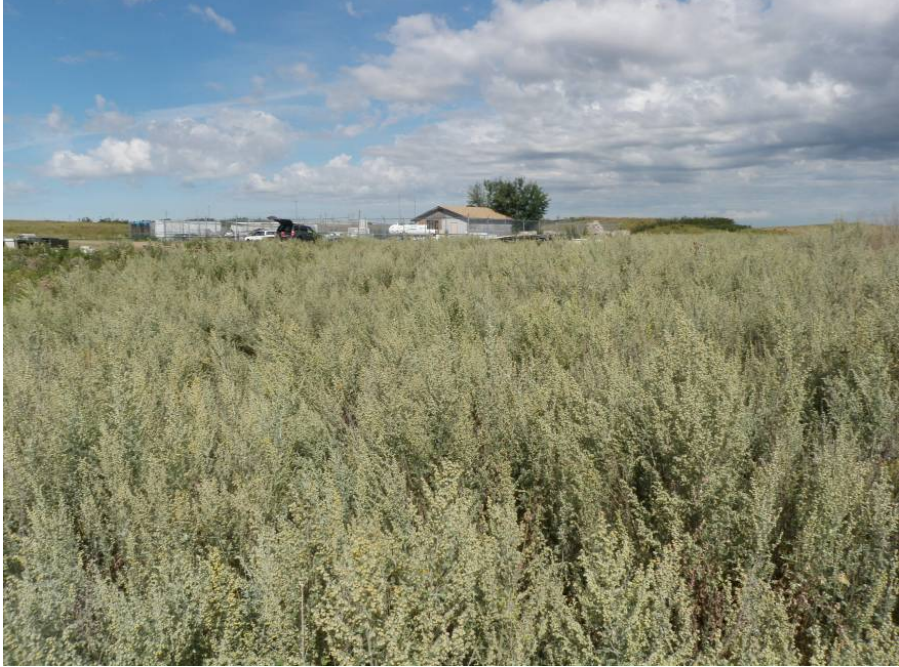
Environmental Assessment Report Former Landfill, Drumheller Institution		Project No: 2026-1102
Photo ID 1

Direction: NW		
<b>Description:</b> Top of Former Landfill looking NW towards fence line.

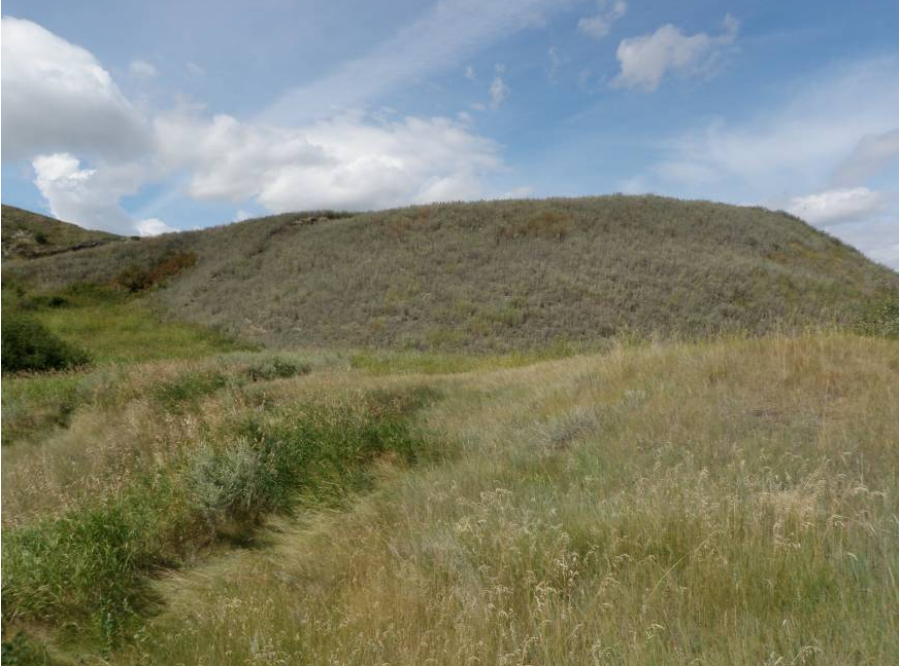
Environmental Assessment Report Former Landfill, Drumheller Institution		Project No: 2026-1102
Photo ID 2

Direction: NW		
<b>Description:</b> View of the Former Landfill looking NW.

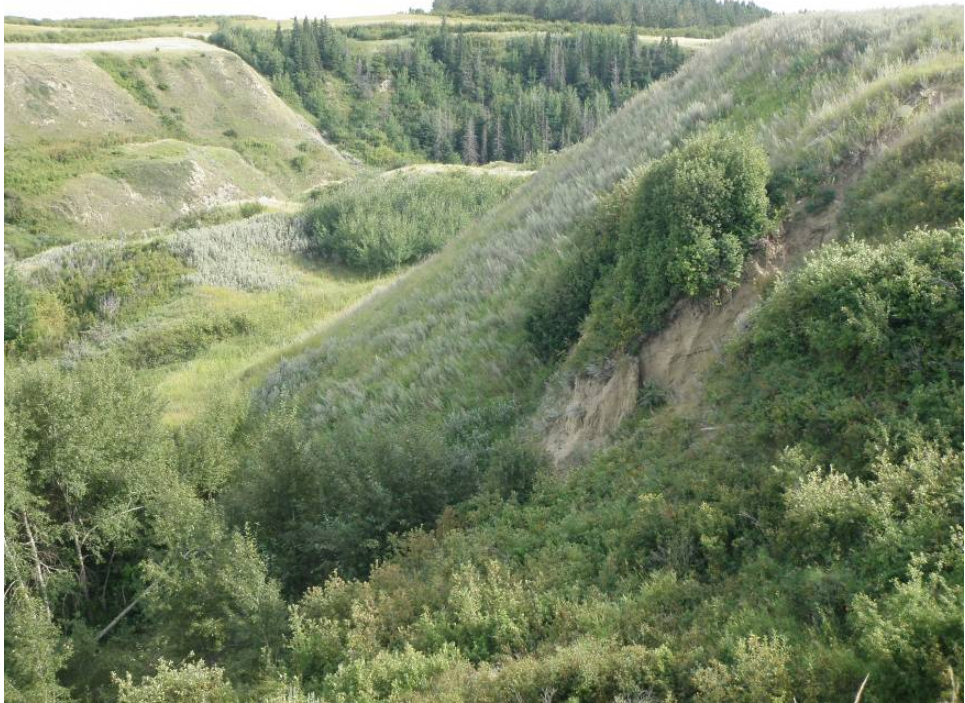
Environmental Assessment Report Former Landfill, Drumheller Institution		Project No: 2026-1102
Photo ID 3

Direction: SE		
<b>Description:</b> View of Former Landfill looking SE. Note slope failure on the right hand side of photo.

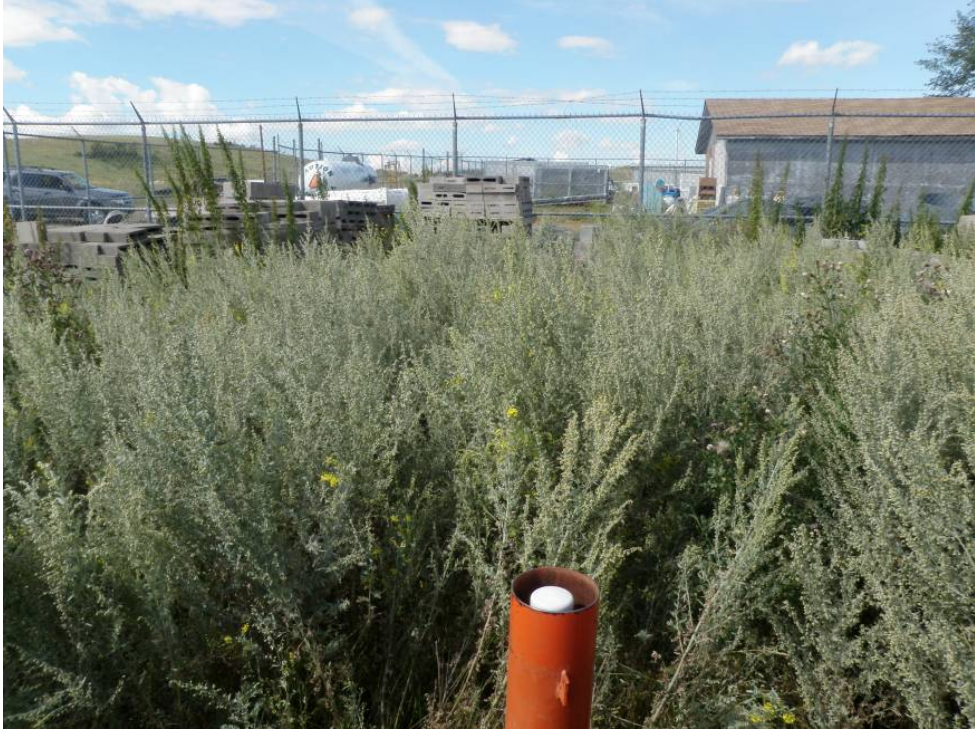
Environmental Assessment Report Former Landfill, Drumheller Institution		Project No: 2026-1102
Photo ID 4

Direction: W		
<b>Description:</b> View of MW99-03 on top of Landfill. Well located adjacent to Landfill fence line.

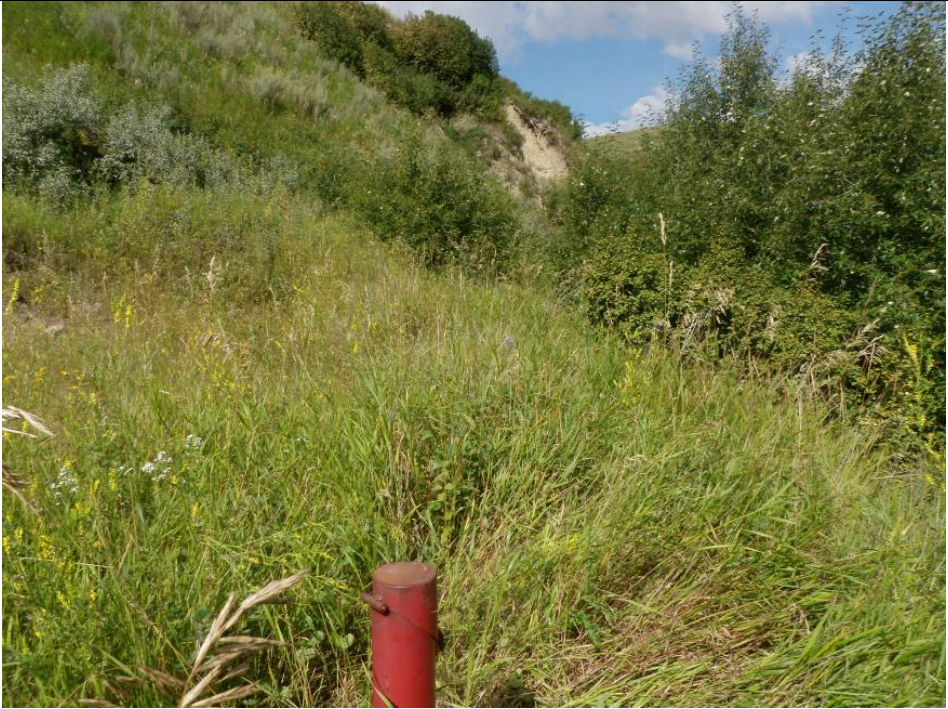
Environmental Assessment Report Former Landfill, Drumheller Institution		Project No: 2026-1102
Photo ID 5

Direction: NW		
<b>Description:</b> View of MW05-1. Wetland area is located just beyond trees at the top right hand corner of photo. Slope failure area located in top background of photo.

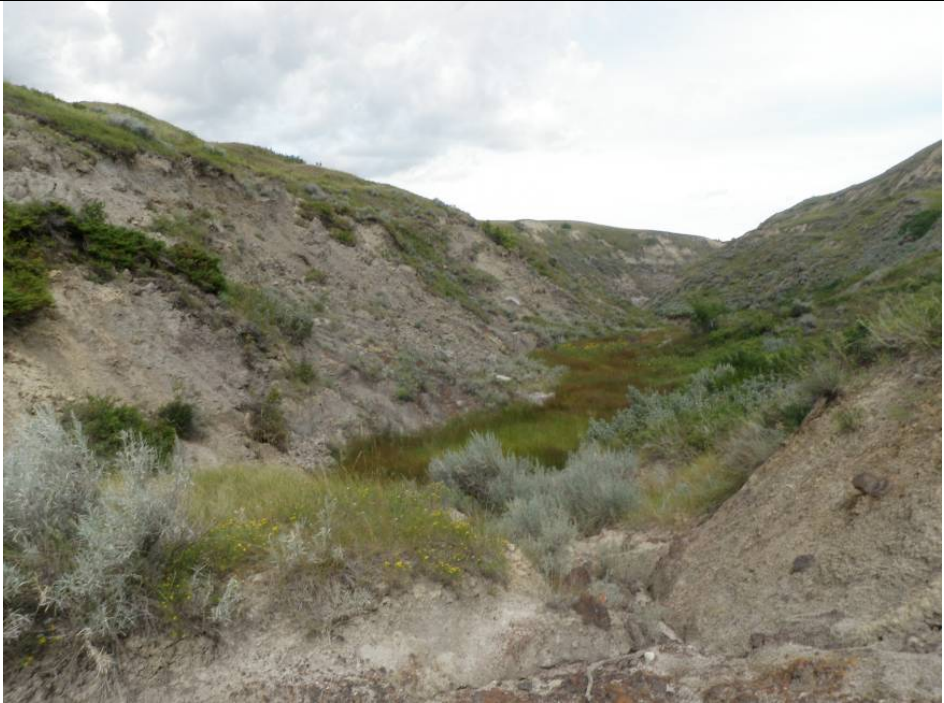
Environmental Assessment Report Former Landfill, Drumheller Institution		Project No: 2026-1102
<b>Photo ID 7</b>

<b>Direction: S</b>		
<b>Description:</b> Stream bed at bottom of coulee. View looking south towards background sample location.

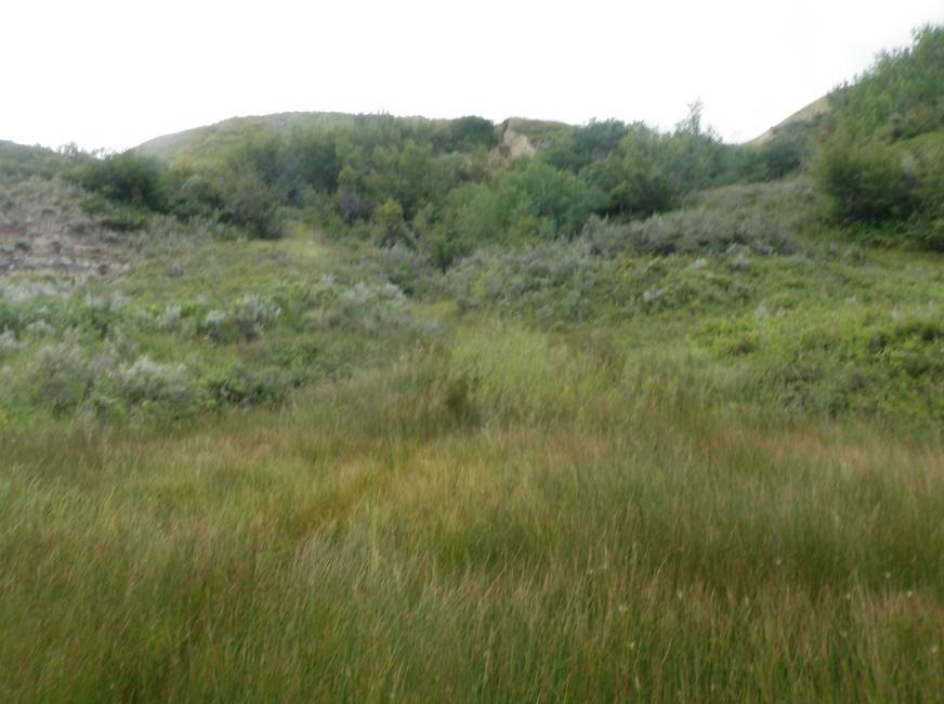
Environmental Assessment Report Former Landfill, Drumheller Institution		Project No: 2026-1102
<b>Photo ID 8</b>

<b>Direction: W</b>		
<b>Description:</b> Looking west up at Former Landfill. Standing where seepage meets the stream bed (DRUM-SW/SED-4). Note slope failure on right side of Landfill.

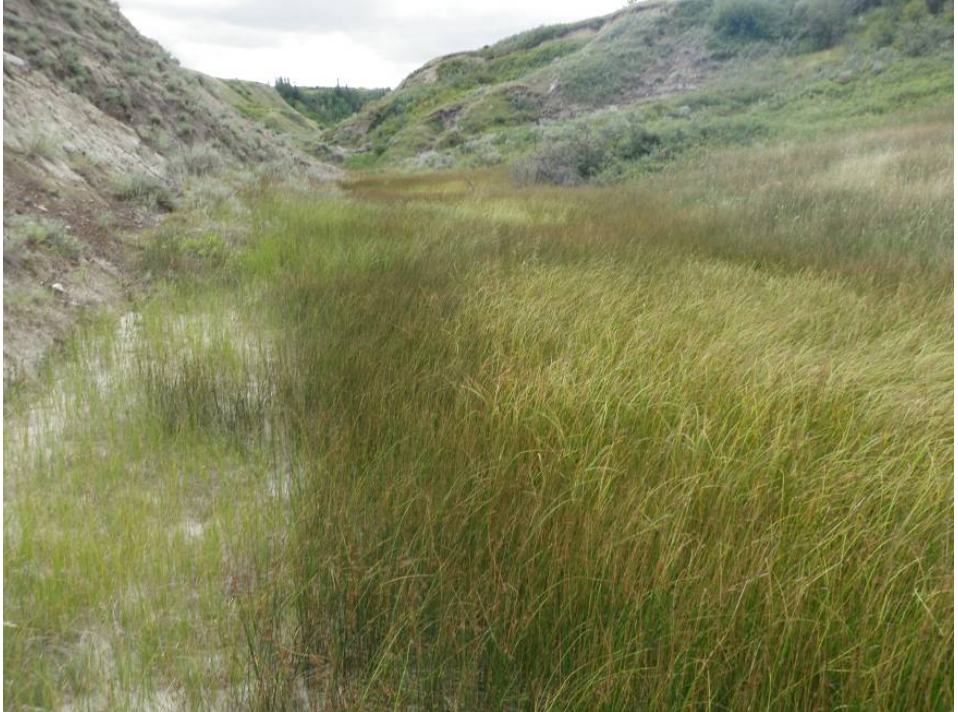
Environmental Assessment Report Former Landfill, Drumheller Institution		Project No: 2026-1102
Photo ID 9

Direction: S		
<b>Description:</b> Stream bed at bottom of coulee. Looking south towards Landfill.

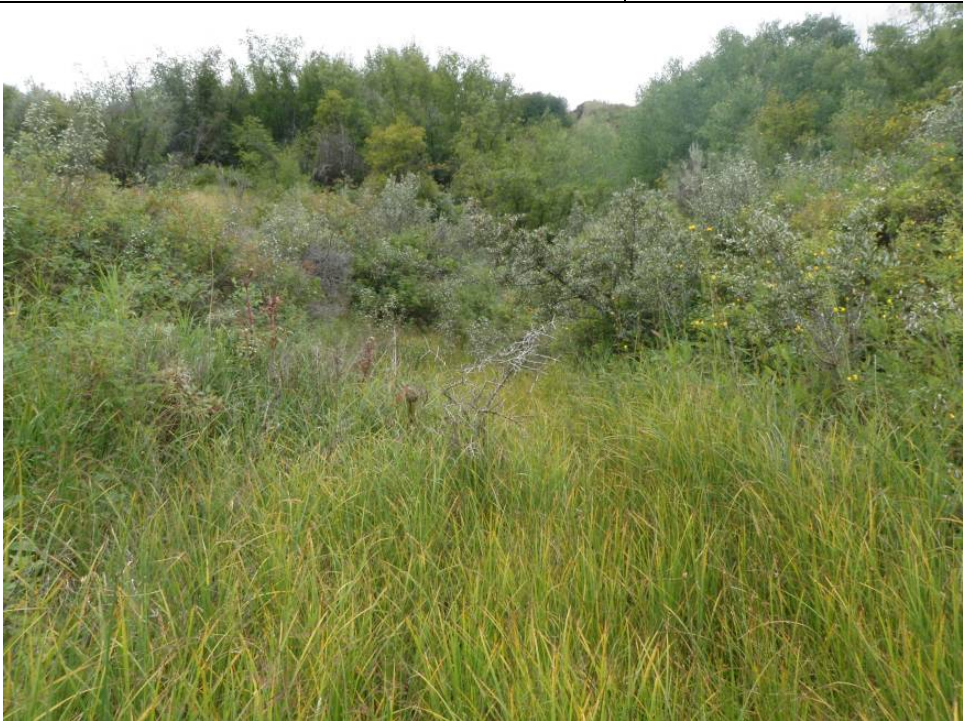
Environmental Assessment Report Former Landfill, Drumheller Institution		Project No: 2026-1102
Photo ID 10

Direction: W		
<b>Description:</b> View of seepage drainage pathway looking west towards Landfill. Drainage pathway is heavily vegetated.

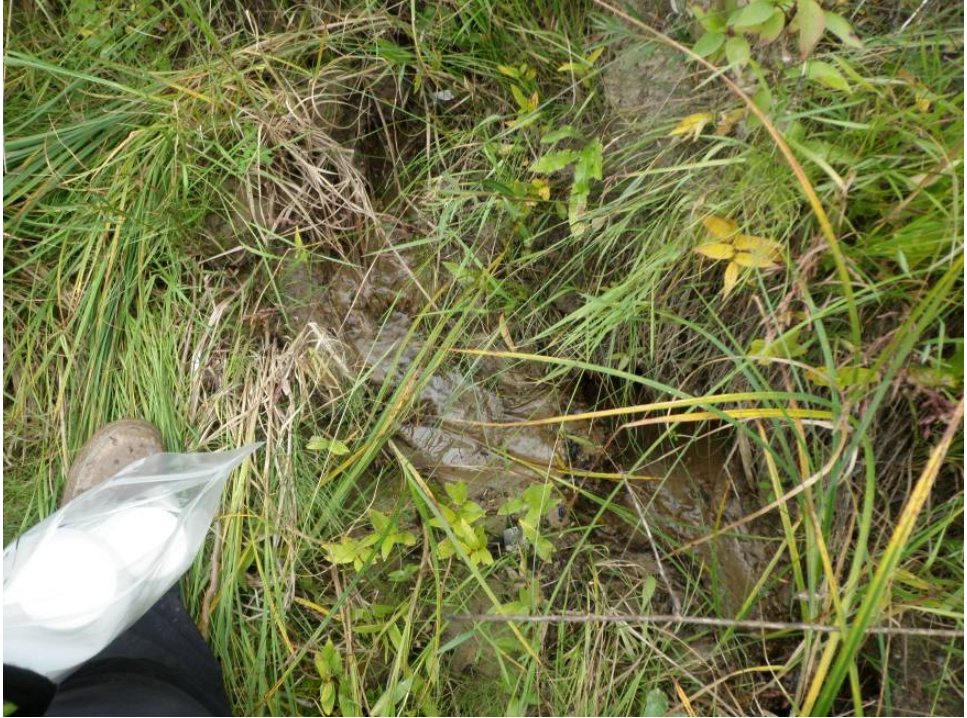
Environmental Assessment Report Former Landfill, Drumheller Institution		Project No: 2026-1102
Photo ID 11

Direction: N/A		
<b>Description:</b> Seepage drainage pathway. Flow is minimal.

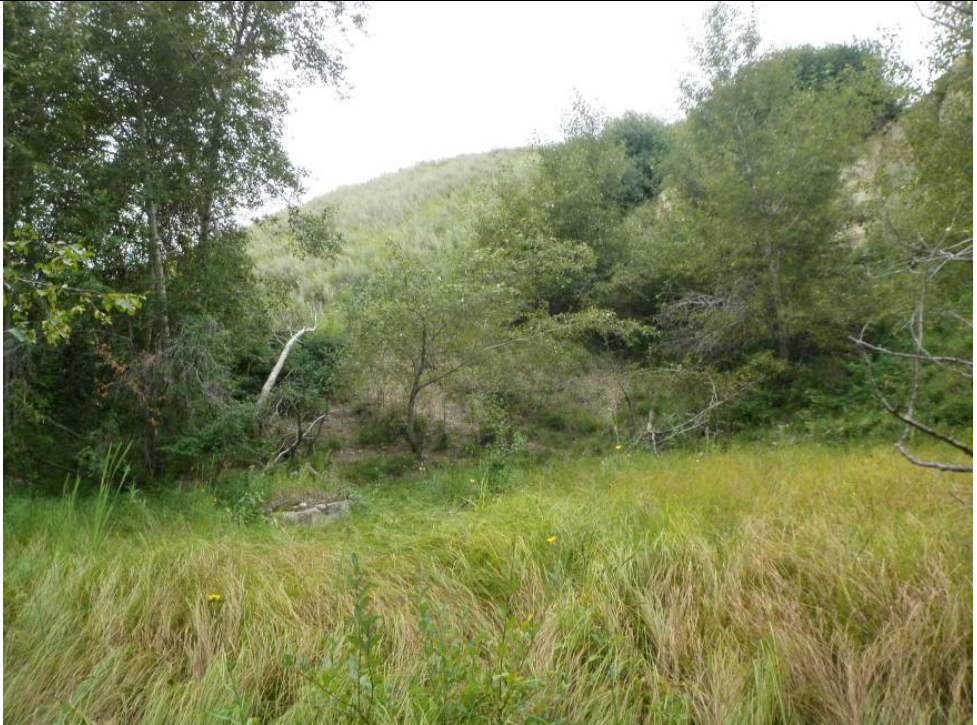
Environmental Assessment Report Former Landfill, Drumheller Institution		Project No: 2026-1102
Photo ID 12

Direction: SW		
<b>Description:</b> Wetland area located at toe of Landfill. View towards SW up at Landfill. This area is a low lying depression.

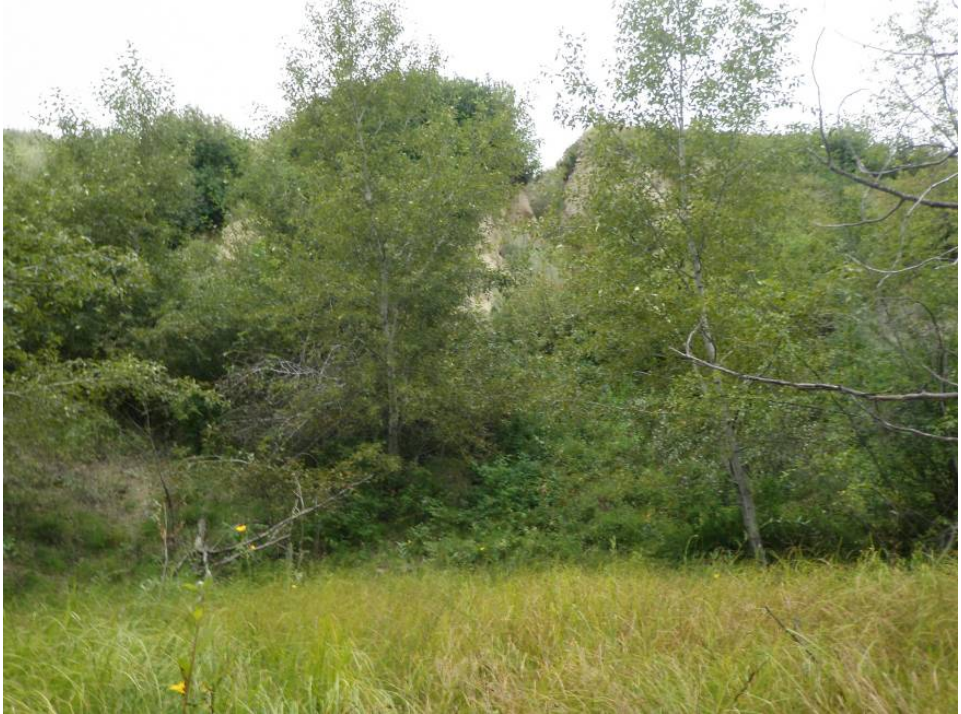
Environmental Assessment Report Former Landfill, Drumheller Institution		Project No: 2026-1102
Photo ID 13

Direction: W		
<b>Description:</b> Wetland area. View towards the west and the slope failure.

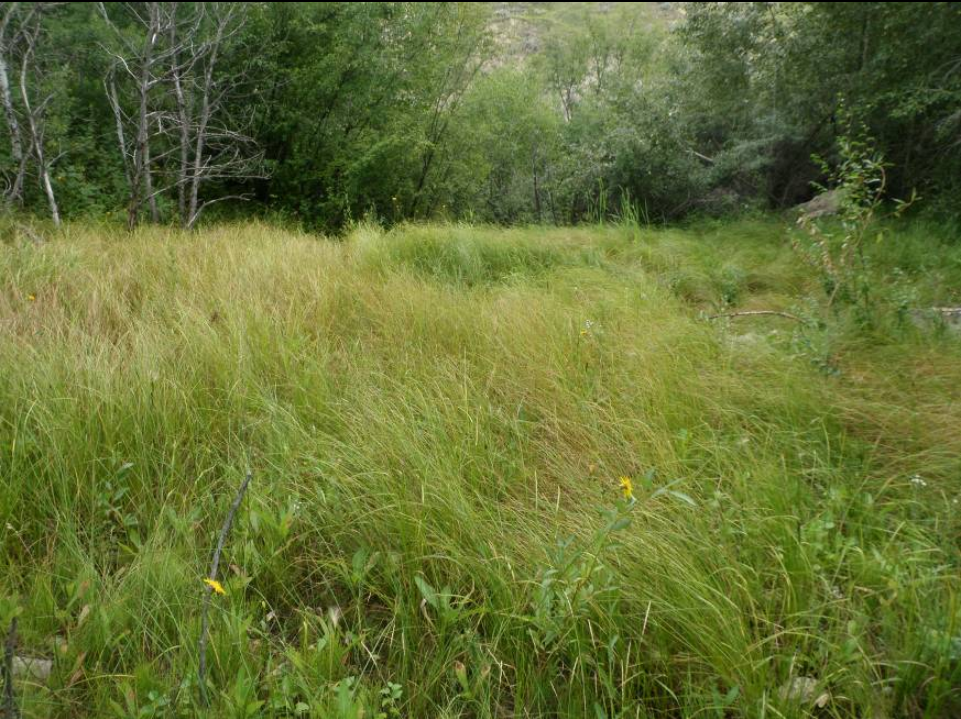
Environmental Assessment Report Former Landfill, Drumheller Institution		Project No: 2026-1102
Photo ID 14

Direction: E		
<b>Description:</b> View of wetland area towards E. The seepage drainage pathway exits wetland and flows down slope towards stream bed from here.

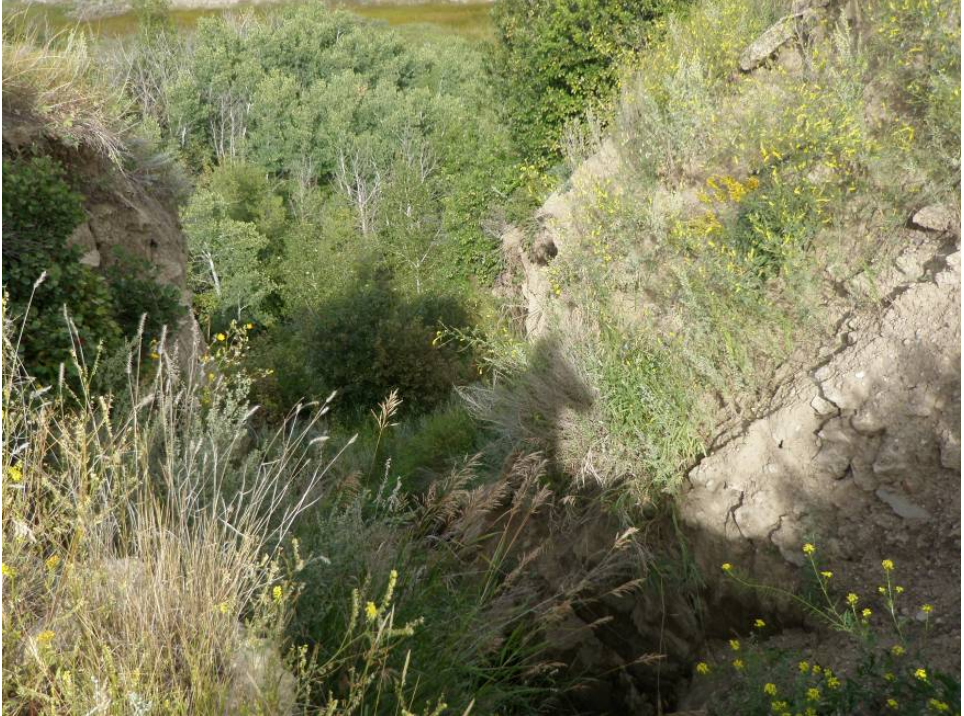
Environmental Assessment Report Former Landfill, Drumheller Institution		Project No: 2026-1102
Photo ID 15

Direction: E		
Description: Standing at top of the Former Landfill at the slope failure looking E.

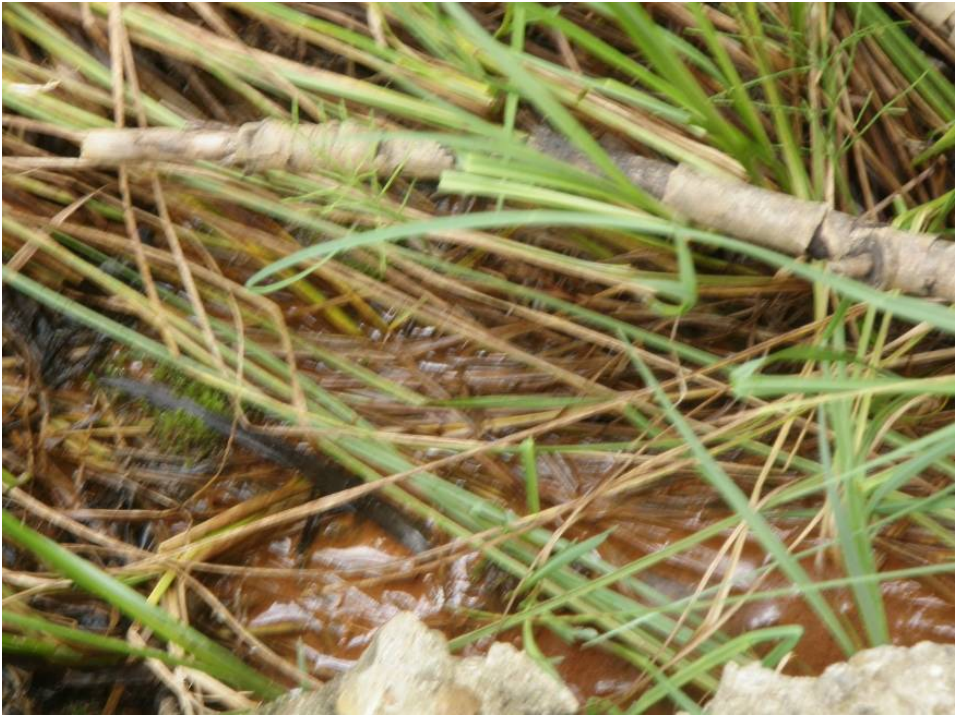
Environmental Assessment Report Former Landfill, Drumheller Institution		Project No: 2026-1102
Photo ID 18

Direction: N/A		
<b>Description:</b> View of the bright orange colour of colloidal iron oxides at the DRUM-SEEP1A sampling location. Note the biofilm ("sheen"-like appearance, with angular edges) of iron-reducing bacteria on the surface.

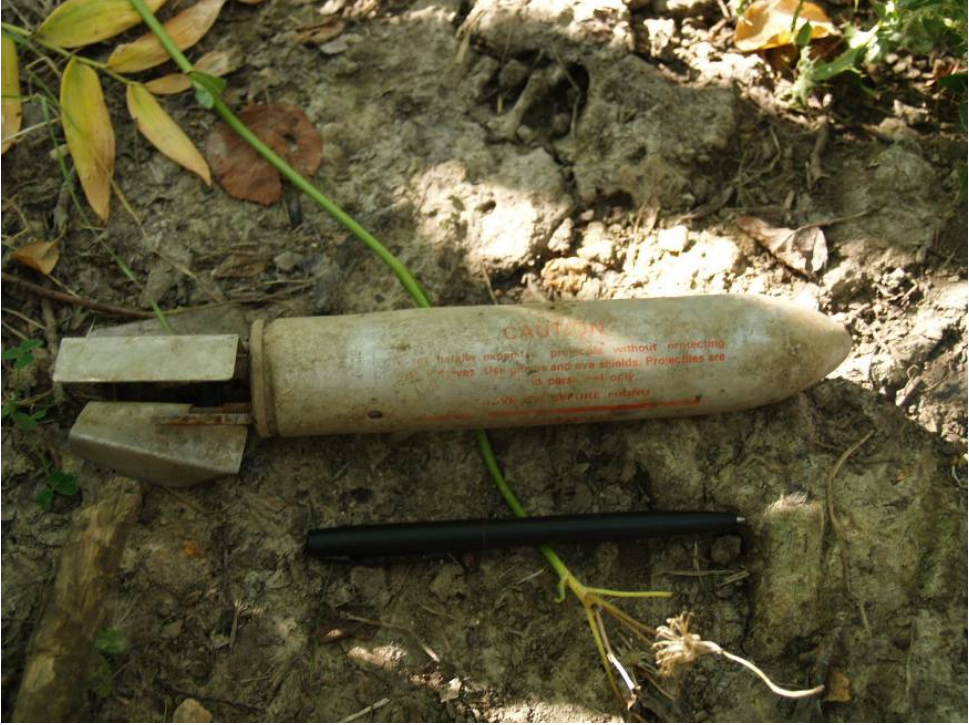
Environmental Assessment Report Former Landfill, Drumheller Institution		Project No: 2026-1102
Photo ID 19

Direction: N/A		
<b>Description:</b> Canister found during site reconnaissance. Confirmed to be tear gas, but has been decommissioned prior to disposal.

- The site specific health and safety plan developed in support of the RAP will include provisions to contact CSC staff should any tear gas canisters (similar to the one found in August 2011) be encountered during construction.

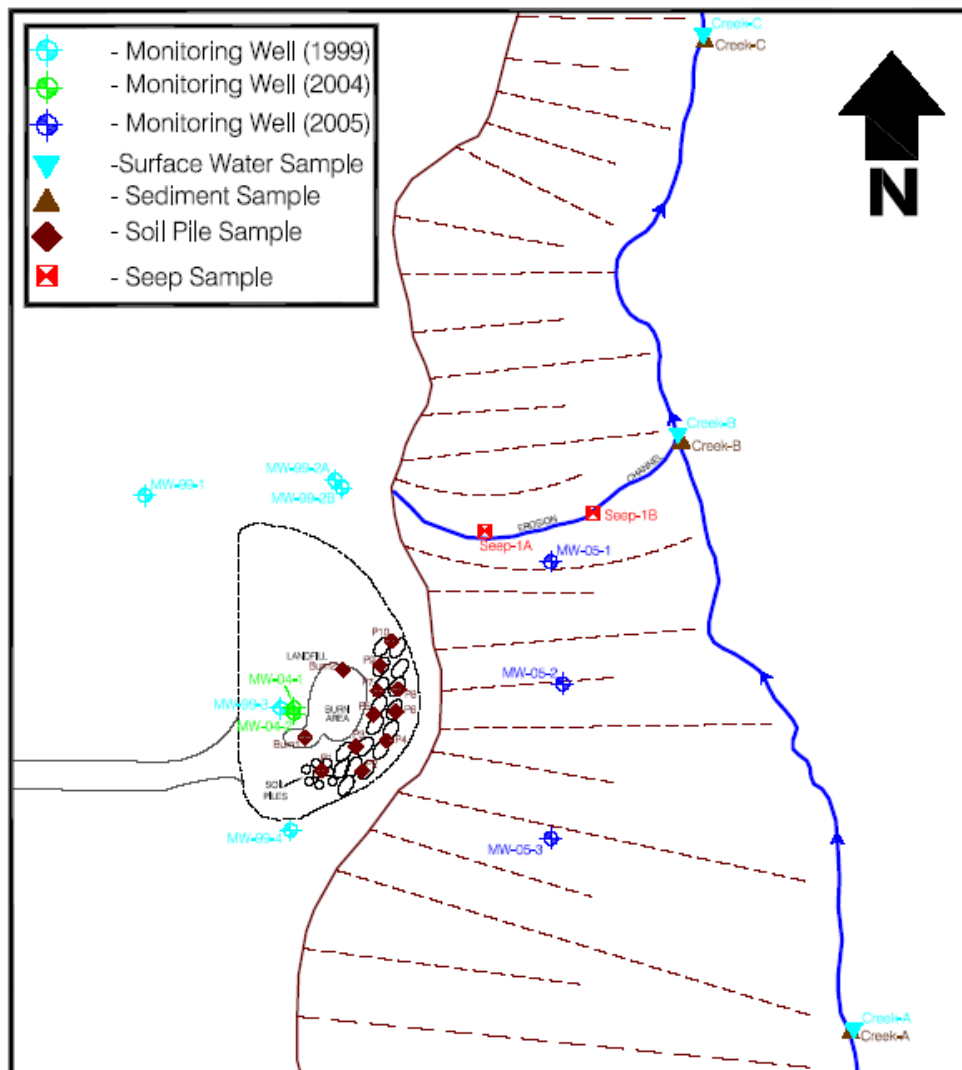
**Site Plan Showing Landfill and Investigation Locations**

As illustrated, the landfill occupies an area of approximately 3 hectares adjacent to a deep ravine or coulee. Spoil piles and a burn area occupy the top of the landfill. A creek runs along the base of the coulee. The creek flows northerly and is approximately 50 to 60 m lower in elevation than landfill grade. A groundwater spring discharges out of the coulee slope, approximately 20 m north of the landfill. The spring discharge location is at about 5 to 10 m below landfill grade.

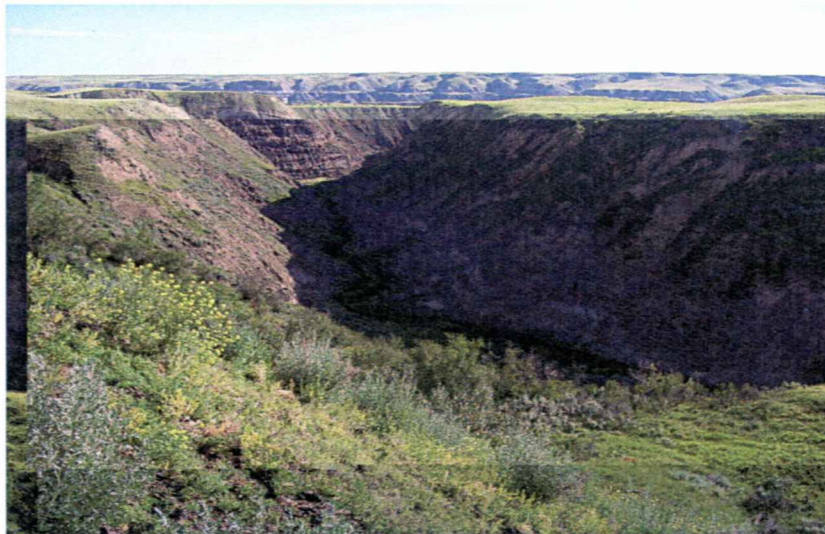
The institution is at an elevation of about 800 masl (metres above sea level) (Alberta 2003). The site topography drops steeply to the east and south towards a creek (see Photograph 2) located east of the landfill. The creek drains into the Red Deer River located approximately 1.5 km to the northeast, with an approximate elevation of 680 masl.

**Photograph 2: Creek at bottom of gully, looking west.**

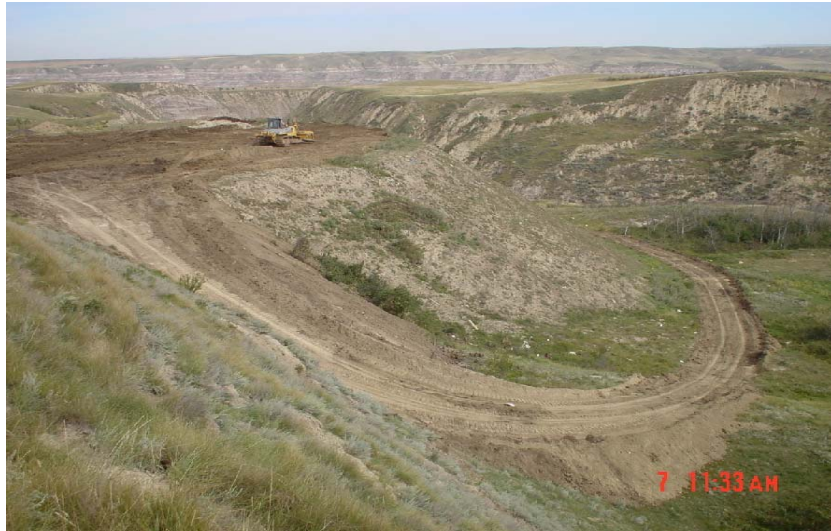
A bulldozer was utilized to create access for the drilling rig to the toe area of the landfill (Photograph 5) on August 29, 2005. This was carried out to mitigate safety concerns identified in previous investigations and site visits.

**Photograph 5: Access to toe of the landfill.**

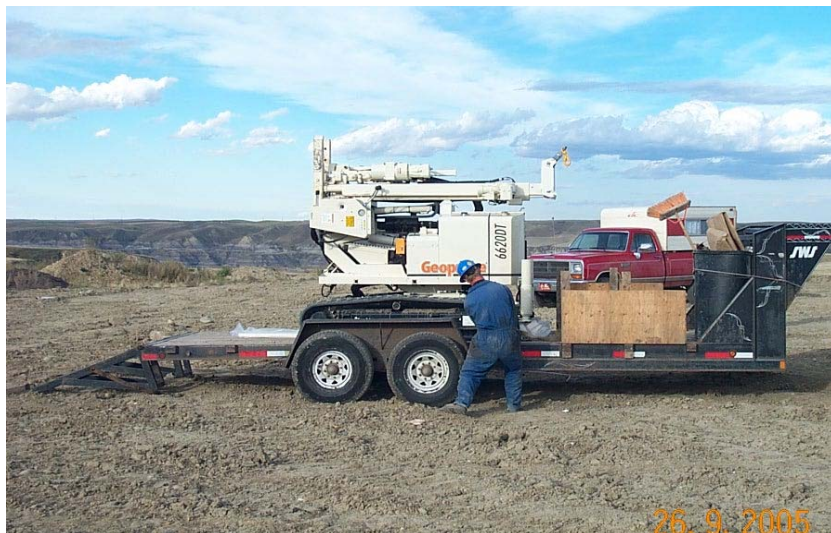
The drilling program involved the advancement of 3 boreholes (MW-05-1, MW-05-2 and MW-05-3) each of which was completed with a monitoring well, at the locations shown on Figure 3, provided in Attachment A. Drilling was carried out by Enviro-Core Sampling Ltd. on September 26, 2005. Boreholes with inner diameters (I.D.) of 114 mm were advanced to depths of 9.1 m to 11.5 m below grade, using a track-mounted direct push unit drilling rig (Model 6620DT), shown in photograph 6, equipped with split-spoon samplers.

**Photograph 6: Truck-mounted direct push unit used for drilling of boreholes.**

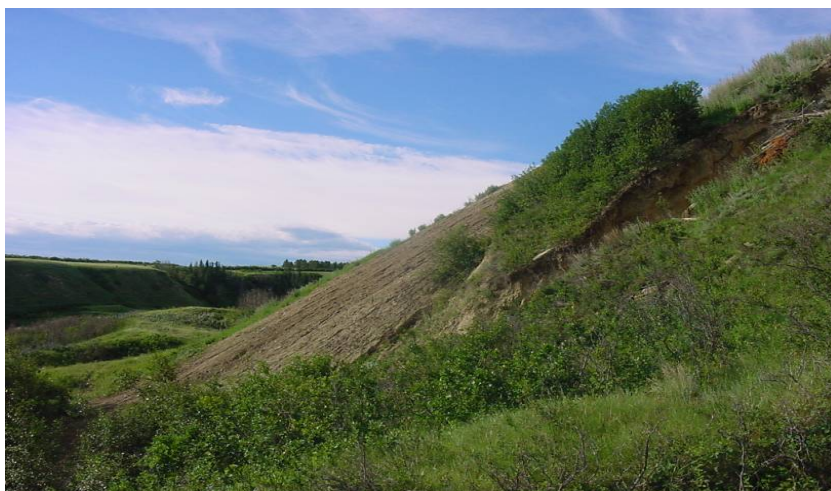
- iron staining is visible at the seep on the landfill slope.

**Photograph 7: Erosion on landfill slope, top right of photo.**

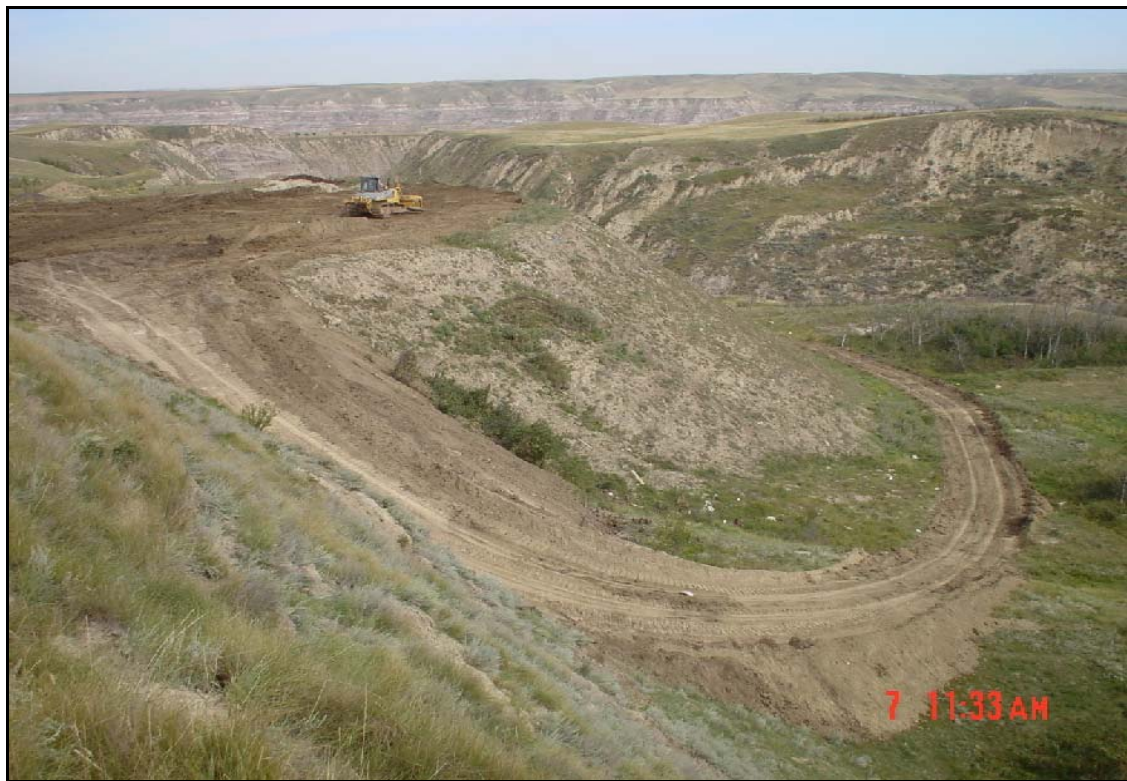
**Photograph 2 – View after sloping work at landfill.**

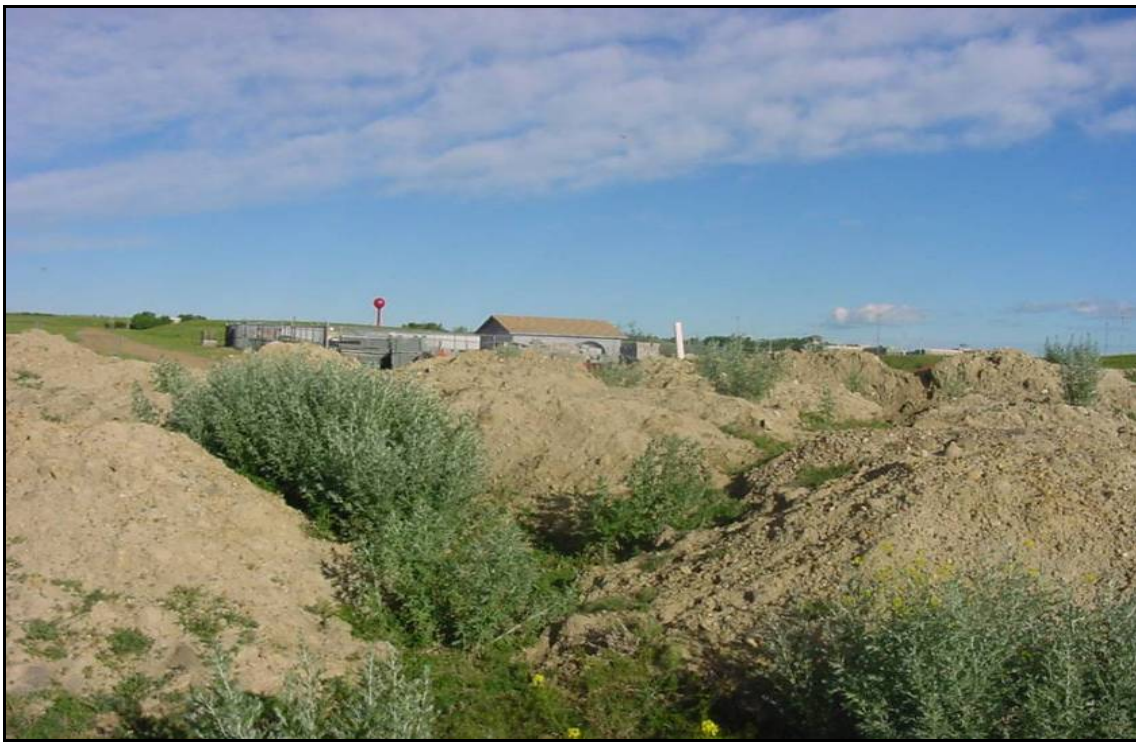
**Photograph 4** – Soil Piles on top of the landfill.

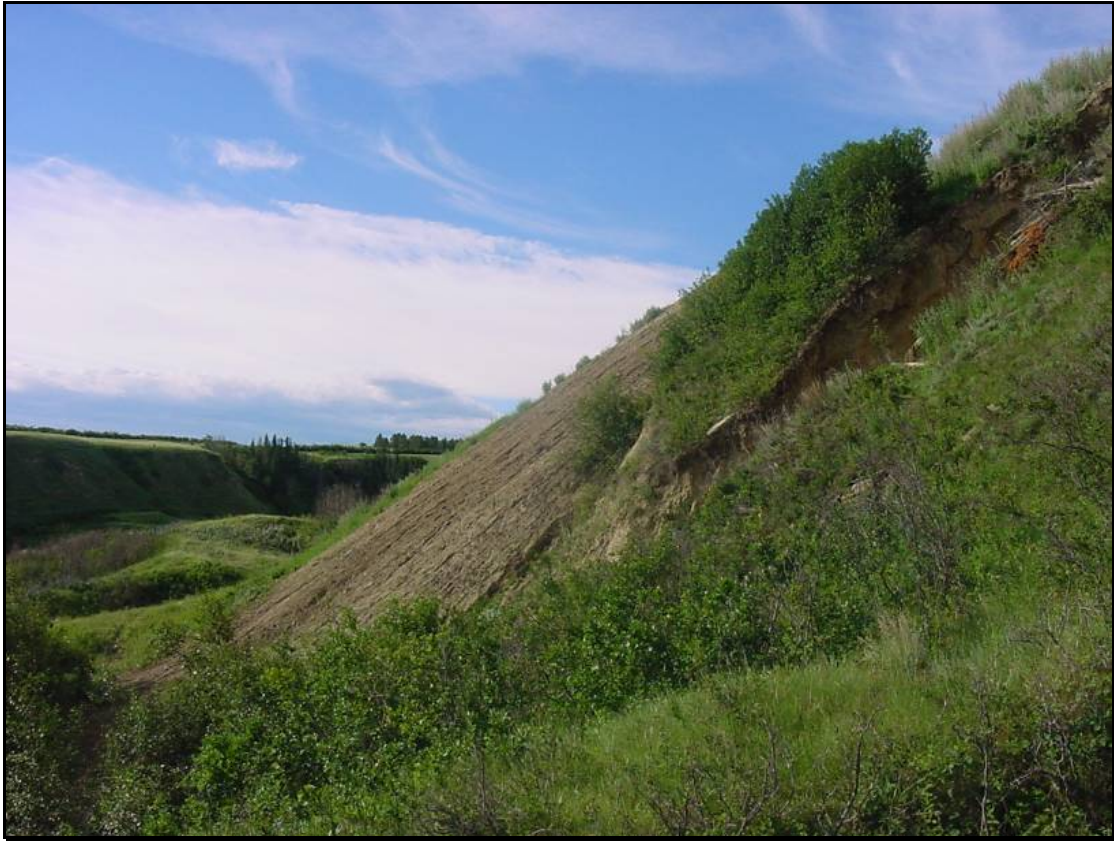
- the soil cover on the landfill slope does not appear to be compacted and there is visible erosion (see photograph 7);
- the landfill slope was relatively steep with slope angles being approximately 45 degrees;

**Photograph 7** – Visible erosion of landfill slope.

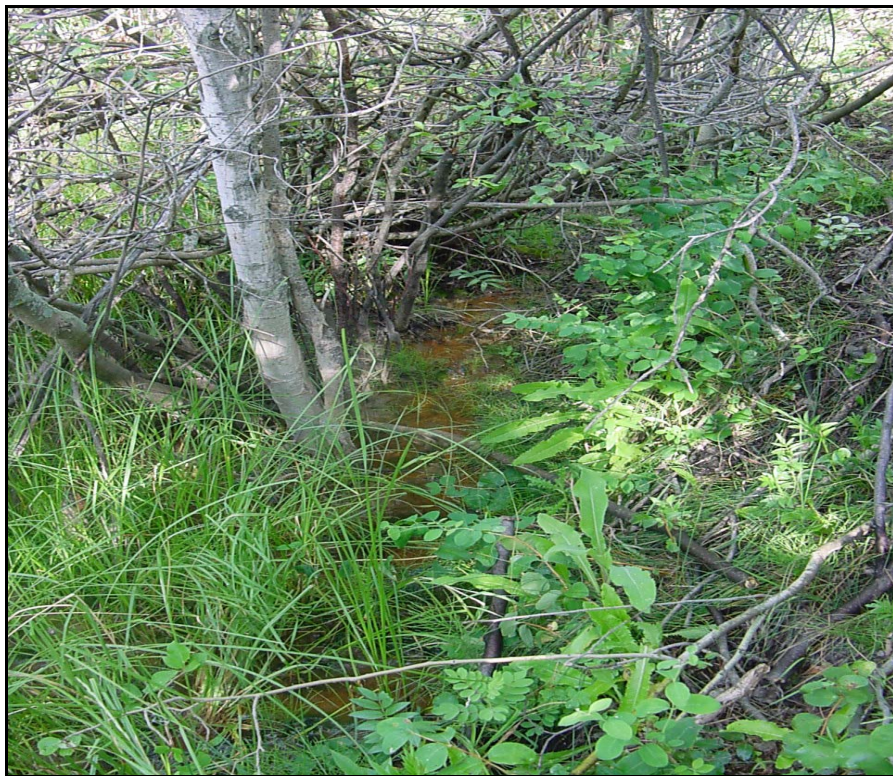
**Photograph 8** - Seep on east side of landfill. Note iron staining in water.

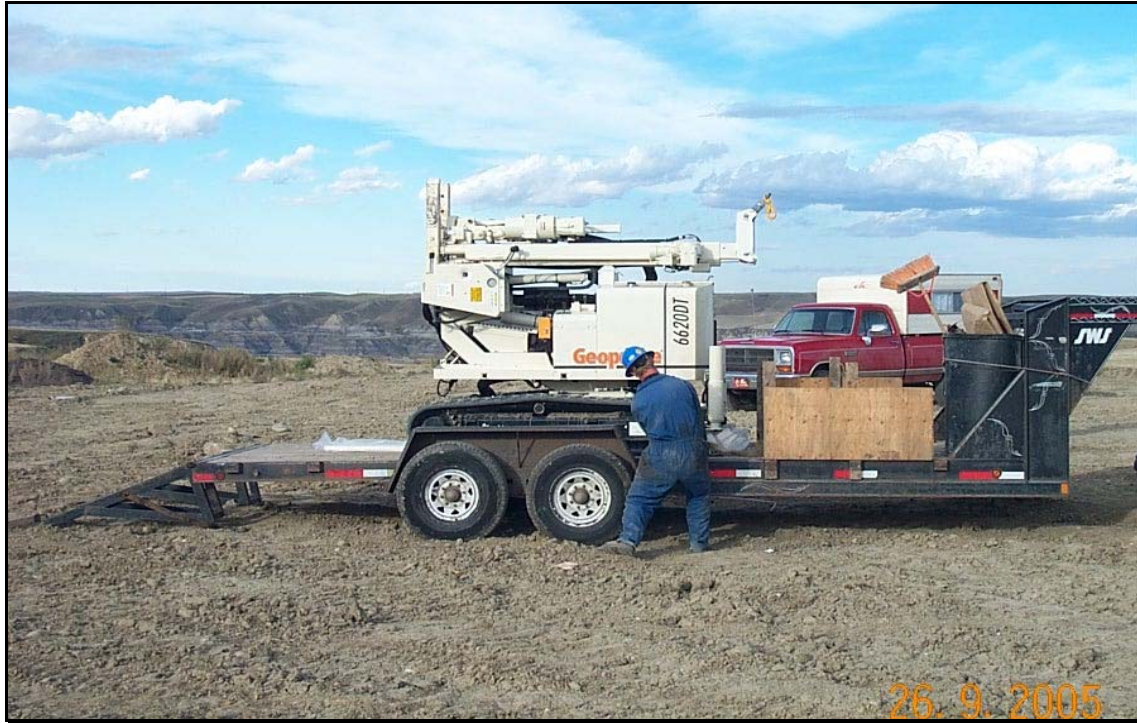
**Photograph 9** - Truck-mounted direct push unit used for borehole drilling.

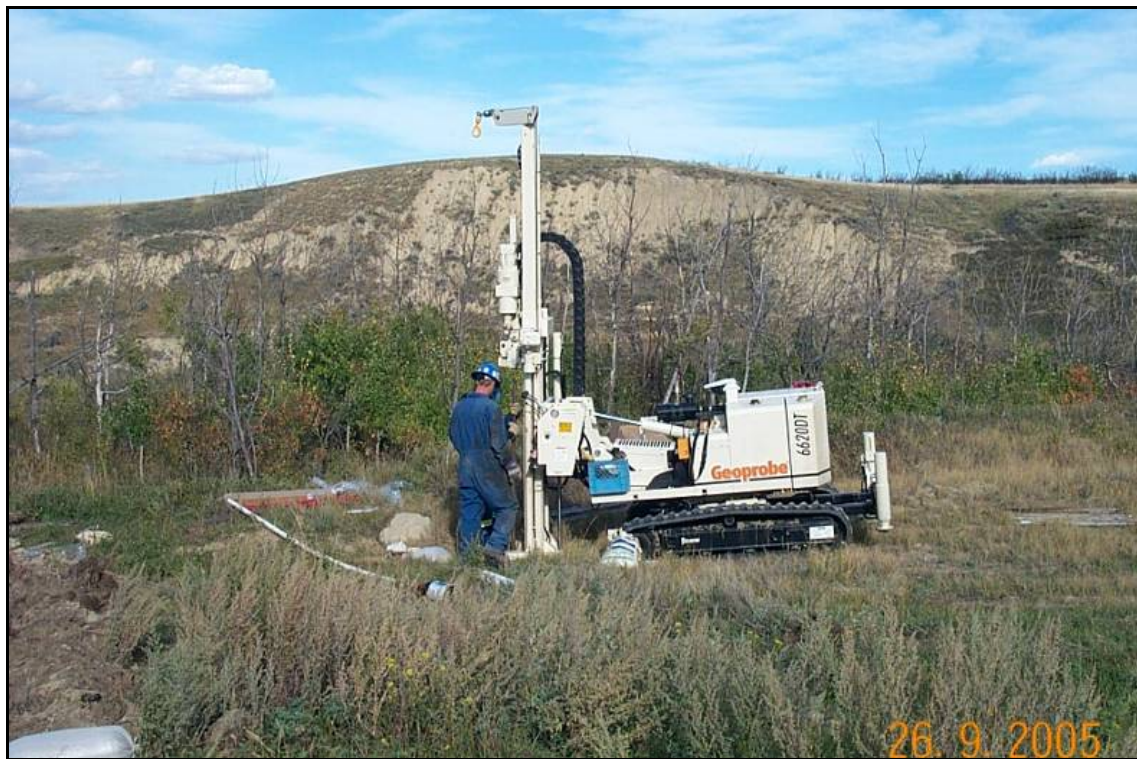
**Photograph 10** – Drilling of borehole 05-3

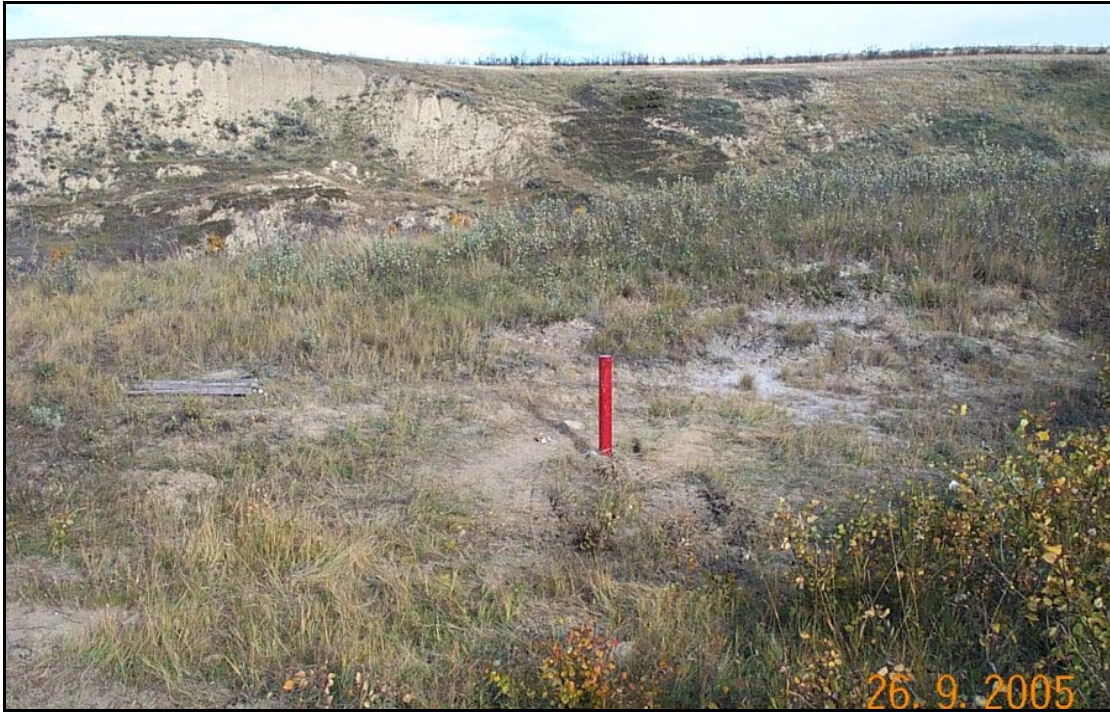
**Photograph 11** – Monitoring well 05-2.

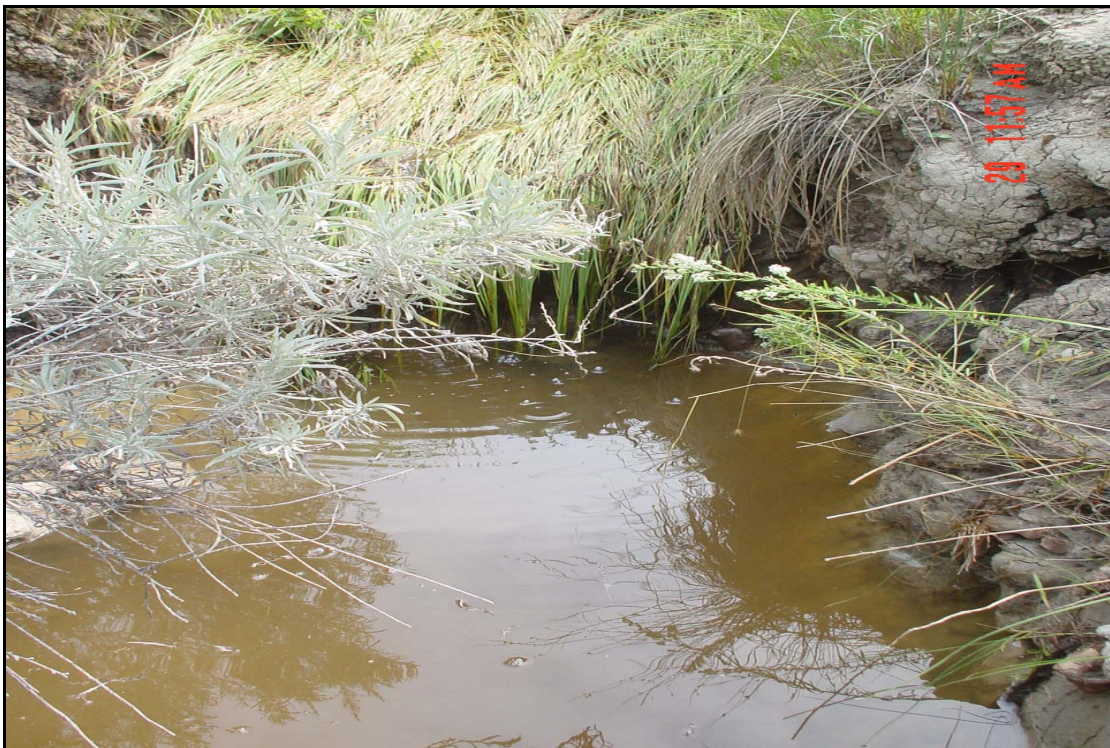
**Photograph 12** – Seep location.
